## Site Photos

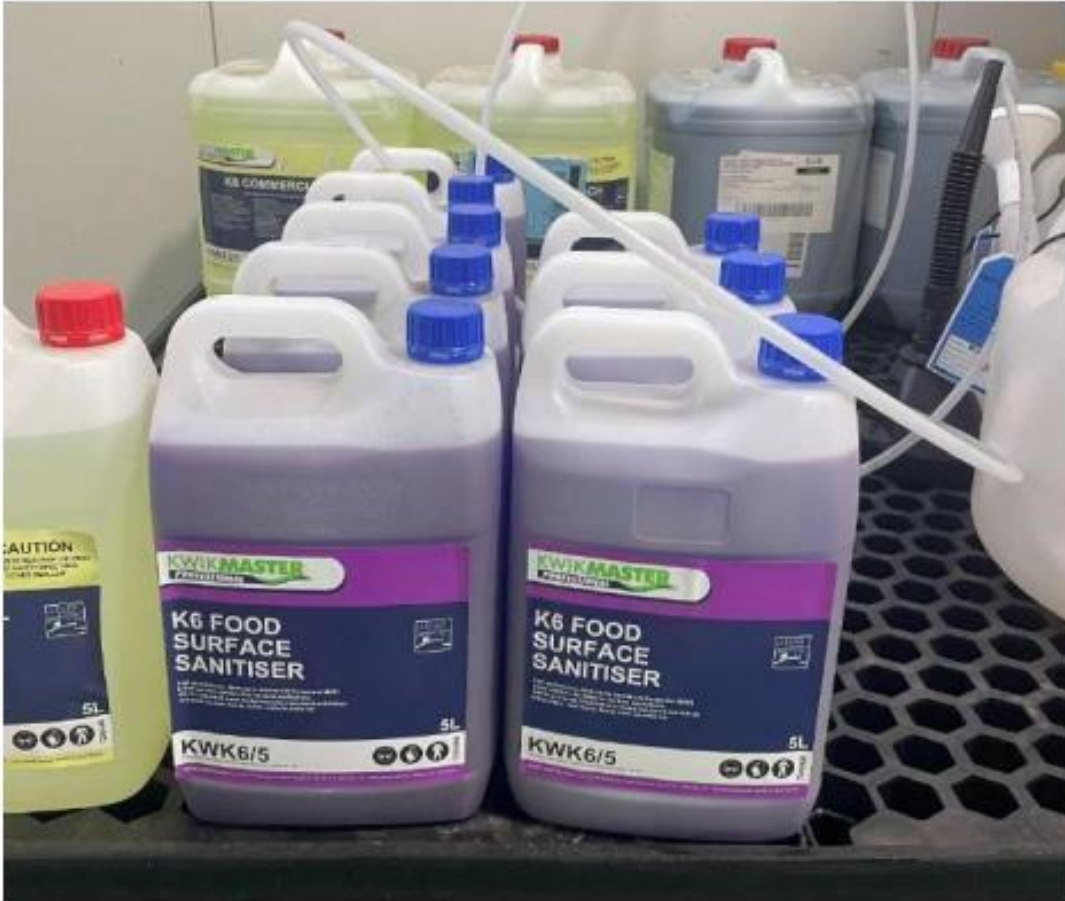
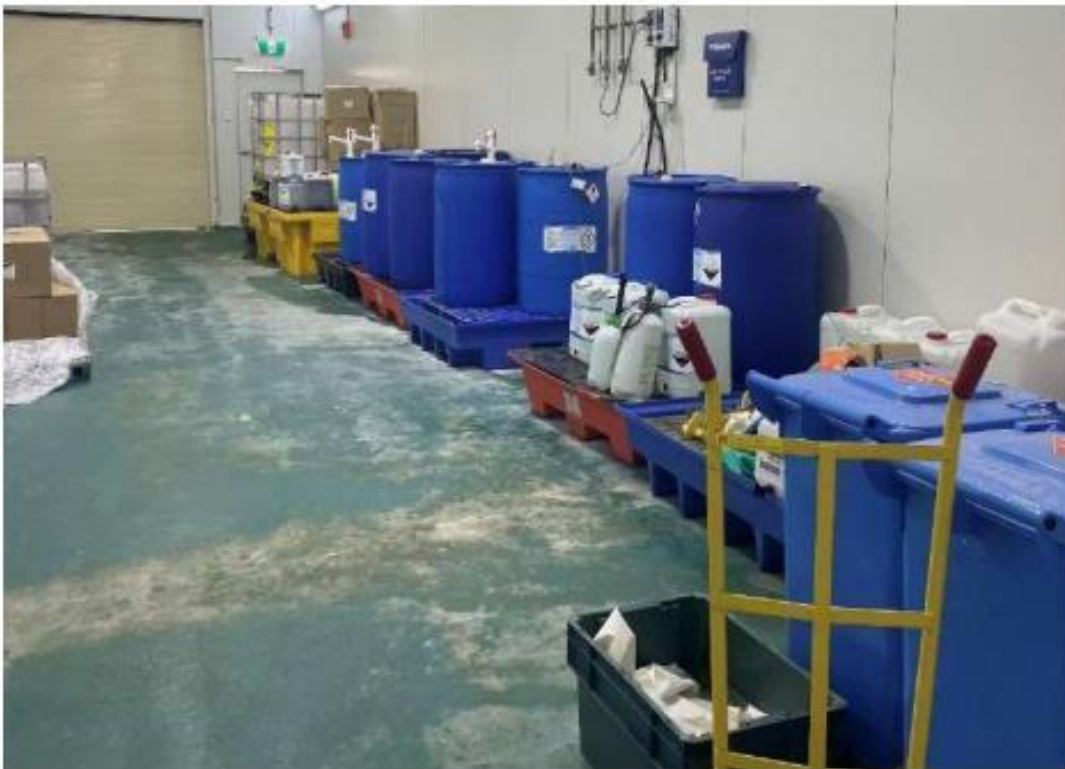
Figure 17: Stock stored in Chemical Room

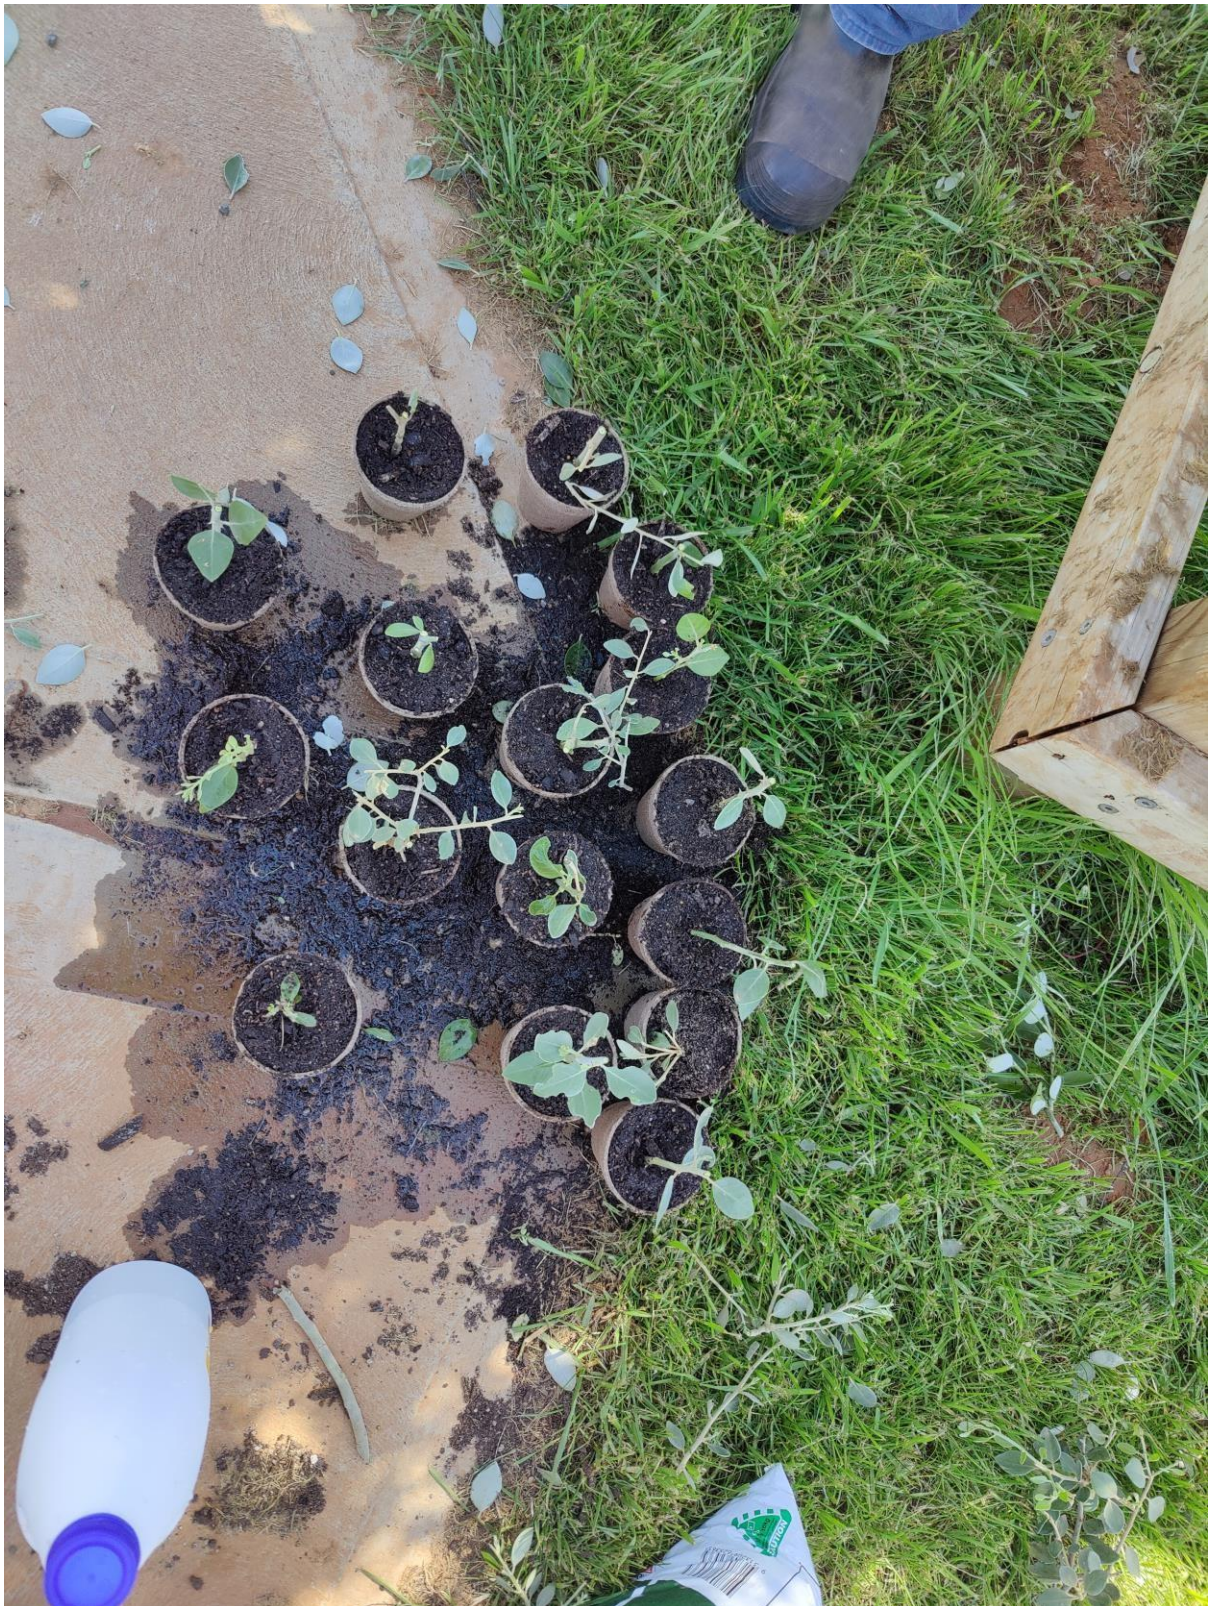
*Figure 18: Gurri tree cuttings taken on 19/09/2023 and being propagated by TFI*

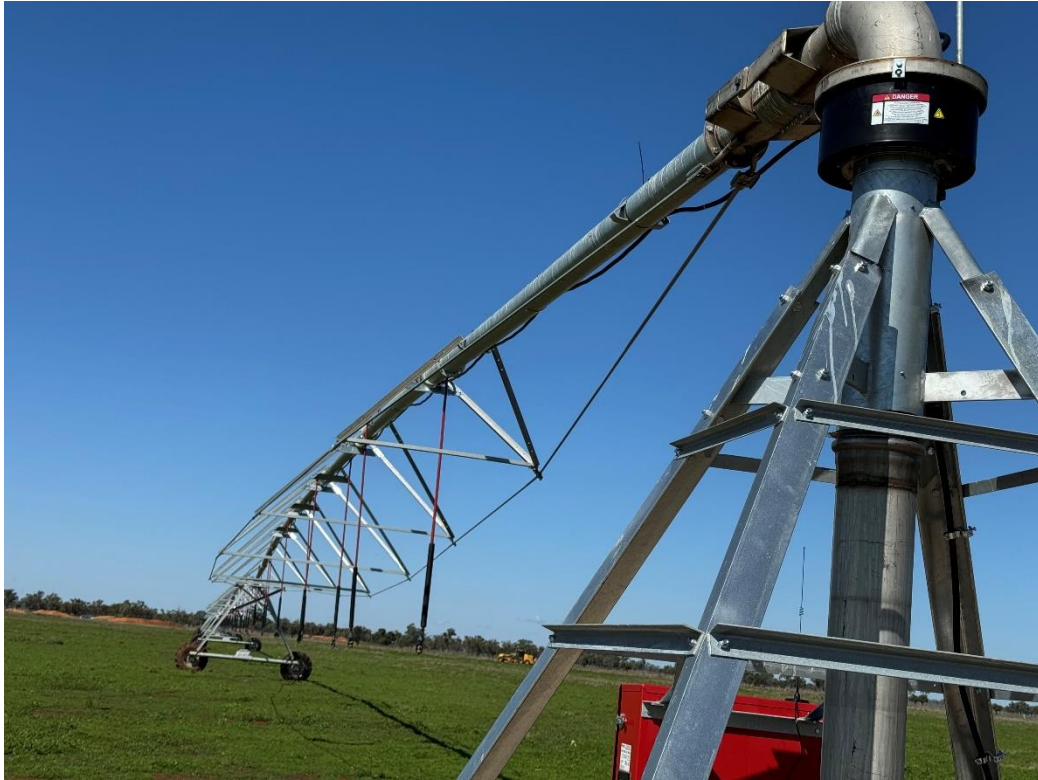
Figure 19: Center Pivot Irrigator

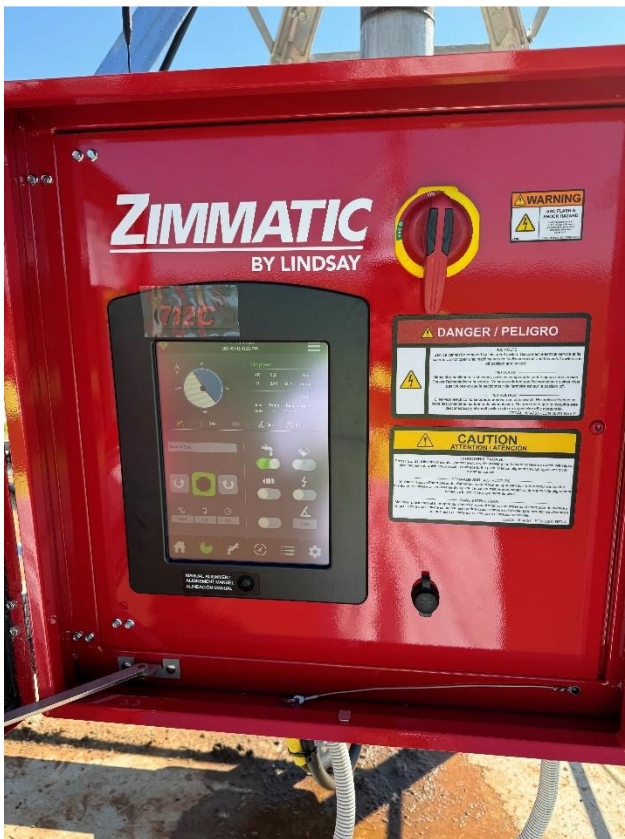
Figure 20: Center Pivot Control Panel

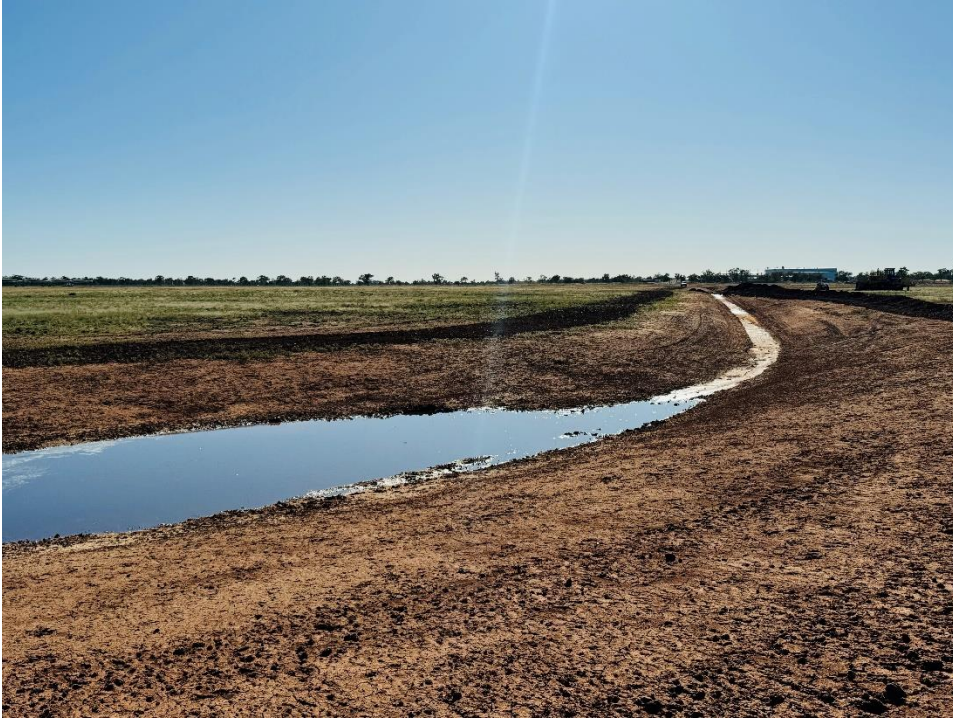
*Figure 21: Tail-water Pond and Swale Drain*

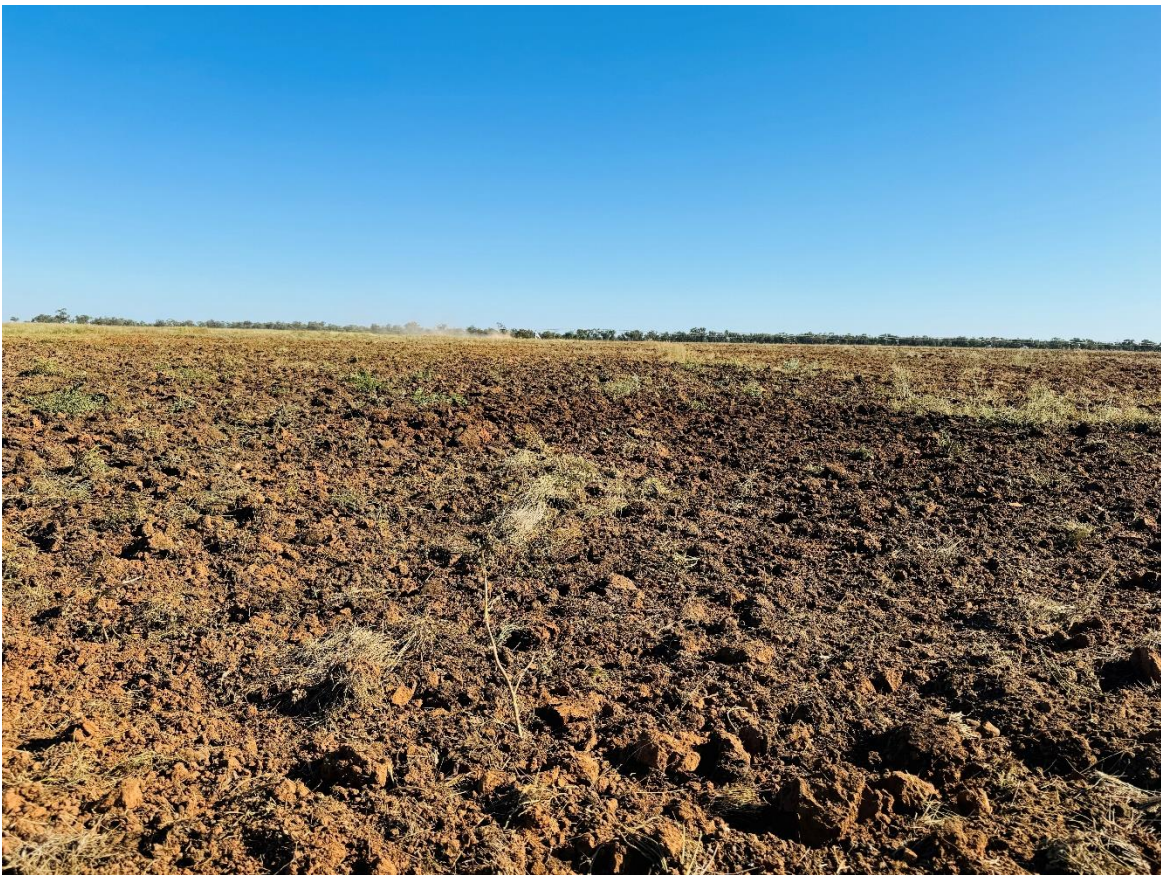
*Figure 22: Irrigation Land prepared for Cropping*
