# Hazardous Materials Survey

34 Albert Avenue & 57-61 Archer St, Chatswood NSW

**Report No:** E26224.E10\_Rev0

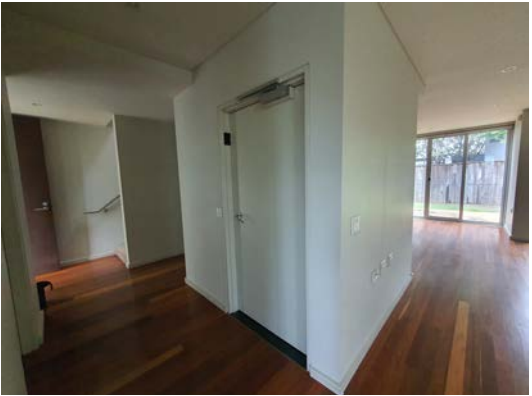
| Location | Material | Friability | Sample | Analysis Result | Quantity | Condition / Accessibility | Priority | Date of Identification | Recommendations / Comments | Photograph |
|---|---|---|---|---|---|---|---|---|---|---|
| Internal, Unit 1, elevator shaft, throughout | Possible hazardous materials | Unknown | - | - | Unknown | Unknown | Unknown | 22/08/2024 | Inspect when access is made available, prior to demolition | |

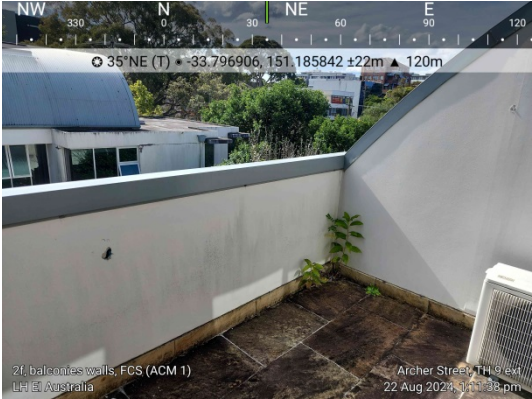
| Location | Material | Friability | Sample | Analysis Result | Quantity | Condition / Accessibility | Priority | Date of Identification | Recommendations / Comments | Photograph |
|---|---|---|---|---|---|---|---|---|---|---|
| External, Unit 7, second floor, balcony walls | FCS | Non-friable | ACM-01 | No Asbestos Detected | N/A | N/A | N/A | N/A | N/A | |

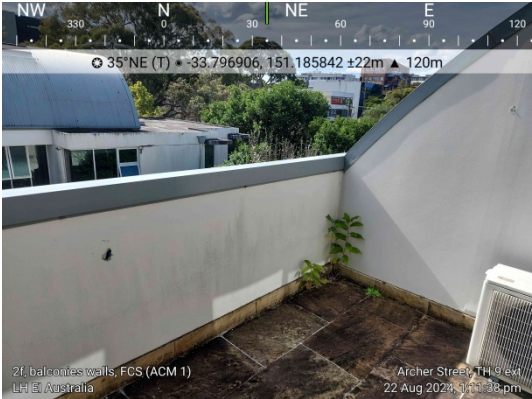
| Location | Material | Friability | Sample | Analysis Result | Quantity | Condition / Accessibility | Priority | Date of Identification | Recommendations / Comments | Photograph |
|---|---|---|---|---|---|---|---|---|---|---|
| External, second floor, balcony walls, throughout | FCS | Non-friable | Visual inspection – similar to ACM-01 | - | N/A | N/A | N/A | N/A | N/A | |

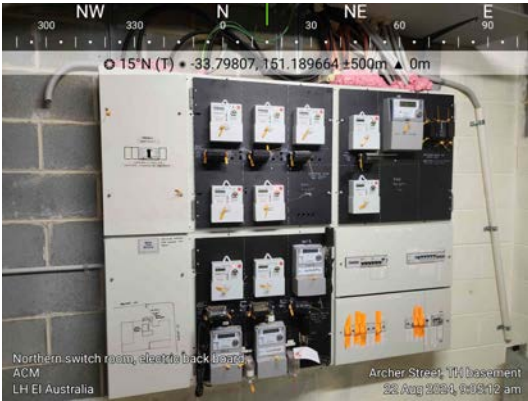
| Internal, basement, north western side, 'plant room', electrical distribution boards | ACM (assumed) | Non-friable | Visual inspection - electrical hazard | - | Approximately 5m <sup>2</sup> | Good / Maintenance only | Priority 4 - Negligible Risk Level | 22/08/2024 | Remove during initial stage of demolition works | |

The sampling did not include electricity fuse / switch / meter backing boards and capacitors, due to potential electrocution hazard. All black mounting boards were thus assumed to be asbestos-containing.

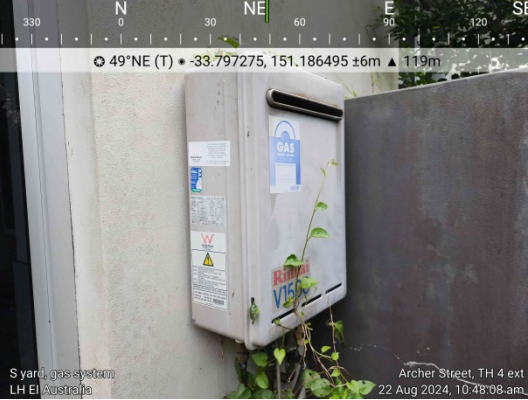
| External, Units 1 -12 instant gas hot water heater, throughout | SMF-lined insulation (assumed) | Sealed | Visual inspection - electrical hazard | - | Approximately 12 x units | Good / Maintenance only | Priority 4 - Negligible Risk Level | 22/08/2024 | Remove during initial stage of demolition works | |

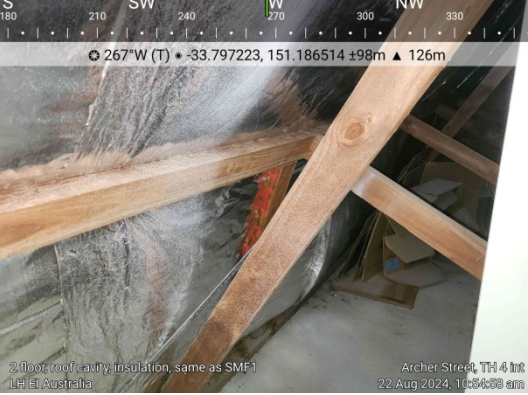
| Internal, northern block second floor, southern wall cavity, roof insulation, throughout | Insulation | Sealed | SMF-1 | No SMF Detected | N/A | N/A | N/A | N/A | N/A | |

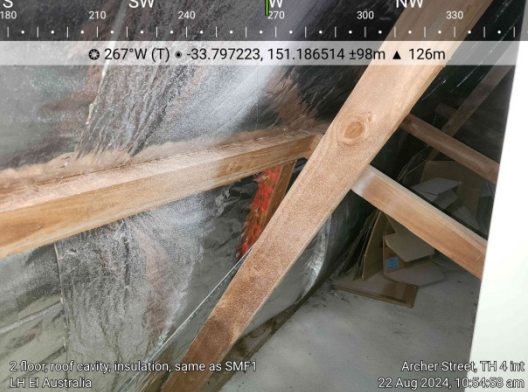
| Internal, southern block, second floor, roof insulation, throughout | Insulation | Sealed | Visual inspection – similar to SMF-1 | No SMF Detected | N/A | N/A | N/A | N/A | N/A | |

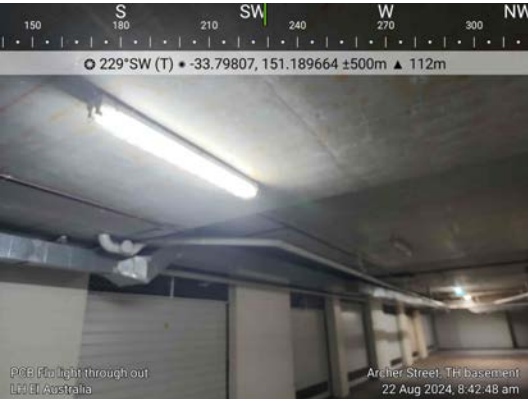
| Internal, basement, florescent lights throughout | PCB-containing single-tube fluorescent light fitting capacitors (assumed) | N/A | Visual inspection - electrical hazard | - | Approximately 40 x units | Good / Maintenance only | Priority 4 - Negligible Risk Level | 22/08/2024 | Remove prior to demolition works. Avoid damage to capacitors. |

All fluorescent light tubes with metal-cased capacitors, as well as any electrical transformers, should be assumed as containing PCBs. Any leaking PCB-containing capacitors / transformers should be disposed prior to the commencement of any demolition works that may cause their disturbance.

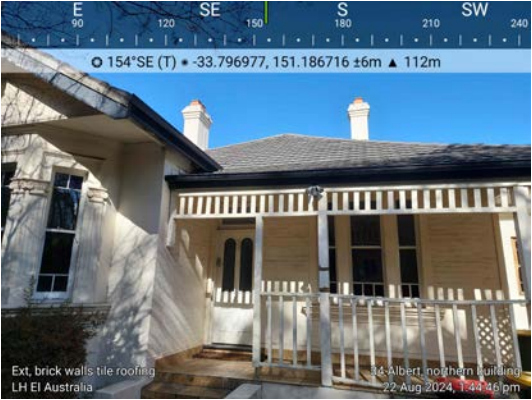
External, southern side, wall, white door and frame

White/Cream Paint

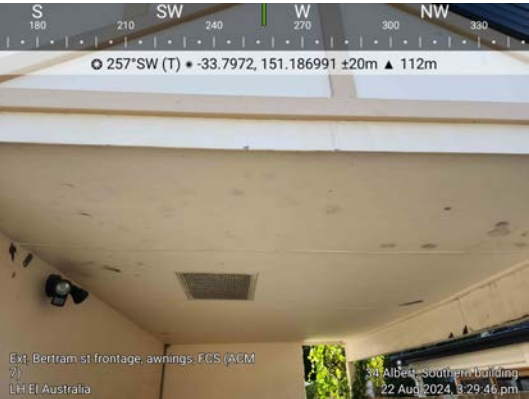
| External, northern & southern sides (carport), awning ceilings | FCS | Non-friable | ACM-07 | No Asbestos Detected | N/A | N/A | N/A | N/A | N/A |

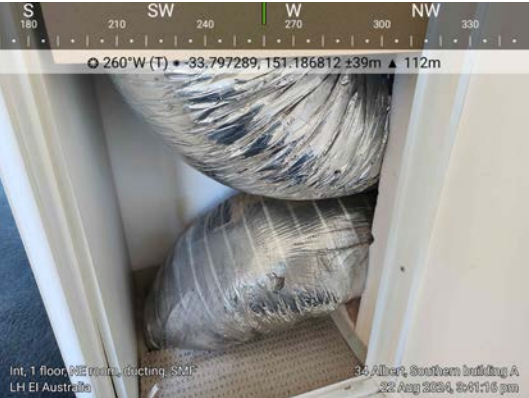
| 34 A, Internal, first floor, northern section, ducting, throughout | Insulation | Sealed | SMF-03 | No SMF Detected | N/A | N/A | N/A | N/A | N/A |

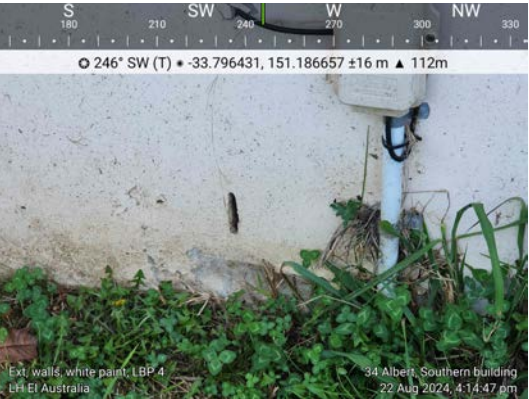
| External, eastern wall/façade, light cream paint | Light Cream Paint | Friable | LBP-04 | 0.003% w/w | N/A | N/A | N/A | N/A | N/A |
