Prepared for: Taronga Conservation Society Australia

# Arboricultural Impact Assessment

Address: Bradleys Head Road, Mosman

Prepared by: Michael Sullings – Consulting Arborist (AQF Level 5)  
November 17<sup>th</sup>, 2015

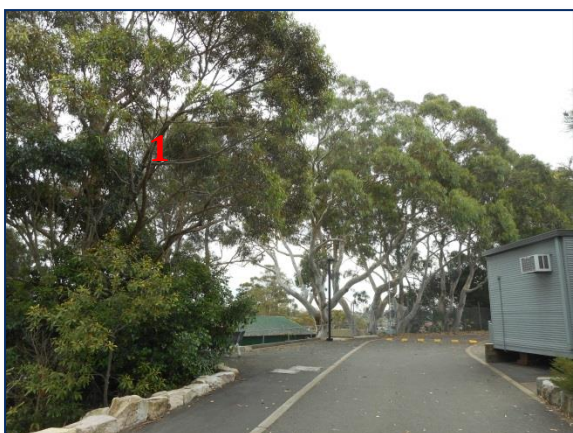
Figure 7 – Tree 1 – a mature specimen of Bangalay (*Eucalyptus botryoides*) – as viewed from the southeast.

Tree 1 is a mature specimen of Bangalay (*Eucalyptus botryoides*), with an approximate height of 12m. It is exhibiting good health and vigour, but only fair structure. It has a co-dominant structure, and exhibits some bark cracking. It has been assessed as having a long ELE, and high significance, and as such has been determined to have a high Retention Value (Priority for Retention). It likely stands far enough from the construction footprint to remain viable, and is to be retained.

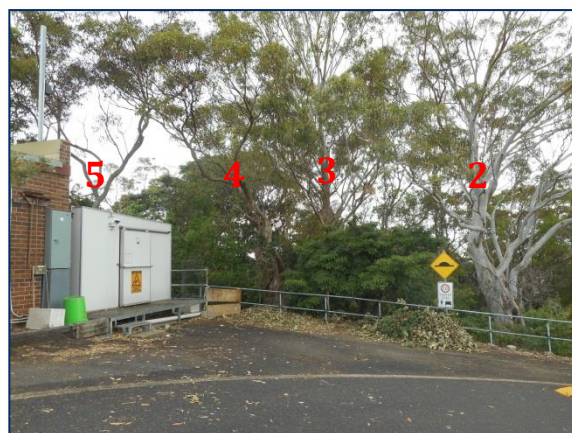
Figure 8 – Trees 2-5 are all mature specimens of *Eucalyptus* varieties. These trees stand within the area of indigenous remnant vegetation listed as 240L in the *Section 170 Register*.

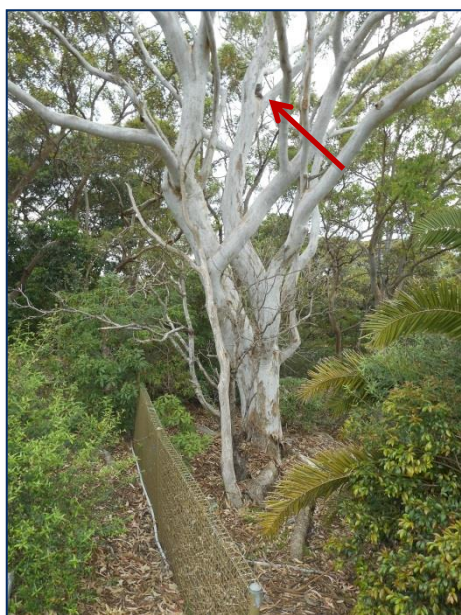
Figure 9 – Tree 2, as viewed from the north, is probably the most significant tree that stands to be impacted by the works. NOTE: Tree 2 contained a nesting Tawny Frogmouth (red arrow) at time of inspection.

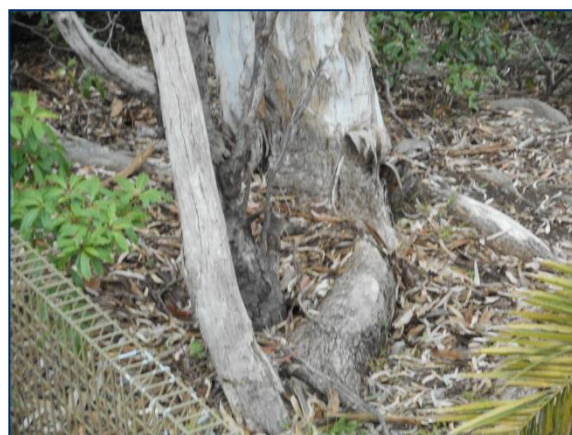
Figure 10 – Tree 2 exhibits several large surface roots.

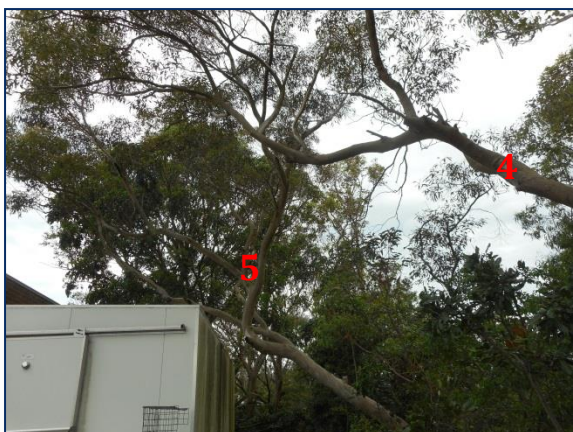
| Tree # | Species | Common Name | Height (m) | DBH/D (mm) | TPZ/SRZ (m) | Health & Vigour | Structure | Defects | SULE | Significance | Distance from construction footprint (m) |
|---|---|---|---|---|---|---|---|---|---|---|---|
| 5 | <i>Eucalyptus punctata</i> | Grey Gum | 10 | 400/450 | 4.8/2.4 | Fair | Poor | Suppressed, Basal lesion | Remove | Low | Leaning/Canopy within footprint |

| Tree | Estimated Life Expectancy | Significance | Retention Value |
|---|---|---|---|
| 5 | Remove | Hazardous | Very Low (Priority for Removal) |

Figure 11 – Tree 5 due to structural concerns is recommended for removal. Trees 4 stands far enough away from the construction footprint that only minor TPZ encroachments are likely. Building demolition methods will need to be tree-sensitive.

Tree 5 is a mature specimen of Grey Gum (*Eucalyptus punctata*), with an approximate height of 10m. It is exhibiting only fair health and vigour, and poor structure. It has a suppressed form, with a northward lean, and the majority of its canopy positioned over the adjacent structure. It also has a considerable bark lesion at ground level. It has been assessed as having a 'remove' ELE, and low significance, and due to its hazardous form has been determined to have a very low Retention Value (Priority for Removal). Tree 5 is recommended for removal.

| Tree # | Species | Recommendation |
|---|---|---|
| 5 | <i>Eucalyptus punctata</i> | Remove (hazardous)<br>Replace with species associated with Sydney Red Gum ( <i>Angophora costata</i> ) communities |

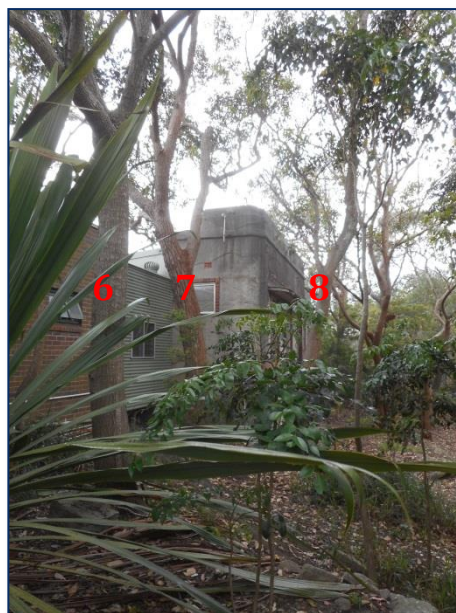
Figure 12 – Trees 6-8 stand within the construction footprint, and will require removal.

| Tree # | Species | Recommendation |
|---|---|---|
| 6 | <i>Radermachera</i> sp. | Remove<br>Replace where appropriate with species associated with Sydney Red Gum ( <i>Angophora costata</i> ) communities |
| 7 | <i>Eucalyptus robusta</i> | Remove<br>Replace where appropriate with species associated with Sydney Red Gum ( <i>Angophora costata</i> ) communities |
| 8 | <i>Eucalyptus robusta</i> | Remove<br>Replace where appropriate with species associated with Sydney Red Gum ( <i>Angophora costata</i> ) communities |

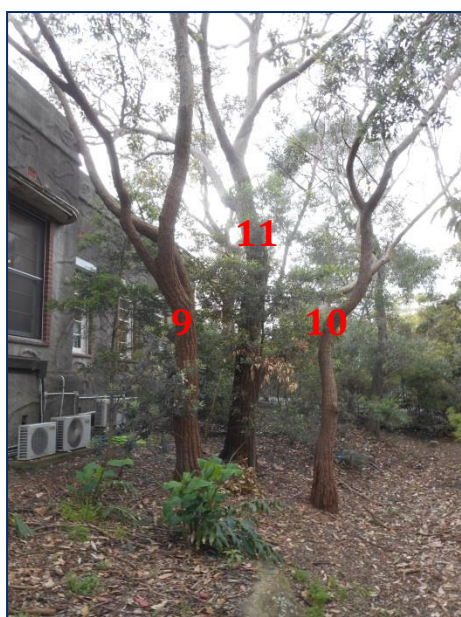
| Tree | Estimated Life Expectancy | Significance | Retention Value |
|---|---|---|---|
| 9 | Remove | Hazardous | Very Low (Priority for Removal) |

Figure 13 – Tree 9 has structural concerns and is recommended for removal. Trees 11 stand within the construction footprint. Tree 10 stands just outside the footprint, these trees are intended to be retained. .

Tree 9 is a mature specimen of Swamp Mahogany (*Eucalyptus robusta*), with an approximate height of 11m. It is exhibiting only poor health and vigour, and poor structure. It has a suppressed form, with a twisted leading branch. It has been assessed as having a 'remove' ELE, and low significance, and due to its hazardous form has been determined to have a very low Retention Value (Priority for Removal). Tree 9 is to be removed.

| Tree # | Species | Recommendation |
|---|---|---|
| 9 | <i>Eucalyptus robusta</i> | Remove (hazardous)<br>Replace with species associated with Sydney Red Gum ( <i>Angophora costata</i> ) communities |

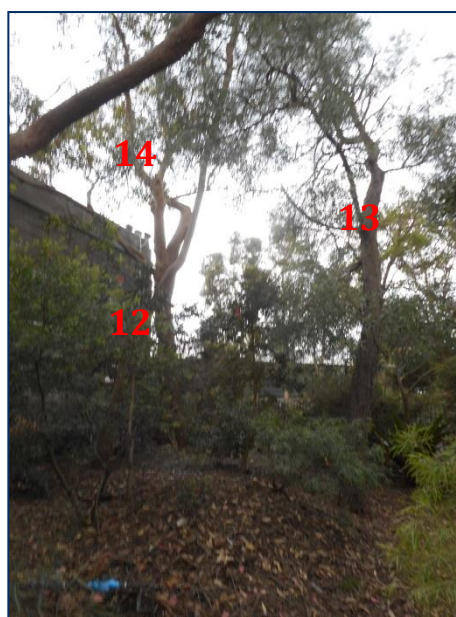
| 14 | <i>Eucalyptus robusta</i> | Swamp Mahogany | 11 | 500/600 | 6.0/2.7 | Fair | Poor | Co-dominance, Extensive decay from ground level into stem | Remove | Low | Leaning/Canopy within footprint<br>Very poor structure |

| Tree | Estimated Life Expectancy | Significance | Retention Value |
|---|---|---|---|
| 14 | Remove | Hazardous | Very Low (Priority for Removal) |

Figure 14 – Tree 14 exhibits severe structural defects and should be removed regardless of the development. Trees 12-13 stand within the construction footprint and are intended to be retained.

| Tree # | Species | Recommendation |
|---|---|---|
| 14 | <i>Eucalyptus robusta</i> | Remove (hazardous)<br>Replace with species associated with Sydney Red Gum ( <i>Angophora costata</i> ) communities |

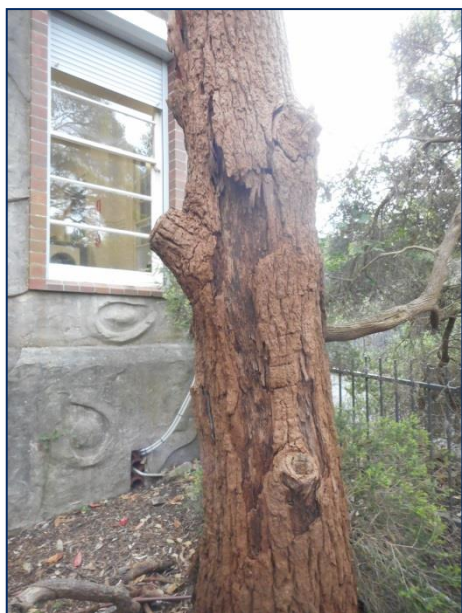
Figure 15 – Tree 14 is exhibiting very poor structure, and only fair health and vigour. Recommended for removal.

Tree 14 is a mature specimen of Swamp Mahogany (*Eucalyptus robusta*), with an approximate height of 11m. It is exhibiting only fair health and vigour, and poor structure. It has extensive decay throughout its lower stem. It has a co-dominant form, with the majority of its canopy positioned over the adjacent structure. It has been assessed as having a 'remove' ELE, and low significance, and due to its hazardous form has been determined to have a very low Retention Value (Priority for Removal). Tree 14 is to be removed.

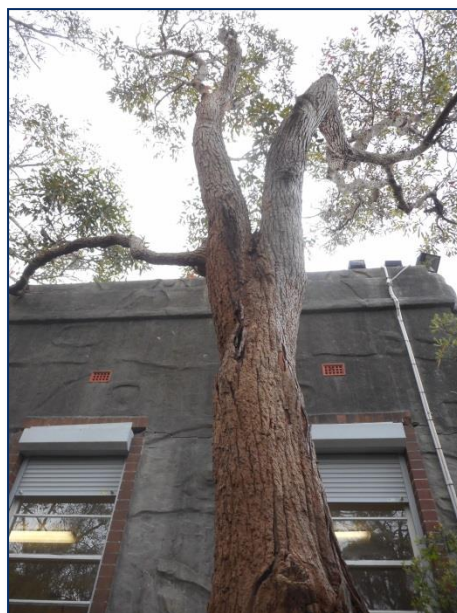
Figure 16 – The co-dominant structure of Tree 14, which has most of its canopy positioned above the adjacent structure, probably due to phototropic growth towards the north. Recommended for removal.

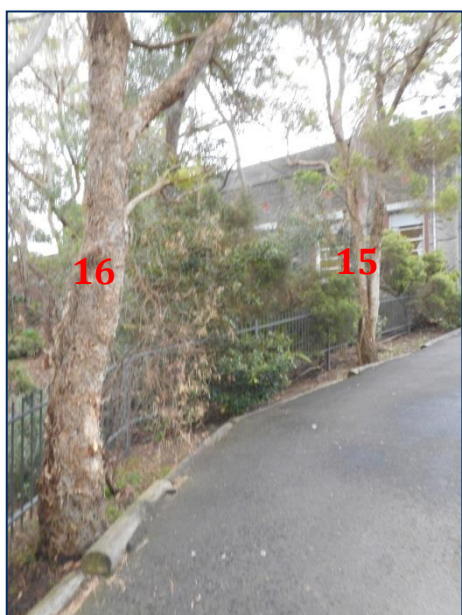
Figure 17 – Trees 15 & 16 stand within the construction footprint and should be removed.

| Tree # | Species | Recommendation |
|---|---|---|
| 15 | <i>Melaleuca linariifolia</i> | Remove<br>Replace where appropriate with species associated with Sydney Red Gum ( <i>Angophora costata</i> ) communities |
| 16 | <i>Melaleuca linariifolia</i> | Remove<br>Replace where appropriate with species associated with Sydney Red Gum ( <i>Angophora costata</i> ) communities |

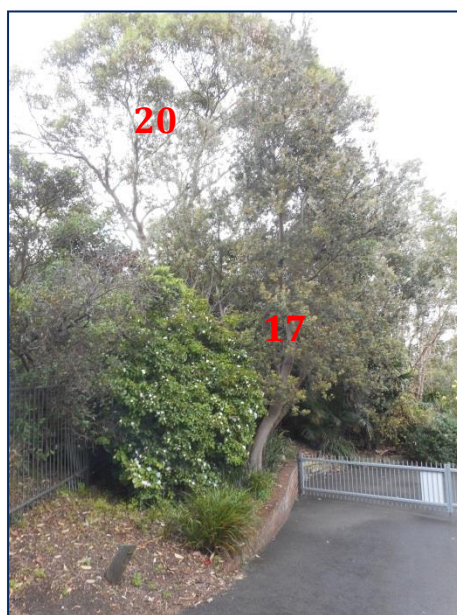
| 20 | <i>Eucalyptus botryoides</i> | Bangalay | 19 | 400/500 | 4.8/2.5 | Good | Fair | Crossing branches, previous failures | Long | Low | |

Figure 18 – Trees 17-20 are within the construction footprint and are to be removed. (Trees 18 & 19 not pictured).

Tree 20 is a mature specimen of Bangalay (*Eucalyptus botryoides*), with an approximate height of 19m. It is exhibiting good health and vigour, but only fair structure. It exhibits crossing branches, and previous failures within its canopy. It has been assessed as having a medium ELE, but low significance, and as such has been determined to have a medium Retention Value (Consider for Retention). It likely stands far enough from the construction footprint to remain viable. Tree 20 is to be retained.

| Tree # | Species | Recommendation |
|---|---|---|
| 17 | <i>Banksia integrifolia</i> | Remove<br>Replace where appropriate with species associated with Sydney Red Gum ( <i>Angophora costata</i> ) communities |

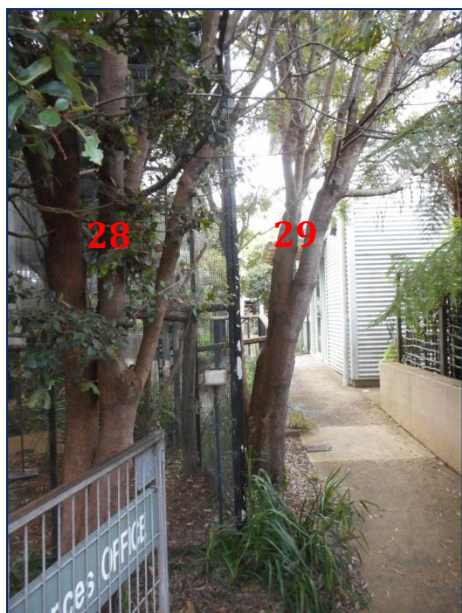
Figure 19 – Trees 28 & 29 – the two largest specimens of Willow-leaved Hakea (*Hakea salicifolia*) – are within the construction footprint and will require removal.

| 28 | <i>Hakea</i><br><i>salicifolia</i> | Remove<br>Replace with species associated with Sydney Red Gum ( <i>Angophora costata</i> ) communities |
| 29 | <i>Hakea</i><br><i>salicifolia</i> | Remove<br>Replace with species associated with Sydney Red Gum ( <i>Angophora costata</i> ) communities |

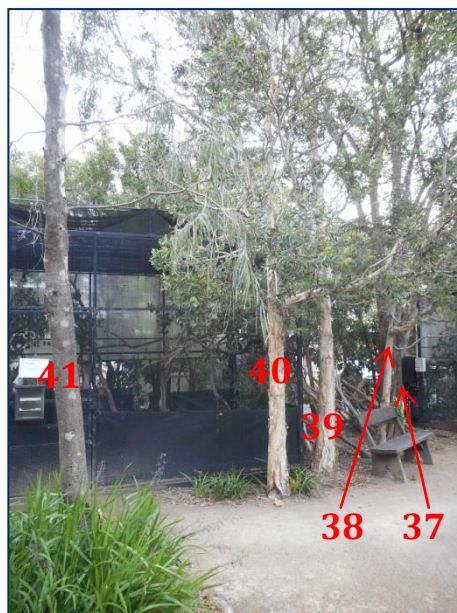
Figure 20 – Trees 37-41 – a Cheese Tree (*Glochidion ferdinandi*), 3x Broad-leaved Paperbarks (*Melaleuca quinquenervia*), and a Woollybutt (*Eucalyptus longifolia*) – are within the construction footprint and will require removal.

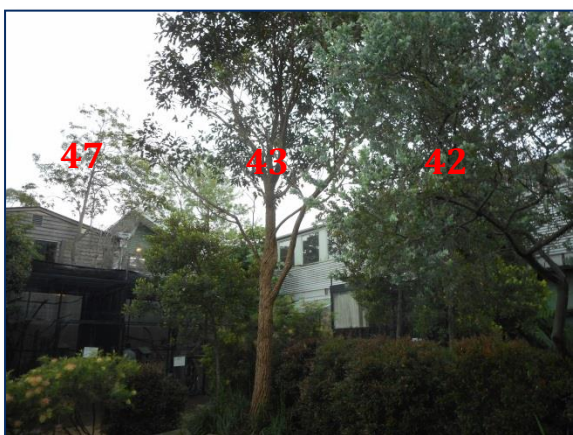
| 43 | <i>Eucalyptus robusta</i> | Swamp Mahogany | 9 | 260/380 | 3.1/2.2 | Good | Poor | Co-dominance with associated defect | Short | Low | |

Figure 21 – Trees 42, 43 & 47 – a Queensland Silver Wattle (*Acacia podalyriifolia*), Swamp Mahogany (*Eucalyptus robusta*), and a Native Frangipani (*Hymenosporum flavum*) – are within the construction footprint and will require removal.

Tree 43 is a semi-mature specimen of Swamp Mahogany (*Eucalyptus robusta*), with an approximate height of 9m. It is exhibiting good health and vigour, but poor structure. It has a co-dominant form, with an associated defect. It has been assessed as having a short ELE, and low significance, and as such has been determined to have a low Retention Value (Consider for Removal). It will require removal to accommodate the demolition works. Tree 43 is to be removed.

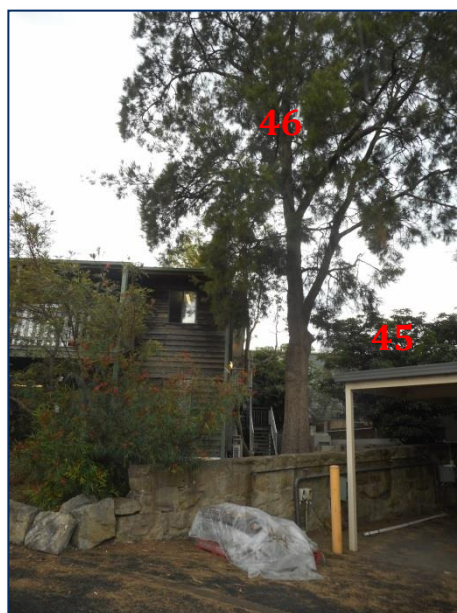
Figure 22 – Trees 45 & 46 – a Sweet Pittosporum (*Pittosporum undulatum*), and a River She Oak (*Casuarina cunninghamiana*) – are within the construction footprint and will require removal.

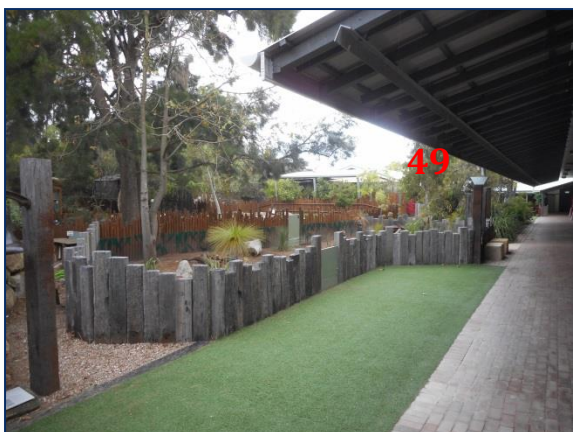
Figure 23 – Tree 49 – a heavily pruned Willow-leaved Hakea (*Hakea salicifolia*) has low significance, but may be suitable for retention if adequate Tree Protection measures are implemented. The other trees within the animal enclosures should remain unaffected.

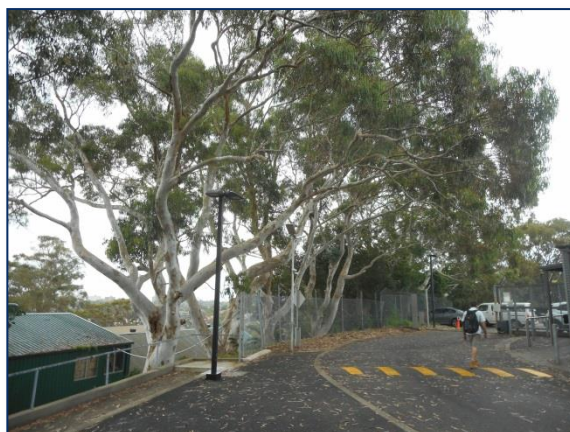
Figure 24 – In the northwest corner of the site stand 4x mature specimens of Maiden's Gum (*Eucalyptus maidenii*). While they stand far enough from the construction footprint that they should not be impacted, it is however likely that they will require some pruning to the branches positioned over the driveway, to accommodate the movement of machinery to and from the site.

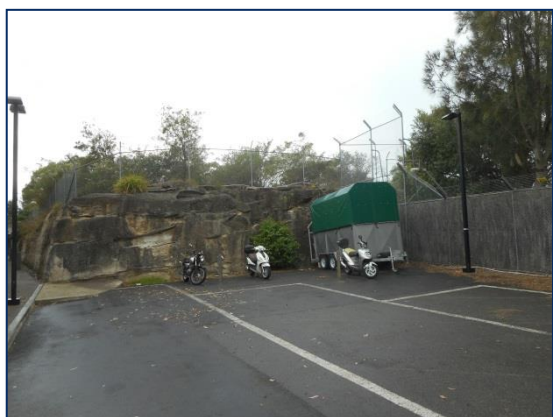
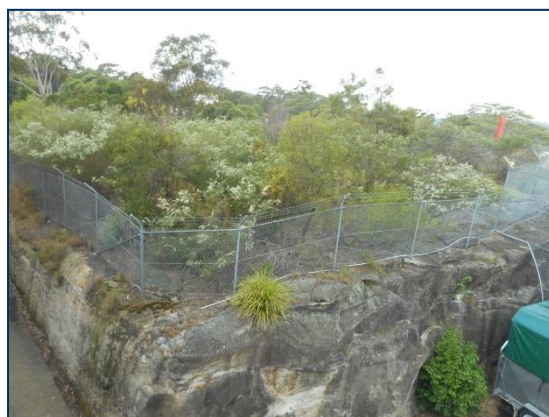
Figures 25 & 26 – The area to the northeast of the site is an area of indigenous remnant vegetation listed as 105L in the *Section 170 Register*. It is fenced, and sits atop a sandstone outcrop that is elevated above the level of the rest of the site. As such, it is very unlikely to be impacted by construction activities, and no controls are considered necessary. Figure 25 shows 105L as viewed from the coach parking area. Figure 26 shows 105L from the top level of the multi-storey car park.
