Hazardous Materials Survey

37 Archer Street, Chatswood NSW

Report No: E26577.E10_Rev0

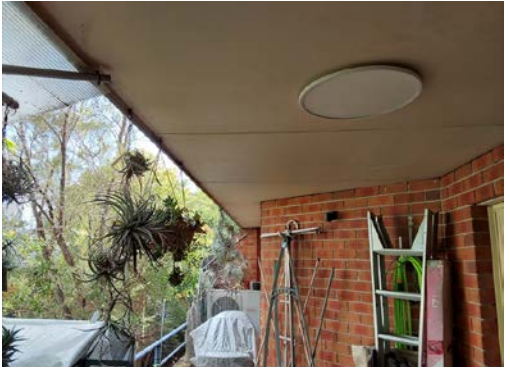
Unit 4, external, first floor, northern balcony, soffit/eave	FCS	Non-friable	Visual inspection - similar to 4-Asb-3	-	N/A	N/A	N/A	N/A	N/A

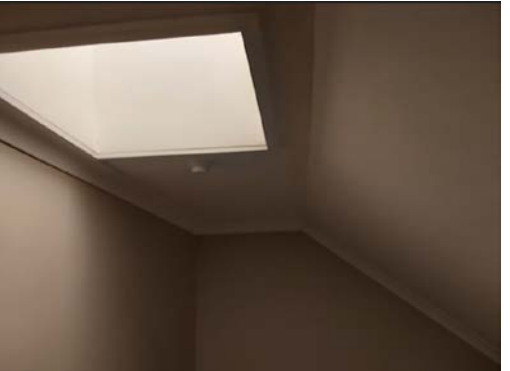
Unit 4, internal, second floor, southern walls and ceiling	FCS	Non-friable	4-Abs-1	No Asbestos Detected	N/A	N/A	N/A	N/A	N/A

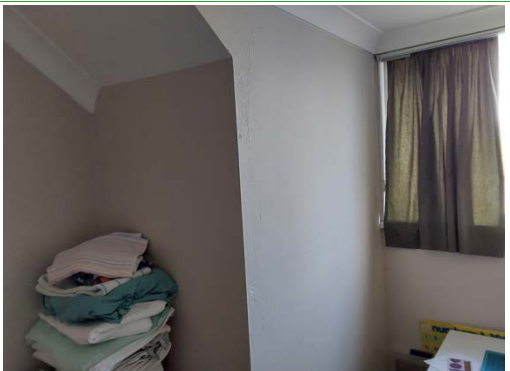
Unit 4, internal, second floor, walls	FCS	Non-friable	4-Asb-2	No Asbestos Detected	N/A	N/A	N/A	N/A	N/A

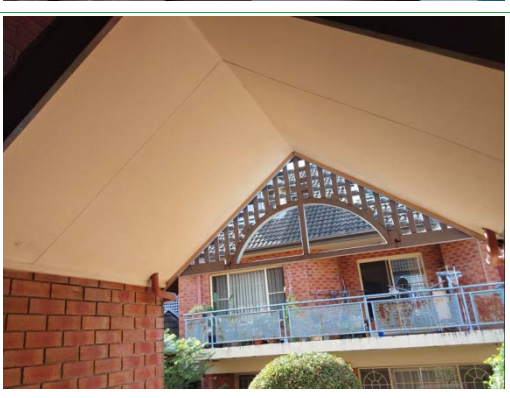
Unit 4, external, entrance way, awning	FCS	Non-friable	4-Asb-3	No Asbestos Detected	N/A	N/A	N/A	N/A	N/A

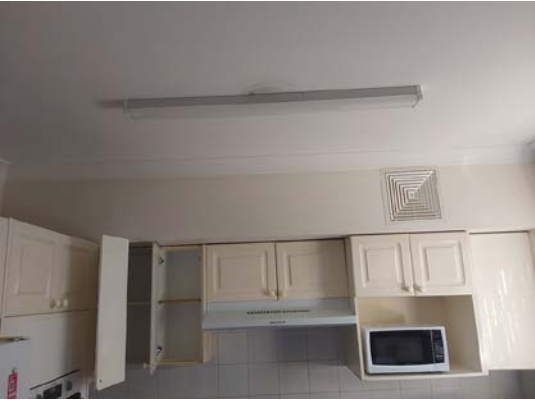
PCB										
Unit 3, Internal, kitchen ceiling, fluorescent light fitting	PCB-containing single-tube fluorescent light fitting capacitors (assumed)	N/A	Visual inspection - electrical hazard	-	1 x fixture	Good / Maintenance only	Priority 4 - Negligible Risk Level	16/12/2024	Remove prior to demolition works. Avoid damage to capacitors.

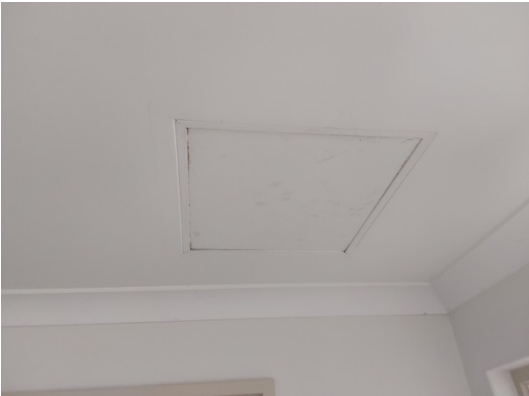
Unit 11, Master Bedroom, ensuite bathroom and walk-in wardrobe	Possible hazardous materials	Unknown	-	-	Unknown	Unknown	Unknown	16/12/2024	Inspect when access is made available, prior to demolition	-
Unit 12, Second Floor, bedroom	Possible hazardous materials	Unknown	-	-	Unknown	Unknown	Unknown	17/12/2024	Inspect when access is made available, prior to demolition	-

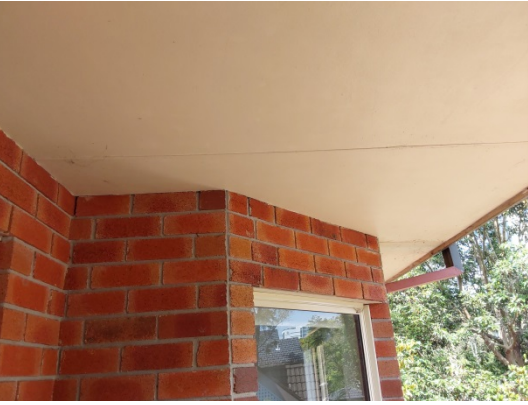
Unit 8, external, first floor, internal, balcony, eave/soffit	FCS	Non-friable	Visual inspection – similar to 4-Asb-3	-	N/A	N/A	N/A	N/A	N/A

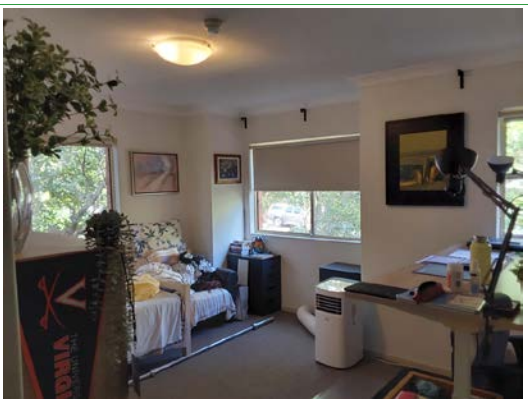
Unit 8, Internal, second floor, walls	FCS	Non-friable	Visual inspection – similar to 4-Asb-1	-	N/A	N/A	N/A	N/A	N/A

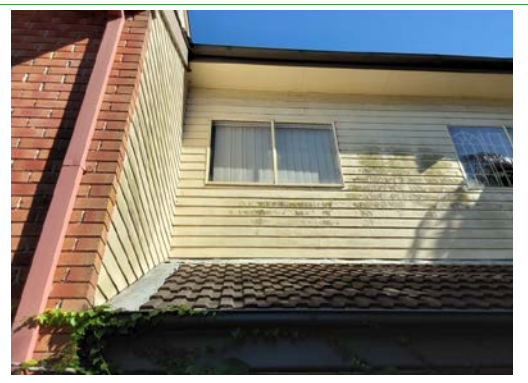
Unit 11, External, eaves	ACM	Non-friable	Visual inspection – similar to 4-Asb-3	-	N/A	N/A	N/A	N/A	N/A

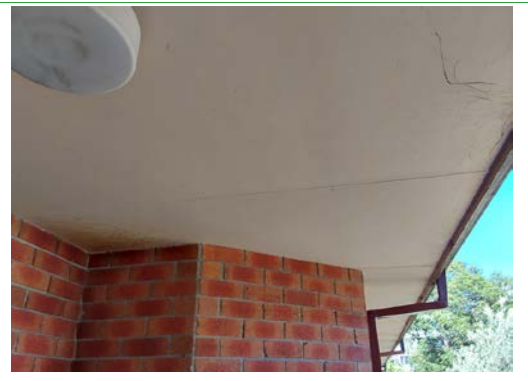
Unit 12, External, balcony, eave/soffit	FCS	Non-friable	Visual inspection – similar to 4-Asb-3	-	N/A	N/A	N/A	N/A	N/A

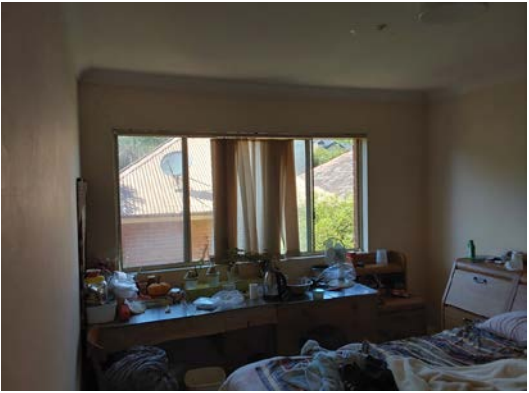
Unit 12, Internal, second floor, walls	FCS	Non-friable	Visual inspection – similar to 4-Asb-1	-	N/A	N/A	N/A	N/A	N/A
--	-----	-------------	--	---	-----	-----	-----	-----	-----

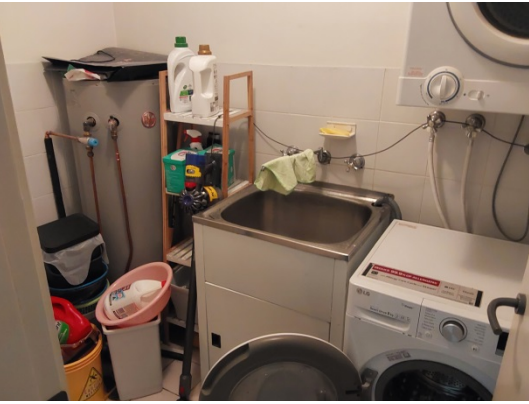
Unit 8, Internal, laundry, water heater unit	SMF (assumed)	Sealed	Visual inspection	-	1 x unit	Good / Maintenance only	Priority 4 - Negligible Risk Level	16/12/2024	Remove during initial stages of demolition works
--	---------------	--------	-------------------	---	----------	-------------------------	------------------------------------	------------	--

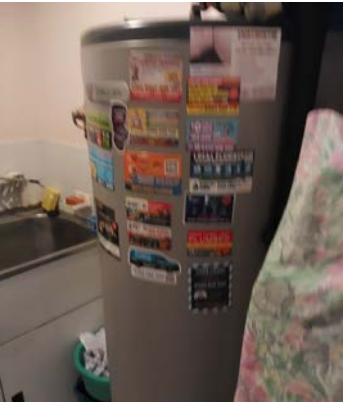
Unit 9, Internal, laundry, water Heater unit	SMF (assumed)	Sealed	Visual inspection	-	1 x unit	Good / Maintenance only	Priority 4 - Negligible Risk Level	16/12/2024	Remove during initial stages of demolition works
--	---------------	--------	-------------------	---	----------	-------------------------	------------------------------------	------------	--

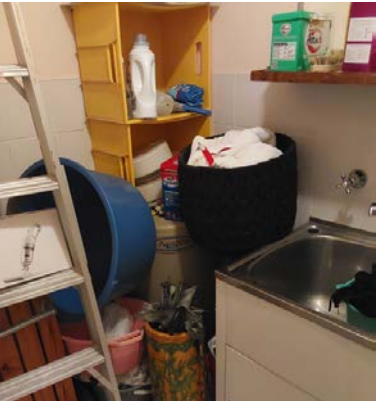
Unit 12, Internal, laundry, water heater unit	SMF (assumed)	Sealed	Visual inspection	-	1 x unit	Good / Maintenance only	Priority 4 - Negligible Risk Level	16/12/2024	Remove during initial stages of demolition works

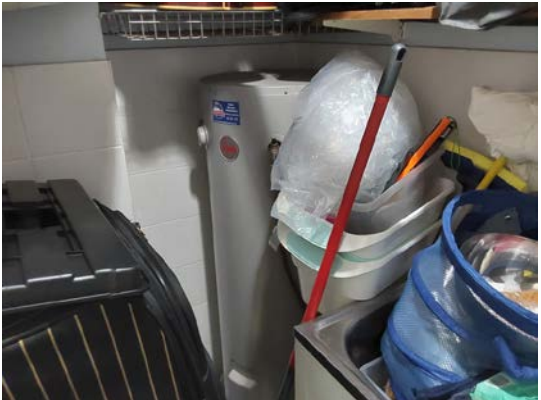
Unit 13, Internal, laundry, water heater unit	SMF (assumed)	Sealed	Visual inspection	-	1 unit	Good / Maintenance only		16/12/024	Remove during initial stages of demolition works

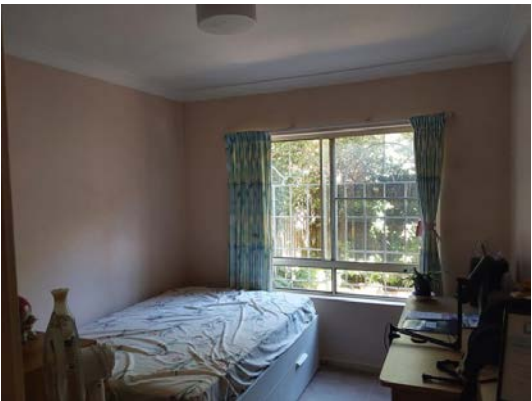
Unit 9, Internal, kitchen, living room and bedroom, walls throughout	Pink LBP	Non-friable	9-Pb-1	0.15% w/w	Approximately 90m²	Good / Regular	Priority 3 - Low Risk Level	16/12/024	Remove grossly peeling paint. Stabilise remaining membrane. Minimise abrasive works that will disturb paint during demolition.

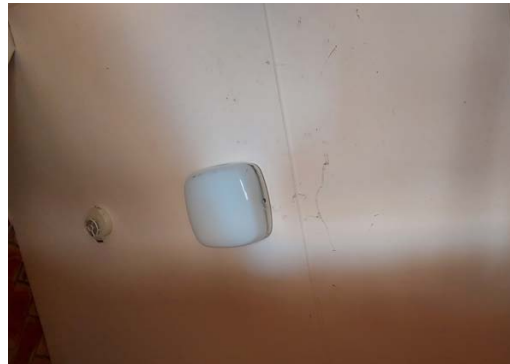
ACM											
Basement, Internal, west boundary stairwell and toilet ceiling	FCS	Non-friable	Ext-Asb-1	No Asbestos Detected	N/A	N/A	N/A	N/A	N/A

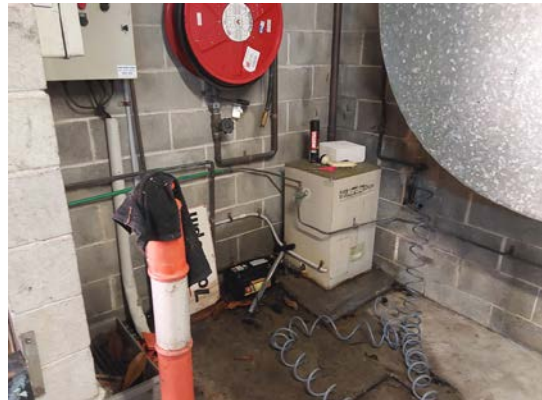
SMF											
Internal, basement, north-eastern entrance corner water heater unit	SMF (assumed)	Sealed	Visual inspection	-	1 unit	Good / Maintenance only	Priority 4 - Negligible Risk Level	17/12/2024	Remove during initial stages of demolition works

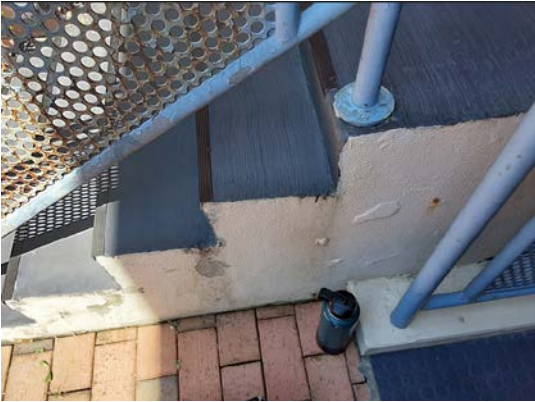
Common Area, External, stairwell throughout, fence and ceiling paint	Blue Paint	Non-friable	Ext-Pb-1	0.063% w/w	N/A	N/A	N/A	N/A	N/A	 
Common Areas, External, stairwell side, fence paint	Pale Yellow Paint	Non-friable	Ext-Pb-2	0.006% w/w	N/A	N/A	N/A	N/A	N/A
