ESR Developments (Australia) Pty Ltd

**Hazardous Building Materials Survey**

130 Wentworth Avenue  
Banksmeadow, NSW

4 November 2024

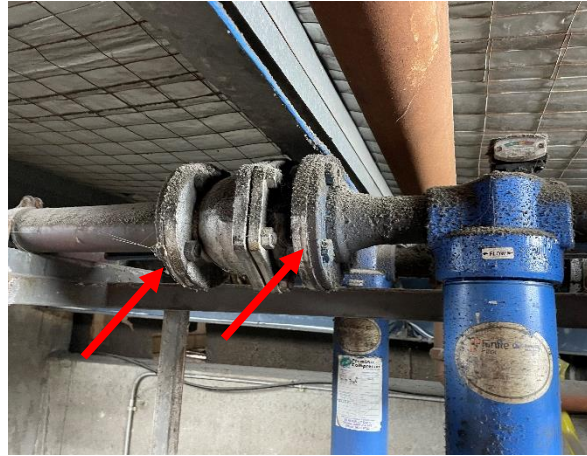
Photo 2: Main Warehouse – asbestos containing gaskets to redundant compressor pipework in central east portion, mezzanine level

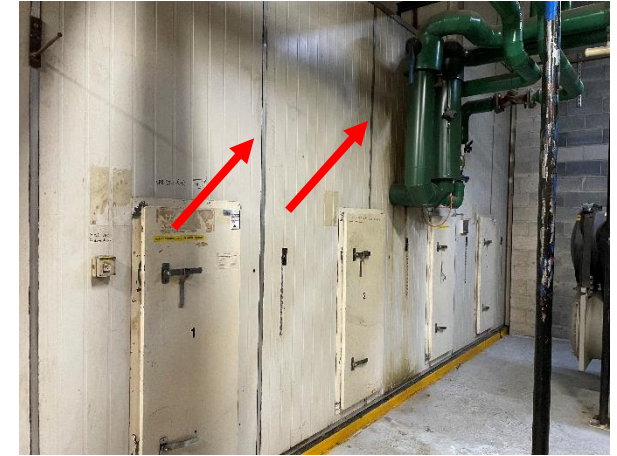
Photo 3: Main Warehouse – asbestos containing white mastic to the wall joins within the air handling units in central portion mezzanine plant room

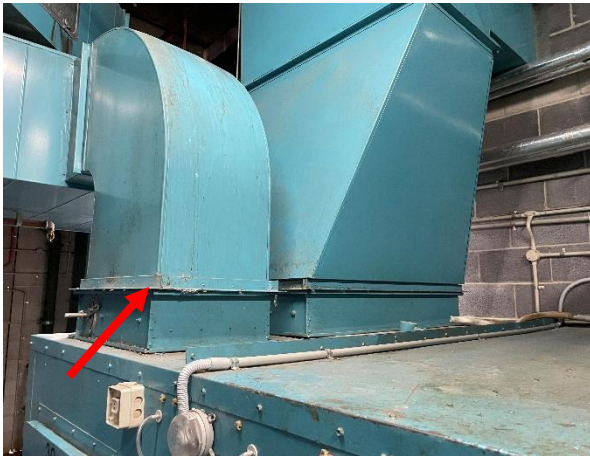
Photo 4: Main Warehouse – asbestos containing grey mastic to fire dampeners in air handling unit within administration plant room

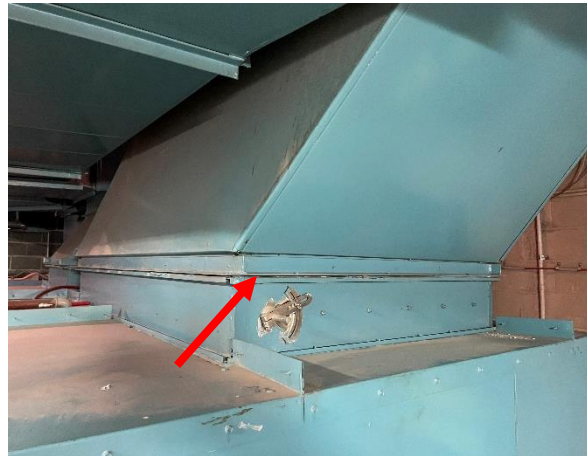
Photo 5: Main Warehouse – asbestos containing grey mastic to fire dampeners in air handling unit within administration plant room

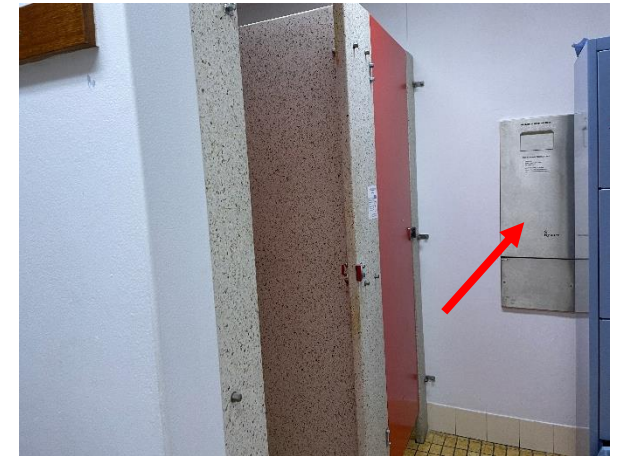
Photo 6: Main Warehouse – assumed internal asbestos containing insulation to incinerators within female toilets

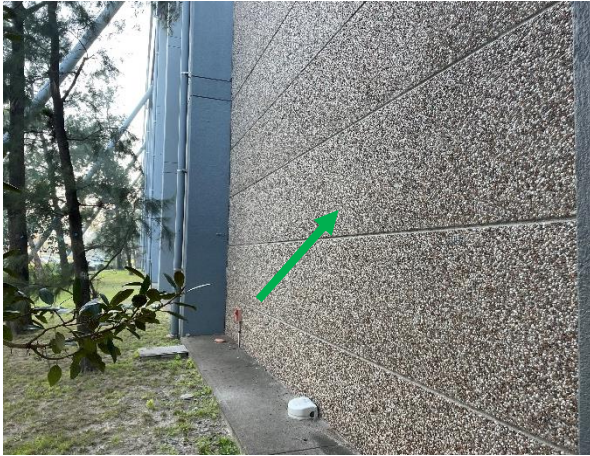
Photo 7: Main Warehouse – non-asbestos containing pebblecrete to the external walls

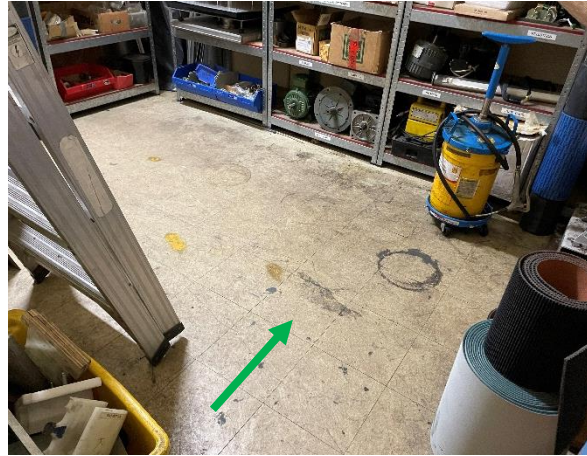
Photo 8: Main Warehouse – non-asbestos containing beige vinyl tiles to the floor of the store room within the central east portion

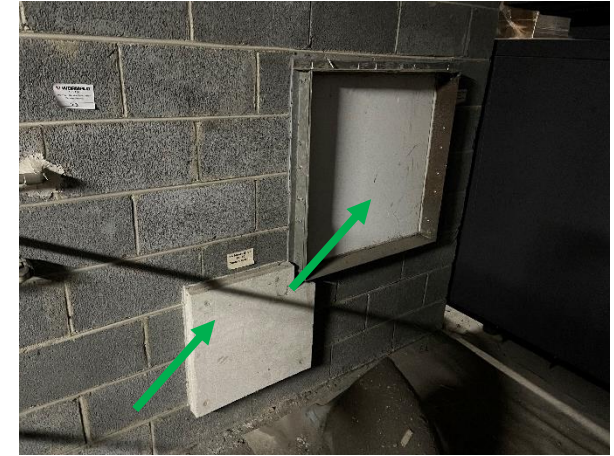
Photo 9: Main Warehouse – non-asbestos containing millboard to the wall penetrations within plant room 2 in central east portion

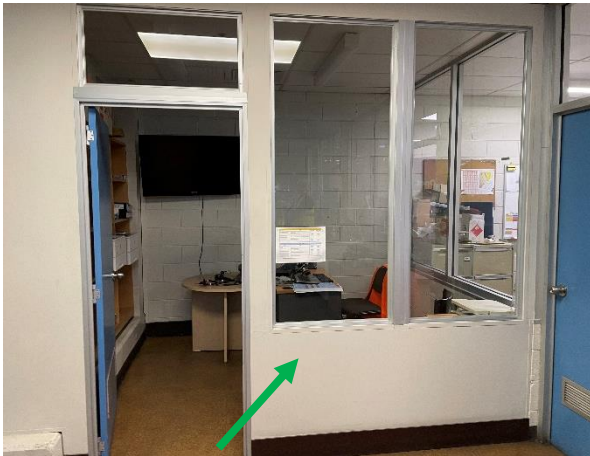
Photo 10: Main Warehouse – non-asbestos containing fibre cement sheeting to the mezzanine office walls in central portion

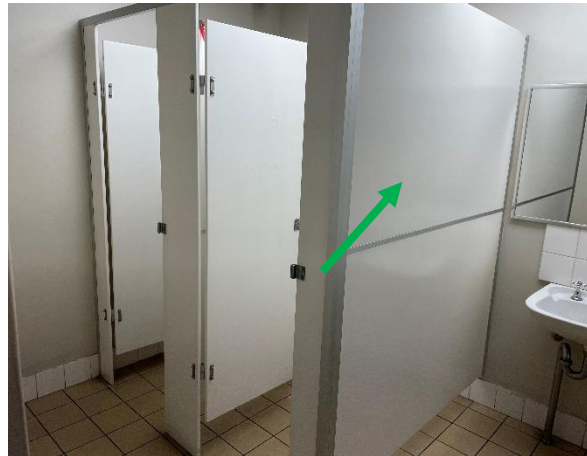
Photo 11: Main Warehouse – non-asbestos containing compressed fibre cement sheeting to the toilet cubicle walls and doors within the central portion

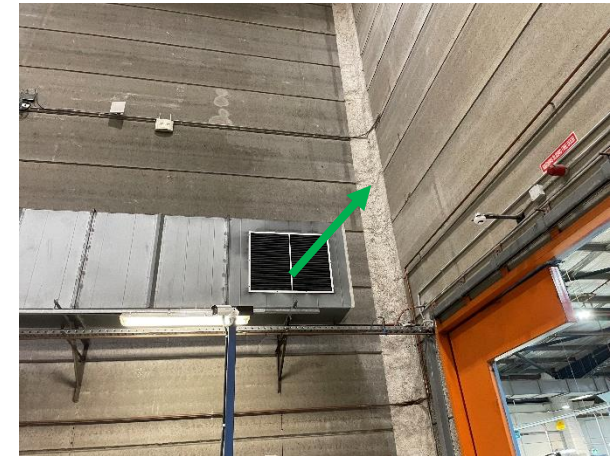
Photo 12: Main Warehouse – non-asbestos containing vermiculite to the steel framework within the west portion

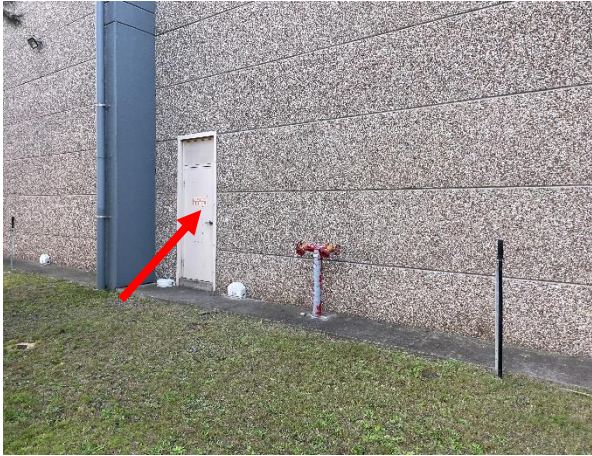
| JBS&G<br>SAMPLE NO. | LOCATION | MATERIAL DESCRIPTION | PHOTO<br>NUMBER | ACCESSIBLE<br>AREA? | FRIABILITY | ANALYTICAL RESULT | MATERIAL<br>CONDITION | APPROX.<br>QUANTITY | ACTION REQUIRED | DATE OF LAST<br>INSPECTION (INCL.<br>COMPANY NAME<br>AND INITIALS) | DATE OF CONTROL<br>ACTION &/OR<br>REMOVAL |
|---|---|---|---|---|---|---|---|---|---|---|---|
| J-L02 | Warehouse, external fire door and door frame | Beige paint | 13 | Yes | - | <b>0.14% w/w</b> | Fair | 10m <sup>2</sup> | Maintain in current condition in accordance with a site LMP and AS4361.2:2017 | 13/09/23<br>JBS&G<br>RS/SL | |

Photo 13: Main Warehouse – lead based beige paint to the external fire doors and frames

Lead based paints identified in the Hazardous Materials Register (**Appendix A**) should be managed in accordance with the AS4361.2-2017. The identified lead based paints were in good to fair condition.

A program of periodic inspection should be undertaken to confirm the materials acceptable condition for the future operation of the site.

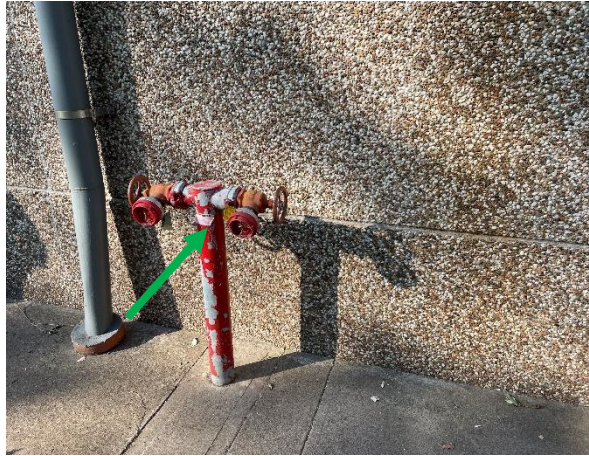
Photo 14: Main Warehouse – non-lead based red paint to the external fire hydrants

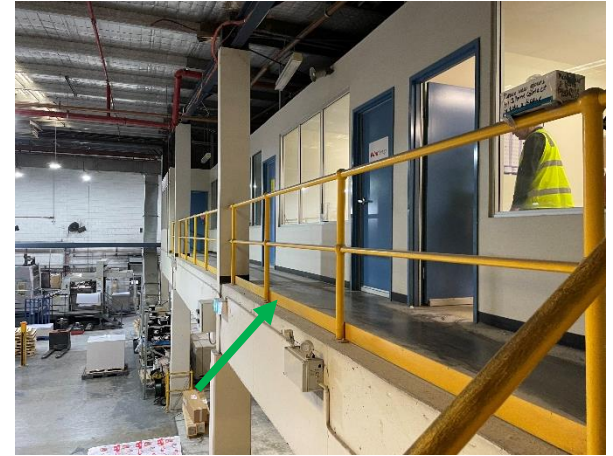
Photo 15: Main Warehouse – non-lead based yellow paint to the internal bollards and handrails

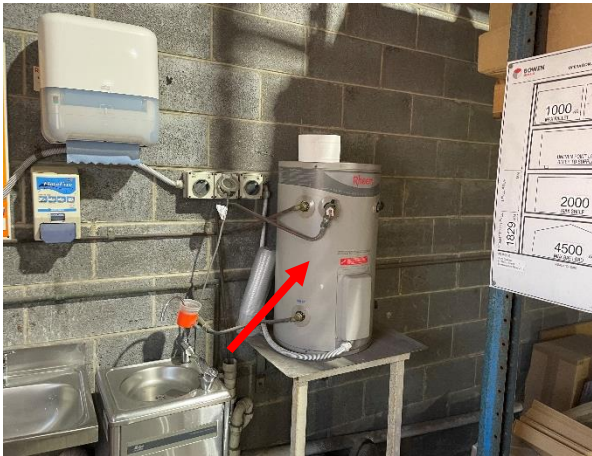
| JBS&G<br>SAMPLE NO. | LOCATION | MATERIAL DESCRIPTION | PHOTO<br>NUMBER | ACCESSIBLE<br>AREA? | FRIABILITY | ANALYTICAL RESULT | MATERIAL<br>CONDITION | APPROX.<br>QUANTITY | ACTION REQUIRED | DATE OF LAST<br>INSPECTION (INCL.<br>COMPANY NAME<br>AND INITIALS) | DATE OF CONTROL<br>ACTION &/OR<br>REMOVAL |
|---|---|---|---|---|---|---|---|---|---|---|---|
| - | Instant and standard hot<br>water systems | Internal insulation | 16 | Yes | Bonded | Assumed SMF | Good | > 10 units | Leave in situ and monitor condition | 13/09/23<br>JBS&G<br>RS/SL | |

Photo 16: Main Warehouse – assumed internal SMF insulation to hot water systems

The synthetic mineral fibres encountered during this inspection were generally contained and deemed to be low risk. A program of periodic inspection should be undertaken to confirm the materials condition for the future operation of the site.

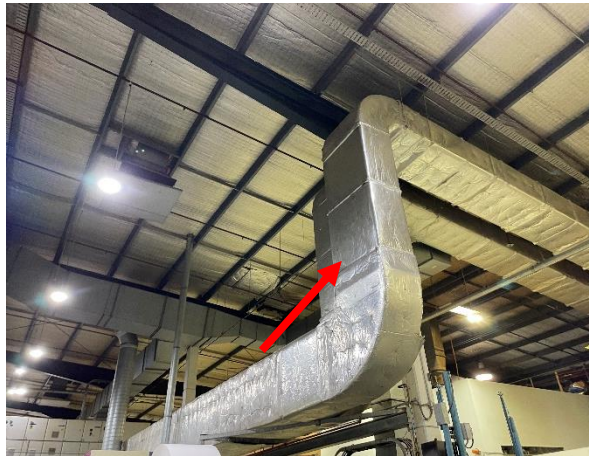
| JBS&G<br>SAMPLE NO. | LOCATION | MATERIAL DESCRIPTION | PHOTO<br>NUMBER | ACCESSIBLE<br>AREA? | FRIABILITY | ANALYTICAL RESULT | MATERIAL<br>CONDITION | APPROX.<br>QUANTITY | ACTION REQUIRED | DATE OF LAST<br>INSPECTION (INCL.<br>COMPANY NAME<br>AND INITIALS) | DATE OF CONTROL<br>ACTION &/OR<br>REMOVAL |
|---|---|---|---|---|---|---|---|---|---|---|---|
| - | Fixed and flexible, air conditioning ducting | Internal insulation | 17 | Yes | Bonded | Assumed SMF | Good | > 1000 m <sup>2</sup> | Leave in situ and monitor condition | 13/09/23<br>JBS&G<br>RS/SL | |

Photo 17: Main Warehouse – assumed SMF insulation to air conditioning ducting

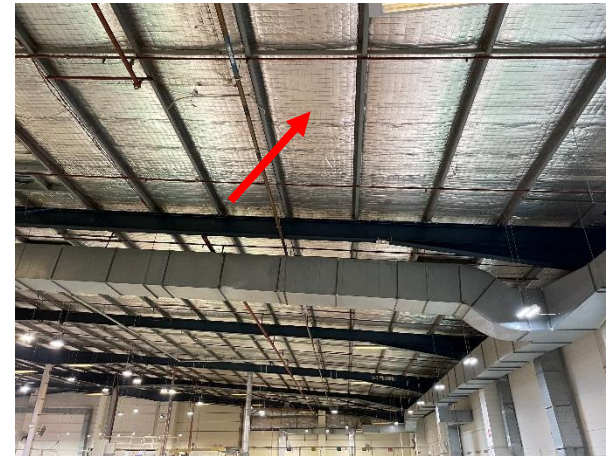
Photo 18: Main Warehouse – assumed SMF insulation to roof sarking

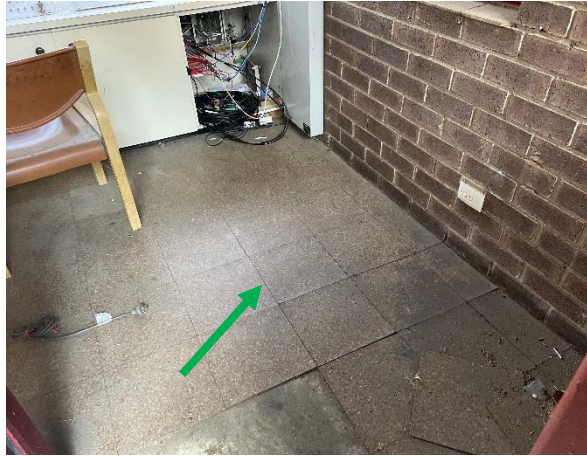
Photo 20: Gate House – non-asbestos containing red and green speckled vinyl floor tiles

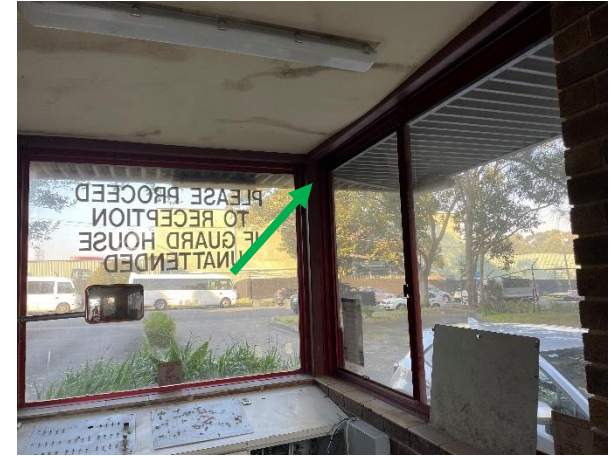
Photo 21: Gate House – lead based maroon paint to the internal and external steel framework

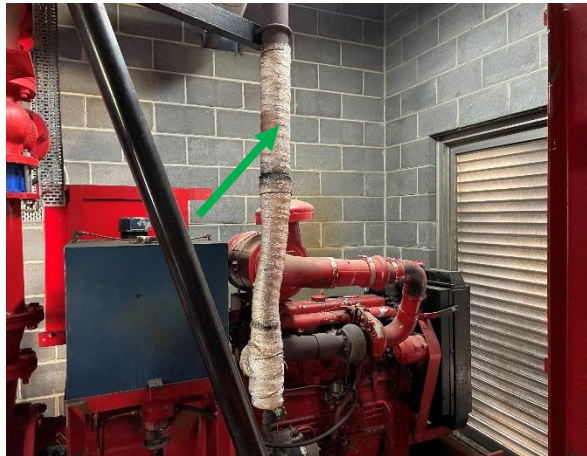
Photo 23: Water Storage Tank and Fire Booster Pump Shed – non-asbestos containing insulation wrap to exhaust pipe

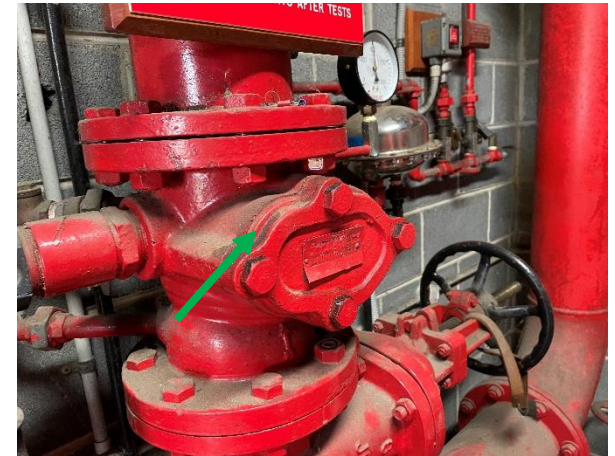
Photo 24: Water Storage Tank and Fire Booster Pump Shed – non-asbestos containing blue gasket to pump sprinkler valve

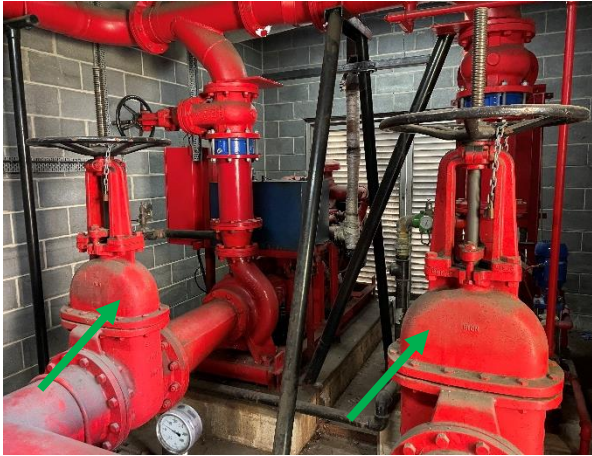
Photo 25: Water Storage Tank and Fire Booster Pump Shed – non-lead based red paint to hydrant pipework
