Report on  
Preliminary Site Investigation (Contamination)

Proposed Redevelopment  
4-6 Popes Road, Woonona

Prepared for  
Illawarra Retirement Trust

Project 40439.06  
July 2023

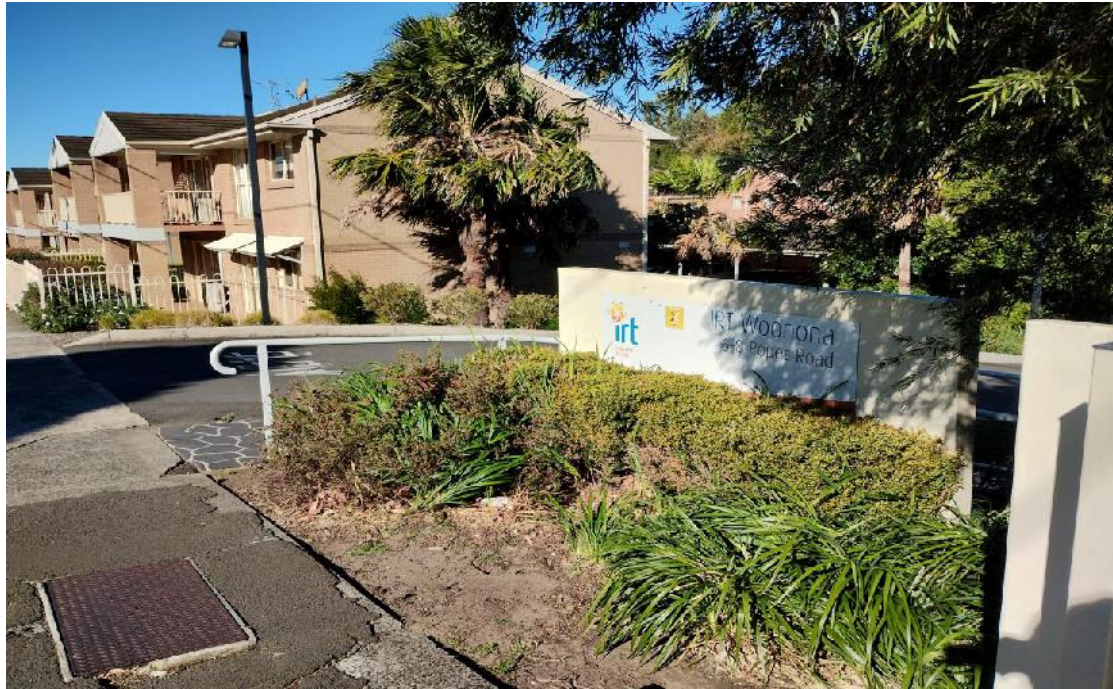
- Paved pathways, seating and landscaped gardens were observed throughout most of the site (refer to Photograph 8, Appendix E);
- Occupied residential structures (Camelia Lodge) were present in the northern most portion of the site, to the east of the main driveway (refer to Photograph 1, Appendix E);

Photo 1: General view of northernmost residential properties (Camelia Lodge) and driveway entry, looking east.

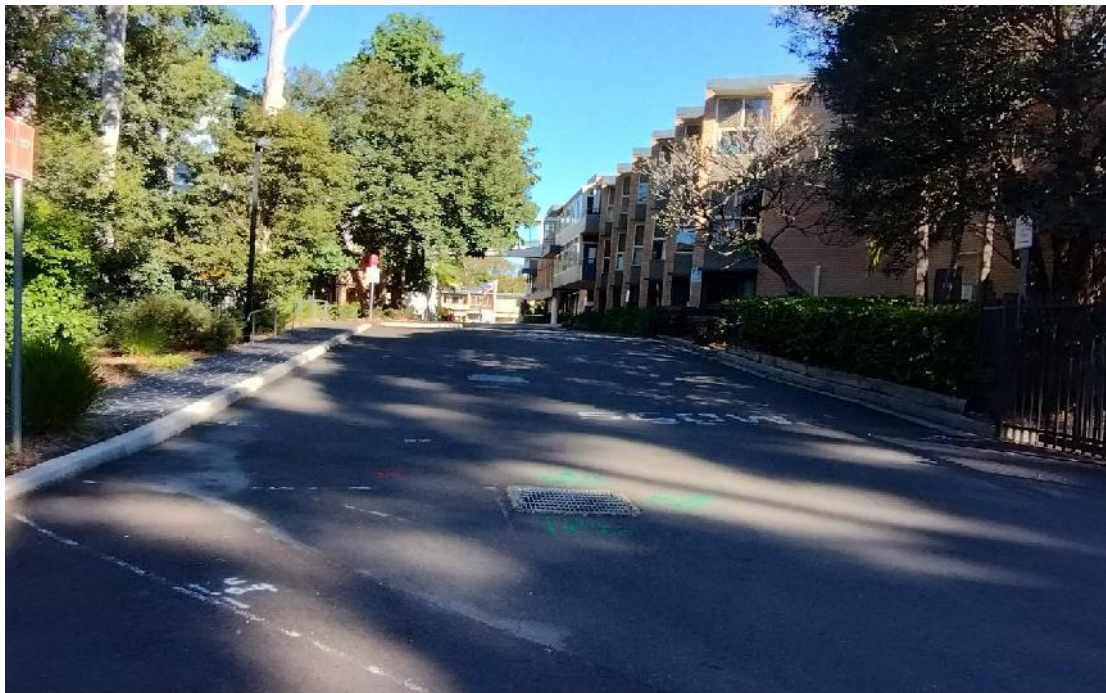
Photo 2: View of driveway in western portion of the site and administration / residential structure (Ribbonwood Lodge), looking south.

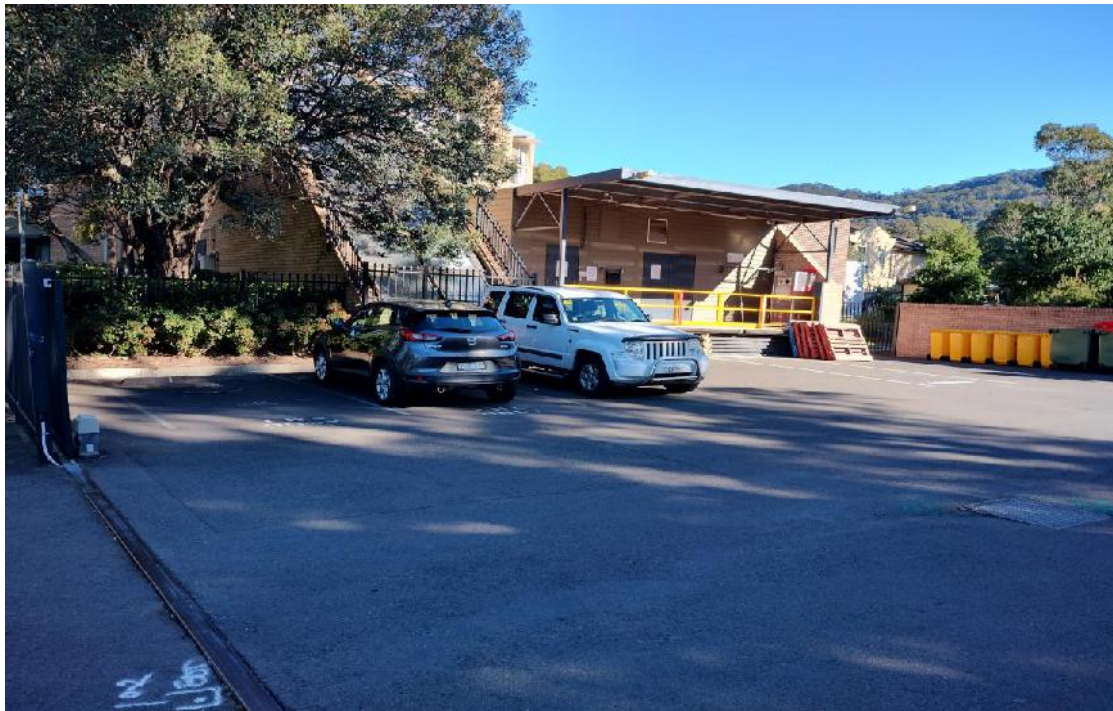
Photo 3: View of northern hardstand carpark, general waste bins and laundry in north western portion of the site, looking south west.

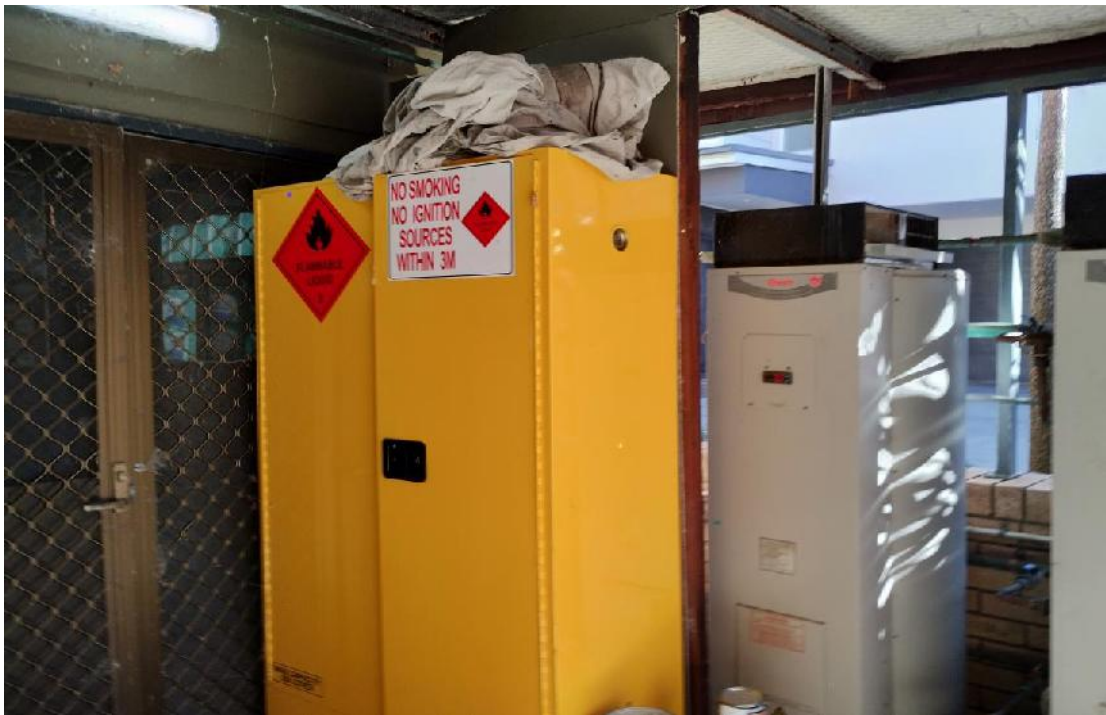
Photo 4: View of flammable liquid storage cupboard adjacent to western boundary of the site.

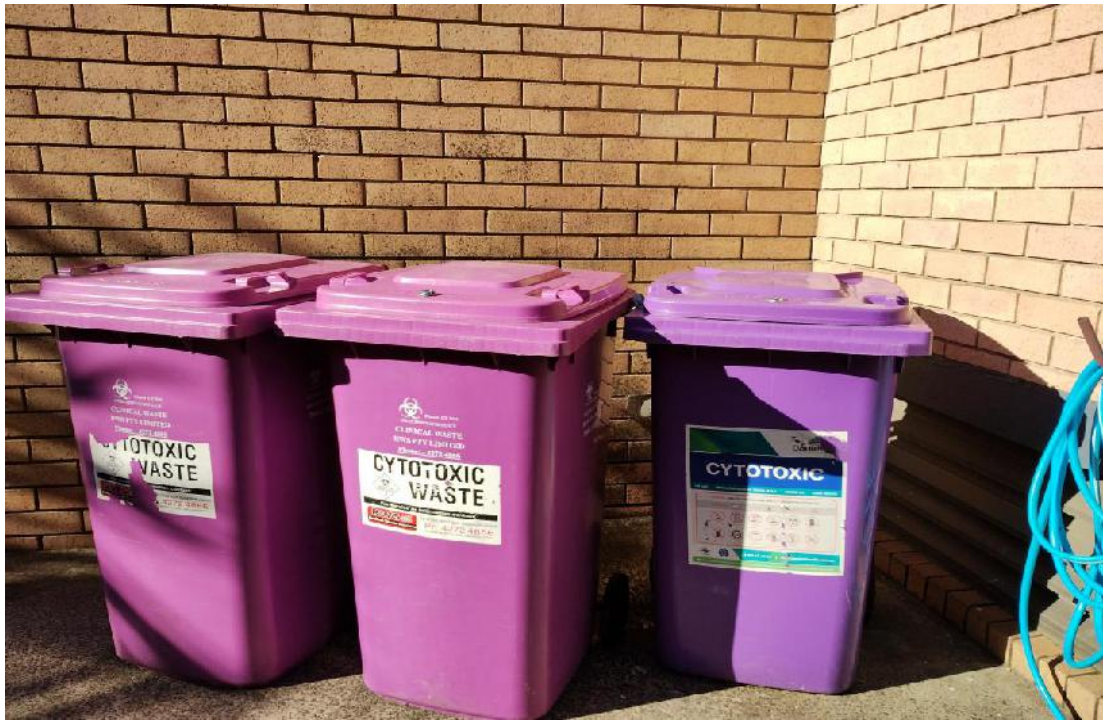
Photo 5: View of cytotoxic waste bin storage adjacent to western boundary of the site.

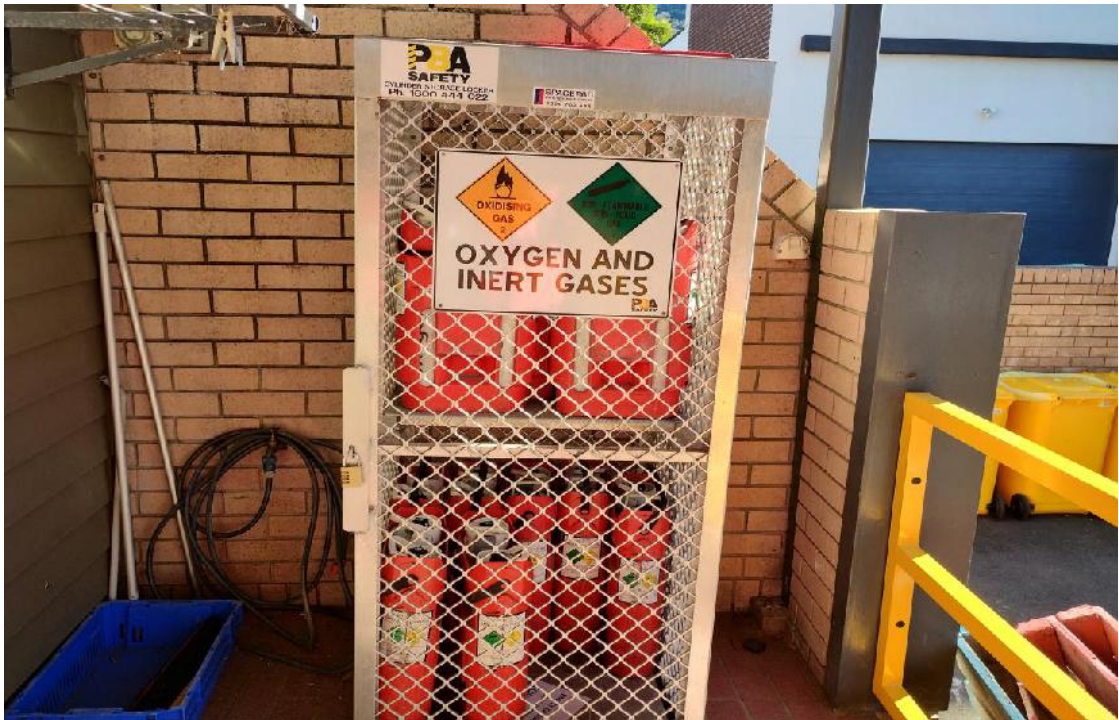
Photo 6: View of padlocked storage locker containing compressed oxygen in front of laundry in north western corner of the site, looking west.

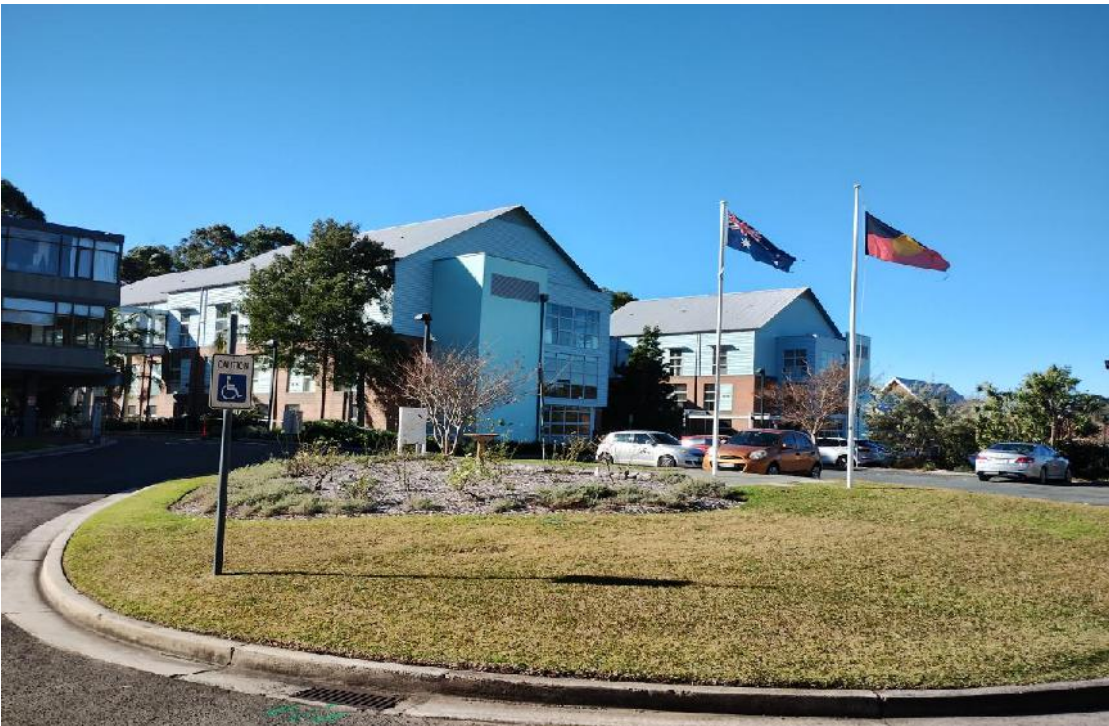
Photo 7: General view of gardens and residential building (Flame Tree Lodge), looking north east.

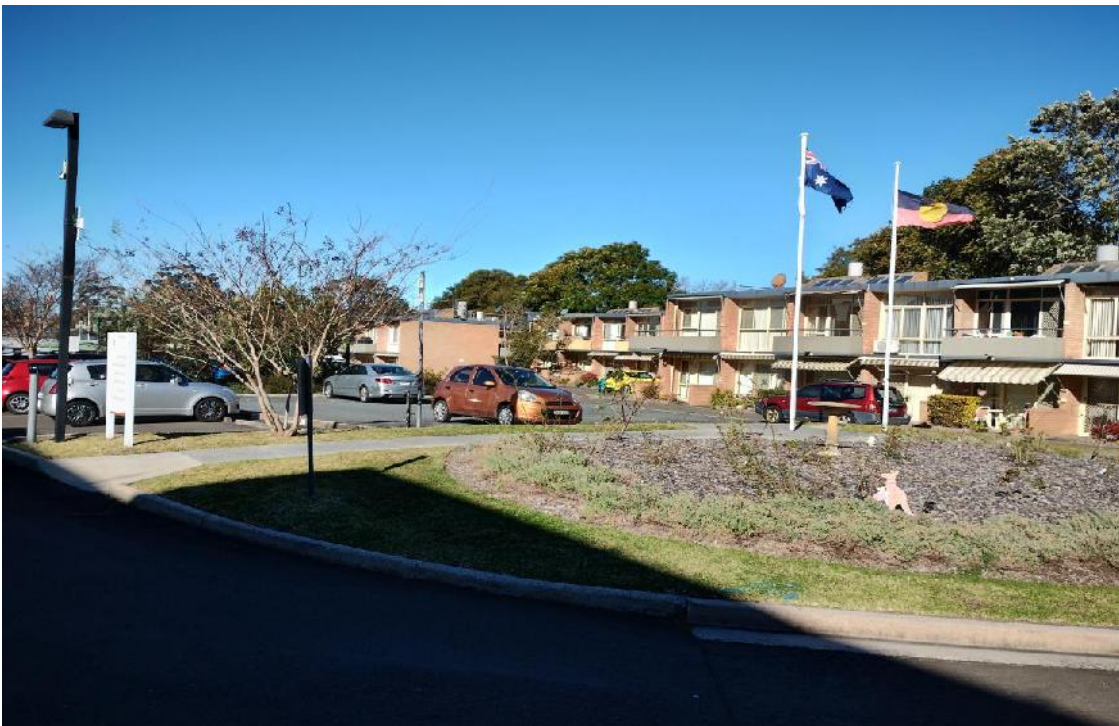
Photo 8: View of main hardstand carpark and residential building (Blueberry Ash Village), looking west.

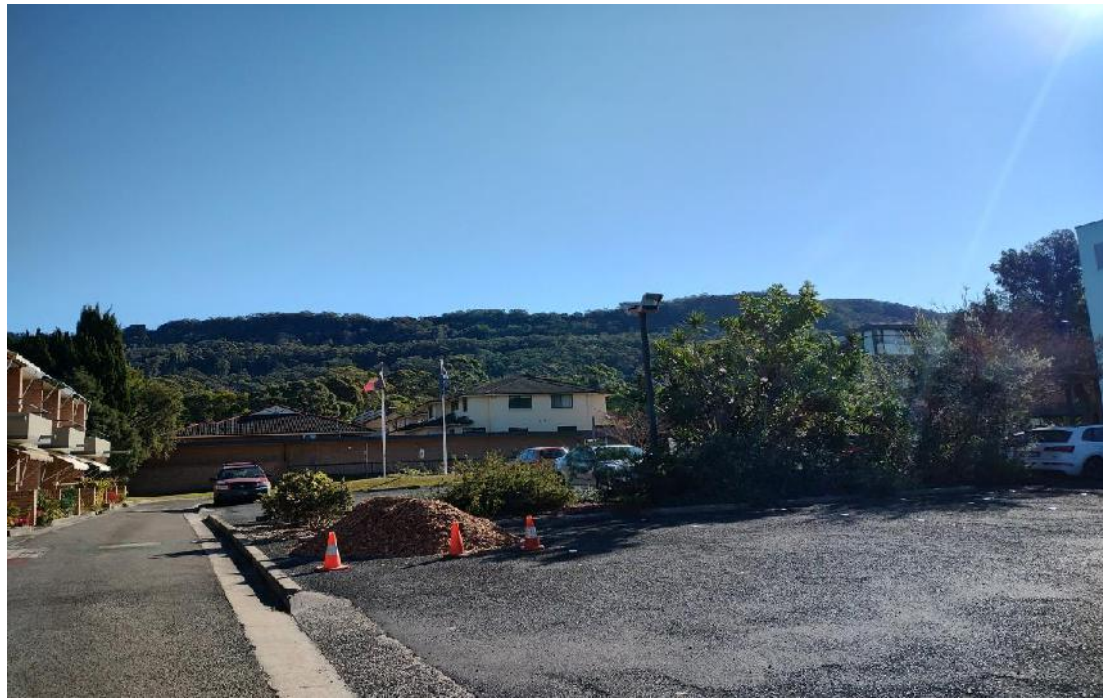
Photo 9: View of main hardstand carpark and mulch stockpile, looking west. General view of the main hardstand carpark in centre of the site and Blueberry Ash Village.

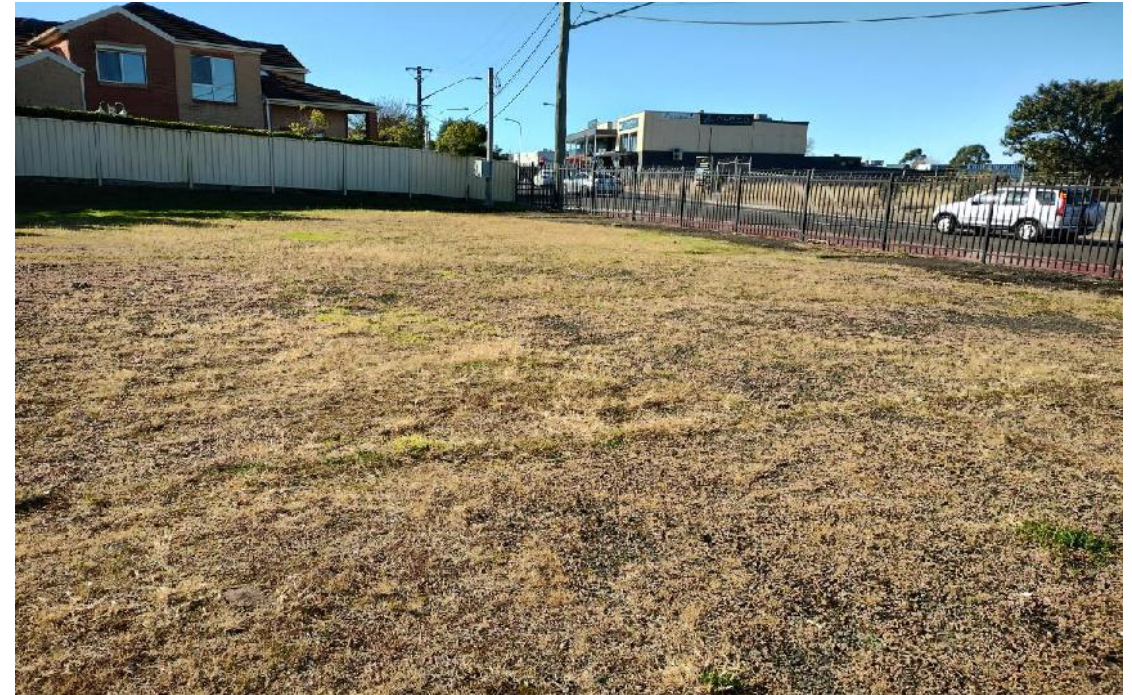
Photo 10: Photo of disturbed grass area with surface gravels and hardstand patches associated with former service station, looking north east.

It is recommended that an intrusive soil investigation of the site is conducted to target areas of fill, (i.e., adjacent to existing structures, creek line) and areas where former buildings have been demolished.

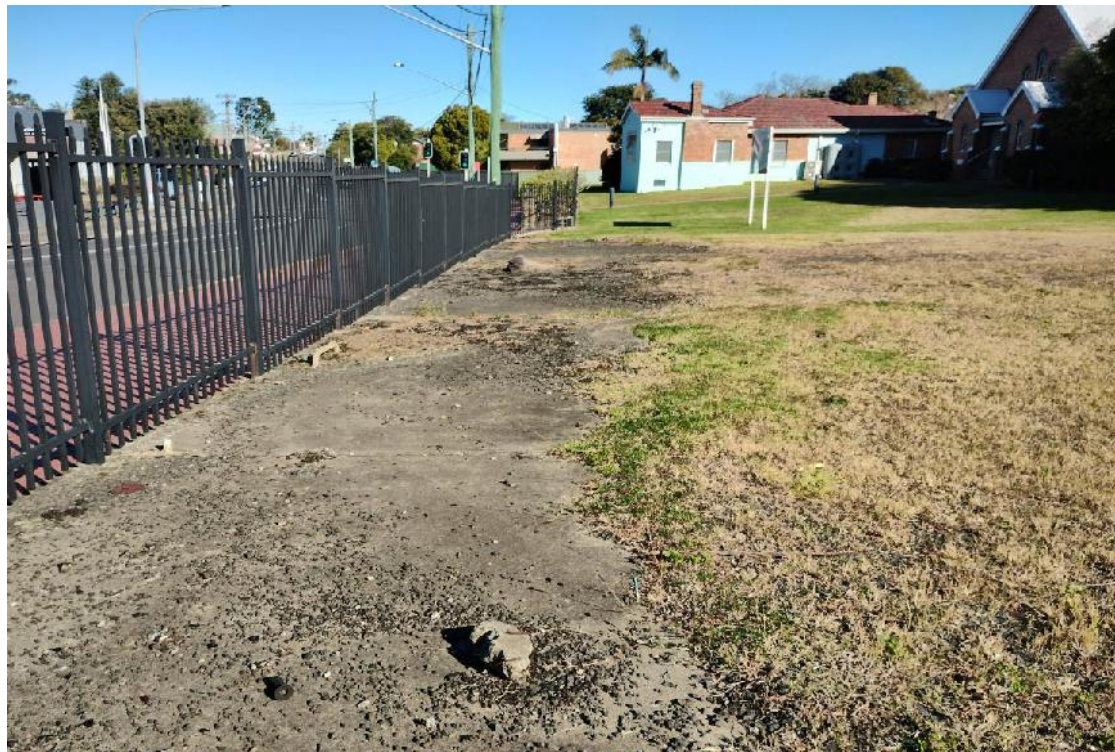
Photo 11: Exposed hardstand and gravels in north eastern portion of the site, looking south.

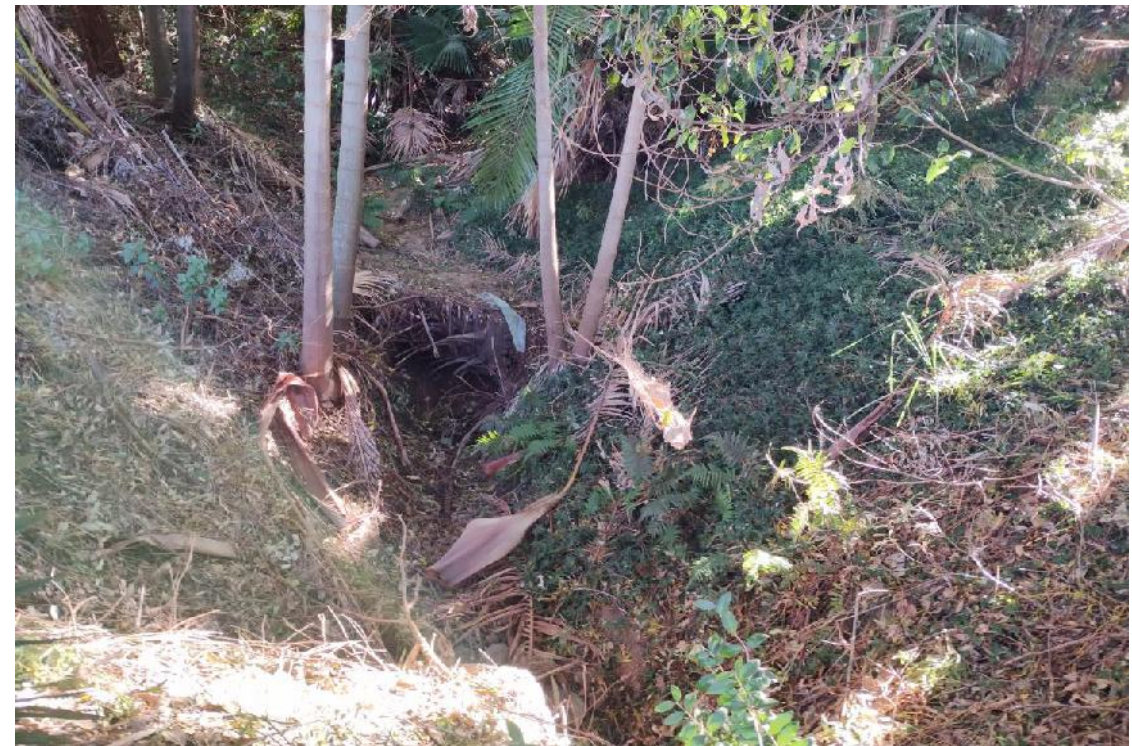
- Dense tree vegetation and a gully depression was visible to the east of the former service station area. Minor amounts of domestic waste were observed on the surface (refer to Photograph 12, Appendix E);

Photo 12: View of vegetated creek line to the east of the former service station area, looking east.

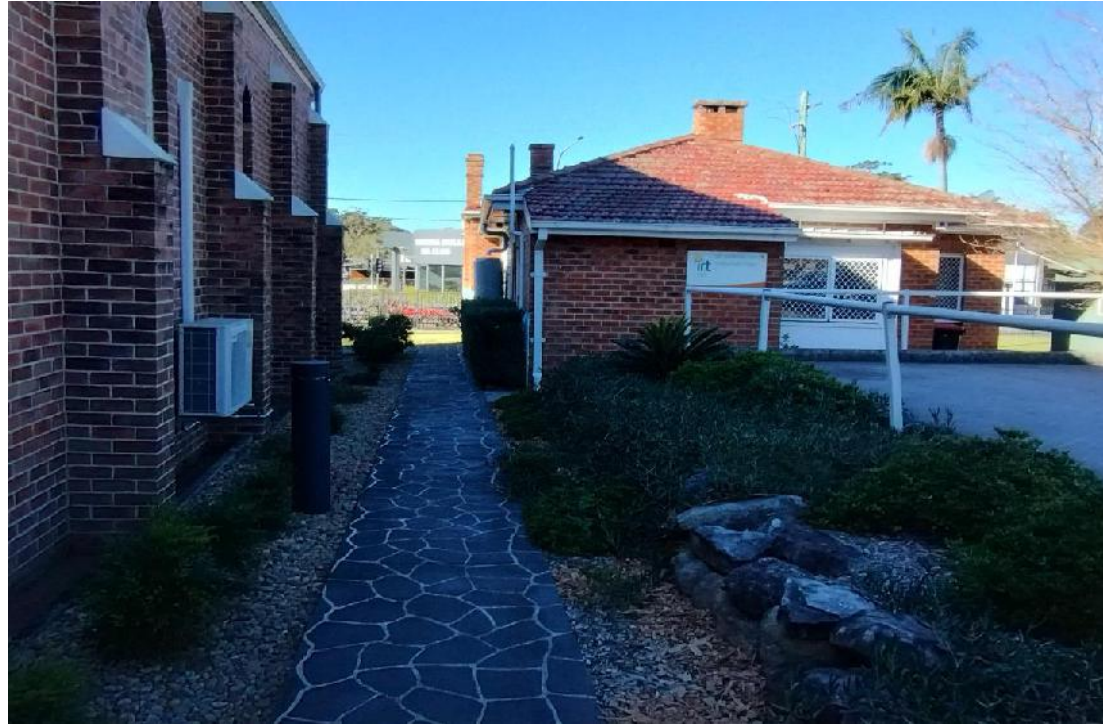
Photo 13: View of pathway adjacent to Blue Gum Sanctuary and the church, looking north.

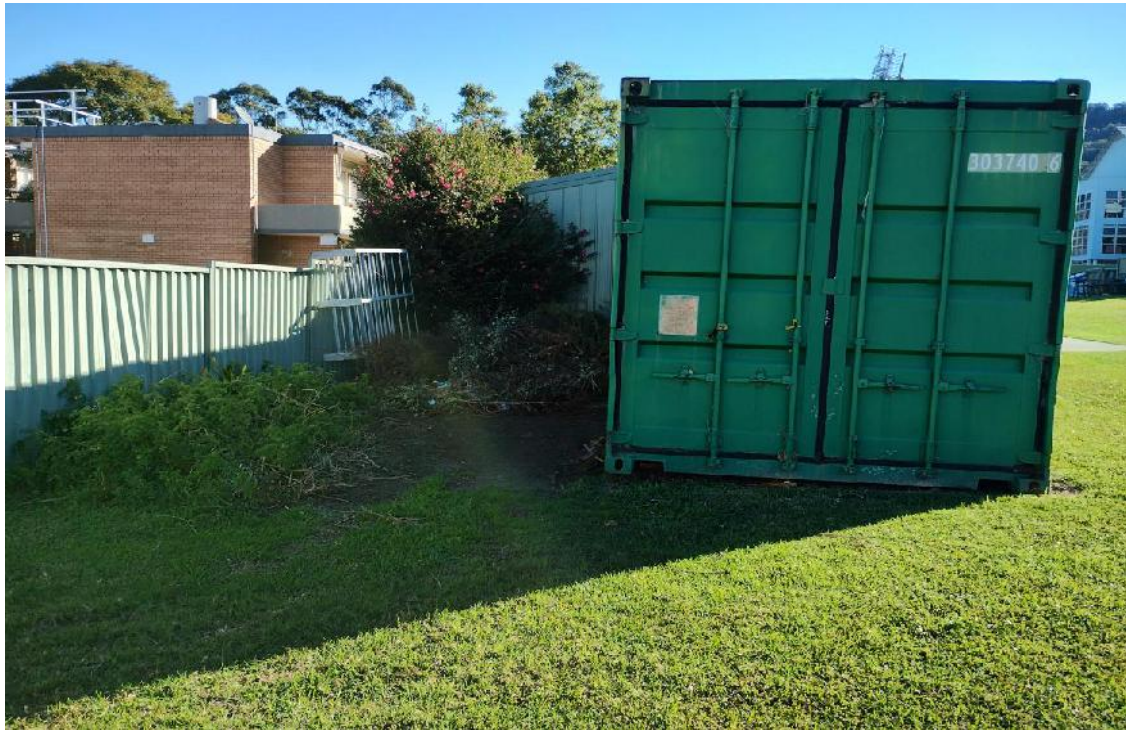
Photo 14: Storage container and tree debris storage area located east of main carpark, looking west.

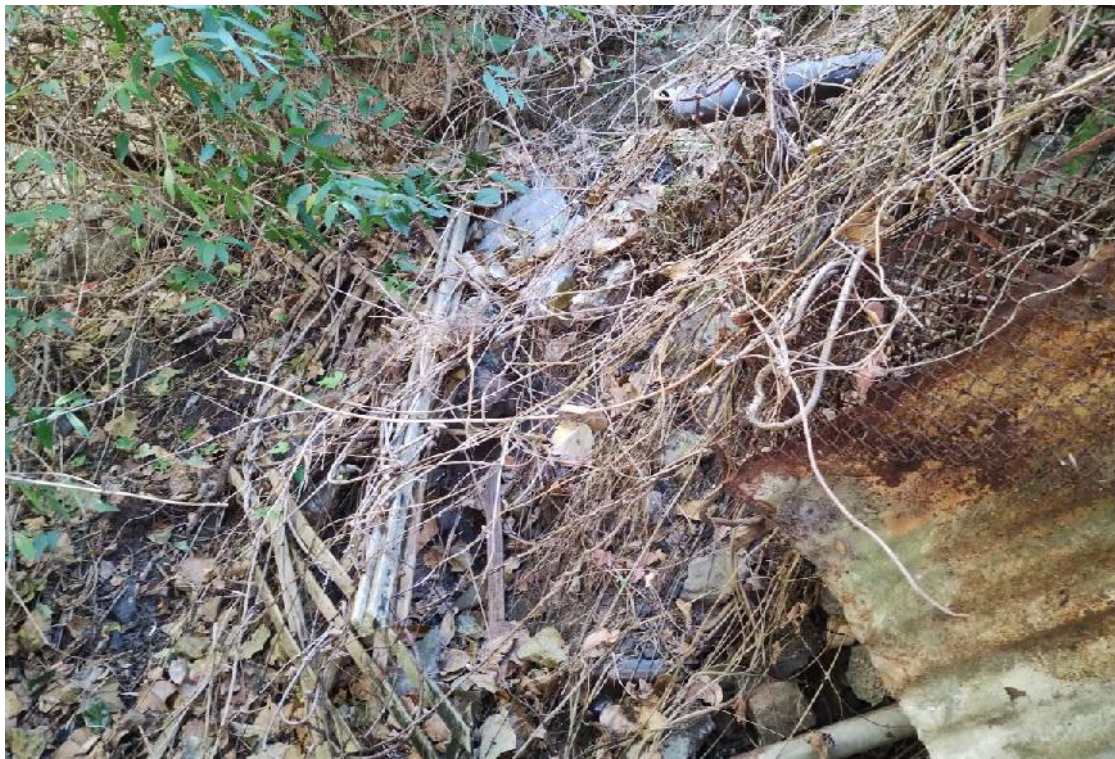
- A creek line (Collins Creek) and area of riparian vegetation was visible in the south western portion of the site. A tributary of Collins Creek was also visible adjacent to the south western site boundary which appeared to terminate in the south western corner of the site. Dumped building materials (including metal sheeting and timber) were visible in the vegetation directly south west of Blueberry Ash Village. Bricks were observed in a section of the creek line (refer to Photographs 15 and 19, Appendix E); and

Photo 15: Dumped building materials (i.e. corrugated metal sheeting, scrap metal, wire fencing) visible in tree vegetation along western boundary located south west of Blueberry Ash Village.

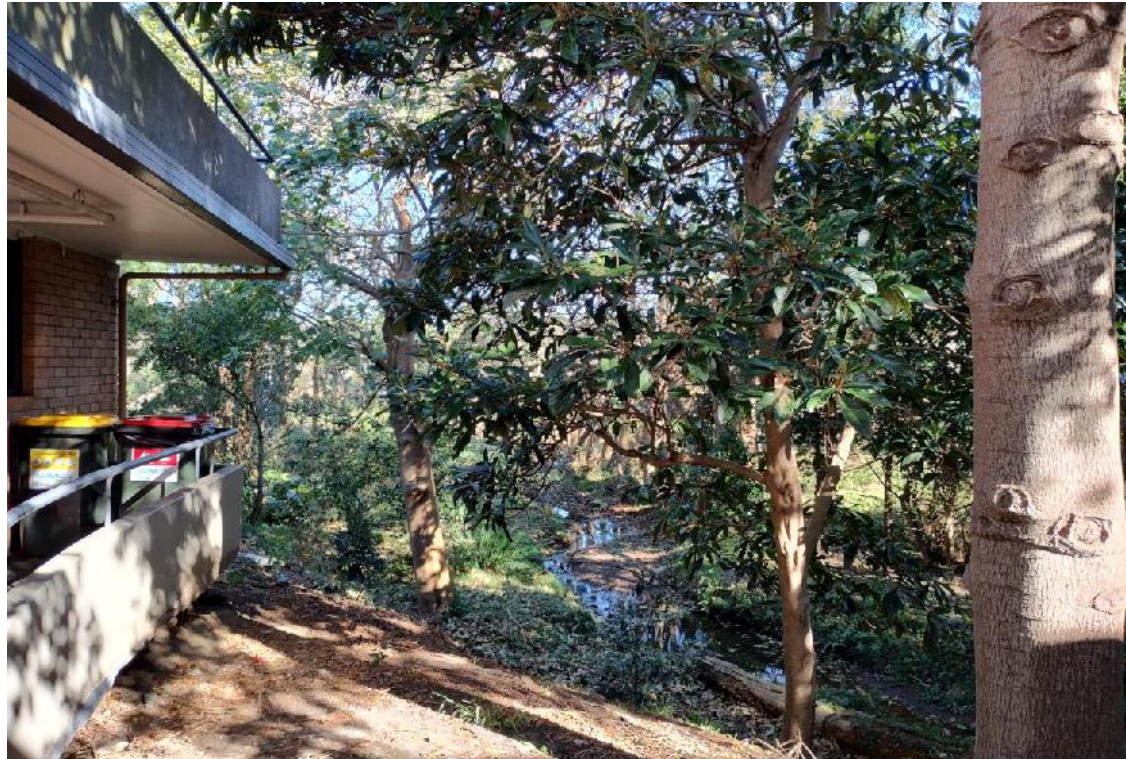
Photo 16: View of Collins Creek from Blueberry Ash Village, looking south east.

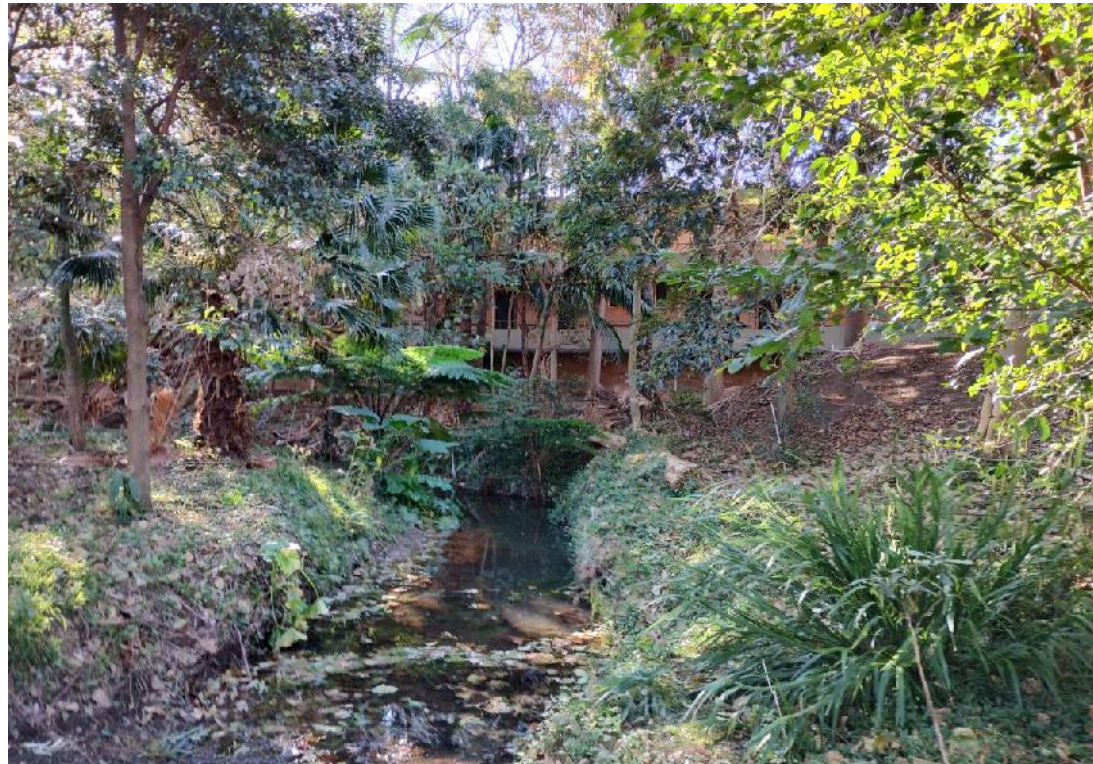
Photo 17: General view of creekline to the south of Bluberry Ash Village, looking north west.

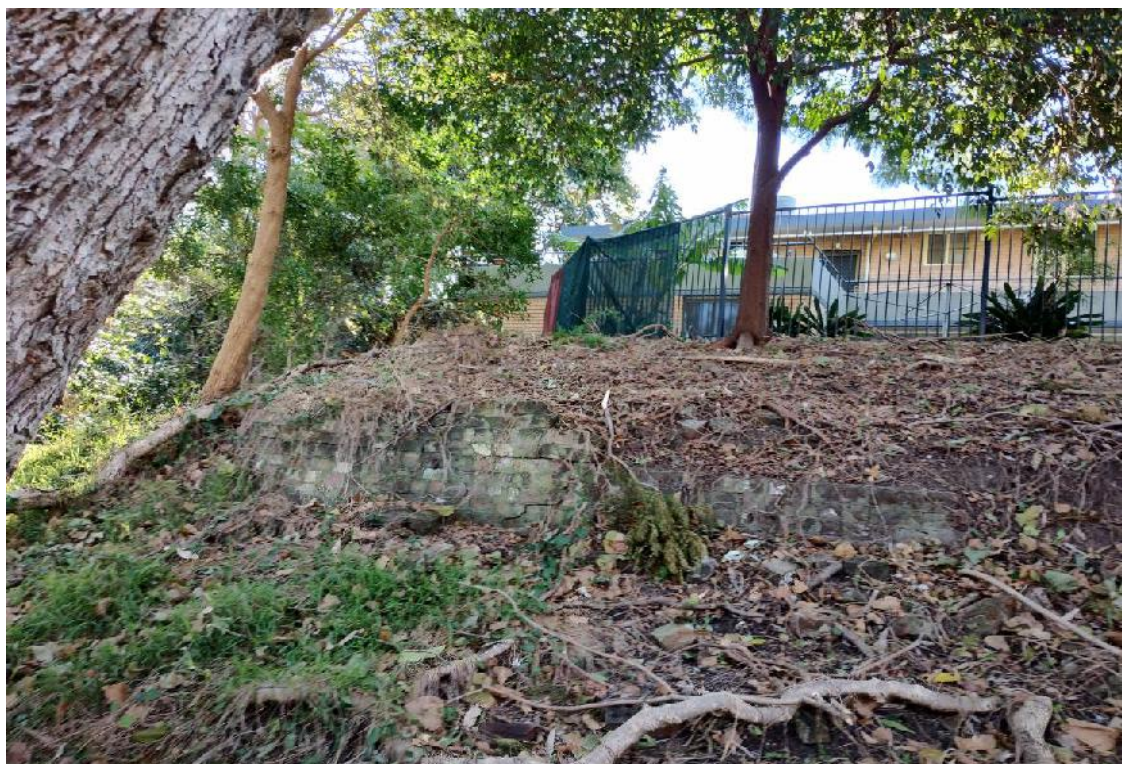
Photo 18: General view of south face of Blueberry Ash Village and former brick battering, looking north.

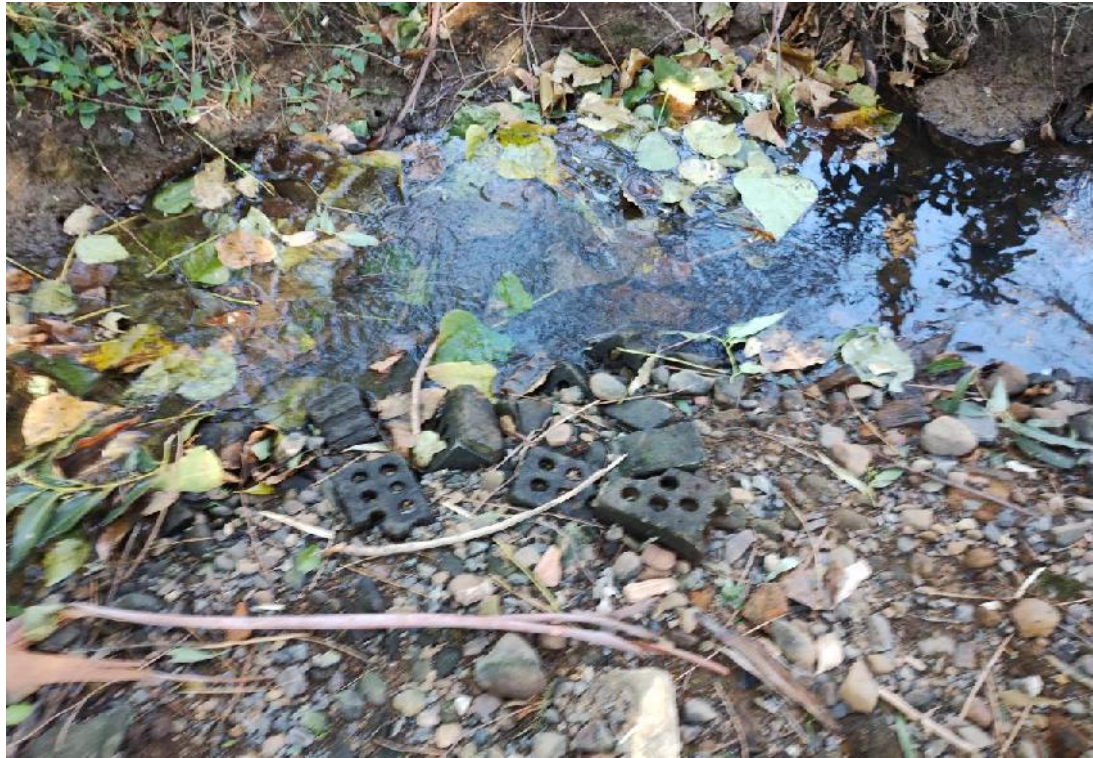
Photo 19: General view of bricks located in creekline bank.

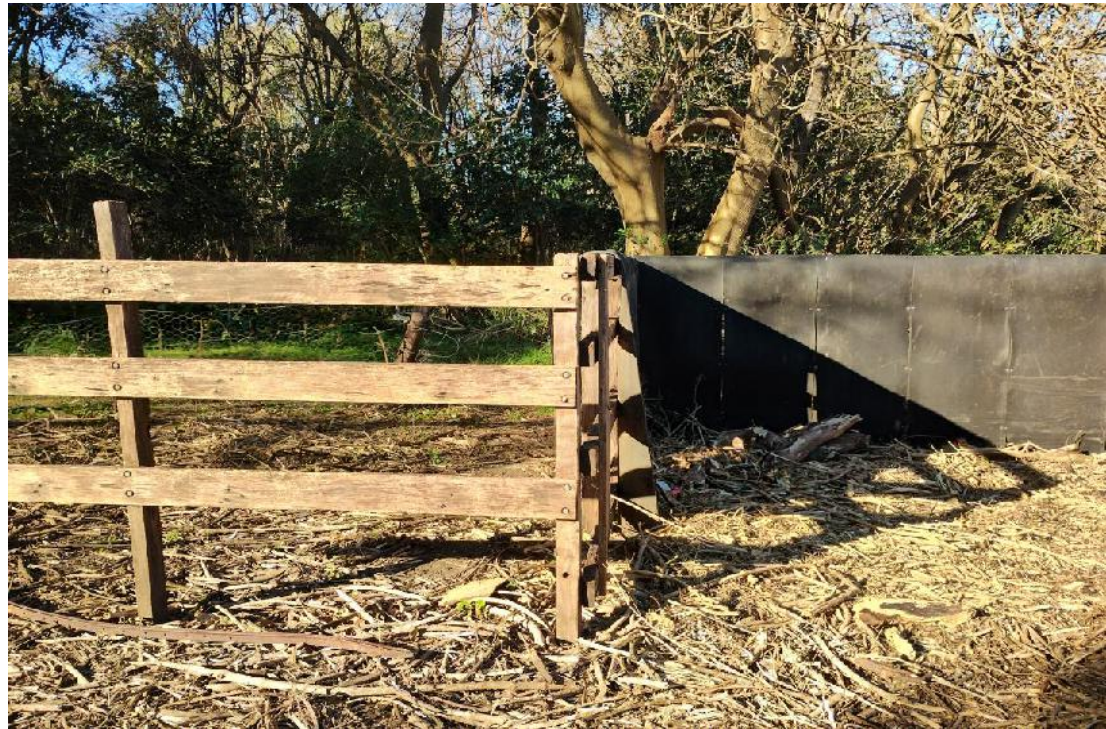
Photo 20: General view of former pen struecture in south western corner of the site, looking
