HAZARDOUS MATERIALS MANAGEMENT REGISTER

City of Parramatta

B003261, Riverside Theatres

Nov 2018

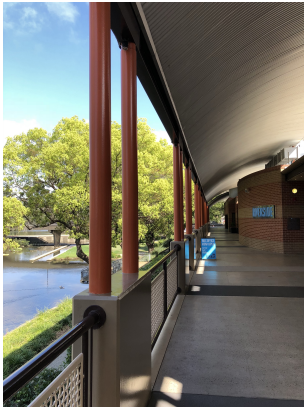
B003261-L24.2 Orange top coat External GF
External Riverside walkway Metal structural
beams

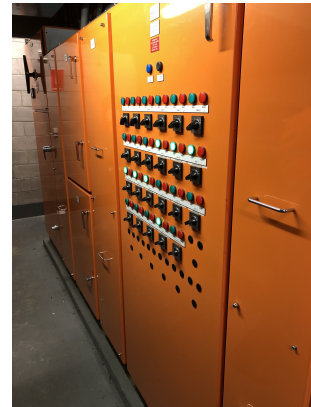
B003261-L24 Orange top coat Internal L1 Plant
Room 1 Electrical box

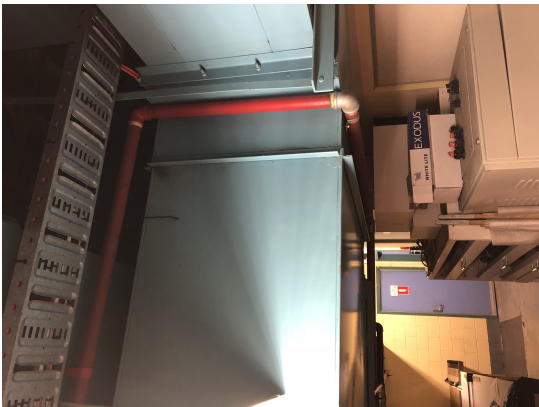
B003261-L3.1 Red undercoat Internal L1 Plant
Room 1 Metal pipework & ladder

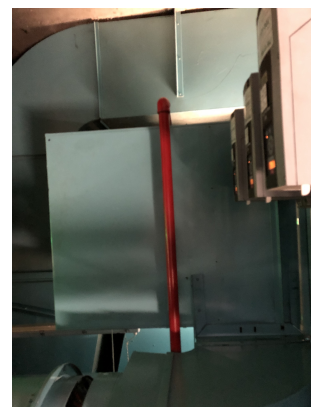
B003261-L3.2 Red undercoat Internal L1 Plant
Room 2 Metal pipework & ladder

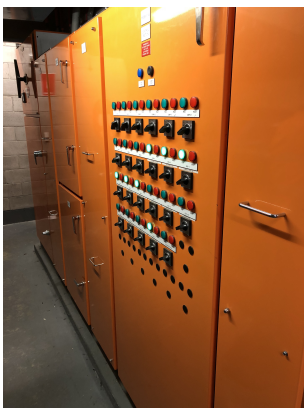
B003261-L24.1 Orange top coat Internal L1 Plant
Room 2 Electrical box

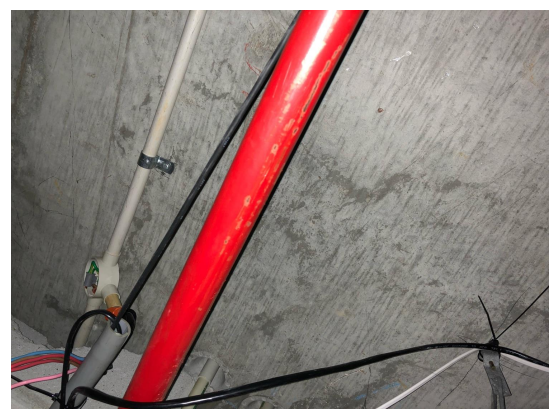
B003261-L11 Red top coat Internal GF Dressing
room 1 Metal gas pipework throughout ground
floor

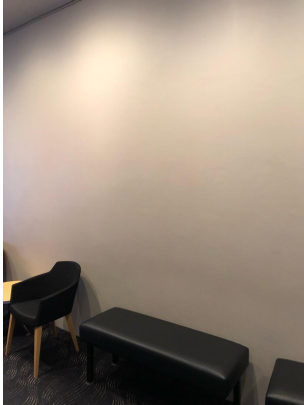
B003261-L22 Internal GF Bar Area Walls

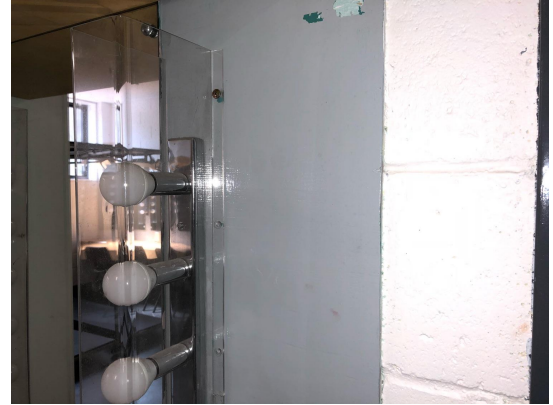
B003261-L14 Grey top coat Internal GF Dressing room 1 Timber wall paneling

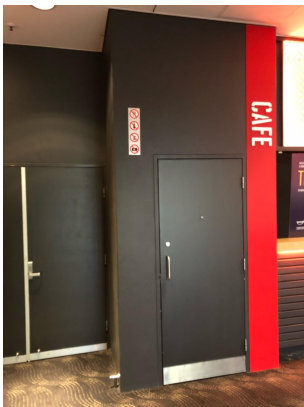
B003261-L21 Black top coat Internal GF Café Walls surrounding café

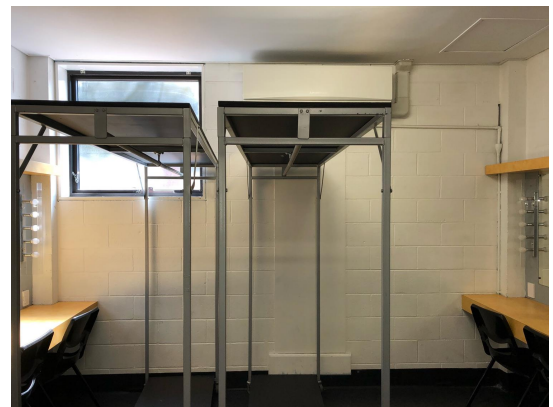
B003261-L12 White top coat Internal GF Dressing room 1 Walls

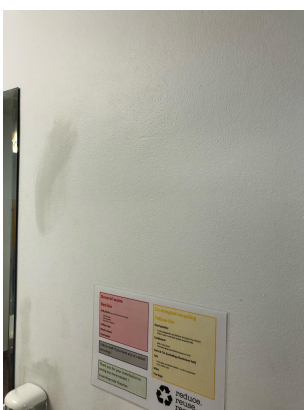
B003261-L15 Light blue topcoat with yellow undercoat Internal GF Dressing room 1 toilets Walls

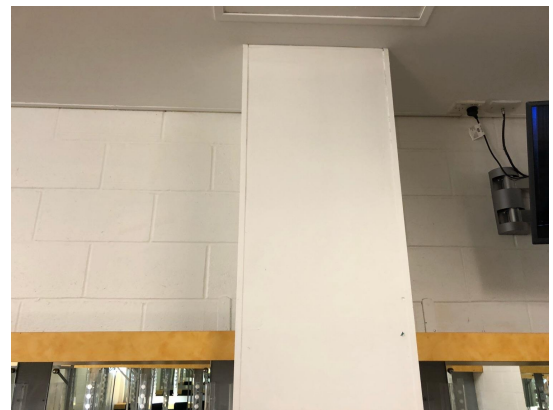
B003261-A4 Asbestos Cement Internal GF Dressing room 1 Boxing panels

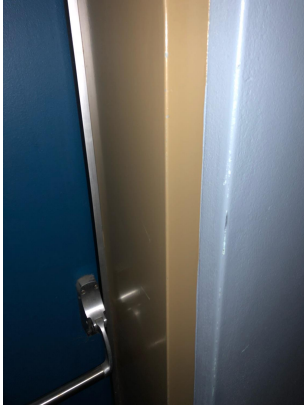
B003261-L19 Light brown top coat to blue undercoat Internal GF Fire exit lobby to courtyard
Metal Frame work

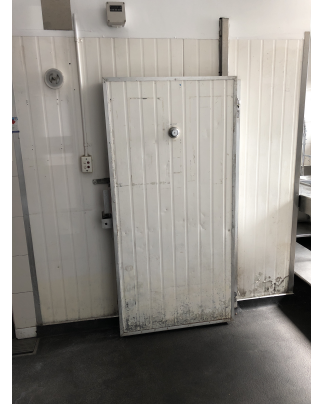
Internal GF Kitchen Area No access within fridges due to being locked

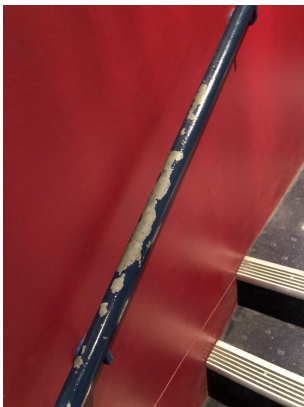
B003261-L20 Dark blue top coat to light blue undercoat Internal GF Fire exit lobby to courtyard
Metal Handrails

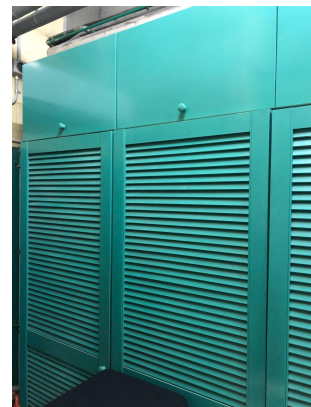
B003261-L8.3 Green top coat to blue undercoat Internal GF Laundry Room Timber built cupboards

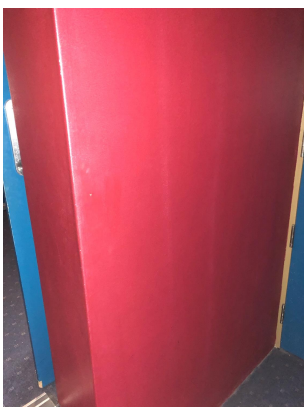
B003261-L17 Red top coat Internal GF Fire exit lobby to courtyard Walls

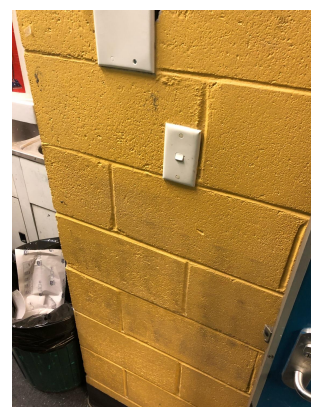
B003261-L10.1 Dark yellow top coat Internal GF Laundry Room Walls lower level

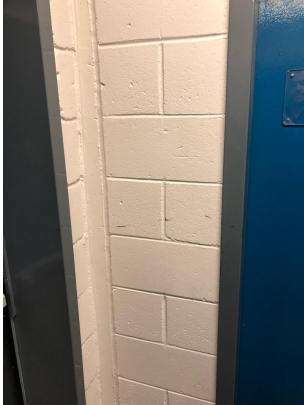
B003261-L16.1 Grey top coat with yellow undercoat Internal GF Lobby leading to courtyard Walls

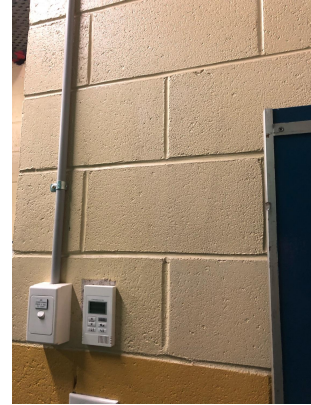
B003261-L9.2 Light yellow top coat Internal GF Laundry Room Walls high level

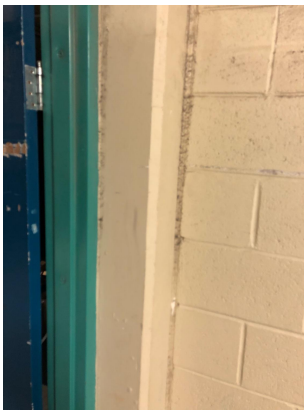
B003261-L1.2 Green top coat to brown undercoat Internal GF Technical office Walls

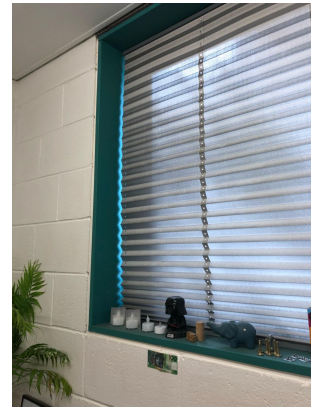
B003261-L8.1 Green top coat to blue undercoat Internal GF Operations manager Window surround

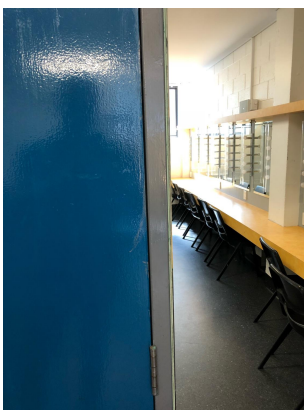
B003261-L1.1 Green top coat to brown undercoat Internal GF Westside of Ground Floor Doors throughout ground floor

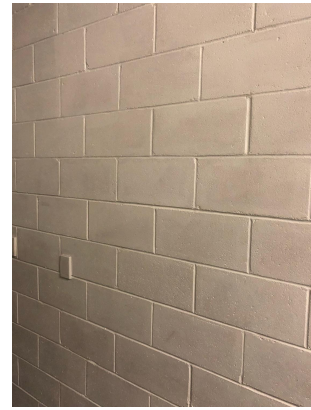
B003261-L9.3 Light yellow undercoat Internal GF Production room Walls beneath green and blue

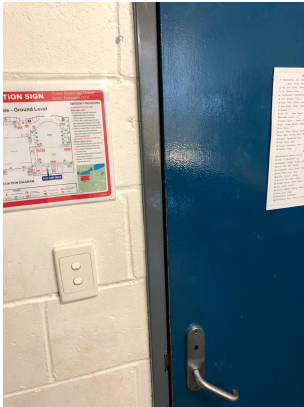
B003261-L13 Grey top coat Internal GF Whole
Ground Floor Door frames

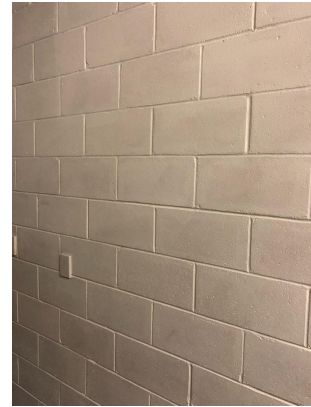
B003261-L12.4 White top coat Internal GF
Production room Walls

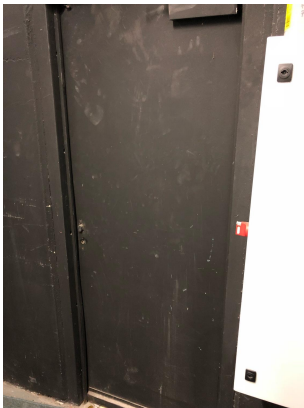
B003261-A3 Asbestos insulation board Internal
B1 Orchestra Pit Door internal lining

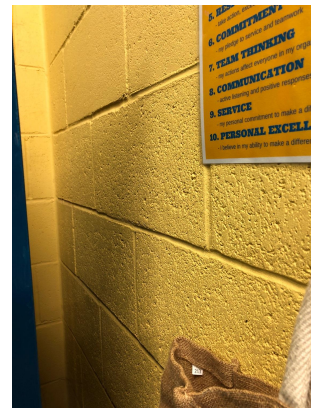
B003261-L9.1 Light yellow top coat Internal GF
Technical office Walls

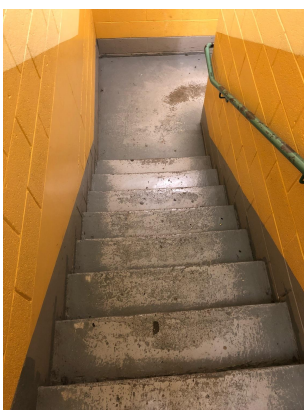
B003261-L7 Grey top coat Internal B1 Stairs to
basement Floor paint

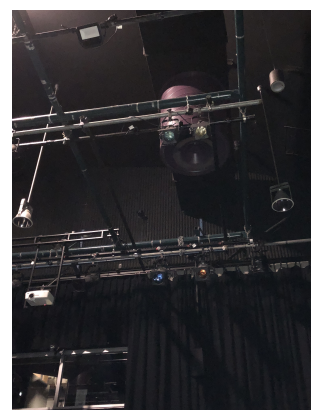
Internal GF Throughout No access above 2.7
meters high due to height restrictions

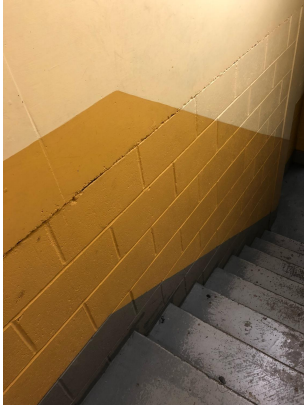
B003261-L10 Dark yellow top coat Internal B1
Stairs to basement Lower level dark yellow

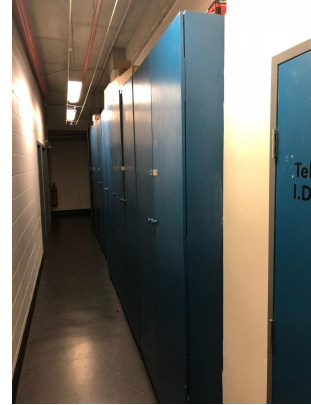
B003261-L8.2 Green top coat to blue undercoat
Internal GF Walkway Timber built cupboards

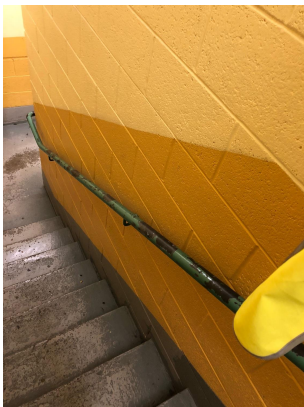
B003261-L8 Green top coat to blue undercoat
Internal B1 Stairs to basement Metal Handrails

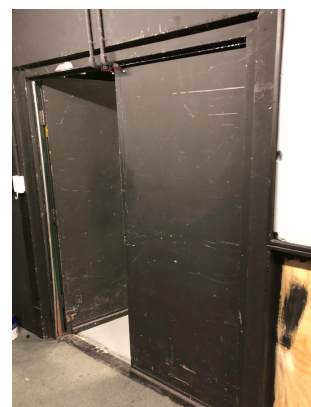
B003261-L6 Black top coat to red undercoat
Internal B1 Orchestra Pit Doors & door frames

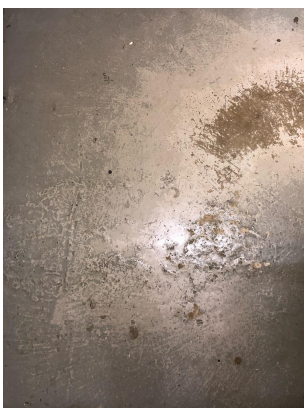
B003261-L7.1 Grey top coat Internal B1 Substage
Floor paint

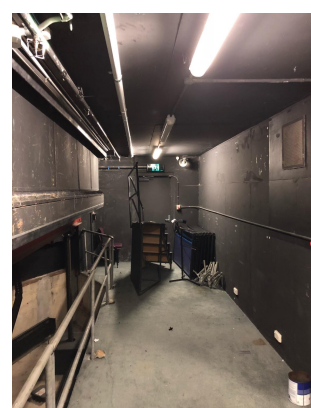
B003261-L6.1 Black top coat to red undercoat
Internal B1 Orchestra Pit Walls & Ceiling

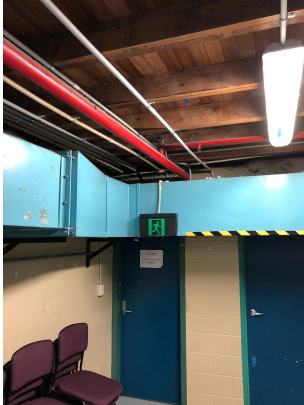
B003261-A2 Mastic Internal B1 Substage Mastic to metal ductwork

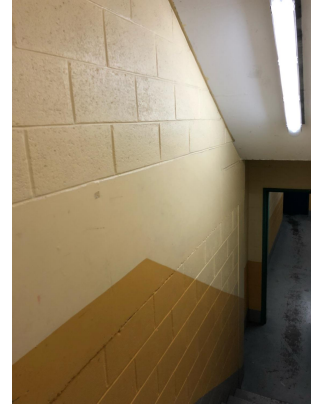
B003261-L9 Light yellow top coat Internal B1 Stairs to basement Higher level light yellow

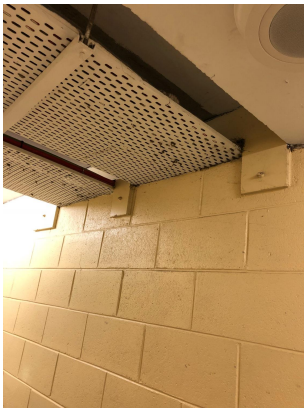
B003261-A1 Asbestos Cement Internal B1 Walkway Panels around high level cabling

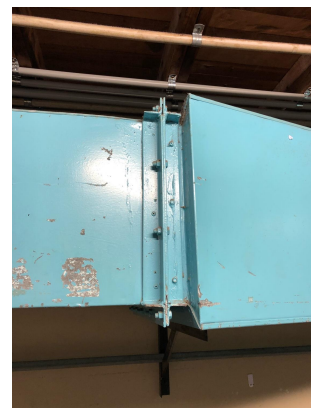
B003261-L5 Blue top coat to white undercoat Internal B1 Substage Metal Ductwork

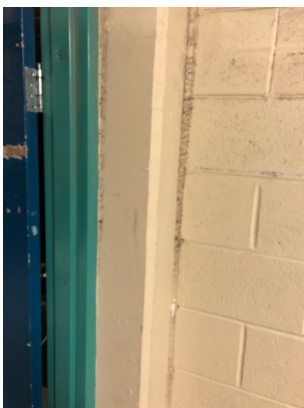
B003261-L1 Green top coat to brown undercoat Internal B1 Whole Level Door frames throughout basement

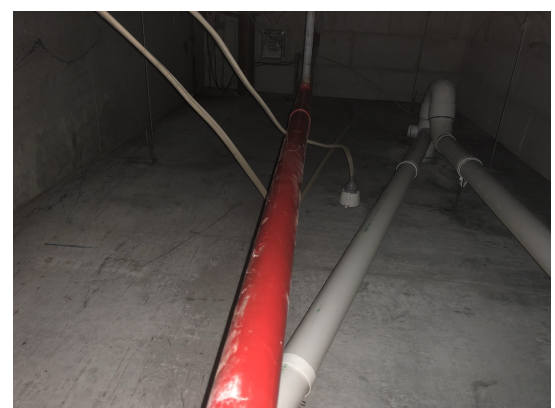
B003261-L3 Red top coat Internal B1 Whole Level Metal gas pipework throughout basement

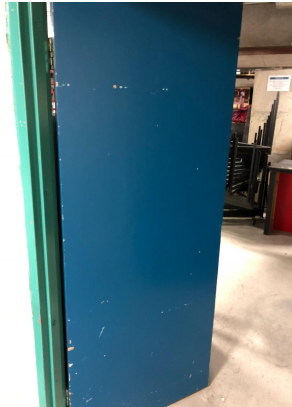
#	Reference #	Hazard	Results	Material Description	Location	Quantity	Friability	Overall Risk Rating ¹	Action Item	RECOMMENDED TIME FRAMES
110	B003261-L2	Lead	<0.1 %w/w	Blue top coat to white undercoat	Internal, B1, Whole Level, Doors throughout basement	25 m ²	n/a	n/a	A5	-

B003261-L2 Blue top coat to white undercoat
Internal B1 Whole Level Doors throughout
basement

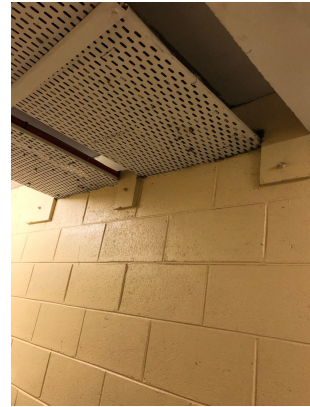
B003261-L4 Cream top coat Internal B1 Whole
Level Walls
