# Riverside Theatres

## Geotechnical Report (SSDA submission)

Reference: GE-RP-0001

Final | 4 March 2025

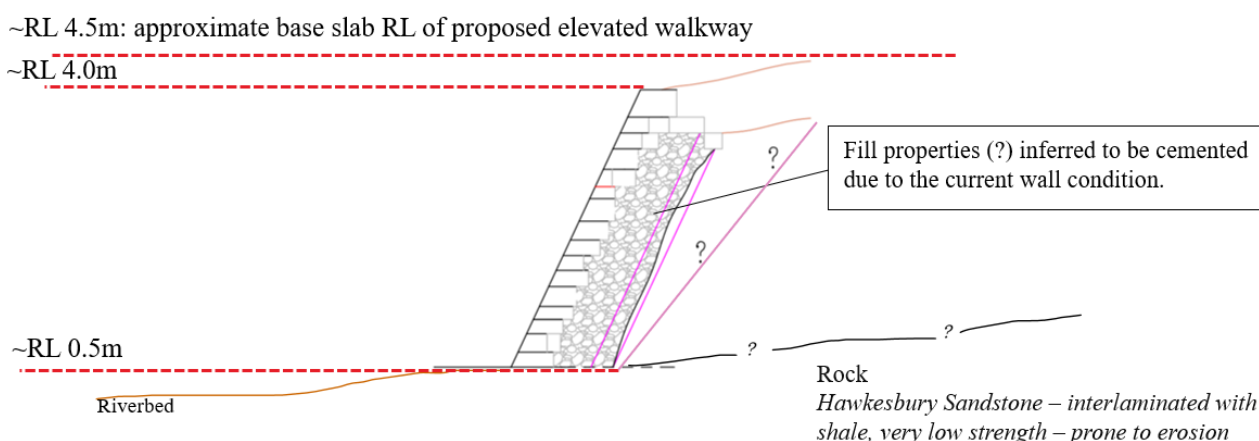
Figure 5 Indicative Section of the Parramatta Riverbed and Riverbank Wall

Riverbed levels at the time of the second site walkover, where the river was drained for access, varied between ~RL+0.5m at the toe of the Parramatta Riverbank Wall to ~RL-1.0m at the middle of the riverbed.

In the exposed sections of the riverbed, bedrock outcrop was visible consisting of weathered sandstone interlaminated with shale. An indicative section is provided below.

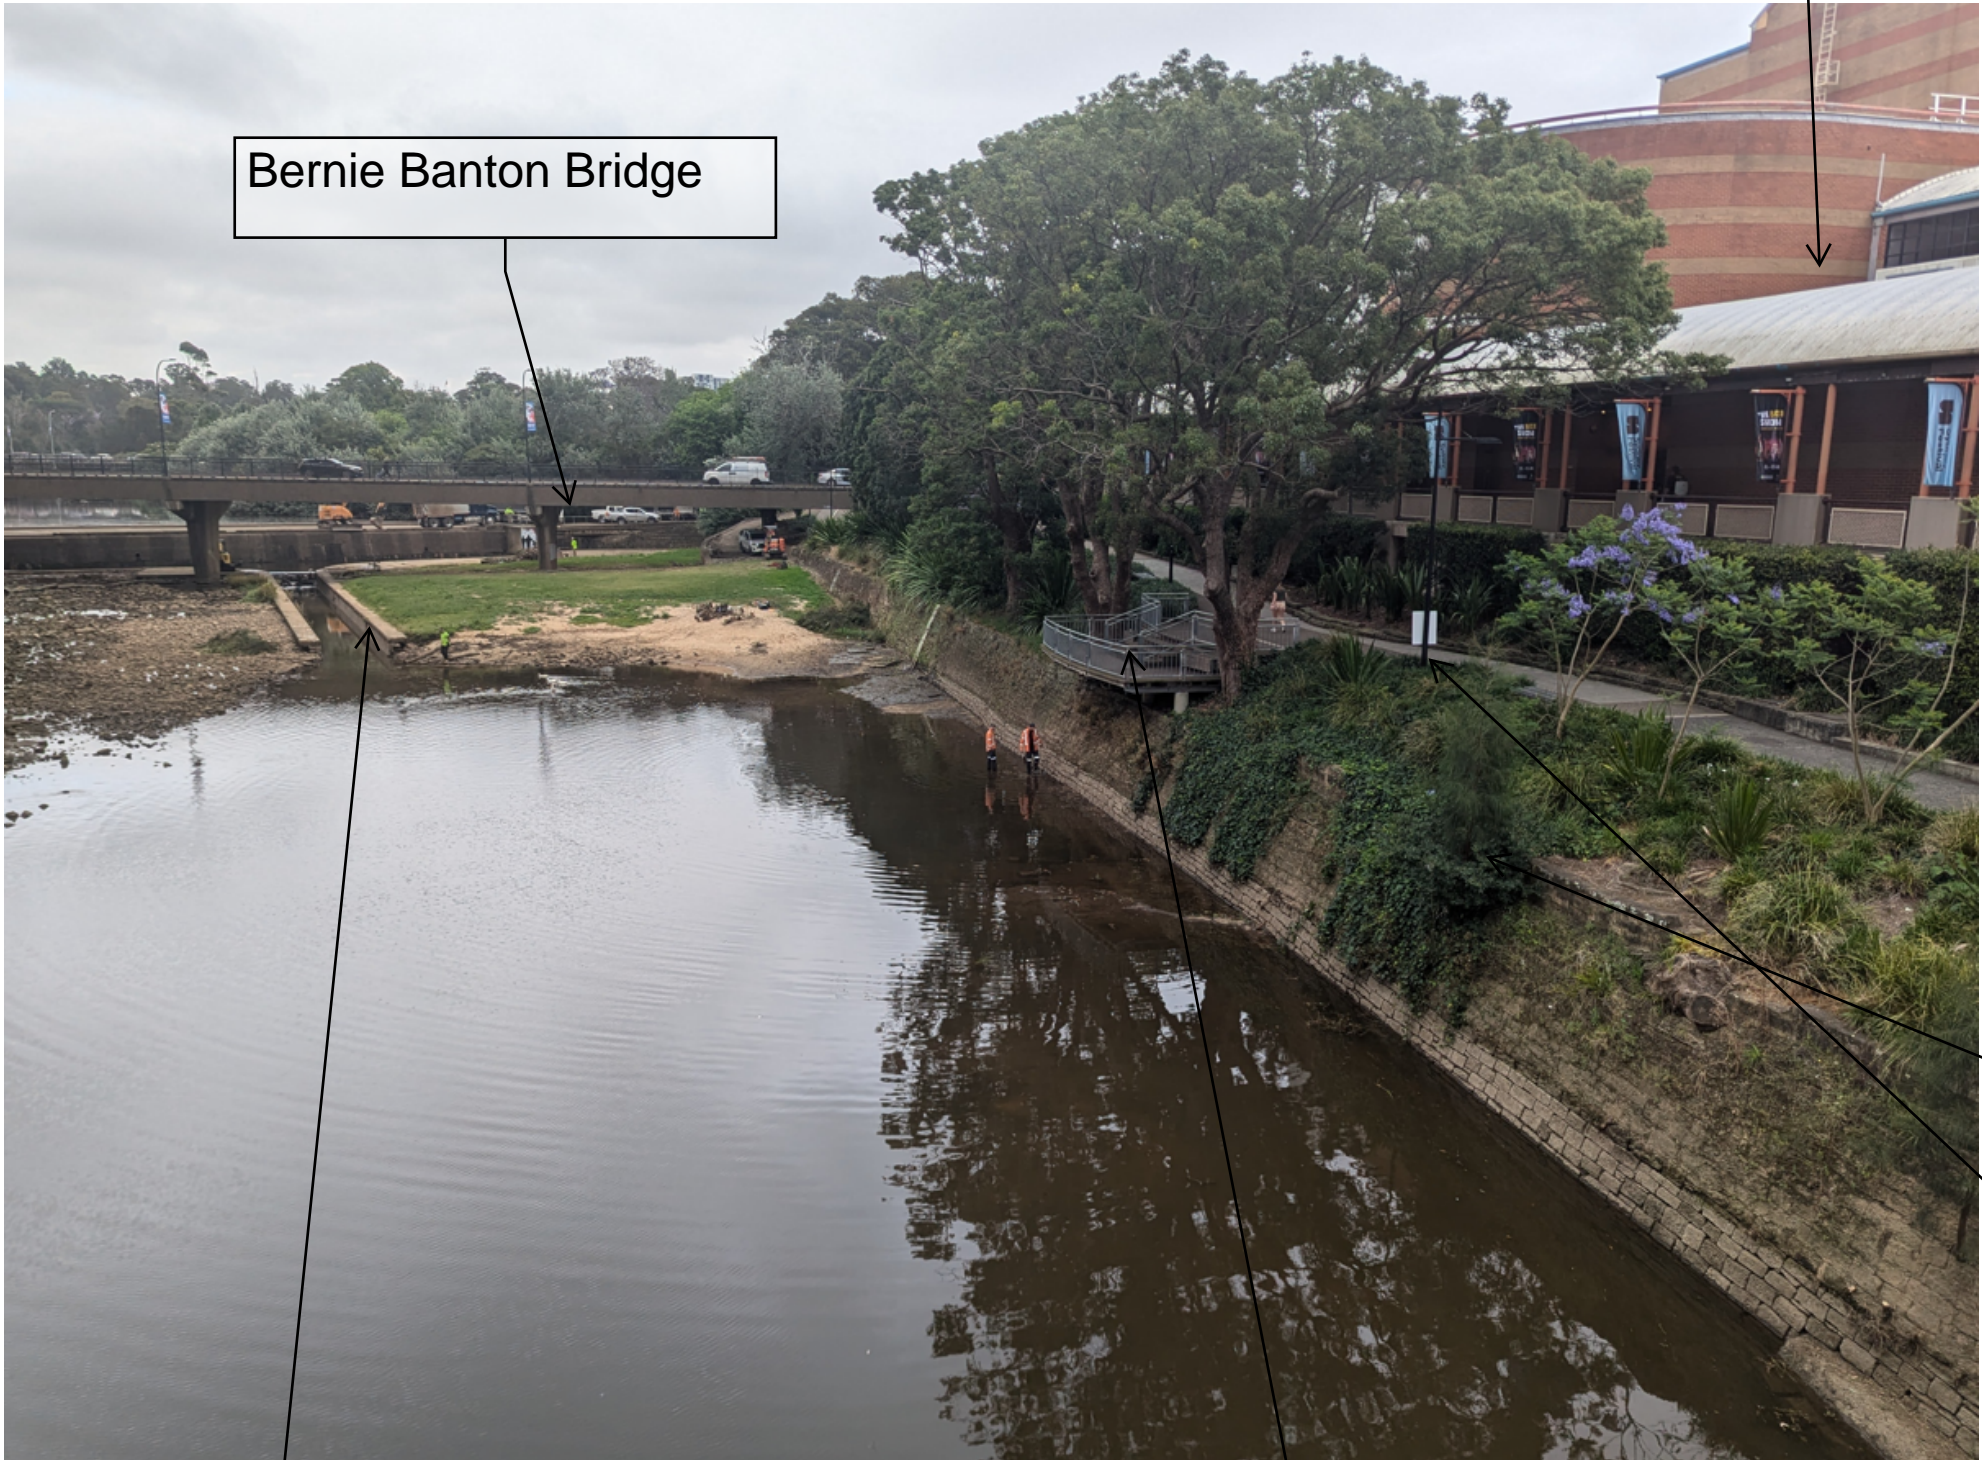
The wall is approximately 10-15m offset from the edge of the Riverside Theatres and of varying heights of 3-4m. There are visible signs of wear on the wall with vegetation growing out of the gaps in between the masonry blocks. Lower sections, normally submerged due to the river level, appear to have little to no mortar left. There also appears to be tree roots that have grown into the wall. In upper sections of the wall, mulch and algae cover the sandstone blocks. From the visual inspection the maintenance of the wall visual condition appears to be infrequent, particularly on the western end of the wall.

Various lightpoles along the Riverbank Wall

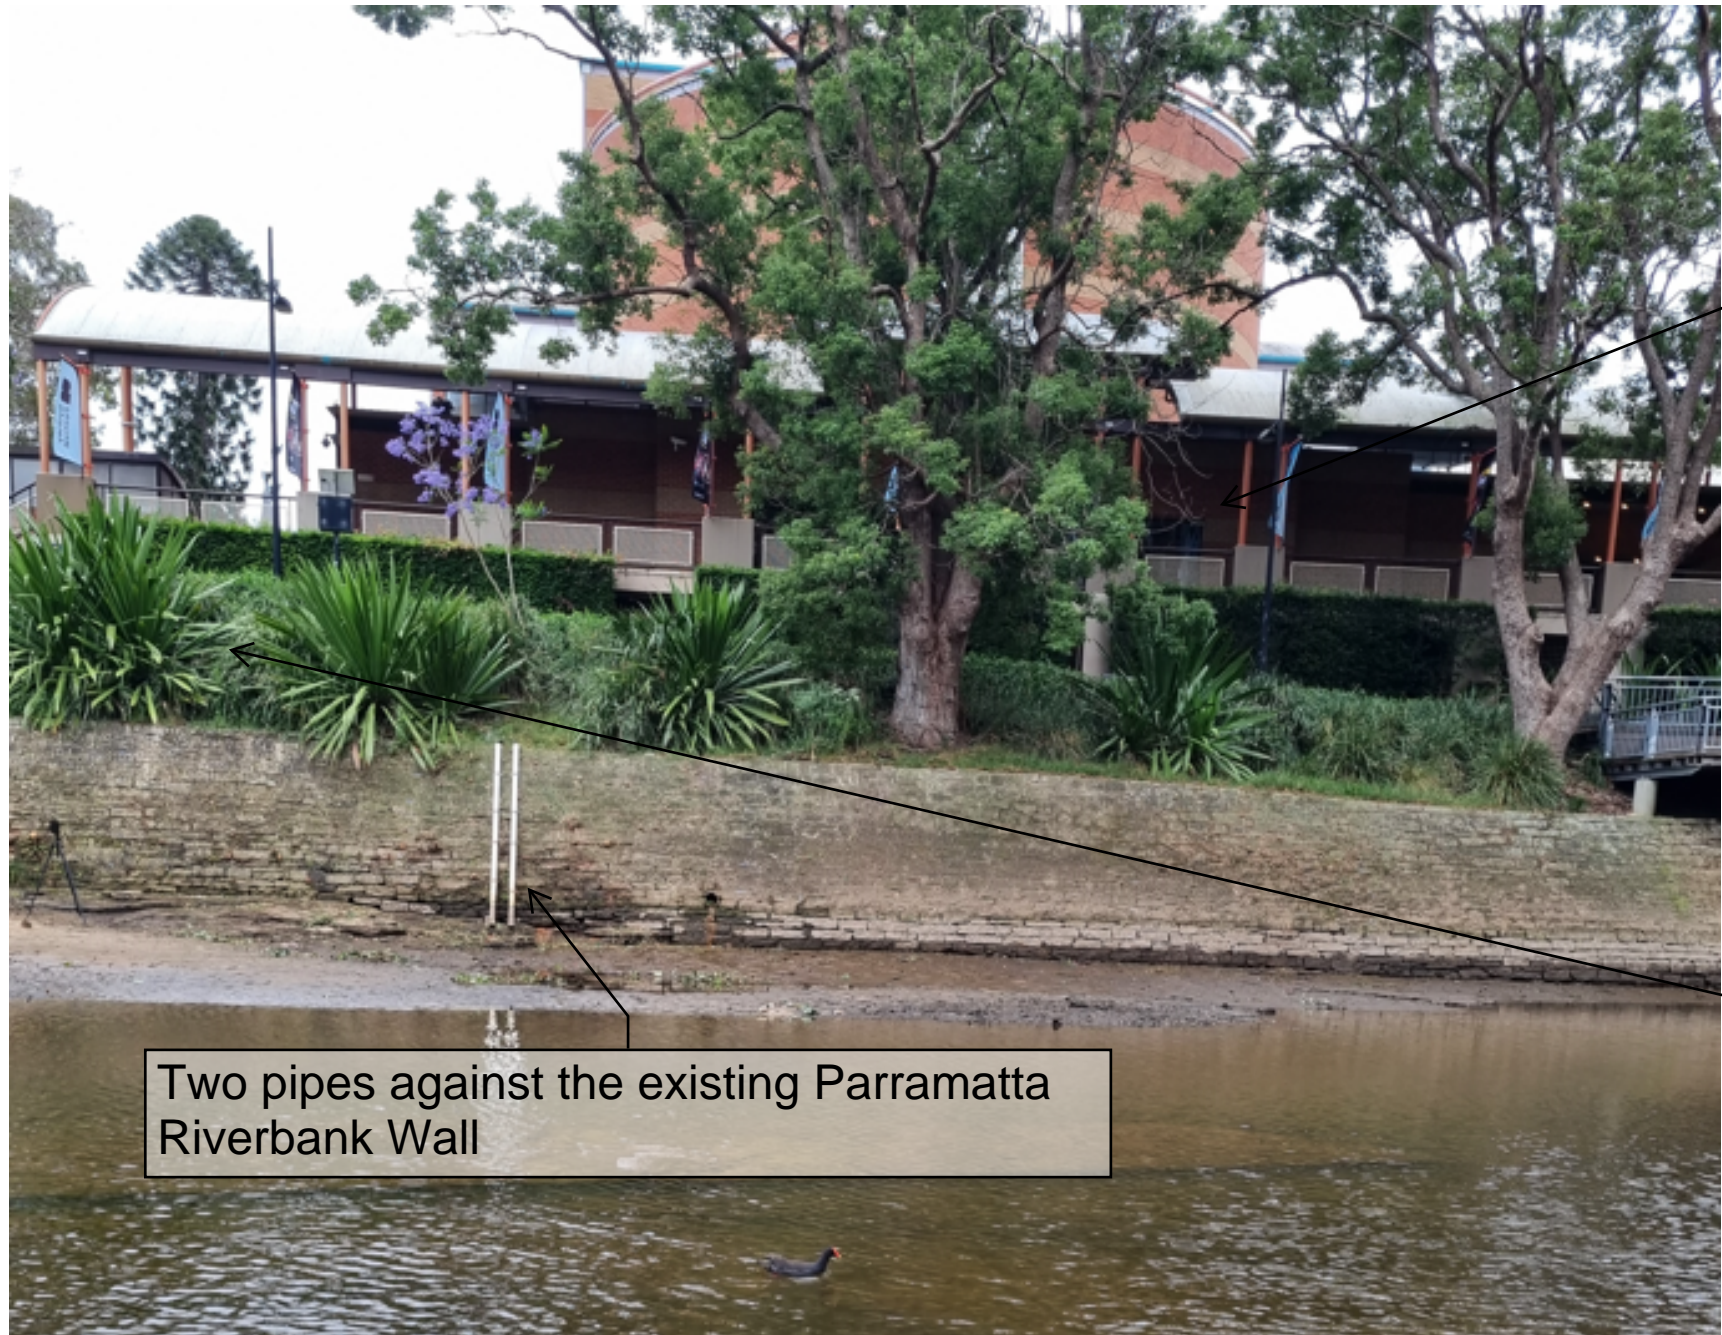
Steep slopes  $>45^\circ$  and grown vegetation - difficult access

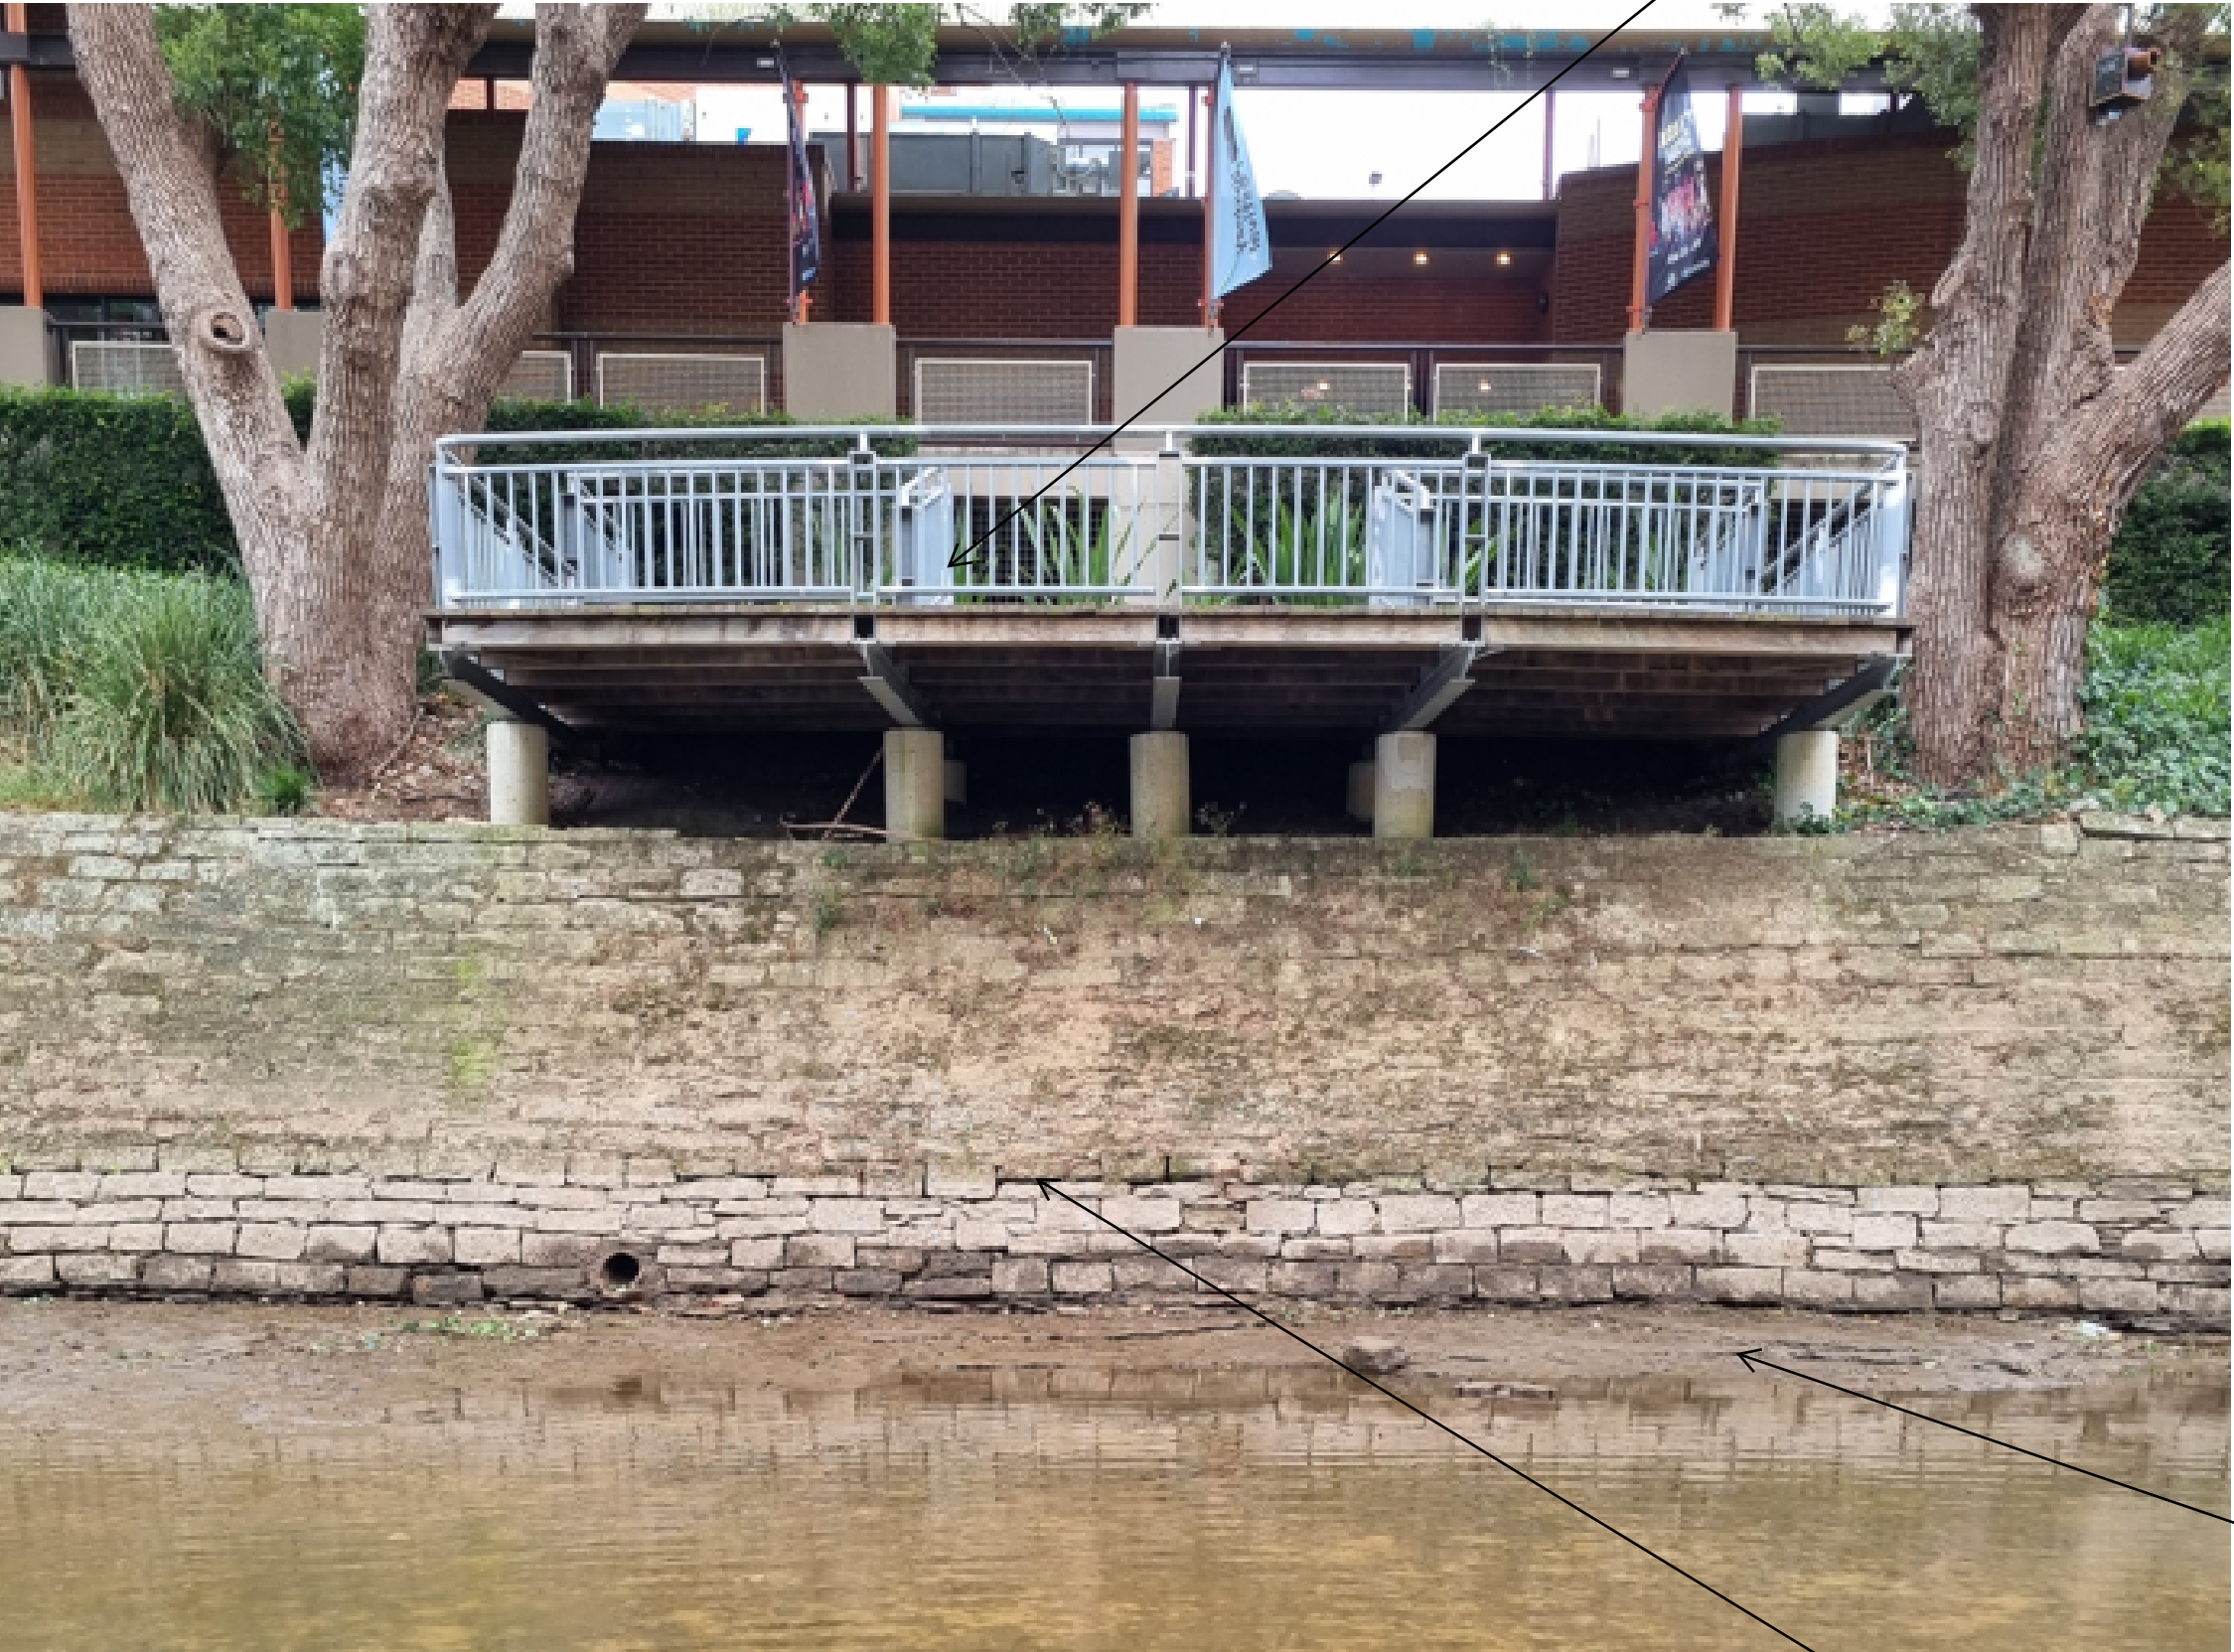
Highly weathered rock  
observed at surface of  
riverbed

Blocks without mortar -  
typically under river level

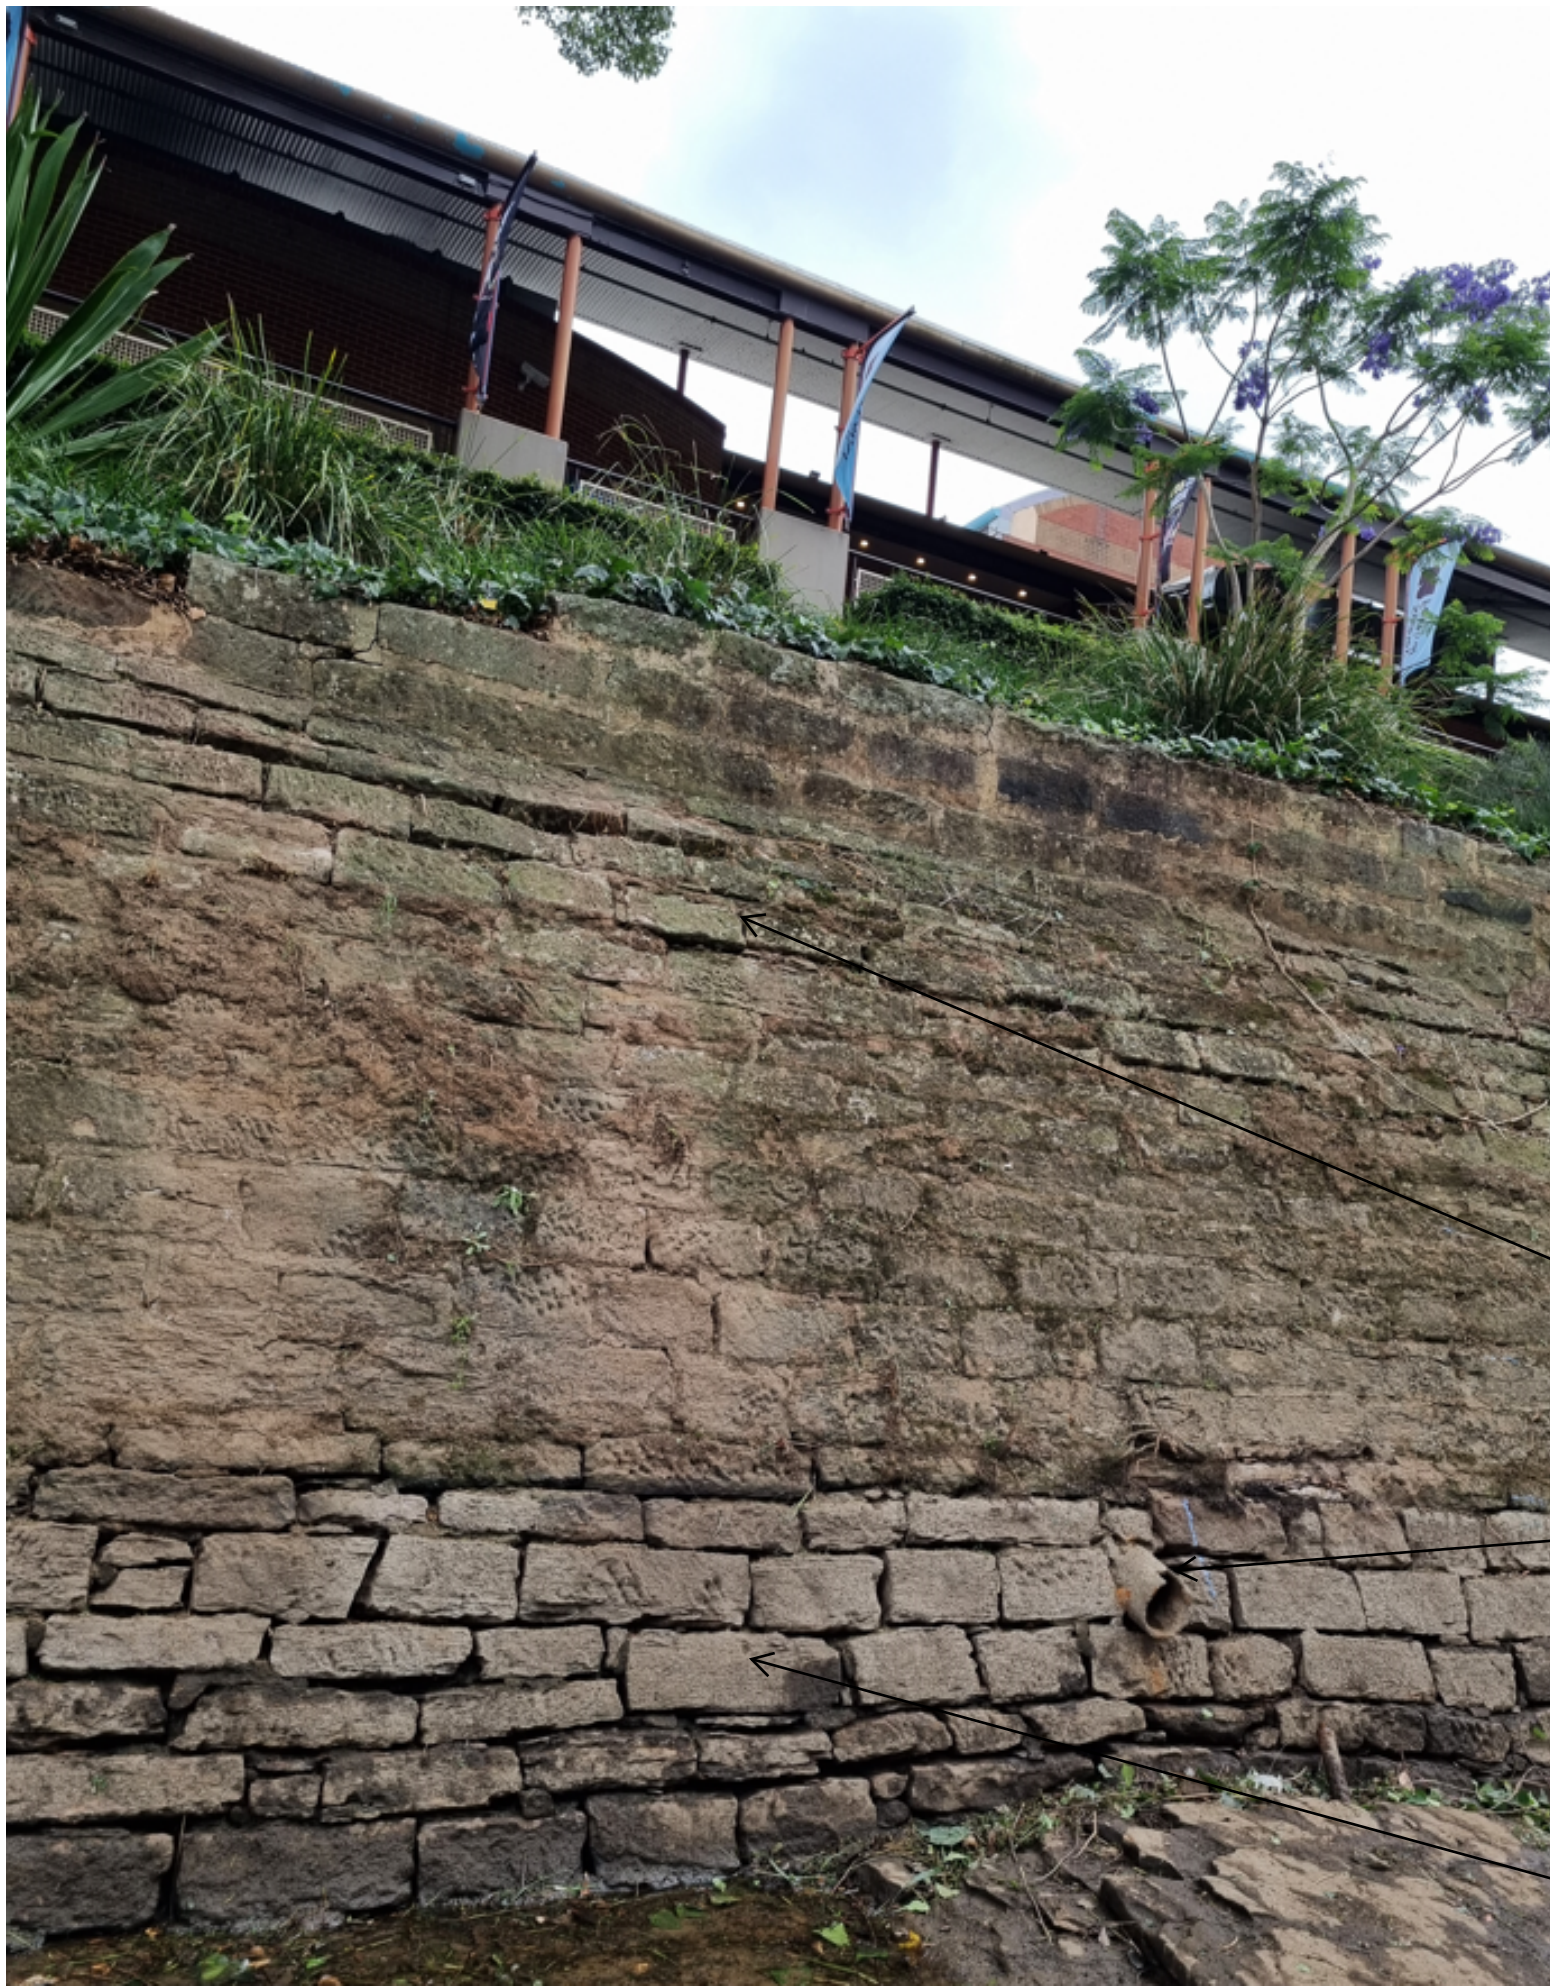
A piled platform also sits in the middle of the southern boundary of the Site overlooking onto the river, over the wall. Some longitudinal cracks were observed on the wall in this area. There also appears to be sandstone blocks dislodged, likely during the initial construction process of the piled platform.

Vegetation removed. Some blocks have dislodged

Broken plastic piping

Blocks without mortar - typically under river level
