## **Asbestos & Lead Paint Risk Assessment Report**

**Building Ref: H02**

**The Darlington Centre**

**16/05/2012**

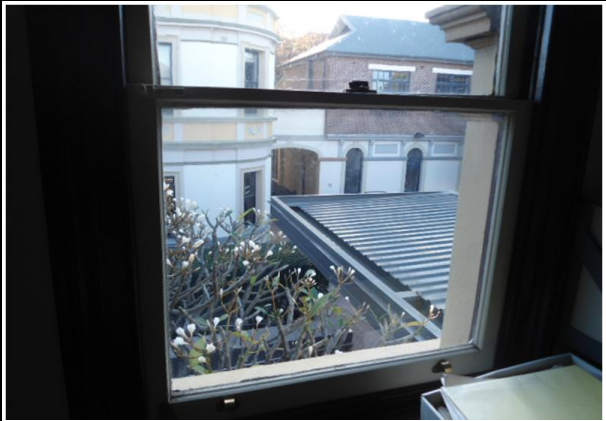
Photo No: J105234-H02-7909 Result: Lead Paint  
Positive 9.9%

Location-Level: L02  
Room-Location: All rooms - Various Throughout  
Feature-Material: Windows - Cream - Upper coloured paint system

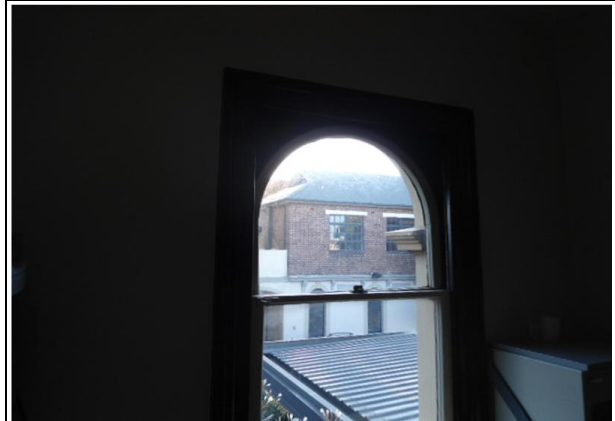
Photo No: J105234-H02-7910 Result: Lead Paint  
Positive 5.4%

Location-Level: L02  
Room-Location: All areas - Various Throughout  
Feature-Material: Window frames - White - Lower coloured paint system

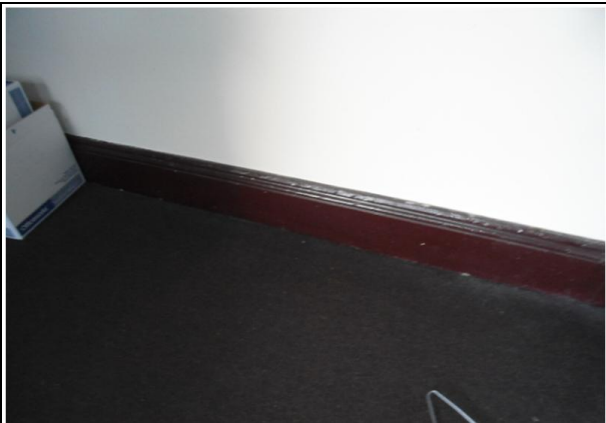
Photo No: J105234-H02-7911 Result: Lead Paint  
Presumed Positive

Location-Level: L02  
Room-Location: All areas - Throughout  
Feature-Material: Skirting board - White - Lower coloured paint system

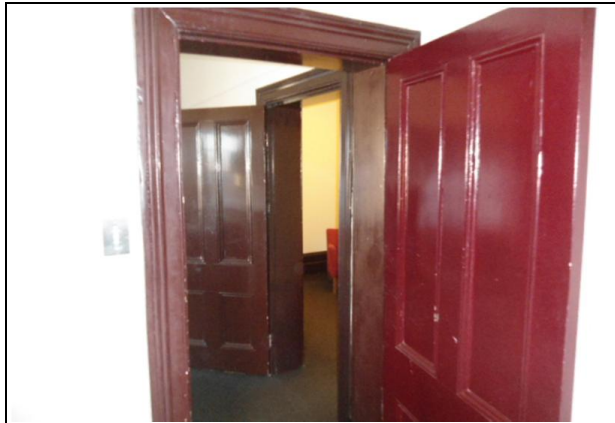
H02	L02	All areas	Various Throughout	Door frame - White - Lower coloured paint system	Lead Paint	Similar to J105234-H02-LP-2	Presumed Positive	J105234-H02-7912	10 m2	Fair	-	-	-	-	-	May-17	Engage an appropriate contractor to remove peeling paint and paint over with a coat of lead-free coat as part of ongoing maintenance. Maintain in good condition. If refurbishment works are likely to involve the disturbance of confirmed lead containing paint, dust suppression techniques should be utilized.	
H02	L02	Exterior	Various Throughout	Window frames - White - Lower coloured paint system	Lead Paint	J105234-H02-LP-3	Positive 2.3%	J105234-H02-7916	15 unit/s	Poor	-	-	-	-	-	May-13	Engage an appropriate contractor to remove peeling paint and paint over with a coat of lead-free coat as part of ongoing maintenance. Maintain in good condition. If refurbishment works are likely to involve the disturbance of confirmed lead containing paint, dust suppression techniques should be utilized.

Photo No: J105234-H02-7912 Result: Lead Paint  
Presumed Positive

Location-Level: L02  
Room-Location: All areas - Various Throughout  
Feature-Material: Door frame - White - Lower coloured paint system

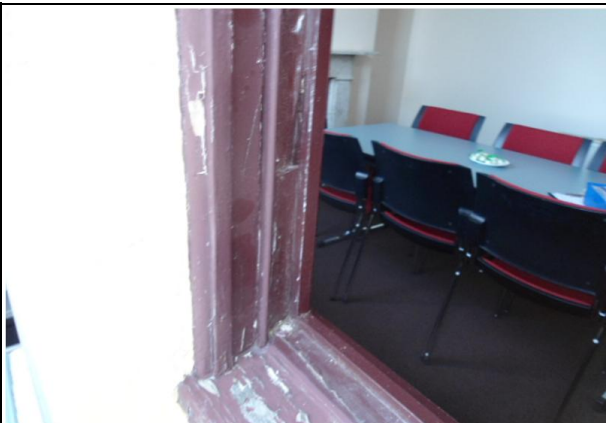
Photo No: J105234-H02-7916 Result: Lead Paint  
Positive 2.3%

Location-Level: L02  
Room-Location: Exterior - Various Throughout  
Feature-Material: Window frames - White - Lower coloured paint system

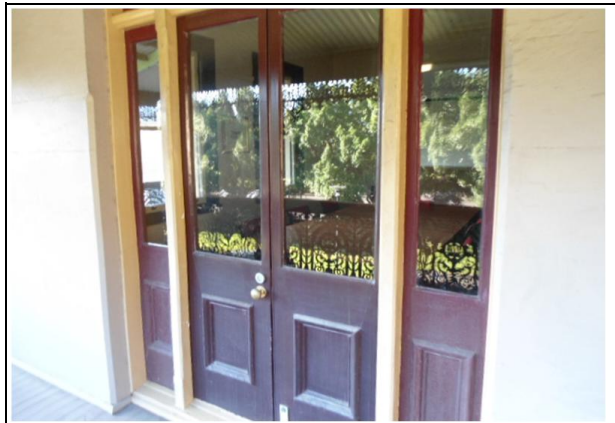
Photo No: J105234-H02-7917 Result: Lead Paint  
Presumed Positive

Location-Level: L02  
Room-Location: Verandah - Various  
Feature-Material: Windows & door frames - White - Lower coloured paint system

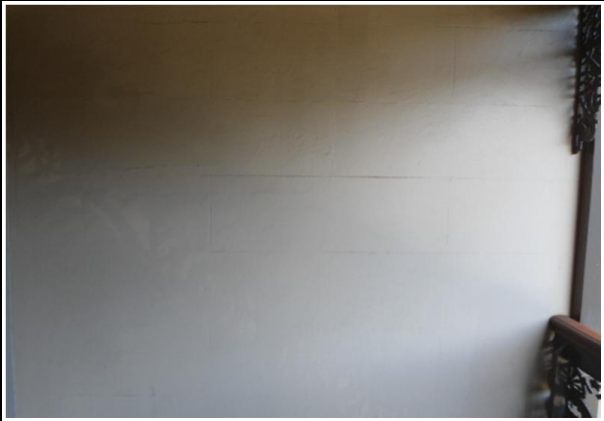
Photo No: J105234-H02-7919 Result: Lead Paint Positive

Location-Level: L02  
Room-Location: Exterior - Throughout  
Feature-Material: Walls - White - Lower coloured paint system

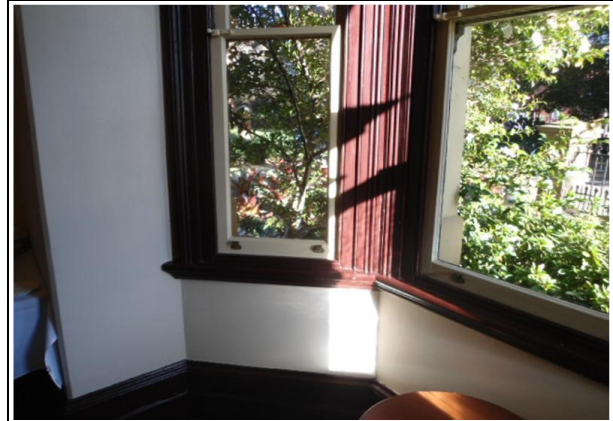
Photo No: J105234-H02-7921 Result: Lead Paint Presumed Positive

Location-Level: L01  
Room-Location: 100-105 & 110 - Various Throughout  
Feature-Material: Windows - Cream - Upper coloured paint system

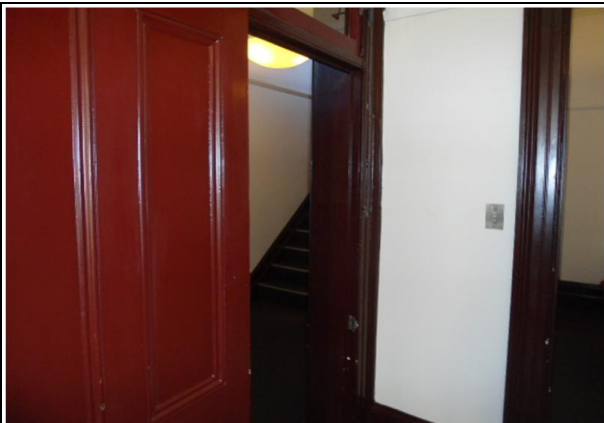
H02	L01	100-105 & 110	Various Throughout	Door frame - White - Lower coloured paint system	Lead Paint	Similar to J105234-H02-LP-2	Presumed Positive	J105234-H02-7922	10 m2	Fair						May-17	Engage an appropriate contractor to remove peeling paint and paint over with a coat of lead-free coat as part of ongoing maintenance. Maintain in good condition. If refurbishment works are likely to involve the disturbance of confirmed lead containing paint, dust suppression techniques should be utilized.		
H02	L01	100-105 & 110	Throughout	Skirting board - White - Lower coloured paint system	Lead Paint	Similar to J105234-H02-LP-2	Presumed Positive		10 m2	Fair						May-17	Engage an appropriate contractor to remove peeling paint and paint over with a coat of lead-free coat as part of ongoing maintenance. Maintain in good condition. If refurbishment works are likely to involve the disturbance of confirmed lead containing paint, dust suppression techniques should be utilized.

Photo No: J105234-H02-7922 Result: Lead Paint Presumed Positive

Location-Level: L01  
Room-Location: 100-105 & 110 - Various Throughout  
Feature-Material: Door frame - White - Lower coloured paint system

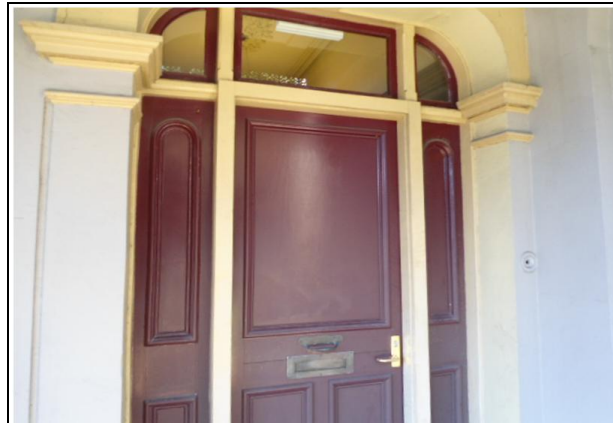
Photo No: J105234-H02-7928 Result: Lead Paint Presumed Positive

Location-Level: L01  
Room-Location: 100-105 & 110 - Various Throughout  
Feature-Material: Windows & doors - White - Lower coloured paint system

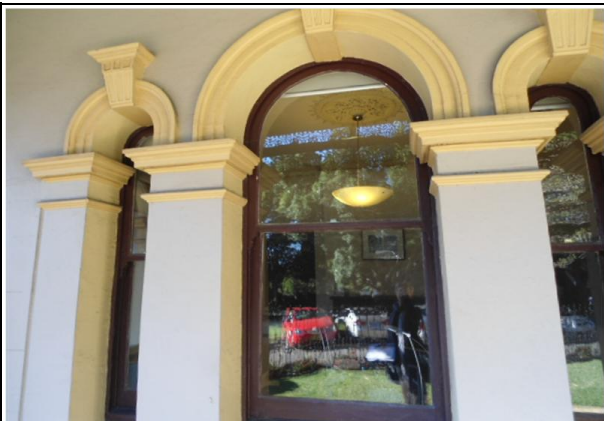
Photo No: J105234-H02-7929 Result: Lead Paint Presumed Positive

Location-Level: L01  
Room-Location: 100-105 & 110 - Various Throughout  
Feature-Material: Windows & door frames - Cream - Upper coloured paint system

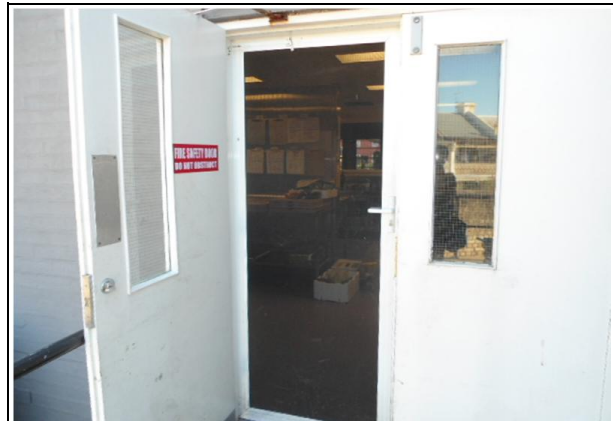
H02	L01	Exterior	West	Fire door - Double - Fire door core	Asbestos	No-Not Practical	Presumed Positive	J105234-H02-7925	1 unit/s	Good	Friable	Low	Low	Not Labelled	P3	May-13	Label and maintain current good condition. Confirm status when required once isolated. Remove under controlled conditions by a Class A (friable) licensed contractor prior to demolition or refurbishment.		
H02	L01	Exterior	West	Door - White - Upper coloured paint system	Lead Paint	LeadCheck	Negative												
H02	L01	Central Garden Verandah	Various	Balcony posts - Black - Upper coloured paint system	Lead Paint	LeadCheck	Negative

Photo No: J105234-H02-7925 Result: Asbestos Presumed Positive

Location-Level: L01  
Room-Location: Exterior - West  
Feature-Material: Fire door - Double - Fire door core

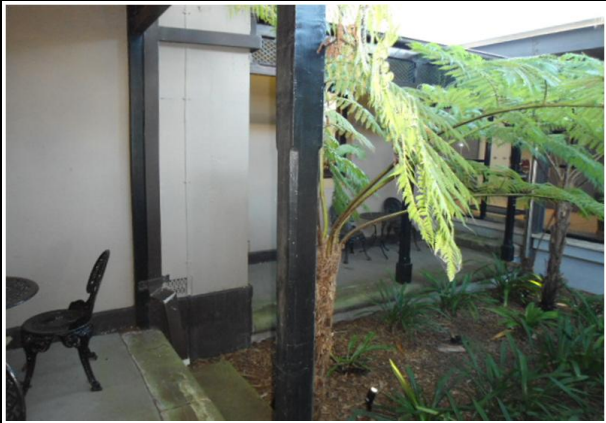
Photo No: J105234-H02-7924 Result: Lead Paint Positive

Location-Level: L01  
Room-Location: Central Garden Verandah - Various  
Feature-Material: Balcony posts - White - Lower coloured paint system
