Asbestos & Lead Paint Risk Assessment Report

Building Ref: H01

Darlington Campus

Sydney University Regiment

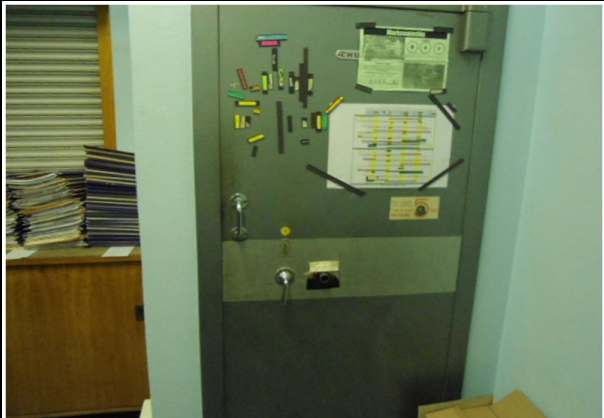
Photo No: J105234-H01-8730 Result: Presumed Positive

Location-Level: First Floor
Room-Location: BLDG 3 - Room H6 - East
Feature-Material: Safe - Insulation

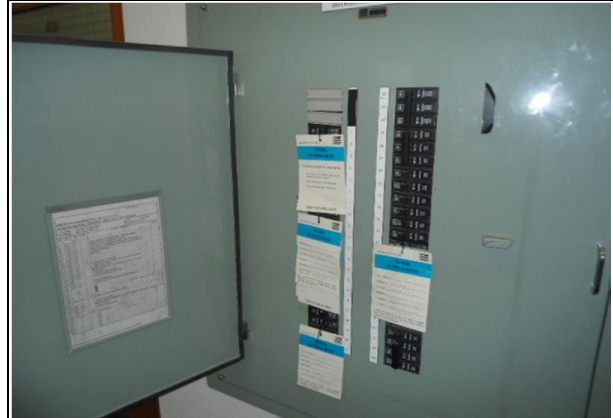
Photo No: J105234-H01-8732 Result: Presumed Positive

H01	First Floor	All areas	Various Throughout	Switchboard – Internal components - Electrical backing board	Asbestos	No-Live	Presumed Positive	J105234-H01-8732	2 m2	Good	Non-Friable	Low	Low	Not Labelled	P4	Jun-17	Label and maintain in-situ. Confirm status once isolated. Remove by an appropriately licensed contractor under controlled conditions prior to demolition or refurbishment.		
H01	First Floor	BLDG 3 - Stairs	Various Throughout	Floor coverings - Vinyl floor tiles	Asbestos	J105234-H01-3	Negative												
H01	First Floor	BLDG 3 - All Rooms	Throughout	Ceiling - Sprayed insulation	Asbestos	No-Not Practical	Presumed Positive	J105234-H01-8729	100 m2	Poor	Friable	Low	Medium	Labelled	P2	Jun-13	Restricted access to ceiling space to authorised and trained personnel only. Confirm status when practicable. Remove by a Class A (friable) licensed contractor prior to demolition or refurbishment.		
H01	First Floor	BLDG 2 - BLDG 3 Passage / Theatrette	West	Fire door - Double - Fire door core - Vermiculite	Asbestos	J105234-H01-4	Negative

Location-Level: First Floor
Room-Location: All areas - Various Throughout
Feature-Material: Switchboard – Internal components - Electrical backing board

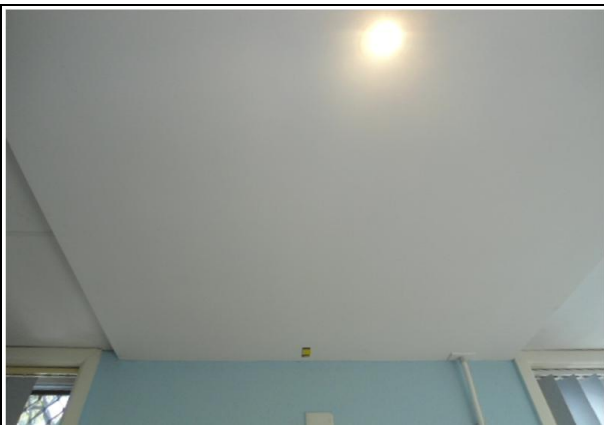
Photo No: J105234-H01-8729 Result: Presumed Positive

Location-Level: First Floor
Room-Location: BLDG 3 - All Rooms - Throughout
Feature-Material: Ceiling - Sprayed insulation

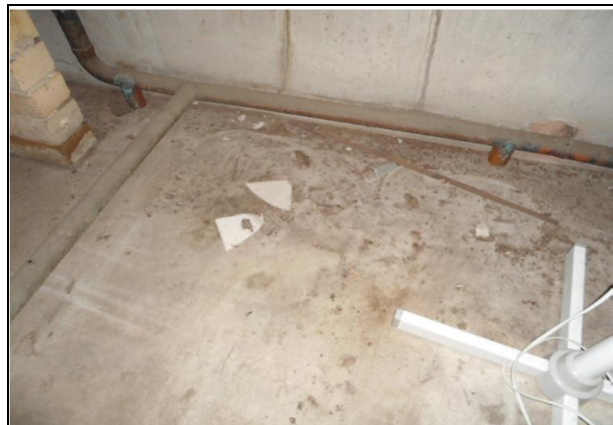
Photo No: J105234-H01-8722 Result: Positive

Location-Level: First Floor
Room-Location: BLDG 2 - Room 59 - Boiler Room - East
Feature-Material: Debris – To floor - Fibre cement sheet - and sprayed insulation

9	J105234-H01 09	First Floor - Interior - BLDG 2 - Room 59 - Boiler Room - East - Debris - To floor - Fibre cement sheet & sprayed insulation A: Unpainted gold-grey fibre-cement sheet material B: Grey loosely-formed vitreous fibrous material A: ~ 34 x 20 x 5 mm B: ~ 14 x 4 x 1 mm	A: Chrysotile (white asbestos) Organic Fibres B: No Asbestos Detected
10	J105234-H01 10	First Floor - Interior - BLDG 2 - Room 59 - Boiler Room - Various Throughout - Pipe insulation - Bandage wrap - Bituminous paper Black-brown resinous, bituminous fibrous sheet material ~ 60 x 30 x <1 mm	No Asbestos Detected Organic Fibres

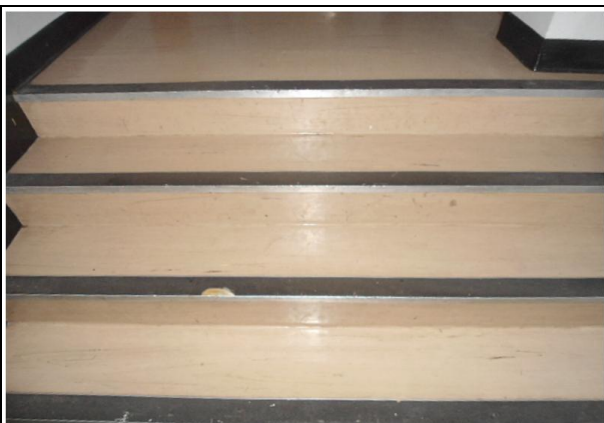
Photo No: J105234-H01-8725 Result: Positive

Location-Level: First Floor
Room-Location: BLDG 2 - Porch / Corridor - North
Feature-Material: Stair nosing - Bituminous material

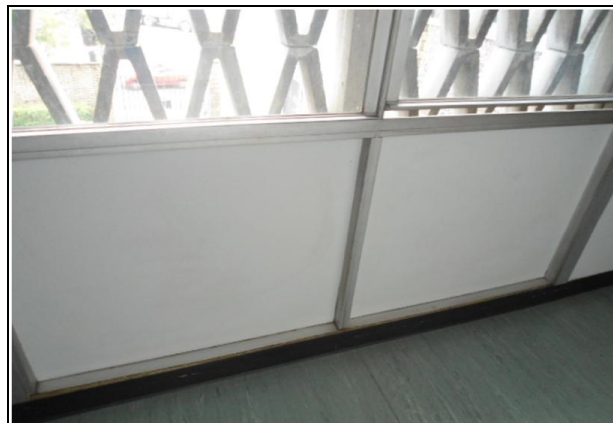
Photo No: J105234-H01-8739 Result: Presumed Positive

Location-Level: First Floor
Room-Location: BLDG 1 & BLDG 2 Link Bridge - Exterior - Northeast
Feature-Material: Infill panels - Fibre cement sheeting - Below windows

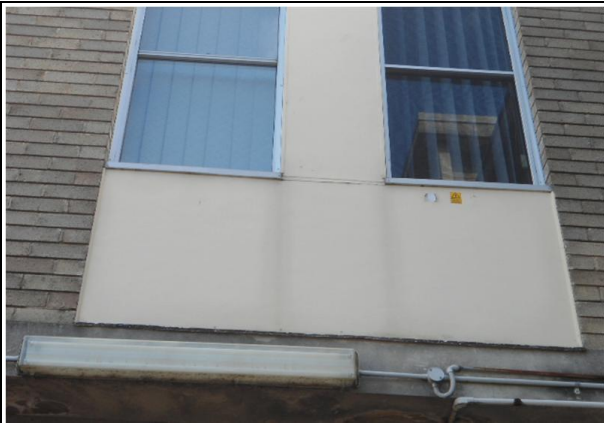
Photo No: J105234-H01-8749 Result: Presumed Positive

Location-Level: First Floor
Room-Location: BLDG 3 - Exterior - East
Feature-Material: Window surround - Fibre cement sheeting

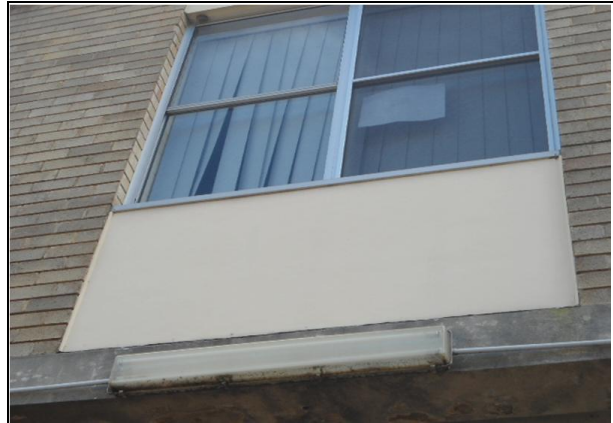
Photo No: J105234-H01-8750 Result: Presumed Positive

Location-Level: First Floor
Room-Location: BLDG 3 & Link Bridge - Exterior - Various
Feature-Material: Infill panels - High level - Fibre cement sheeting

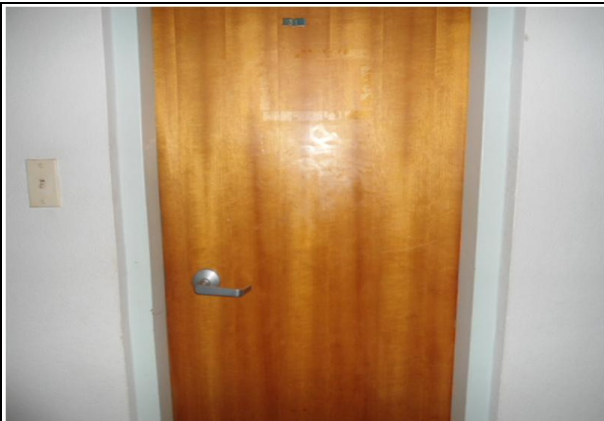
Photo No: J105234-H01-8763 Result: Presumed Positive

Location-Level: First Floor
Room-Location: BLDG 1 - Emergency Exit Stairwell - Various
Feature-Material: Fire door - Single - Fire door core

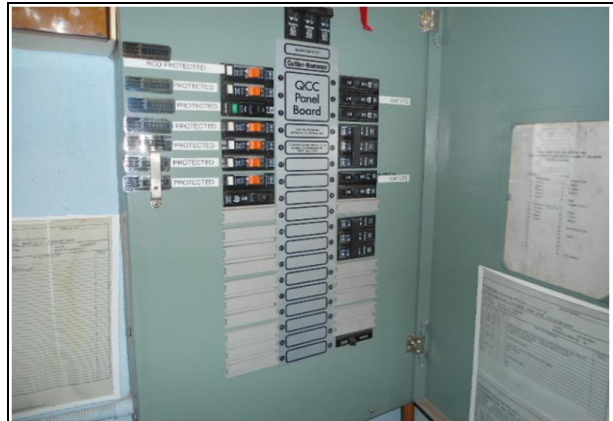
Photo No: J105234-H01-8745 Result: Presumed Positive

Location-Level: Ground Floor
Room-Location: All areas - Various Throughout
Feature-Material: Switchboard – Internal components - Electrical backing board

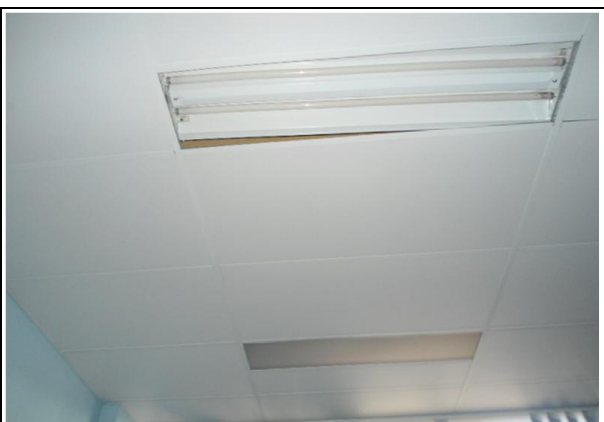
Photo No: J105234-H01-8749 Result: Presumed Positive

H01	Ground Floor	BLDG 3 - All Rooms	Throughout	Ceiling above suspended ceiling - - Sprayed Insulation	Asbestos	No-Not Practical	Presumed Positive	J105234-H01-8749	100 m2	Poor	Friable	Low	Medium	Not Labelled	P2	Jun-13	Restricted access to ceiling space to authorised and trained personnel only. Confirm status when practicable. Remove by a Class A (friable) licensed contractor prior to demolition or refurbishment.	
H01	Ground Floor	BLDG 3	Various	Fire door - Single - Fire door core	Asbestos	No-Not Practical	Presumed Positive	J105234-H01-8747	2 unit/s	Good	Friable	Low	Low	Not Labelled	P3	Jun-13	Label and maintain in good condition. Confirm status when practicable. Remove door in it's entirety by a Class A (friable) licensed contractor under controlled conditions prior to demolition or refurbishment.	
H01	Ground Floor	BLDG 2 - Exterior	Various Throughout	Window frames - Pebble-dash cladding - Construction joint mastic - Rubber	Asbestos		Presumed Negative

Location-Level: Ground Floor
Room-Location: BLDG 3 - All Rooms - Throughout
Feature-Material: Ceiling above suspended ceiling - - Sprayed Insulation

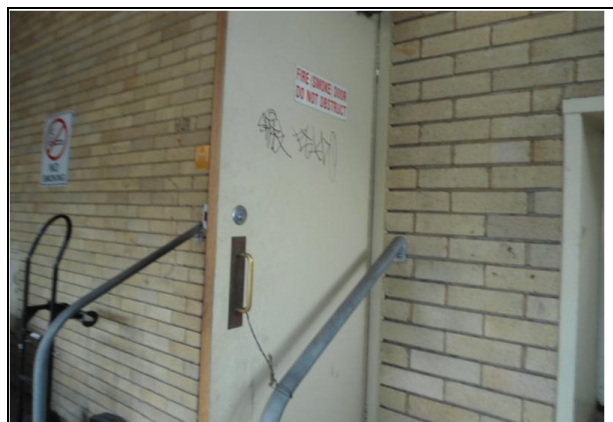
Photo No: J105234-H01-8747 Result: Presumed Positive

Location-Level: Ground Floor
Room-Location: BLDG 3 - Various
Feature-Material: Fire door - Single - Fire door core

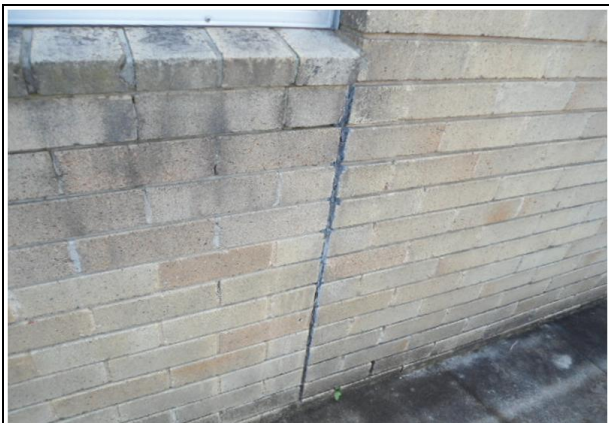
Photo No: J105234-H01-8756 Result: Positive

Location-Level: Ground Floor
Room-Location: BLDG 2 - Exterior - Various Throughout
Feature-Material: Expansion joints – Walls - Construction joint mastic

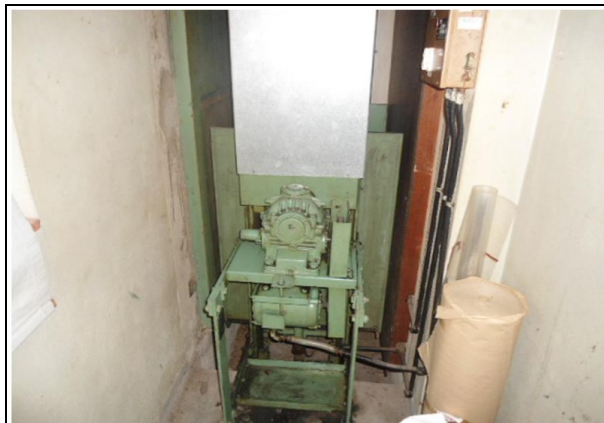
Photo No: J105234-H01-8757 Result: Presumed Positive

H01	Ground Floor	BLDG 1 & BLDG 3 - Motor Room	Various	Lift motor - Friction pads	Asbestos	No-Live	Presumed Positive	J105234-H01-8757	2 unit/s	Good	Non-Friable	Low	Low	Not Labelled	P4	Jun-17	Label and maintain in-situ. Confirm status once isolated. Remove by an appropriately licensed contractor under controlled conditions prior to demolition or refurbishment.	
H01	Ground Floor	BLDG 1 & BLDG 3 - Motor Room	Various	Switchboard – Internal components - Electrical backing board	Asbestos	No-Live	Presumed Positive	J105234-H01-8758	2 m2	Good	Non-Friable	Low	Low	Not Labelled	P4	Jun-17	Label and maintain in-situ. Confirm status once isolated. Remove by an appropriately licensed contractor under controlled conditions prior to demolition or refurbishment.	
H01	Ground Floor	BLDG 3 - Cleaners Cupboard	Various	Fire door - Single - Fire door core - (Labelled Wormald 200_)	Asbestos		Presumed Negative

Location-Level: Ground Floor
Room-Location: BLDG 1 & BLDG 3 - Motor Room - Various
Feature-Material: Lift motor - Friction pads

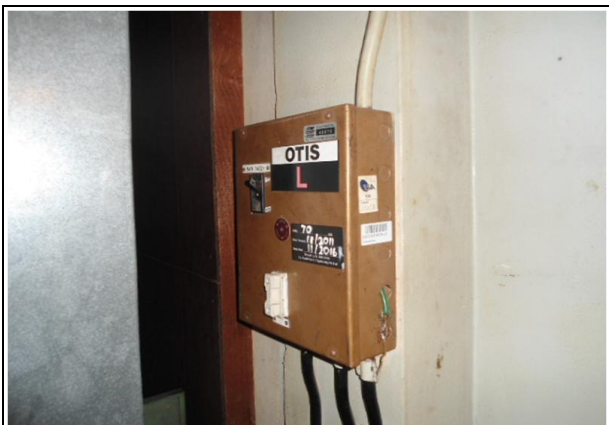
Photo No: J105234-H01-8758 Result: Presumed Positive

Location-Level: Ground Floor
Room-Location: BLDG 1 & BLDG 3 - Motor Room - Various
Feature-Material: Switchboard – Internal components - Electrical backing board

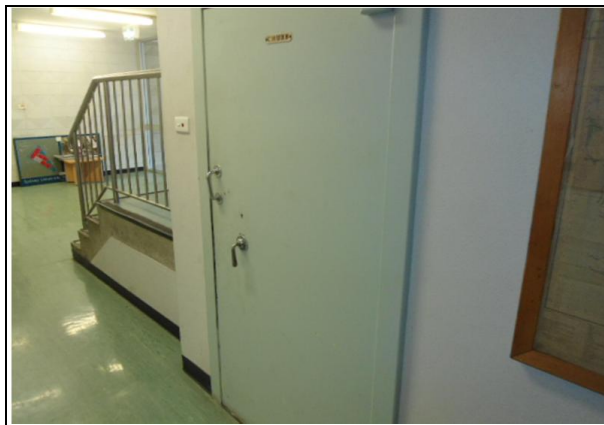
Photo No: J105234-H01-8759 Result: Presumed Positive

H01	Ground Floor	BLDG 1 - Strong Room		Door - Insulation	Asbestos	No-Not Practical	Presumed Positive	J105234-H01-8759	1 unit/s	Good	Friable	Low	Low	Not Labelled	P3	Jun-13	Label and maintain in good condition. Confirm status if practicable. Remove safe door in it's entirety by a Class A (friable) licensed contractor under controlled conditions prior to demolition or refurbishment.	
H01	Ground Floor	BLDG 1 - Emergency Exit Stairwell	Throughout	Ceiling - Sprayed insulation	Asbestos	J105234-H01-18	Negative

Location-Level: Ground Floor
Room-Location: BLDG 1 - Strong Room -
Feature-Material: Door - Insulation

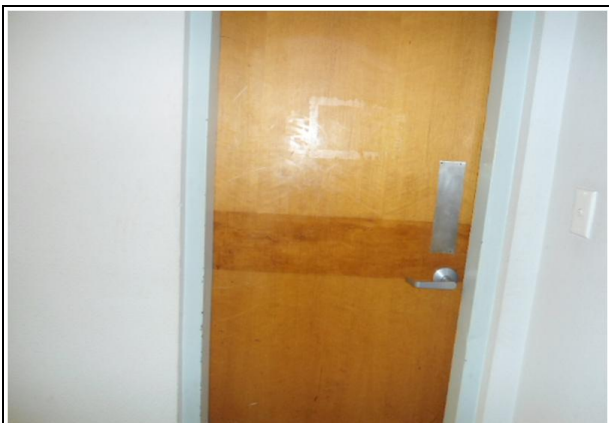
Photo No: J105234-H01-8761 Result: Presumed Positive

Location-Level: Ground Floor
Room-Location: BLDG 1 - Emergency Exit Stairwell - Various
Feature-Material: Fire door - Single - Fire door core
