# **ELECTROLYSIS RISK ASSESSMENT REPORT**

## **BILLBERGIA**

### **8 WILSON STREET, CHATSWOOD, NSW 2067**

DOCUMENT NUMBER: N-001004/NSW-P100482

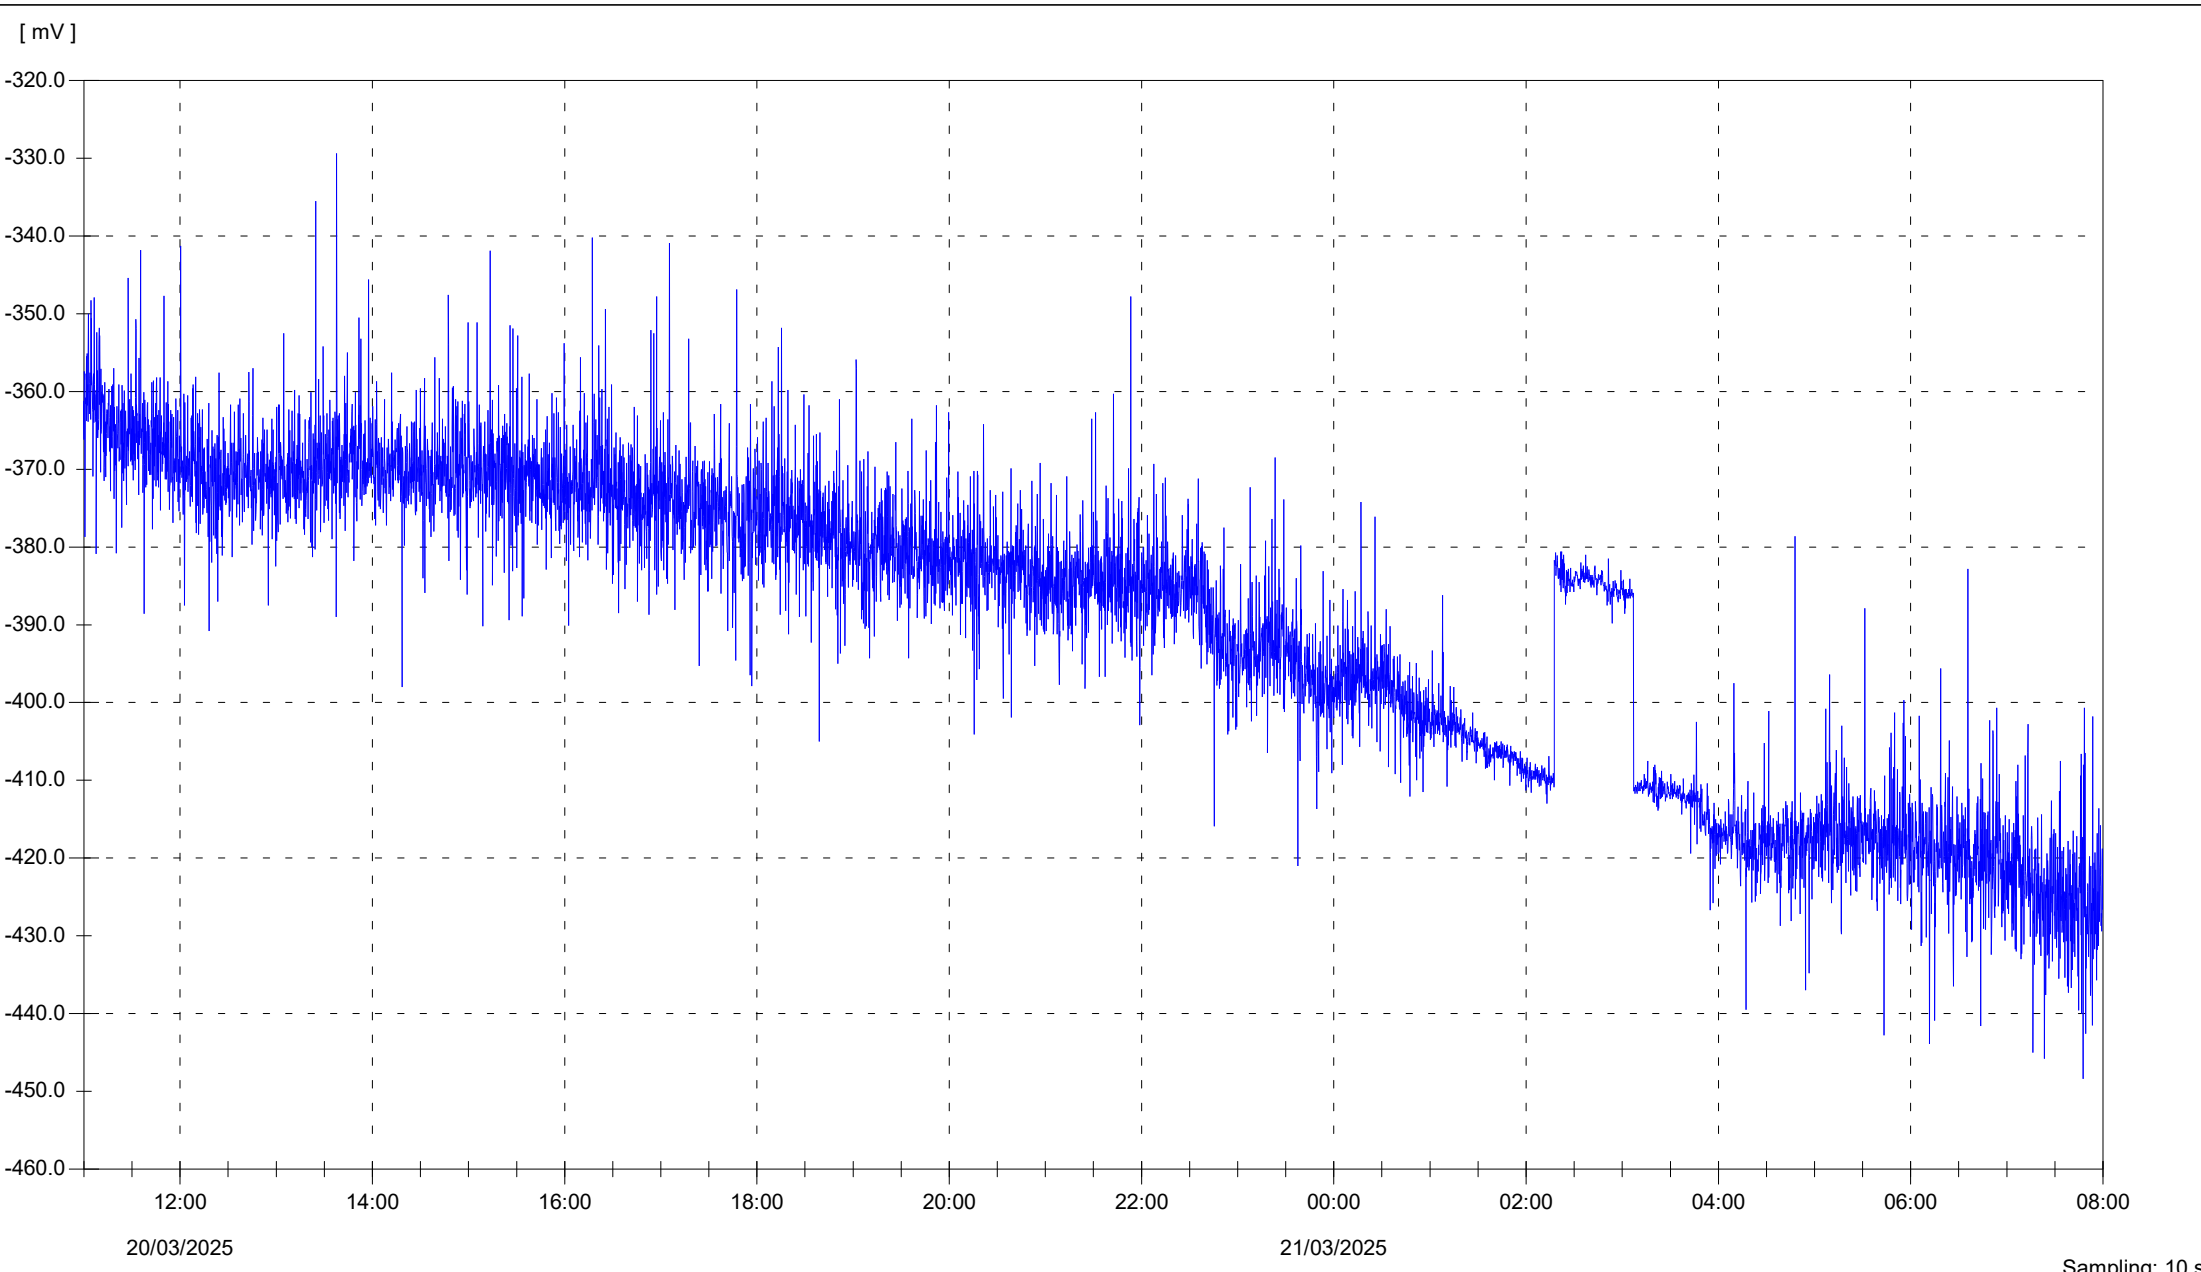
**Electrolysis Risk Testing - Parallel**  
**8 Wilson St, Chatswood NSW 2067**  
**Data Logger: 6205**  
**Parallel To The Rail**

| Test Number | Data Logging Test Performed | Test Duration | Observed Fluctuations |
|---|---|---|---|
| 1 | Data logging voltage gradients between steel earth stakes parallel to the T9 rail line. The earth stakes were approximately 50 m apart. | 20-hours | Most fluctuations within 10 mV.<br>Maximum fluctuation of 38 mV. |

1. Data logging voltage gradients between steel earth stakes parallel to the rail show stray current effects are within acceptable limits but at times exceed acceptable limits.

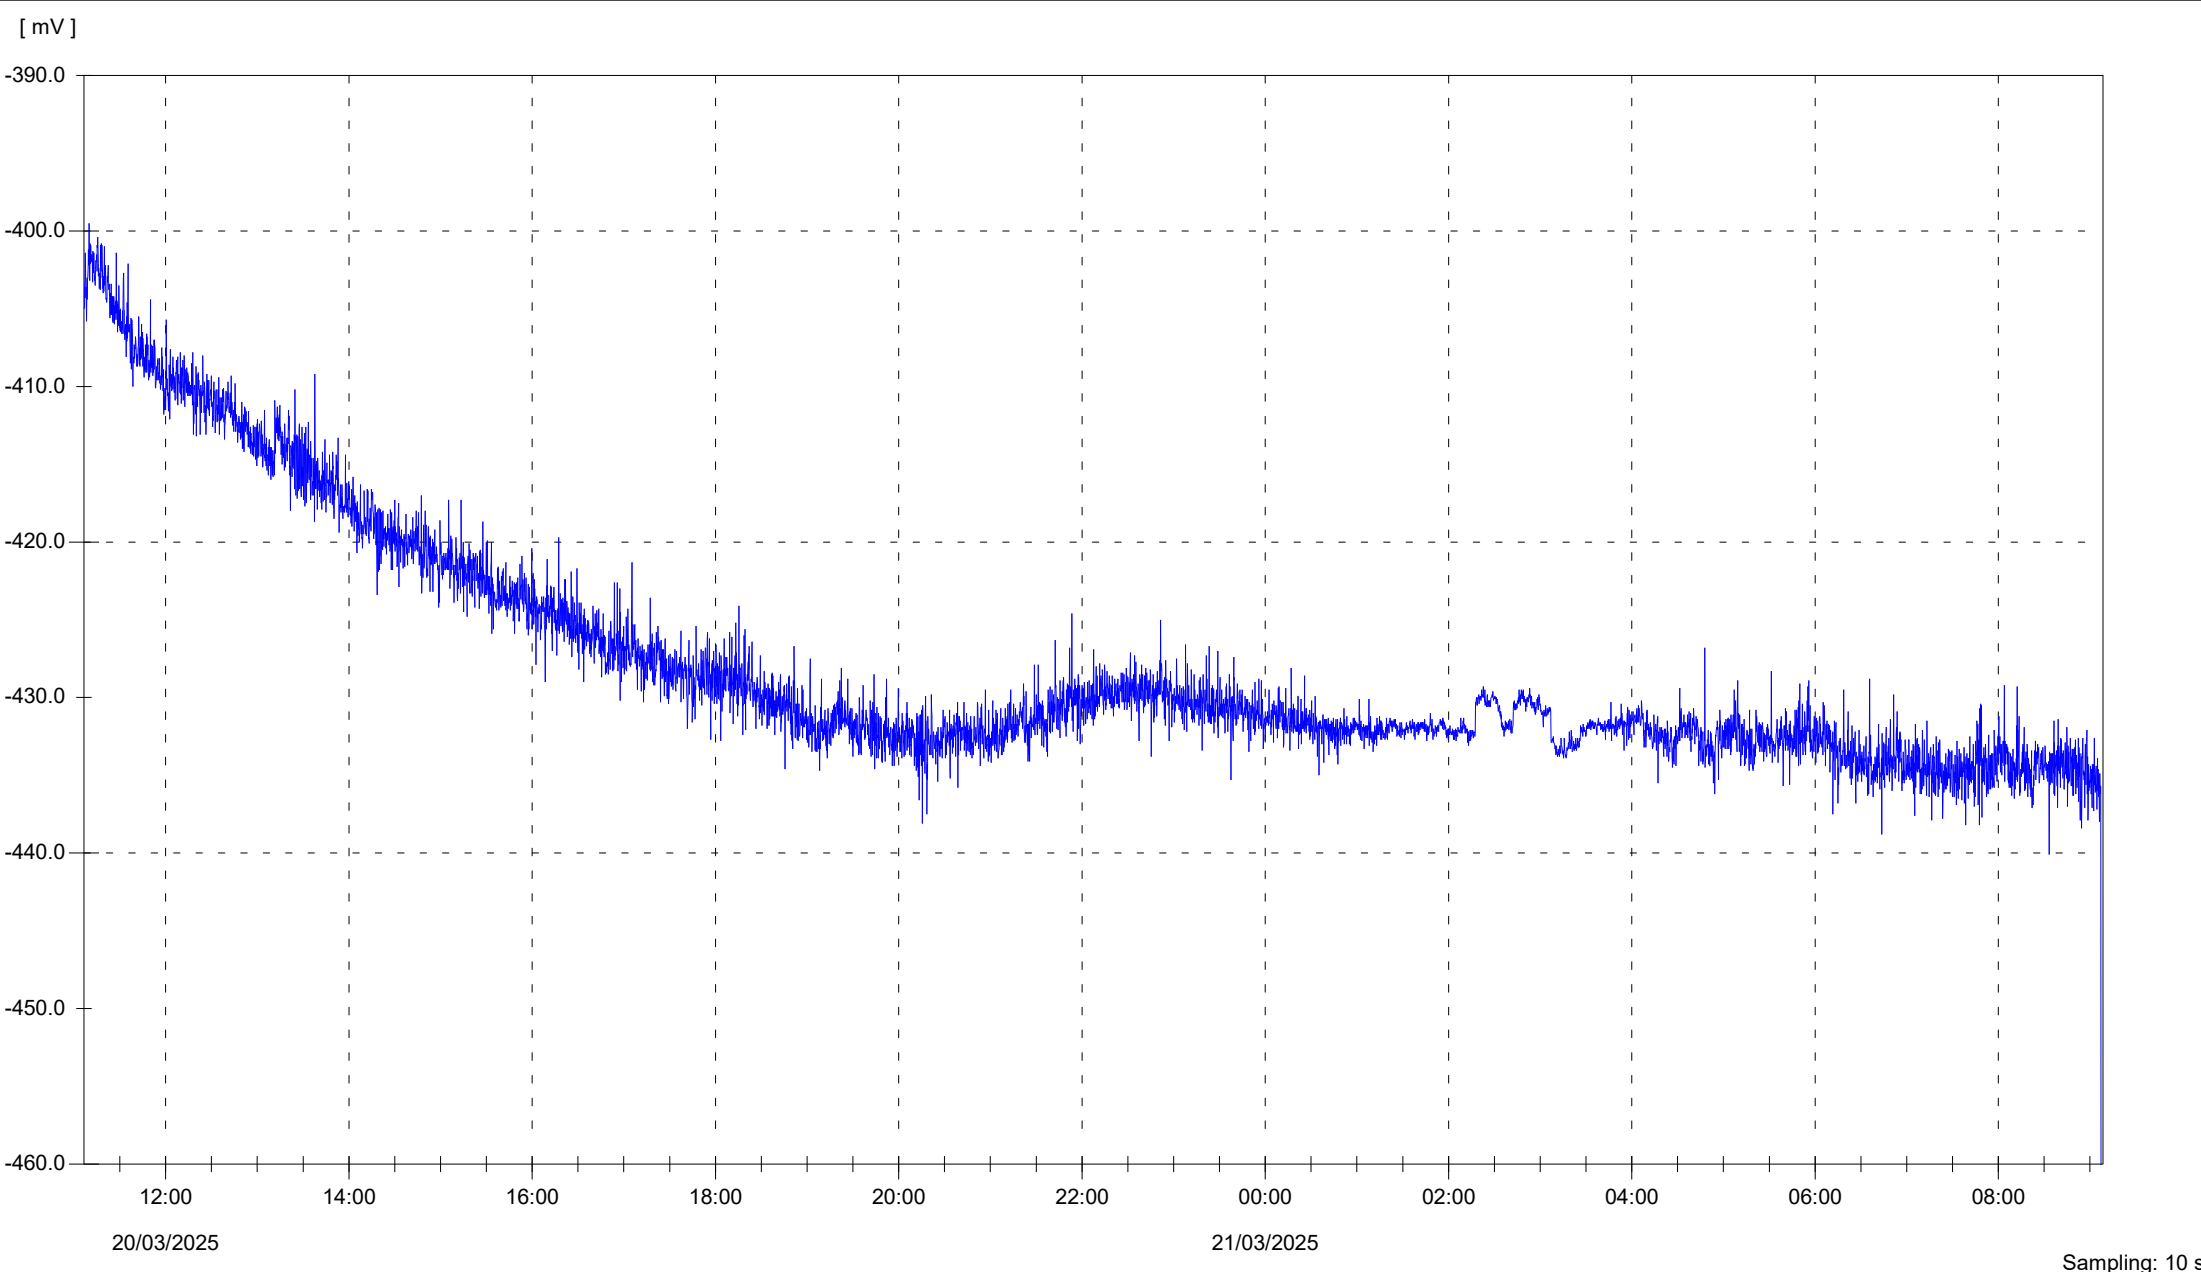
**Electrolysis Risk Testing - Perpendicular**  
**8 Wilson St, Chatswood NSW 2067 Data**  
**Logger: 6212**  
**Perpendicular to Rail**

| Test Number | Data Logging Test Performed | Test Duration | Observed Fluctuations |
|---|---|---|---|
| 2 | Data logging voltage gradients between steel earth stakes perpendicular to the T9 rail line. The earth stakes were approximately 40 m apart. | 20-hours | Fluctuations within 10 mV. |

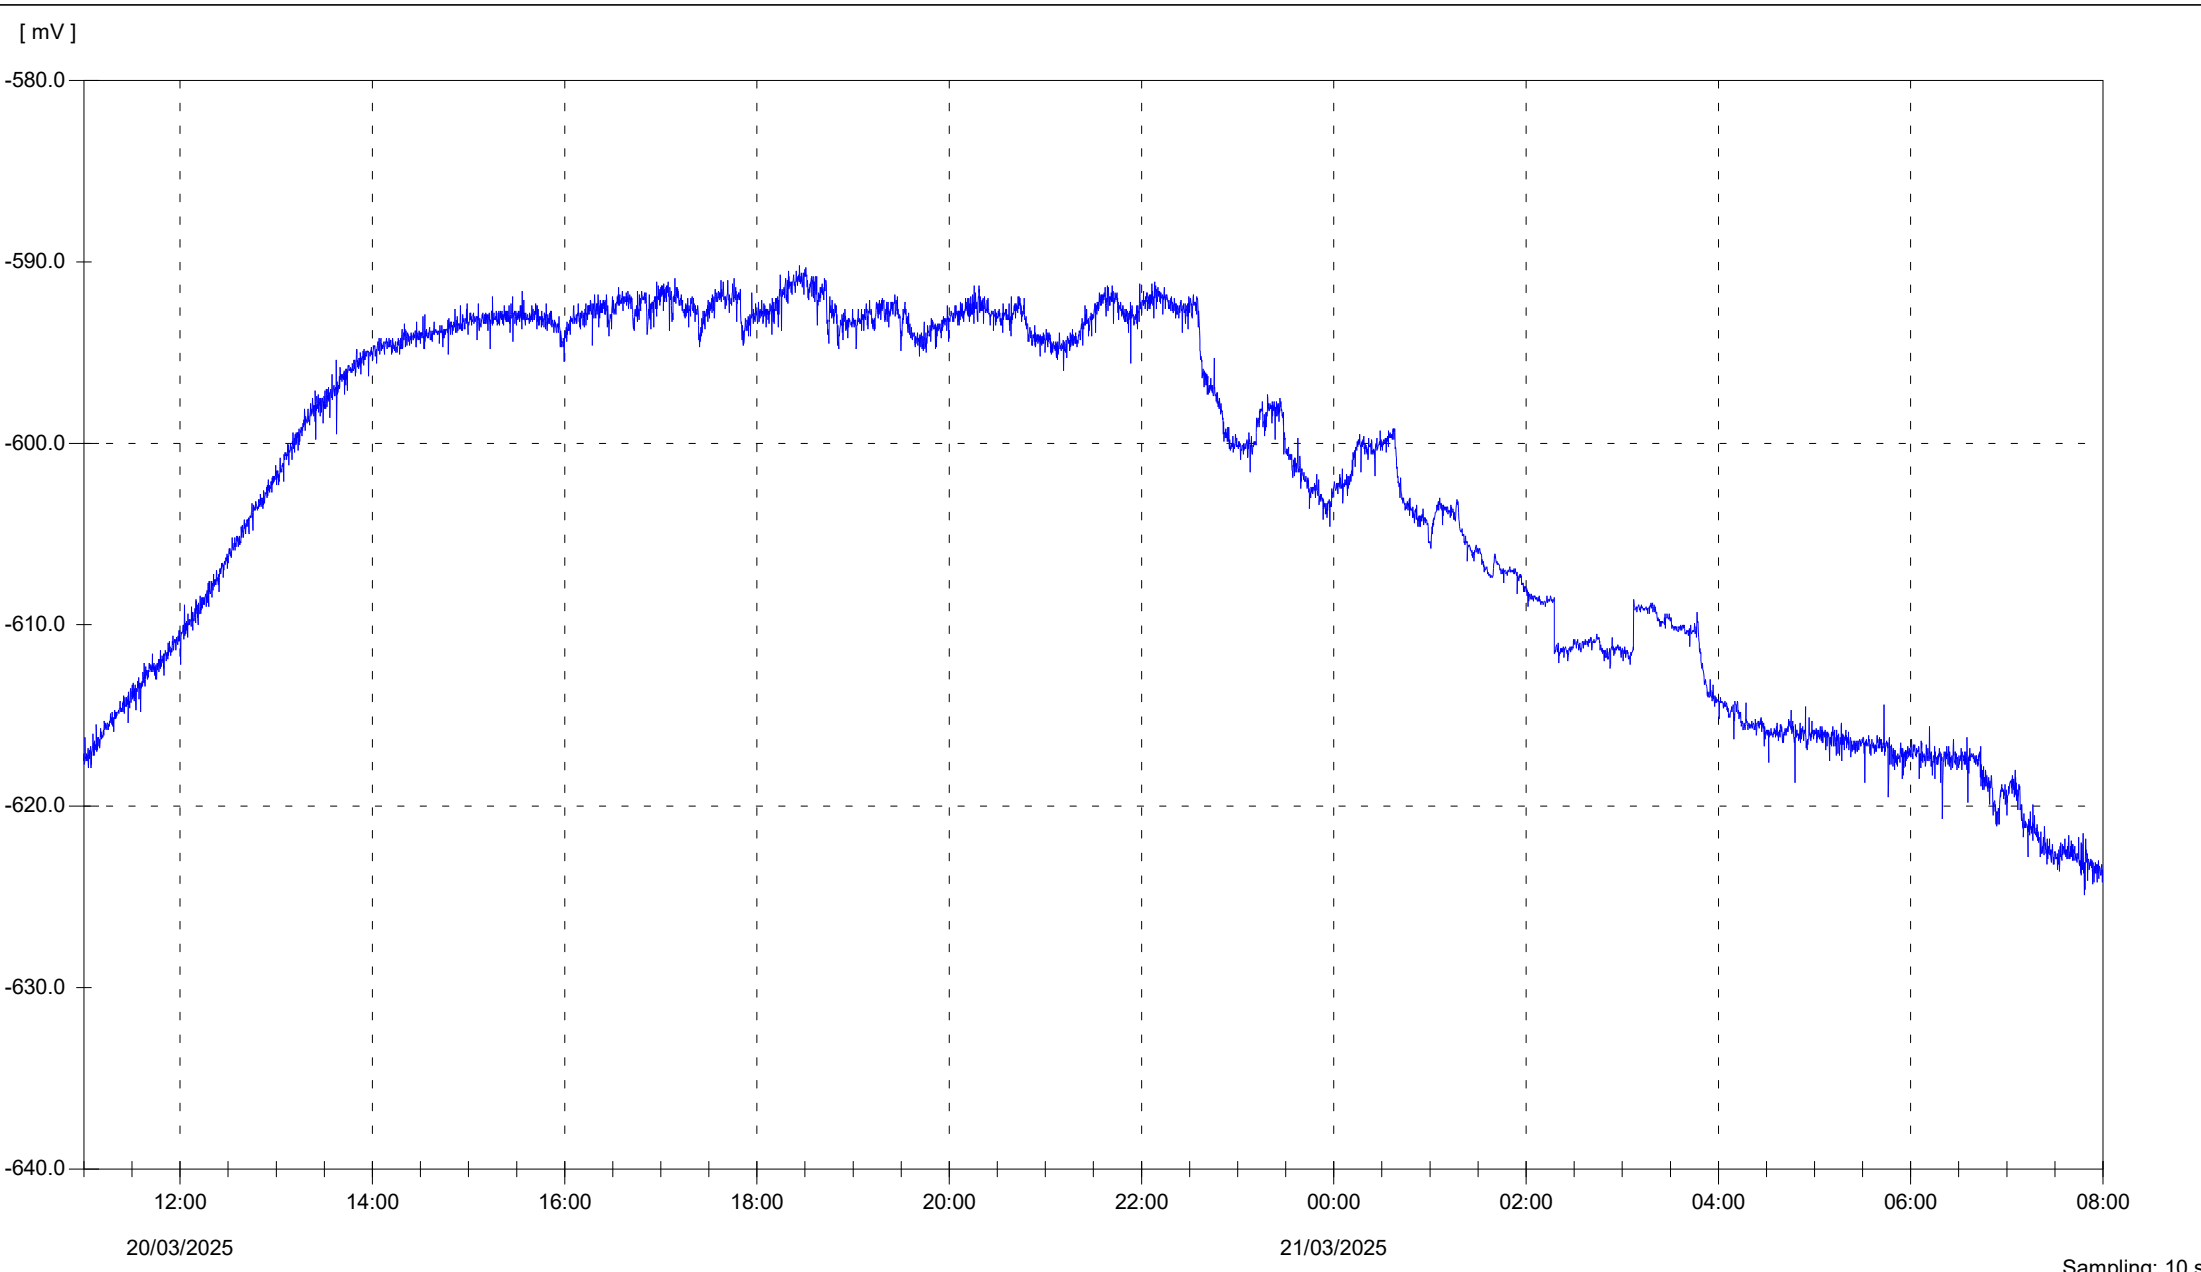
**Electrolysis Risk Testing - Guardrail**  
**8 Wilson St, Chatswood NSW 2067**  
**Data Logger: 6205**  
**Guardrail Parallel To The Rail**

| Test Number | Data Logging Test Performed | Test Duration | Observed Fluctuations |
|---|---|---|---|
| 3 | Data logging the potential of a guardrail at the eastern boundary of the site, adjacent to the rail corridor. | 20-hours | Fluctuations within 5 mV. |

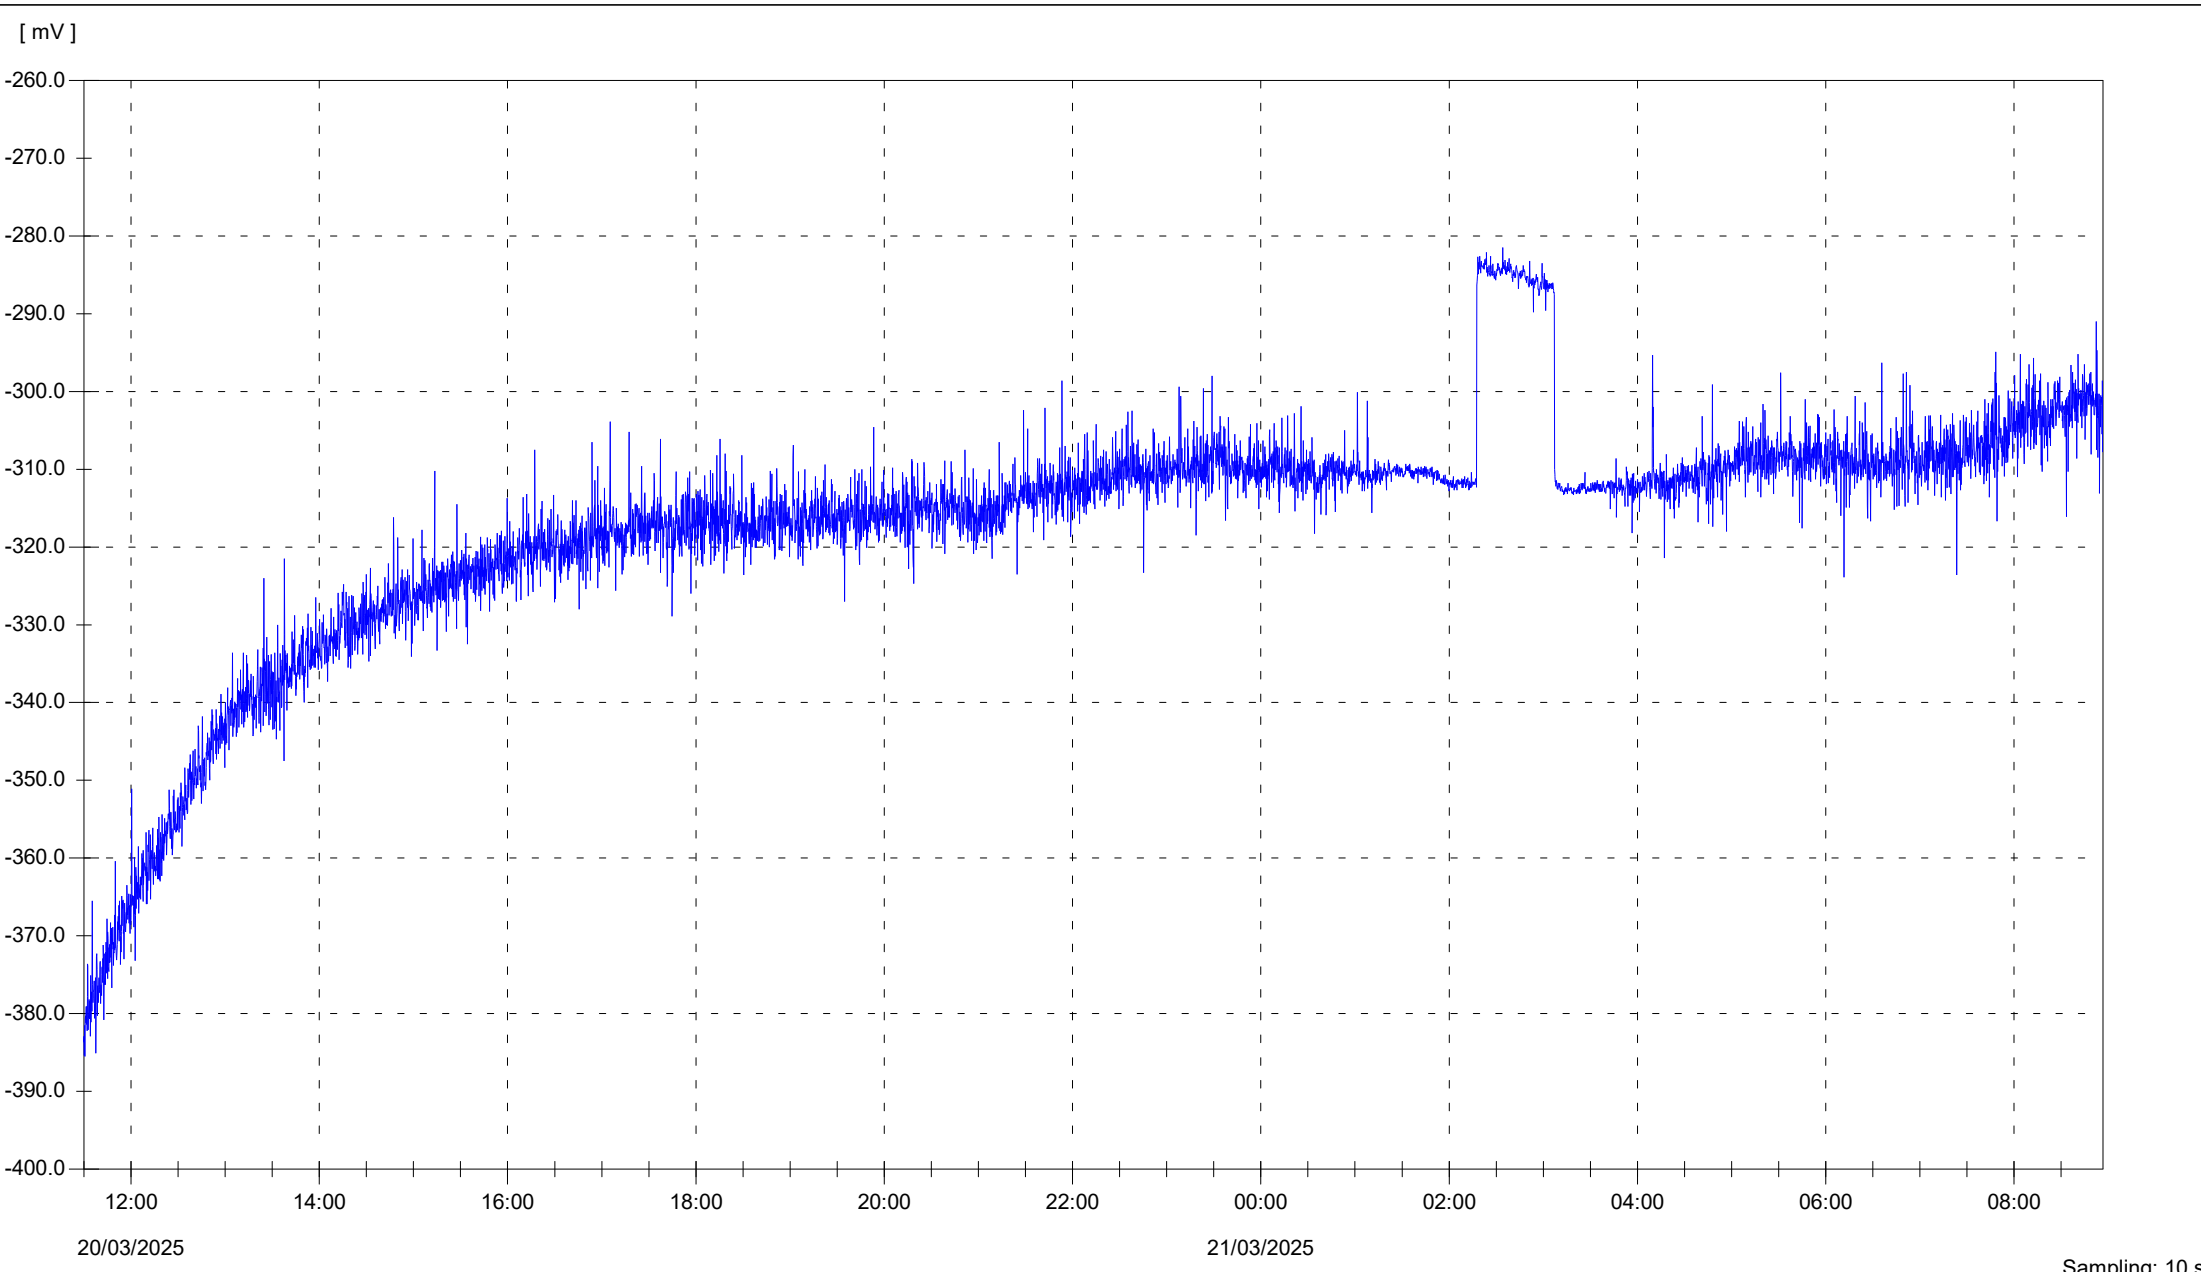
**Electrolysis Risk Testing - Water Pipe**  
**8 Wilson St, Chatswood NSW 2067**  
**Data Logger: 2748**  
**Water Pipe Adjacent To Rail Corridor**

| Test Number | Data Logging Test Performed | Test Duration | Observed Fluctuations |
|---|---|---|---|
| 4 | Data logging the potential of a water service pipe at the eastern boundary of the site, adjacent to the rail corridor. | 20-hours | Most fluctuations within 5 mV.<br>Maximum fluctuation of 15 mV. |

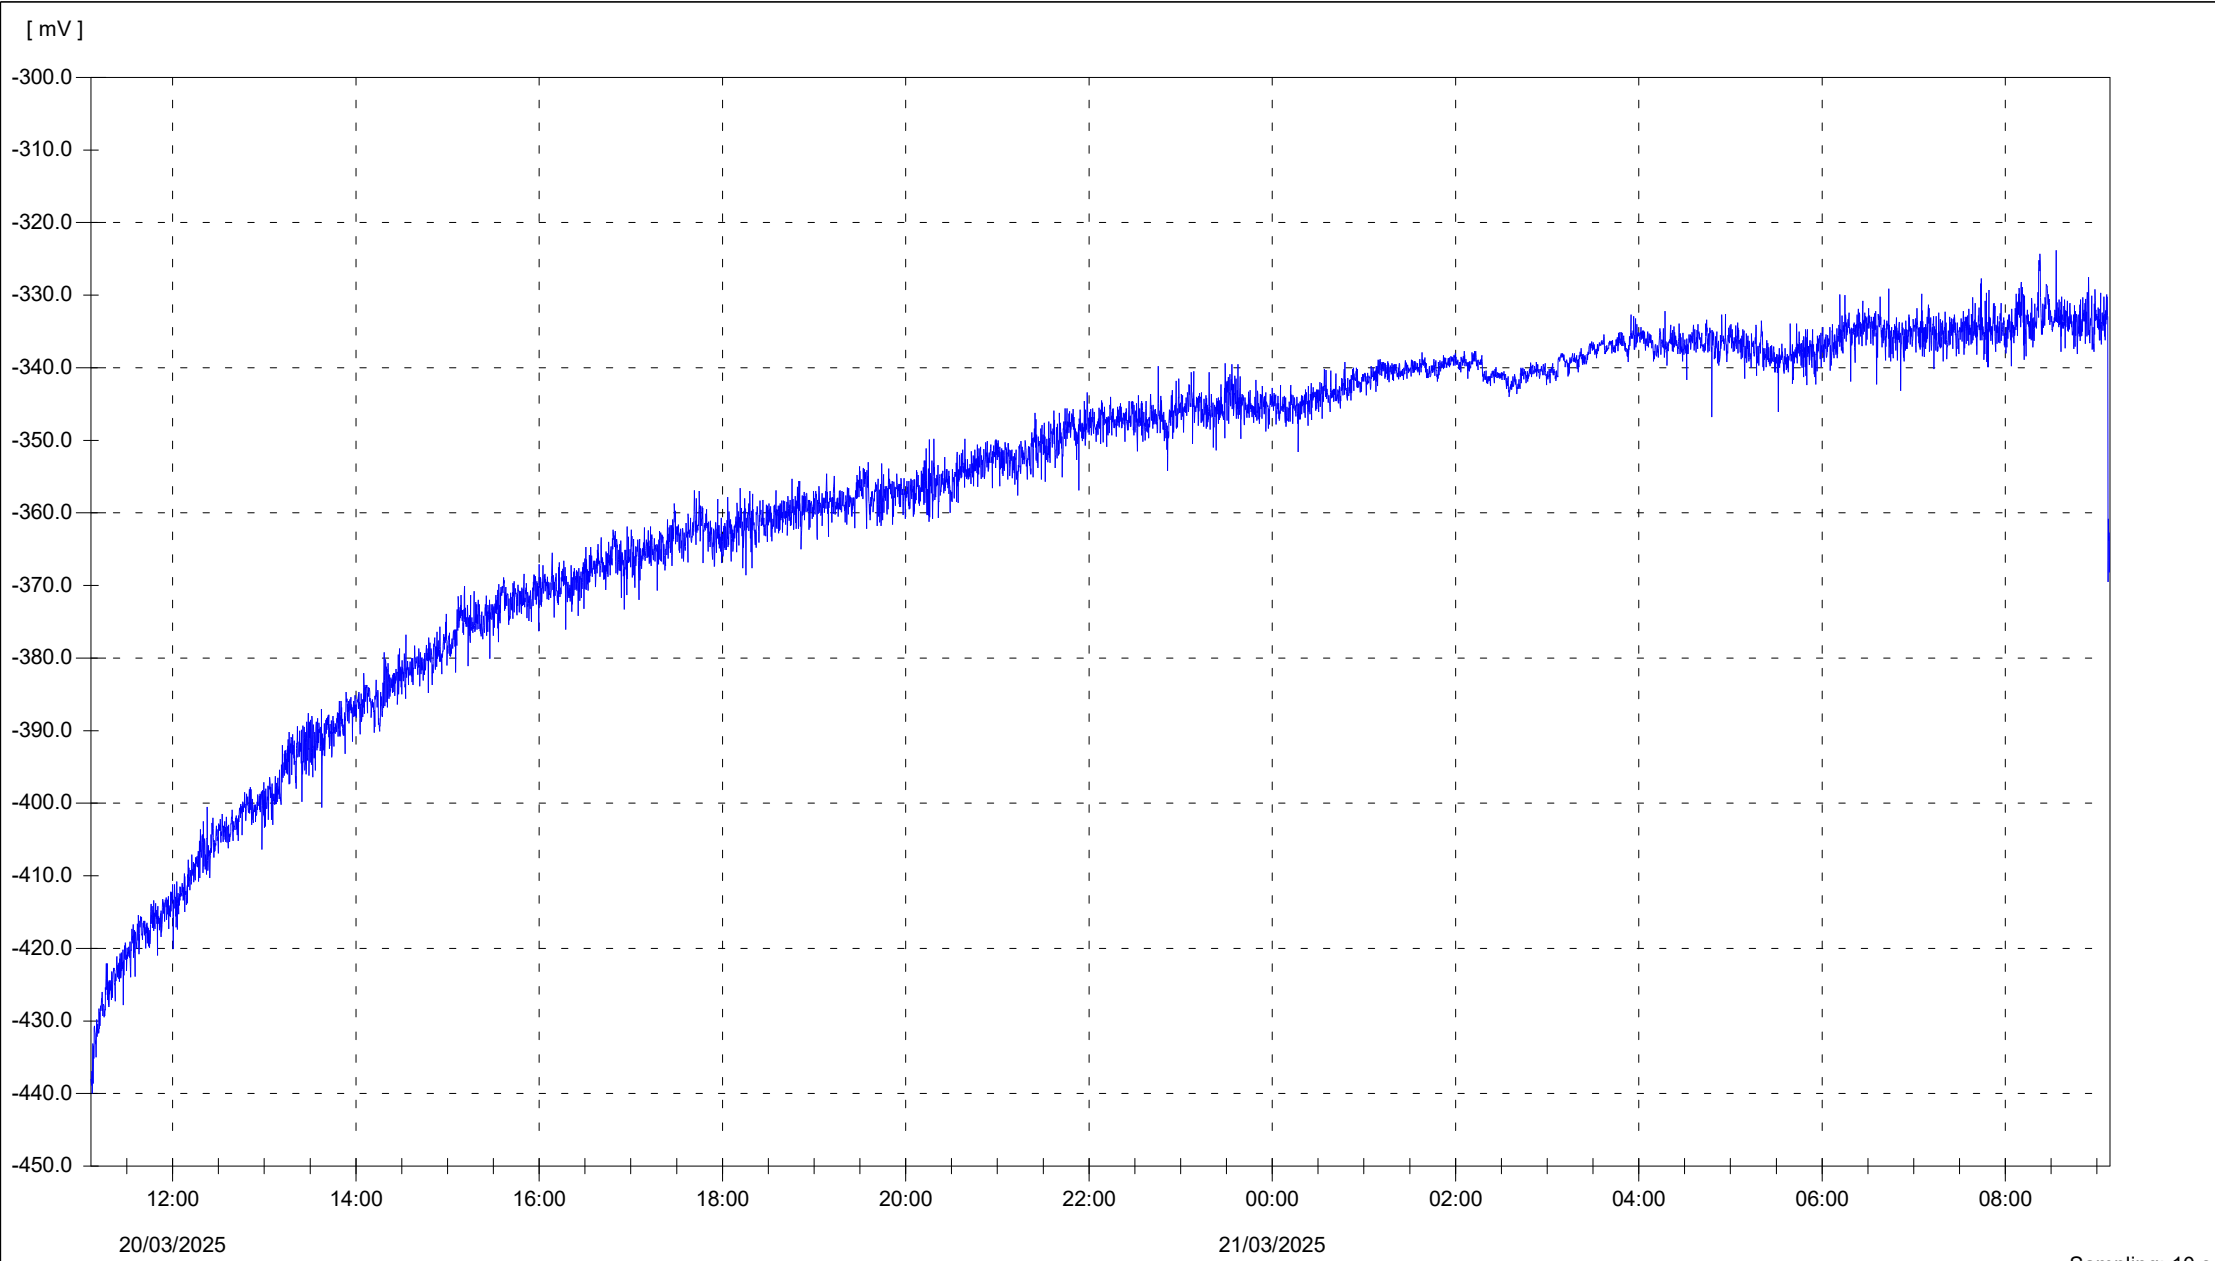
**Electrolysis Risk Reporting- Water Main**  
**8 Wilson St, Chatswood NSW 2067**  
**Data Logger: 3401**  
**Water Main Adjacent To Pacific Highway**

| Test Number | Data Logging Test Performed | Test Duration | Observed Fluctuations |
|---|---|---|---|
| 5 | Data logging the potential of a water service pipe at the western boundary of the site, adjacent to Pacific Highway. | 20-hours | Most fluctuations within 5 mV.<br>Maximum fluctuation of 15 mV. |

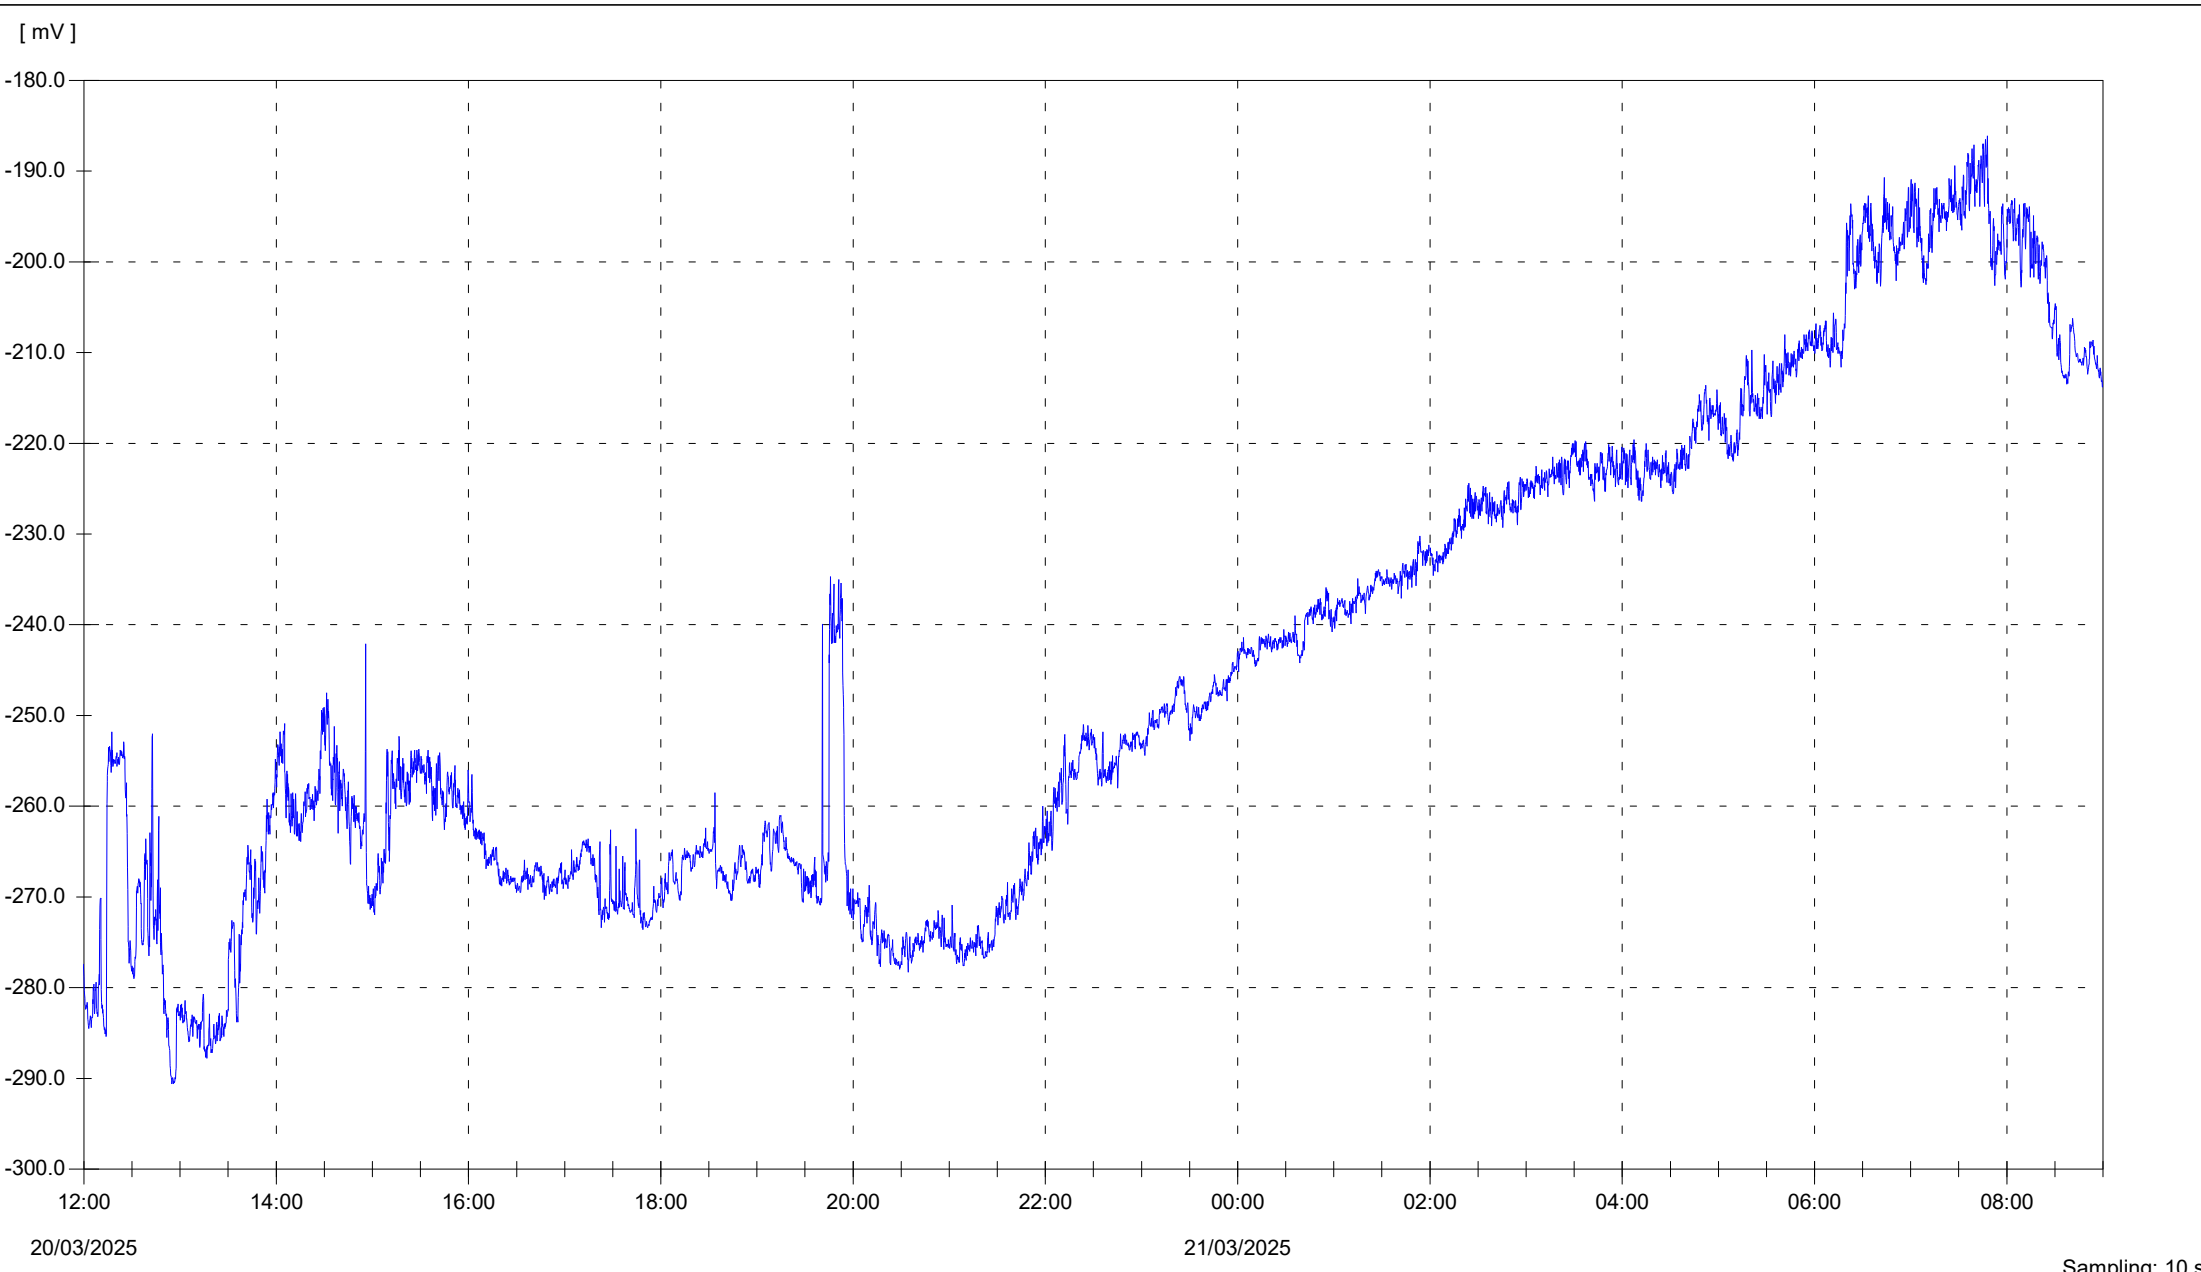
**Electrolysis Risk Testing - Water Main**  
**8 Wilson St, Chatswood NSW 2067**  
**Data Logger: 3391**  
**Water Main Adjacent to O'Brien Street**

| Test Number | Data Logging Test Performed | Test Duration | Observed Fluctuations |
|---|---|---|---|
| 6 | Data logging the potential of a water service pipe at the northwest boundary of the site, adjacent to Pacific Highway | 20-hours | Fluctuations within 5 mV. |

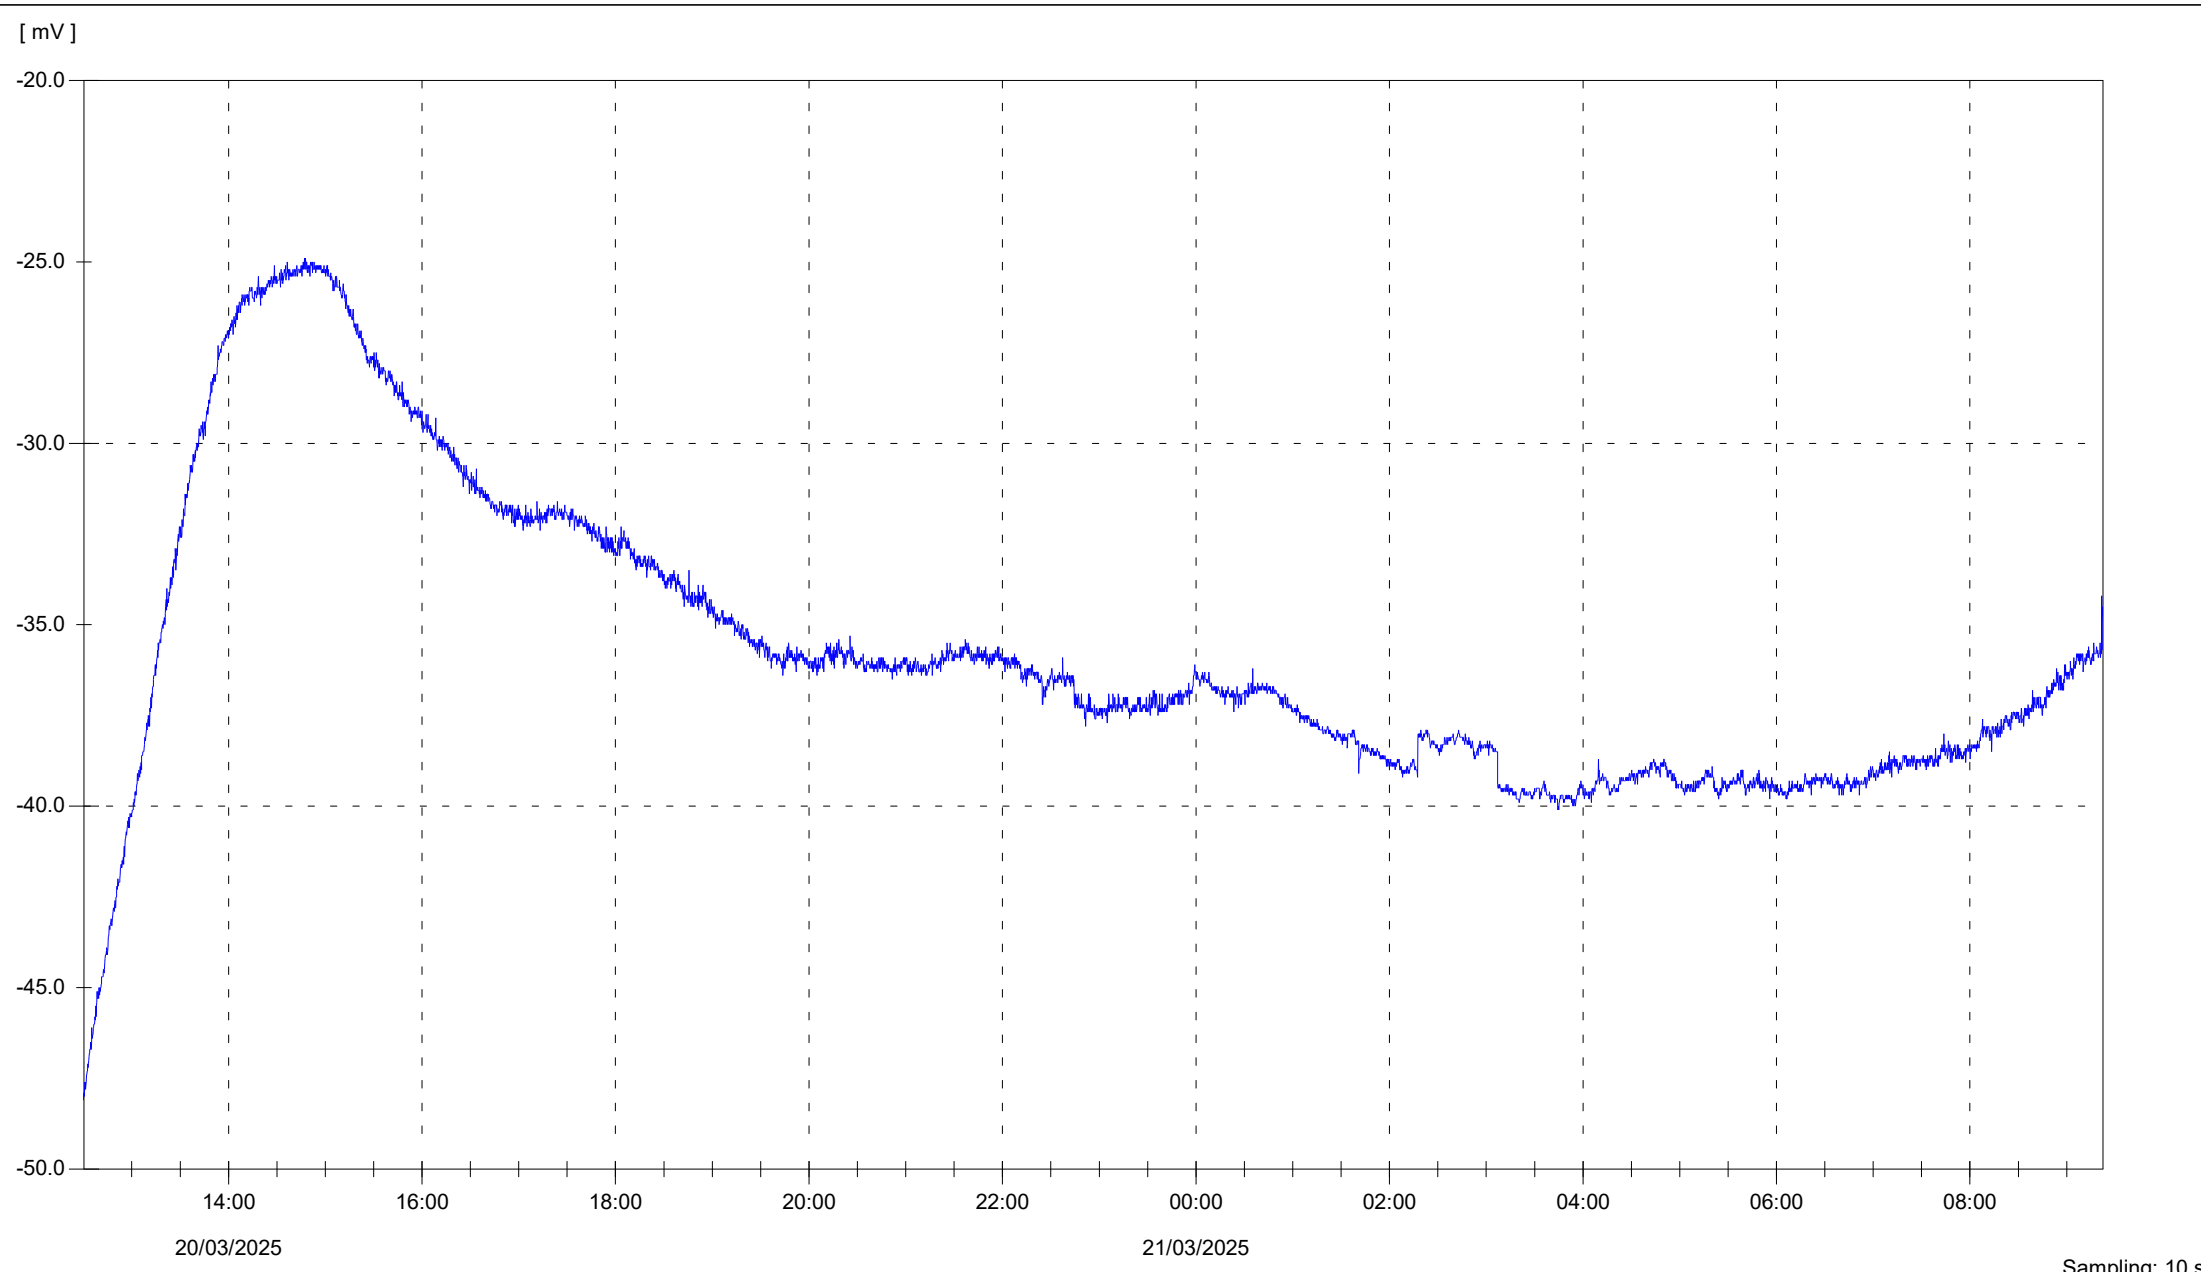
**Electrolysis Risk Testing - Gas Main**  
**8 Wilson St, Chatswood NSW 2067**  
**Data Logger: 3396**  
**Gas Main Pipe Adjacent To O'Brien St**

| Test Number | Data Logging Test Performed | Test Duration | Observed Fluctuations |
|---|---|---|---|
| 7 | Data logging the potential of a gas service pipe at the northwest boundary of the site, adjacent to O'Brien Street. | 20-hours | Fluctuations within 5 mV. |
