# Destructive Hazardous Materials (HAZMAT) Assessment

Campbelltown Arts Centre – 1 Art Gallery Road, Campbelltown, NSW, 2560

Prepared for: Campbelltown City Council

EP4556.001\_v3 9 March 2026

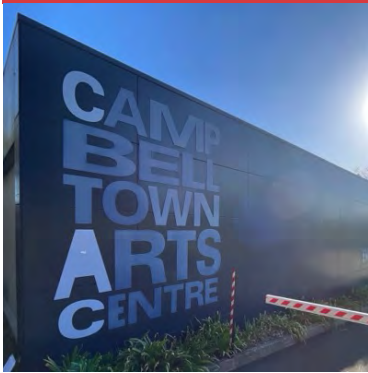
### PHOTO 1

Condition: Good.

Result: **Asbestos Not Detected.**

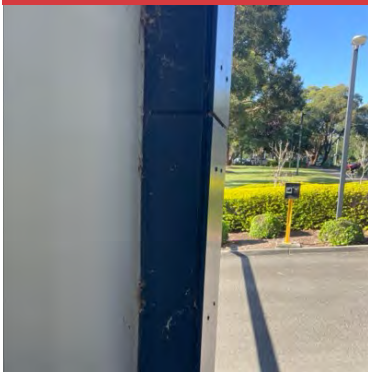
### PHOTO 2 (CLOSE-UP)

Condition: Good.

Result: **Asbestos Not Detected.**

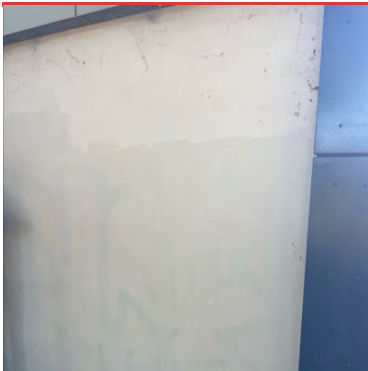
### PHOTO 3

Condition: Good.

Result: **Lead not detected above 0.1% weight/weight (w/w).**

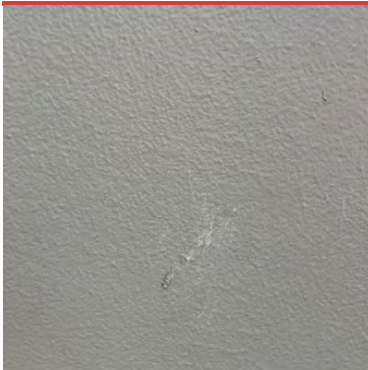
### PHOTO 4 (CLOSE-UP)

Condition: Good.

Result: **Lead not detected above 0.1% weight/weight (w/w).**

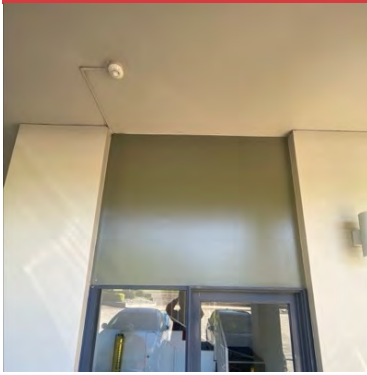
### PHOTO 5

Location: Exterior, southern elevation, adjacent reception.  
Infill panel.

Condition: Good.

Result: Asbestos Not Detected

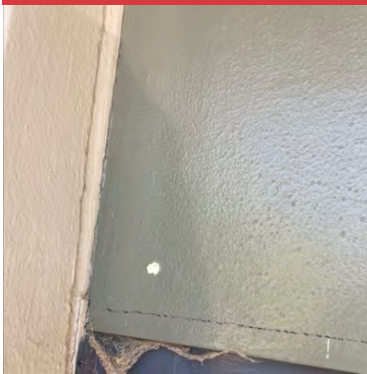
### PHOTO 6 (CLOSE-UP)

Location: Exterior, southern elevation, adjacent reception. Infill panel.

Condition: Good.

Result: Asbestos Not Detected

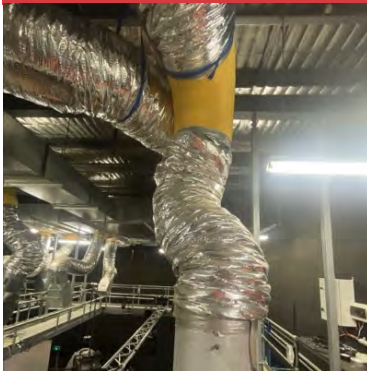
### PHOTO 7

Location: Interior, Theatre, Level 1, air conditioning ductwork.

Condition: Good.

Result: Suspected to contain Synthetic Mineral Fibre (SMF) material.

| EP4556.001_CCC_Arts Centre Destructive HAZMAT Register_v1 | | | | | | | | | Material Status and Risk Assessment | | | | | | | | | | Required Actions | |
|---|---|---|---|---|---|---|---|---|---|---|---|---|---|---|---|---|---|---|---|---|
| 31 | Art Gallery Interior Level 1 | Theatre | Ceiling level | Ductwork - Flexible | Insulation material - internal | SMF | Visually assessed | N/A | Suspected synthetic mineral fibre | 50 | m | - | Full covered | Good | Low | Low | PA | No | Remove under controlled SMF conditions as per Code of Practice for the Safe Use of Synthetic Mineral Fibres (NCHRC: 2006 (1990)). | 7 |

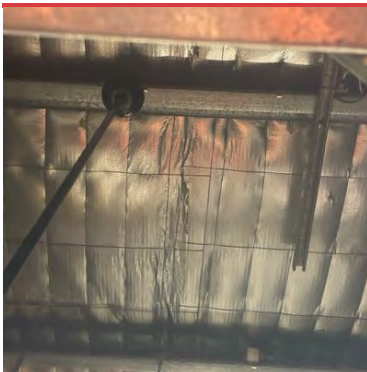
### PHOTO 8

Location: Interior, Theatre, Level 1, underside of roof - sarking insulation.

Condition: Good.

Result: Suspected to contain Synthetic Mineral Fibre (SMF) material.

| EP4556.001_CCC_Arts Centre Destructive HAZMAT Register_v1 | | | | | | | | | Material Status and Risk Assessment | | | | | | | | | | Required Actions | |
|---|---|---|---|---|---|---|---|---|---|---|---|---|---|---|---|---|---|---|---|---|
| 32 | Art Gallery Interior Level 1 | Theatre | Beneath roof | Sarking insulation | Insulation material | SMF | Visually assessed | N/A | Suspected synthetic mineral fibre | 1,000 | m² | - | Full covered | Good | Low | Low | PA | No | Remove under controlled SMF conditions as per Code of Practice for the Safe Use of Synthetic Mineral Fibres (NCHRC: 2006 (1990)). | 8 |

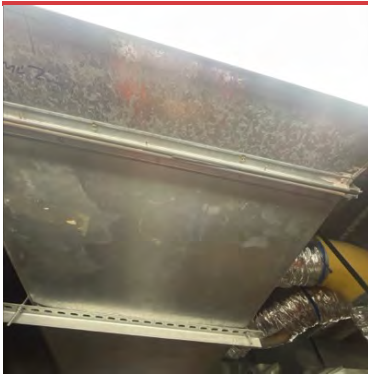
### PHOTO 9

Condition: Good.

Result: Suspected to contain Synthetic Mineral Fibre (SMF) material.

| EP4556.001_CCC_Arts Centre Destructive HAZMAT Register_v1 | | | | | | | | | Material Status and Risk Assessment | | | | | | | | | | Required Actions | |
|---|---|---|---|---|---|---|---|---|---|---|---|---|---|---|---|---|---|---|---|---|
| 33 | Art Gallery Interior Level 1 | Theatre | Ceiling level | Ductwork - Fixed | Insulation material - internal | SMF | Visually assessed | N/A | Suspected synthetic mineral fibre | 70 | m | - | Metal housing | Good | Low | Low | PA | No | Remove under controlled SMF conditions as per Code of Practice for the Safe Use of Synthetic Mineral Fibres (NCHRC: 2006 (1990)). | 9 |

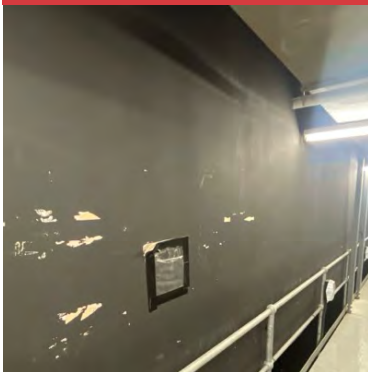
### PHOTO 10

Condition: Good.

Result: Lead not detected above 0.1% weight/weight (w/w).

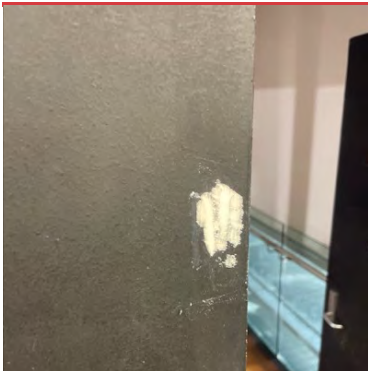
### PHOTO 11 (CLOSE-UP)

Condition: Good.

Result: Lead not detected above 0.1% weight/weight (w/w).

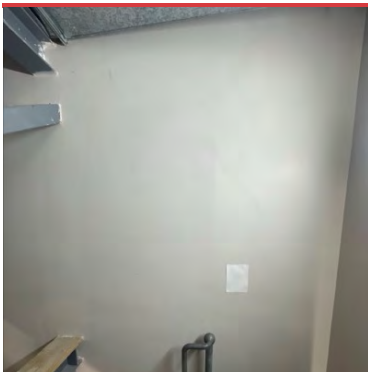
### PHOTO 12

Condition: Good.

Result: Lead not detected above 0.1% weight/weight (w/w).

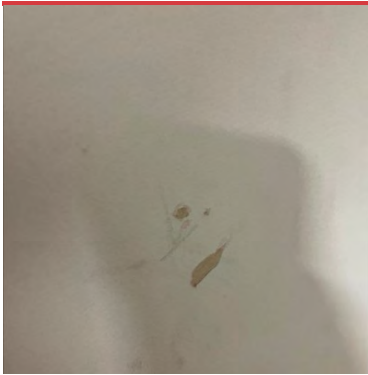
### PHOTO 13 (CLOSE-UP)

Condition: Good.

Result: Lead not detected above 0.1% weight/weight (w/w).

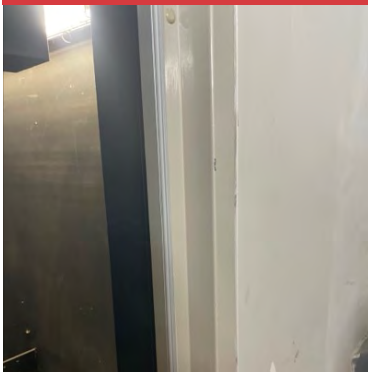
### PHOTO 14

Condition: Good.

Result: Lead not detected above 0.1% weight/weight (w/w).

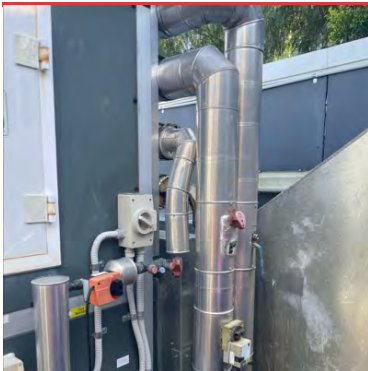
### PHOTO 15

Condition: Good.

Result: Suspected to contain Synthetic Mineral Fibre (SMF) material.

| EP4556.001_CCC_Arts Centre Destructive HAZMAT Register_v1 | | | | | | | | | Material Status and Risk Assessment | | | | | | | | | | Required Actions | |
|---|---|---|---|---|---|---|---|---|---|---|---|---|---|---|---|---|---|---|---|---|
| 30 | Art Gallery Exterior | Roof top | Plant area | Pipework | Insulation material - internal | SMF | Visually assessed | N/A | Suspected synthetic mineral fibre | 1000 | m | - | Metal housing | Good | Low | Low | PA | No | Remove under controlled SMF conditions as per Code of Practice for the Safe Use of Synthetic Mineral Fibres (NCHRC: 2006 (1990)). | 15 |

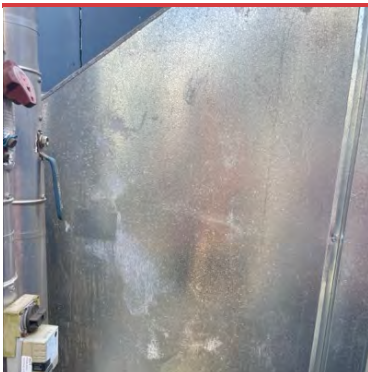
### PHOTO 16

Location: Exterior, Roof, air conditioning ductwork.

Condition: Good.

Result: Suspected to contain Synthetic Mineral Fibre (SMF) material.

| EP4556.001_CCC_Arts Centre Destructive HAZMAT Register_v1 | | | | | | | | | Material Status and Risk Assessment | | | | | | | | | | Required Actions | |
|---|---|---|---|---|---|---|---|---|---|---|---|---|---|---|---|---|---|---|---|---|
| 29 | Art Gallery Exterior | Roof top | Plant area | Air conditioning duct work | Insulation material - internal | SMF | Visually assessed | N/A | Suspected synthetic mineral fibre | 2 | m | - | Metal housing | Good | Low | Low | PA | No | Remove under controlled SMF conditions as per Code of Practice for the Safe Use of Synthetic Mineral Fibres (NCHRC: 2006 (1990)). | 16 |

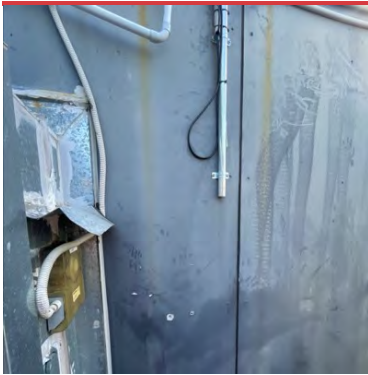
#### PHOTO 17

Condition: Good.

Result: **Asbestos Not Detected.**

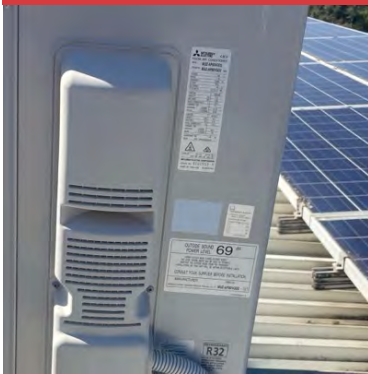
#### PHOTO 18 (CLOSE-UP)

Location: Roof top area, Mitsubishi branded air conditioning unit.

Condition: Good.

Result: R32/HFC32 refrigerant detected via tag. Not considered to be an Ozone Depleting Substance (ODS).

| EP4556.001_CCC_Arts Centre Destructive HAZMAT Register_v1 | | | | | | | | | Material Status and Risk Assessment | | | | | | | | | | Required Actions | |
|---|---|---|---|---|---|---|---|---|---|---|---|---|---|---|---|---|---|---|---|---|
| 38 | Art Gallery Exterior | Roof top | Plant area | Air conditioning unit - Mitsubishi branded | Refrigerant gas (R32)/HCFC32 | Ozone Depleting Substances | Visually assessed | N/A | Not ozone depleting | 1 | Unit(s) | - | - | - | - | - | - | - | Not considered to be an ODS. This refrigerant gas should however be appropriately decanted and disposed of by a licensed contractor in accordance with the Ozone Protection and Synthetic Greenhouse Gas Management Amendment Regulation 2012 as it has the potential to contribute to global warming. Ozone Depleting Potential (ODP): 0.00 Global Warming Potential (GWP): 675 | 18 and 19 |

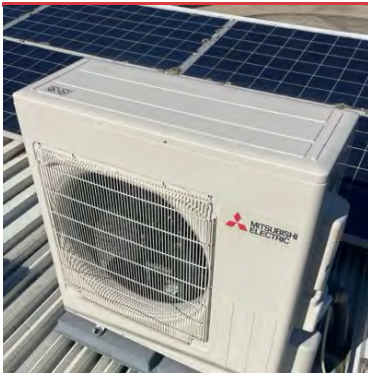
#### PHOTO 19

Location: Roof top area, Mitsubishi branded air conditioning unit.

Condition: Good.

Result: R32/HFC32 refrigerant detected via tag. Not considered to be an Ozone Depleting Substance (ODS).

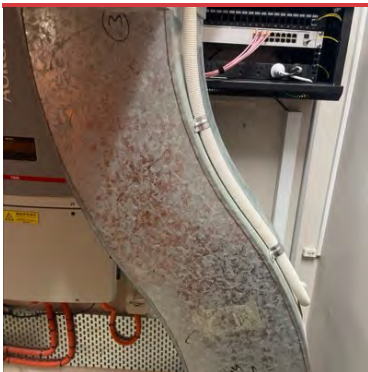
#### PHOTO 20

Location: Interior, plant room beneath roof - air conditioning ductwork.

Condition: Good.

Result: Suspected to contain Synthetic Mineral Fibre (SMF) material.

| EP4556.001_CCC_Arts Centre Destructive HAZMAT Register_v1 | | | | | | | | | Material Status and Risk Assessment | | | | | | | | | | Required Actions | |
|---|---|---|---|---|---|---|---|---|---|---|---|---|---|---|---|---|---|---|---|---|
| 34 | Art Gallery Interior Level 1 | Adjacent to roof access | Plant room | Ductwork - Fixed | Insulation material - internal | SMF | Visually assessed | N/A | Suspected synthetic mineral fibre | 2 | m | - | Metal housing | Good | Low | Low | PA | No | Remove under controlled SMF conditions as per Code of Practice for the Safe Use of Synthetic Mineral Fibres (NCHRC: 2006 (1990)). | 20 |

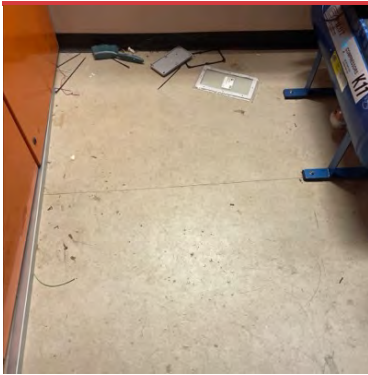
#### PHOTO 21

Location: Interior, plant room beneath roof - floor coverings.

Condition: Good.

Result: **Asbestos Not Detected.**

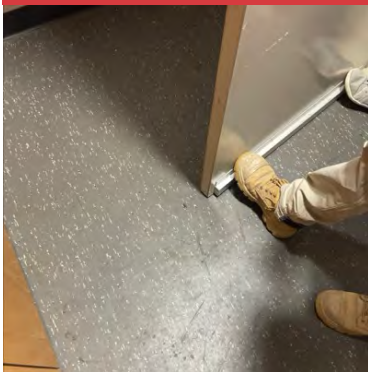
#### PHOTO 22

Location: Interior, plant room beneath roof, landing outside of plant room - floor coverings.

Condition: Good.

Result: **Asbestos Not Detected.**

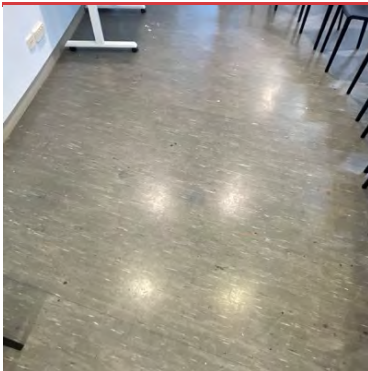
#### PHOTO 23

Location: Interior, level 1, work shop 4 - floor coverings.

Condition: Good.

Result: **Asbestos Not Detected.**

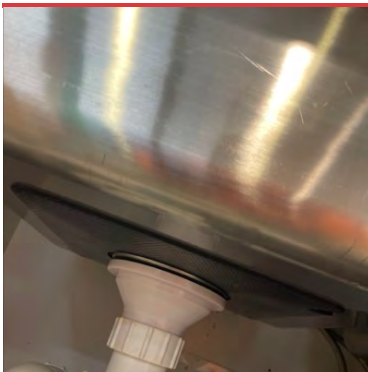
#### PHOTO 24

Location: Interior, level 1, work shop 4, beneath sink - sink pad.

Condition: Good.

Result: **Asbestos Not Detected.**

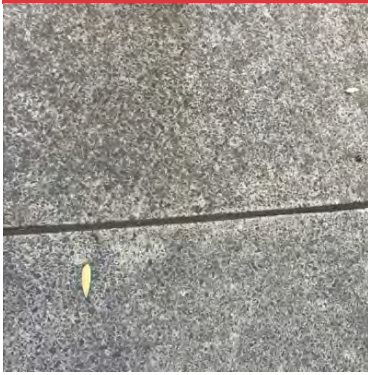
#### PHOTO 25

Condition: Good.

Result: **Asbestos Not Detected.**

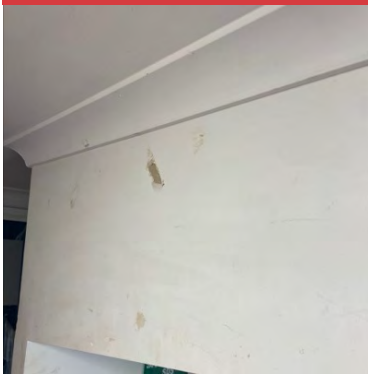
#### PHOTO 26

Condition: Good.

Result: **Lead not detected above 0.1% weight/weight (w/w).**

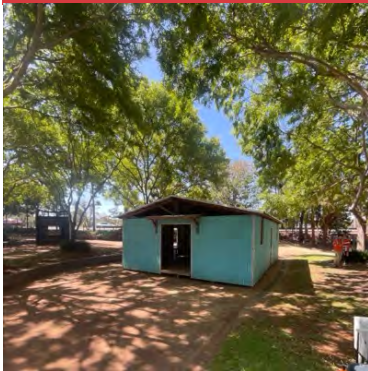
#### PHOTO 27

Location: Blue shed across bridge. Inspected and constructed of timber and metal.

Suspected not to contain lead-containing paint.

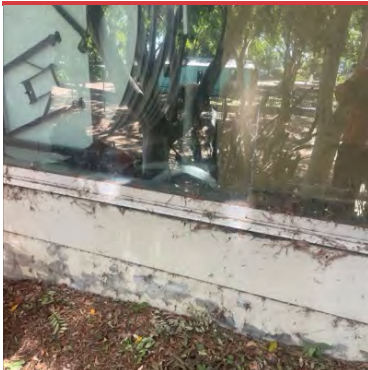
#### PHOTO 28 (CLOSE-UP)

Condition: Poor (flaking).

Result: **Lead not detected above 0.1% weight/weight (w/w).**

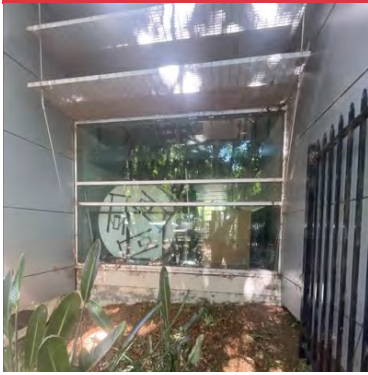
#### PHOTO 29

Location: Exterior, eastern elevation. Beneath windows.

Condition: Poor (flaking).

Result: Lead not detected above 0.1% weight/weight (w/w).

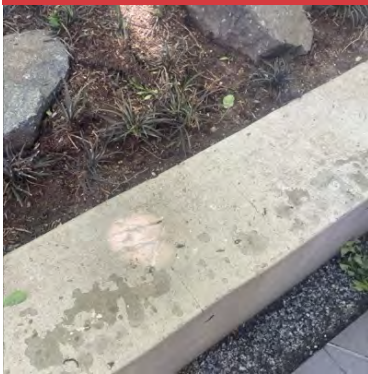
#### PHOTO 30

Location: Exterior, eastern elevation. Garden bed - Retaining wall.

Condition: Poor (flaking).

Result: Lead not detected above 0.1% weight/weight (w/w).

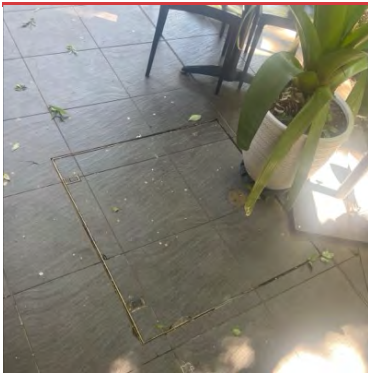
#### PHOTO 31

Location: Patio adjacent cafe. Ground pit.

No access.

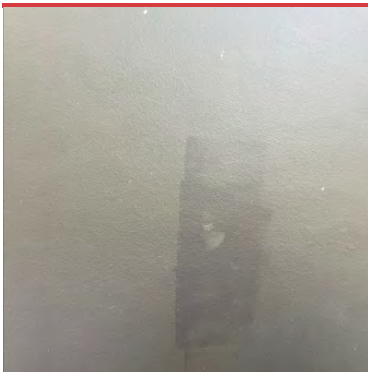
#### PHOTO 32

Location: Exterior, eastern elevation cafe alfresco area - walls.

Condition: Good.

Result: Lead not detected above 0.1% weight/weight (w/w).

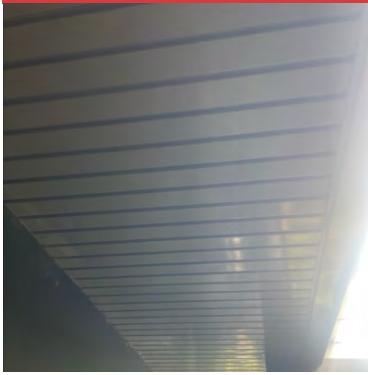
### PHOTO 33

Location: Adjacent to cafe - eaves.

Suspected to be constructed of metal.

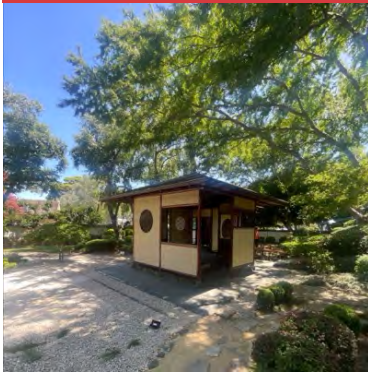
### PHOTO 34

Location: Japanese Garden - buildings.

Inspected and suspected to be constructed of timber and stipple render.

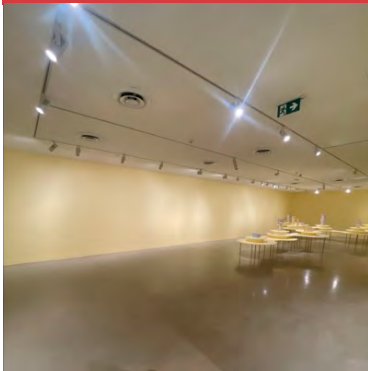
### PHOTO 35

Location: Interior, gallery - walls.

Condition: Good.

Result: Lead not detected above 0.1% weight/weight (w/w).

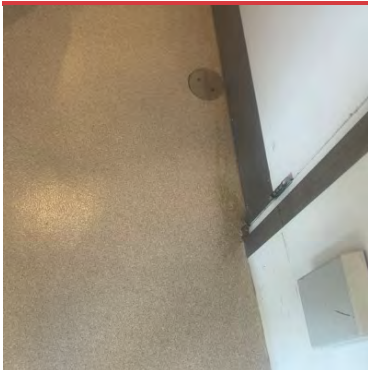
### PHOTO 36

Location: Interior, left hand side of main entrance, adjacent to lift - floor coverings.

Condition: Good.

Result: Asbestos Not Detected.

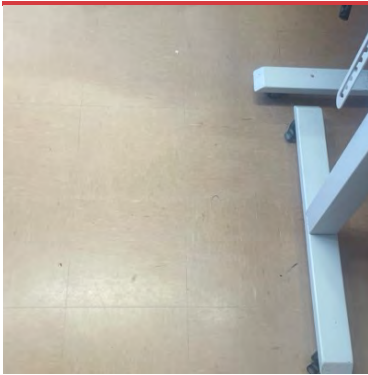
#### PHOTO 37

Location: Interior, ground level, Workshop 2 - floor covering.

Condition: Good.

Result: Asbestos Not Detected.

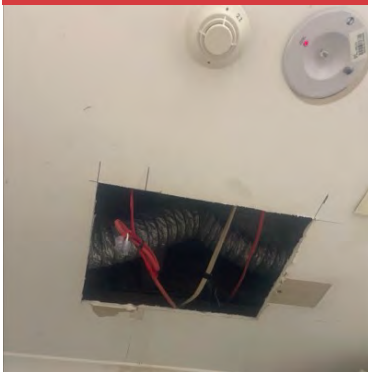
#### PHOTO 38

Location: Interior, ground level, chemical store adjacent to workshop/store room - air conditioning ductwork.

Condition: Good.

Result: Suspected to contain Synthetic Mineral Fibre (SMF) material.

| EP4556.001_CCC_Arts Centre Destructive HAZMAT Register_v1 | | | | | | | | | Material Status and Risk Assessment | | | | | | | | | | Required Actions | |
|---|---|---|---|---|---|---|---|---|---|---|---|---|---|---|---|---|---|---|---|---|
| 35 | Art Gallery Interior Ground level | Chemical store adjacent to workshop | Ceiling cavity above workshop/storeroom | Ductwork - Flexible | Insulation material - internal | SMF | Visually assessed | N/A | Suspected synthetic mineral fibre | >10 | m | - | Full covered | Good | Low | Low | PA | No | Remove under controlled SMF conditions as per Code of Practice for the Safe Use of Synthetic Mineral Fibres (NCHRC: 2006 (1990)). | 38 |

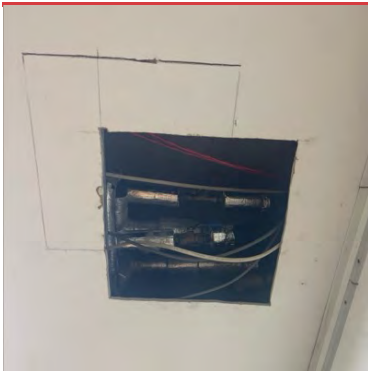
#### PHOTO 39

Location: Interior, ground level, chemical store adjacent to workshop/store room - pipework.

Condition: Good.

Result: Suspected to contain Synthetic Mineral Fibre (SMF) material.

| EP4556.001_CCC_Arts Centre Destructive HAZMAT Register_v1 | | | | | | | | | Material Status and Risk Assessment | | | | | | | | | | Required Actions | |
|---|---|---|---|---|---|---|---|---|---|---|---|---|---|---|---|---|---|---|---|---|
| 36 | Art Gallery Interior Ground level | Chemical store adjacent to workshop | Ceiling cavity above workshop/storeroom | Pipework | Insulation material - internal | SMF | Visually assessed | N/A | Suspected synthetic mineral fibre | >1 | m | - | Metal housing | Good | Low | Low | PA | No | Remove under controlled SMF conditions as per Code of Practice for the Safe Use of Synthetic Mineral Fibres (NCHRC: 2006 (1990)). | 39 |

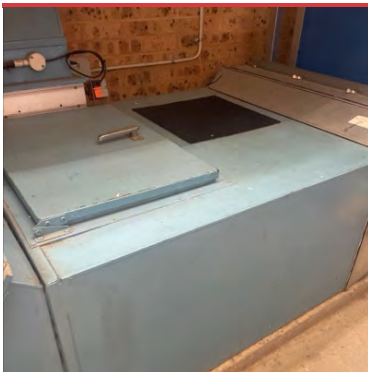
#### PHOTO 40

Location: Plant room adjacent to offices on L1 - air conditioning ductwork.

Condition: Good.

Result: Lead not detected above 0.1% weight/weight (w/w).

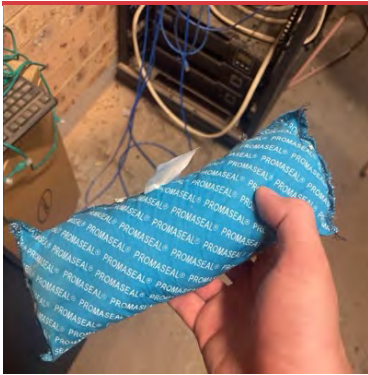
#### PHOTO 41

Condition: Good.

Result: Suspected to contain Synthetic Mineral Fibre (SMF) material.

| EP4556.001_CCC_Arts Centre Destructive HAZMAT Register_v1 | | | | | | | | | Material Status and Risk Assessment | | | | | | | | | | Required Actions | |
|---|---|---|---|---|---|---|---|---|---|---|---|---|---|---|---|---|---|---|---|---|
| 37 | Art Gallery Interior Level 1 | Adjacent to offices | Plant room | Penetrations - Fire gaskets | Insulation material - internal | SMF | Visually assessed | N/A | Suspected synthetic mineral fibre | 5 | Unit(s) | - | Fabric cover | Good | Low | Low | PA | No | Remove under controlled SMF conditions as per Code of Practice for the Safe Use of Synthetic Mineral Fibres (NCHRC: 2006 (1990)). | 41 |

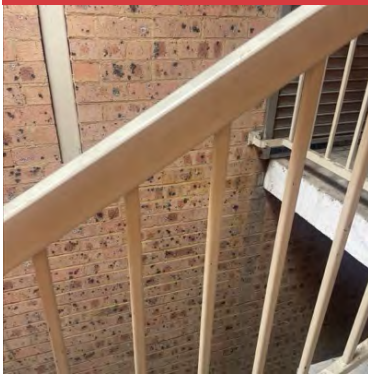
#### PHOTO 42

Condition: Good.

Result: **Lead detected at 0.12% weight/weight (w/w). Therefore considered to be lead-containing paint.**

- Workers undertaking lead risk work must be provided with health monitoring before lead risk work starts and one month after starting.
- Removal works should be conducted in accordance with the requirements of AS/NZS 4361.2:2017 Guide to Hazardous Paint Management – *Part 2: Residential and commercial buildings*.

- Lead containing paint removal methodologies can include chemical strippers (peels), heat guns and wet scraping.
- Workers involved in lead paint removal should wear appropriate Personal Protective Equipment (PPE), including respirators (P2 or N95), gloves, disposable overalls, and safety goggles. This prevents inhalation or skin contact with lead particles. It is also a requirement for workers involved with processing lead materials to undertake regular health monitoring.

- Following the completion of LCP removal works, all material used or generated in the removal works (e.g., wipes, cloths, vacuum bags, disposable PPE) must be sealed within 200 µm plastic bags and appropriately labelled as LCP waste. All LCP waste must be disposed of at an EPA-licensed hazardous waste facility in accordance with NSW hazardous waste disposal guidelines.

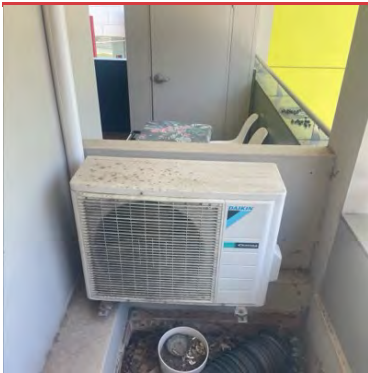
#### PHOTO 43

Location: Exterior, Level 1, Balcony adjacent to L1 offices - air conditioning unit (Daikin Branded).

Condition: Good.

Result: R410a refrigerant gas. Therefore not considered to be ozone depleting.

| EP4556.001_CCC_Arts Centre Destructive HAZMAT Register_v1 | | | | | | | | | Material Status and Risk Assessment | | | | | | | | | | Required Actions | |
|---|---|---|---|---|---|---|---|---|---|---|---|---|---|---|---|---|---|---|---|---|
| 39 | Art Gallery Exterior Level 1 | Adjacent to offices | Balcony | Air conditioning unit - Daikin branded | Refrigerant gas (R410A) | Ozone Depleting Substances | Visually assessed | N/A | Not ozone depleting | 1 | Unit(s) | - | - | - | - | - | - | - | Not considered to be an ODS. This refrigerant gas should however be appropriately decanted and disposed of by a licensed contractor in accordance with the Ozone Protection and Synthetic Greenhouse Gas Management Amendment Regulation 2012 as it has the potential to contribute to global warming. Ozone Depleting Potential (ODP): 0.00 Global Warming Potential (GWP): 2,088 | 43 |

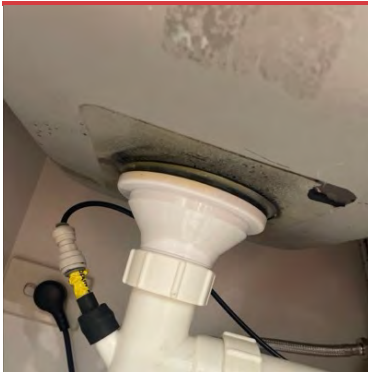
#### PHOTO 44

Condition: Good.

Result: **Asbestos Not Detected.**

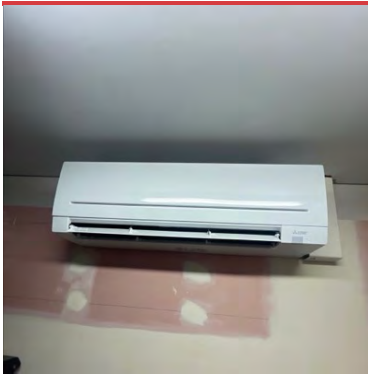
#### **PHOTO 45**

Location: Interior, Level 1, computer room adjacent to Seminar Room - air conditioning unit.

Condition: Good.

| EP4556.001_CCC_Arts Centre Destructive HAZMAT Register_v1 | | | | | | | | | Material Status and Risk Assessment | | | | | | | | | | Required Actions | |
|---|---|---|---|---|---|---|---|---|---|---|---|---|---|---|---|---|---|---|---|---|
| 40 | Art Gallery Interior Level 1 | Adjacent to Seminar Room | Computer room | Air conditioning unit | Refrigerant gas (R32) | Ozone Depleting Substances | Visually assessed | N/A | Not ozone depleting | 1 | Unit(s) | - | - | - | - | - | - | - | Not considered to be an ODS. This refrigerant gas should however be appropriately decanted and disposed of by a licensed contractor in accordance with the Ozone Protection and Synthetic Greenhouse Gas Management Amendment Regulation 2012 as it has the potential to contribute to global warming. Ozone Depleting Potential (ODP): 0.00 Global Warming Potential (GWP): 675 | 45 |

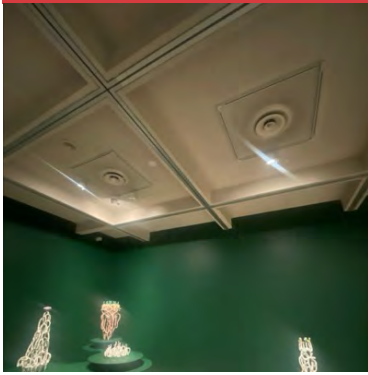
#### **PHOTO 1B**

Location: Main large gallery, ceiling - south western corner.

Condition: Good.

Result: **No asbestos detected.**

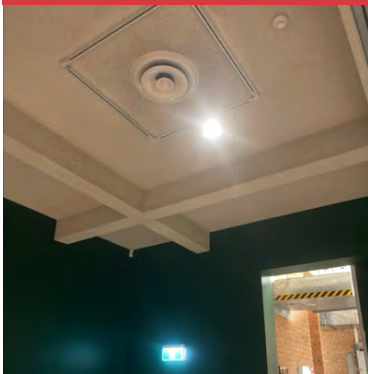
#### **PHOTO 2B**

Location: Main large gallery, ceiling - south eastern corner.

Condition: Good.

Result: **No asbestos detected.**

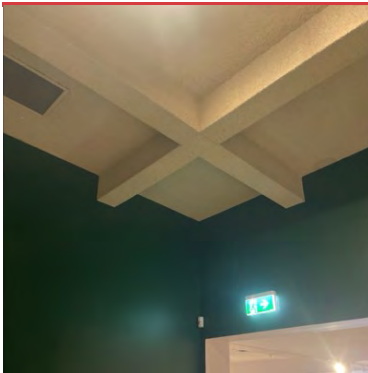
#### **PHOTO 3B**

Location: Main large gallery, ceiling - north eastern corner.

Condition: Good.

Result: **No asbestos detected.**

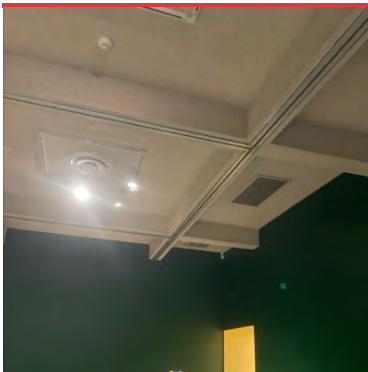
#### **PHOTO 4B**

Location: Main large gallery, ceiling - north western corner.

Condition: Good.
