**Re: Heritage Engineering at Lands Building –Ceiling Condition based on available inspections**

| Project: | Sandstone Precinct. Department of Lands Project | | | | | | | | | | | |
| Title: | Heritage Ceiling Matrix | | | | | | | | | | | |

**Preliminary Report on Permanent Stabilisation Detail of Lath and  
Plaster Ceiling at Department of Lands Building**

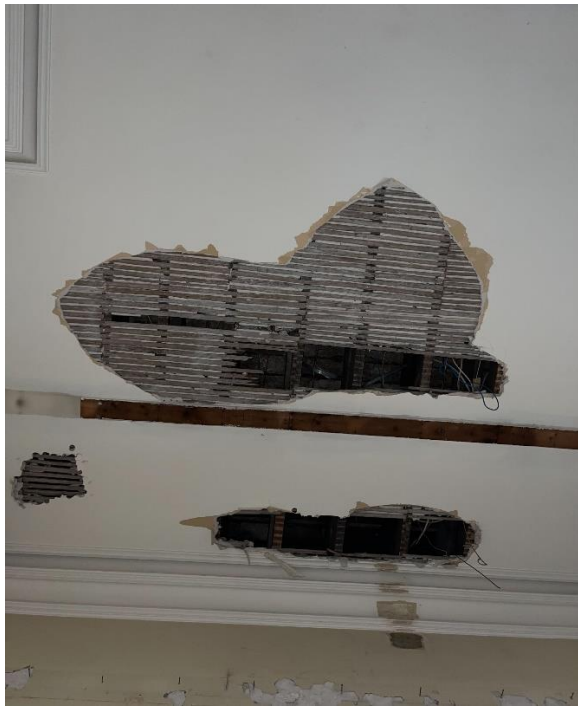
- Collapsed timber and lath plaster ceilings were identified in several rooms throughout the Department of Lands Building. The ceiling collapse in these areas appears to be consistent with the cause being water ingress, including failure of the nails used to fix the timber laths to the existing floor joists. This is supported by testing from the durability consultant, BCRC, which found that nails were corroded in the areas they assessed (see BCRC report ref N10250-4 dated 14 April 2022).

*Photograph 5 – Typical example of collapsed timber lath and plaster ceiling*

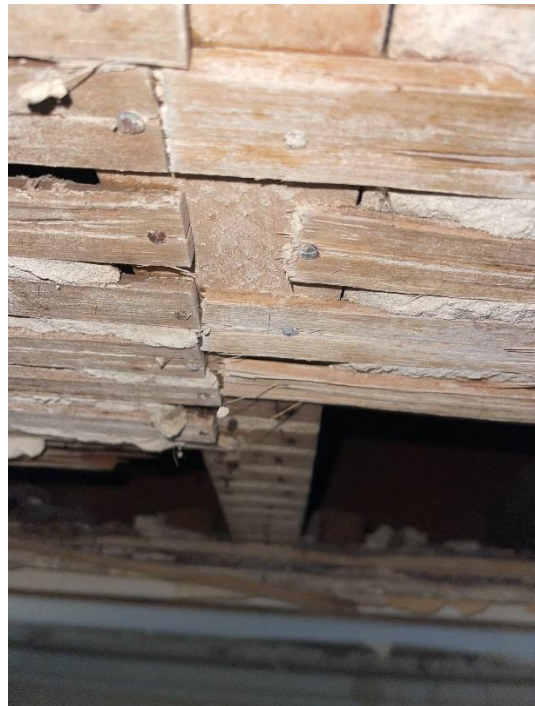
*Photograph 6 – Typical example of failure of lath and plaster ceilings due to splitting of timber battens. Splitting likely caused by corrosion of iron nails.*

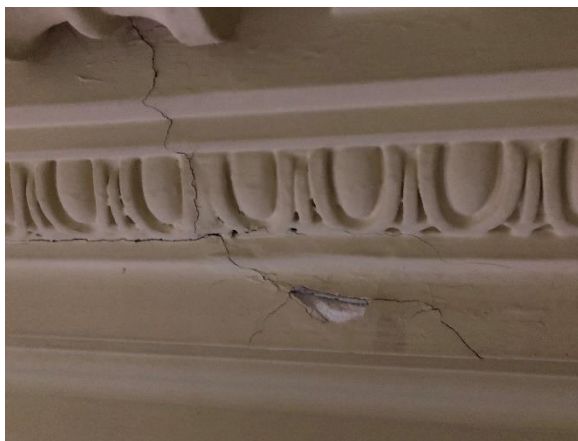
*Photograph 7 – Typical cracking to decorative moulding, evidence of water damage present*

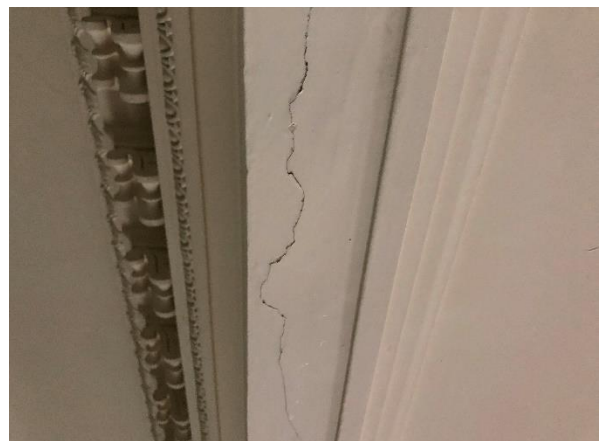
*Photograph 8 – Typical cracking to the decorative moulding, parallel to the timber laths, indicative of failure of the lath "key"*

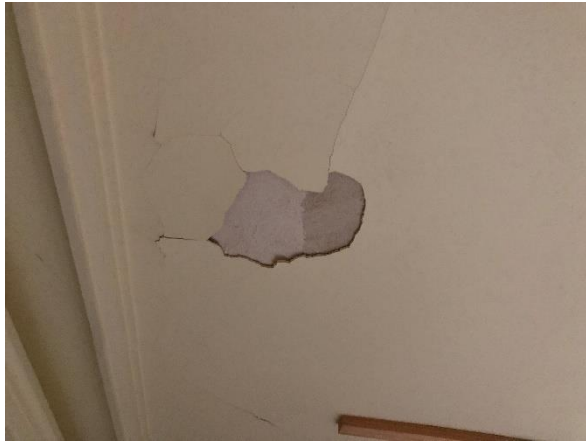
*Photograph 9 – Typical example of separation of paint from plaster*

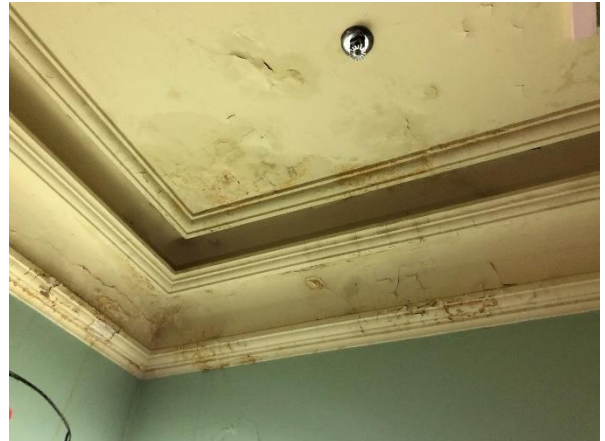
*Photograph 10 – Moisture damage to timber lath and plaster ceiling*

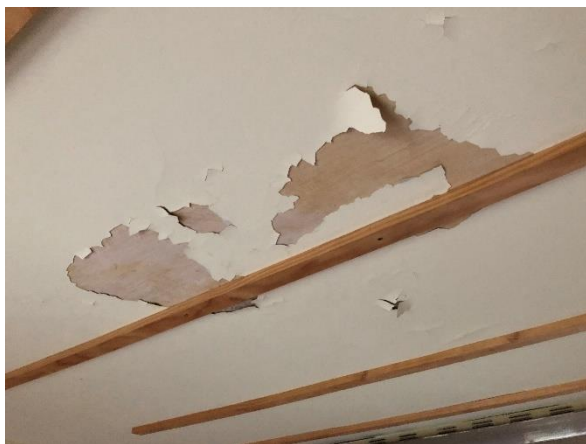
*Photograph 11 – Typical photo of delaminating paint system*

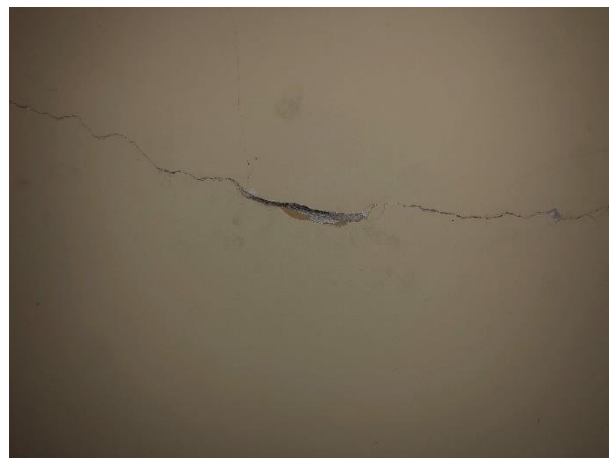
*Photograph 12 – Full depth crack to plaster*

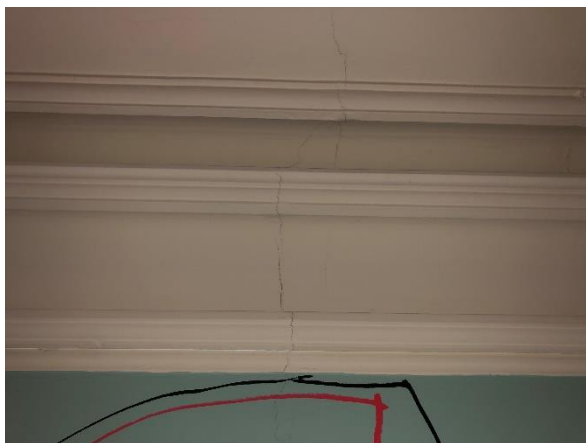
*Photograph 13 – Typical hairline cracking through decorative cornice*

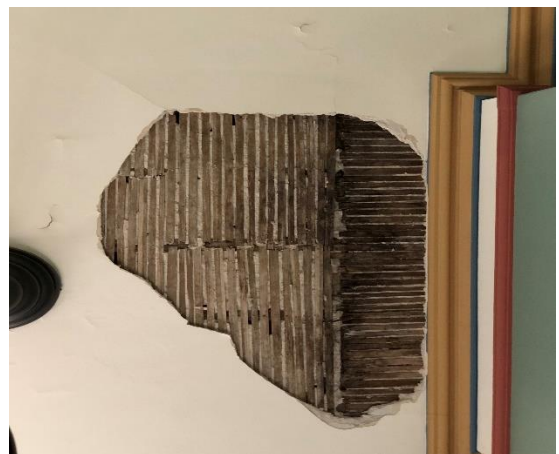
*Photograph 14 – Ceiling collapse, discoloration of timber laths suggestive of moisture damage. Framing of laths appears to have changed here.*

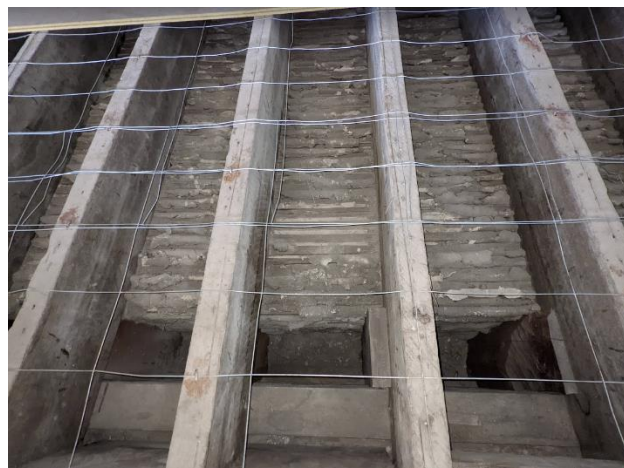
Photograph 15 – Example of missing keys at topside of timber lath ceiling

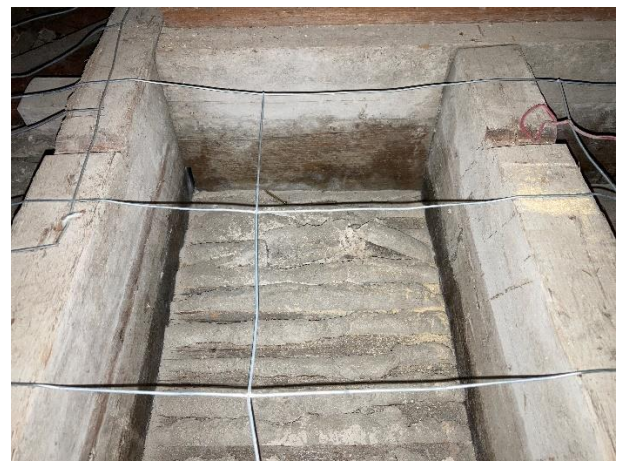
Photograph 16 – Example of broken key at timber lath ceiling

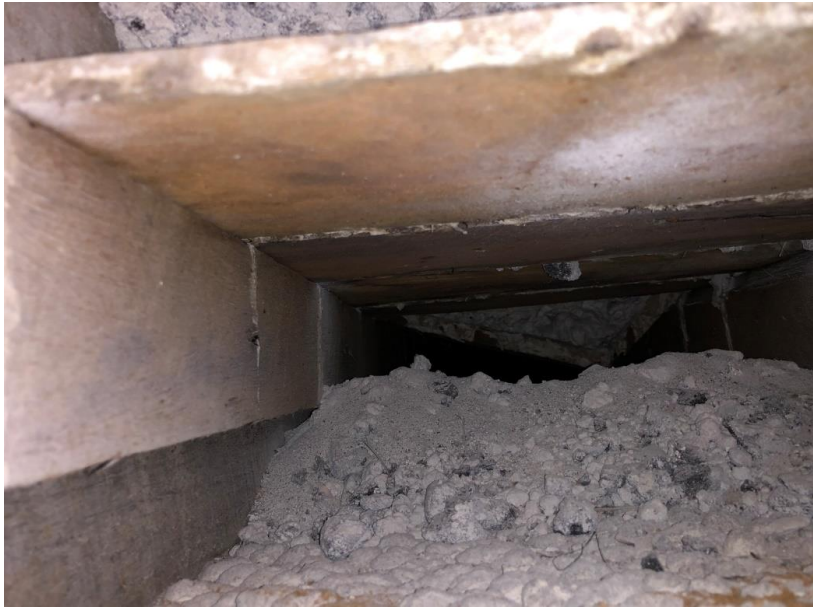
Photograph 17 - Example of collapsed coke breeze infill concrete Room 226 ceiling penetration

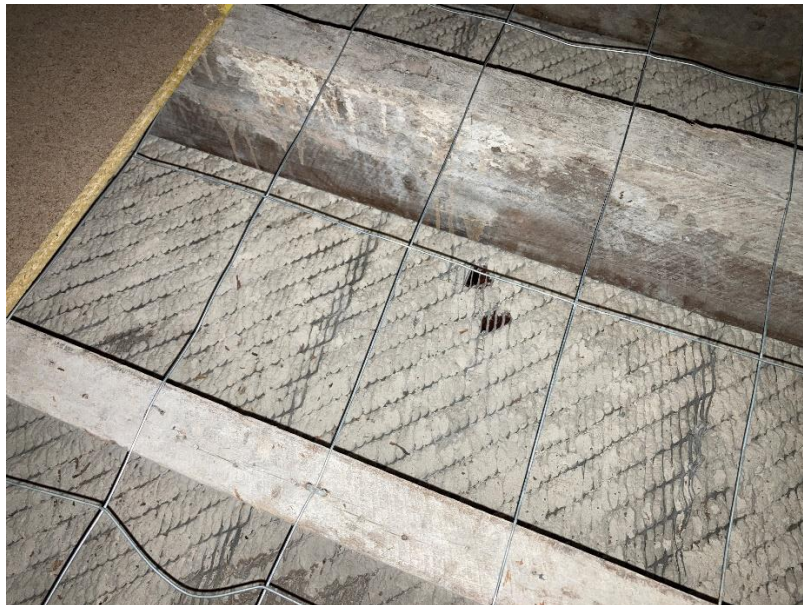
Photograph 20 – Example of damage to keys on metal lath ceiling

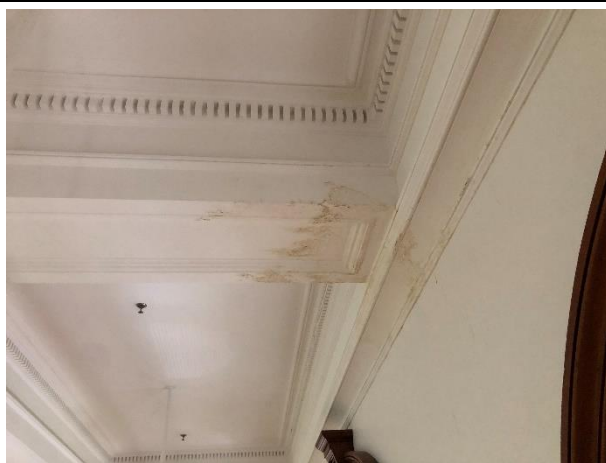
*Photograph 21 – Evidence of water ingress and staining to metal lath ceiling*

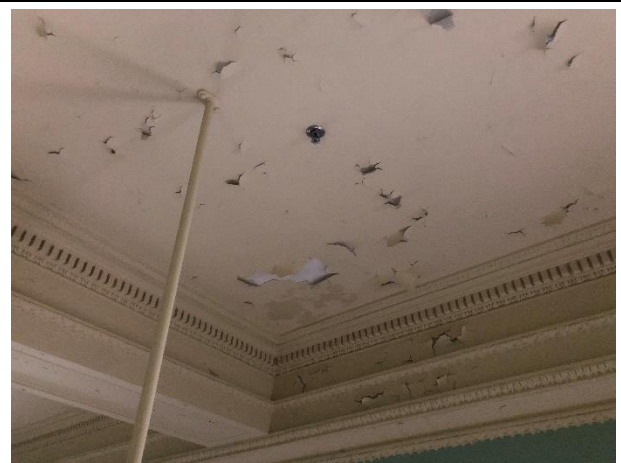
*Photograph 22 – Delamination and flaking ceiling paint system*

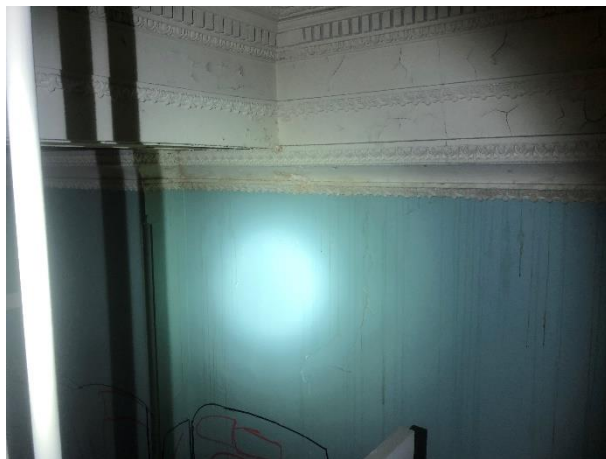
*Photograph 23 – Evidence of water ingress and staining to lath ceilings*

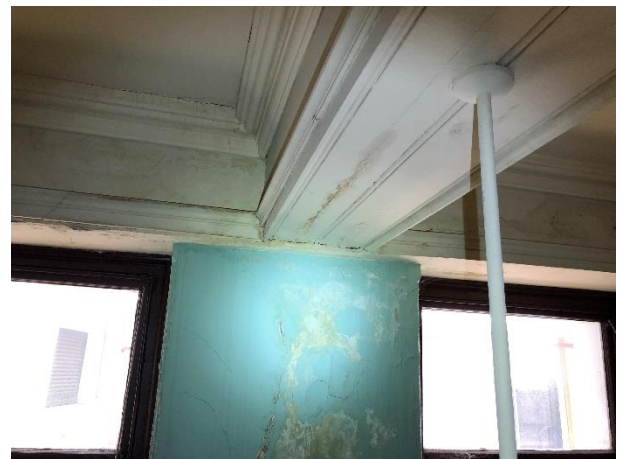
*Photograph 24 – Evidence of water ingress and staining to lath ceilings. Likely due to water ingress from façade*
