Demolition/Refurbishment Hazardous Materials Risk Assessment
Office of Finance and Services
Ultimo Public School
Quarry Street, Ultimo NSW 2007

Site Reference: 001-Ultimo PS

Our Reference: C107477 : J140648

Date: October 2015

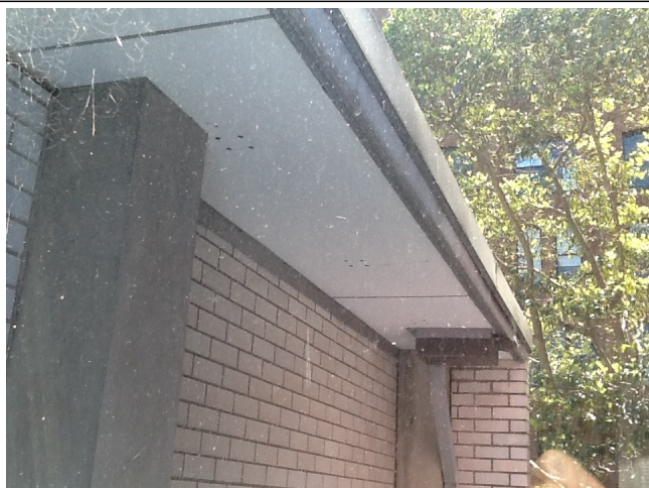
Photo No: J140648-001-Ultimo PS-Photo161
Result: Asbestos - Presumed Positive
Building/Level: Building BOOA-Ground Level
Room/Location: Exterior-North & South
Feature/Material: Eaves-Fibre Cement Sheetting

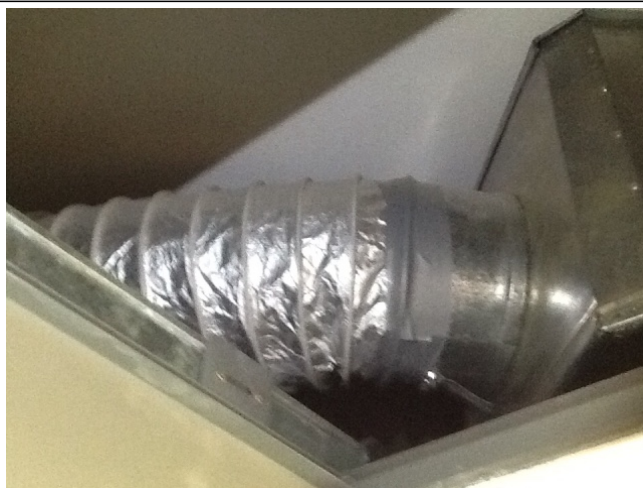
Photo No: J140648-001-Ultimo PS-Photo025
Result: SMF - Presumed Positive
Building/Level: Building BOOA-Ground Level
Room/Location: All Rooms-Throughout
Feature/Material: Flexible Ductwork Insulation-Insulation Material

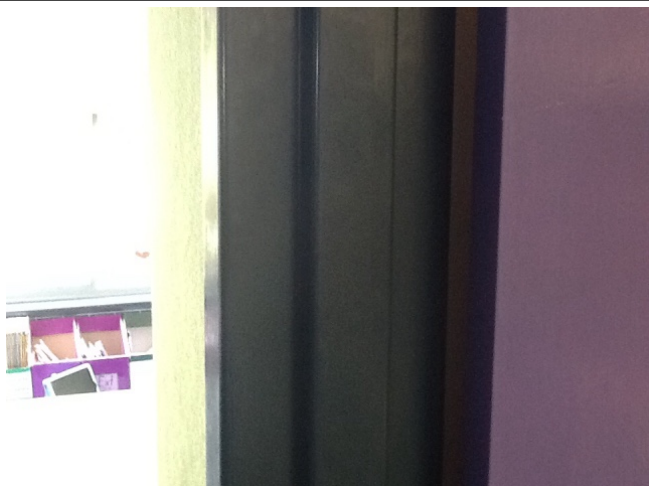
Photo No: J140648-001-Ultimo PS-Photo008
Result: Lead (Paint) - Presumed Positive
Building/Level: Building BOOA-Ground Level
Room/Location: AR0018-Throughout
Feature/Material: Door & Frame-Upper & Lower Paint System/s

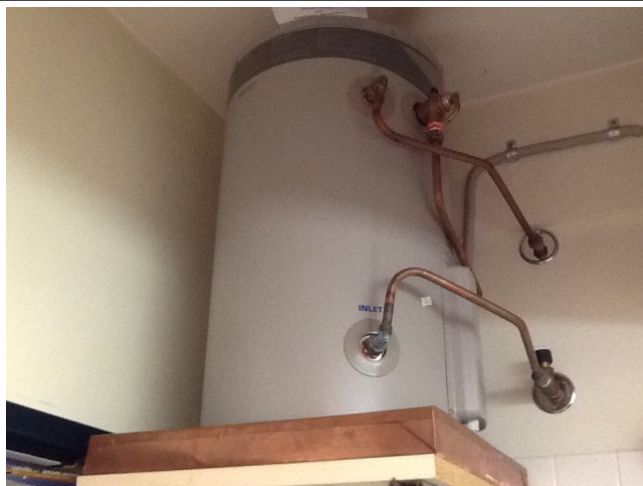
Photo No: J140648-001-Ultimo PS-Photo019
Result: SMF - Presumed Positive
Building/Level: Building BOOA-Ground Level
Room/Location: AR0019-Southwest
Feature/Material: Hot Water Heater-Insulation Material

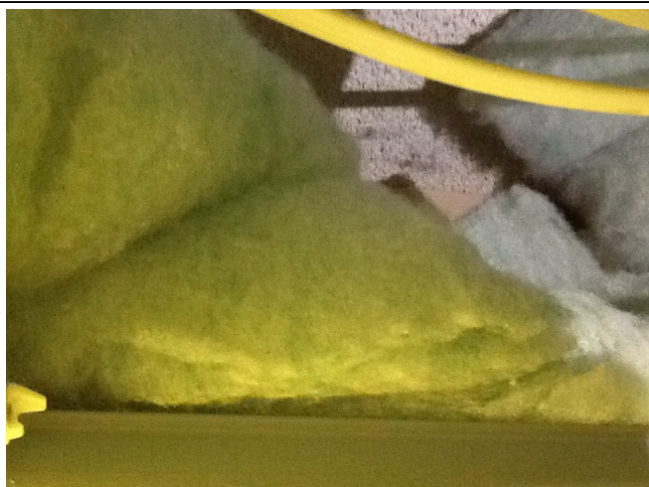
Photo No: J140648-001-Ultimo PS-Photo066
Result: SMF - Positive
Building/Level: Building BOOA-Level 2
Room/Location: All Rooms-ceiling Space
Feature/Material: Ceiling Space-Insulation Batt/s

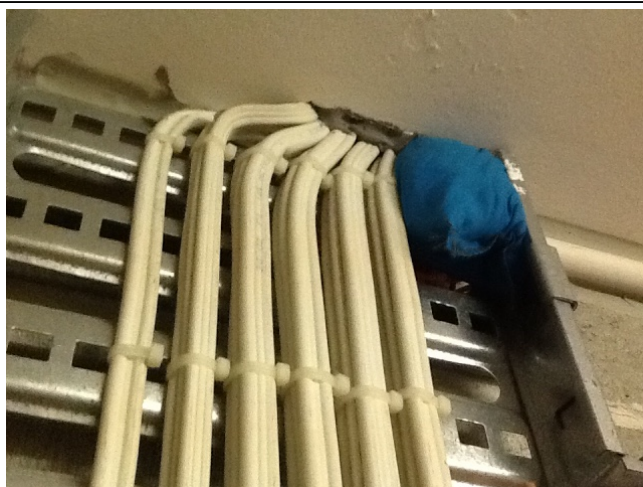
Photo No: J140648-001-Ultimo PS-Photo092
Result: SMF - Presumed Positive
Building/Level: Building BOOA-Level 2
Room/Location: AR2036-Throughout
Feature/Material: Riser-Pillow Insulation

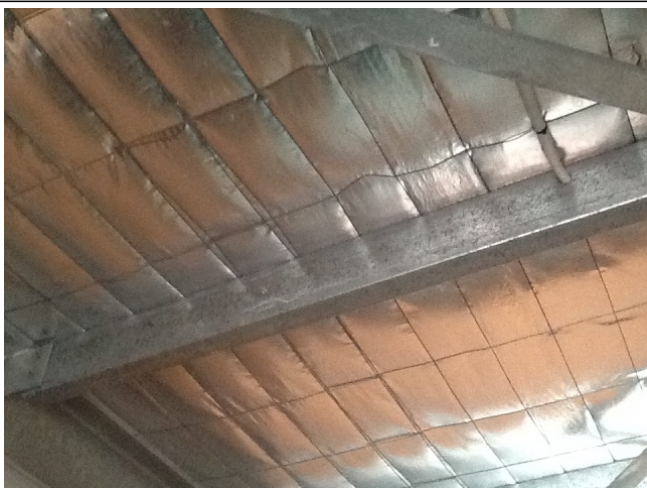
Photo No: J140648-001-Ultimo PS-Photo159
Result: SMF - Positive
Building/Level: Building BOOC-Ground Level
Room/Location: CR0007-Throughout
Feature/Material: Roof Lining-Sarking Insulation

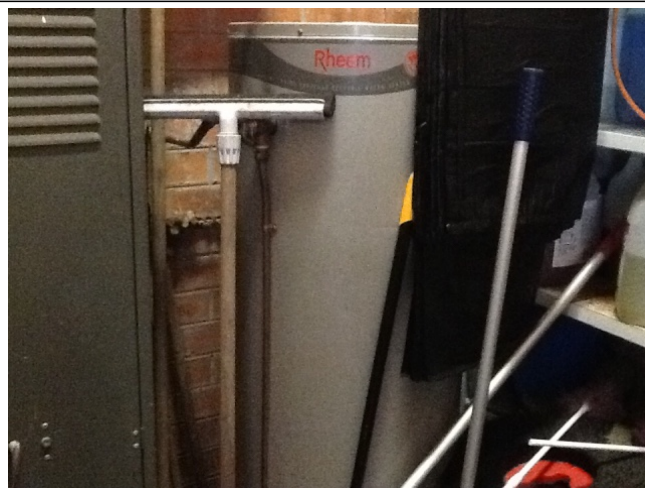
Photo No: J140648-001-Ultimo PS-Photo097
Result: SMF - Presumed Positive
Building/Level: Building BOOD-Ground Level
Room/Location: DR0002-South
Feature/Material: Hot Water Heater-Insulation Material

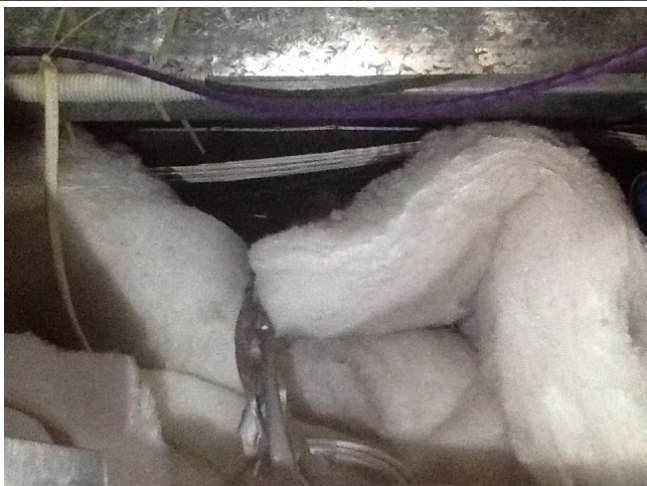
Photo No: J140648-001-Ultimo PS-Photo115
Result: SMF - Positive
Building/Level: Building BOOD-Level 1
Room/Location: All Rooms-Throughout
Feature/Material: Ceiling Space-Insulation Batts

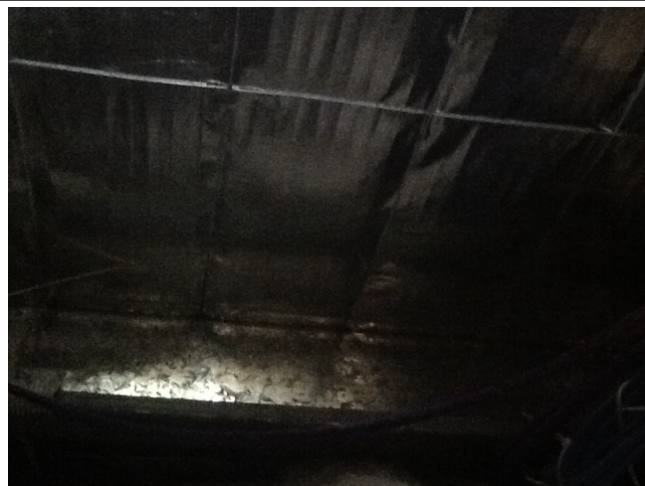
Photo No: J140648-001-Ultimo PS-Photo114
Result: SMF - Positive
Building/Level: Building BOOD-Level 1
Room/Location: All Rooms-Throughout
Feature/Material: Roof Lining-Sarking Insulation
