Arboricultural Impact Assessment

Shore Physical Education Centre

3rd of June 2016

RE: Arboricultural Impact Assessment of fifty trees for the Shore Physical Education Centre.

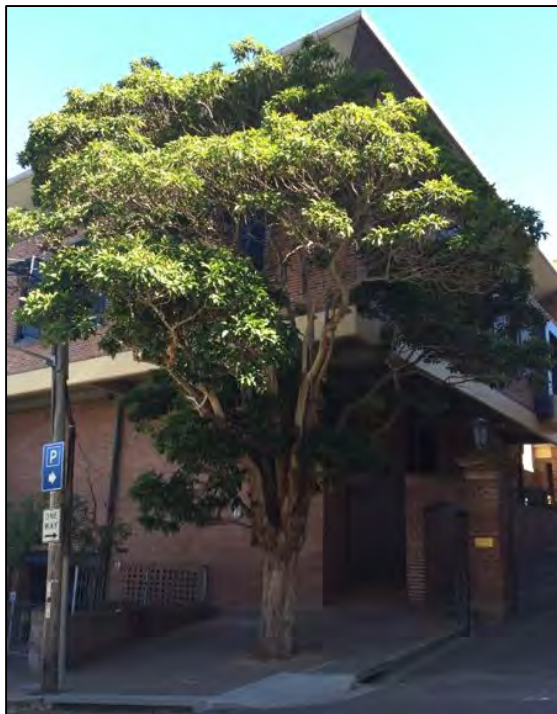
Fig. 5: Depicts Tree 33 in its growing environment.
Source: Austin 11/05/2016

- 7.5.3 Tree 33 – Queensland Box (*Lophostemon confertus*) has a High Retention Value. The tree is located on the foot path on William Street and is likely to be owned by council. The tree is significant in the local landscape given its size and age. The TPZ required for the successful retention of this tree is a 6.4m radius measured from the trunk.

- 10.2.1 Tree 33 will require trunk protection as outlined in Figure 27 below.

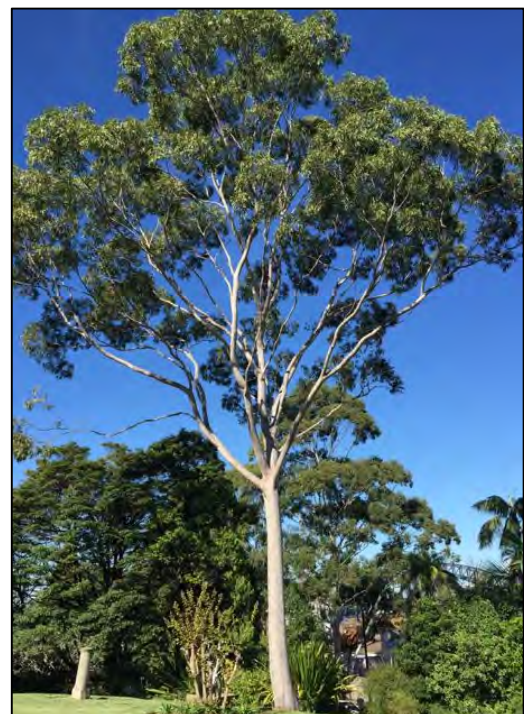
Fig. 6: Depicts Tree 93 in its growing environment.
Source: Austin 11/05/2016

- 7.5.4 Tree 93 – Spotted Gum (*Corymbia maculata*) has a High Retention Value. The tree is situated in a prominent lawn area on the southern portion of the site. The tree is significant in the local landscape given its size and age. The TPZ required for the successful retention of this tree is a 5.6m radius measured from the trunk.

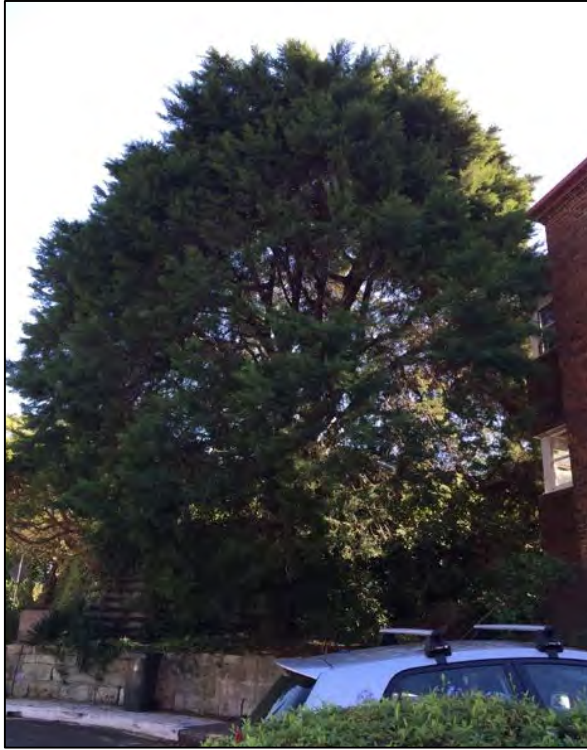
Fig. 7: Depicts Tree 18 in its growing environment. Source: Austin 11/05/2016

- 7.5.5 Tree 18 – Cypress (*Cupressus sp.*) has a High Retention Value. The tree is situated in a raised garden bed at the north western corner of the Shore North Sydney residential site. The tree is significant in the local landscape given its size and age. The TPZ required for the successful retention of this tree is a 9.1m radius measured from the trunk.

18	<i>Cupressus sp.</i>	Cypress	15-20	760	920	15-20	1-4/4 Hunter Cres	1	Good	Fair	Mature	15-25	Co-dominant stems;Excessive end weight;Dead wood in canopy	Attractive landscape feature;Amenity value/shade	Reduce length of long low lateral to the north back to small upright. Clear branches from court fence. Monitor major unions for cracks or splits after strong winds or storm events.	9.1	3.2	High	SRZ within proposed footprint	Remove
20	<i>Cupressus torulosa</i>	Bhutan Cypress	5-10	410	520	15-20	1-4/1 Hunter Cres	1	Good	Good	Mature	15-25	Soil compaction	Amenity value/shade;Attractive landscape feature		4.9	2.6	Moderate	No Impact identified	Retain
23	<i>Alectryon tomentosus</i>	Rambutan	<5	110	170	<5	1-4/1 Hunter Cres	1	Good	Good	Semi-Mature	25-50		Amenity value/shade		1.6	1.6	Low	No Impact identified	Retain
25	<i>Magnolia x soulangeana</i>	Saucer Magnolia	5-10	10, 170, 1	490	5-10	1-4/1 Hunter Cres	1	Good	Good	Mature	15-25	Co-dominant stems	Attractive landscape feature;Amenity value/shade		3.7	2.5	Moderate	No Impact identified	Retain

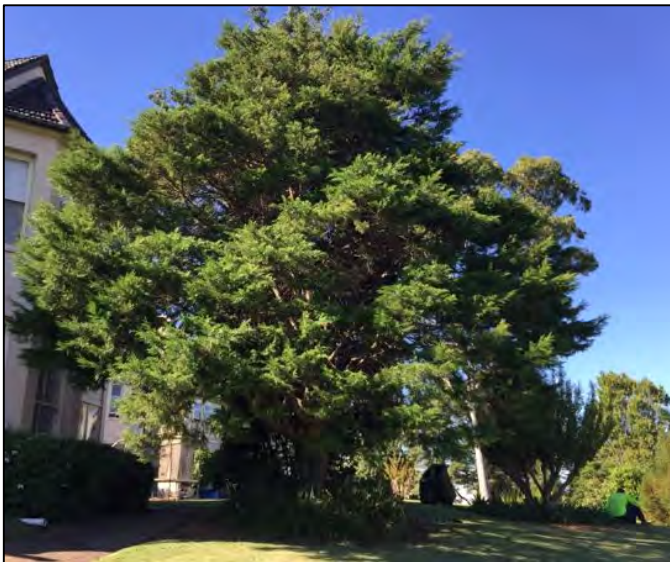
Fig. 8: Depicts Tree 88 in its growing environment. Source: Austin 11/05/2016

7.6.4 Trees 88 - Monterey Cypress (*Hesperocyparis macrocarpa*) and 89 Leyland Cypress (*Cupressocyparis leylandii*) were determined to be of Moderate Retention Value. These mature cypress trees were of medium size growing in the south west portion of the Shore North Sydney Campus site. The TPZs required for the successful retention of these trees are currently: 6.4m and 6.5m respectively.

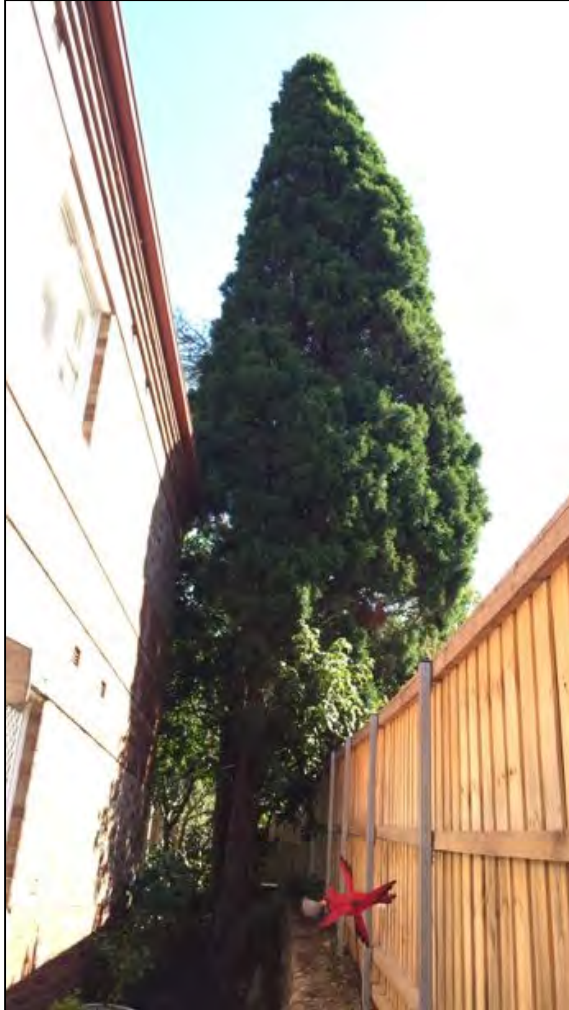
Fig. 10: Depicts Tree 20 in its growing environment.
Source: Austin 11/05/2016

7.6.5 Trees 20 and 29 - Bhutan Cypress's (*Cupressus torulosa*) were determined to be of Moderate Retention Value. These mature cypress trees were of medium size growing in the south west portion of the Shore North Sydney residential site. The TPZs required for the successful retention of these trees are currently: 4.9m and 4.4m respectively.

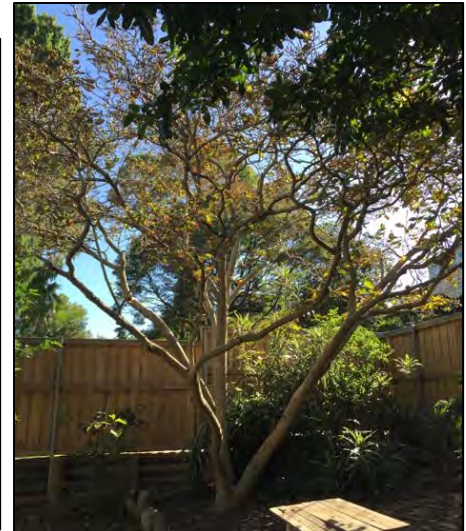
Fig. 13: Depicts Tree 25 in its growing environment. Source: Austin 11/05/2016

- 7.6.6 Tree 25 – Saucer Magnolia (*Magnolia x soulangeana*) has a Moderate Retention Value. This mature Magnolia tree was growing in the south west portion of the Shore North Sydney Residential site The TPZ required for the successful retention of this tree is currently 3.7m.
- 7.6.7 Tree 50 – Frangipani (*Plumeria acuminata*) has a Moderate Retention Value. This mature Frangipani tree was growing in the middle of the Shore North Sydney Campus. The TPZ required for the successful retention of this tree is currently 3.4m.

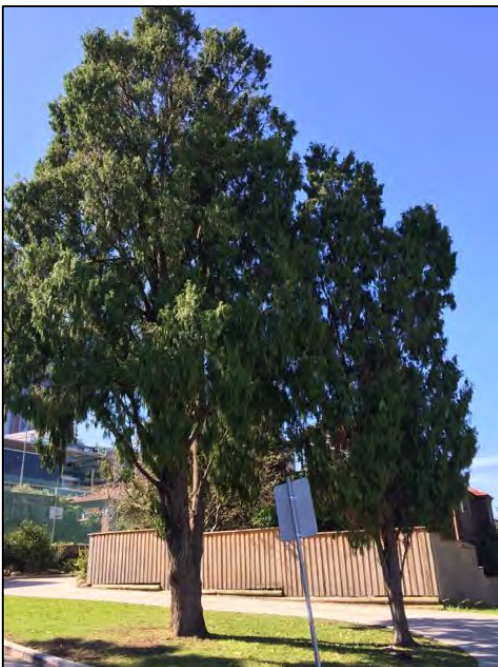
Fig. 14: Depicts Trees 110 (left) and 109 (right) in their growing environment. Source: Austin 11/05/2016

- 7.6.8 Trees 109 and 110 - Chinese Weeping Cypress's (*Cupressus funebris*) were determined to be of Moderate Retention Value. These mature cypress trees were of medium size growing in the southern portion of the Shore North Sydney Campus site. The TPZs required for the successful retention of these trees are currently: 3.8m and 7.2m respectively.

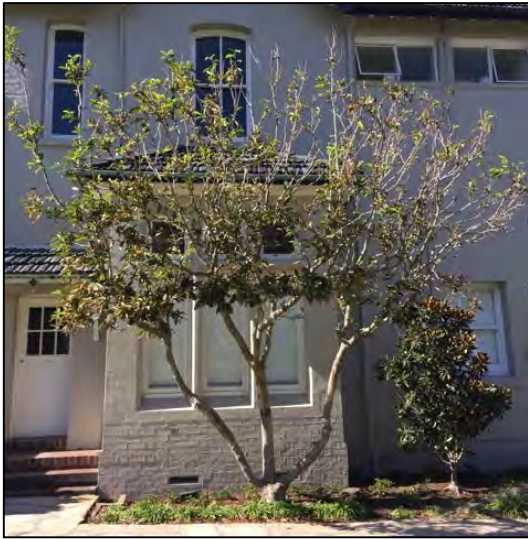
Fig. 15: Depicts Tree 54 in its growing environment.
Source: Austin 11/05/2016

- 7.7.4 Tree 54 – Magnolia (*Magnolia x soulangeana*) is of Low Retention Value. This mature Magnolia is of small size with fair health and structure. This tree is being browsed by possums. The TPZ required for the successful retention of this tree is currently 1.9m.

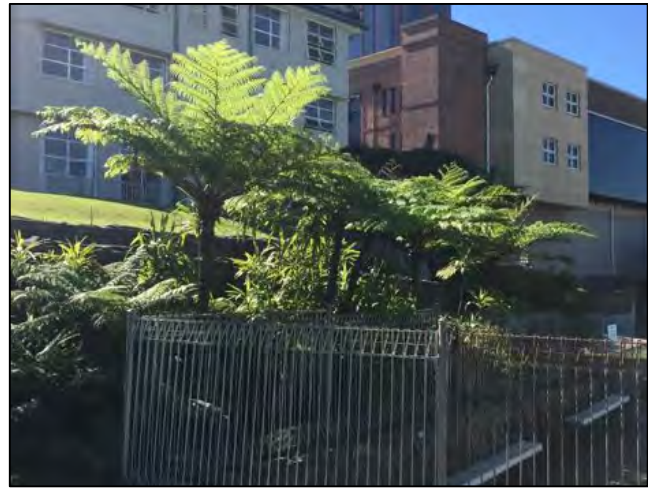
Fig. 16: Depicts Tree 47 (A group of 8 tree ferns) in their growing environment. Source: Austin 11/05/2016

- 7.7.5 Tree 47 – A group of 8 Tree ferns (*Cyathea cooperii*) are of Low Retention Value. The tree ferns are easily replaceable. . The TPZ required for the successful retention of each tree fern tree is currently 1.5m.

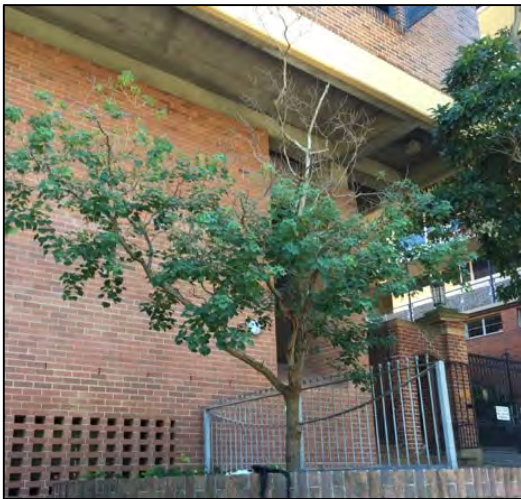
Fig. 17: Depicts Tree 34 in its growing environment. Source: Austin 11/05/2016

- 7.7.6 Tree 34 – Chinese Tallow (*Sapium sebiferum*) tree is of Low Retention Value. This semi mature tree is of small size with fair health and structure. This tree has a short Tree life expectancy of 5-10 years. The TPZ required for the successful retention of this tree is currently 1.7m.
- 7.7.7 Tree 95 – Pittosporum (*Pittosporum undulatum*) is of Low Retention Value. This mature tree is of moderate size with fair health and structure. This tree is located immediately onto of a rock shelf which reduces its life expectancy and retention value. The TPZ required for the successful retention of this tree is currently 5.4m

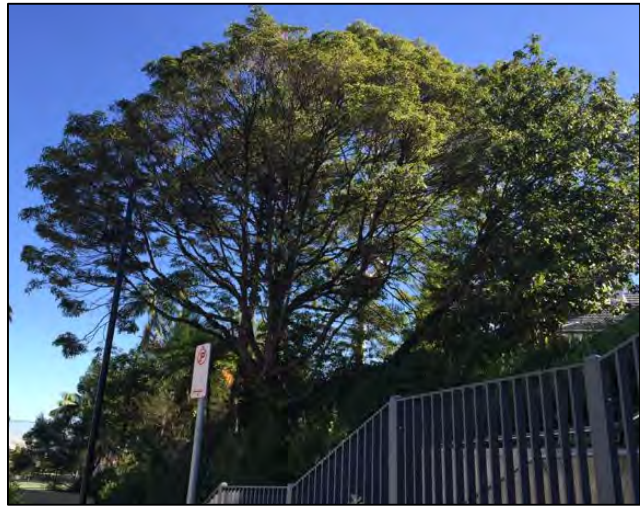
Fig. 18: Depicts Tree 95 in its growing environment. Source: Austin 11/05/2016

95	<i>Pittosporum undulatum</i>	Sweet Pittosporum	10-15	450	600	10-15		1	Fair	Fair	Mature	5-10	Dieback;Wound(s);Co-dominant stems;Epicormic growth;Soil problems;Previous failures	Amenity value/shade	No roots below cliff Monitor for root plate movement after heavy rains or serious wind events	5.4	2.7	Low	SRZ within proposed footprint	Remove
96	<i>Alectryon tomentosus</i>	Rambutan	5-10	180	250	<5		1	Good	Fair	Semi-Mature	10-15	Parasitic plant/Mistletoe;Wound(s);Suppressed;Soil problems;Abnormal lean	Amenity value/shade	Monitor for root plate movement after heavy rains or serious wind events	2.2	1.9	Low	SRZ within proposed footprint	Remove
99	<i>Howea forsteriana</i>	Kentia Palm	<5	110	150	5-10		1	Good	Good	Mature	25-50		Amenity value/shade		1.5	1.5	Low	SRZ within proposed footprint	Remove
100	<i>Archontophoenix alexandrae</i>	Alexandra Palm	<5	250	400	5-10		1	Good	Good	Mature	25-50		Amenity value/shade		3	2.3	Low	SRZ within proposed footprint	Remove

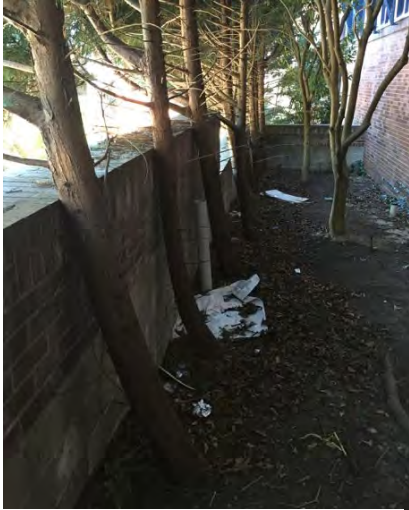
7.7.8 Tree 36 – A group of 16 Leyland Cypress (*Cupressocyparis leylandii*) are of Low Retention Value. These semi mature trees are of small size with poor structure are planted under powerlines, are pushing against a retaining wall which results in a short life expectancy of 5-10 years. The TPZ required for the successful retention of these trees is currently 2.2m each. .

Fig. 19: Depicts Trees 36 in their growing environment pushing against the wall. Source: Austin 11/05/2016

36	<i>Cupressocyparis leylandii</i>	Leyland Cypress	<5	180	240	5-10		16	Good	Poor	Semi-Mature	5-10	Wound(s);Abnormal lean	Attractive landscape feature;Amenity value/shade	16 trees in hedge planting. 8 of which are pushing against wall and located beneath powerlines. Short ULE for group. Removal and replacement is recommended.	2.2	1.9	Low	No Impact identified	Retain
37	<i>Elaeocarpus obuvatus</i>	Mountain Quandong	5-10	140, 100	220	5-10		1	Fair	Fair	Semi-Mature	15-25	Suppressed;Dieback;Poor pruning;Wound(s);Epicormic growth			2.2	1.8	Low	No Impact identified	Retain
38	<i>Elaeocarpus obuvatus</i>	Mountain Quandong	5-10	130, 120	220	5-10		1	Good	Fair	Semi-Mature	15-25	Suppressed;Dieback;Poor pruning;Wound(s);Epicormic growth			2.2	1.8	Low	No Impact identified	Retain
39	<i>Elaeocarpus obuvatus</i>	Mountain Quandong	5-10	160	190	5-10		1	Fair	Fair	Semi-Mature	15-25	Suppressed;Dieback;Poor pruning;Wound(s);Epicormic growth			1.9	1.7	Low	No Impact identified	Retain

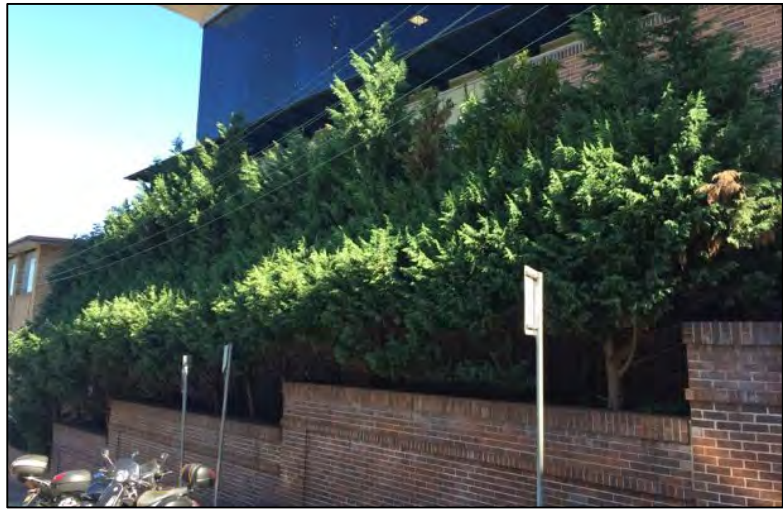
Fig. 20: Depicts Trees 36 in their growing environment growing under powerlines. Source: Austin 11/05/2016

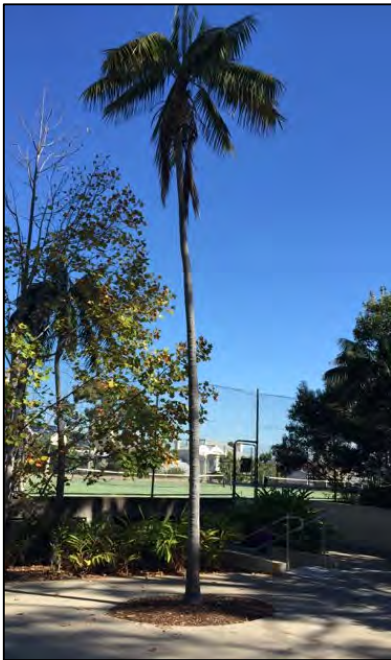
Fig. 21: Depicts Tree 104 in its growing environment. Source: Austin 11/05/2016

7.7.9 Tree 104 – Kentia Palm (*Howea forsteriana*) tree is of Low Retention Value. This mature palm is of medium size with good health and structure. This palm is easily transplantable or replaceable. The TPZ required for the successful retention of this tree is currently 1.7m.
