# Arborist Report

## Hunter Sports High

project no: **11029.5**  
date: **Friday, 29 January 2016**  
revision: **A**

date: 29-01-2016  
project no: 11029.5  
site: Pacific Highway, Gateshead  
council: Lake Macquarie City Council  
proposal: Major Capital Works Upgrade

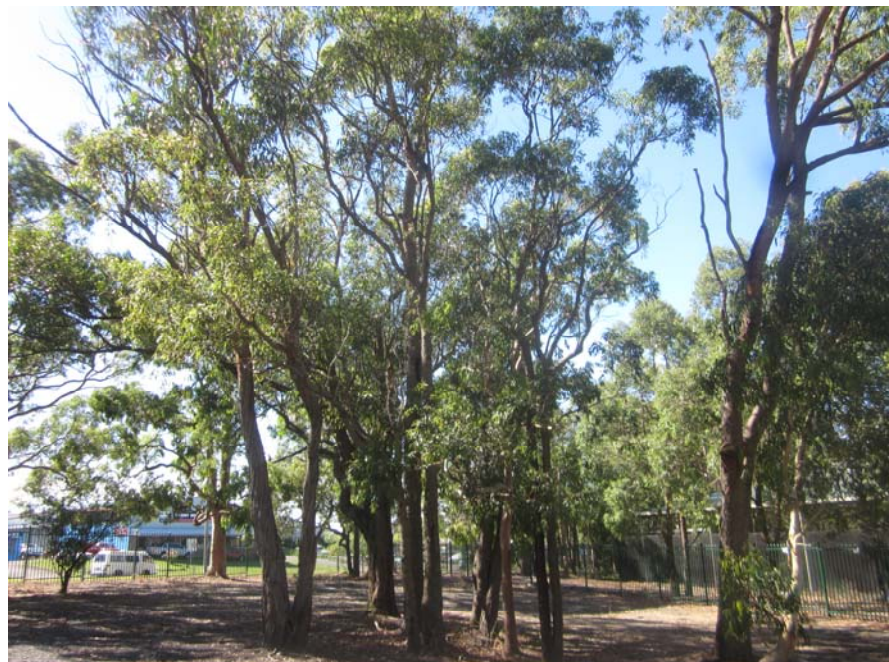
FIGURE 2: TREES WITHIN THE INFORMAL CAR PARKING AREA WHICH IS TO BE RETAINED.

With the proposed retention of the existing informal car park a greater number of trees can now be retained, however pruning out dead wood and other poorly structured branches should be undertaken on retained trees to reduce the risk of injury or damage.

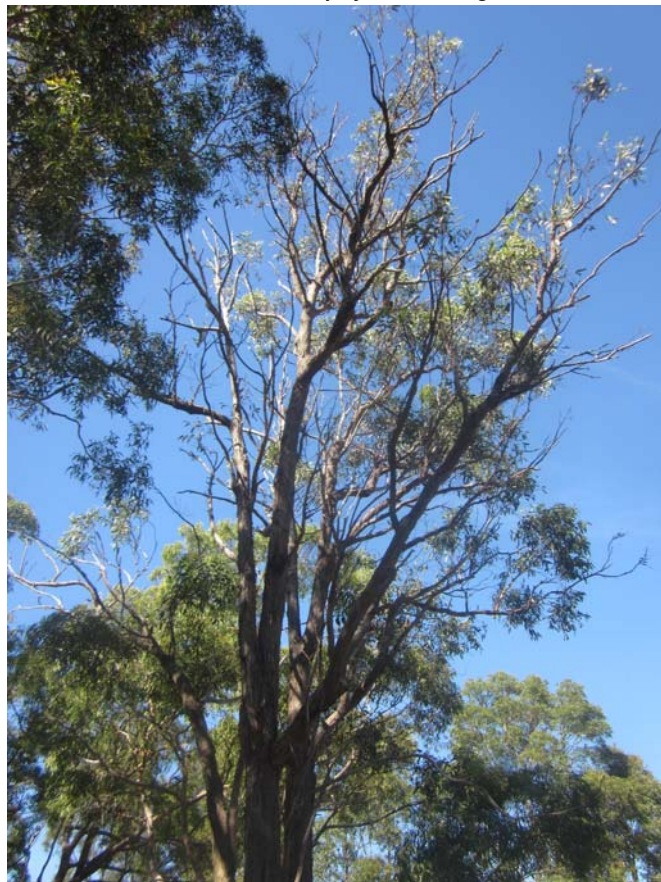
A further 7 trees with a **Z** rating should be removed due to their low ULE rating and the potential risk they pose. These trees are 4, 6, 33, 36, 46, 75 and 78.

**FIGURE 3:** A NUMBER OF TREES NOT AFFECTED BY WORKS SHOULD BE REMOVED SUCH AS TREE 33 WHICH IS LOCATED WITHIN THE INFORMAL CAR PARK AREA.
