Arborist Report

Hunter Sports High

project no: 11029.5
date: Friday, 29 January 2016
revision: A

date: 29-01-2016
project no: 11029.5
site: Pacific Highway, Gateshead
council: Lake Macquarie City Council
proposal: Major Capital Works Upgrade

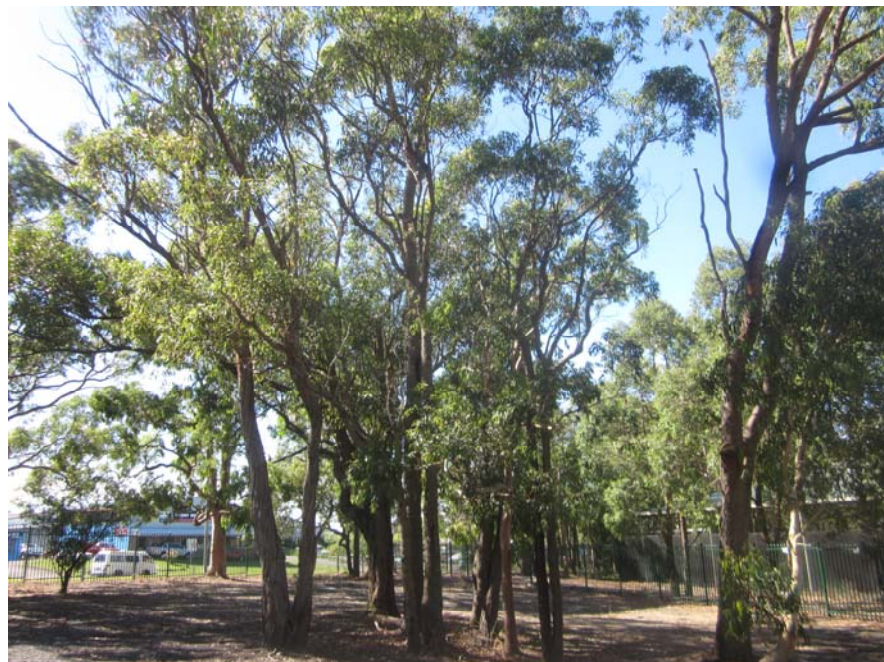
FIGURE 2: TREES WITHIN THE INFORMAL CAR PARKING AREA WHICH IS TO BE RETAINED.

With the proposed retention of the existing informal car park a greater number of trees can now be retained, however pruning out dead wood and other poorly structured branches should be undertaken on retained trees to reduce the risk of injury or damage.

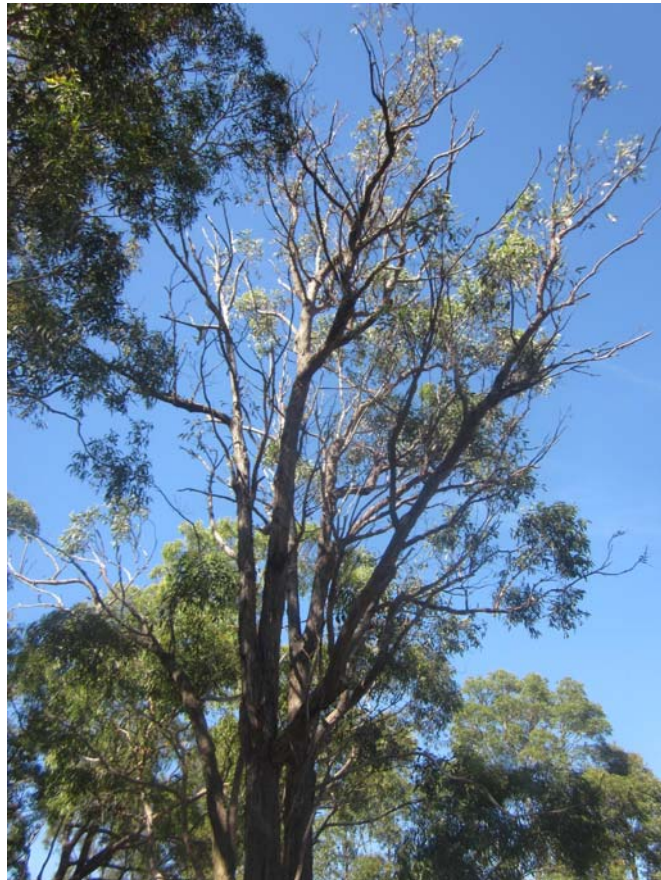
A further 7 trees with a Z rating should be removed due to their low ULE rating and the potential risk they pose. These trees are 4, 6, 33, 36, 46, 75 and 78.

FIGURE 3: A NUMBER OF TREES NOT AFFECTED BY WORKS SHOULD BE REMOVED SUCH AS TREE 33 WHICH IS LOCATED WITHIN THE INFORMAL CAR PARK AREA.

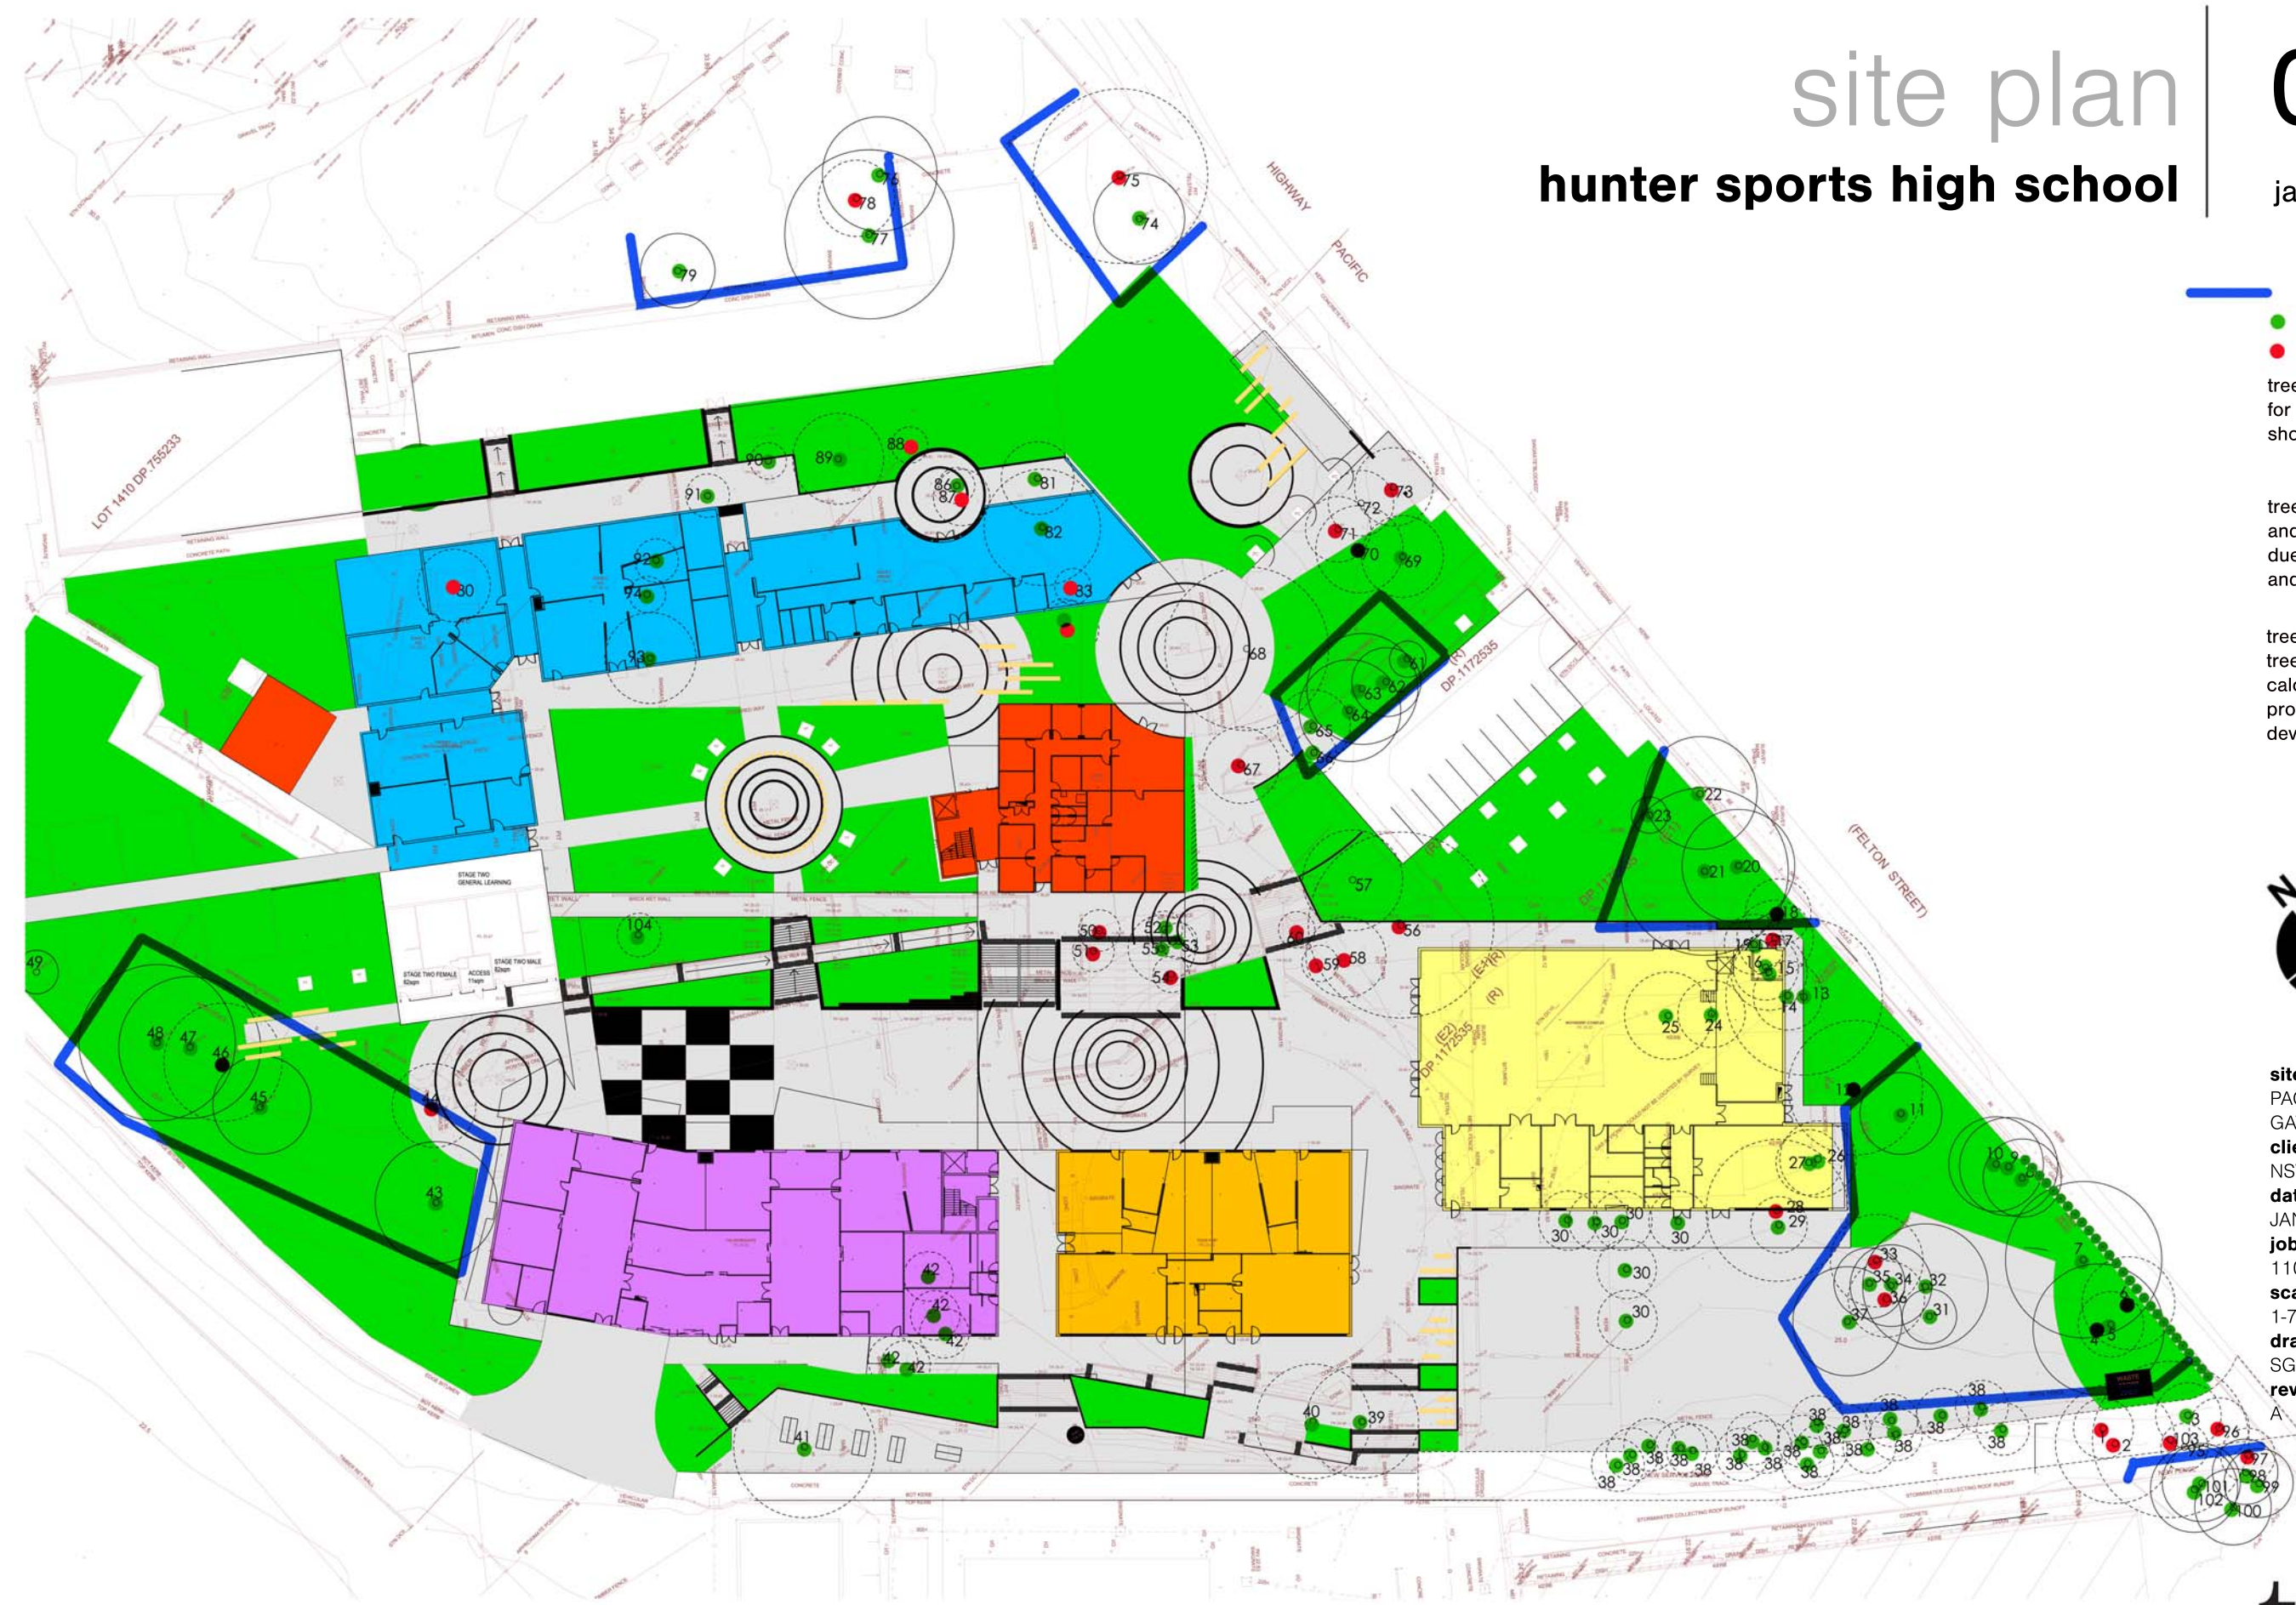
site plan

z rated tree
- trees requiring removal for the proposed works shown dashed.

trees 4, 6, 33, 36, 46, 75 and 78 should also be removed due to their low useful life expectancy and risk factor.
