## Arboricultural Impact Assessment

### **Darlington Road Terraces Mixed Use Building Additions and Alterations to the Darlington Road Terraces and Public Domain Improvements**

**19<sup>th</sup> November, 2016**

C90746

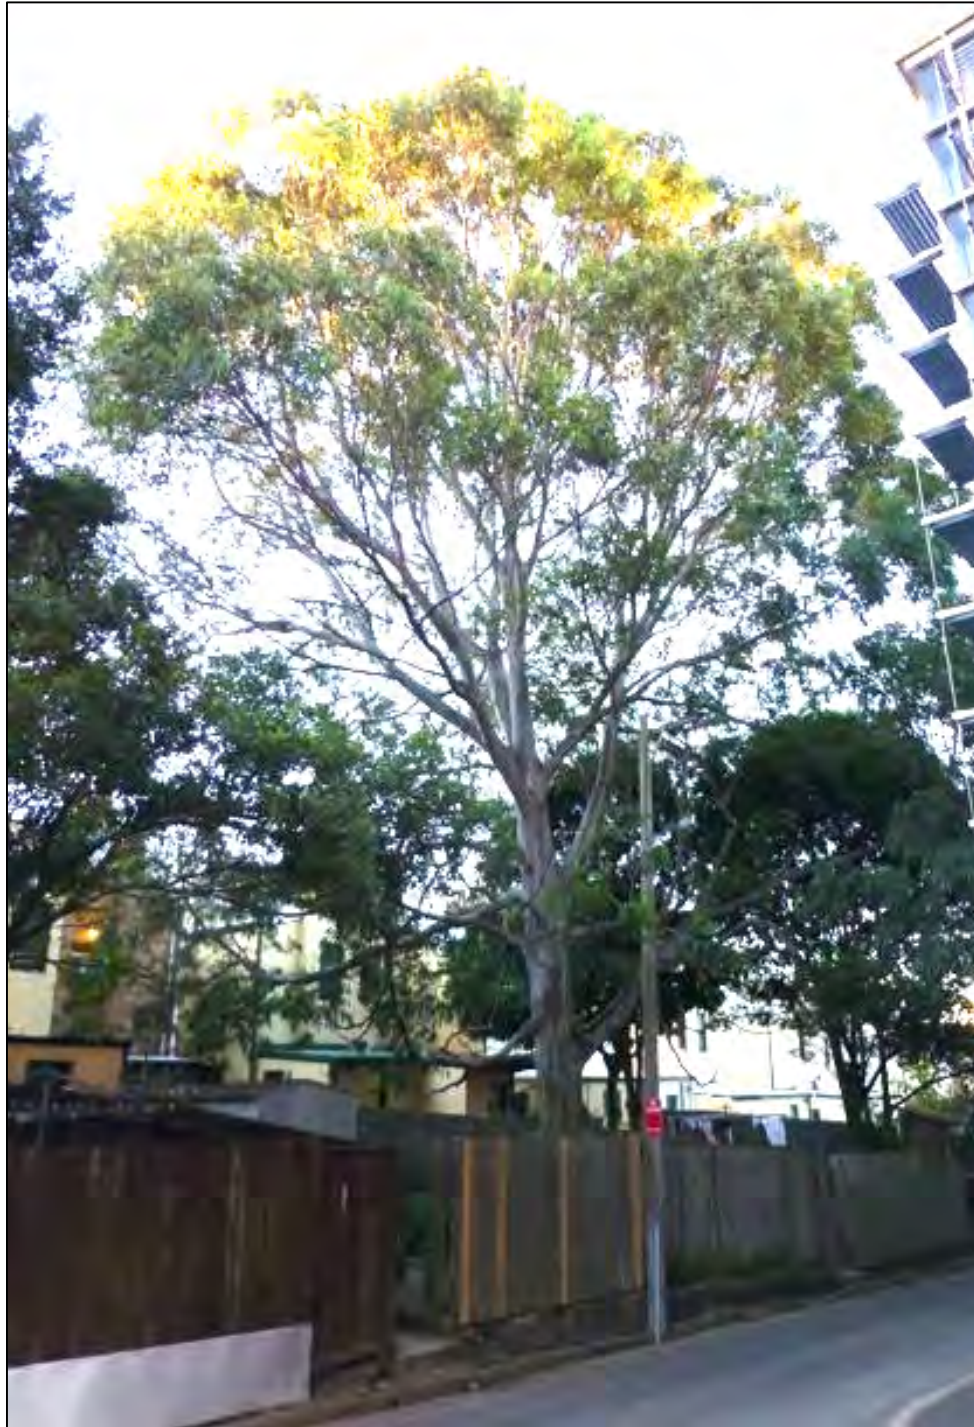
7.2.2 Tree 11, *Eucalyptus saligna* (Sydney Blue Gum) has a High Retention Value This tree makes a significant contribution to the landscape character of the area and has a life expectancy of more than 50 years. The Tree Protection Zone (TPZ) required for the successful retention of this tree is 9.1m radius measured from the trunk. The Structural Root Zone (SRZ) is 3.3m.

**Figure 4:** Tree 11 in its growing environment. Source Austin 18/06/2014

- 9.2.13 Minor branch tip pruning will be required to accommodate the 12m high edge of Building B depicted in Figure 24. It is anticipated that this involves the pruning of 3 branches of 75mm diameter to ascending sub branches, 6m from the trunk.

- 9.2.14 Seven (7) branches will require pruning in order to raise the canopy of Tree 11 sufficiently to incorporate the decking area beneath the canopy. The tree has minimal pruning in the past, hence the low canopy. The branches are elongated and shaded out with minimal pruning options. It has been determined that the pruning would total around 15% of the total canopy and will not have a detrimental effect on tree health. The pruning requires the removal of branches to 5m height including seven branches with diameters of 110, 250, 250, 100 and 3 branches of 80 mm. The removal of a significant quantity of deadwood is also required at this stage.

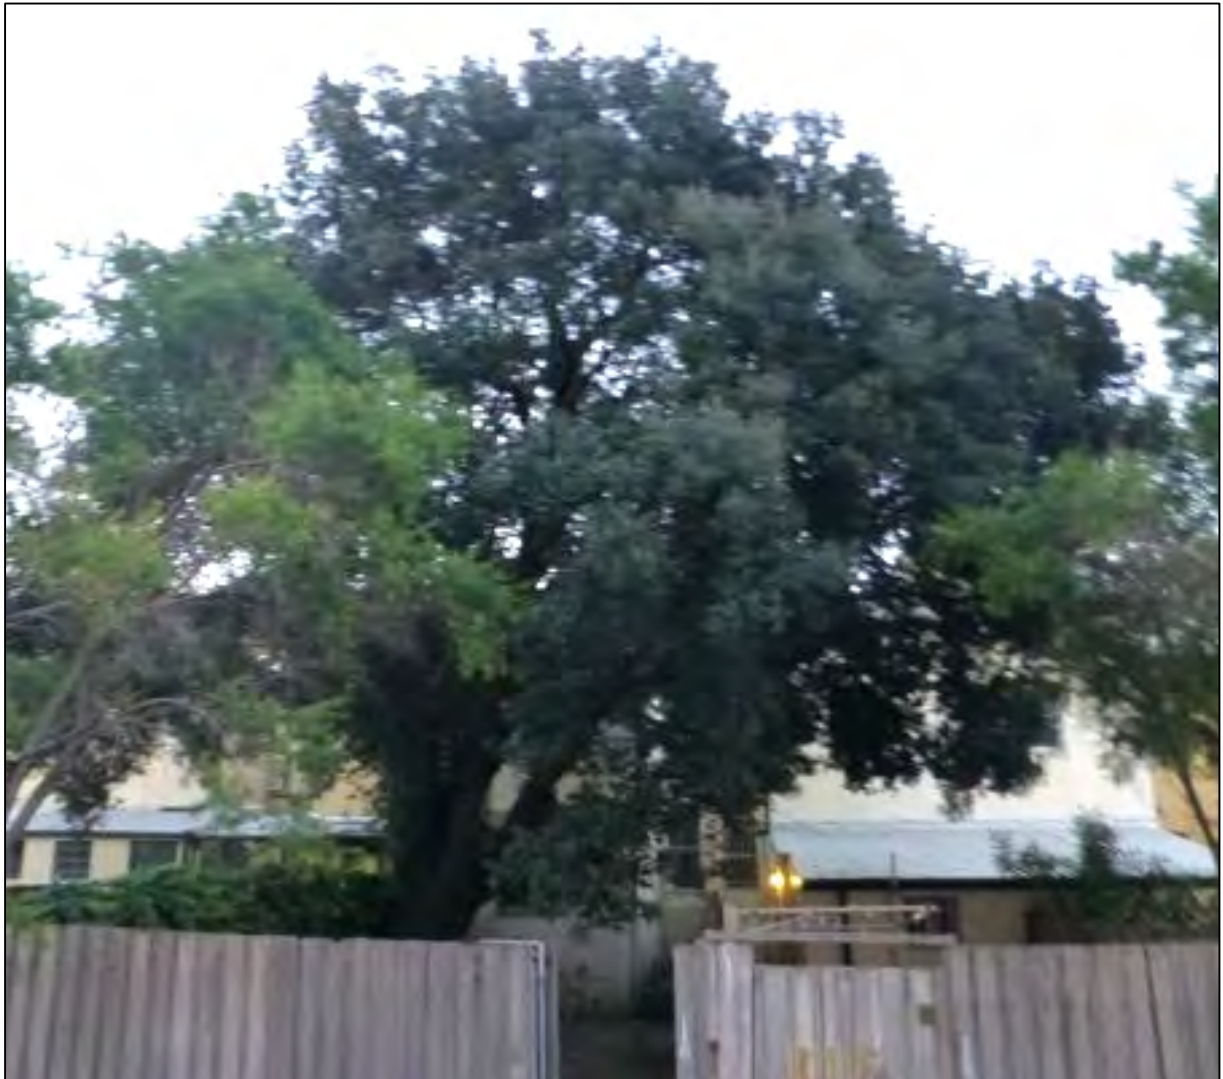
- 7.2.3 Tree 25, *Quercus ilex* (Evergreen Oak) has a High Retention Value. This tree makes a significant contribution to the landscape character of the area and has a life expectancy of 30 – 50 years. The Tree Protection Zone (TPZ) required for the successful retention of this tree is 9.2m radius measured from the trunk. The Structural Root Zone (SRZ) is 3.1m.

**Figure 5:** Tree 25 in its growing environment. Source Austin 18/06/2014

8.2.2 The removal of the High Retention Value tree number 25 is required in order for this development to proceed. The removal of this tree does not impact upon the Concept Landscape Plan found within the approved, Campus Improvement Plan.

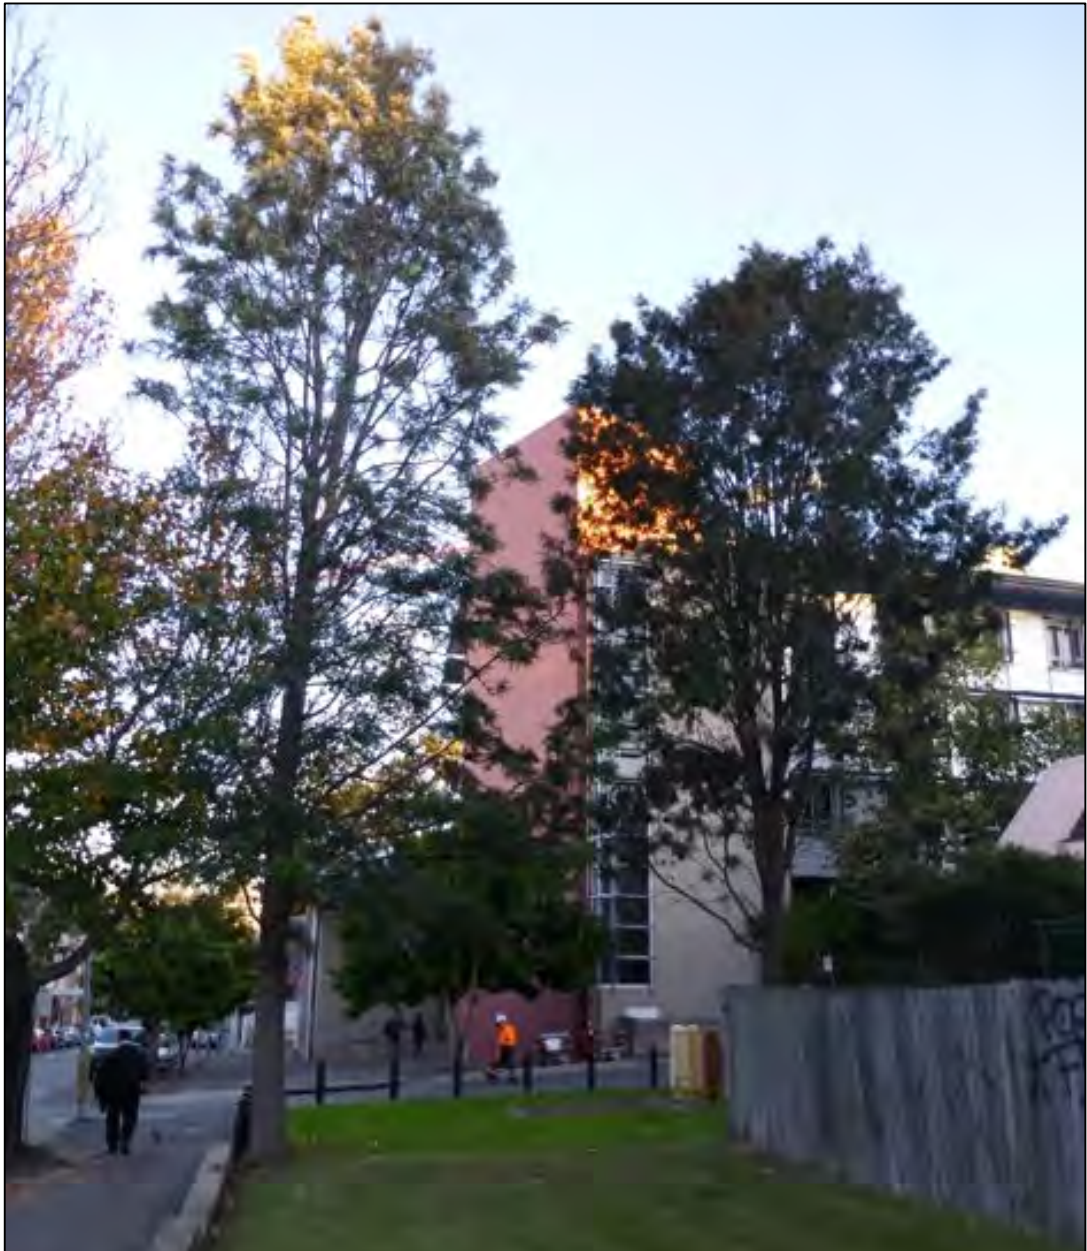
- 7.2.4 Four (4) trees were considered to have Moderate Retention Values.
- 7.2.5 Tree 1, *Grevillia robusta* (Silky Oak) has a Moderate Retention Value. The TPZ required for the successful retention of this tree is 4.2m radius measured from the trunk.
- 7.2.6 Tree 2, *Allocasurina toralosa* (Forest She Oak) has a Moderate Retention Value. The TPZ required for the successful retention of this tree is 3.6m radius measured from the trunk.

**Figure 6:** Tree 1 (left) and 2 (right) in their growing environments. Source Austin 18/06/2014

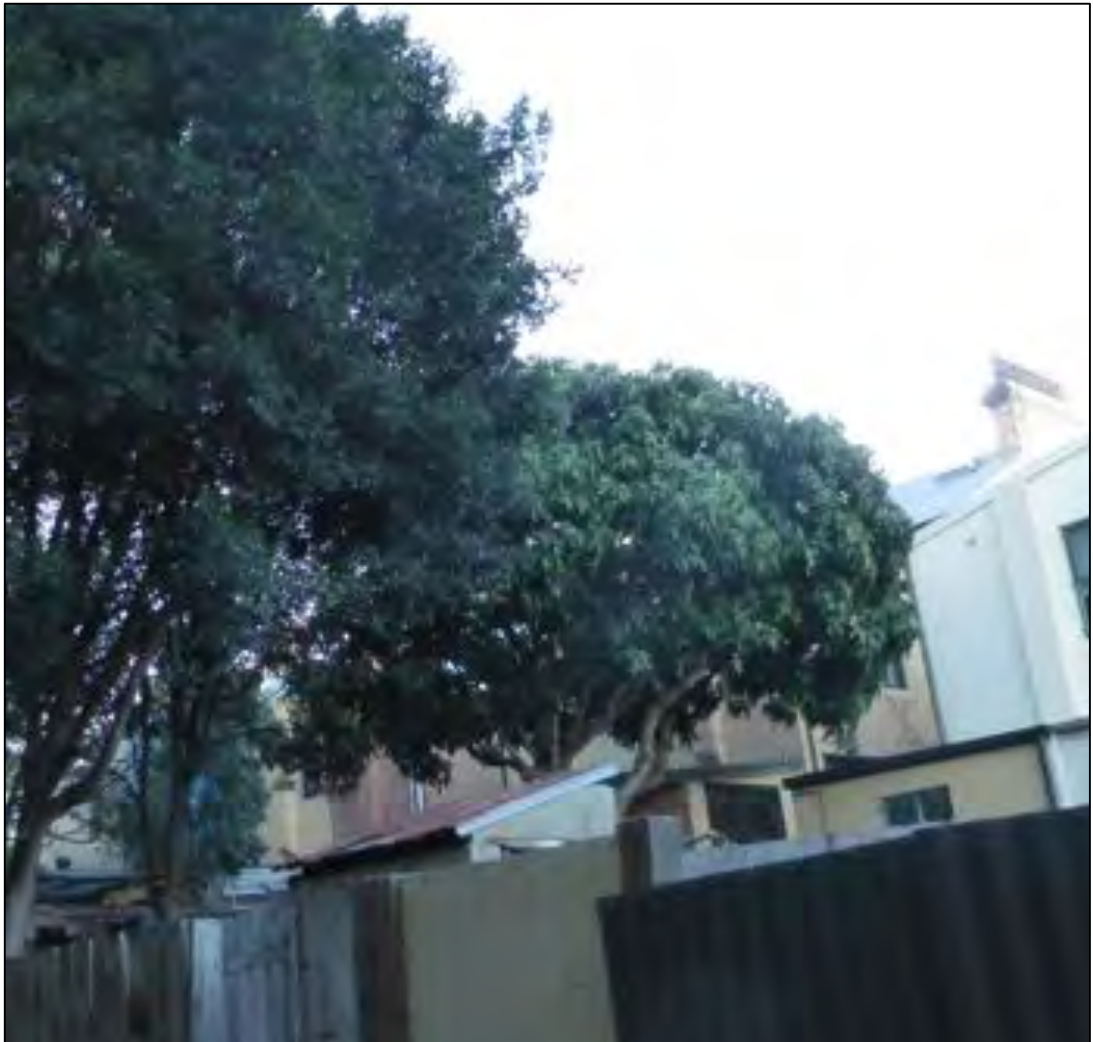
- 7.2.7 Tree 7, *Mangifera indica* (Mango) has a Moderate Retention Value. The TPZ required for the successful retention of this tree is 5.9 radius measured from the trunk.

**Figure 7:** Tree 7 in its growing environment. Source Austin 18/06/2014

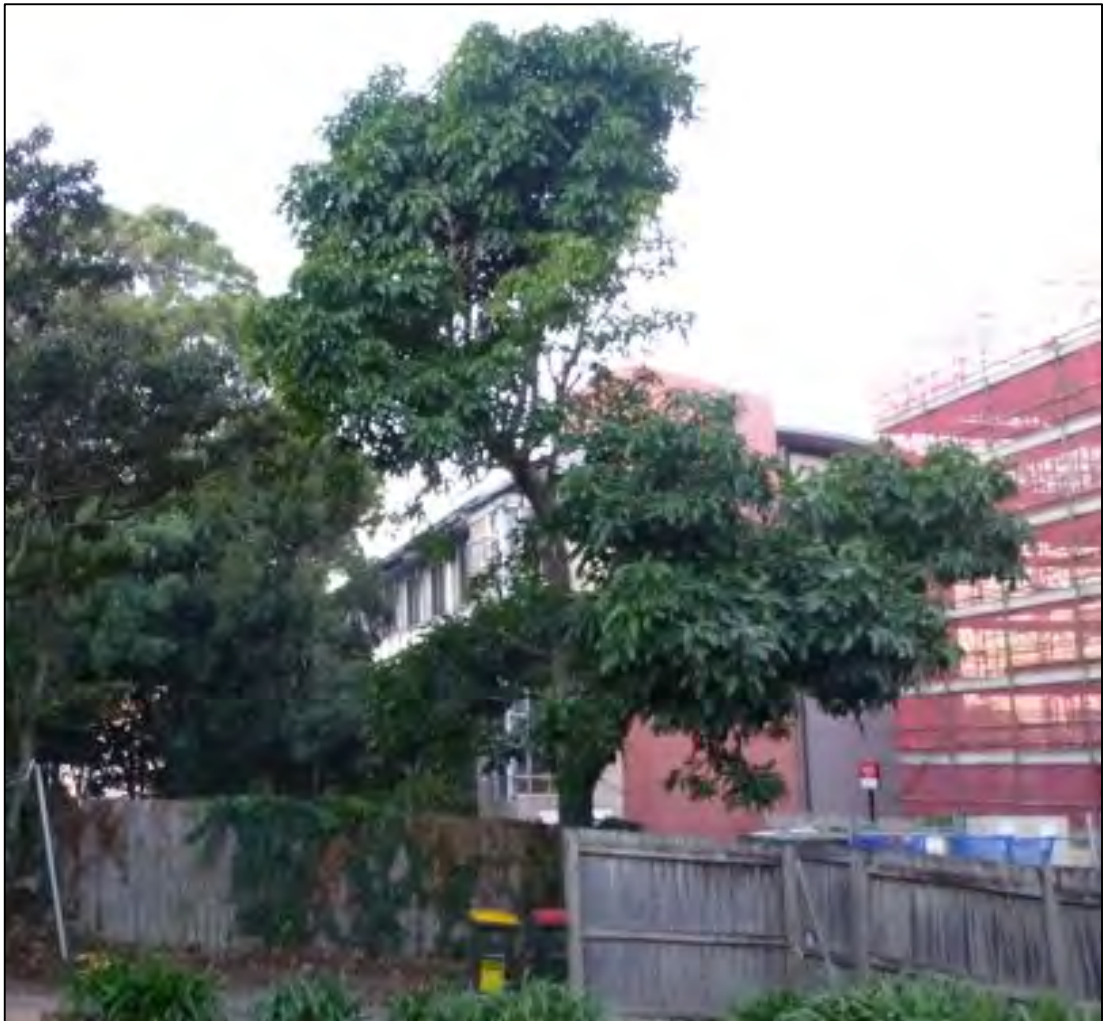
- 7.2.8 Tree 20, *Brachychiton acerifolius* (Illawarra Flame tree) has a Moderate Retention Value. The TPZ required for the successful retention of this tree is 4.3m radius measured from the trunk.

**Figure 8:** Tree 20 in its growing environment. Source Austin 18/06/2014

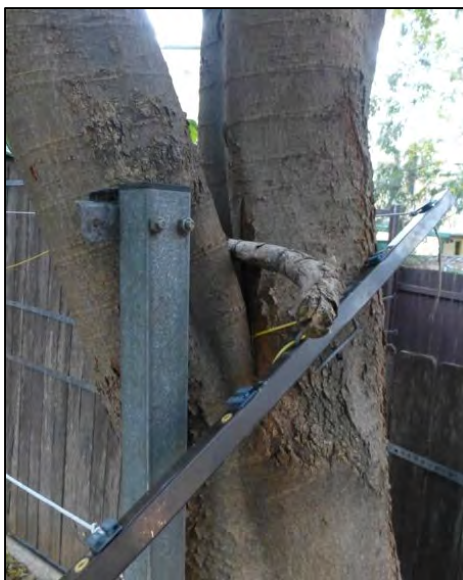
- 7.2.12 Some Low Retention Value trees (Tree numbers 6, 10, 15, 16, 17, 21, 23, 24, 27, 30 & 31) have significant structural defects that have an increased probability of branch or whole tree failure which greatly reduces the useful life expectancy of these trees.

**Figure 9:** Tree 17 has co dominant stems with a severe bark inclusion resulting in a likely probability of failure. Source Austin 18/06/2014

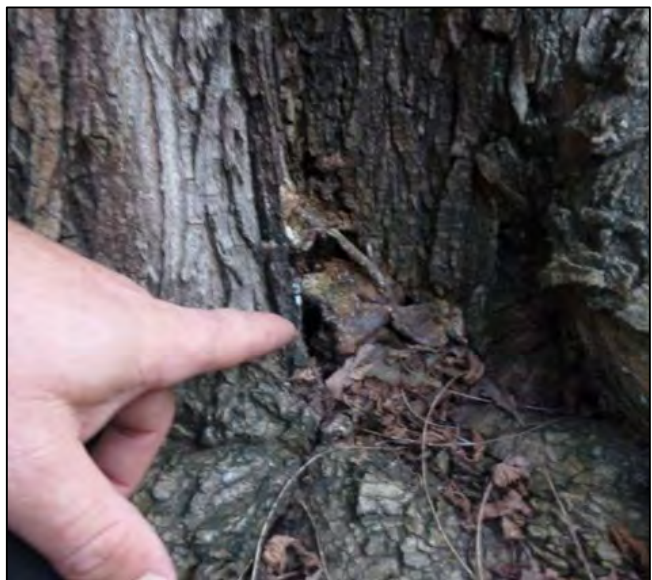
**Figure 10:** Tree 27 has been pruned for power line clearance, has a confined and swollen root crown with fungal fruiting bodies observed at ground level. Source Austin 18/06/2014

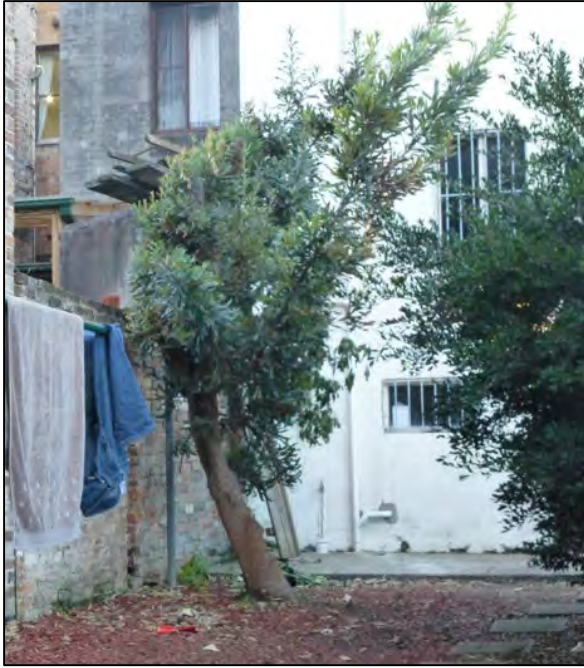
**Figure 11:** Tree 3 has been poorly pruned. Source Austin 18/06/2014

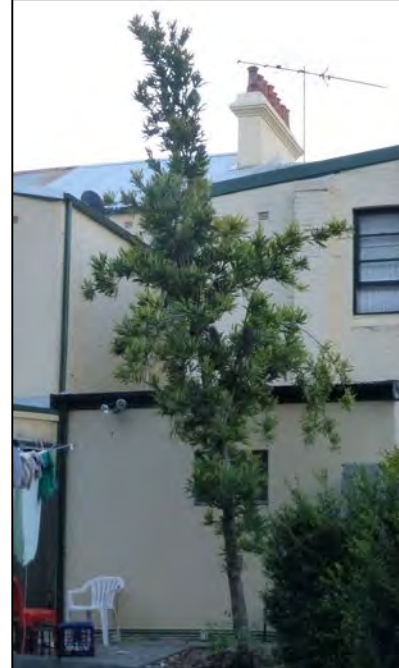
- 7.2.10 Certain Low Retention Value trees (Tree numbers 3 4, 5, 8, 9, 14, 18, 19, 28, 29, & 32) were found to be small and replacement would attain the same significance within the landscape within 5 years.

**Figure 12:** Tree 4 is easily replaceable and is insignificant in the landscape. Source Austin 18/06/2014

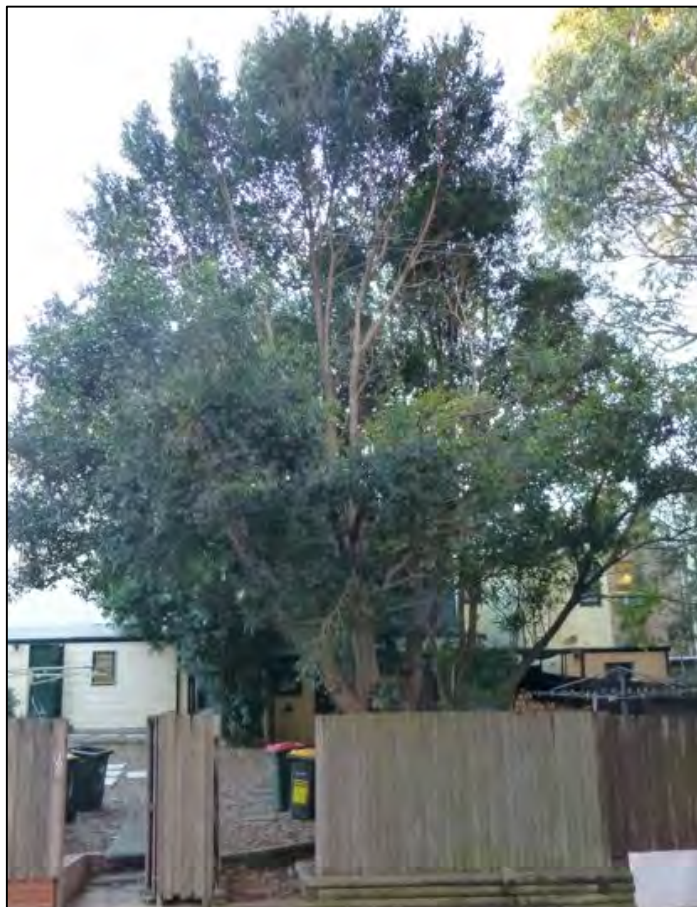
- 7.2.11 Other Low Retention Value trees (Tree numbers 12, 13, 22 & 26) have been either poorly pruned or lopped for power line service line clearance. These poor pruning practices have misshapen the canopies and resulted in shorter life expectancies for these trees.

**Figure 13:** Tree 12 has been pruned for power line clearance and has a misshapen canopy. Source Austin 18/06/2014

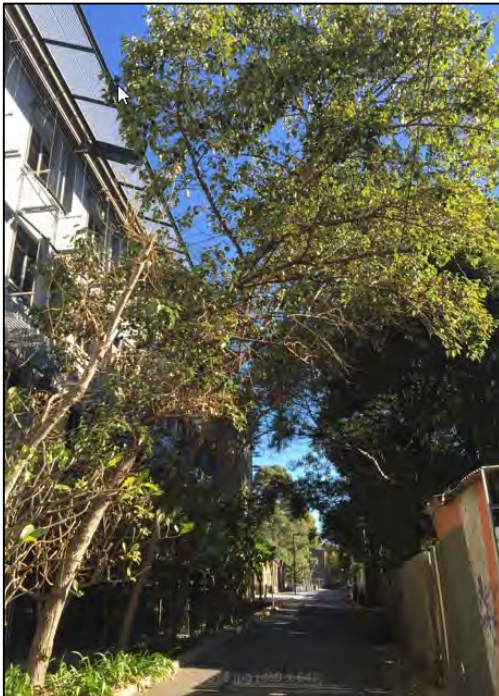
**Figure 14:** Depicts Trees 179 and 180 which have skewed canopies overhanging Darlington Lane.  
Source: Austin 27/05/2016

- 10.1.1 The eleven (11) existing *Populus deltoides* (Poplar) numbered between 171 and 183 recommended for removal should be replaced with *Populus nigra Italica* (Lombardy Poplar) which has a fastigate form which will fit the growing environment and continue current character of the lane and provide the benefits of the deciduous species. See Appendix F for species profile and data sheet.
- 10.1.2 The location of the new plantings should be situated in the same location as the existing Poplars.

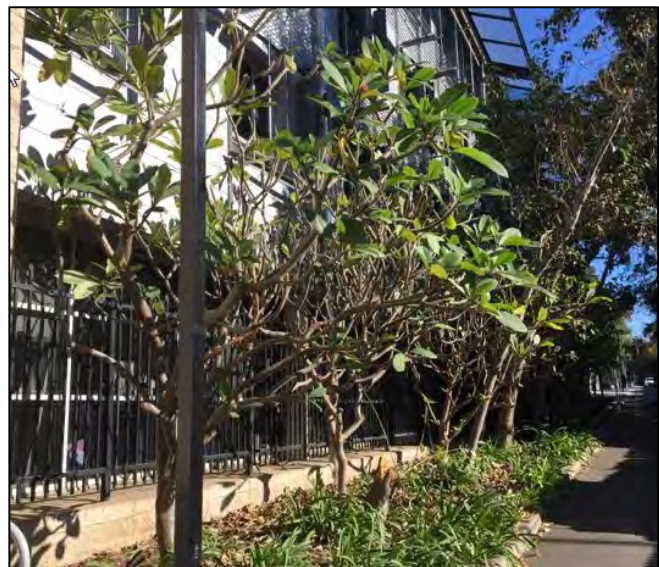
**Figure 15:** Depicts Trees 880, 880a, and 880b which are located beneath the *Populus deltoides* growing in the garden bed adjacent to Darlington Lane. Source: Austin 27/05/2016

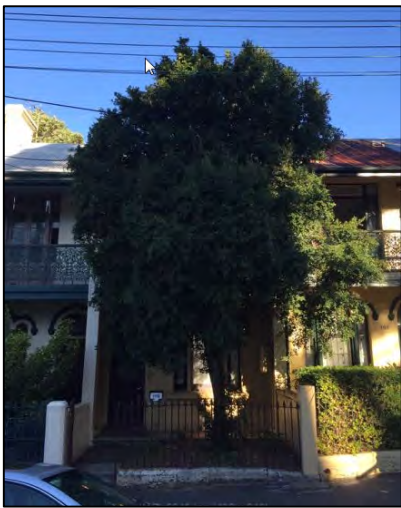
**Figure 16:** Tree 55 (*Syzygium paniculatum*) is located in the front garden of 105 Darlington Road has a Moderate Retention Value. . Source Austin 27/05/2016

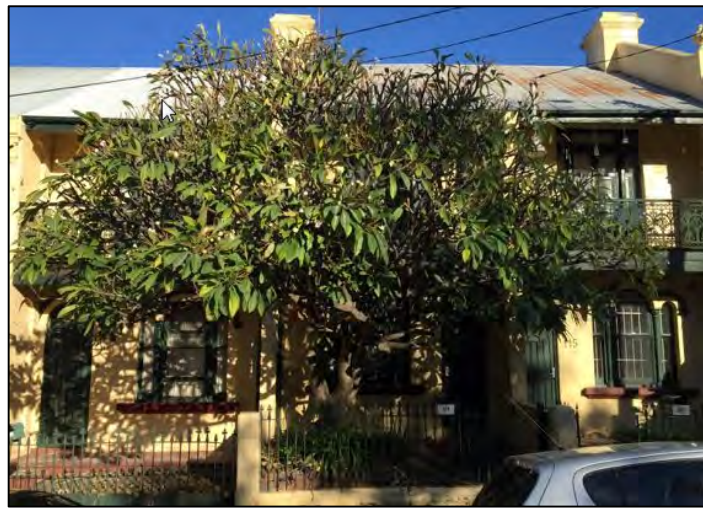
**Figure 17:** Tree 57 (*Pumeria sp*) is located in the front garden of 114 Darlington Road has a Moderate Retention Value. .Source Austin 27/05/2016

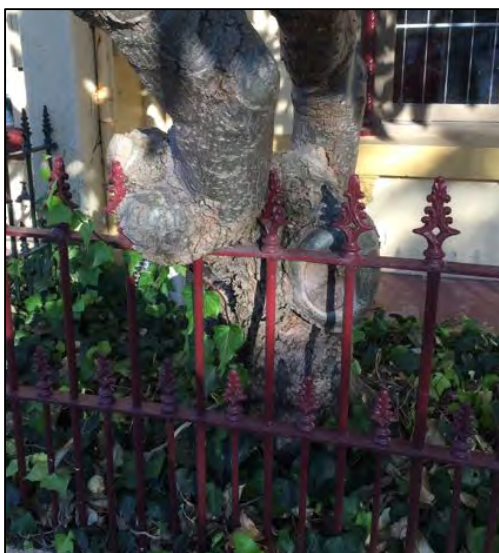
**Figure 18:** Tree 61 (*Pumeria sp*) is located in the front garden of 125 Darlington Road has a Remove Retention Value. Source Austin 27/05/2016

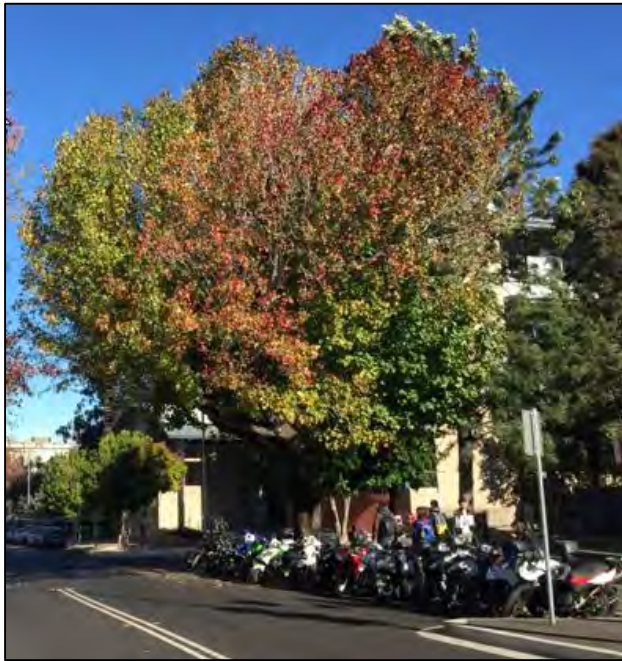
**Figure 19:** Tree 33 (*Liquidambar styraciflua*) is located on the footpath on the southern side of Codrington St and has a Moderate Retention Value. Source Austin 27/05/2016

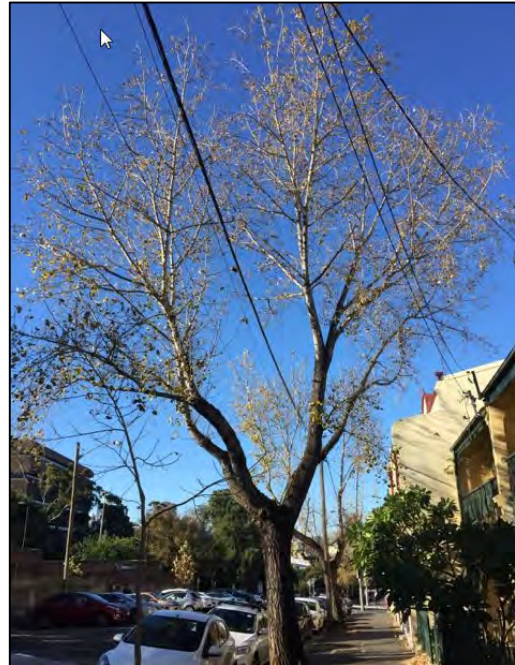
**Figure 20:** Tree 36 (*Populus deltoides*) is located on the footpath outside 95 Darlington Road and has a Moderate Retention Value. Source Austin 27/05/2016

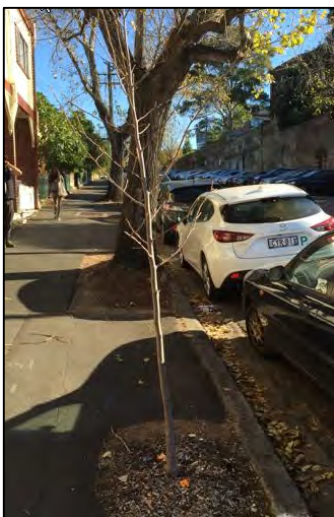
**Figure 21:** Tree 34 (*Liriodendron tulipifera*) is located on the footpath outside 90 Darlington Road and has a Low Retention Value as it is easily replaceable. . Source Austin 27/05/2016

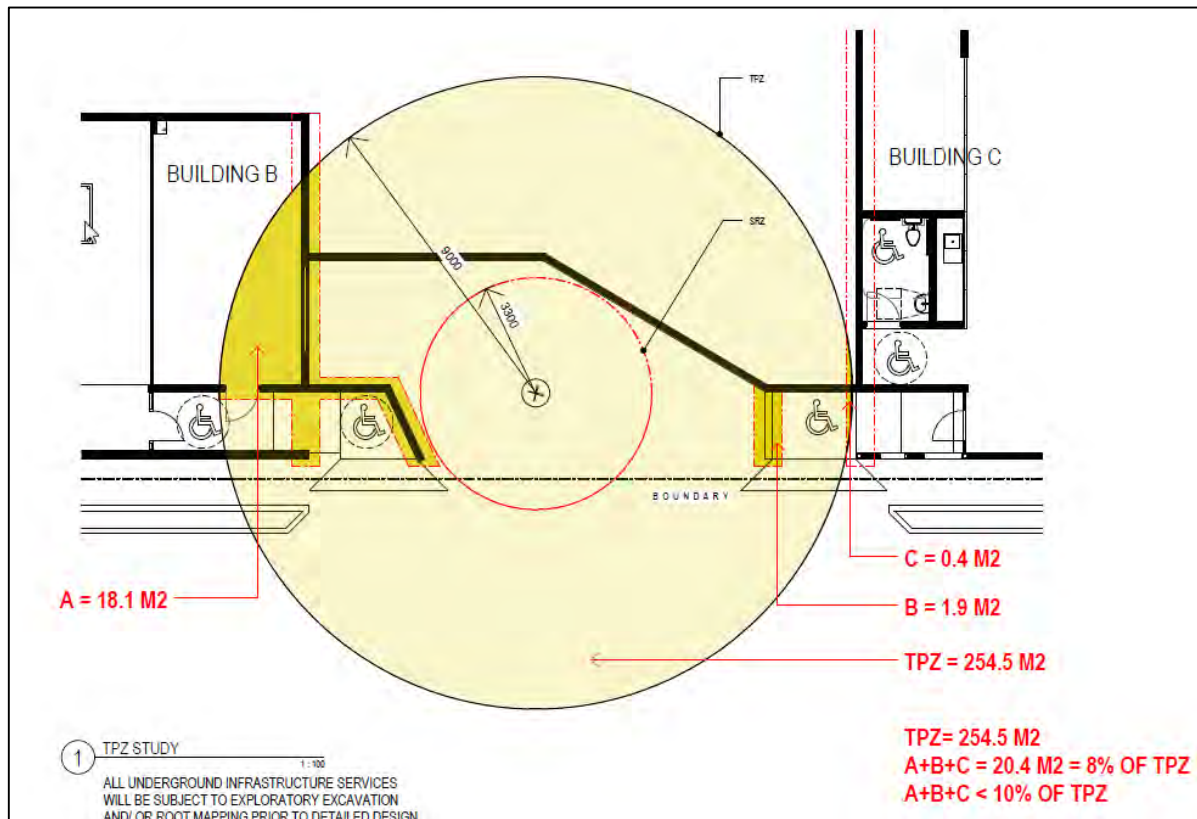
**Figure 24:** Details the encroachments into the TPZ of Tree 11. Source: Darlington Road Terraces Mixed Use Development, Building C&D- Level 1, by AJ+C Architects, Project 14051, Drawing number SK.1\_D, Dated 17/11/2016.

- 9.2.10 Strip footings associated with the disabled access ramps should be altered to minimize impacts if multiple roots greater than 40mm diameter are encountered during excavation. Pier and beam footings should be utilized and consideration to the weight of the supported structure which requires these footings should be made.

- 9.2.11 Open space within the TPZ will be used for planting and the area beneath the deck remain mulched.
- 9.2.12 Surfaces used within the TPZ must be porous.

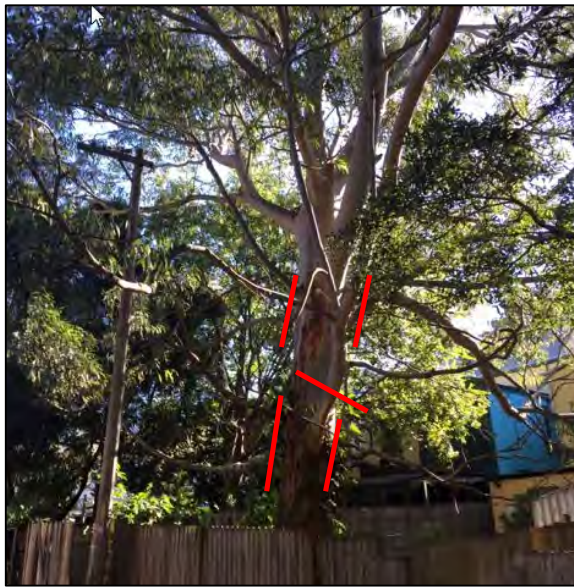
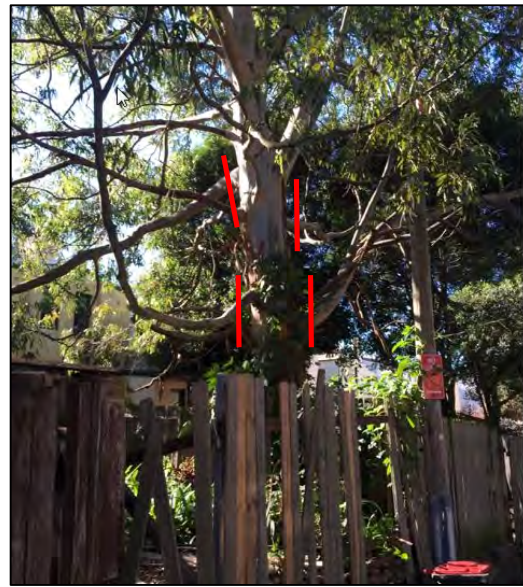
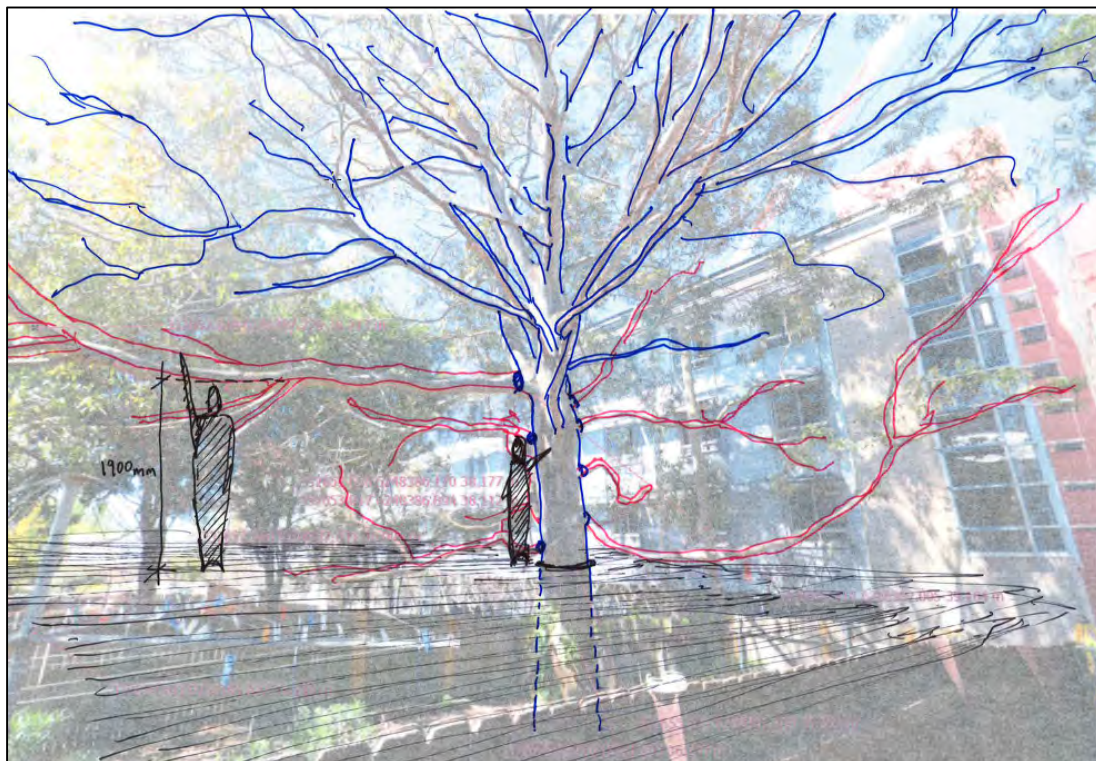
**Figure 25:** Indicates the pruning required for tree 11.  
Source Austin 27/05/2106

**Figure 26:** Indicates the pruning required for tree 11.  
Source Austin 27/05/2106

**Figure 27:** Hand drawn overlay which indicates the pruning required for tree 11. Red branches will require removal while blue branches remain. Source Josh Wrathall, AJ+C Architects 31/10/2014.

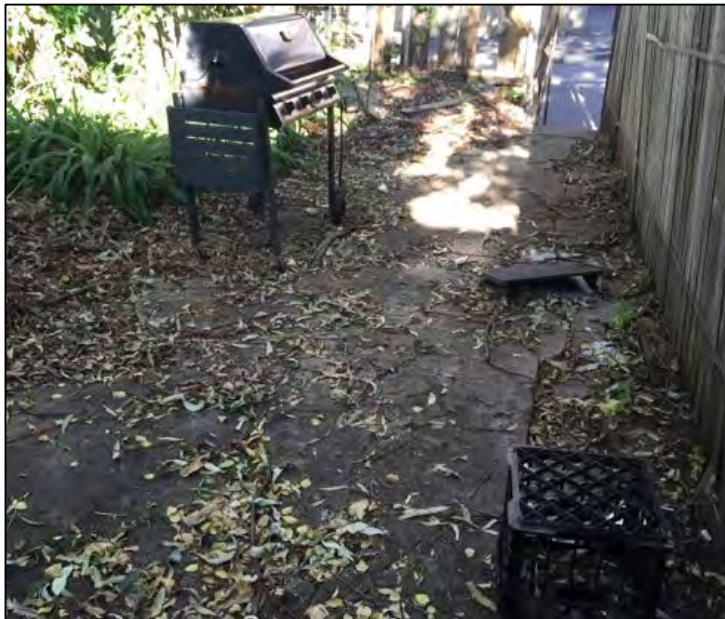
**Figure 28:** The old concrete paths located with the TPZ of tree 11 that require hand removal or machine removal with Arborist supervision. . Source Austin 27/05/2016

- 9.2.18 Demolition within the root zone will be required as old concrete pathways are present. Demolition must occur by hand or with a small (<3tonne) rubber tracked excavator working with arborist supervision. Old footing located in the root zone should remain if there is likely to be root damage from their removal.

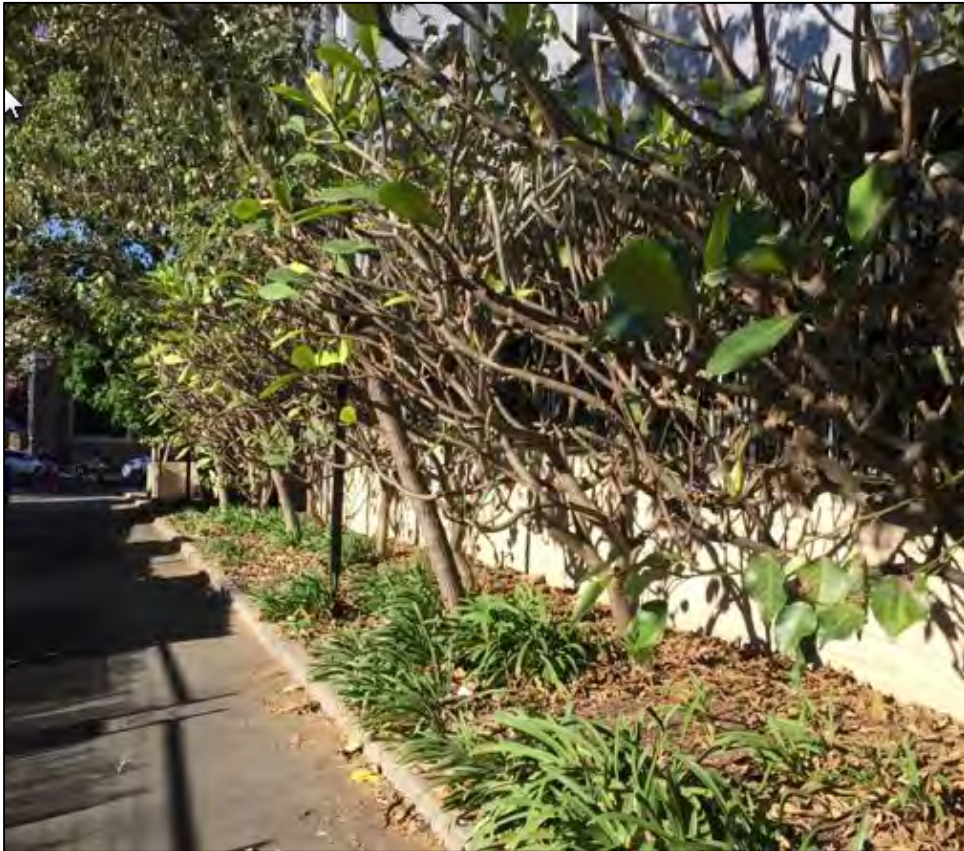
**Figure 29:** The nineteen *Plumeria sp* (Frangipanis) that require tree protection fencing along the edge of Darlington Lane.  
Source Austin 27/05/2106

- 9.5.1 The nineteen (19) *Plumeria sp* (Frangipanis) numbered 880, 880a – 880i, 879, 879a – 879h require Tree protection fencing along the garden bed edge on the eastern side of Darlington Lane.
