**THE UNIVERSITY OF SYDNEY
DARLINGTON ROAD TERRACES
(14051)**

**9605
TERRACES INTERNAL CONDITION
PROPOSED CONSERVATION SCHEDULE**

A visual internal inspection was conducted on 27/07/16 with CIS and AJ+C on the Darlington Road Terraces existing conditions. The intent is to classify the terraces into 3 categories with the level of refurbishment required.

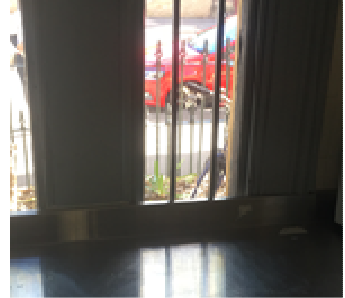
TERRACE NO.	INTERNAL CONDITION CLASSIFICATION	SPECIAL CONDITIONS	PHOTOS
No.131	A	<ul style="list-style-type: none"> Ceiling rose to be retained where it does not interfere with new walls. Allow to patch up existing window architrave in existing kitchen behind stainless steel splashback. <u>Remove existing Fireplace (to accommodate proposed Bathroom) and Relocate Fireplace to Terrace 129 (to proposed Lounge Room)</u>

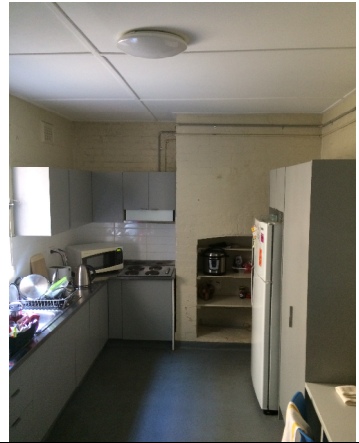
No.130	A	<ul style="list-style-type: none"> <u>Remove existing Mantle (to accommodate proposed Bathroom) and Relocate Mantle to Terrace 129 (to proposed Front Bedroom on Ground Floor)</u> 	
No.129	A	<ul style="list-style-type: none"> Allow for removal of 4 existing aluminium windows and replace with double hung timber windows (refer to drawings for locations). Existing kitchen with painted brick wall, allow for direct stick plasterboard with new cornice and new skirting to where new bedroom is proposed. New plasterboard to abut existing door and window frames. Investigate the cause of the mould evident in upstairs back bedroom and provide treatment to prevent it recurring. <u>Remove existing Stair (to accommodate proposed Lounge Room) and apply outline of demolished stair painted as a graphic on Terrace wall (west wall).</u> Refer to Suggested methods of interpreting removed Stairs above.

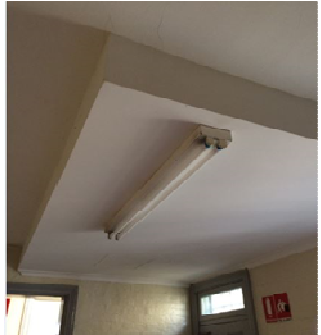
TERRACE NO.	INTERNAL CONDITION CLASSIFICATION	SPECIAL CONDITIONS	PHOTOS
No.127	A	<ul style="list-style-type: none"> Remove distribution board in living room. <u>Remove existing Fireplace (to accommodate proposed Bathroom and Comms. Cupboard) and Relocate Fireplace to Terrace 128 (to proposed Dining Room)</u> <u>Remove existing Stair (to accommodate proposed Hallway) and apply outline of demolished stair painted as a graphic on Terrace wall (west wall).</u> <u>Refer to Suggested methods of interpreting removed Stairs above.</u>

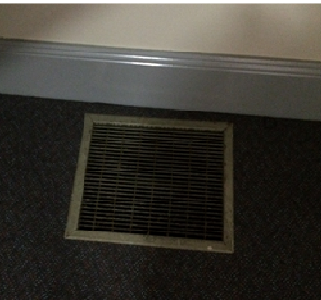
No.126	B	<ul style="list-style-type: none"> Remove floor grille under stair case and make good floor. Allow for removal of 4 existing aluminium windows and replace with double hung timber windows. (refer to drawings for locations) <u>Remove existing Mantle (to accommodate proposed Bathroom) and Relocate Mantle to Terrace 128 (to proposed Front Bedroom on Ground Floor)</u>

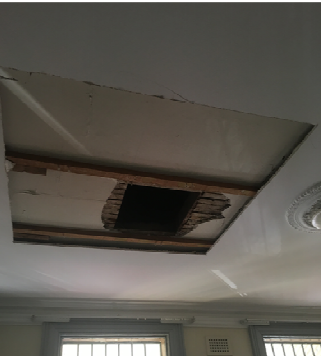
No.125	B	<ul style="list-style-type: none"> Existing kitchen with painted brick wall, allow for direct stick plasterboard with new cornice and new skirting to where new meeting room is proposed. New plasterboard to abut existing door and window frames. <u>Remove existing Stair (to accommodate proposed Hallway) and apply outline of demolished stair painted as a graphic on Terrace wall (west wall). Refer to Suggested methods of interpreting removed Stairs above.</u>

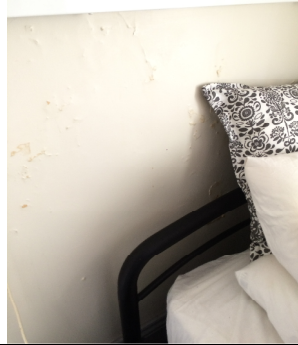
No.117	B	<ul style="list-style-type: none"> Retain decorative ceiling. Allow for removal of 1 existing aluminium window and replace with double hung timber window. (refer to drawings for location) <u>Remove existing Mantle (to accommodate proposed Bathroom) and Relocate Mantle to Terrace 118 (to proposed Front Bedroom on Ground Floor)</u> <u>Remove existing Stair (to accommodate proposed Hallway) and apply outline of demolished stair painted as a graphic on Terrace wall (east wall). Refer to Suggested methods of interpreting removed Stairs above.</u>

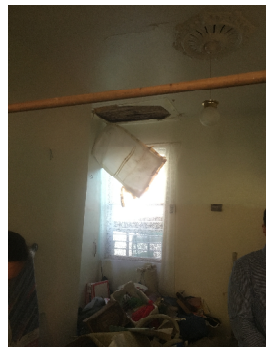
TERRACE NO.	INTERNAL CONDITION CLASSIFICATION	SPECIAL CONDITIONS	PHOTOS
No.104	C	<ul style="list-style-type: none"> Repair and replace ceilings where required, allow for 50 sqm of new ceiling. Patch and repair upstairs external balcony door, allow for new hinges and weather seal.

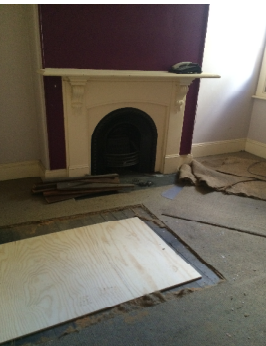
No.102	B	<ul style="list-style-type: none"> Repair any damaged timber floor boards, allow for replacement of 5 sqm to match existing. <u>Remove existing Stair (to accommodate proposed Administration Reception) and apply outline of demolished stair painted as a graphic on Terrace floor or part of reception joinery. Refer to Suggested methods of interpreting removed Stairs above.</u>

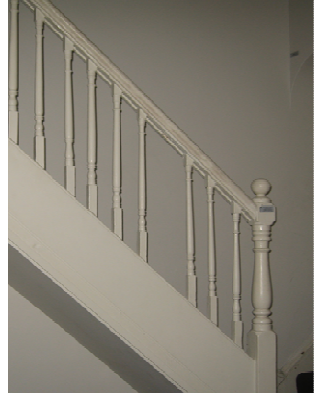
TERRACE NO.	INTERNAL CONDITION CLASSIFICATION	SPECIAL CONDITIONS	PHOTOS
No.101	A	<ul style="list-style-type: none"> Allow for spindle, where missing to balustrade as required. Allow for removal of 1 existing aluminium window and replace with double hung timber window. (refer to drawing for location)

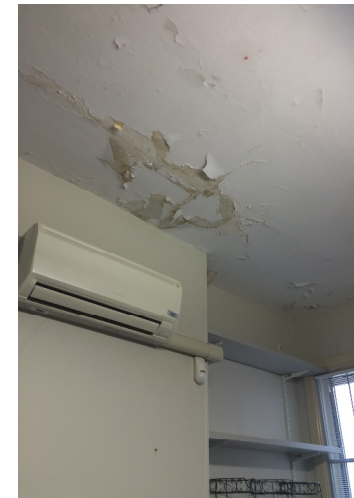
TERRACE NO.	INTERNAL CONDITION CLASSIFICATION	SPECIAL CONDITIONS	PHOTOS
No. 98	B	<ul style="list-style-type: none"> Note this building hazmat report states, level 1 wall lining and ceiling lining is positive for asbestos. The report also states the paint systems contain positive traces of lead. Refer to Hazmat report for appropriate removal procedure. Allow for removal of 3 existing aluminium windows and replace with double hung timber windows. (refer to drawings for locations) Allow for plasterboard lining to framed wall in upstairs middle bedroom. Repair ceiling where required. Rectify the source of damage to the ceiling. Remove wall mounted rails along stair. <u>Remove existing Fireplace (to accommodate proposed Bathroom) and Relocate Fireplace to Terrace 106 (to proposed Lounge Room)</u> <u>Remove existing Mantle (to accommodate proposed Bathroom) and Relocate Mantle to Terrace 106 (to proposed Lounge Room)</u> <u>Remove existing Stair (to accommodate proposed Hallway) and apply outline of demolished stair painted as a graphic on Terrace wall (west wall). Refer to Suggested methods of interpreting removed Stairs above.</u>

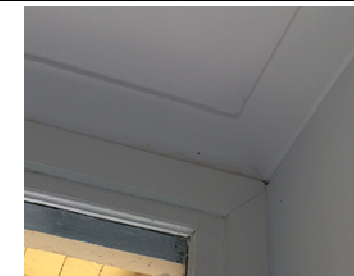
No. 97 NOT IN SCOPE			
No. 96	A	<ul style="list-style-type: none"> Investigate the cause of waterdamage evident to the cornice over the entry hallway ceiling cornices and provide treatment to prevent it recurring. Investigate the cause of leaks at balcony and provide treatment to prevent it recurring.
