Moorebank Precinct East – Stage 2 WSUD Independent Audit

Report Prepared for:
Department of Planning &
Infrastructure and Environment

September, 2023
Project No. 255

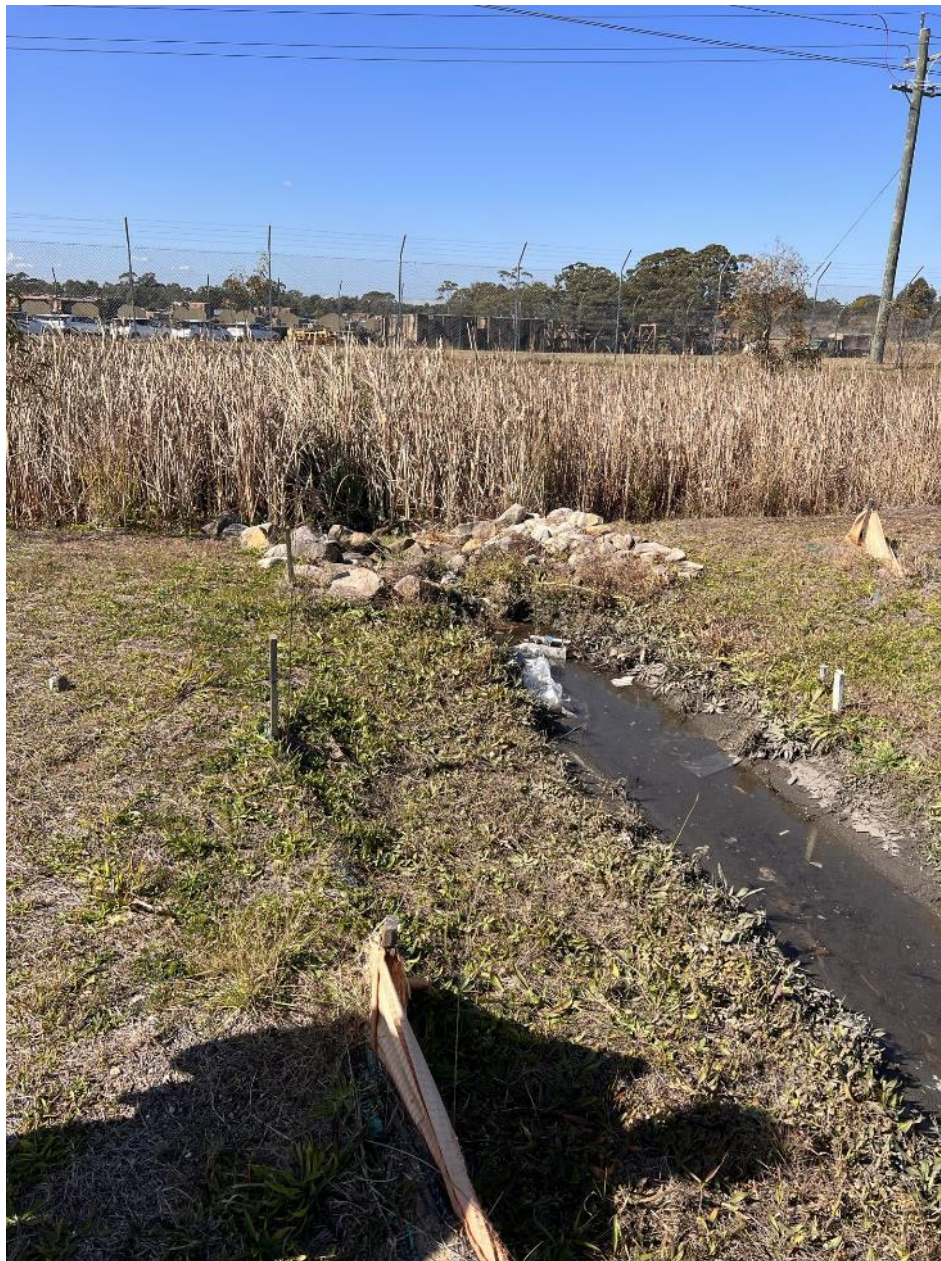
Photo	Description
  A photograph of a bioretention basin, labeled OSD 1. The basin is filled with dense, brownish-yellow vegetation, indicating improved plant growth. The basin is surrounded by a concrete curb, and the surrounding area is dry and sandy. In the background, there are industrial buildings and a clear blue sky.	<p>OSD 1 bioretention basin showing much improved plant growth throughout whole basin, denuded batters</p>

- 1) Vegetate the batters with a mix of small shrubs and drought tolerant plants such as Lomandra. This will help to shade the bioretention system through summer as well as suppress weeds. It is preferable to have a well-established vegetative cover rather than continuously spraying the basin batters with glyphosate which is toxic to macroinvertebrates and aquatic fauna and which will ultimately impact on water quality.

- 2) At very low cost, LOGOS would be able to place a small weir inside the OSD 1 outlet pit. This would raise the water level in the bioretention basin by nominally 200mm. This would aid in plant survival during extreme summer heat and drought. Given there has been good investment in getting the vegetation to achieve good coverage, this low cost action would then protect the investment in vegetation in the basin.

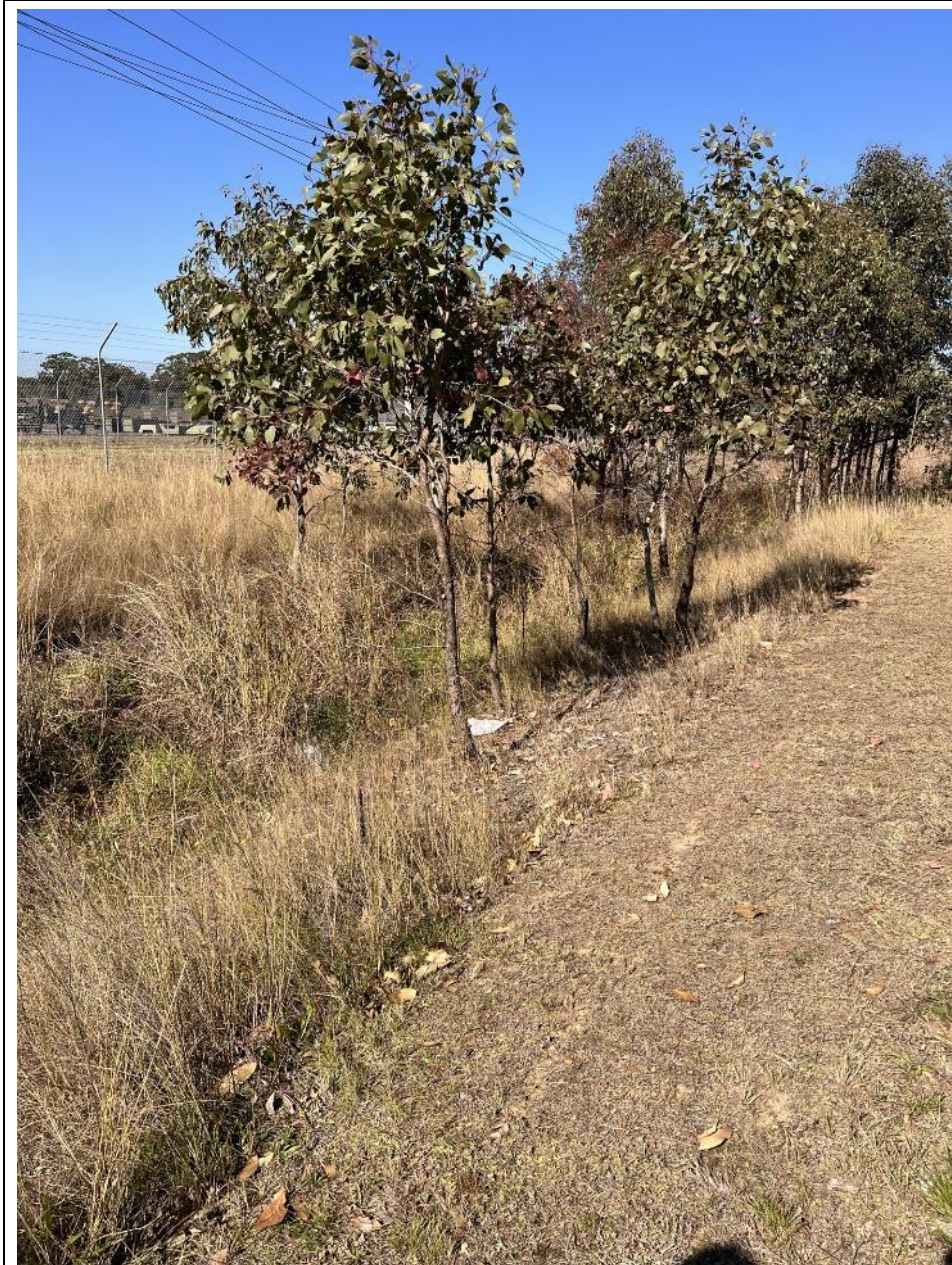
Photo showing some litter present prior to discharge into Swale 1. This is from an untreated part of the existing development which is yet to be developed.

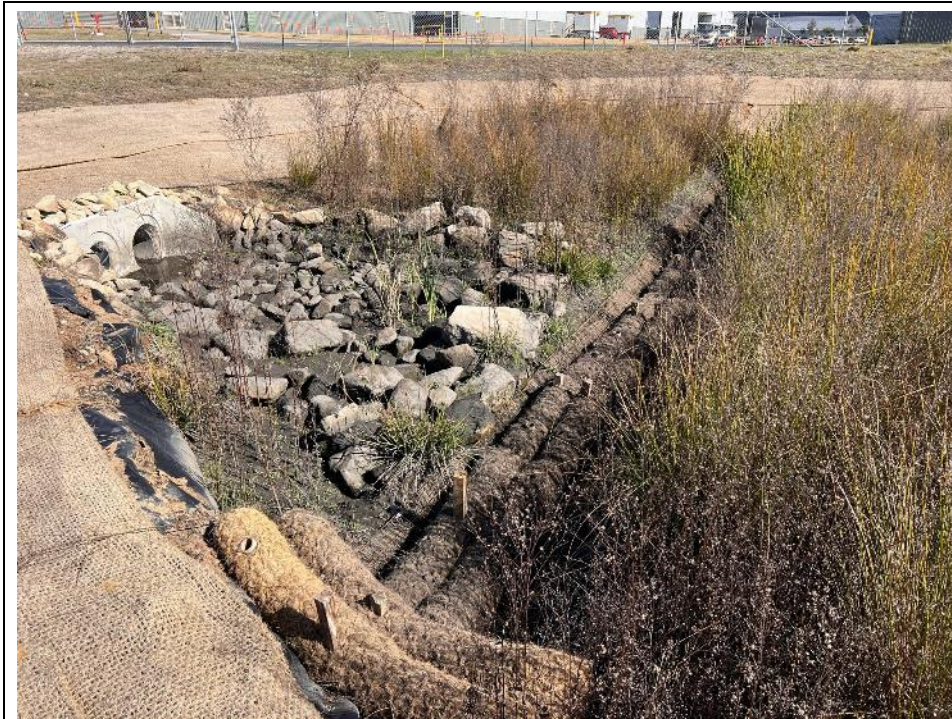
Swale adjacent to the OSD 1 in good condition – following maintenance and removal of weeds. Typha is healthy and frogs were present in the swale.
