**Report on Hazardous Building Materials
(HAZMAT) Survey**

3-5 Help Street, Chatswood NSW

Prepared for Loftex Chatswood Pty Limited

Project 232749.00

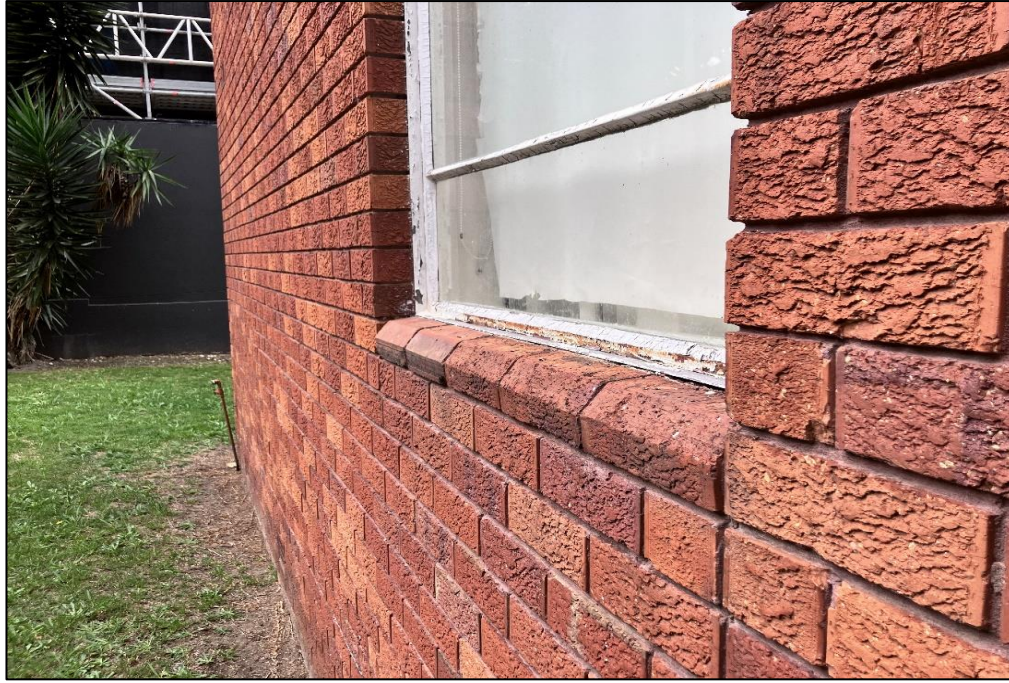
Photograph 1: 3 Help Street, exterior, northern façade, ground floor, window frame, glazing putty, no asbestos detected by analysis.

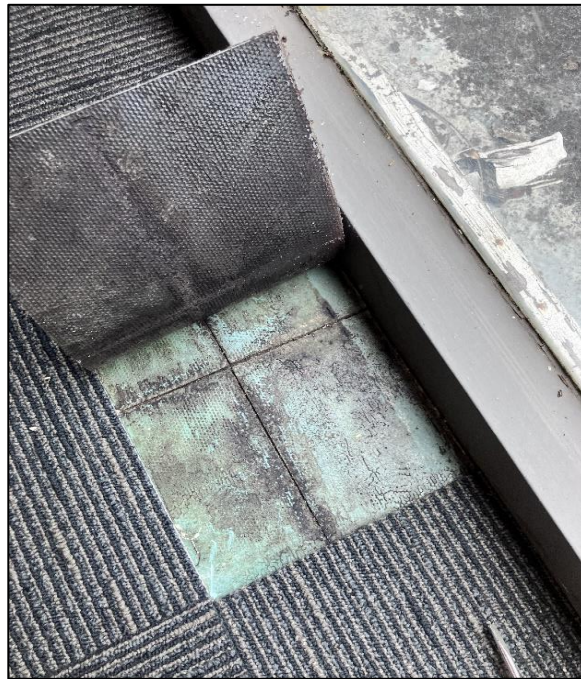
Photograph 2: 3 Help Street, stairwells generally, landings and stairs, floor, below carpet, vinyl tiles, suspected asbestos.

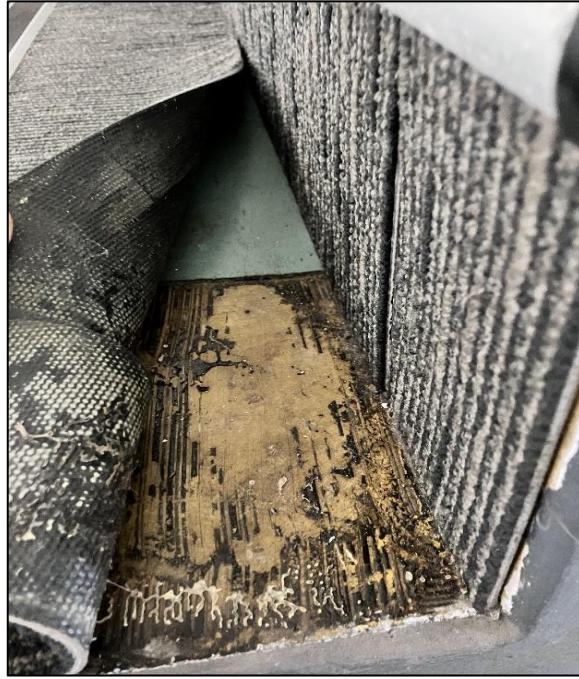
Photograph 3: 3 Help Street, stairwells generally, landings and stairs, floor, below carpet, vinyl tiles, suspected asbestos.

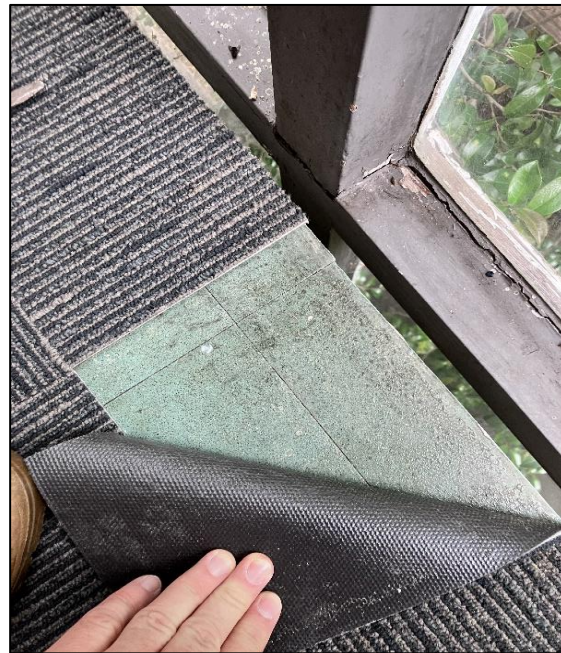
Photograph 4: 3 Help Street, stairwells generally, landings and stairs, floor, below carpet, vinyl tiles, suspected asbestos.

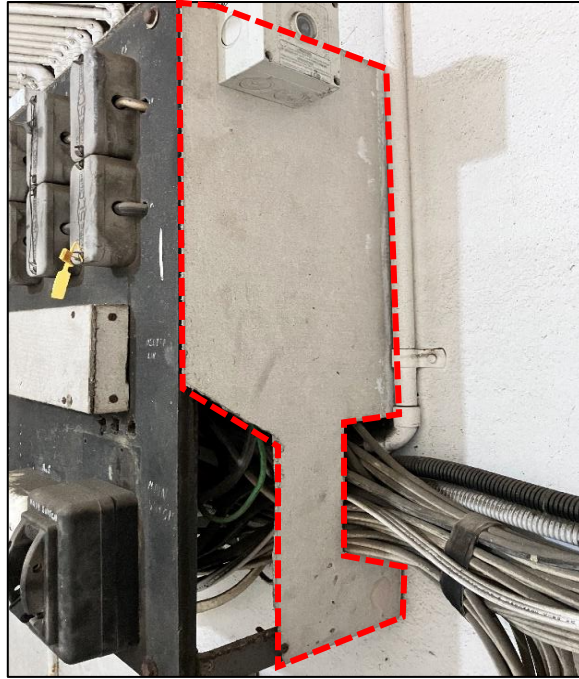
Photograph 5: 3 Help Street, interior, centre stairwell, ground floor, electrical panel, fibre cement linings, asbestos detected by analysis.

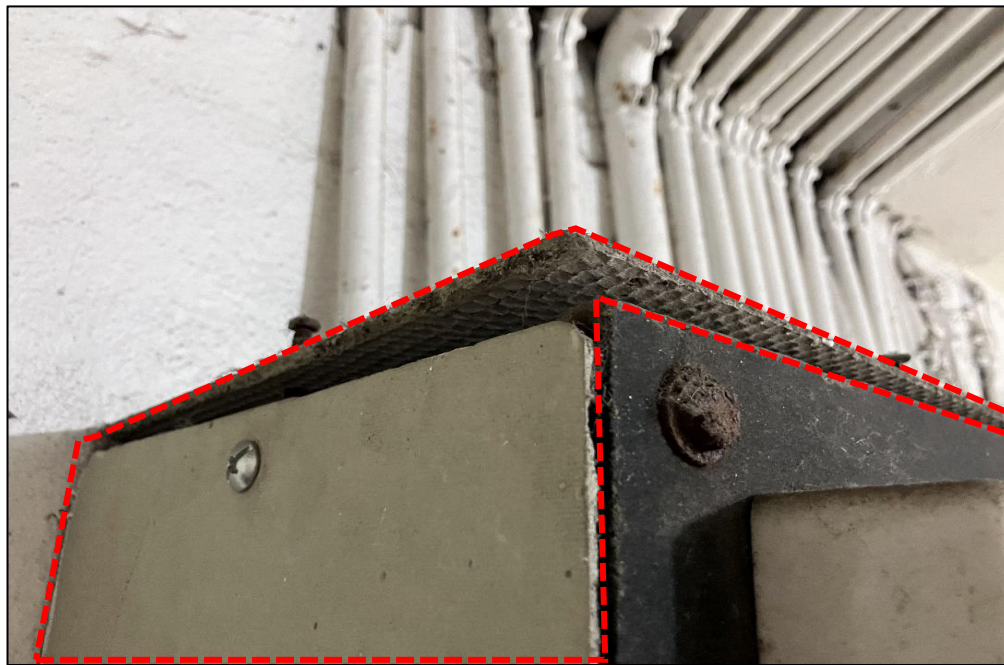
Photograph 6: 3 Help Street, interior, centre stairwell, ground floor, electrical panel, fibre cement linings, asbestos detected by analysis.

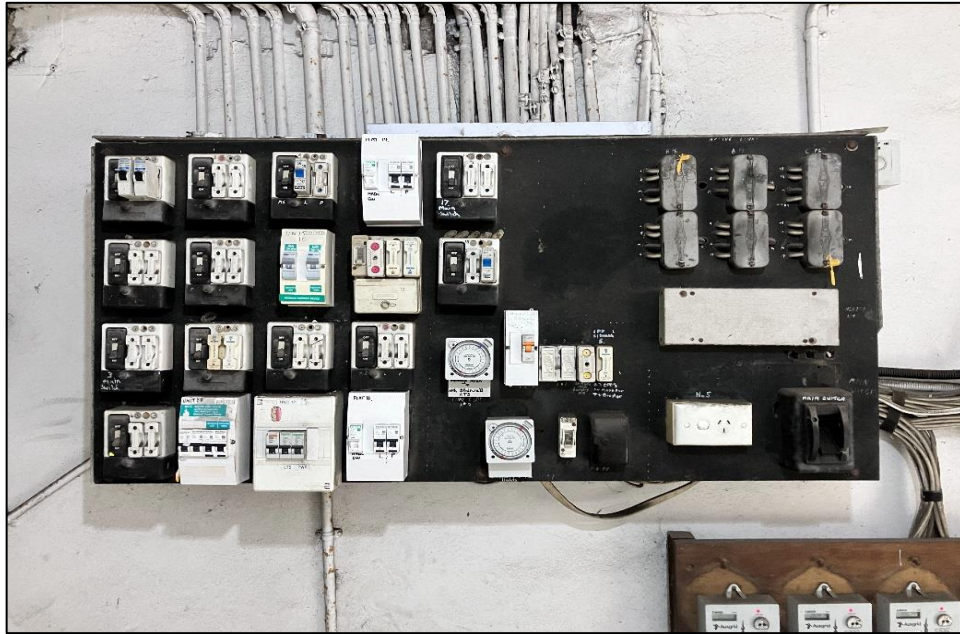
Photograph 7: 3 Help Street, interior, centre stairwell, ground floor, electrical panel, resinous board(s), suspected asbestos.

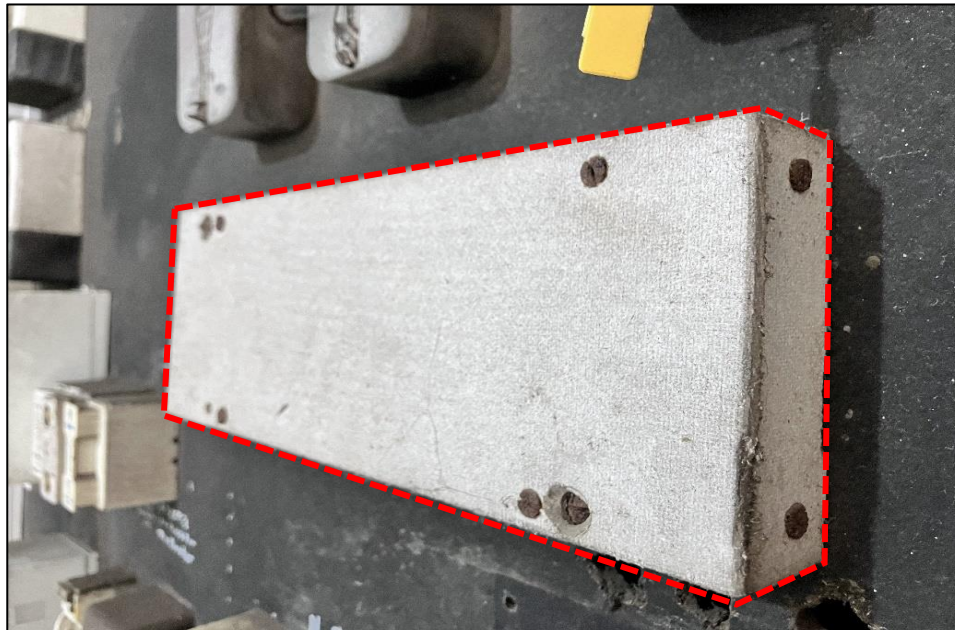
Photograph 8: 3 Help Street, interior, centre stairwell, ground floor, linings to front of electrical panel, fibre cement sheeting, suspected asbestos.

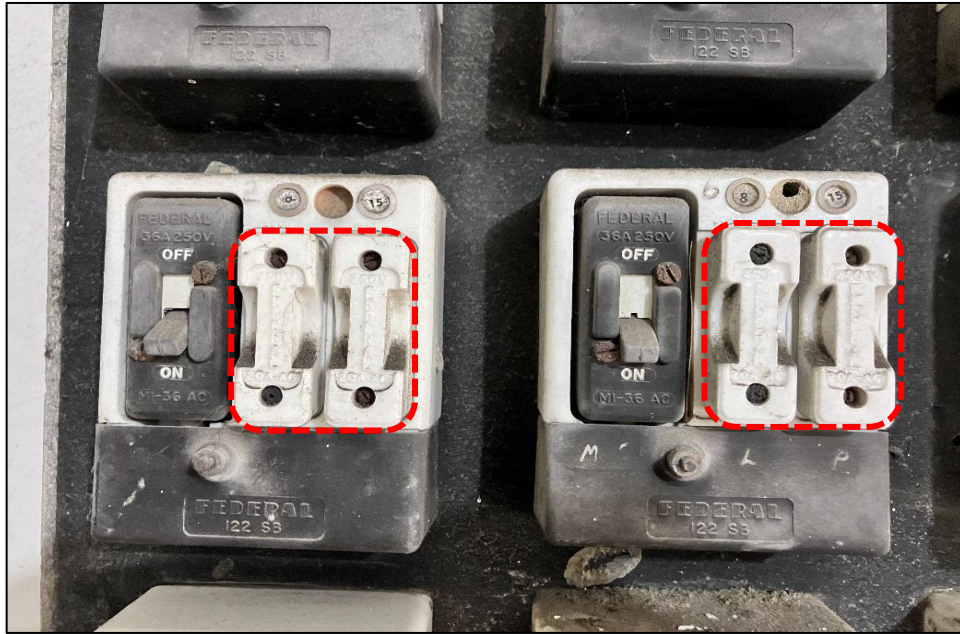
Photograph 9: 3 Help Street, interior, centre stairwell, ground floor, ceramic fuses, internal insulation (if present), suspected asbestos.

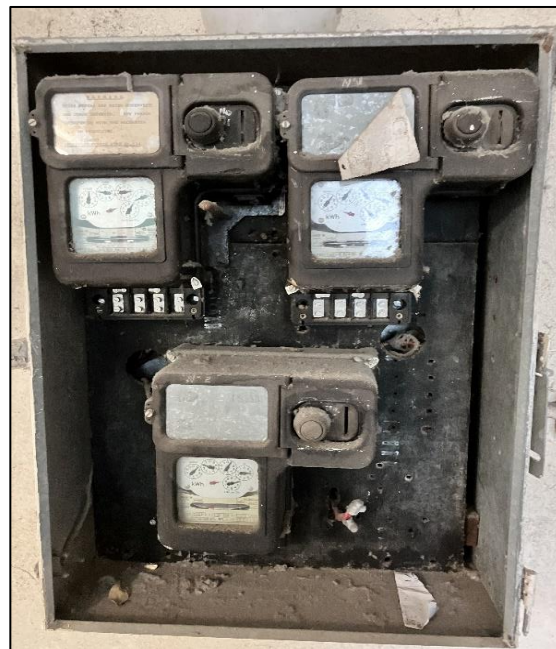
Photograph 10: 3 Help Street, interior, ground floor, Laundry, electrical panel, resinous board(s), suspected asbestos.

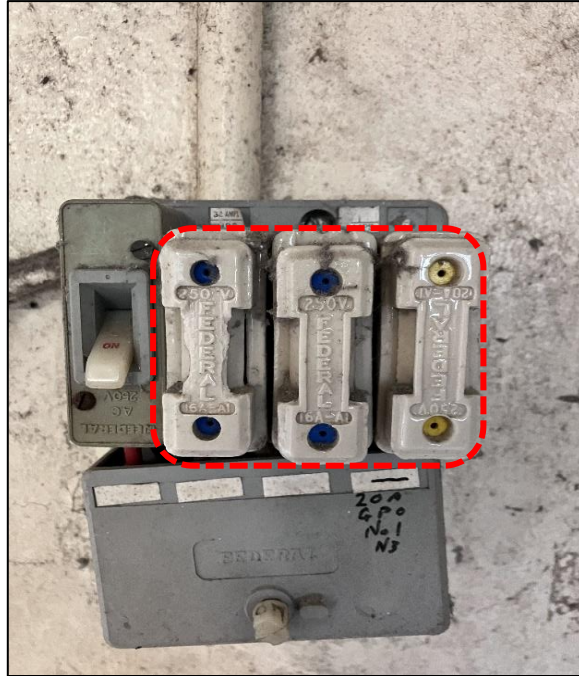
Photograph 11: 3 Help Street, interior, ground floor, Laundry, ceramic fuses, internal insulation (if present), suspected asbestos.

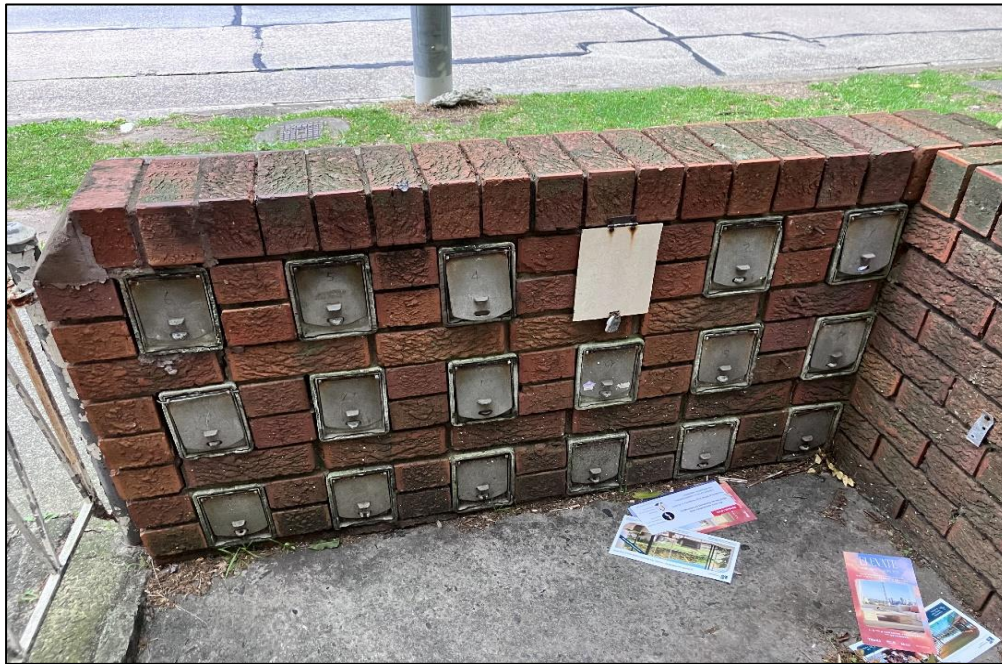
Photograph 12: 3 Help Street, exterior, southern yard, mailbox linings, fibre cement product, asbestos detected by analysis.

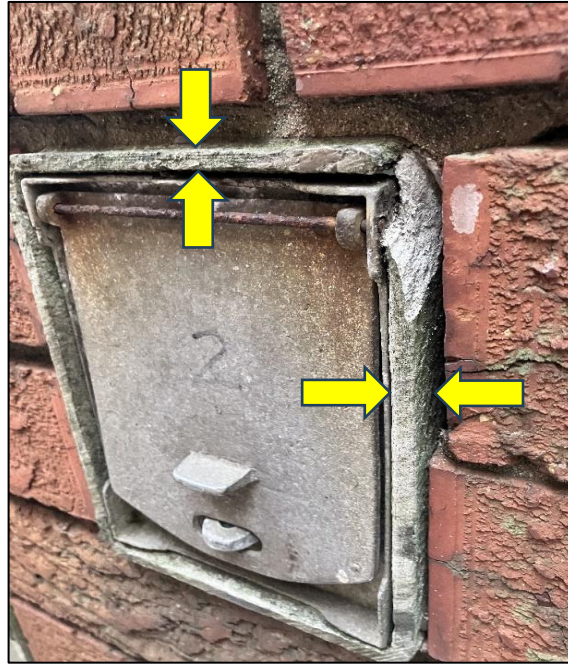
Photograph 13: 3 Help Street, exterior, southern yard, mailbox linings, fibre cement product, asbestos detected by analysis.

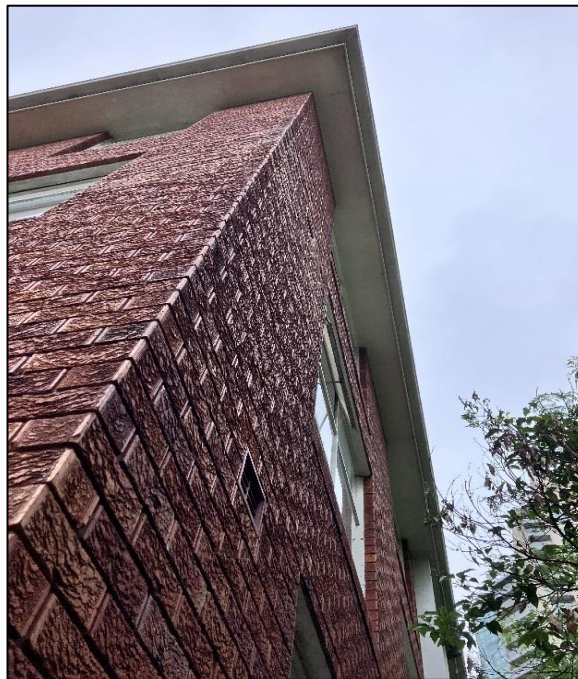
Photograph 14: 3 Help Street, exterior, eave linings generally, fibre cement sheeting, suspected asbestos.

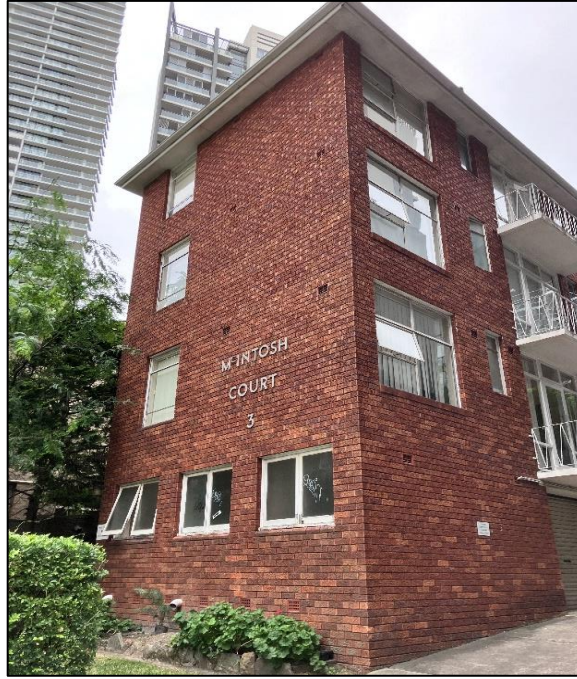
Photograph 15: 3 Help Street, exterior, eave linings generally, fibre cement sheeting, suspected asbestos.

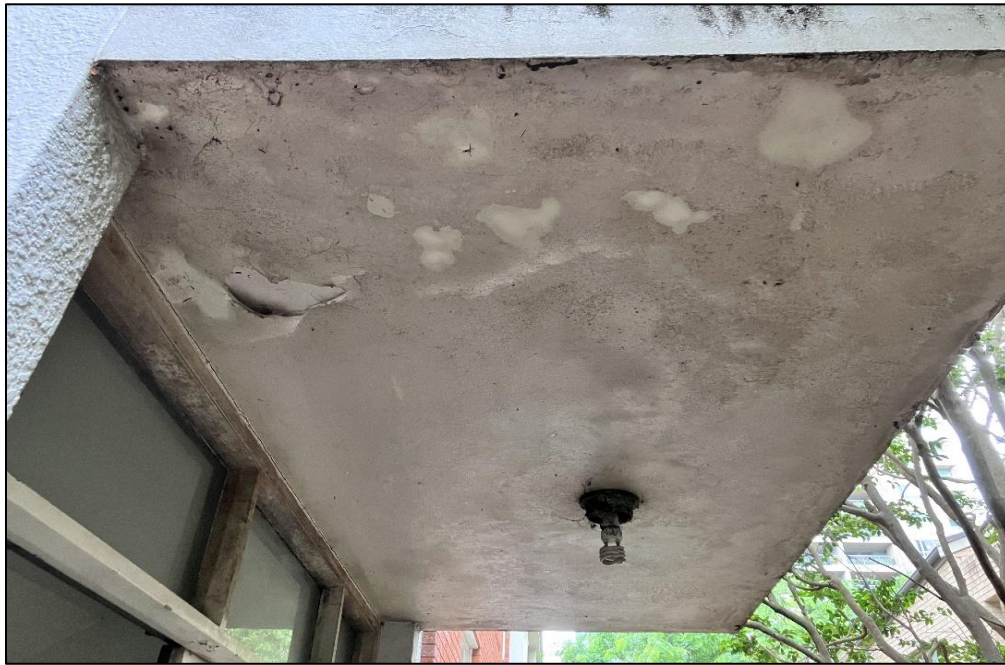
Photograph 18: 3 Help Street, exterior, western facade, northern end, concrete awning, white paint, may comprise lead paint.

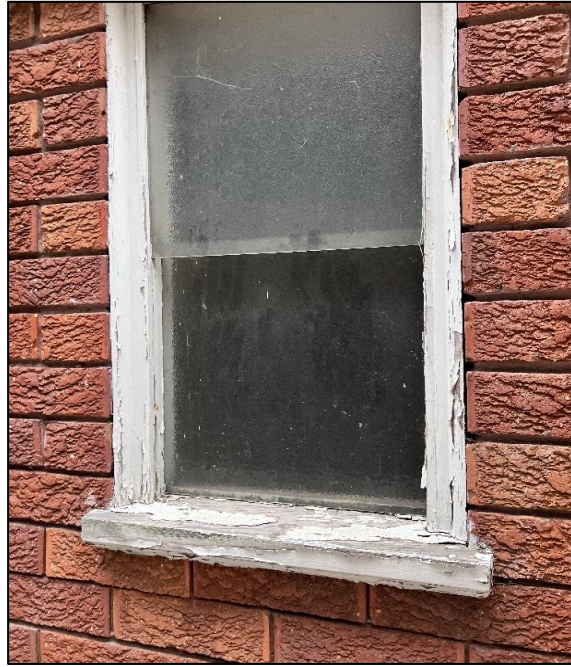
Photograph 19: 3 Help Street, exterior, eastern façade, southern end, window frame, white paint, lead paint detected.

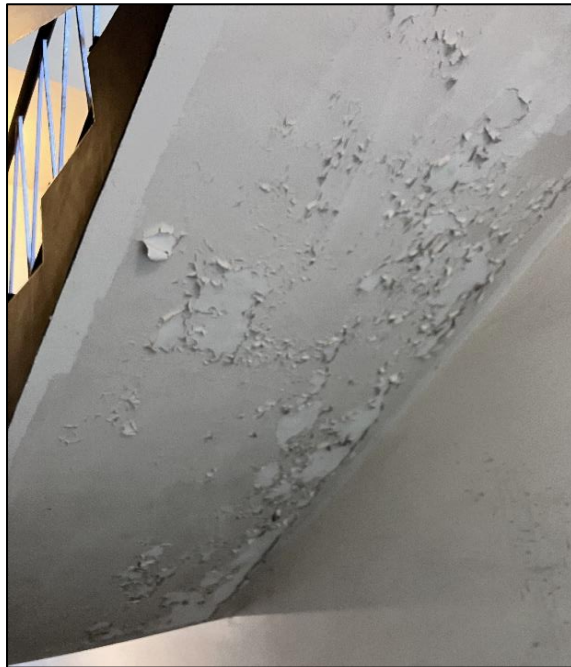
Photograph 20: 3 Help Street, interior, southern stairwell, ground floor, ceiling and base of stairwell, white paint, lead paint not detected.

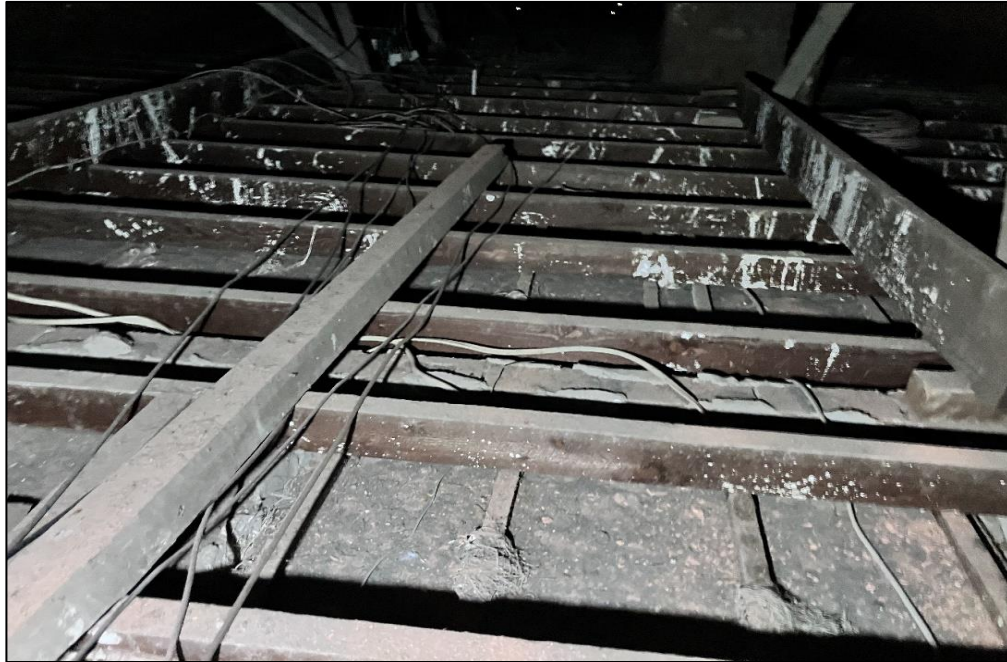
Photograph 21: 3 Help Street, roof cavity, top of ceiling, settled dust/debris, lead detected (130 mg/m²).

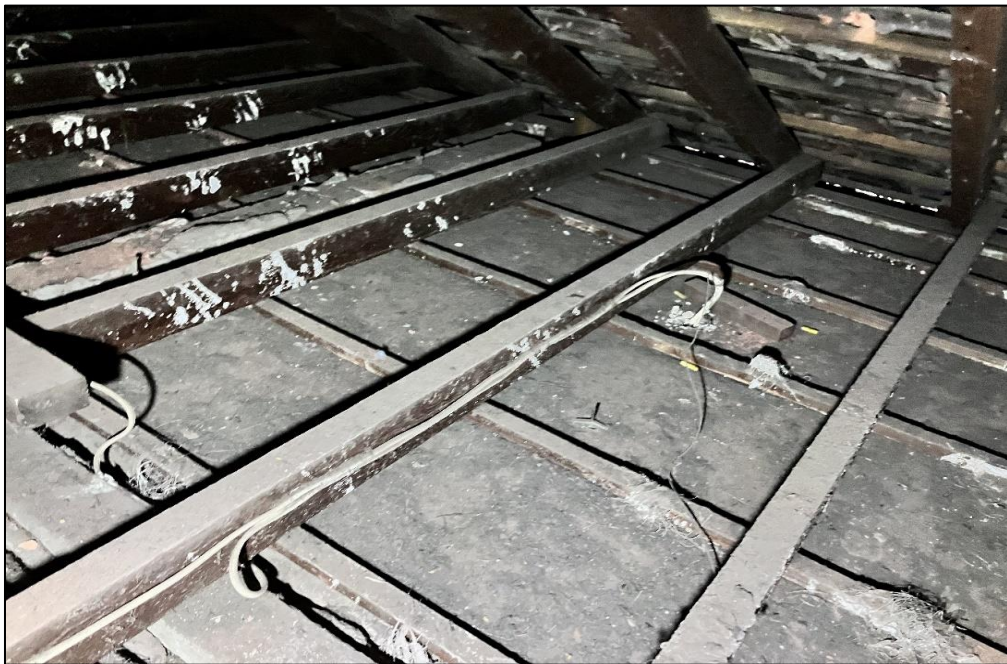
Photograph 22: 3 Help Street, roof cavity, top of ceiling, settled dust/debris, lead detected (130 mg/m²).

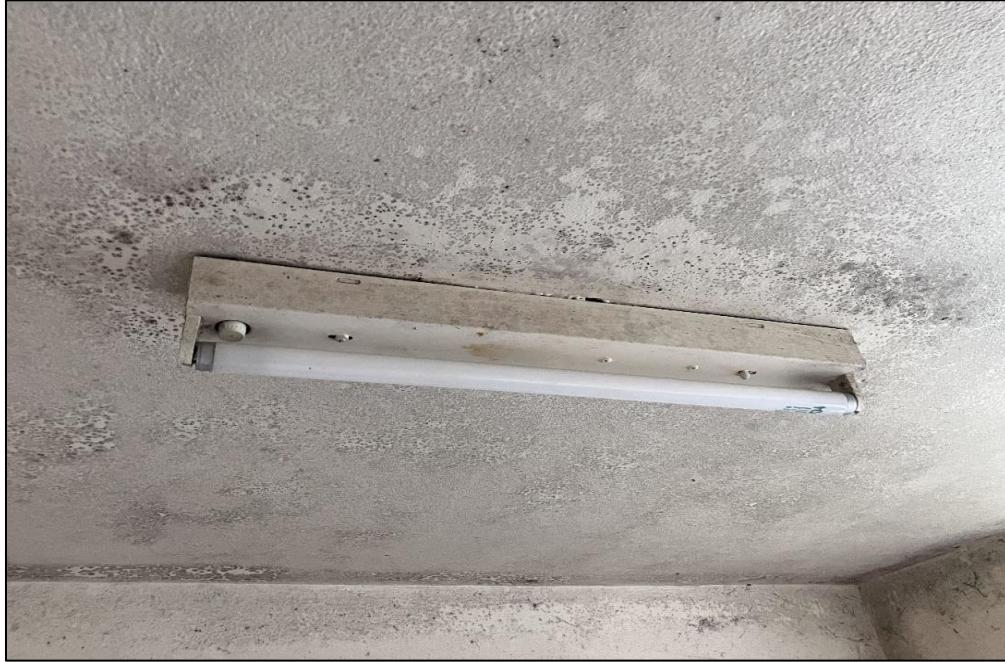
Photograph 23: 3 Help Street, ground floor, Laundry, fluorescent light fittings, internal components (e.g., capacitors), PCB (suspected).

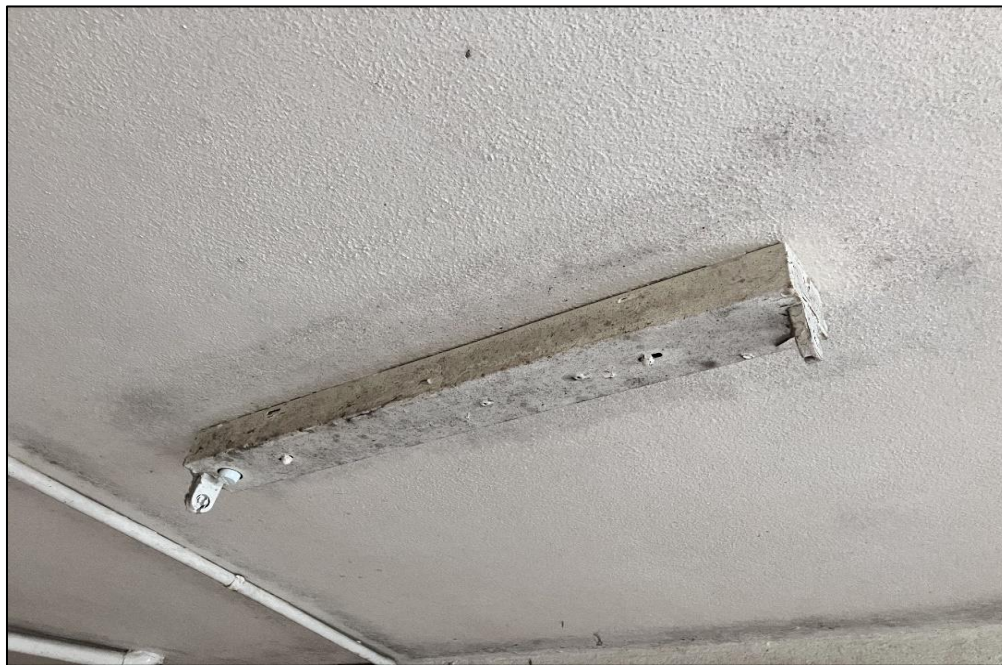
Photograph 24: 3 Help Street, ground floor, Laundry, fluorescent light fittings, internal components (e.g., capacitors), PCB (suspected).

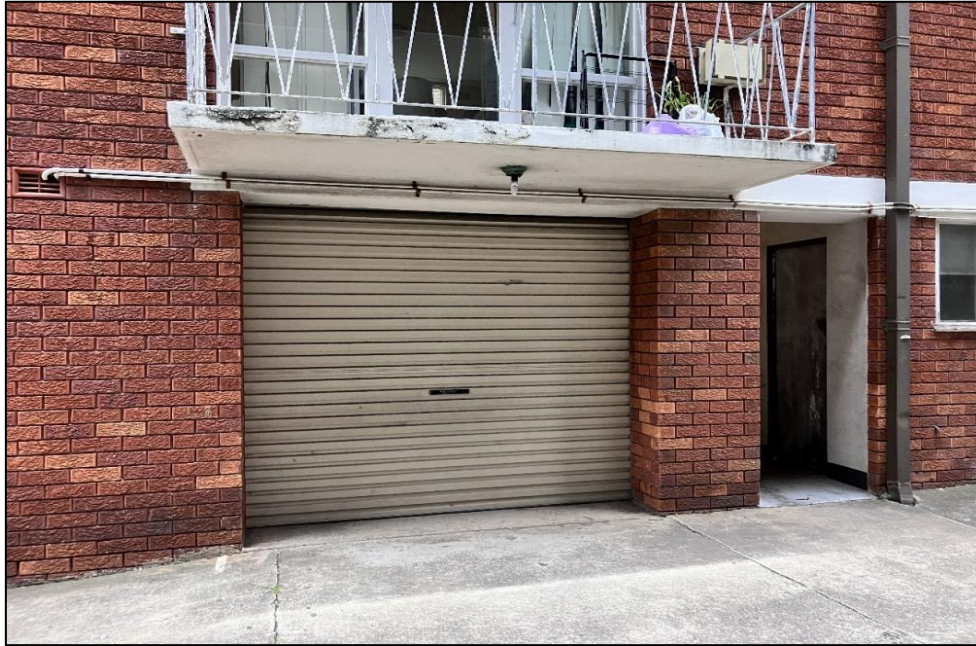
Photograph 25: 3 Help Street, ground floor, garages, suspected fluorescent light fittings, inaccessible (PCB suspected).

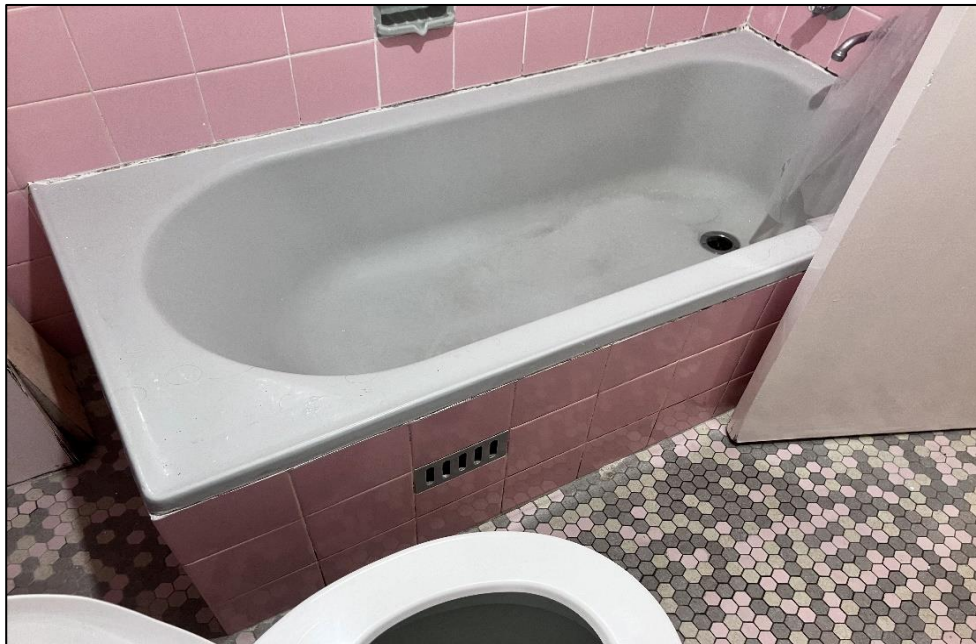
Photograph 26: 3 Help Street, Units 2, 7, 10 and 11, below ceramic tiled surfaces (e.g. walls, bath surrounds), substrate, inaccessible.

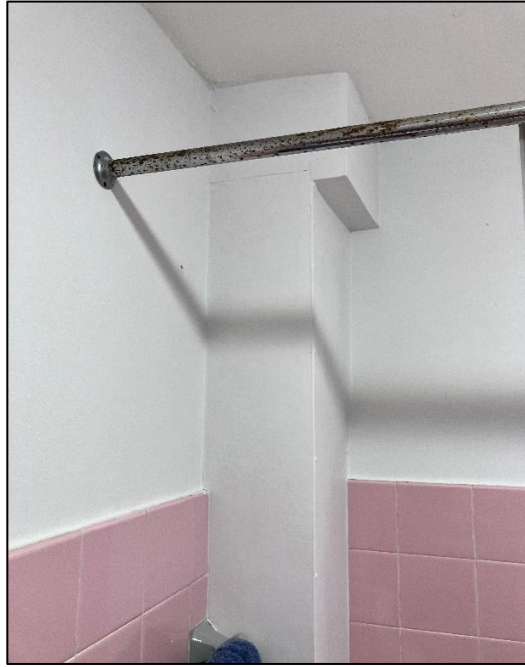
Photograph 27: 3 Help Street, Units 2, 7, 10 and 11, service conduits / risers, internal components, inaccessible.

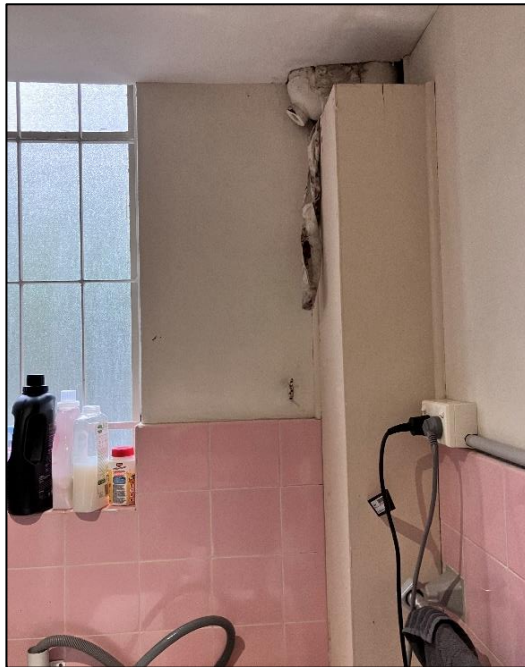
Photograph 28: 3 Help Street, Units 2, 7, 10 and 11, service conduits / risers, internal components, inaccessible.

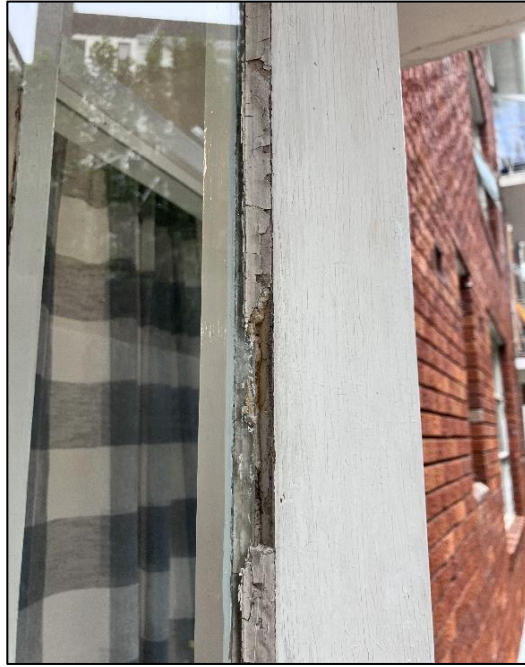
Photograph 29: 3 Help Street, typical balcony, door, glazing putty, no asbestos detected by analysis.

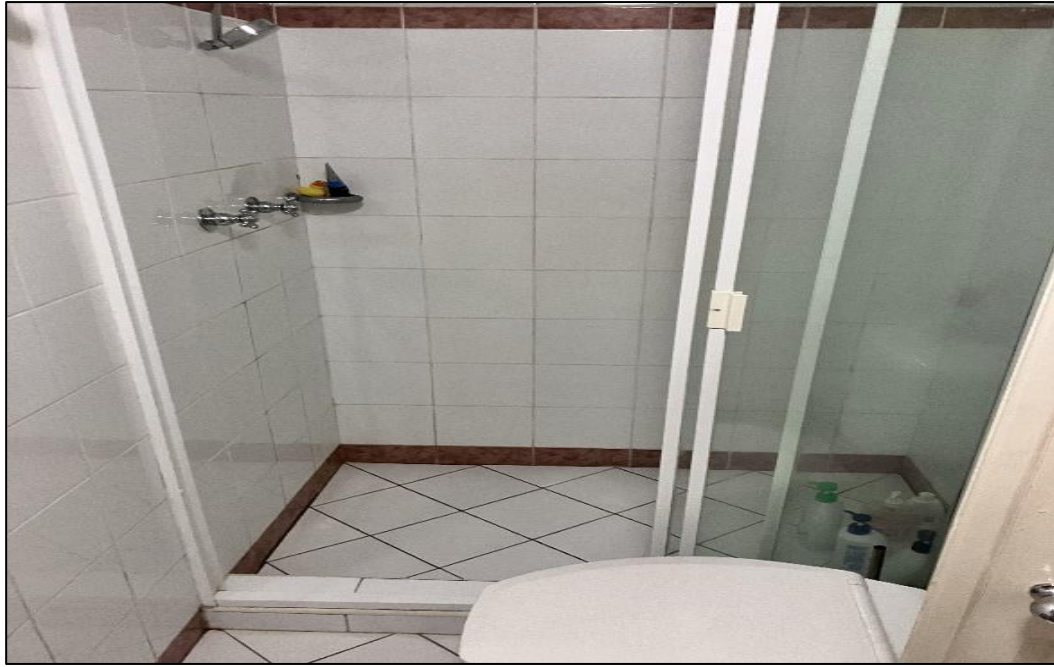
Photograph 1: 5 Help Street, Units 4, 11, 19 and 28, below ceramic tiled surfaces (e.g. walls, floors, bath surrounds), substrate, inaccessible.

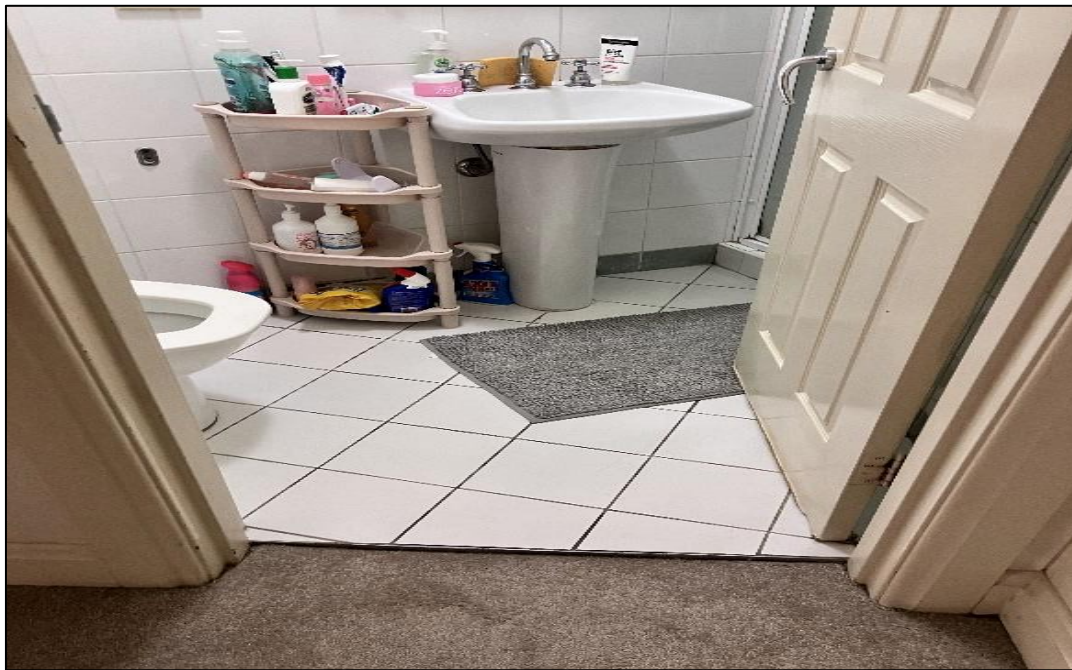
Photograph 2: 5 Help Street, Units 4, 11, 19 and 28, below ceramic tiled surfaces (e.g. walls, floors, bath surrounds), substrate, inaccessible.

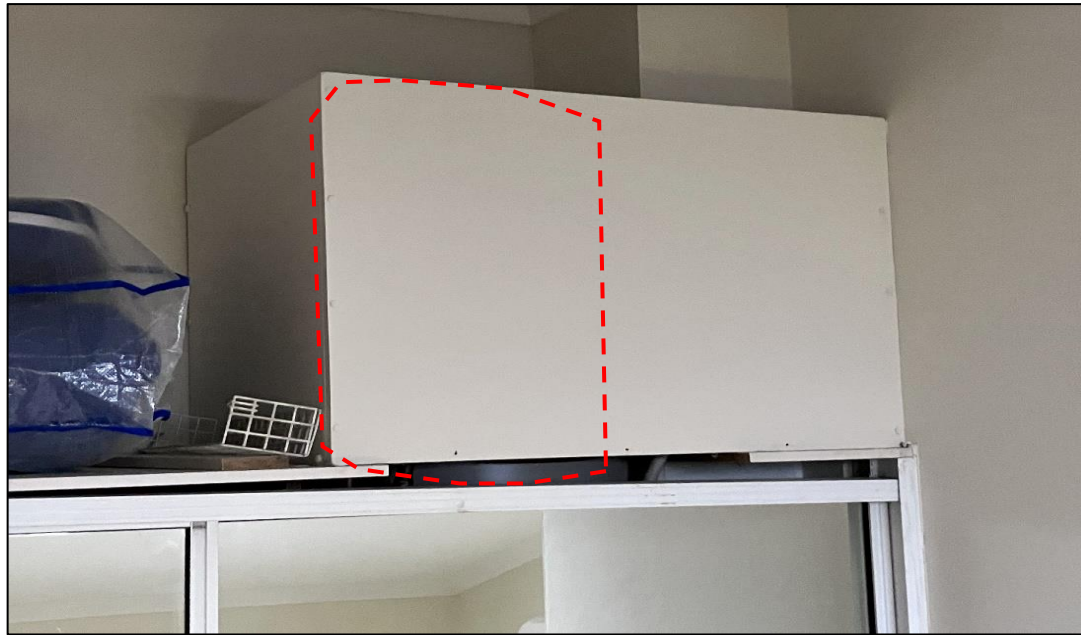
Photograph 3: 5 Help Street, Units 4, 11, 19 and 28, hot water unit(s), bulk insulation, suspected non-asbestos.

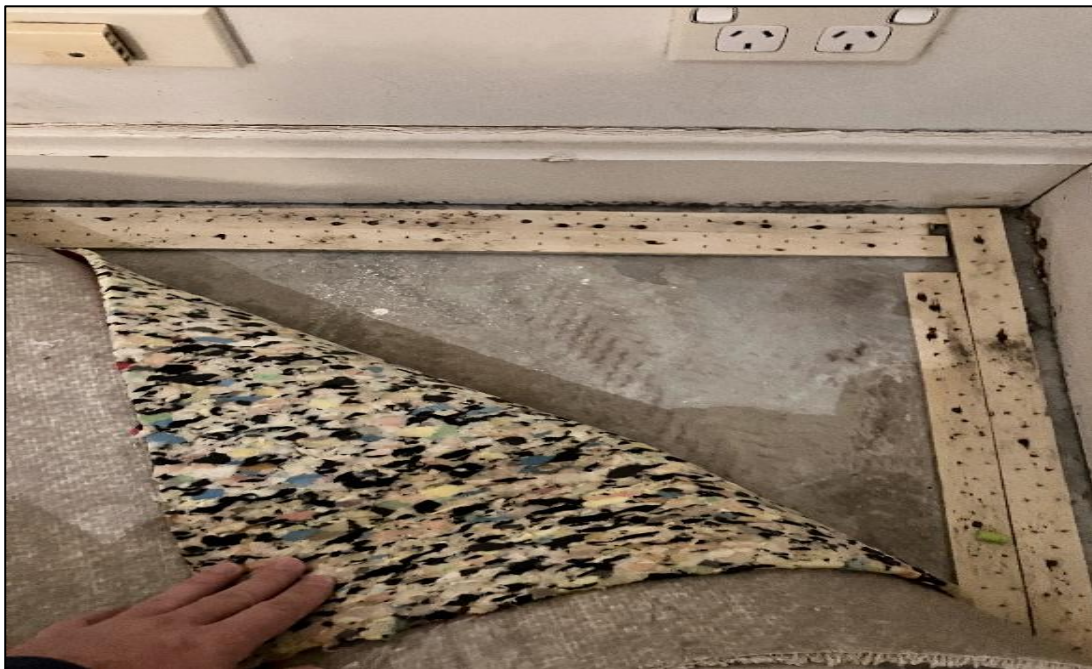
Photograph 4: 5 Help Street, Units 4, 11, 19 and 28, below floor coverings, substrate generally, suspected non-asbestos.

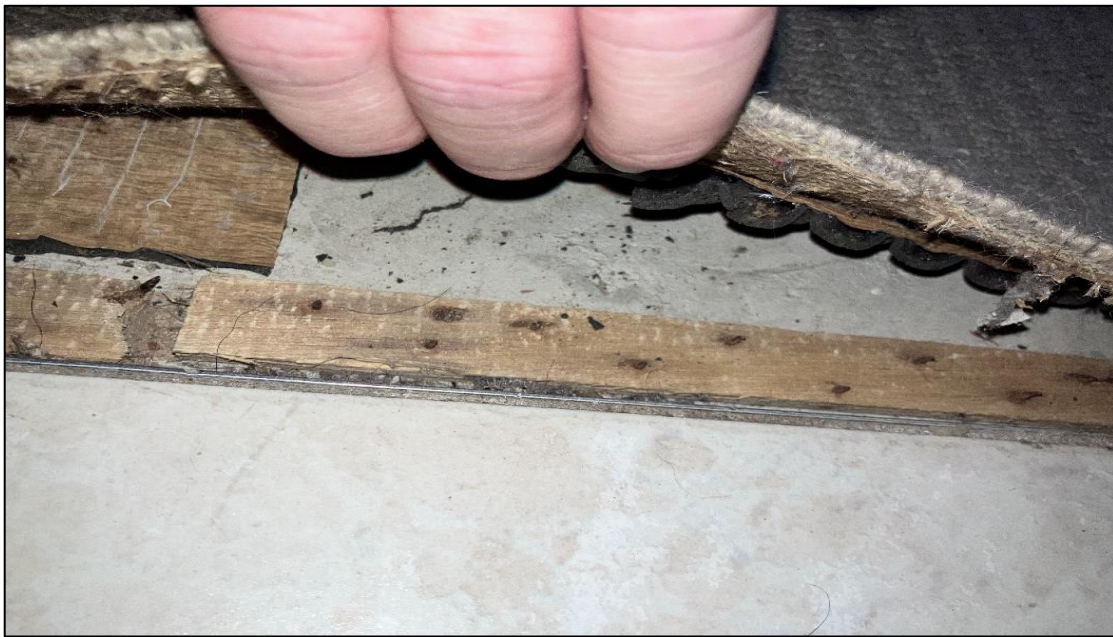
Photograph 5: 5 Help Street, Units 4, 11, 19 and 28, below floor coverings, substrate generally, suspected non-asbestos.

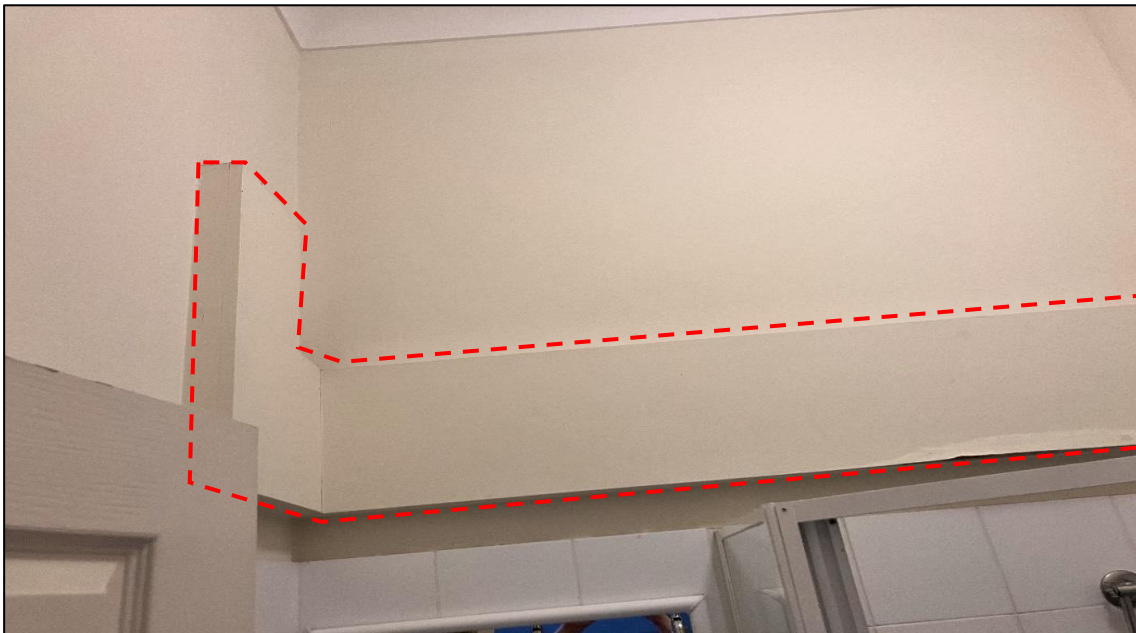
Photograph 6: 5 Help Street, Units 4, 11, 19 and 28, service conduits / risers, internal components, inaccessible.

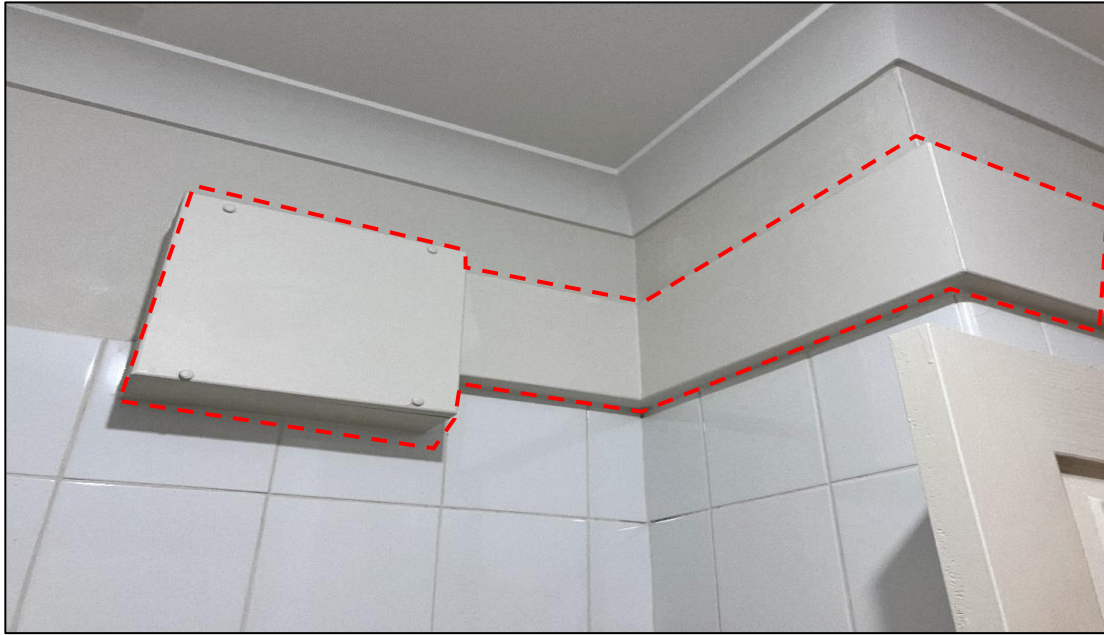
Photograph 7: 5 Help Street, Units 4, 11, 19 and 28, service conduits / risers, internal components, inaccessible.

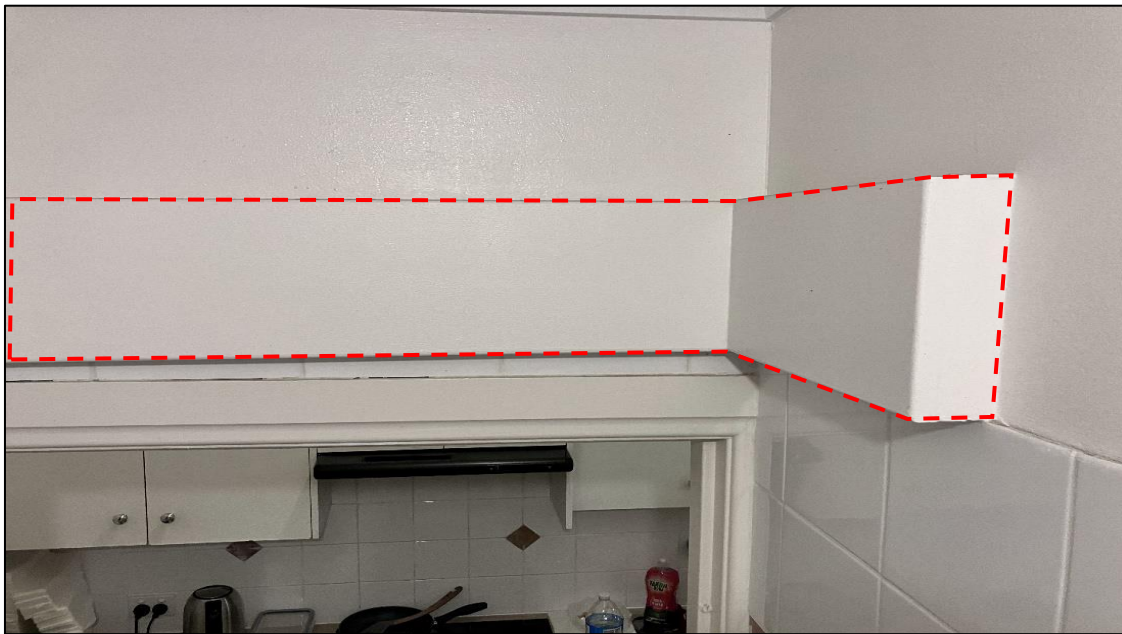
Photograph 8: 5 Help Street, Units 4, 11, 19 and 28, service conduits / risers, internal components, inaccessible.

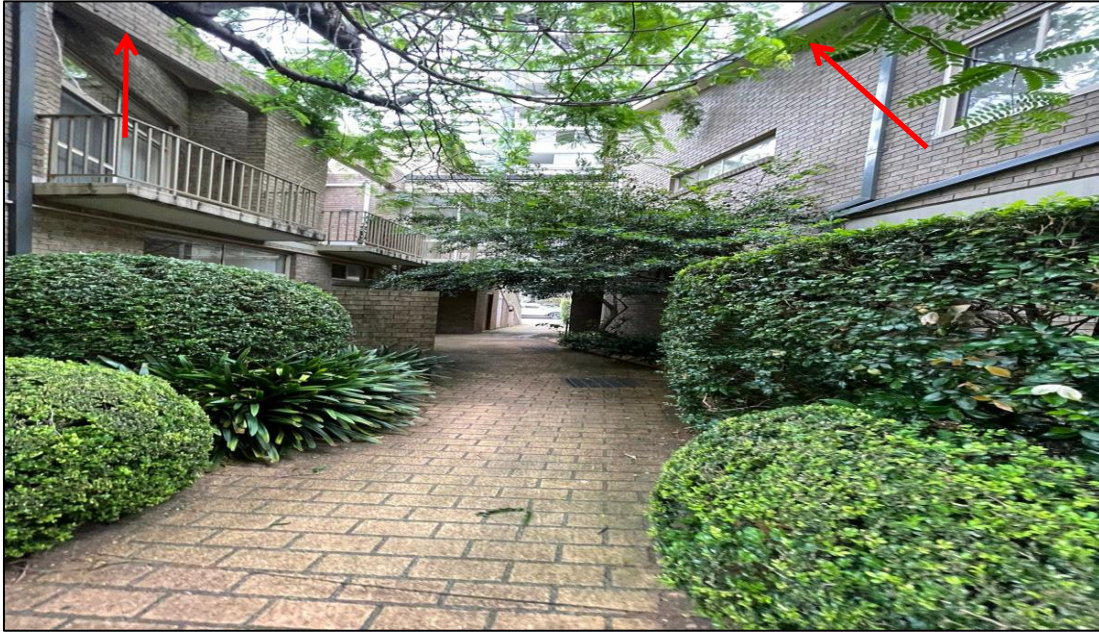
Photograph 9: 5 Help Street, exterior, eave linings generally, fibre cement sheeting, inaccessible suspected asbestos

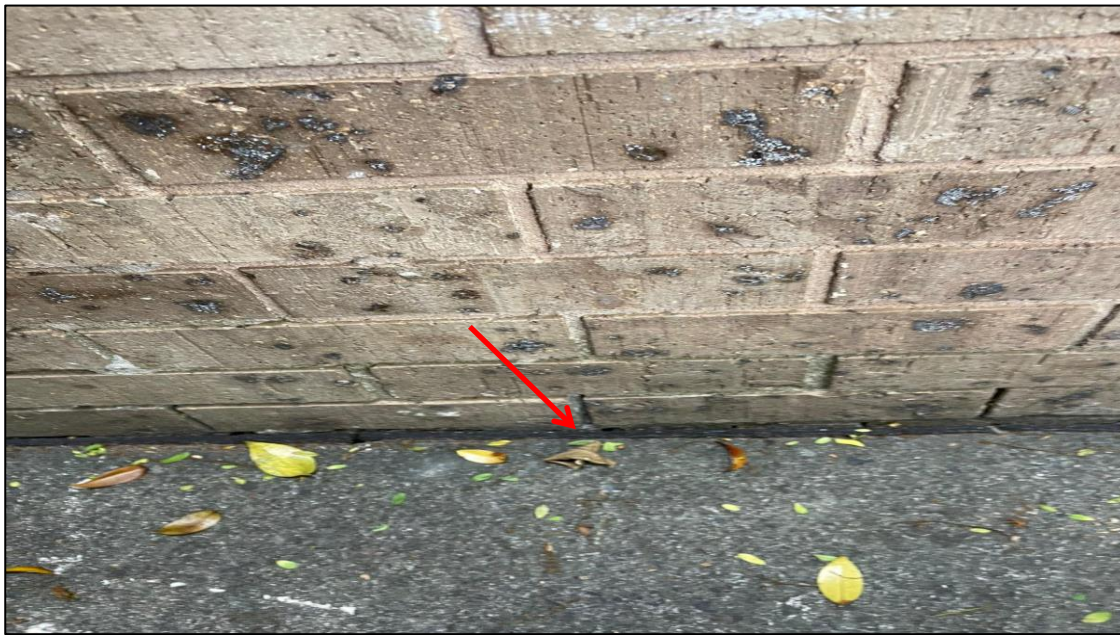
Photograph 10: 5 Help Street, exterior, joining between floor and wall, black bituminous material, no asbestos detected by analysis.

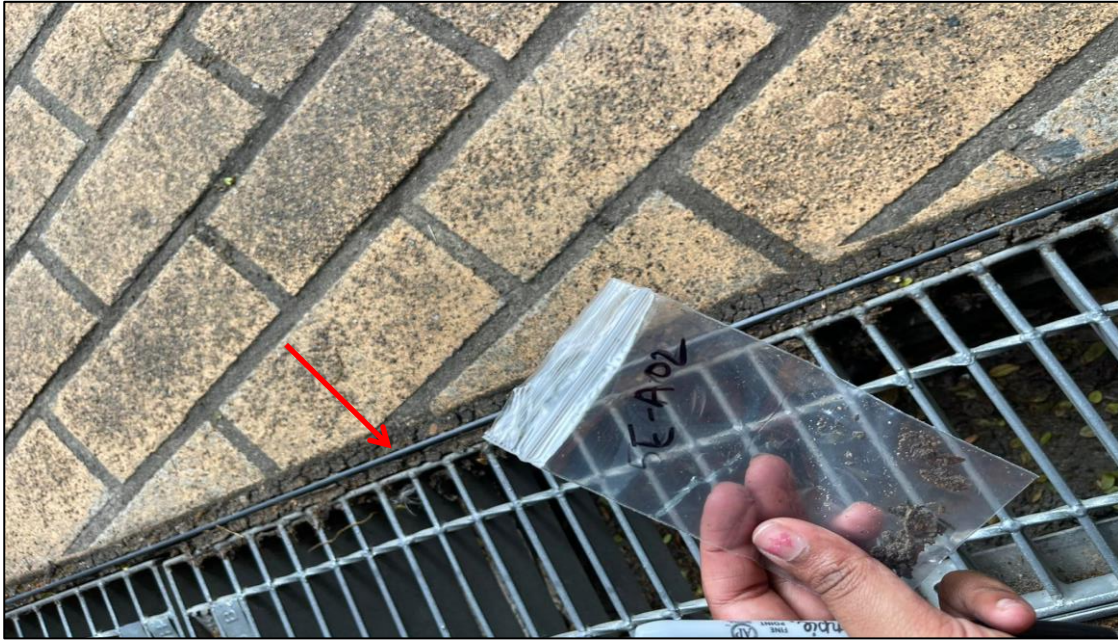
Photograph 11: 5 Help Street, exterior, stormwater drain lining, adhesive-like material, no asbestos detected by analysis.
