**Report on Hazardous Building Materials
(HAZMAT) Survey**

3-5 Help Street, Chatswood NSW

Prepared for Loftex Chatswood Pty Limited

Project 232749.00

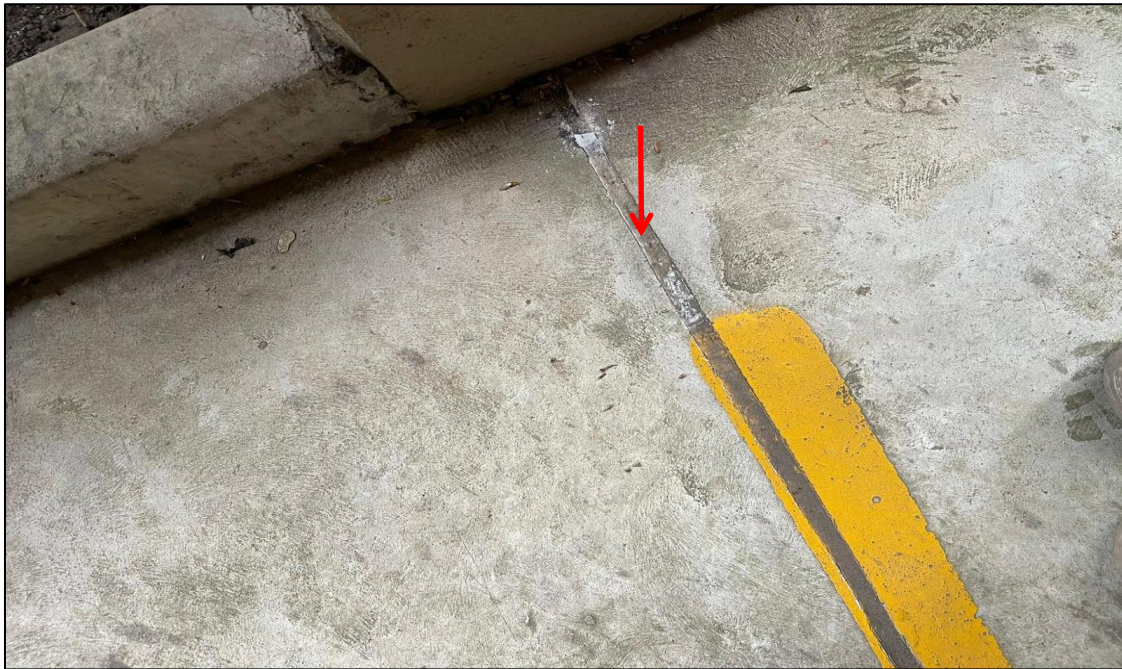
Photograph 12: 5 Help Street, exterior, car park area, joint in concrete, mastic, no asbestos detected by analysis.

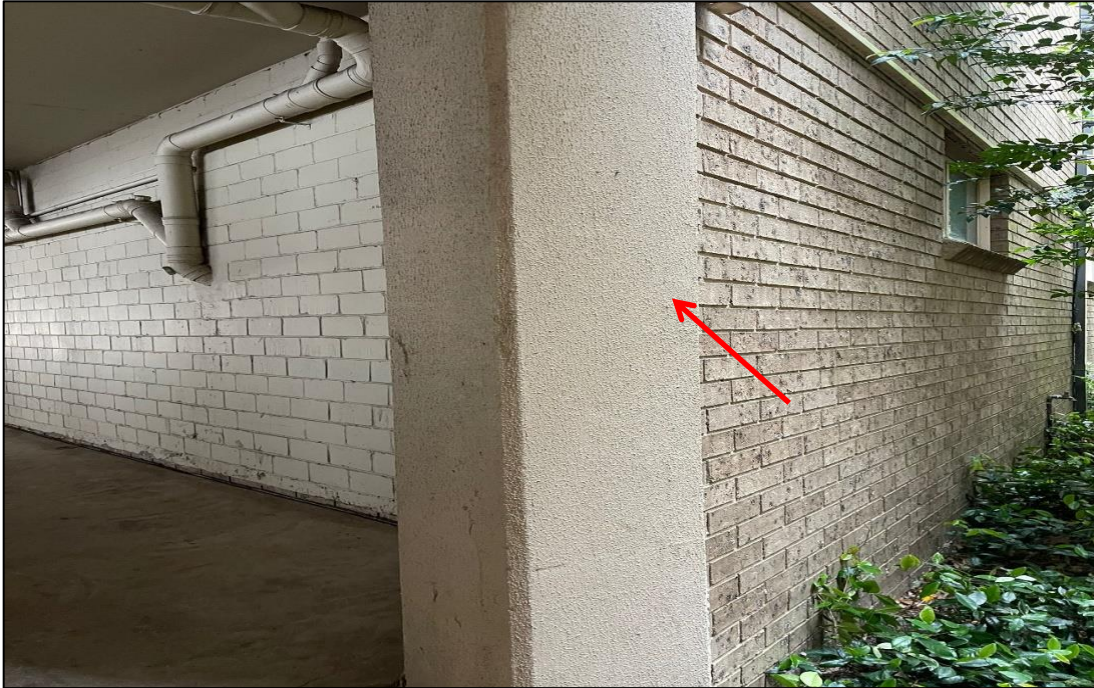
Photograph 13: 5 Help Street, exterior, car park area, column, textured coating, no asbestos detected by analysis.

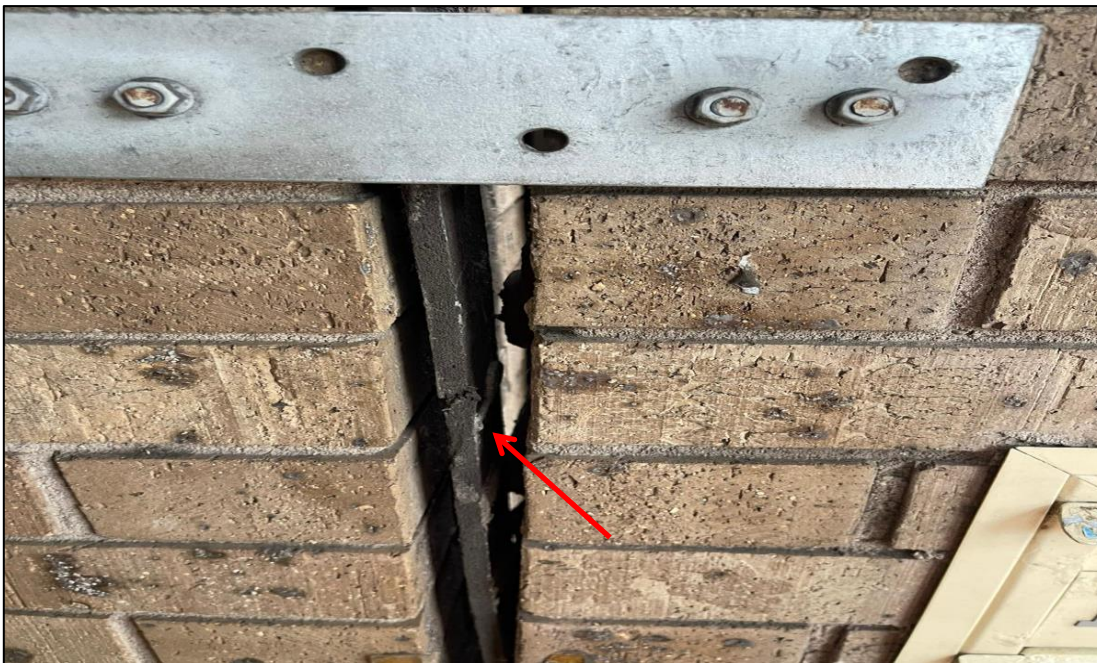
Photograph 14: 5 Help Street, exterior, southern entrance, wall, expansion gap, bituminous lining, no asbestos detected by analysis.

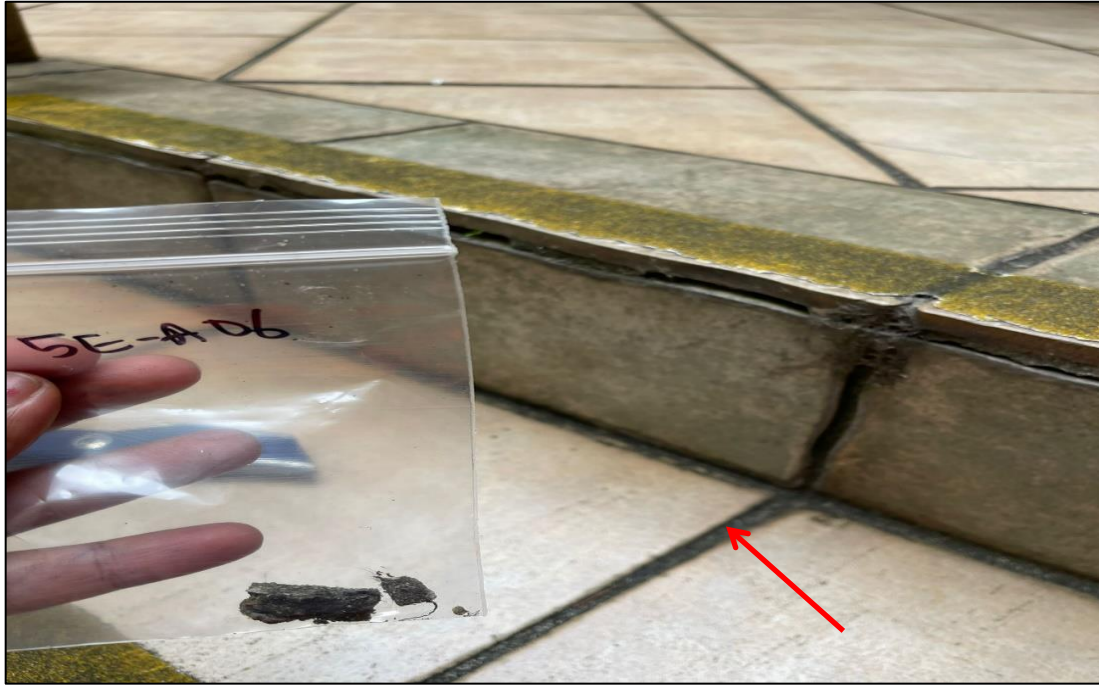
Photograph 15: 5 Help Street, exterior, level 1 staircase, stairs, joint, cement material, no asbestos detected by analysis.

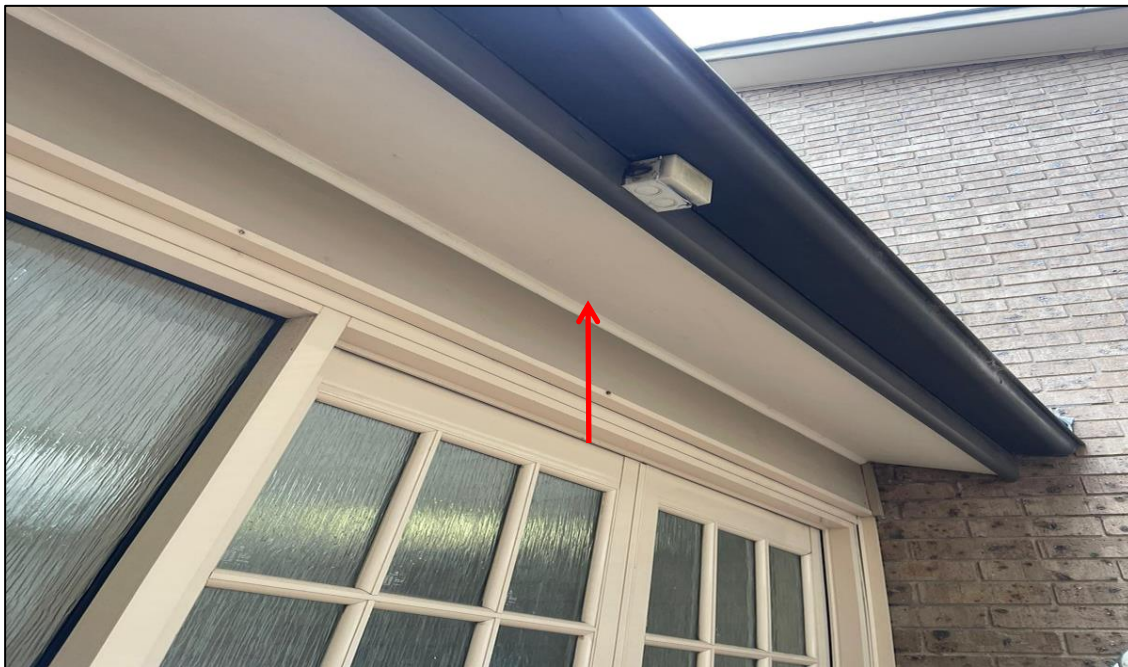
Photograph 16: 5 Help Street, exterior, level 1 staircase, eaves, fibre cement sheeting, no asbestos detected by analysis.

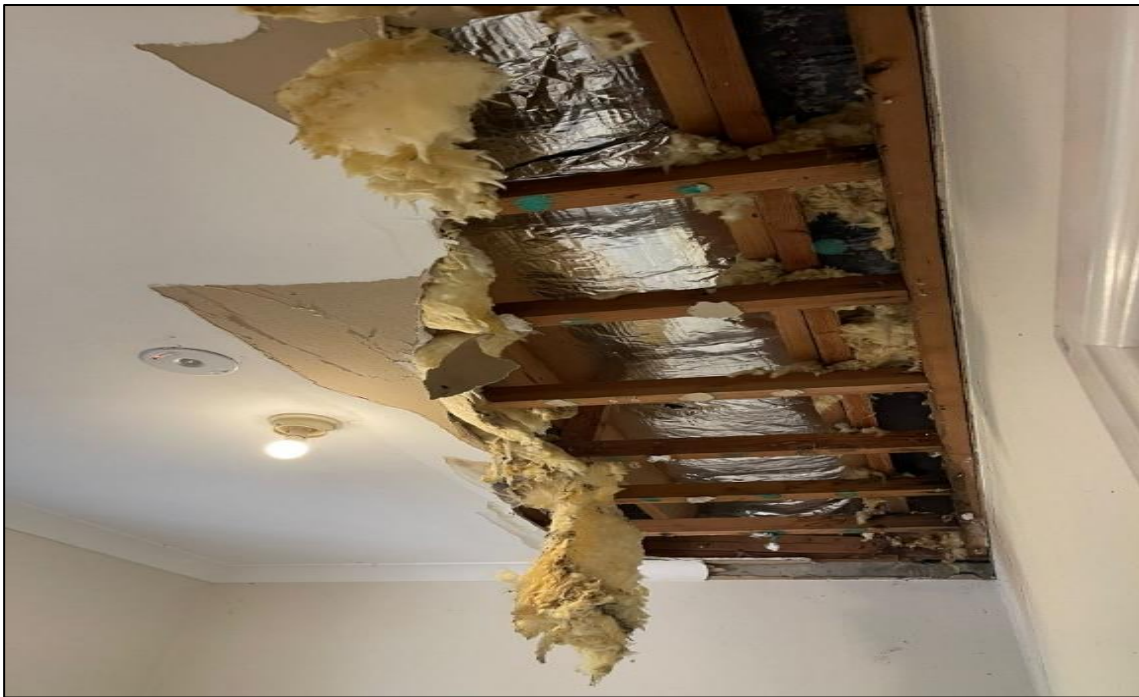
Photograph 17: 5 Help Street, Level 1, southern stairway, ceiling cavity insulation, no asbestos detected by analysis (SMF detected).

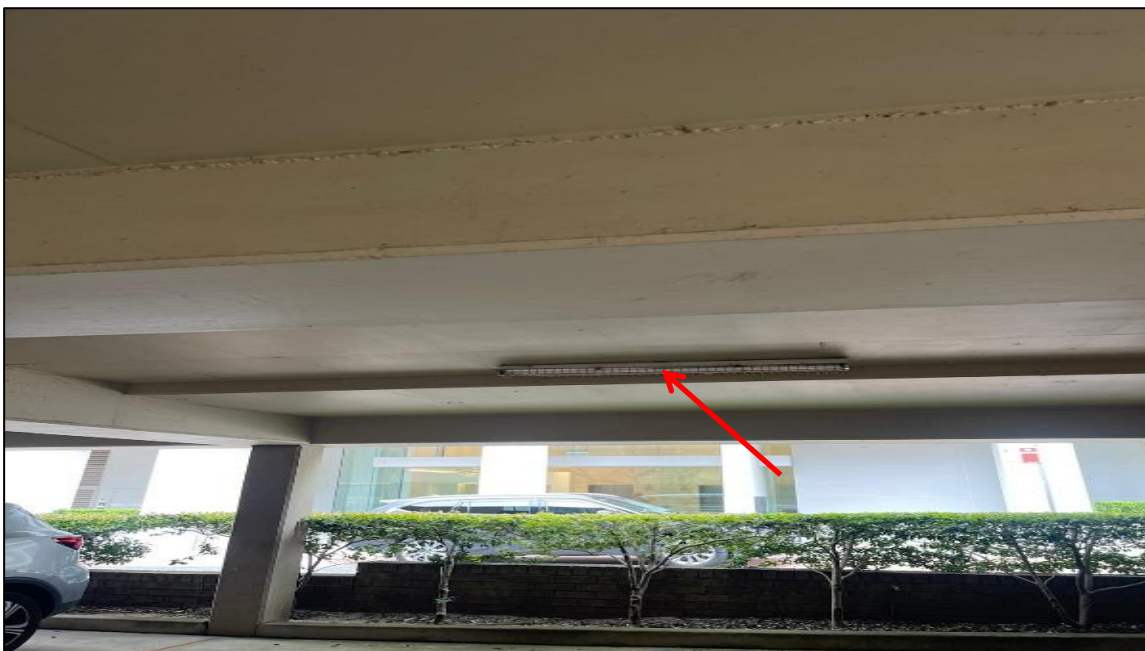
Photograph 18: 5 Help Street, exterior, car park area, ceiling, fluorescent light fittings, internal components (e.g., capacitors / ballasts), PCB (suspected).

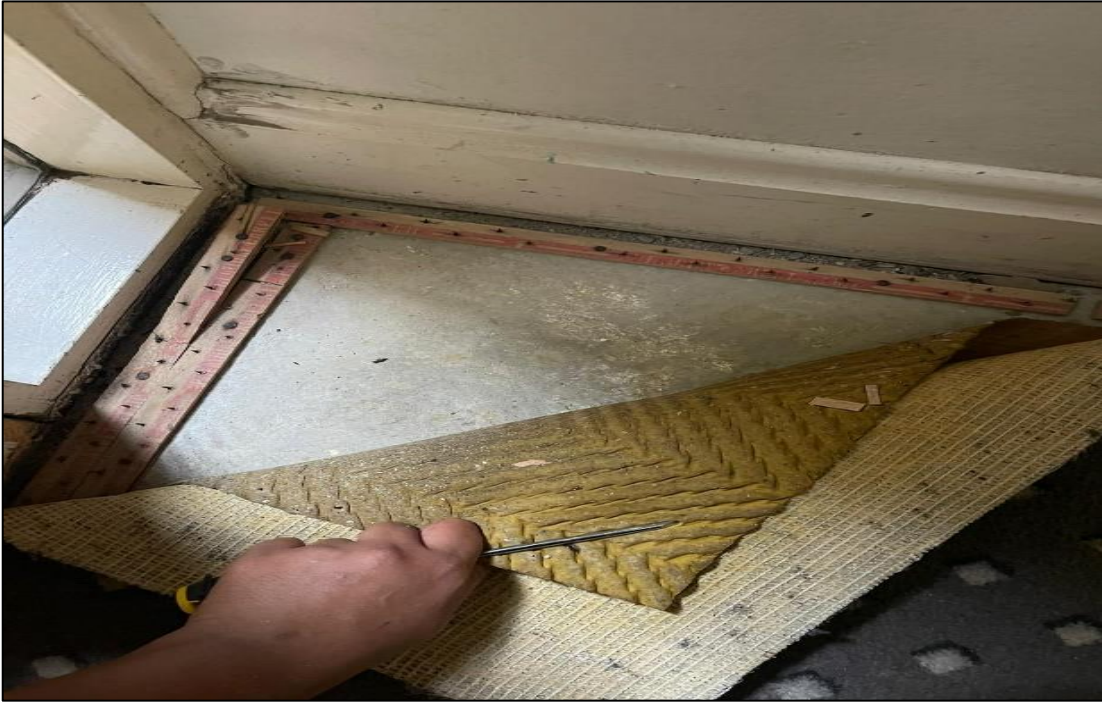
Photograph 19: 5 Help Street, stairwells / flooring generally, landings and stairs), floor, below carpet, concrete flooring, suspected non-asbestos.

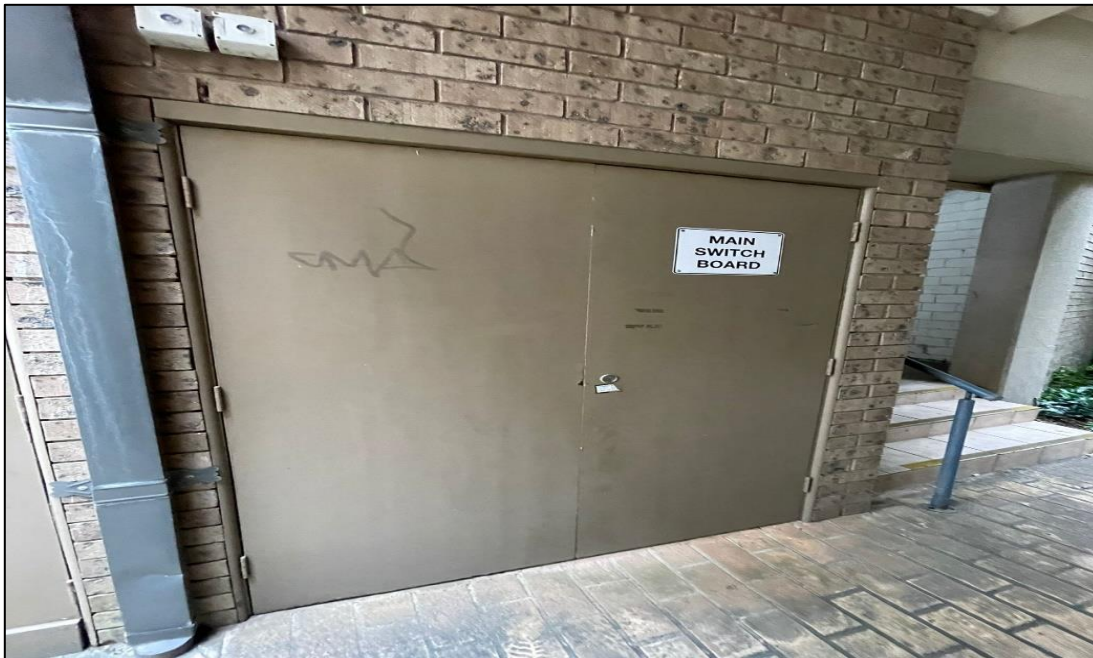
Photograph 20: 5 Help Street, main switch room, electrical cupboard, internal components, suspected asbestos.

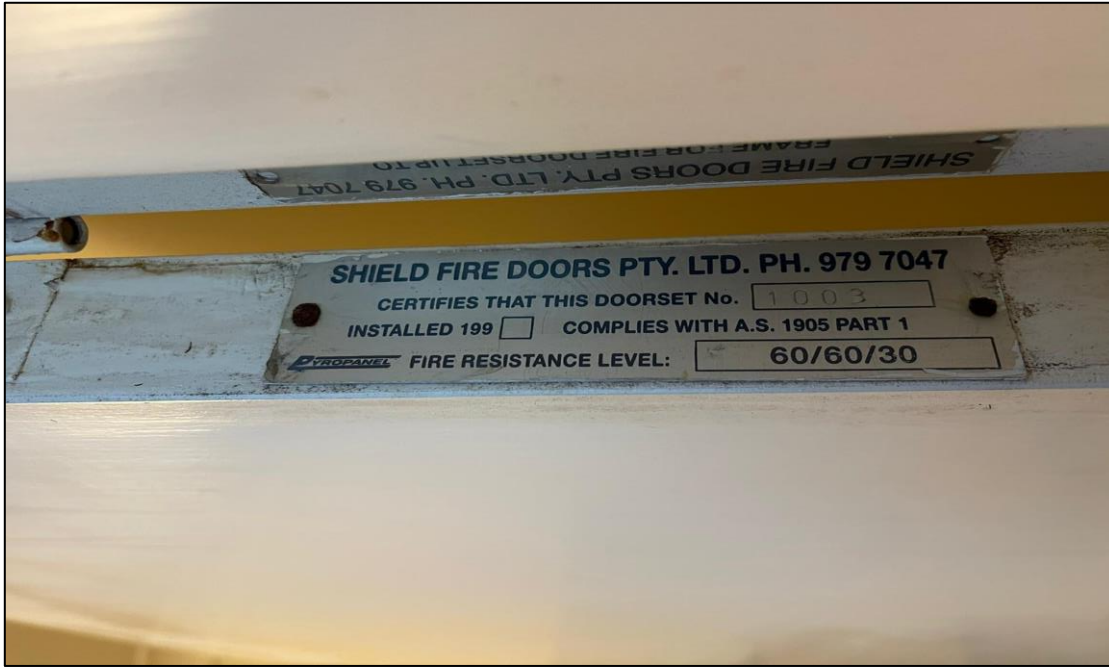
Photograph 21: 5 Help Street, generally, fire door (s), insulation, suspected asbestos.

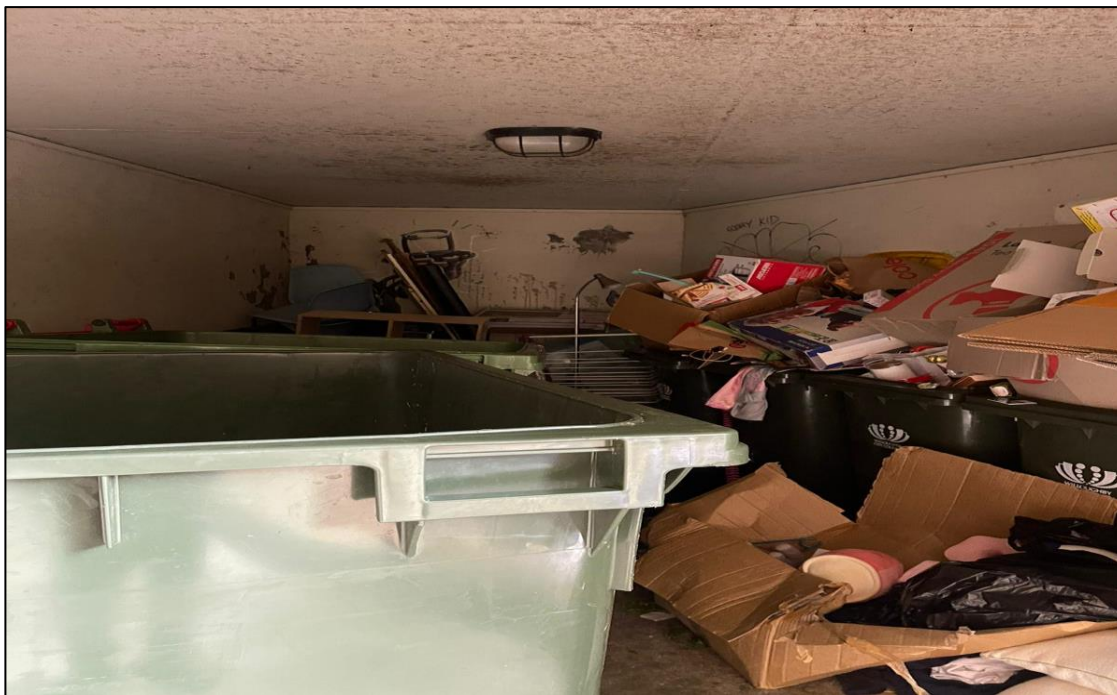
Photograph 22: 5 Help Street, garbage room, throughout, inaccessible.

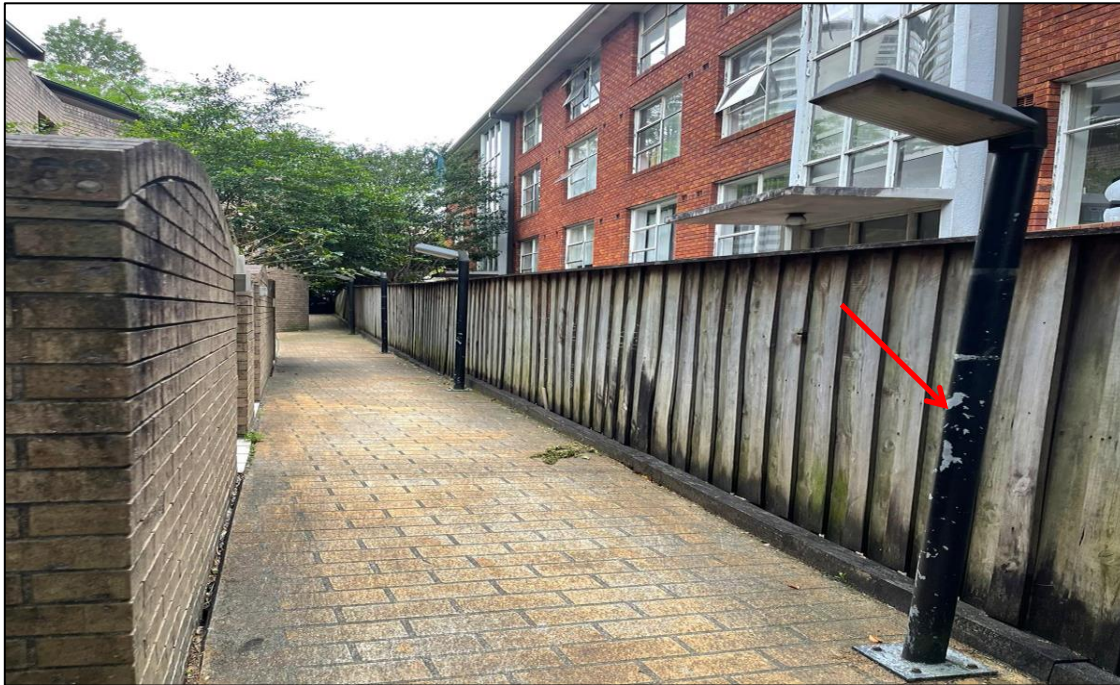
Photograph 23: 5 Help Street, exterior, eastern passageway, light post, black paint, lead paint detected by analysis.

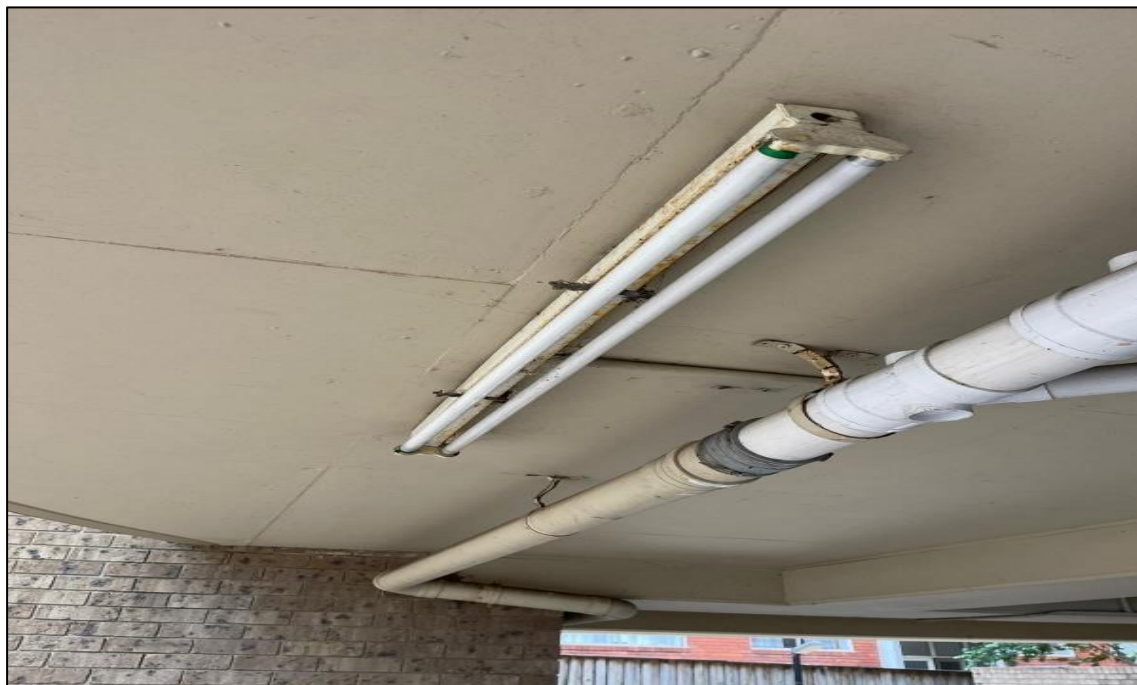
Photograph 24: 5 Help Street, exterior, car park area, ceiling, fluorescent light fittings, internal components (e.g., capacitors / ballasts), PCB (suspected).
