Walsh Bay Arts Precinct - Design Upgrade Risk Assessment

Prepared for

Infrastructure NSW

Compiled by: Wayne Middleton – Principal Consultant

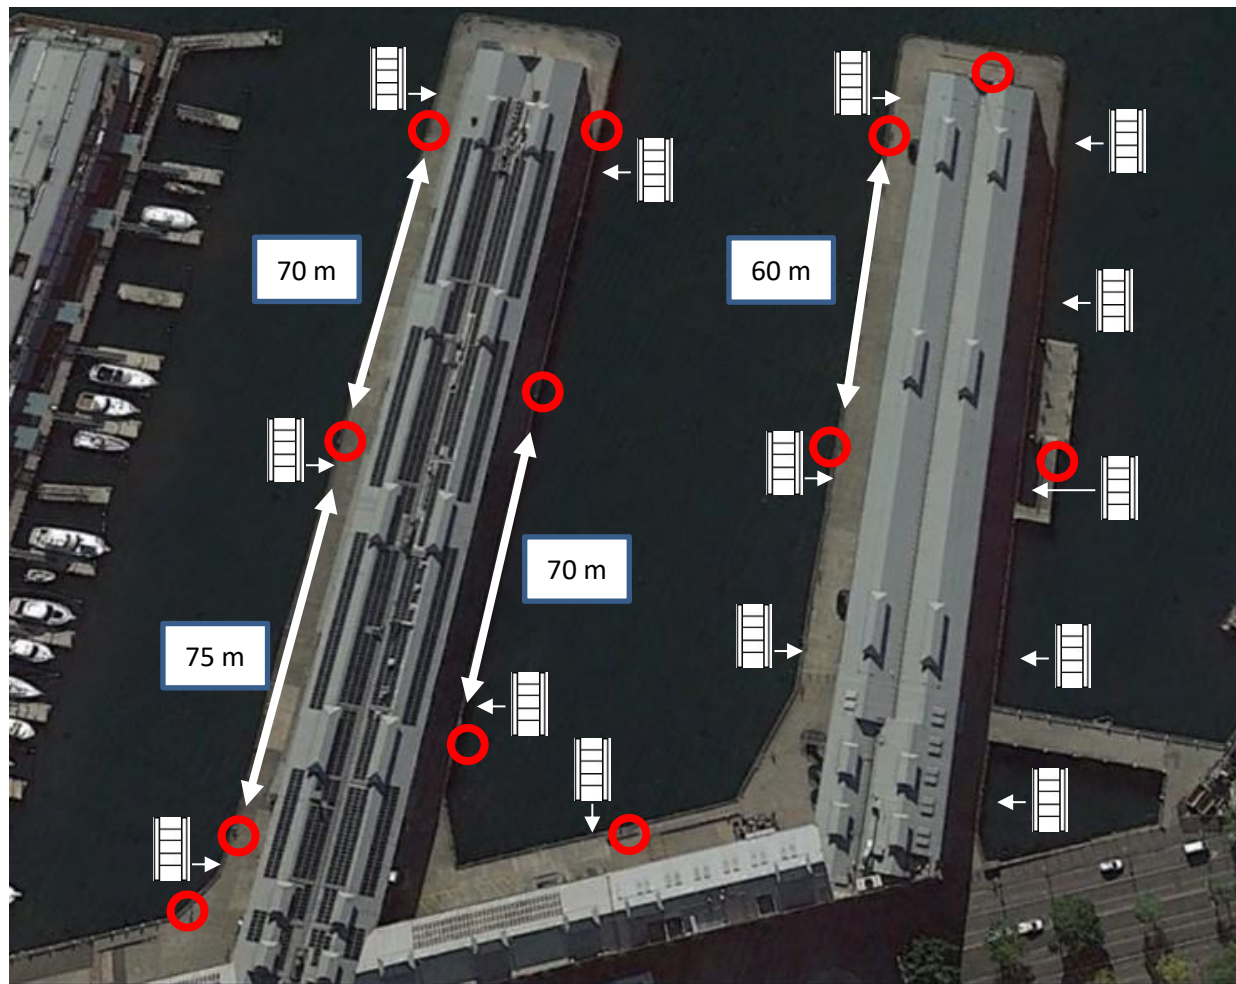
The following issues require urgent attention given the venue is currently operational with members of the public accessing these areas:

- Poorly maintained Life Buoys
- Irregular distances of Ladders

Distance between ladders is irregular and does not meet the recommended Standard as set out earlier in this report of 60m intervals or less.

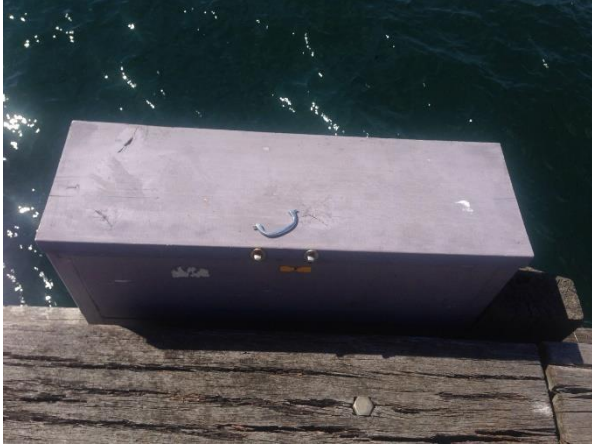
Figure 9 - Damaged Life Buoy Storage Unit at Walsh Bay

The storage boxes of the life buoys are in some cases damaged (e.g. broken handles) and litter has been stuck inside obstructing the buoys. The alarm system used to alert when the buoy is being accessed is inoperable in most units.

When considering a replacement unit, life buoys should be highly visible to anyone in the area. It was noted that the colouring of the life buoys in Walsh Bay of Sydney Harbour are inconsistent with other Harbour standards and most are stored in unobtrusive grey timber boxes. In neighbouring areas such as Barangaroo and Darling Harbour, highly visible, orange-coloured Life Buoys or bright-coloured rescue throw bags are used and located for quick use directly on pylons (see 9.4.1).

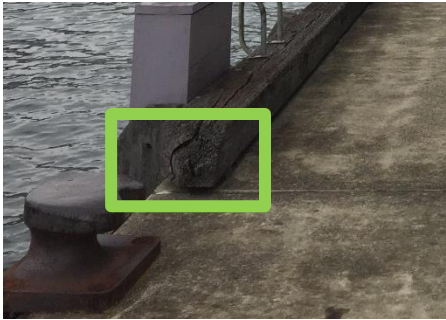
Figure 10 - Distance of Kerb in close Proximity to Pier Edge

The Non-Mountable Kerbs in their current state are outdated and should be replaced to avoid the risk of minor injuries from splintering. INSW has advised that this may create a potential Heritage issue with any restoration of these.

The Kerbs are also in some cases positioned too close to the water's edge so that people sitting on them do not have the required space to place their feet; when they stand up. This can increase the risk of a person standing a toppling forward into the water. There is no high visibility illumination marking the leading edge of Non-Mountable Kerbs which is inconsistent with Cockle Bay.
