# Hazardous Materials Survey

**RTL Co**

177-191 Victoria Rd, Marrickville NSW

**Report Title** Hazardous Materials Survey  
**Project Reference Number:** WEC201.HMS.002  
**Document Date:** 16 December 2024

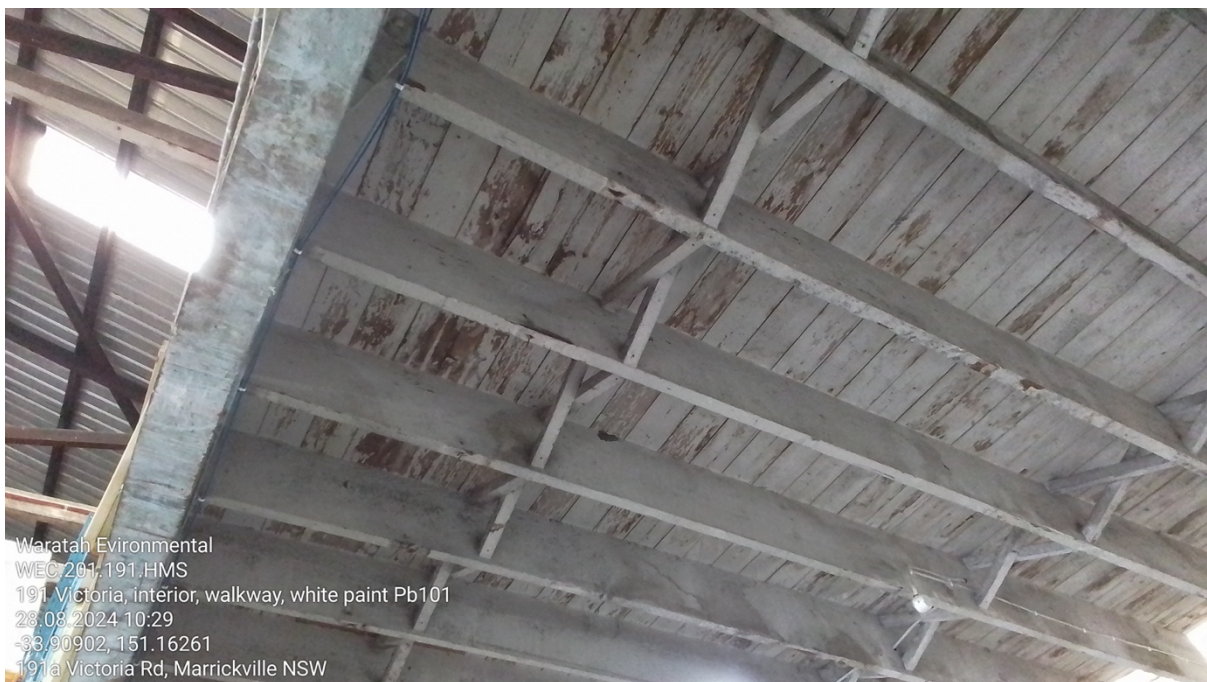
| Location Description | Material | Condition | Sample ID | Analytical Result | Estimated Quantity | Accessibility | Priority Rating | Recommendations | Photograph Register |
|---|---|---|---|---|---|---|---|---|---|
| Warehouse interior, underside of walkway, surface of wood. | White paint system | Poor | Visual assessment | Presumed to contain Pb | 150m <sup>2</sup> | Maintenance only | Priority 3 – Low risk in present condition | Avoid abrasive activities in vicinity of material during demolition. | Photograph 2 |

**Photograph 2:**  
191 Victoria, interior, underside of walkway, white paint system (28/08/24)

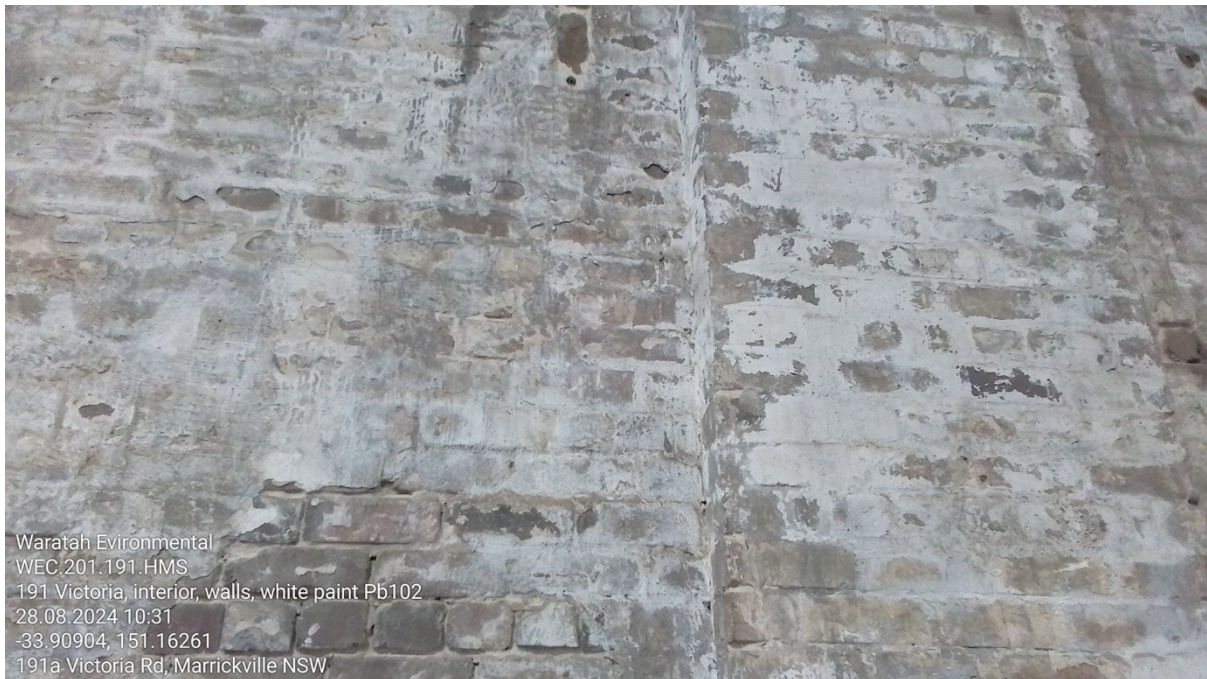
**Photograph 3:**

191 Victoria, interior, walls, white paint system, Pb102 (28/08/24)

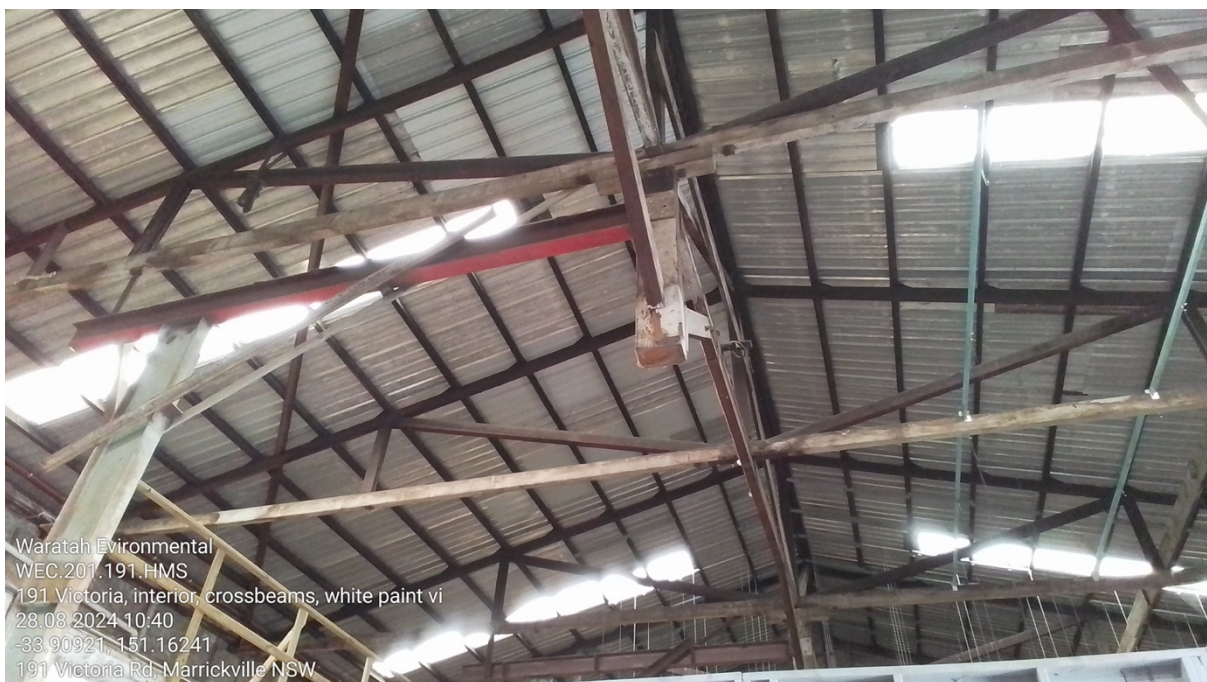
**Photograph 4:**

| Location Description | Material | Condition | Sample ID | Analytical Result | Estimated Quantity | Accessibility | Priority Rating | Recommendations | Photograph Register |
|---|---|---|---|---|---|---|---|---|---|
| Warehouse interior, rafters, surface of crossbeams | White paint system | Poor | Visual assessment | Presumed to contain Pb | 100m <sup>2</sup> | Maintenance only | Priority 3 – Low risk in present condition | Avoid abrasive activities in vicinity of material during demolition. | Photograph 4 |

191 Victoria, interior, rafters, surface of crossbeams, white paint system (28/08/24)

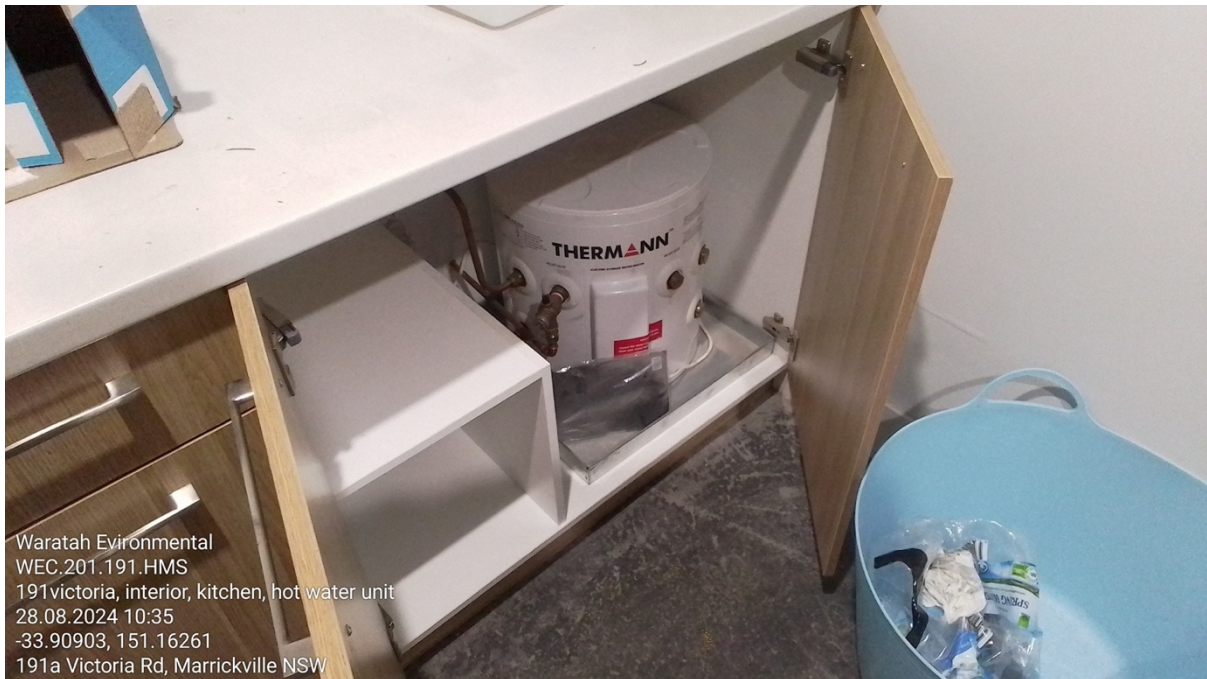
**Photograph 5:**

| Location Description | Material | Condition | Sample ID | Analytical Result | Estimated Quantity | Accessibility | Priority Rating | Recommendations | Photograph Register |
|---|---|---|---|---|---|---|---|---|---|
| Warehouse interior, south kitchenet, hot water system | SMF lining | Good | Visual assessment | Presumed to contain SMF | 1 unit | Maintenance only | Priority 4 – Negligible risk in present condition | Remove during demolition | Photograph 5 |

191 Victoria, interior, kitchenet, hot water system (28/08/24)

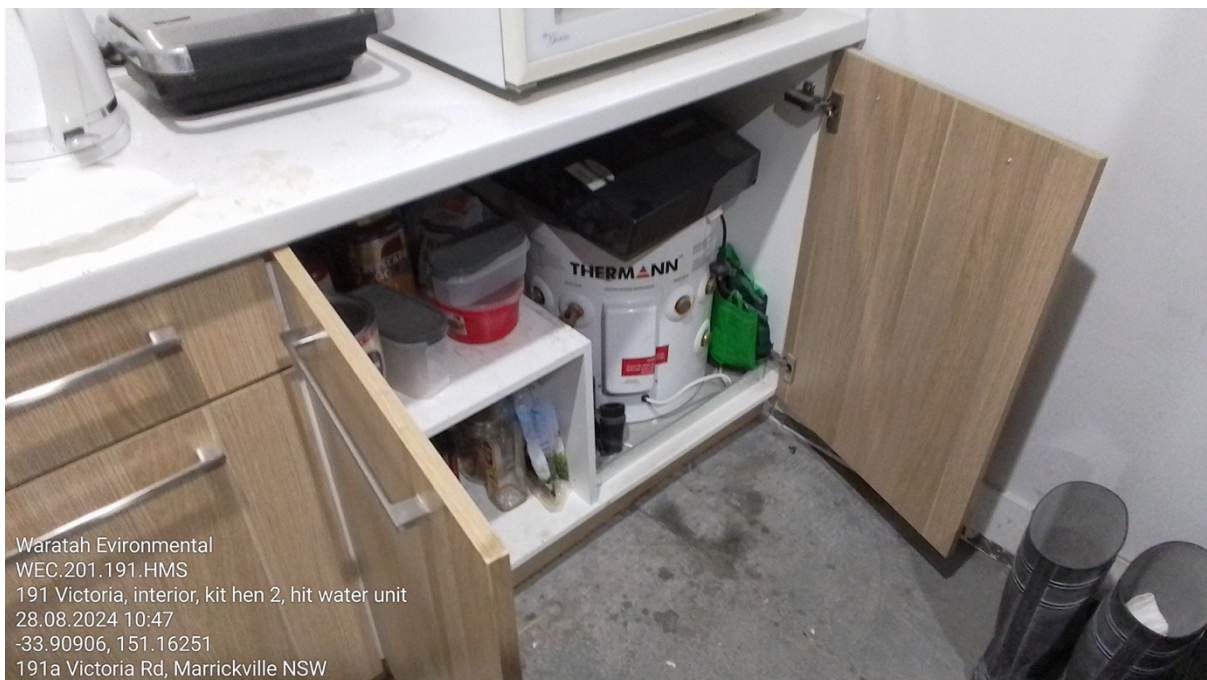
**Photograph 6:**

| Location Description | Material | Condition | Sample ID | Analytical Result | Estimated Quantity | Accessibility | Priority Rating | Recommendations | Photograph Register |
|---|---|---|---|---|---|---|---|---|---|
| Warehouse interior, north kitchenet, hot water system | SMF lining | Good | Visual assessment | Presumed to contain SMF | 1 unit | Maintenance only | Priority 4 – Negligible risk in present condition | Remove during demolition | Photograph 6 |

191 Victoria, interior, 2<sup>nd</sup> kitchenet, hot water system (28/08/24)

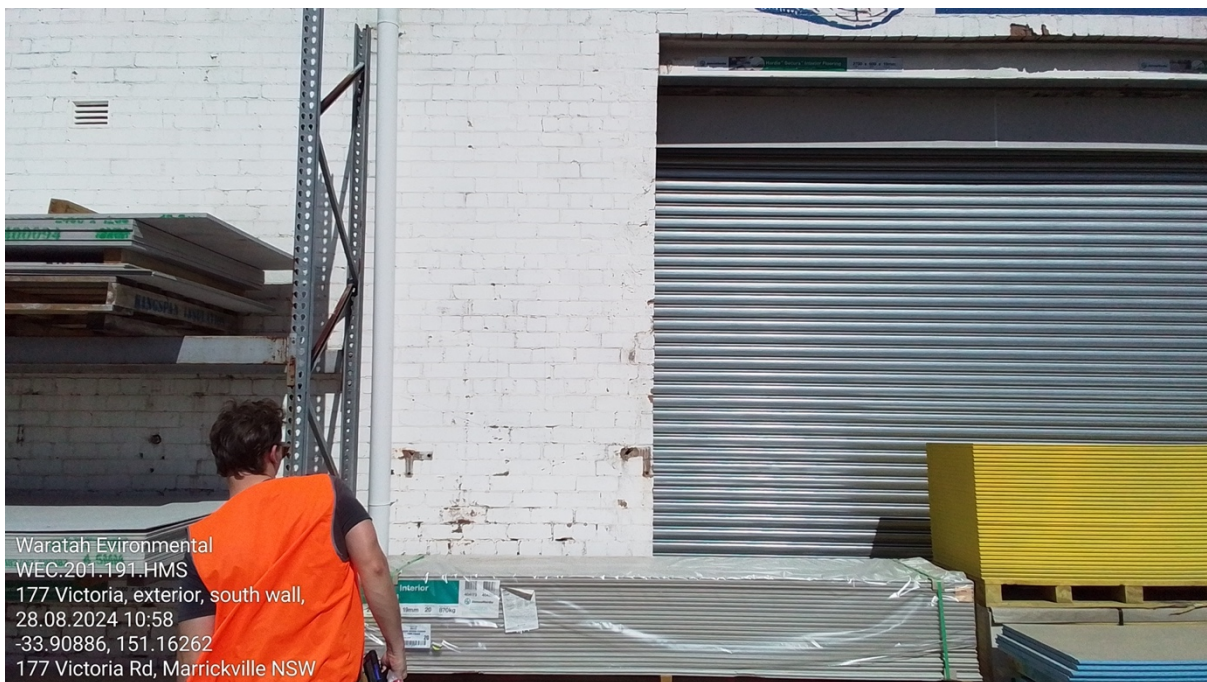
**Photograph 8:**  
177 Victoria, exterior, south wall, white paint system (28/08/24)

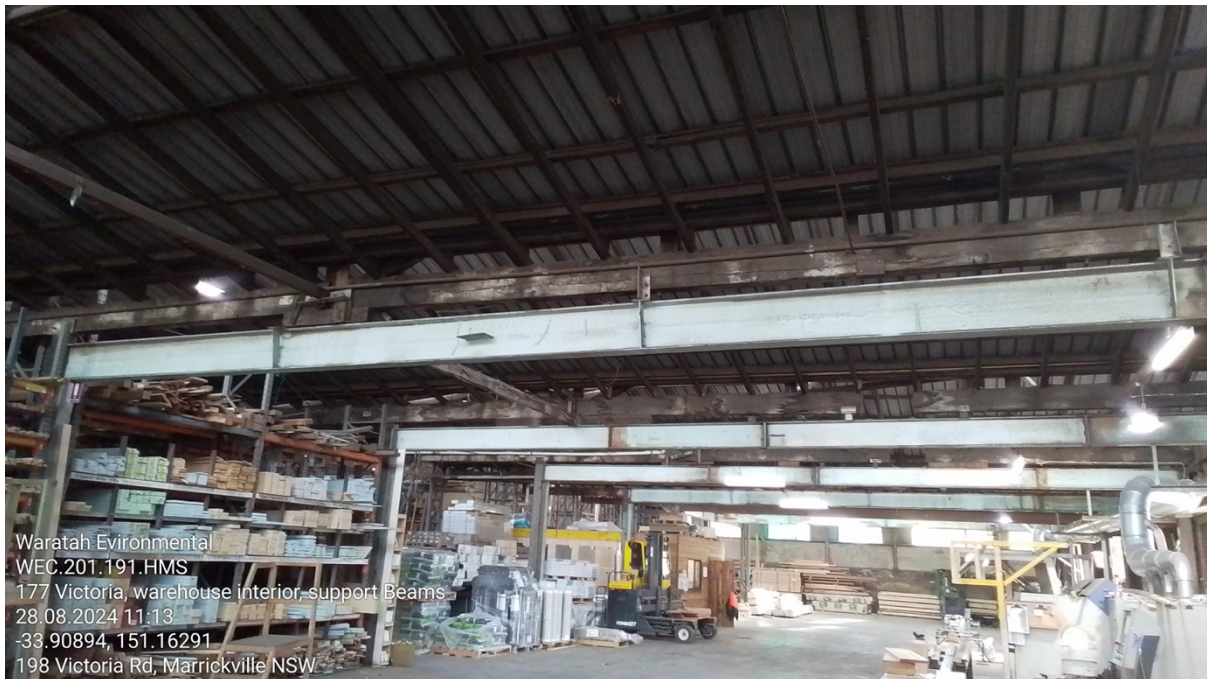
**Photograph 9:**

177 Victoria, warehouse interior, steel crossbeam, teal paint system (28/08/24)

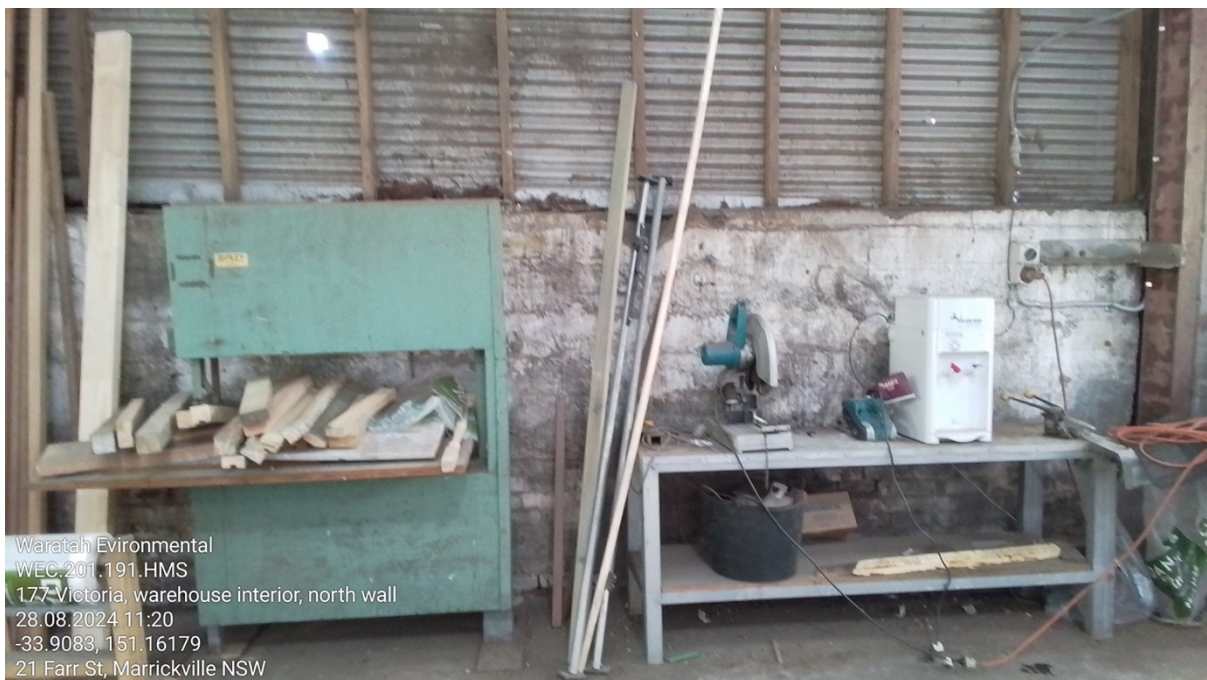
**Photograph 10:**

177 Victoria, warehouse interior, north wall, white paint system (28/08/24)

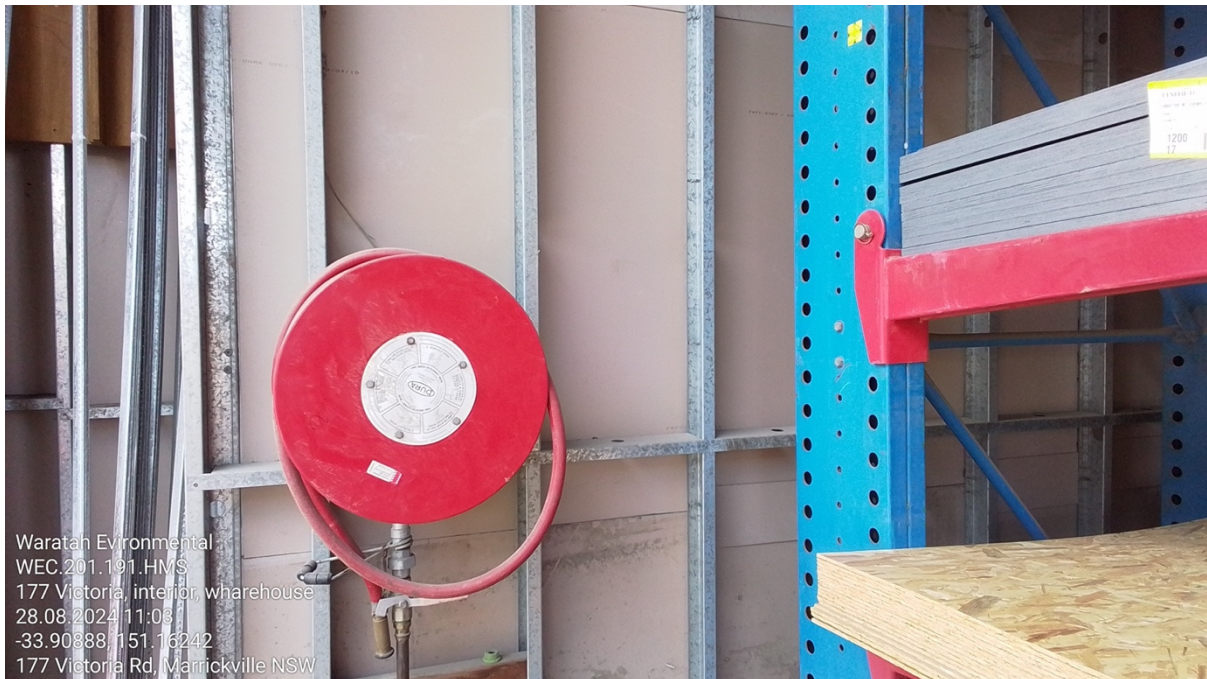
**Photograph 11:**

177 Victoria, warehouse interior, south wall, cement sheet (28/08/24)

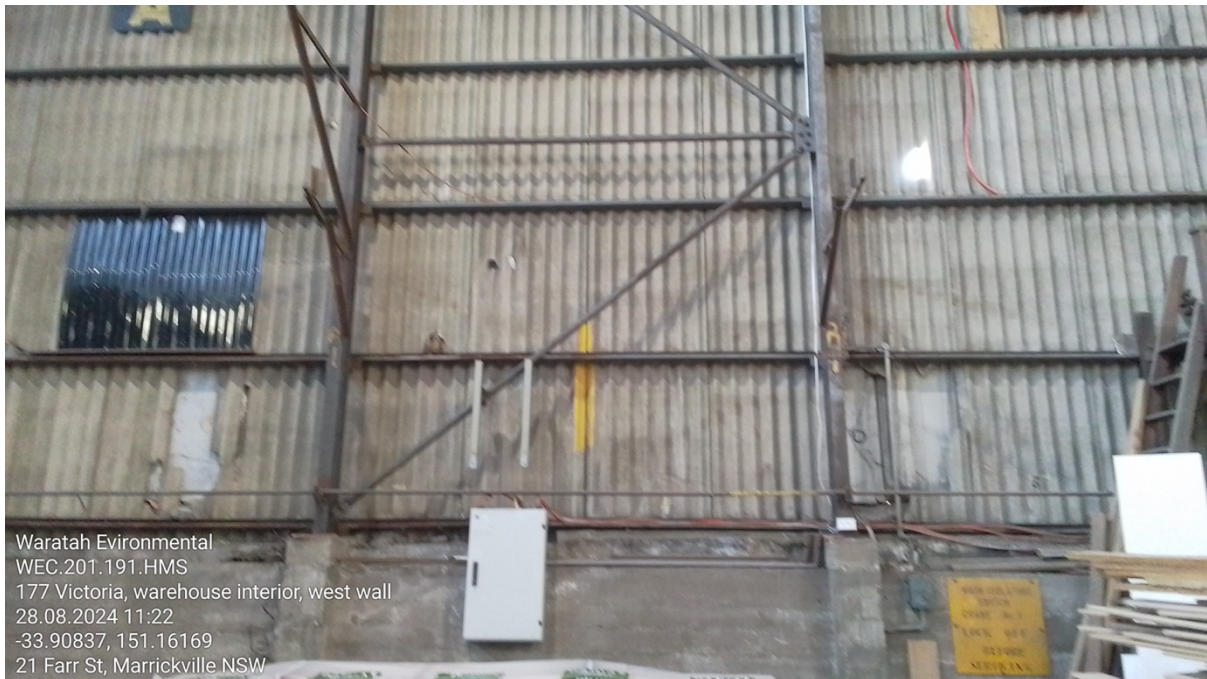
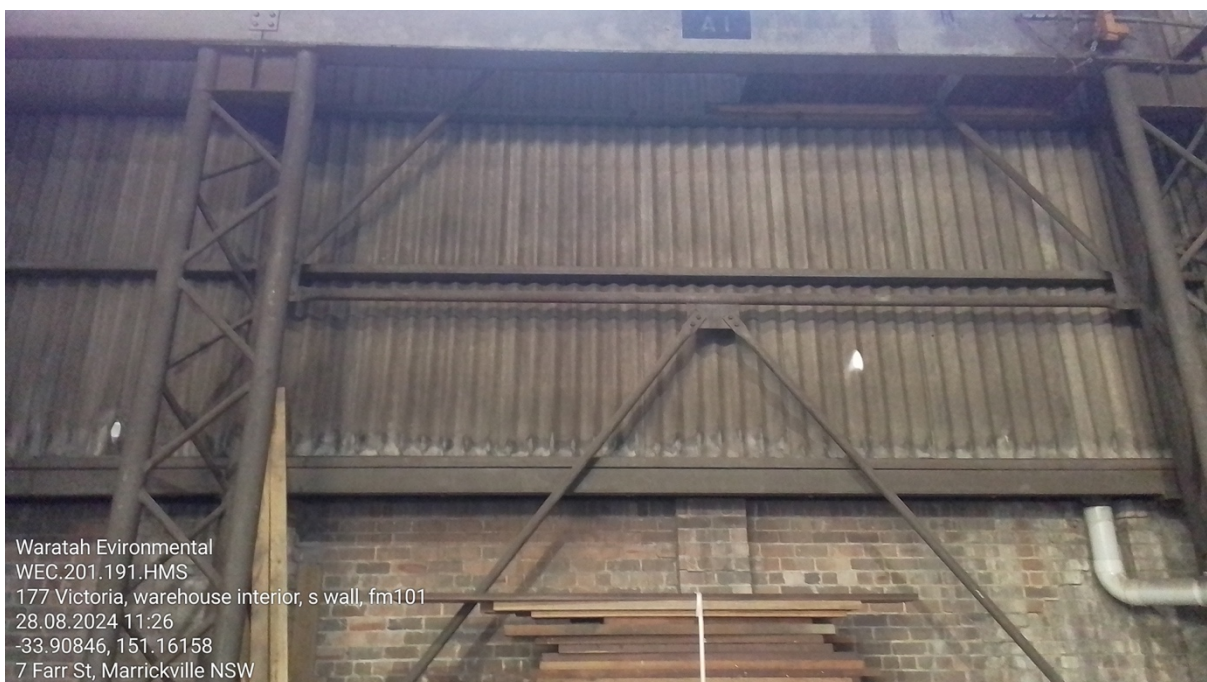
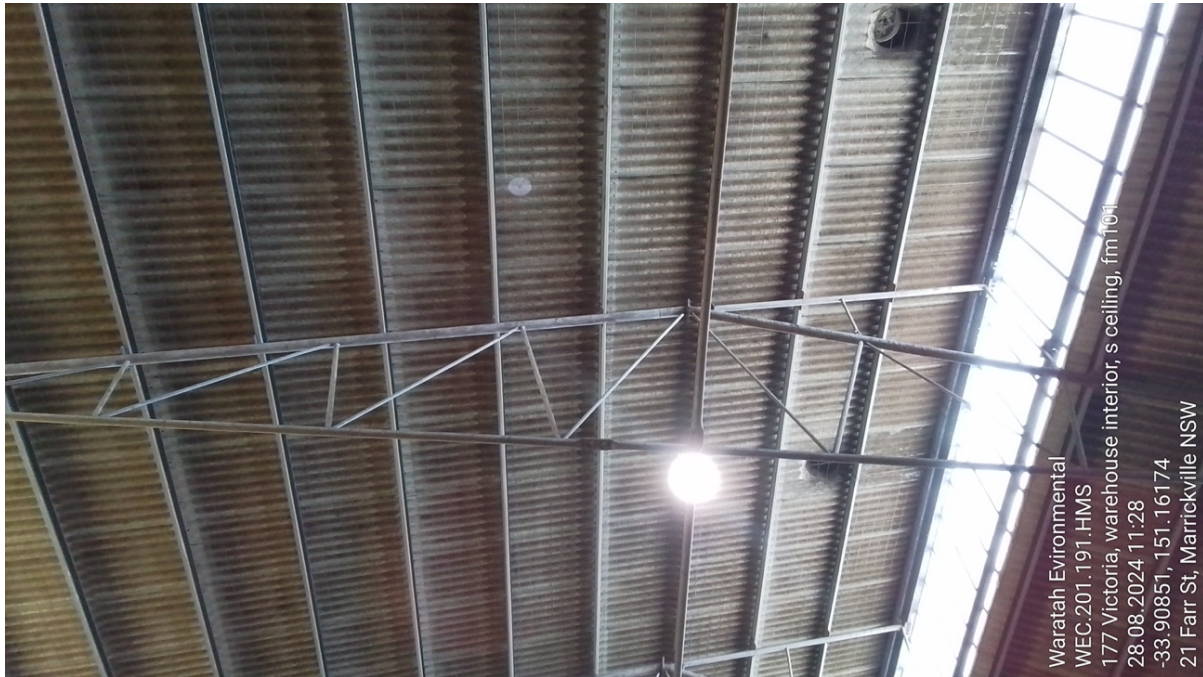
| Location Description | Material | Condition | Sample ID | Analytical Result | Estimated Quantity | Accessibility | Priority Rating | Recommendations | Photograph Register |
|---|---|---|---|---|---|---|---|---|---|
| Warehouse interior, west wall, south wall and ceiling | Corrugated fibre cement | Fair | Fm101 | Asbestos detected | 300m <sup>2</sup> | Maintenance only | Priority 3 – Low risk in present condition | Remove prior to demolition | Photograph 13, Photograph 14, Photograph 15 |

177 Victoria, warehouse interior, west wall, corrugated fibre cement (28/08/24)

177 Victoria, warehouse interior, south wall, corrugated fibre cement (28/08/24)

177 Victoria, warehouse interior, south ceiling, corrugated fibre cement (28/08/24)

It is recommended that all ACM removal be conducted in accordance with a site-specific asbestos management plan (AMP) and subsequent asbestos removal control plan.

The AMP should detail the condition, quantity and location of any ACM designated for removal; all safety control measures required for the duration of ACM removal; any requirement for ongoing monitoring including but not limited to airborne asbestos monitoring (AAMs); and any additional site clearance requirements.

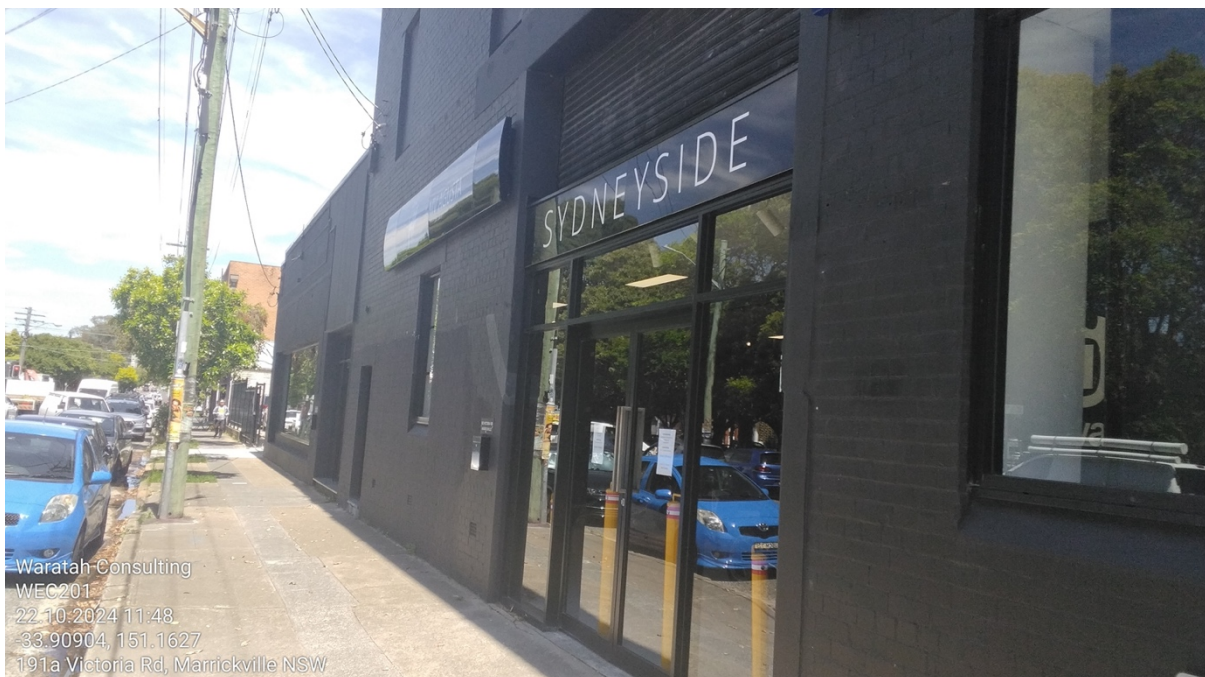
**Photograph 16:**

183 Victoria, exterior, southeast façade, black paint system (22.10.24)

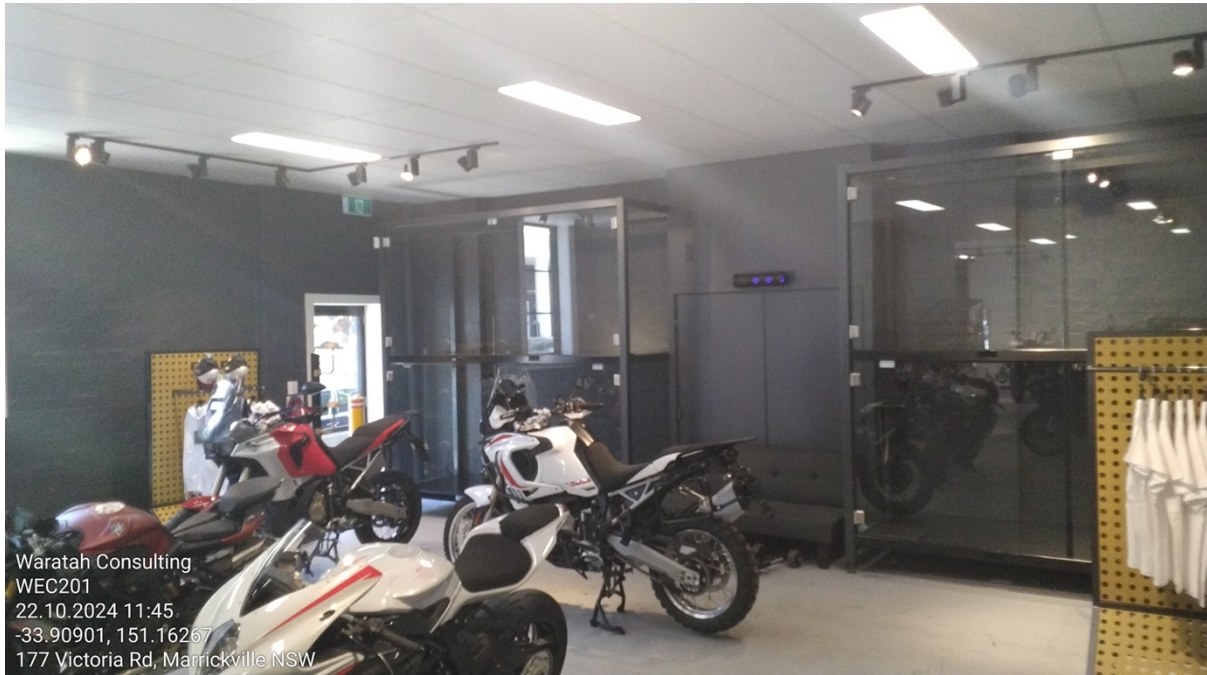
**Photograph 17:**

183 Victoria, commercial interior, main showroom, walls, blue paint system (22.10.24)

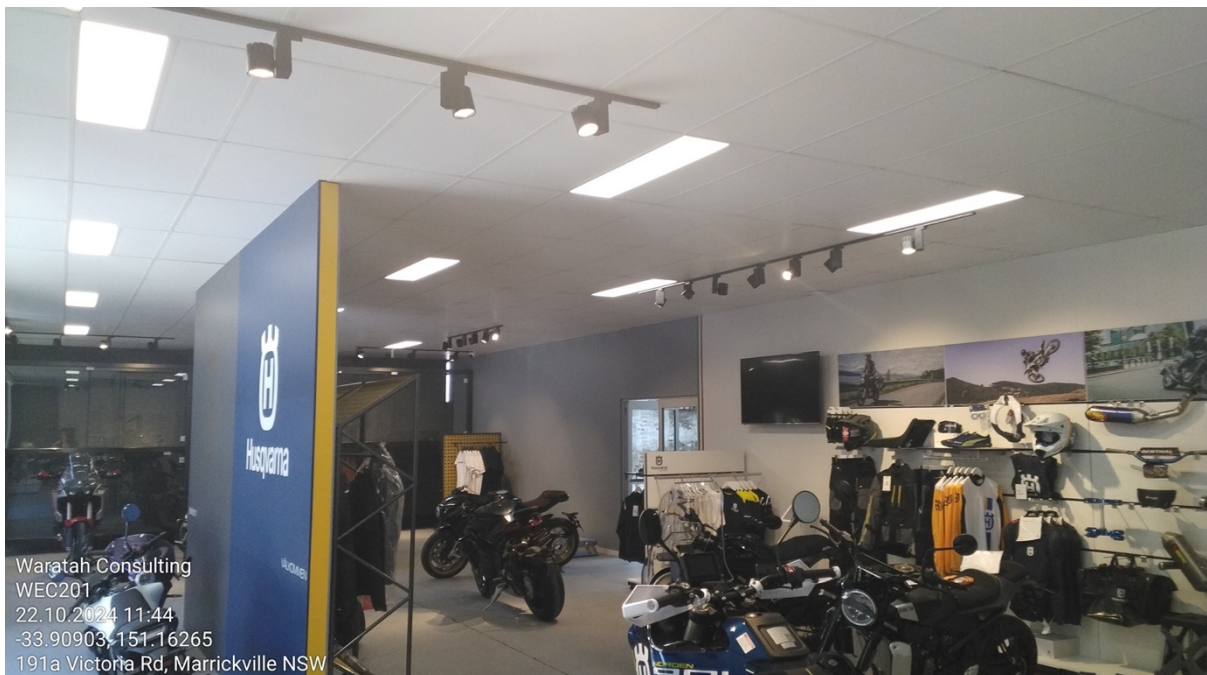
**Photograph 18:**

| Location Description | Material | Condition | Sample ID | Analytical Result | Estimated Quantity | Accessibility | Priority Rating | Recommendations | Photograph Register |
|---|---|---|---|---|---|---|---|---|---|
| Commercial Interior, main showroom, ceiling, throughout | Fluorescent light capacitors | Good | Visual assessment | Presumed to contain PCBs | 14 units | Maintenance only | Priority 4 – Negligible risk in present condition | Remove during demolition | Photograph 18, Photograph 20 |

183 Victoria, commercial interior, main showroom, ceiling, fluorescent light capacitors (22.10.24)

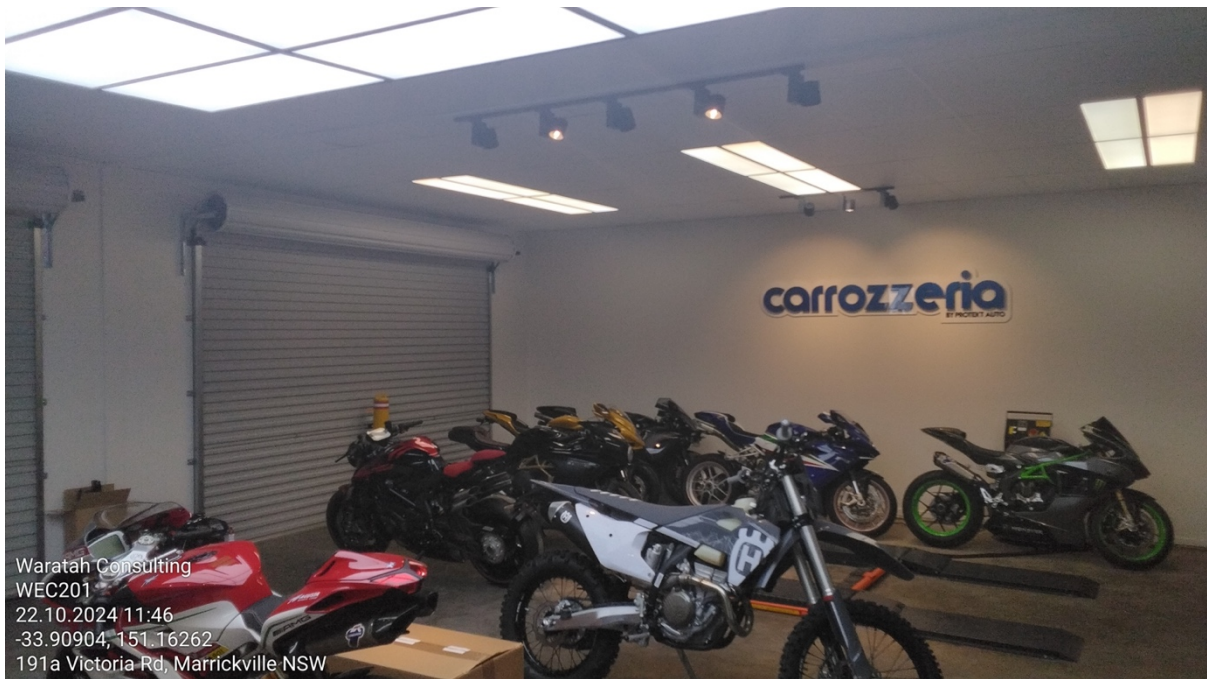
**Photograph 19:**

183 Victoria, commercial interior, rear stock room, walls, white paint system (22.10.24)

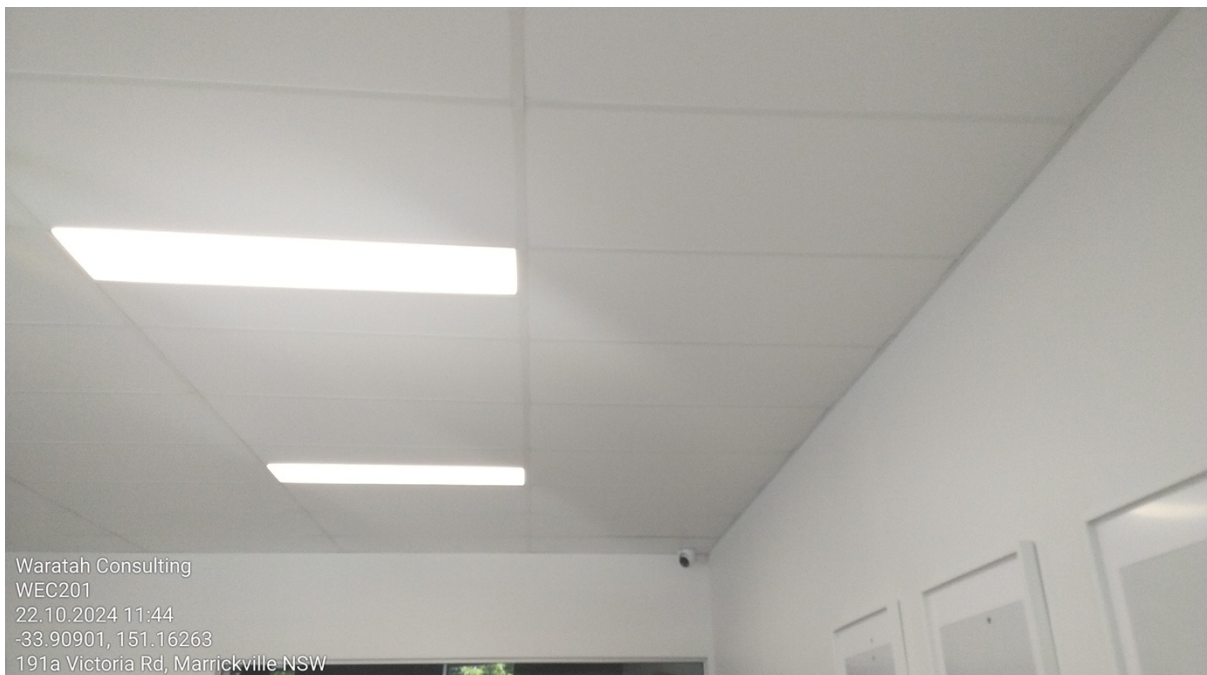
**Photograph 20:**

183 Victoria, commercial interior, main showroom, ceiling, white paint system (22.10.24)
