# Hazardous Materials Survey

**RTL Co**

2-12 Mitchell Street, Marrickville NSW

**Report Title** Hazardous Materials Survey  
**Project Reference Number:** WEC201.HMS.001\_v1.1  
**Document Date:** 16 December 2024

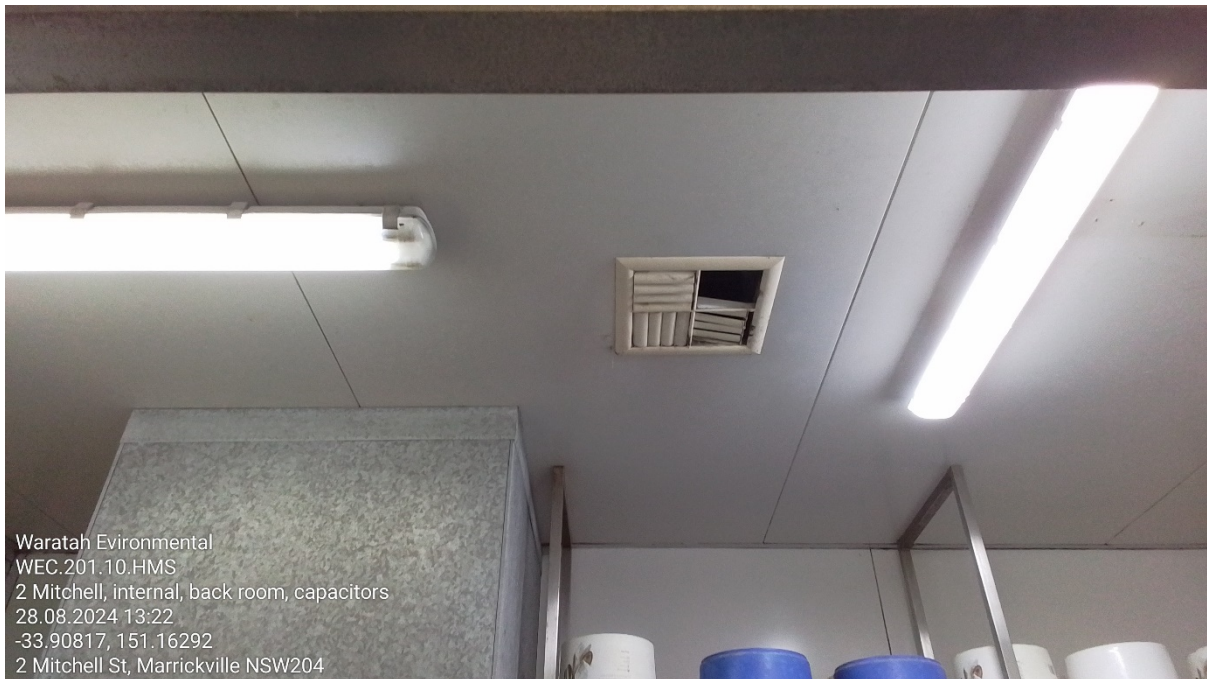
**Photograph 3:**

| Location Description | Material | Condition | Sample ID | Analytical Result | Estimated Quantity | Accessibility | Priority Rating | Recommendations | Photograph Register |
|---|---|---|---|---|---|---|---|---|---|
| Interior, backroom, ceiling | Fluorescent light capacitors | Good | Visual assessment | Presumed to contain PCB | 13 units | Maintenance only | Priority 4 – Low risk in present condition | Remove during demolition | Photograph 3 |

2 Mitchell, interior, backroom, ceiling, fluorescent light fixtures (28/08/24)

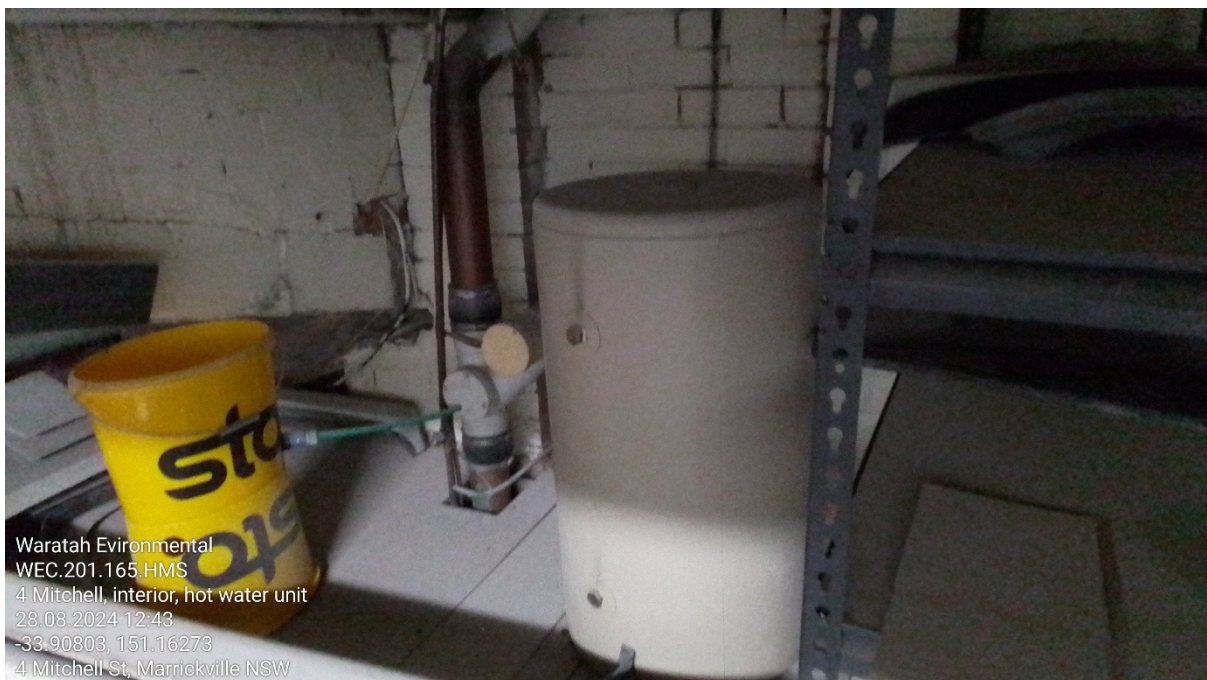
**Photograph 8:**

| Location Description | Material | Condition | Sample ID | Analytical Result | Estimated Quantity | Accessibility | Priority Rating | Recommendations | Photograph Register |
|---|---|---|---|---|---|---|---|---|---|
| Interior, level 1, north storage crevice, hot water unit | SMF lining | Good | Visual assessment | Presumed to contain SMF | 1 unit | Maintenance only | Priority 4 – Low risk in present condition | Remove during demolition | Photograph 8 |

4 Mitchell, interior, level 1, north storage crevice, hot water unit (28/08/24)

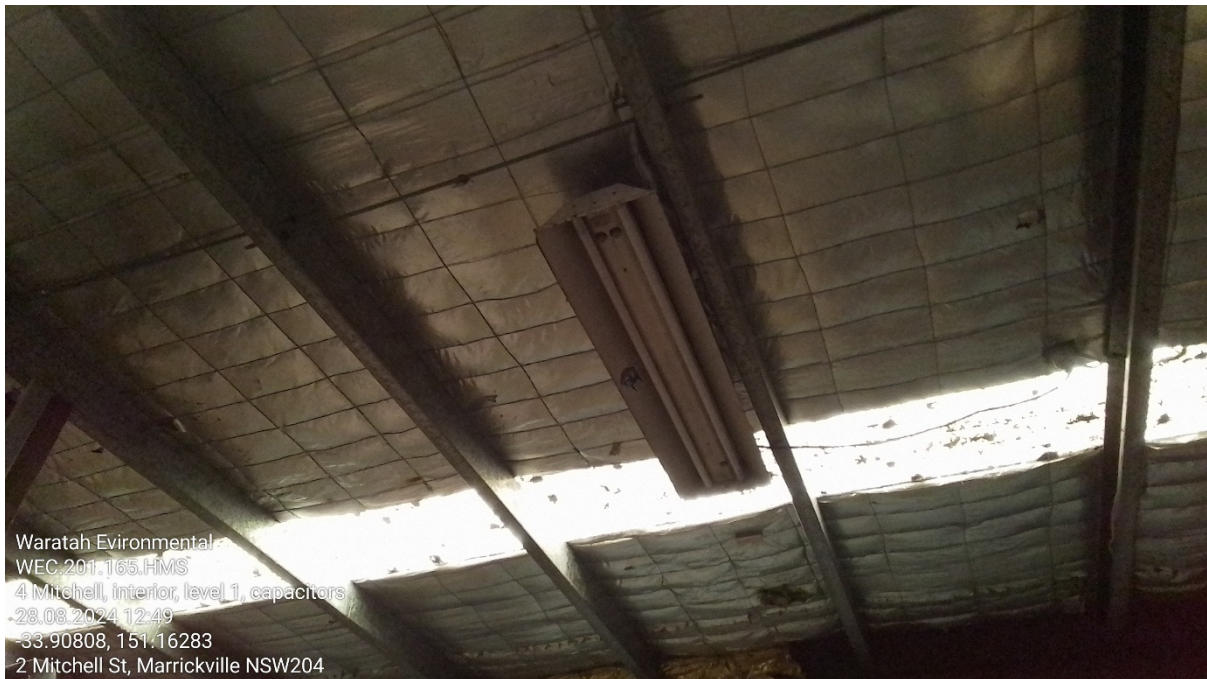
**Photograph 9:**

| Location Description | Material | Condition | Sample ID | Analytical Result | Estimated Quantity | Accessibility | Priority Rating | Recommendations | Photograph Register |
|---|---|---|---|---|---|---|---|---|---|
| Interior, level 1, ceiling | Fluorescent light capacitors | Fair | Visual assessment | Presumed to contain PCB | 3 units | Maintenance only | Priority 4 – Low risk in present condition | Remove during demolition | Photograph 9 |

4 Mitchell, interior, level 1, ceiling, fluorescent light fixtures (28/08/24)

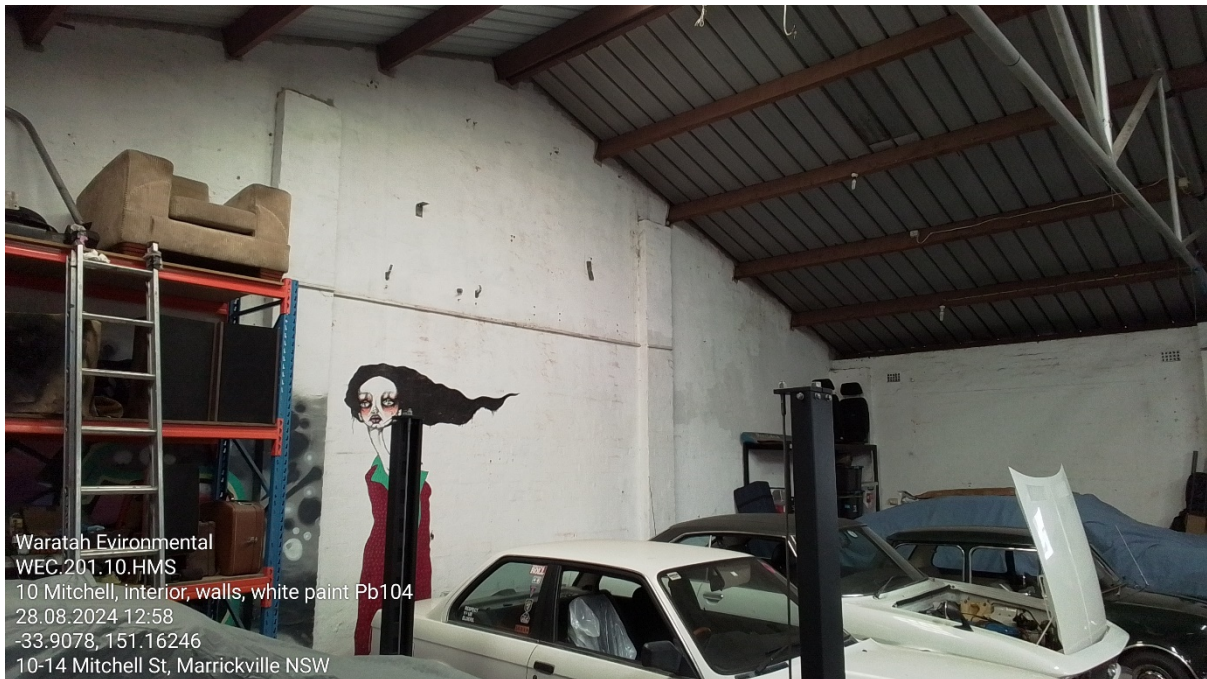
**Photograph 11:**

10 Mitchell, interior, walls throughout, white paint system, Pb104 (28/08/24)

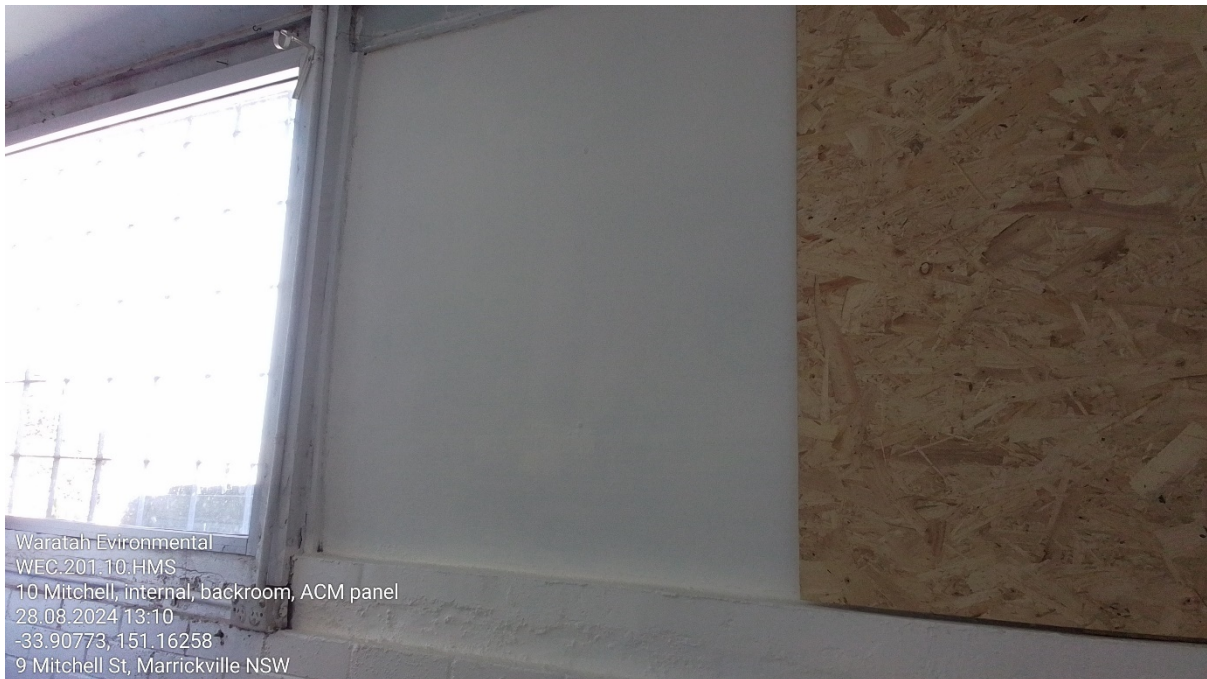
**Photograph 13:**

| Location Description | Material | Condition | Sample ID | Analytical Result | Estimated Quantity | Accessibility | Priority Rating | Recommendations | Photograph Register |
|---|---|---|---|---|---|---|---|---|---|
| Interior, backroom, adjacent window | Cement sheet | Good | Visual assessment | Presumed to contain ACM | 10m <sup>2</sup> | Maintenance only | Priority 3 – Negligible risk in present condition | Avoid abrasive activities in vicinity of material during demolition. | Photograph 13 |

10 Mitchell, interior, backroom, adjacent window, asbestos containing fibre cement (28/08/24)

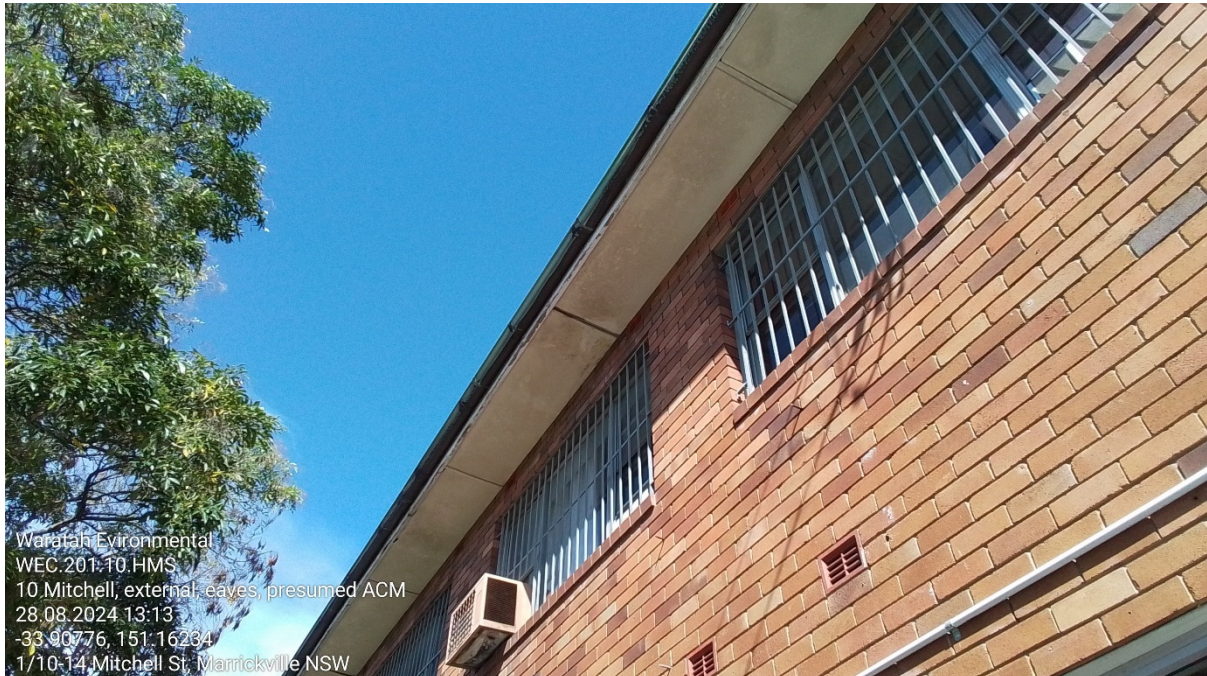
**Photograph 14:**

| Location Description | Material | Condition | Sample ID | Analytical Result | Estimated Quantity | Accessibility | Priority Rating | Recommendations | Photograph Register |
|---|---|---|---|---|---|---|---|---|---|
| Exterior, eaves | Cement sheet | Good | Visual assessment | Presumed to contain ACM | 20m <sup>2</sup> | Maintenance only | Priority 3 – Negligible risk in present condition | Avoid abrasive activities in vicinity of material during demolition. | Photograph 14 |

10 Mitchell, exterior, eaves, asbestos containing fibre cement (28/08/24)

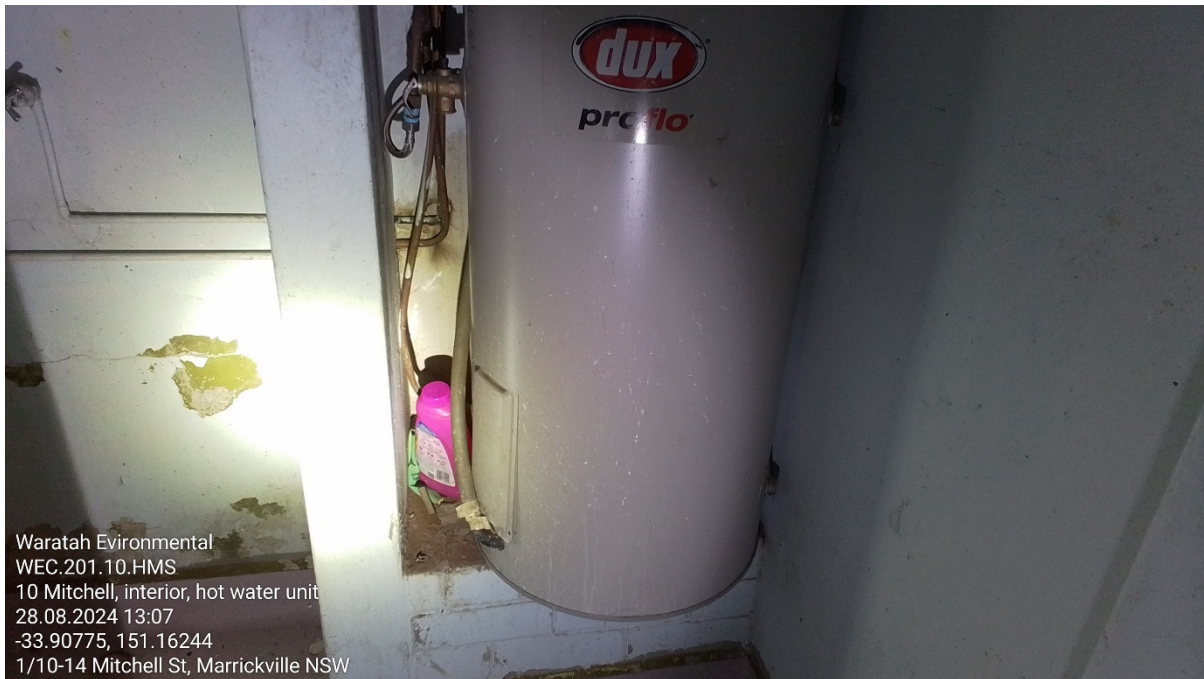
**Photograph 15:**

| Location Description | Material | Condition | Sample ID | Analytical Result | Estimated Quantity | Accessibility | Priority Rating | Recommendations | Photograph Register |
|---|---|---|---|---|---|---|---|---|---|
| Interior, bathroom, hot water unit | SMF lining | Good | Visual assessment | Presumed to contain SMF | 1 unit | Maintenance only | Priority 4 – Low risk in present condition | Remove during demolition | Photograph 15 |

10 Mitchell, interior, bathroom, hot water unit (28/08/24)

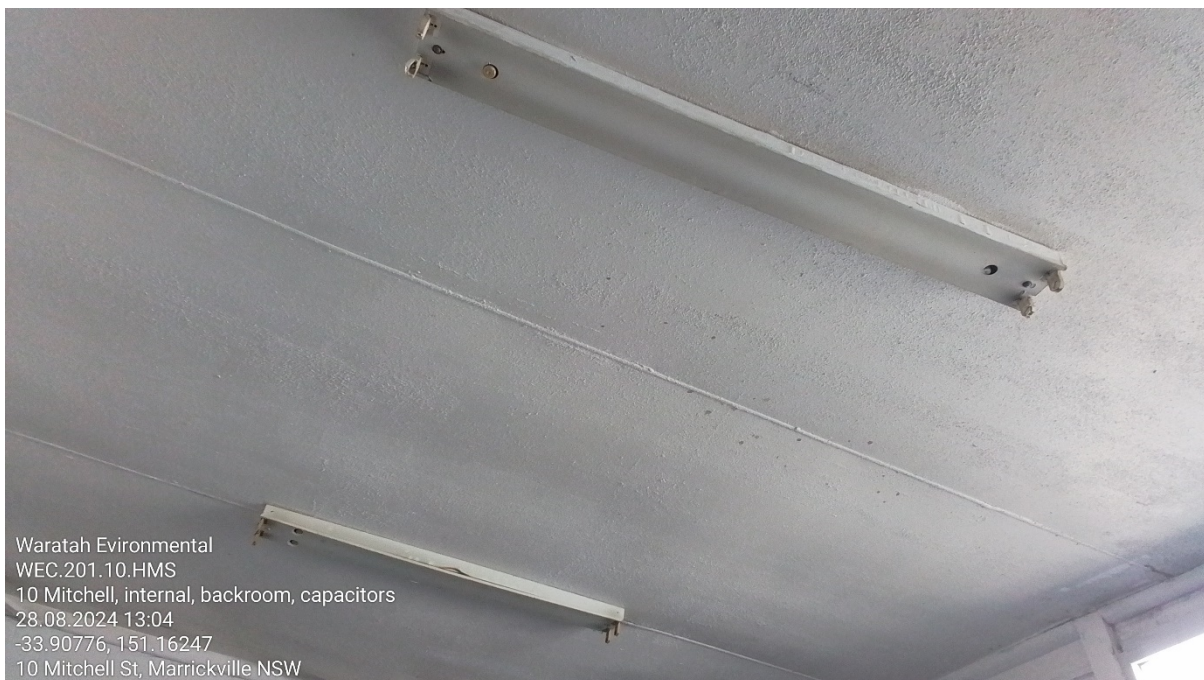
**Photograph 16:**

| Location Description | Material | Condition | Sample ID | Analytical Result | Estimated Quantity | Accessibility | Priority Rating | Recommendations | Photograph Register |
|---|---|---|---|---|---|---|---|---|---|
| Interior, backroom, ceiling | Fluorescent light capacitors | Fair | Visual assessment | Presumed to contain PCB | 4 units | Maintenance only | Priority 4 – Low risk in present condition | Remove during demolition | Photograph 16 |

10 Mitchell, interior, backroom, ceilings, fluorescent light fixtures (28/08/24)

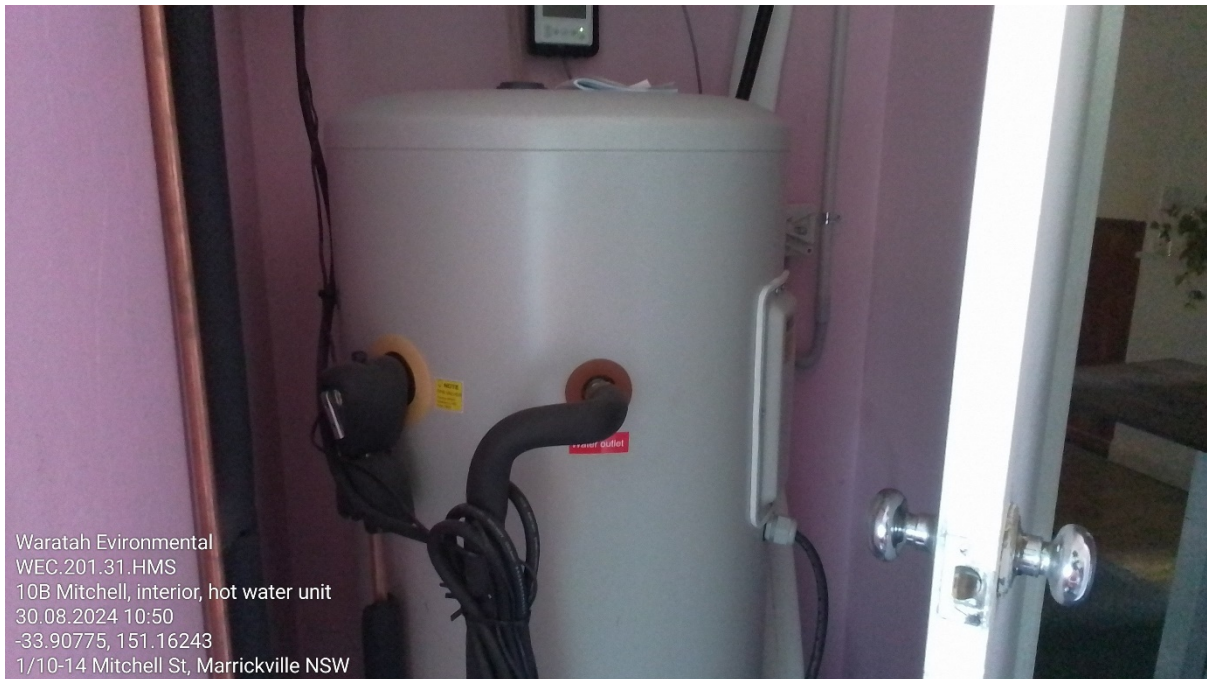
**Photograph 19:**

| Location Description | Material | Condition | Sample ID | Analytical Result | Estimated Quantity | Accessibility | Priority Rating | Recommendations | Photograph Register |
|---|---|---|---|---|---|---|---|---|---|
| Interior, level 1, storage closet, hot water unit | SMF lining | Good | Visual assessment | Presumed to contain SMF | 1 unit | Maintenance only | Priority 4 – Low risk in present condition | Remove during demolition | Photograph 19 |

10B Mitchell, interior, storage closet, hot water unit (28/08/24)

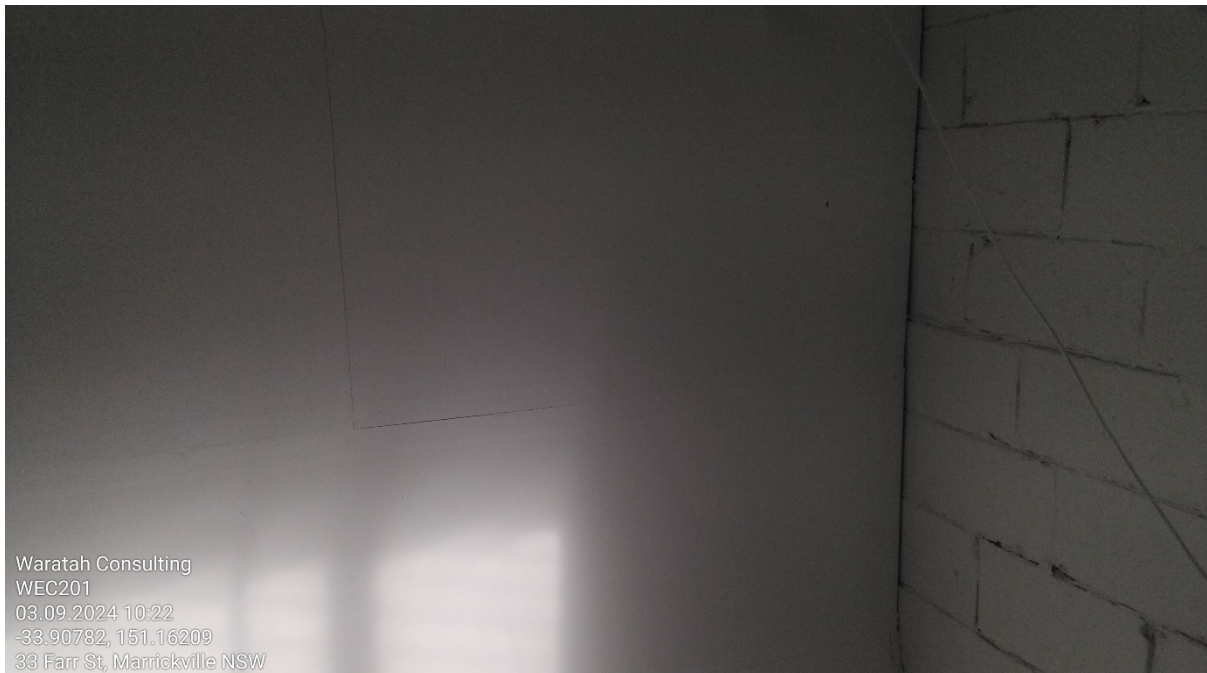
**Photograph 22:**

1/10-14 Mitchell, interior, dividing wall, cement sheet (28/08/24)

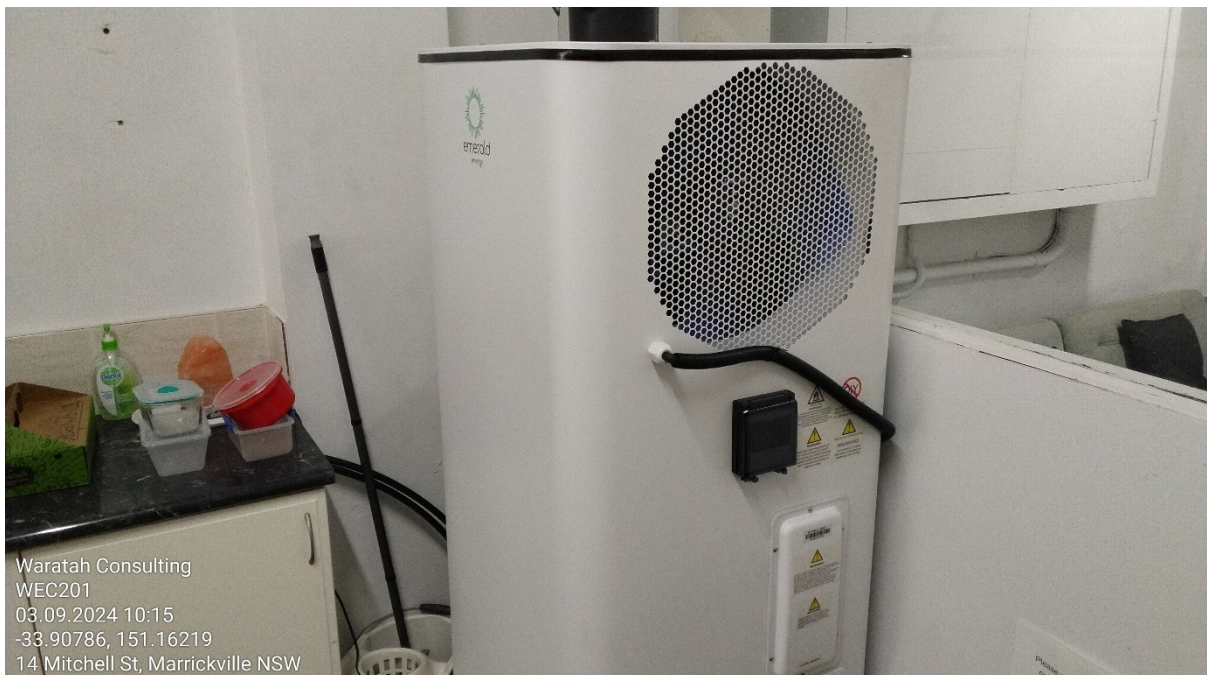
**Photograph 24:**

| Location Description | Material | Condition | Sample ID | Analytical Result | Estimated Quantity | Accessibility | Priority Rating | Recommendations | Photograph Register |
|---|---|---|---|---|---|---|---|---|---|
| Interior, kitchen, hot water unit | SMF lining | Good | Visual assessment | Presumed to contain SMF | 1 unit | Maintenance only | Priority 4 – Low risk in present condition | Remove during demolition | Photograph 24 |

1/10-14 Mitchell, interior, kitchen, hot water unit (28/08/24)

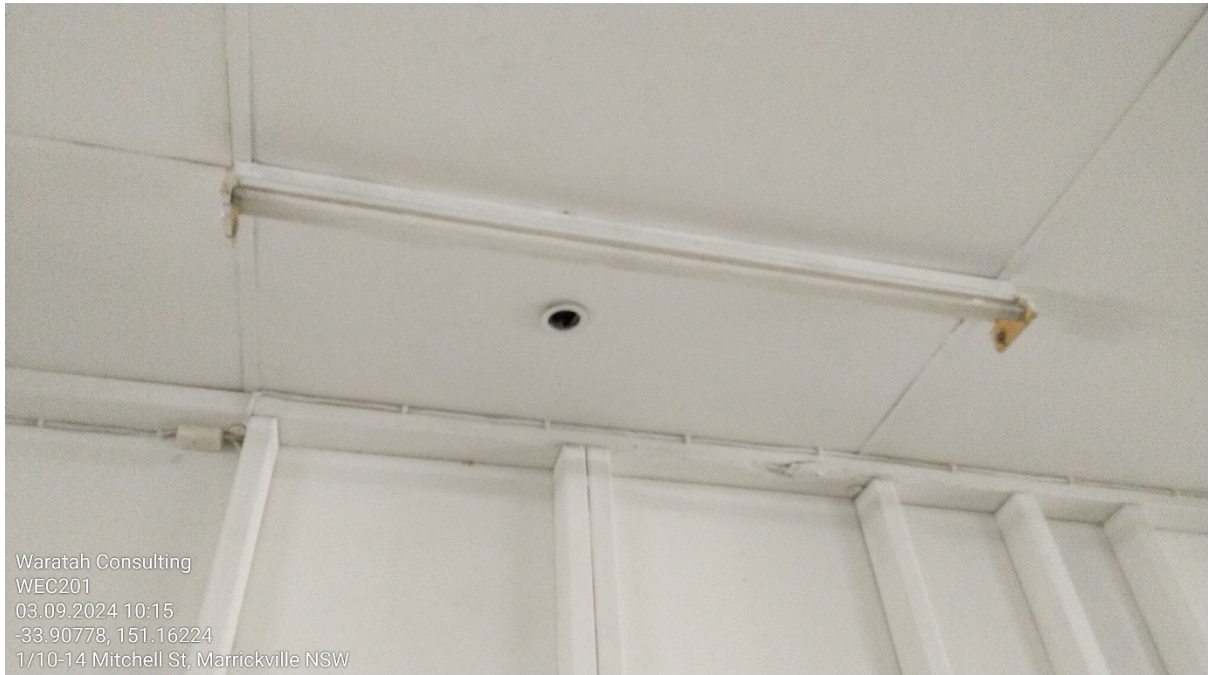
**Photograph 25:**

| Location Description | Material | Condition | Sample ID | Analytical Result | Estimated Quantity | Accessibility | Priority Rating | Recommendations | Photograph Register |
|---|---|---|---|---|---|---|---|---|---|
| Interior, ceilings throughout | Fluorescent light capacitors | Good | Visual assessment | Presumed to contain PCB | 16 units | Maintenance only | Priority 4 – Low risk in present condition | Remove during demolition | Photograph 25 |

1/10-14 Mitchell, interior, ceilings throughout, fluorescent light fixtures (28/08/24)
