# Hazardous Materials Survey

**RTL Co**

7-35 Farr Street, Marrickville NSW

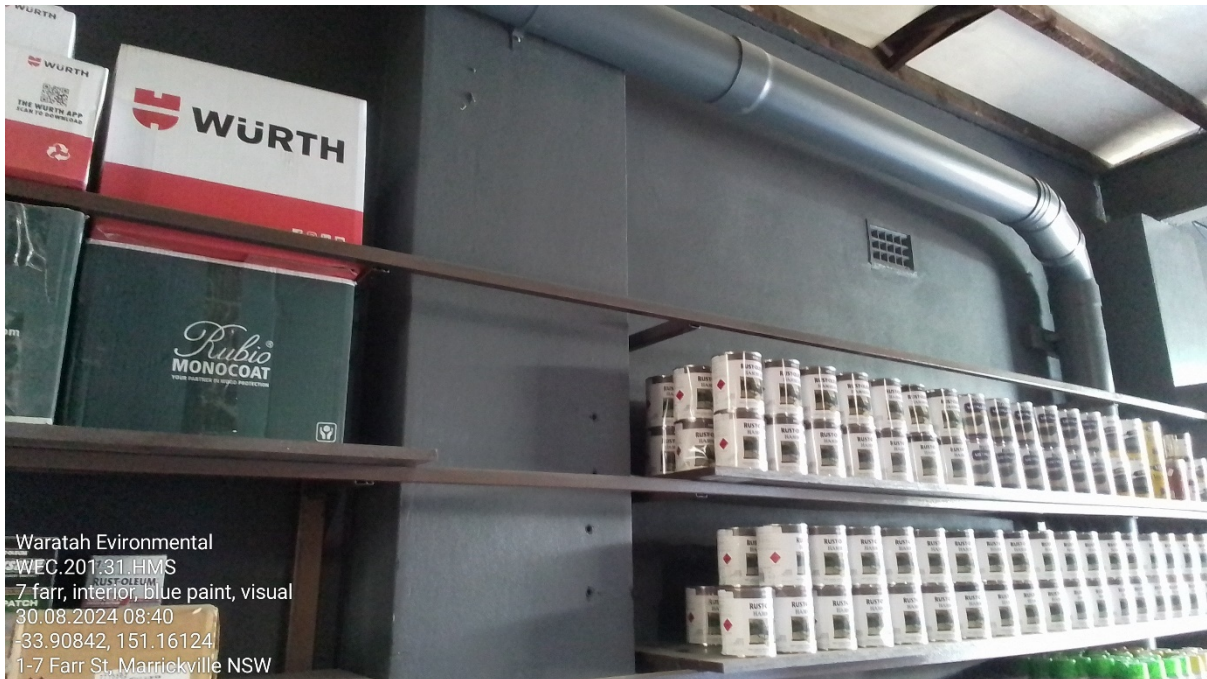
**Photograph 3:**

7 Farr Street, interior, south wall, painted pipe-works, Pb203 (30/08/24)

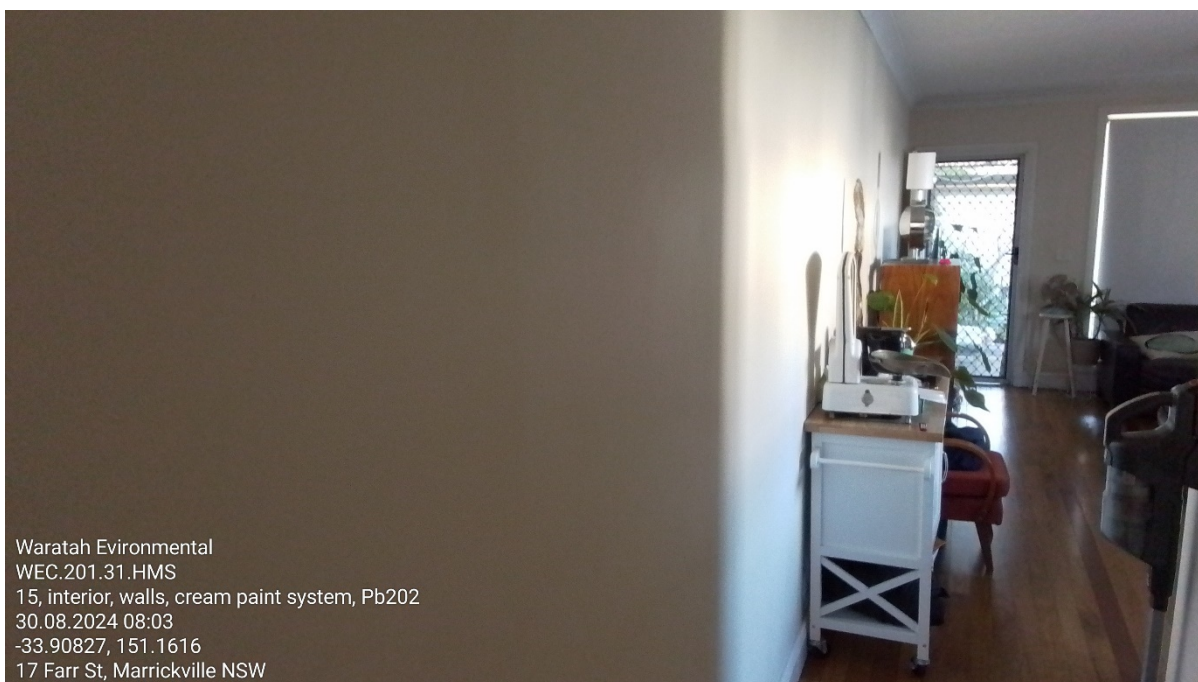
**Photograph 6:**

15 Farr Street, interior walls, throughout, cream paint system, Pb202 (30/08/24)

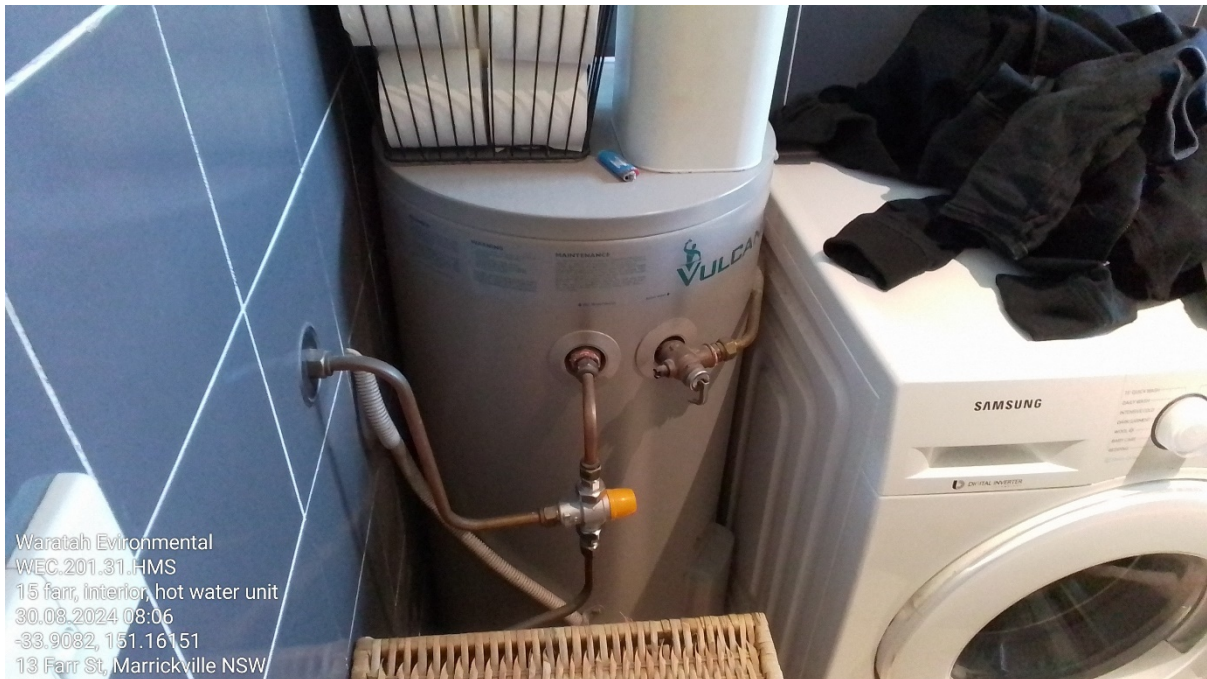
**Photograph 7:**

| Location Description | Material | Condition | Sample ID | Analytical Result | Estimated Quantity | Accessibility | Priority Rating | Recommendations | Photograph Register |
|---|---|---|---|---|---|---|---|---|---|
| Interior, bathroom, hot water unit | SMF lining | Good | Visual assessment | Presumed to contain SMF | 1 unit | Maintenance only | Priority 4 – Negligible risk in present condition | Remove during demolition | Photograph 7 |

15 Farr Street, interior, bathroom, hot water unit (30/08/24)

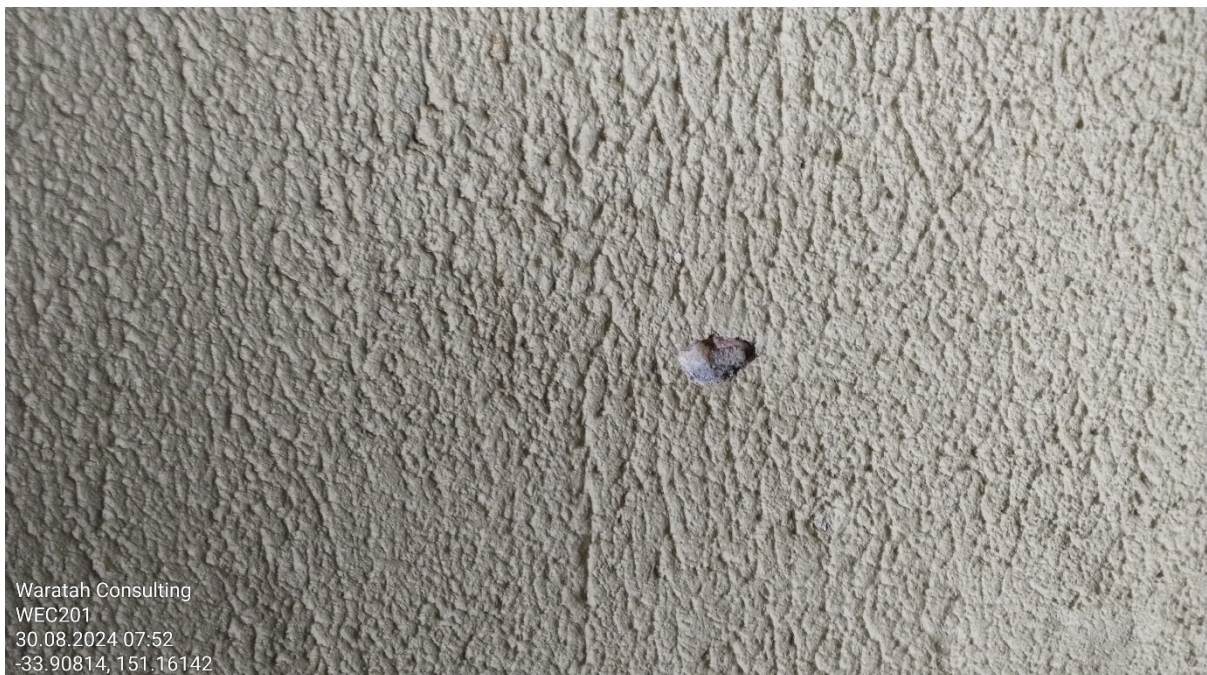
**Photograph 10:**  
17 Farr Street, exterior, walls, render throughout, yellow paint system Pb201 (30/08/24)

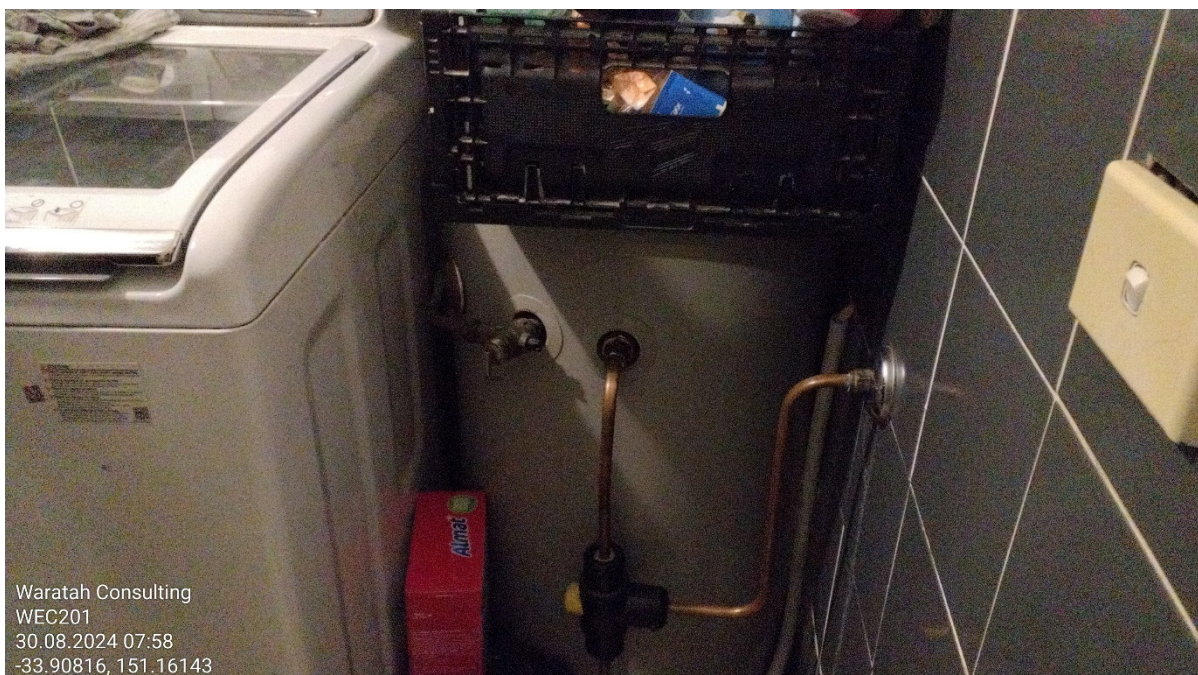
**Photograph 14:**

| Location Description | Material | Condition | Sample ID | Analytical Result | Estimated Quantity | Accessibility | Priority Rating | Recommendations | Photograph Register |
|---|---|---|---|---|---|---|---|---|---|
| Interior, bathroom, hot water unit | SMF lining | Good | Visual assessment | Presumed to contain SMF | 1 unit | Maintenance only | Priority 4 – Negligible risk in present condition | Remove during demolition | Photograph 14 |

17 Farr Street, interior, bathroom, hot water unit (30/08/24)

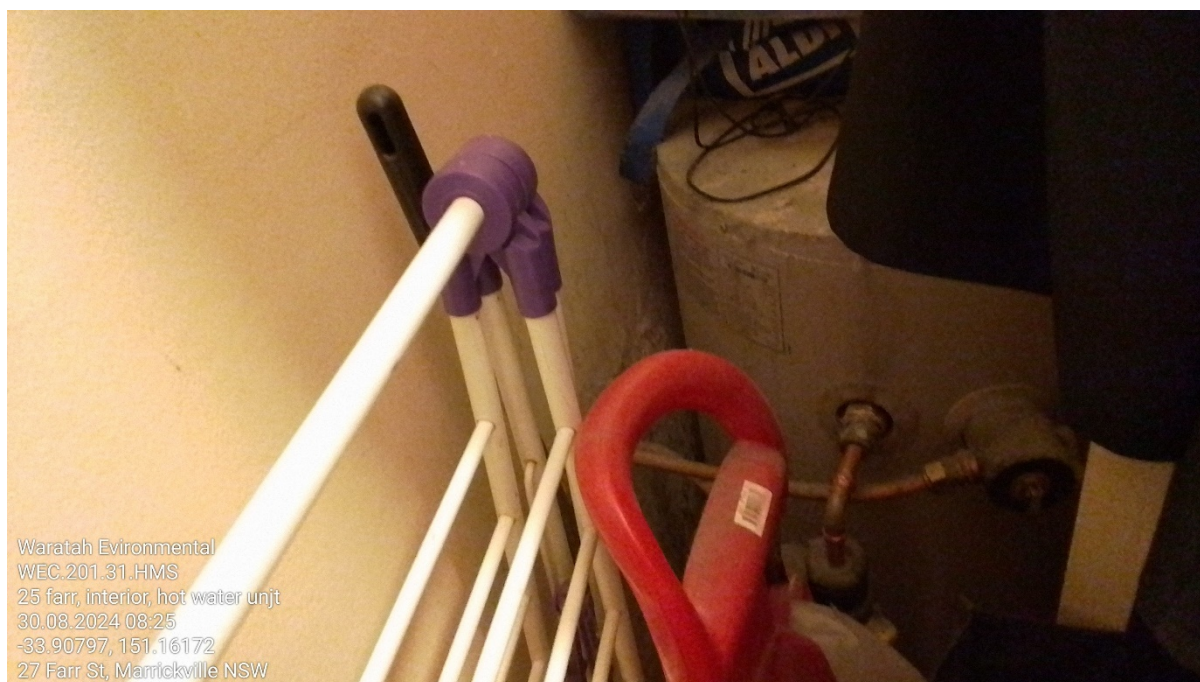
**Photograph 19:**

| Location Description | Material | Condition | Sample ID | Analytical Result | Estimated Quantity | Accessibility | Priority Rating | Recommendations | Photograph Register |
|---|---|---|---|---|---|---|---|---|---|
| Interior, laundry, hot water unit | SMF lining | Good | Visual assessment | Presumed to contain SMF | 1 unit | Maintenance only | Priority 4 – Negligible risk in present condition | Remove during demolition | Photograph 19 |

25 Farr Street, interior, laundry, hot water unit (30/08/24)

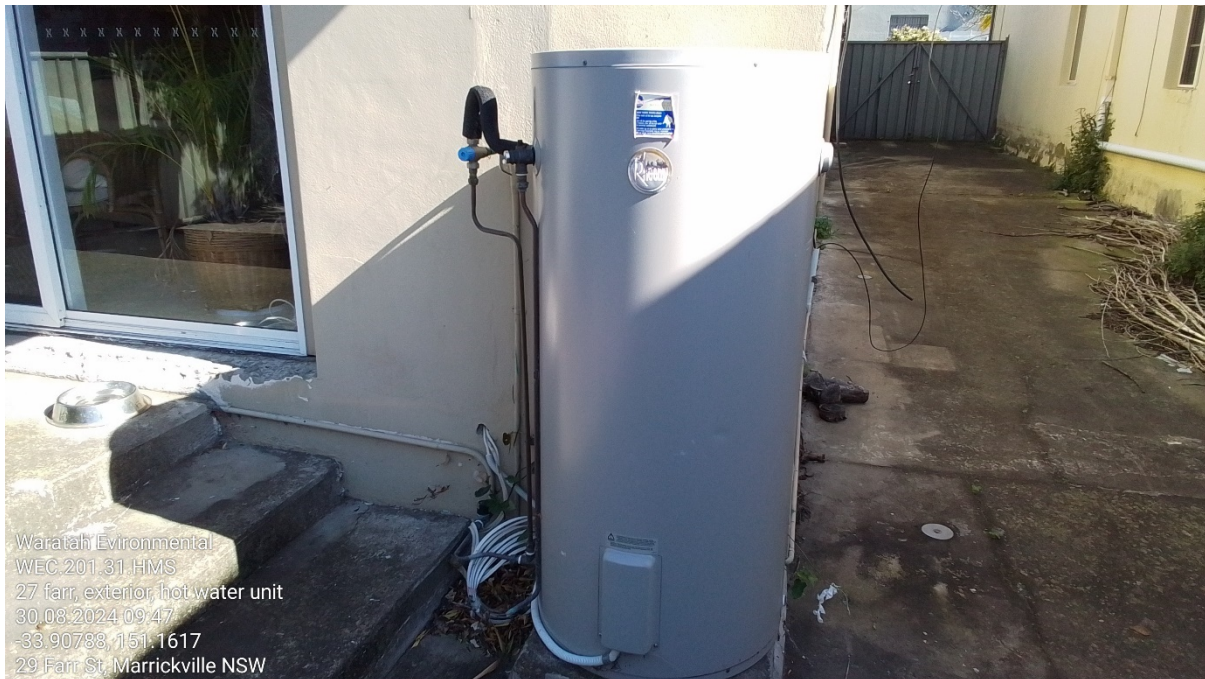
**Photograph 23:**

| Location Description | Material | Condition | Sample ID | Analytical Result | Estimated Quantity | Accessibility | Priority Rating | Recommendations | Photograph Register |
|---|---|---|---|---|---|---|---|---|---|
| Exterior, west façade, hot water unit | SMF lining | Good | Visual assessment | Presumed to contain SMF | 1 unit | Occasional | Priority 4 – Negligible risk in present condition | Remove during demolition | Photograph 23 |

27 Farr Street, exterior, west façade, hot water unit (30/08/24)

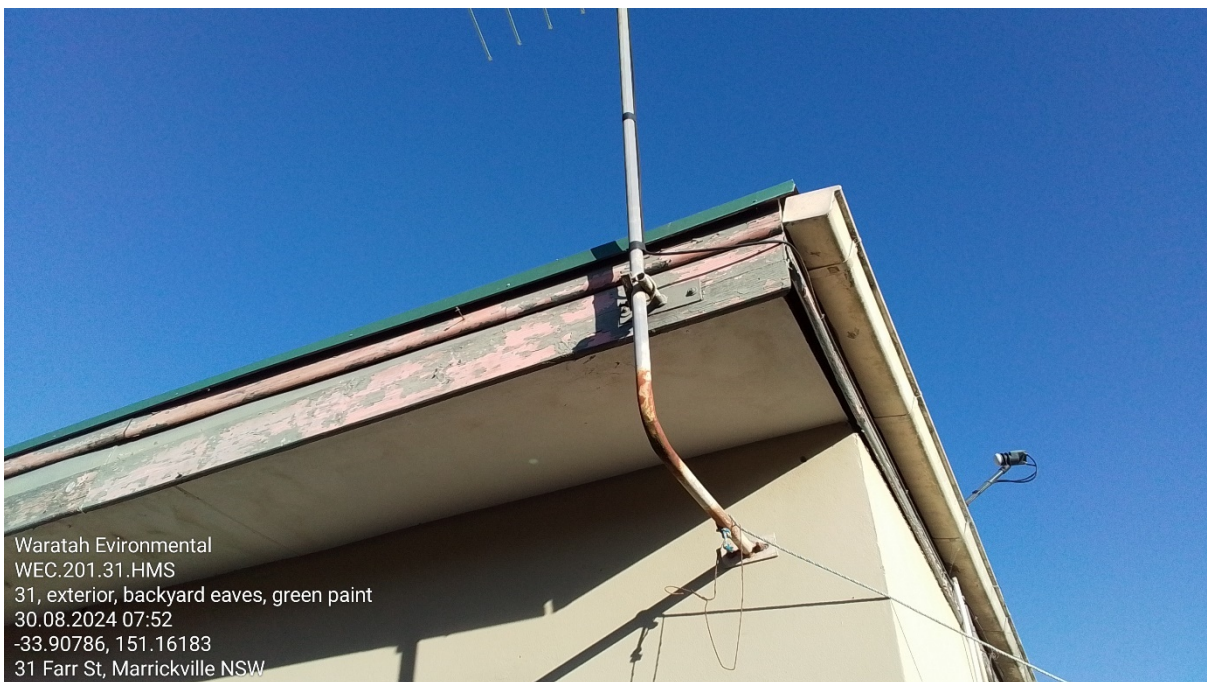
**Photograph 26:**

| Location Description | Material | Condition | Sample ID | Analytical Result | Estimated Quantity | Accessibility | Priority Rating | Recommendations | Photograph Register |
|---|---|---|---|---|---|---|---|---|---|
| Exterior, west façade, eaves | Green paint system | Poor | Visual assessment | Presumed to contain lead | 10m <sup>2</sup> | Maintenance only | Priority 3 – Low risk in present condition | Avoid abrasive activities in vicinity of material during demolition. | Photograph 26 |

31 Farr Street, exterior, west façade, eaves, green paint system (30/08/24)

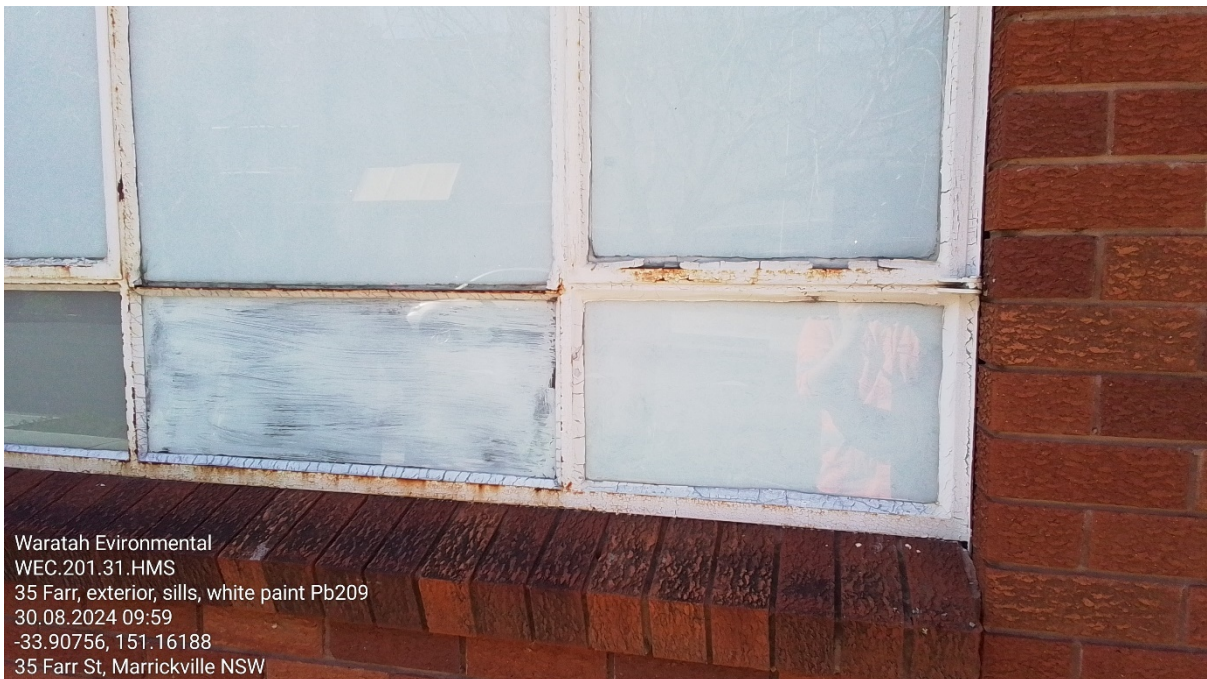
**Photograph 28:**

| Location Description | Material | Condition | Sample ID | Analytical Result | Estimated Quantity | Accessibility | Priority Rating | Recommendations | Photograph Register |
|---|---|---|---|---|---|---|---|---|---|
| Exterior, west façade, windowsills | White paint system | Fair | Pb209 | 0.17% w/w | 100m² | Regular | Priority 3 – Low risk in present condition | Avoid abrasive activities in vicinity of material during demolition. | Photograph 28 |

35 Farr Street, exterior, west façade, windowsills, lead based white paint system Pb209 (30/08/24)

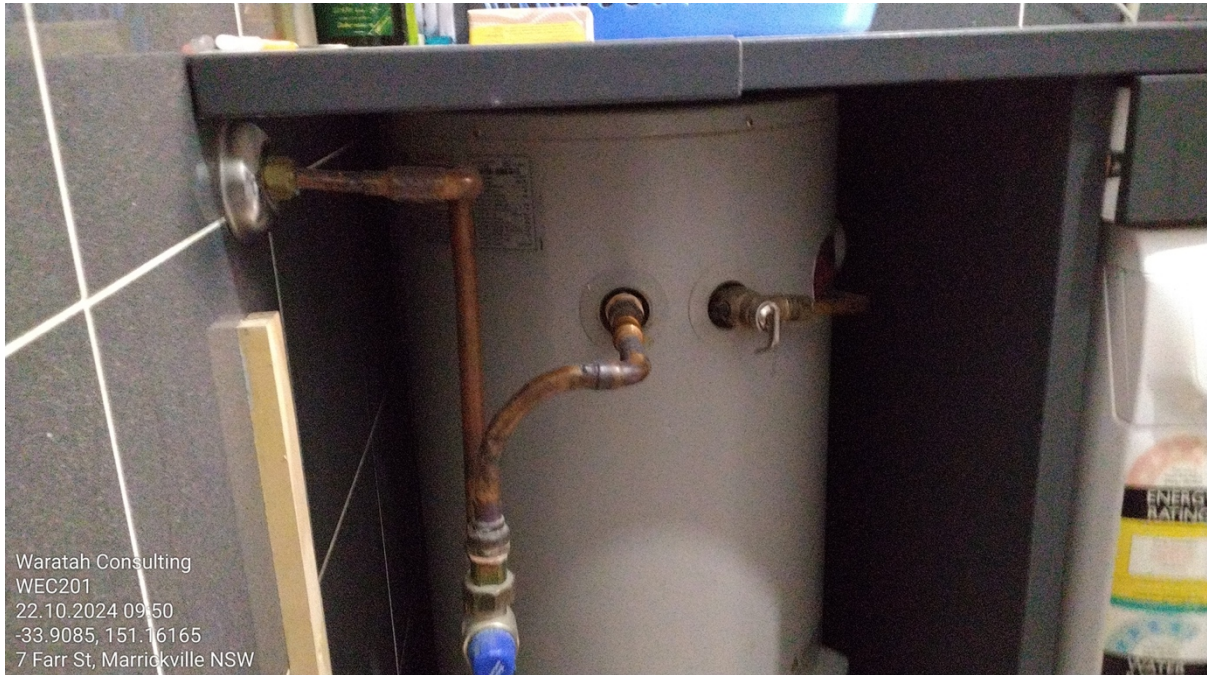
**Photograph 33:**

| Location Description | Material | Condition | Sample ID | Analytical Result | Estimated Quantity | Accessibility | Priority Rating | Recommendations | Photograph Register |
|---|---|---|---|---|---|---|---|---|---|
| Interior, laundry, hot water unit | SMF lining | Good | Visual assessment | Presumed to contain SMF | 1 unit | Maintenance only | Priority 4 – Negligible risk in present condition | Remove during demolition | Photograph 33 |

9 Farr Street, interior, laundry, hot water system (22.10.24)

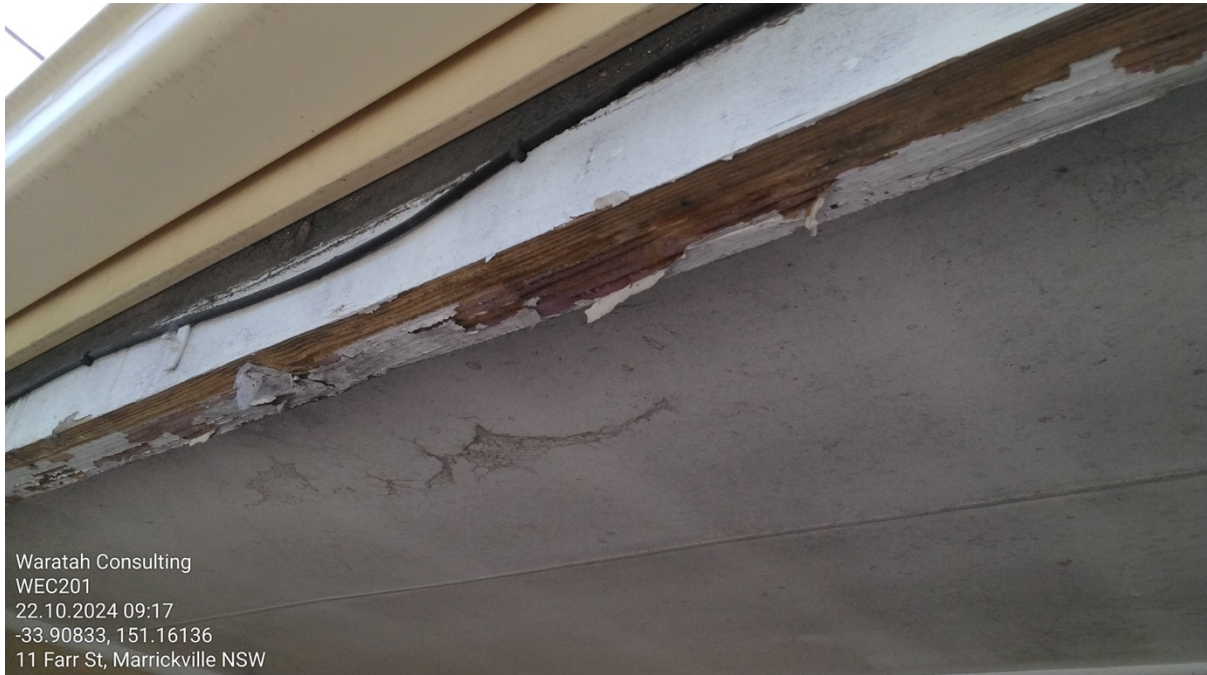
**Photograph 35:**

| Location Description | Material | Condition | Sample ID | Analytical Result | Estimated Quantity | Accessibility | Priority Rating | Recommendations | Photograph Register |
|---|---|---|---|---|---|---|---|---|---|
| Exterior, top of wall, eaves, surface of wood frame | White paint system | Poor | Pb303 | 8.1 %w/w | >5m <sup>2</sup> | Occasional | Priority 3 – Low risk in present condition | Avoid abrasive activities in vicinity of material during demolition. | Photograph 35 |

11 Farr Street, exterior, eaves, wood framing, white paint system, Pb303 (22.10.24)

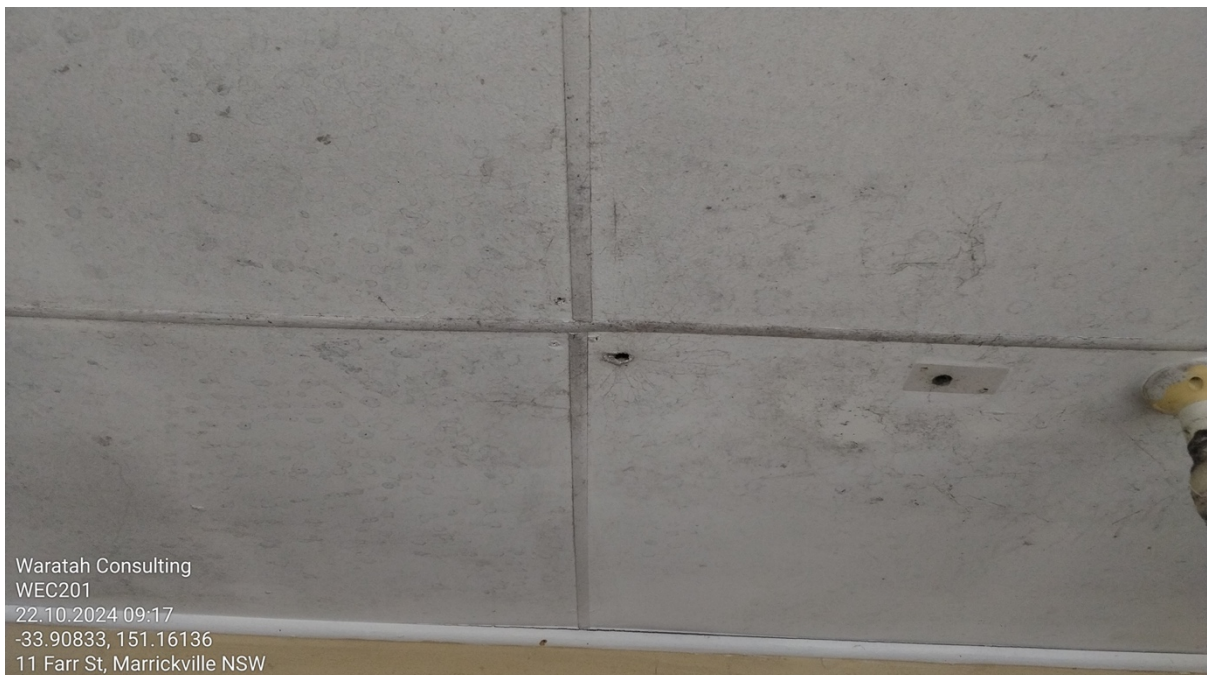
**Photograph 36:**

11 Farr Street, exterior, eaves, cement sheet, FC304 (22.10.24)

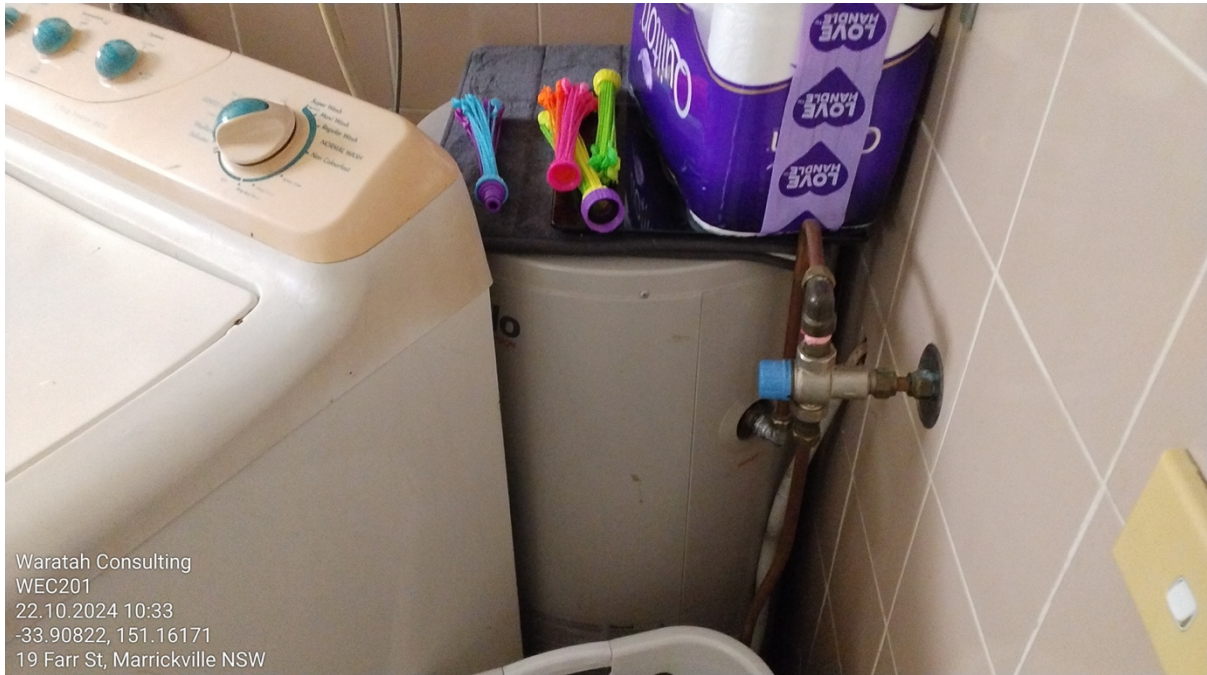
**Photograph 43:**

| Location Description | Material | Condition | Sample ID | Analytical Result | Estimated Quantity | Accessibility | Priority Rating | Recommendations | Photograph Register |
|---|---|---|---|---|---|---|---|---|---|
| Interior, laundry, hot water unit | SMF lining | Good | Visual assessment | Presumed to contain SMF | 1 unit | Maintenance only | Priority 4 – Negligible risk in present condition | Remove during demolition | Photograph 43 |

21 Farr Street, interior, laundry, hot water system (22.10.24)

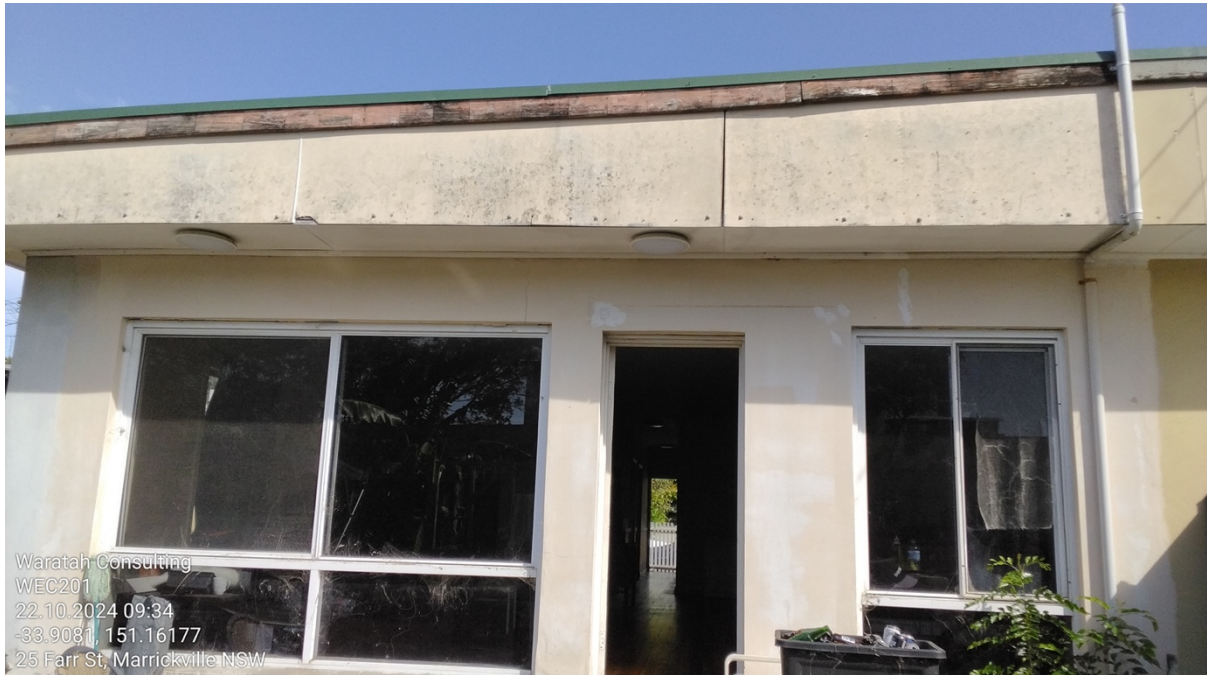
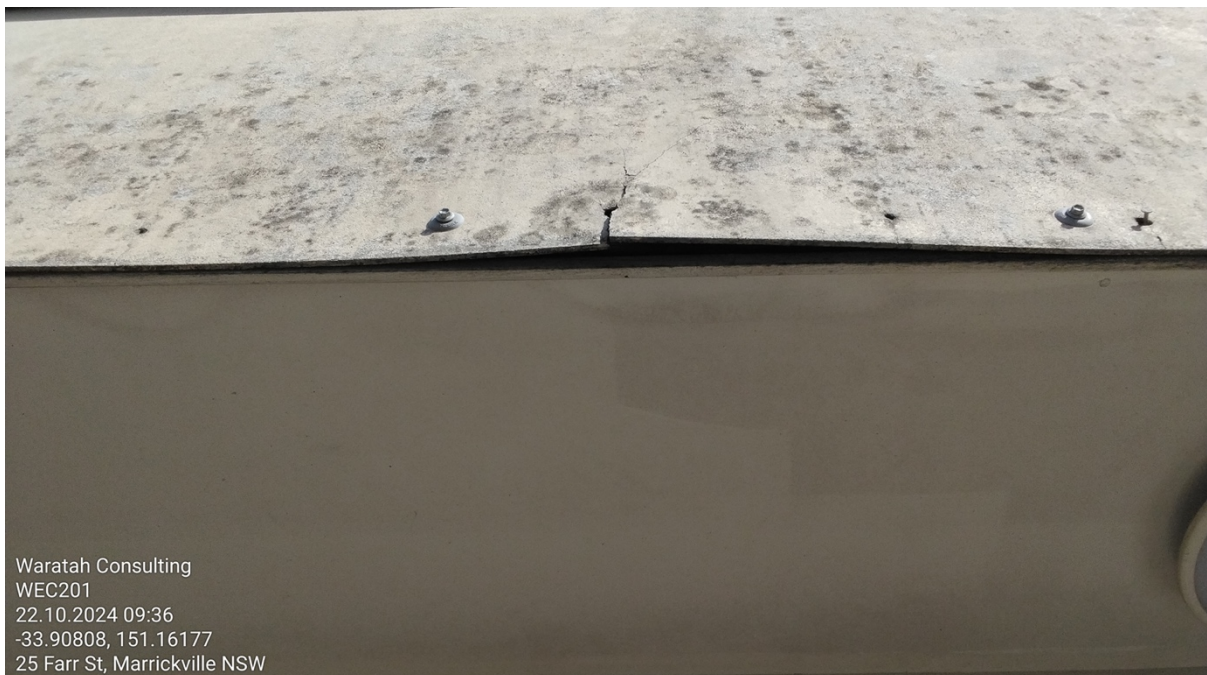
23 Farr Street, exterior, top of wall, eaves, cladding, FC305 (22.10.24)

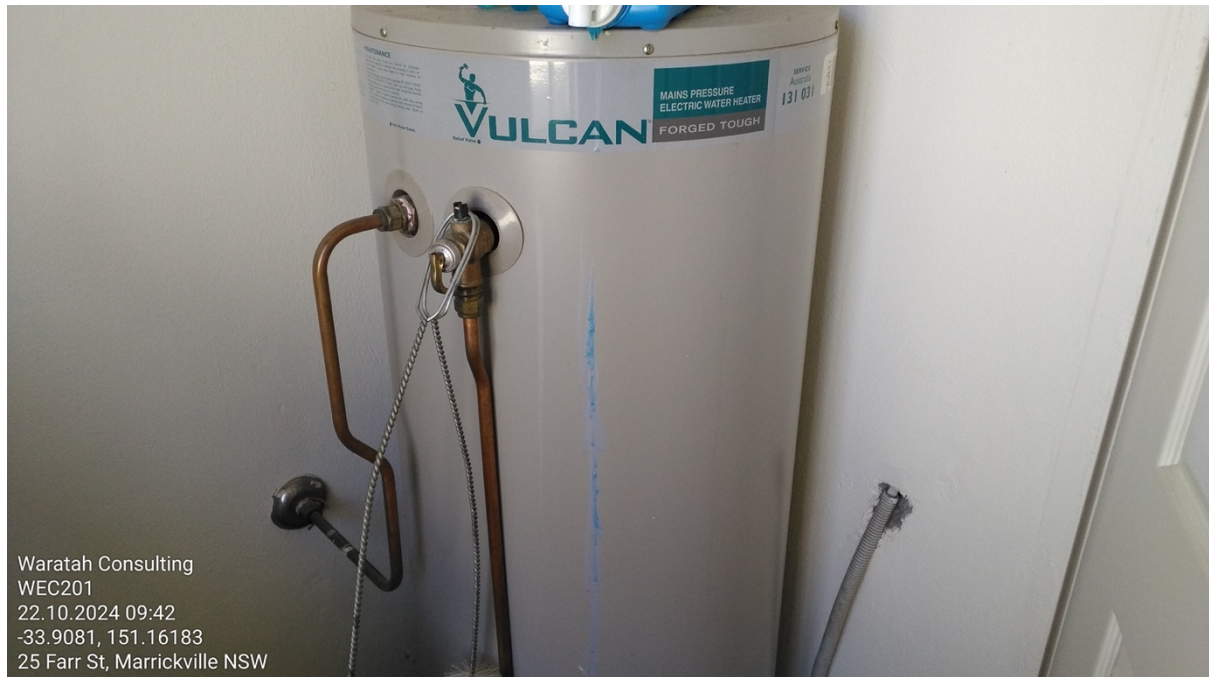
**Photograph 49:**

| Location Description | Material | Condition | Sample ID | Analytical Result | Estimated Quantity | Accessibility | Priority Rating | Recommendations | Photograph Register |
|---|---|---|---|---|---|---|---|---|---|
| Interior, laundry, hot water unit | SMF lining | Good | Visual assessment | Presumed to contain SMF | 1 unit | Maintenance only | Priority 4 – Negligible risk in present condition | Remove during demolition | Photograph 49 |

23 Farr Street, interior, laundry, hot water system (22.10.24)
