Pre-demolition / Pre-refurbishment, Hazardous
Building Materials Assessment
Nine Buildings, Base Hospital, Dubbo, NSW

Prepared for
Health Infrastructure

Project 72811.04

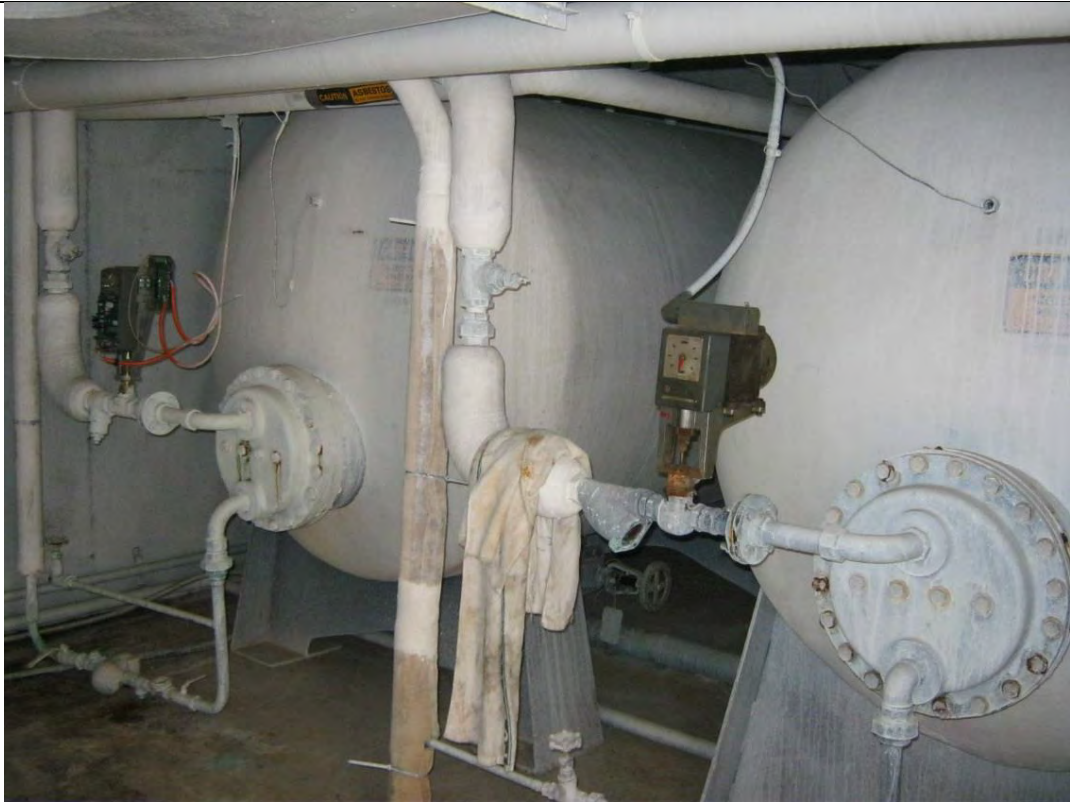
Photograph 1: S Block, Clarifier Room, asbestos insulation

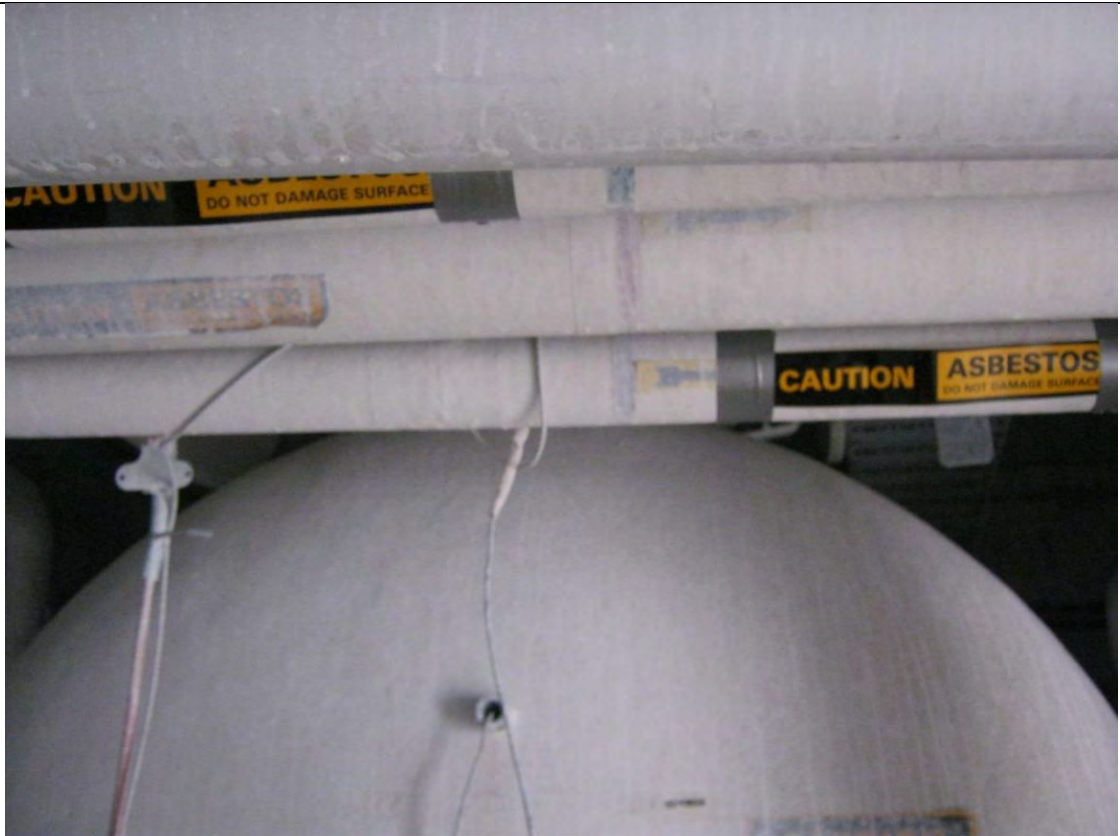
Photograph 2: S Block, Clarifier Room

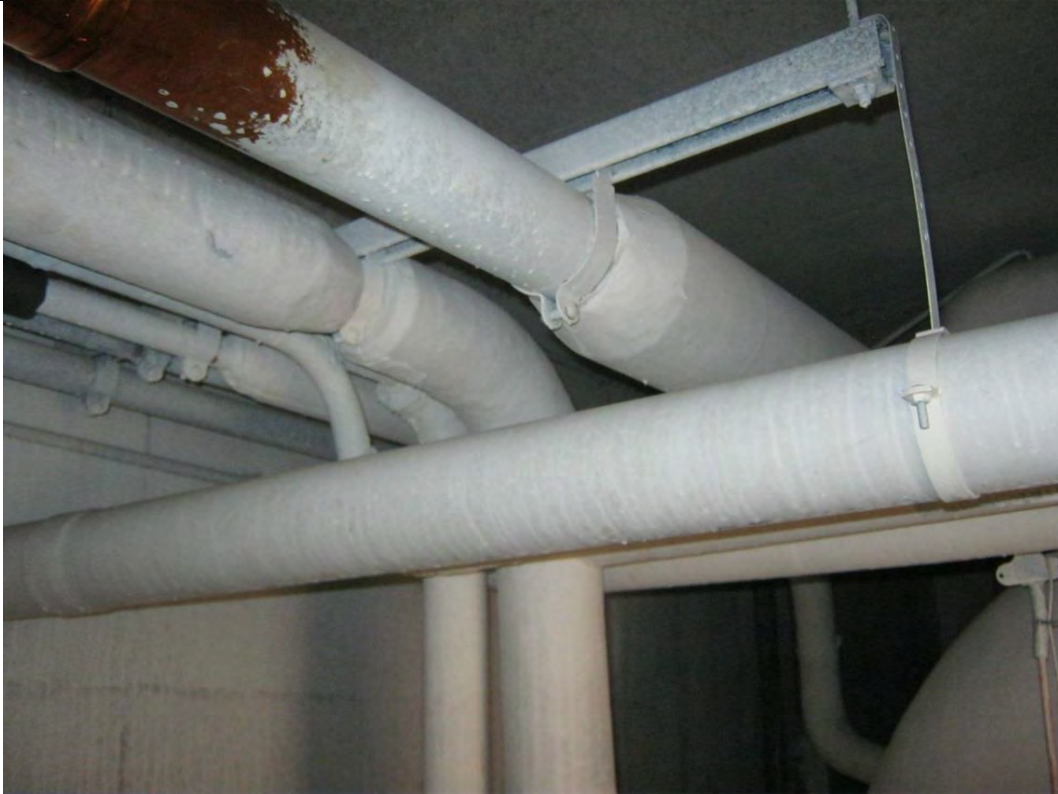
Photograph 3: S Block, Clarifier Room, asbestos pipe lagging

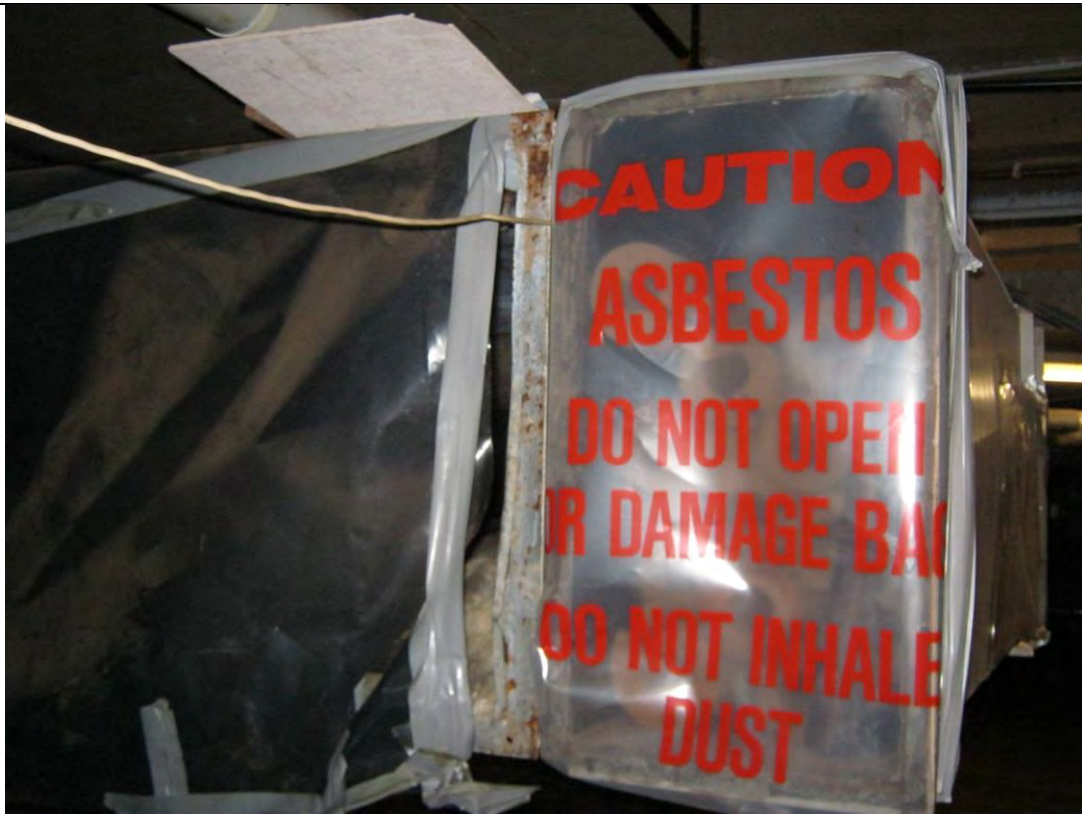
Photograph 4: S Block, Clarifier Room, asbestos waste

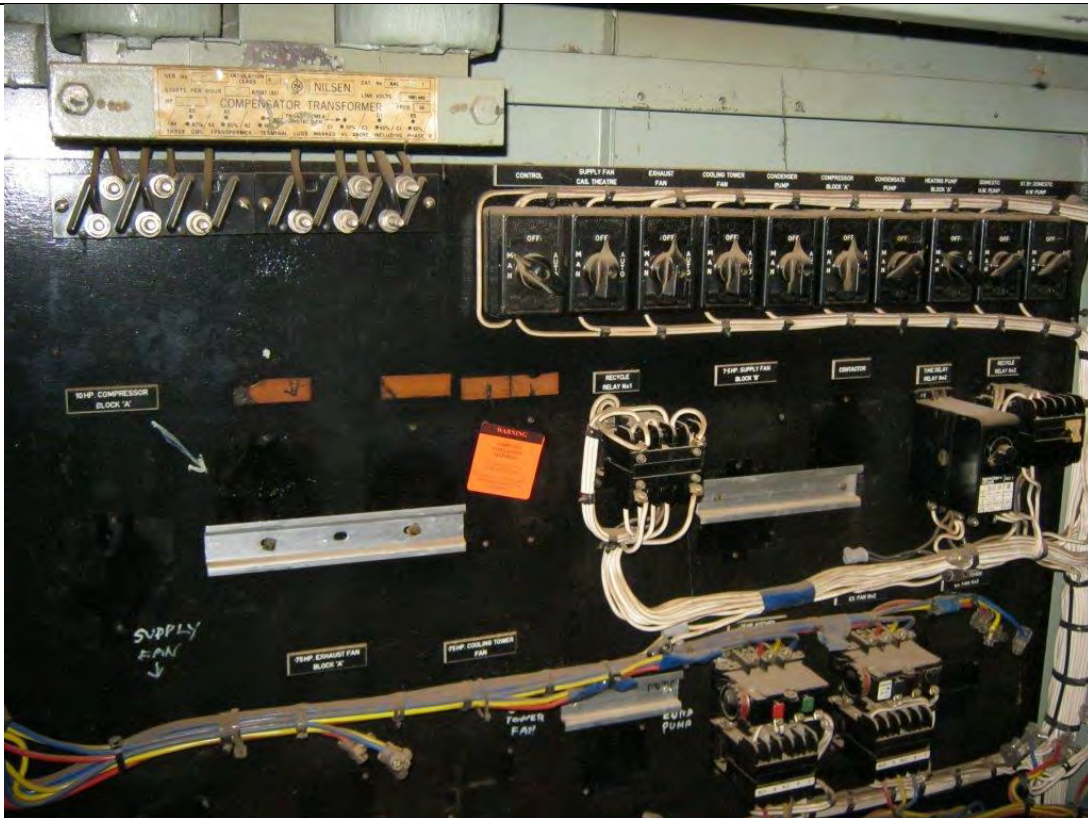
Photograph 6: S Block, Clarifier Room, main switchboard, asbestos label

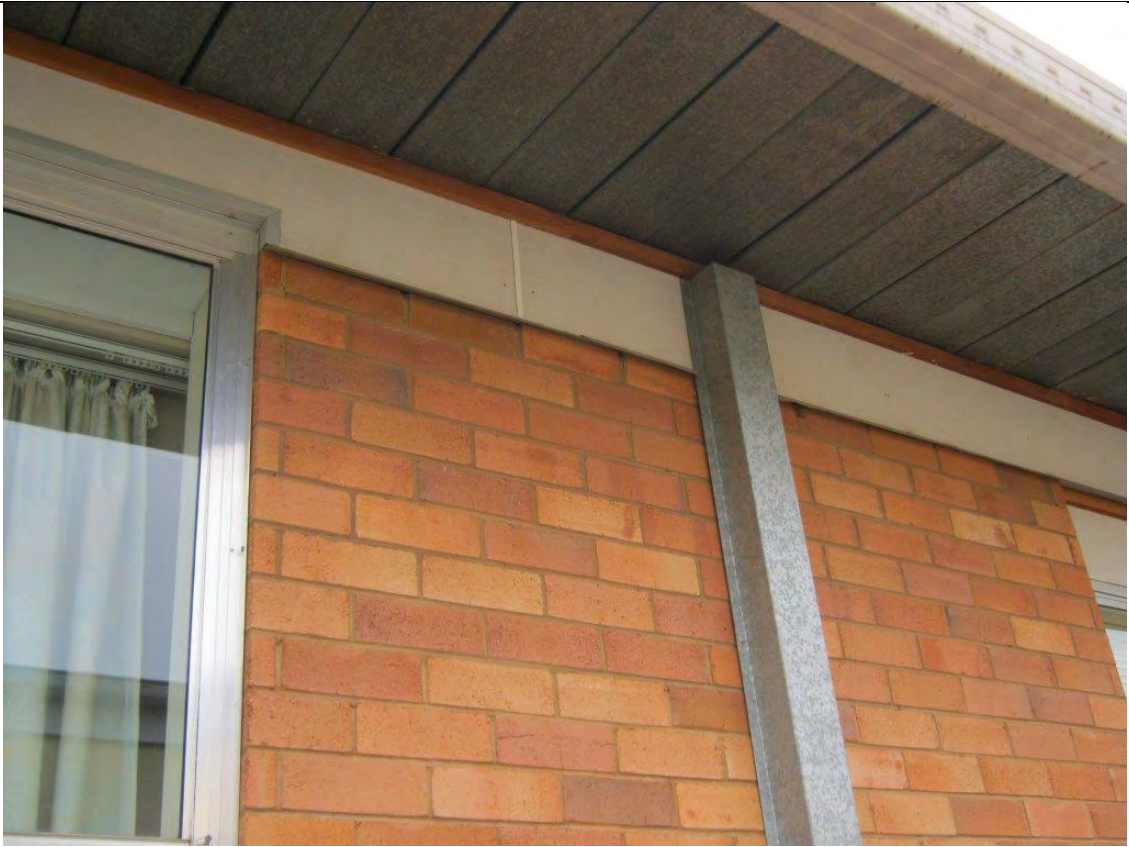
Photograph 7: S Block, Flashing under eaves

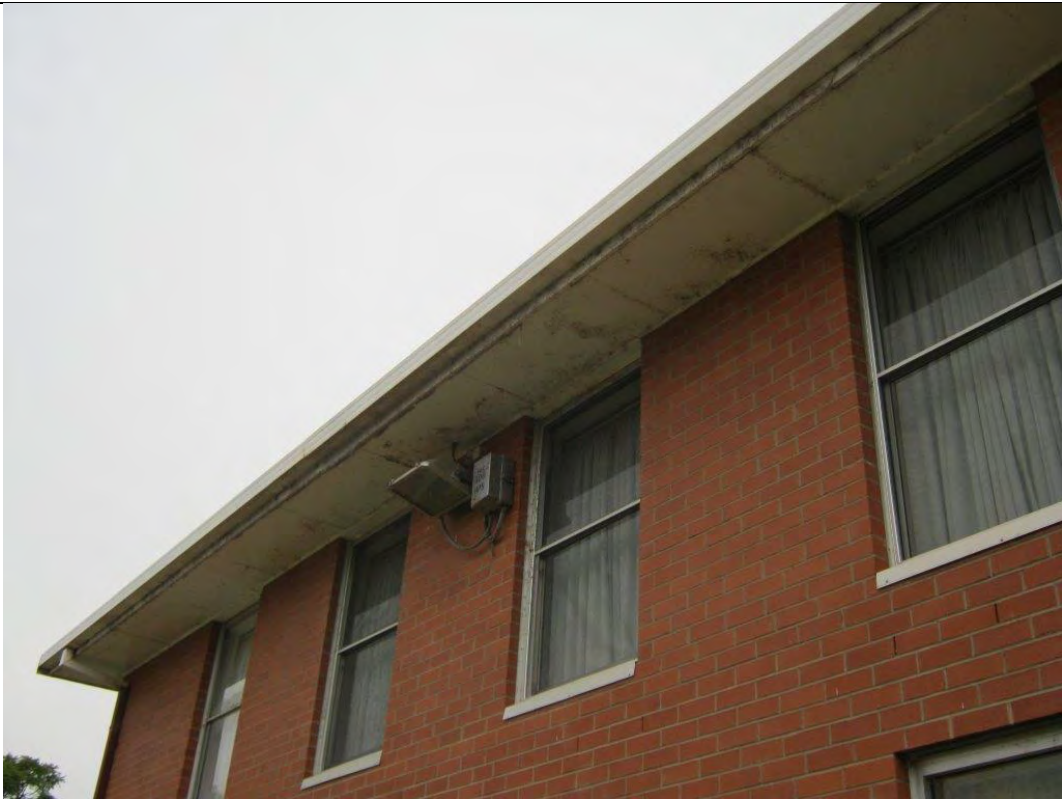
Photograph 8: George Hatch, Soffit

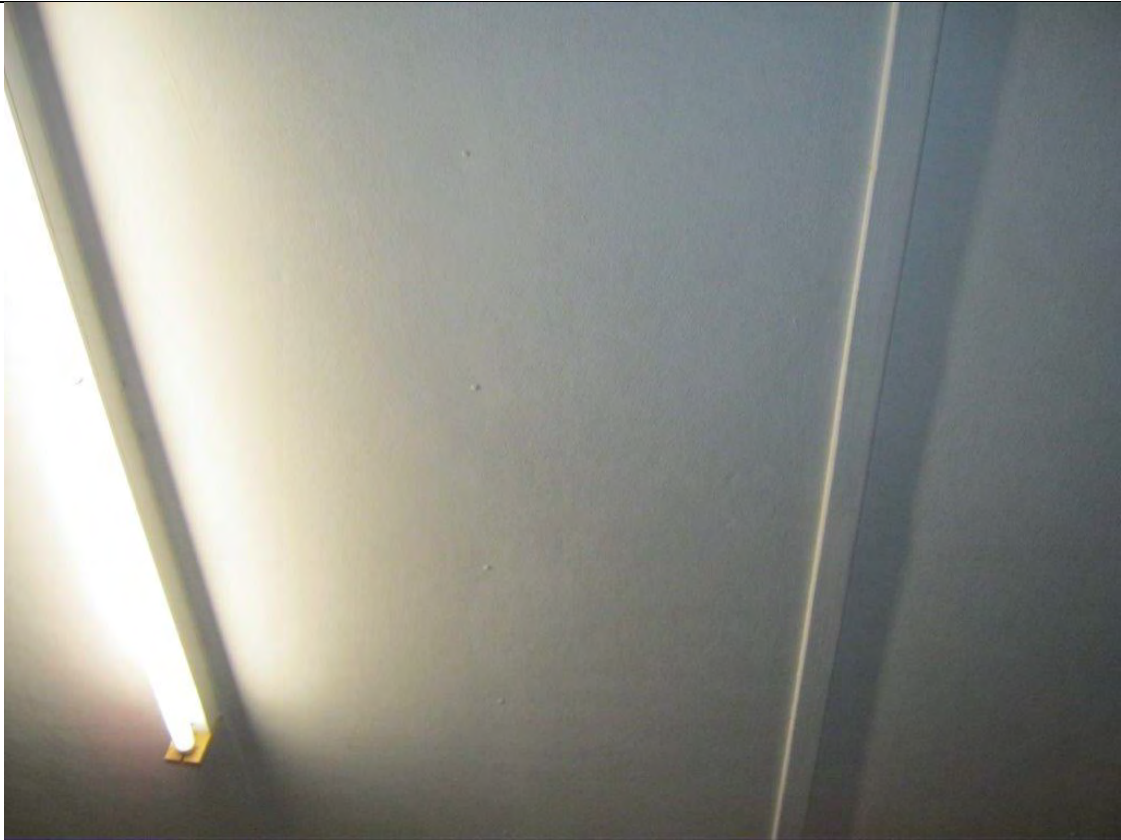
Photograph 9: George Hatch, sheeting under ceiling in enclosed verandahs

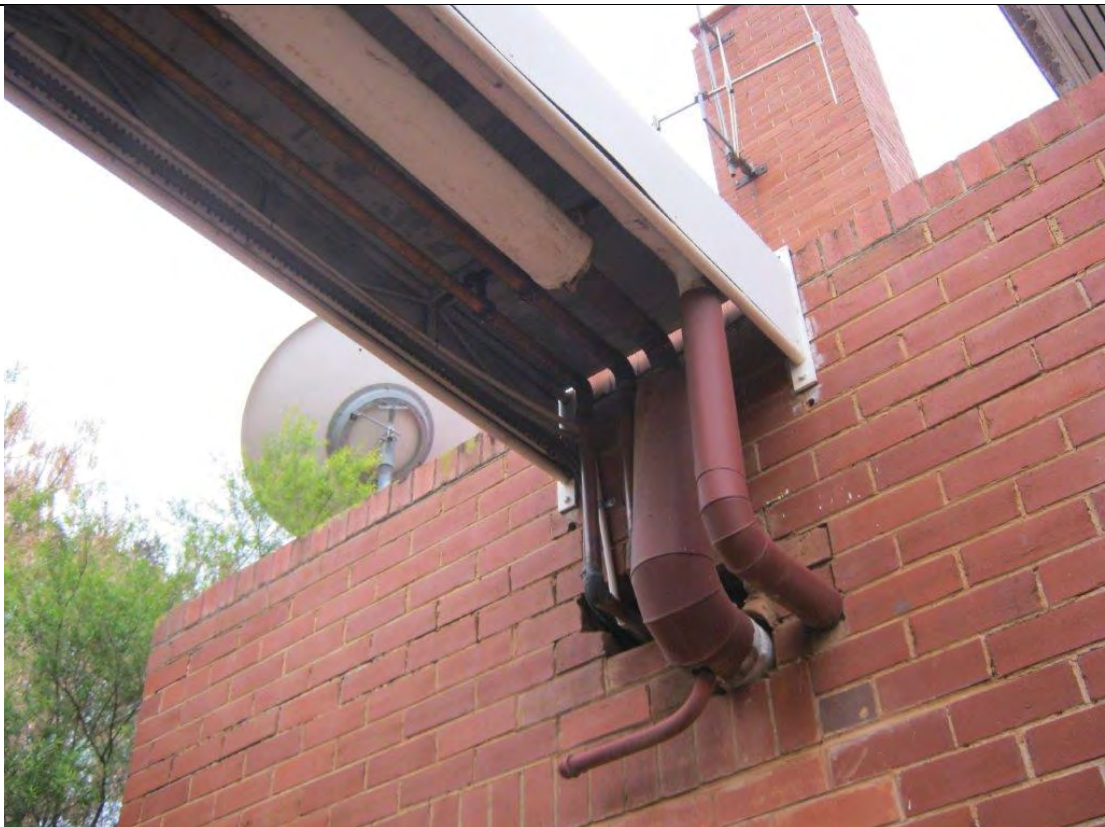
Photograph 10: George Hatch, overhead services ducting, asbestos pipe lagging

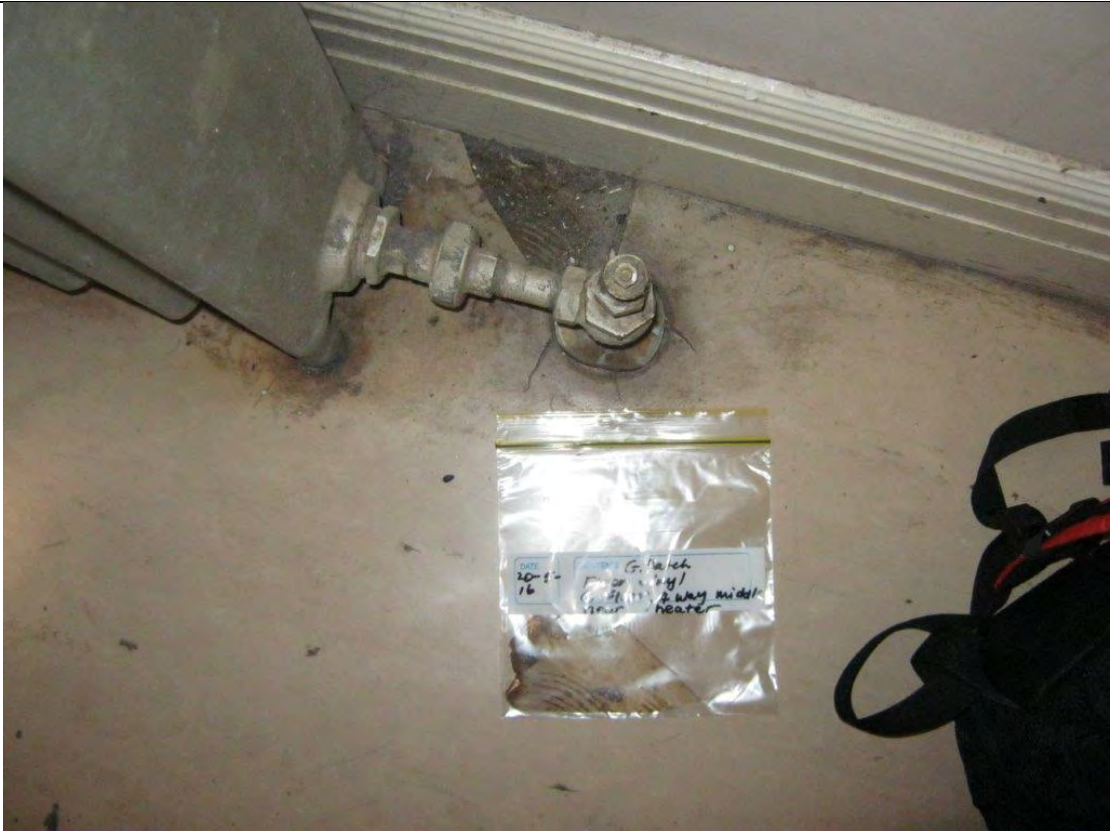
Photograph 11: George Hatch, vinyl floor tile (NAD)

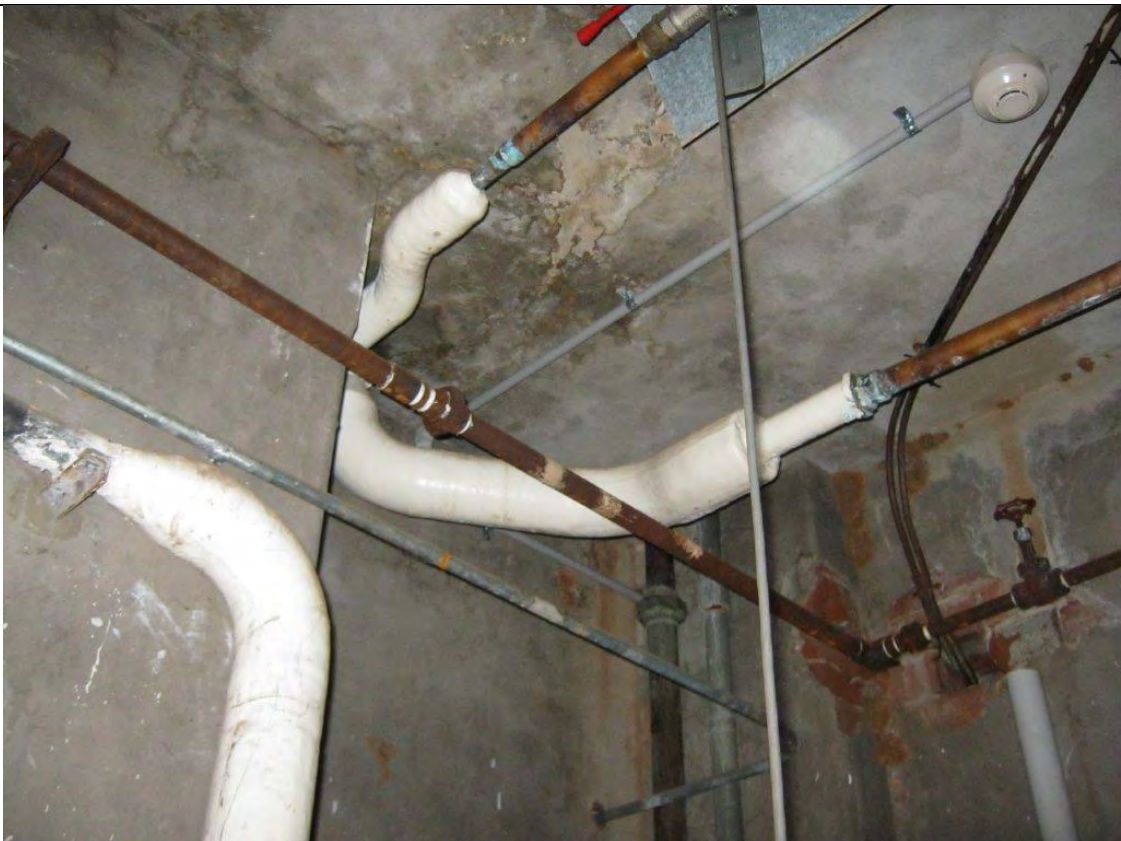
Photograph 12: George Hatch, plant room, asbestos pipe lagging

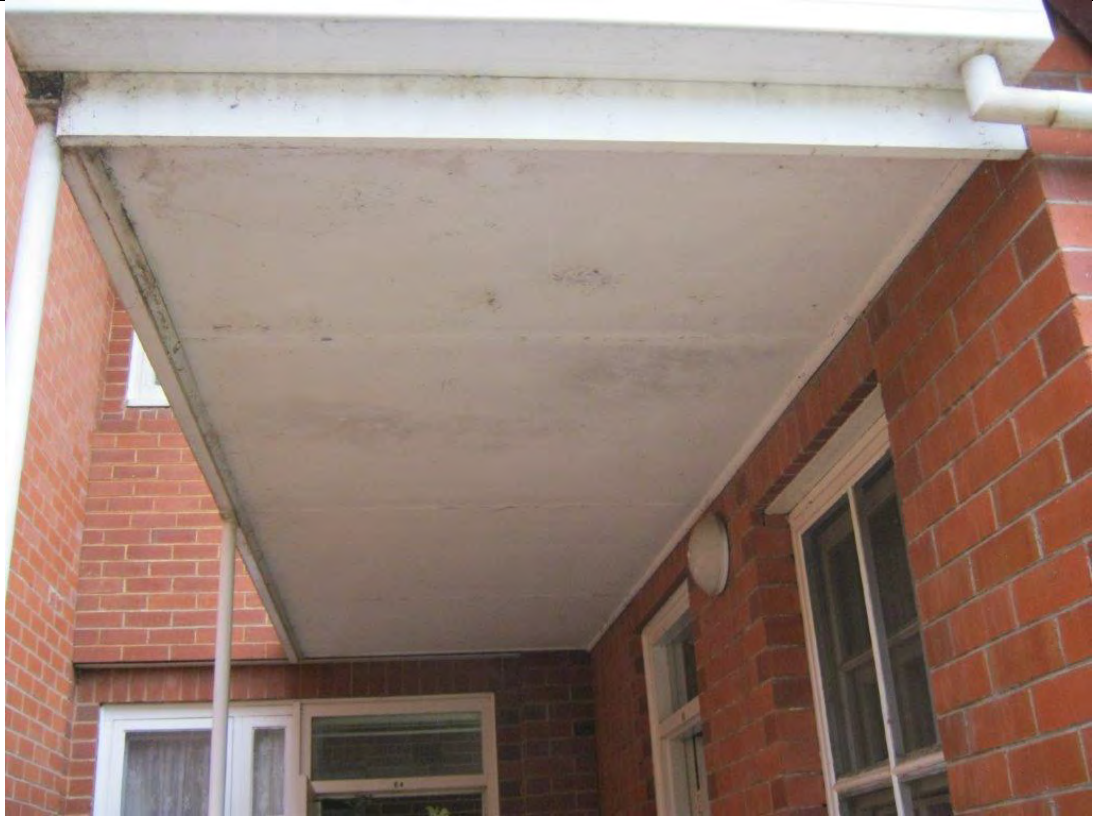
22	Maternity	Ground level	Ceiling panelling under the entry porch	Flat sheeting	Assume asbestos	13	-	Fair condition, remain isolated
23	Maternity	Level 1	Plant room upper doorway and ceiling	Flat sheeting	Assume asbestos	14	-	Fair condition, remain isolated
24	Maternity	Level 1	East end, nursery area	Vinyl floor tiles, old, lower layer	Bonded	15	NAD, SMF	Good condition
25	Maternity	Level 1	East end, nursery area	Vinyl floor tiles, new, upper	Bonded	15	CH, SMF	Good condition
26	Maternity	Ground	Room 80/8	Vinyl floor tiles	Bonded	16	NAD, SMF	Good condition
27	Maternity	Ground	Room 80/9	Vinyl floor tiles	Bonded	-	CH	Good condition
28	Maternity	Level 1	Above fire hose reel	Flat sheeting	Assume asbestos	17	-	Good condition

Photograph 13: Maternity, ceiling panelling

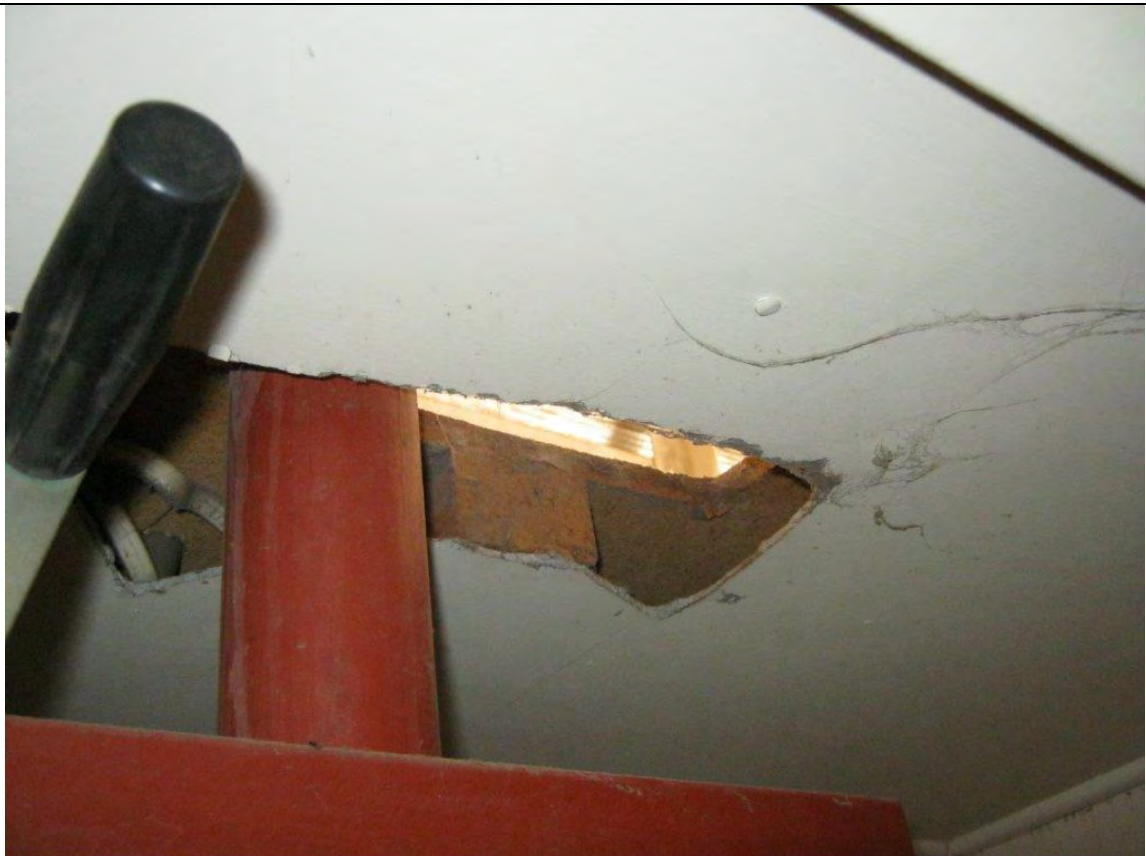
Photograph 14: Maternity, plant room walls and ceiling

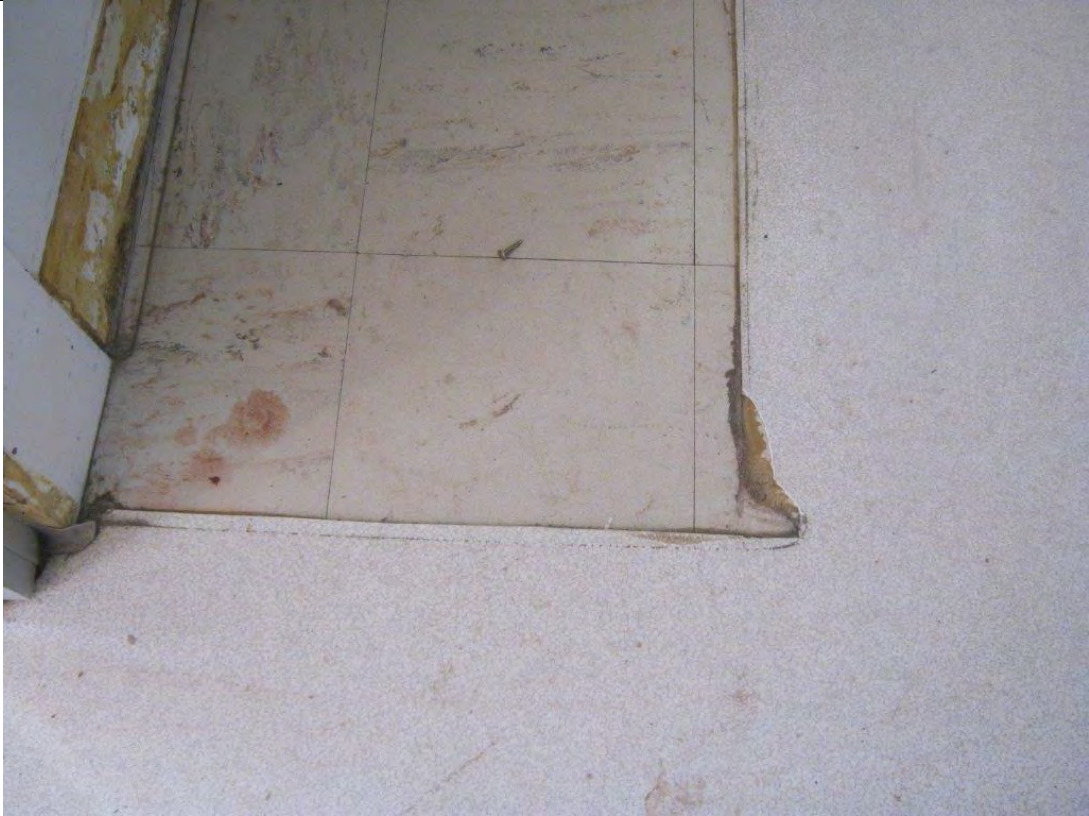
Photograph 15: Maternity, old and new vinyl floor tiles

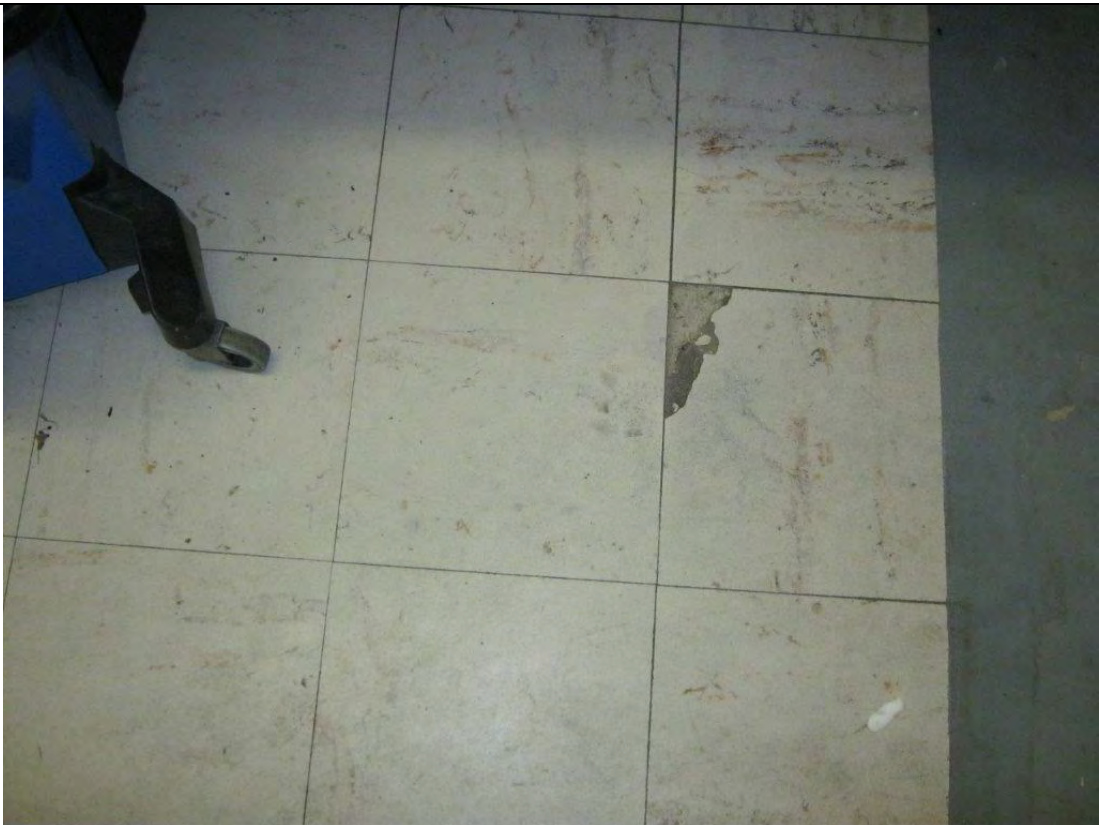
Photograph 16: Maternity, vinyl floor tiles room 80/8

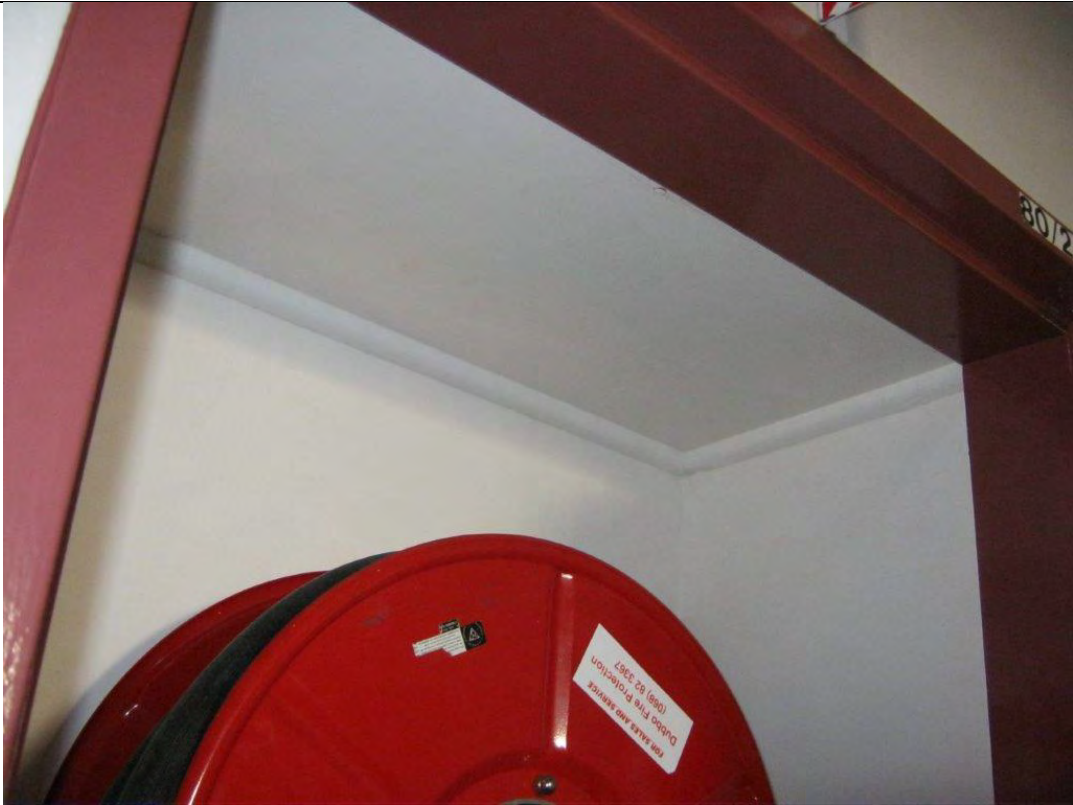
Photograph 17: Maternity, above fire reel

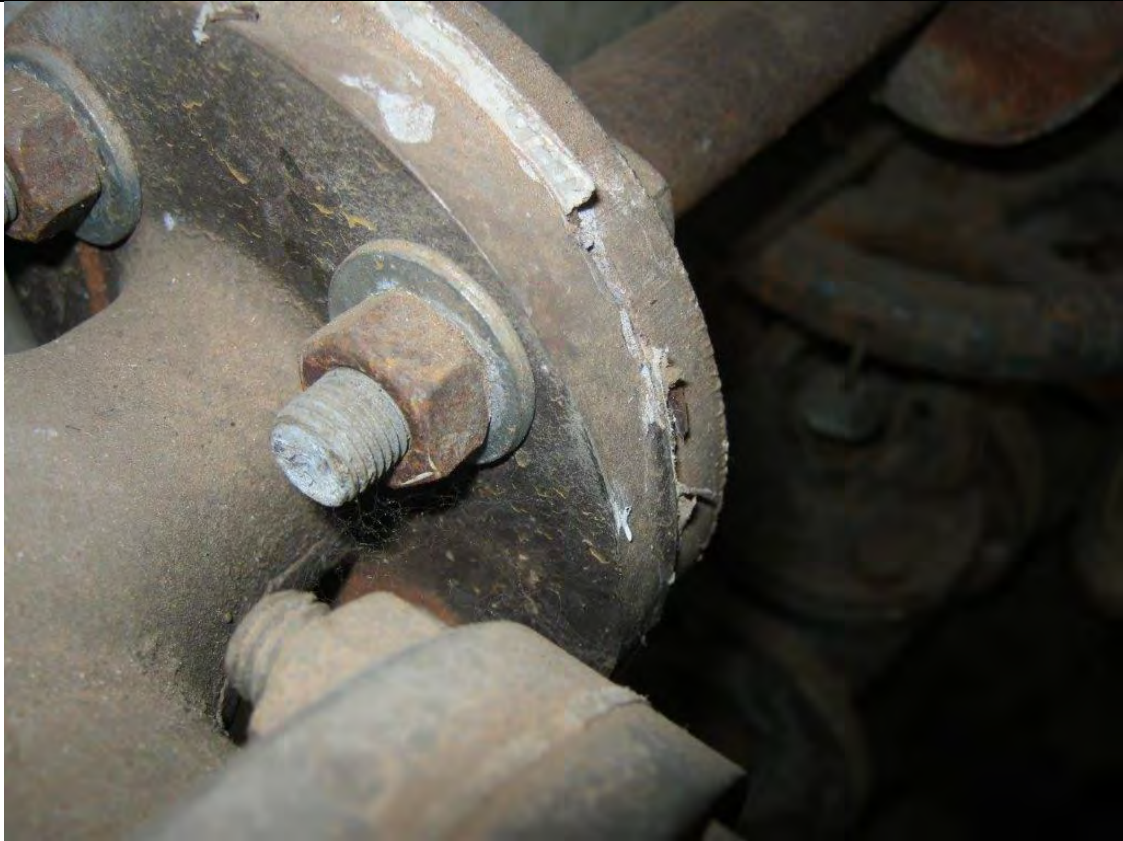
Photograph 18: Maternity, gasket in machinery (NAD)

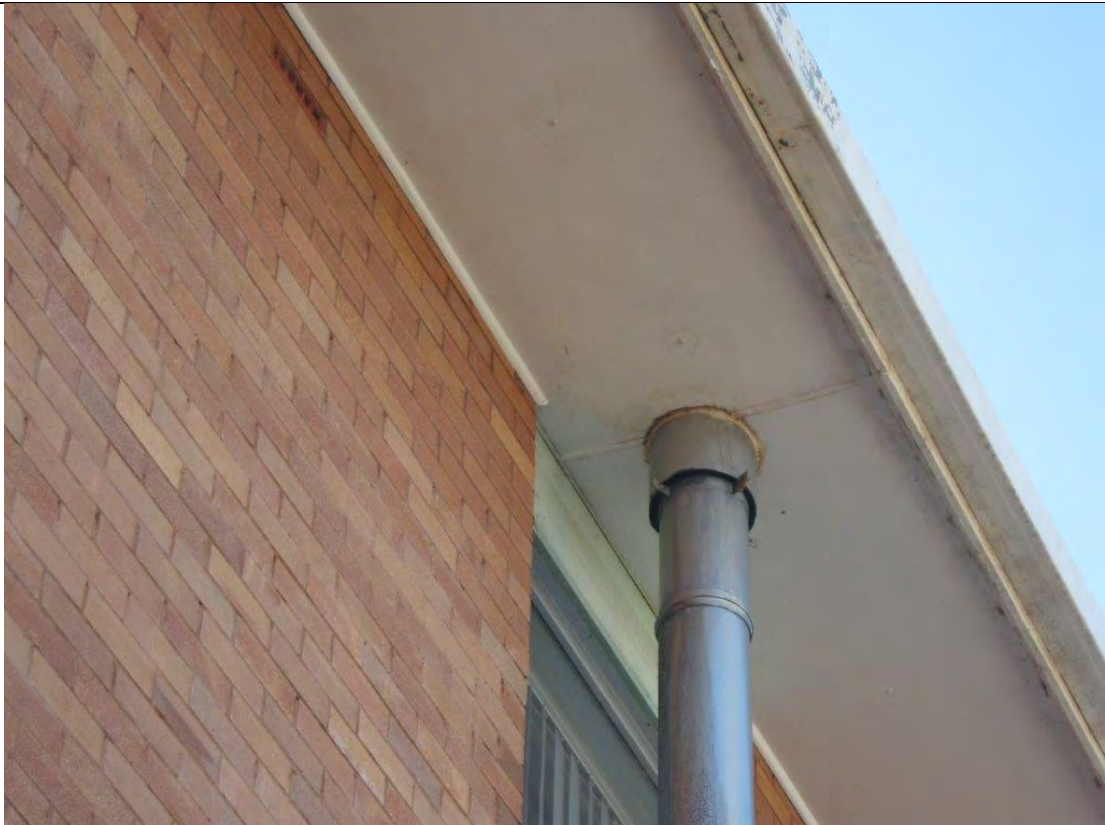
Photograph 24: Maternity, soffit

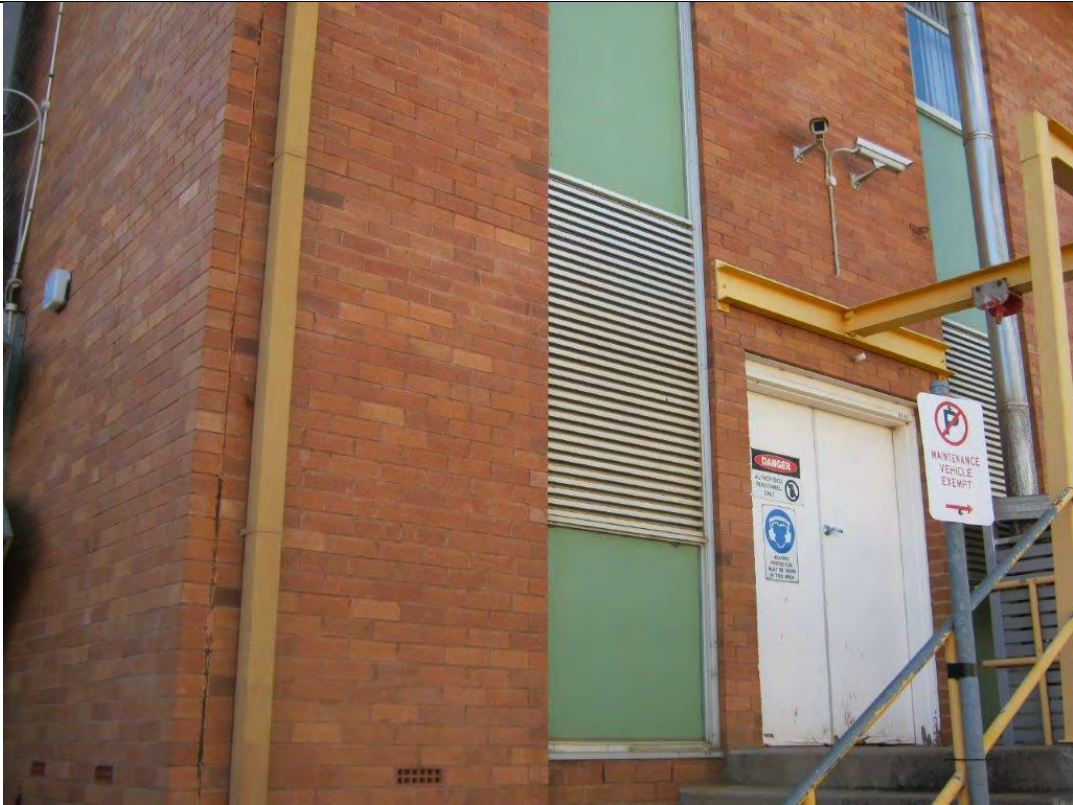
Photograph 25: Maternity, green spandrels

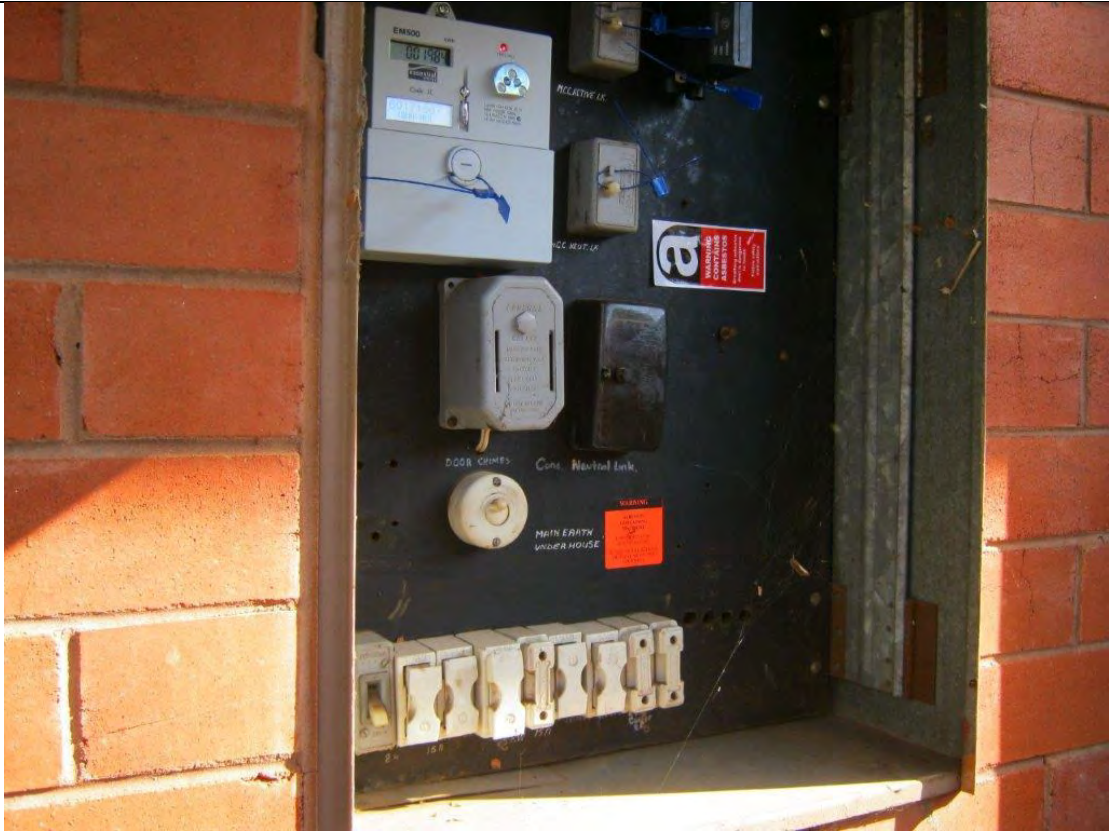
Photograph 27: Doctors accommodation, electrical switchboard, with asbestos label

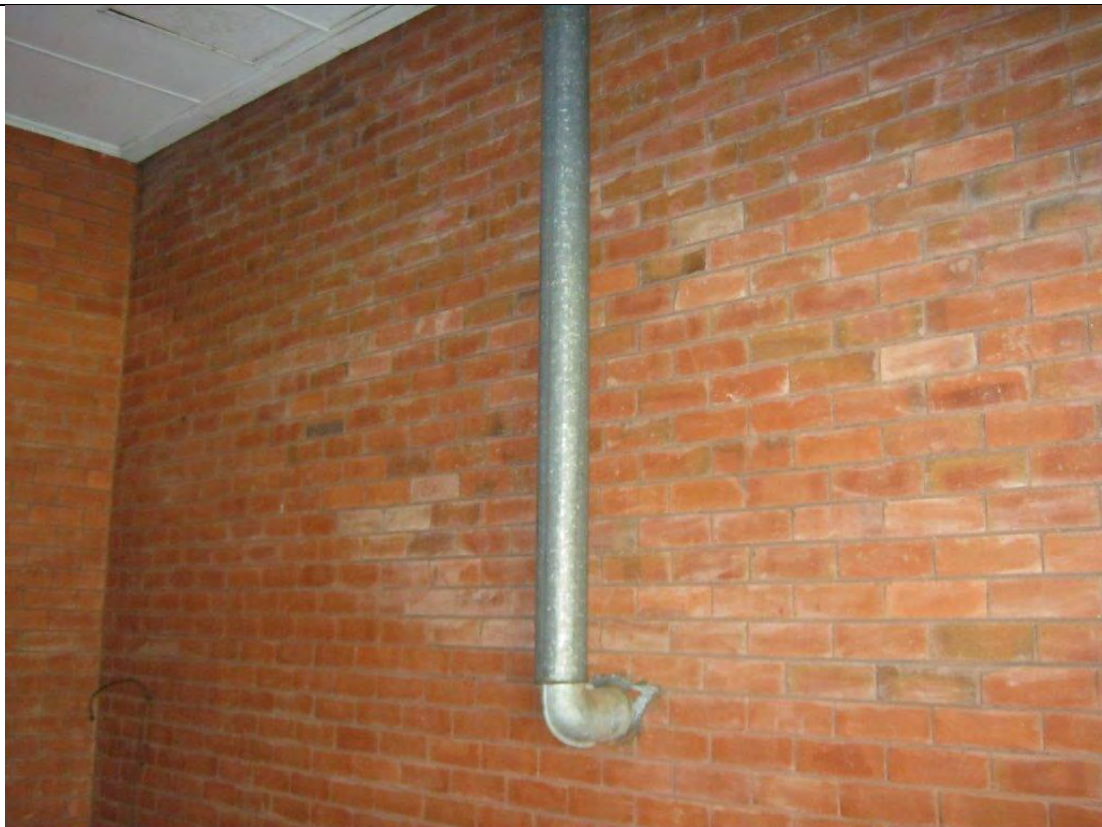
Photograph 28: Doctors accommodation, exhaust chimney in garge

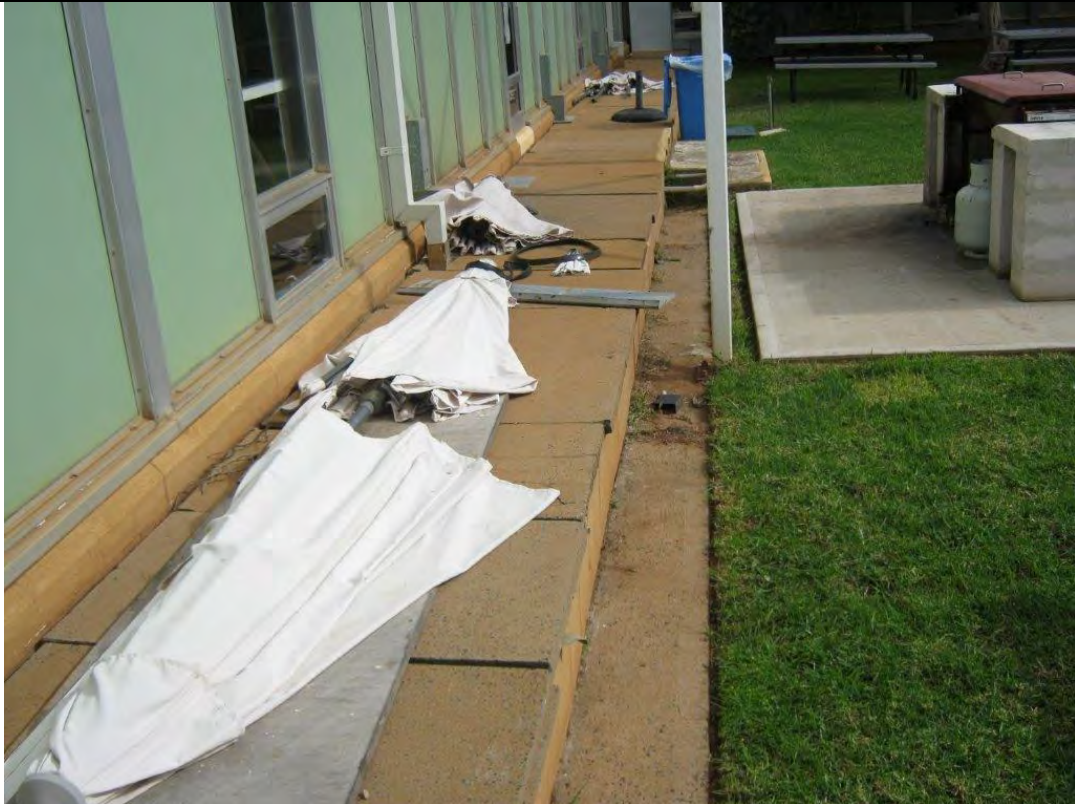
A particular risk area noted is in the below-ground trench on the northern side of the E / W Walkway, where lagged pipes can be seen from the ground surface through gaps between the concrete cover panels. This location is recommended to be remediated by adding more effective cover.

Photograph 36: East / west walkway, belowground trench

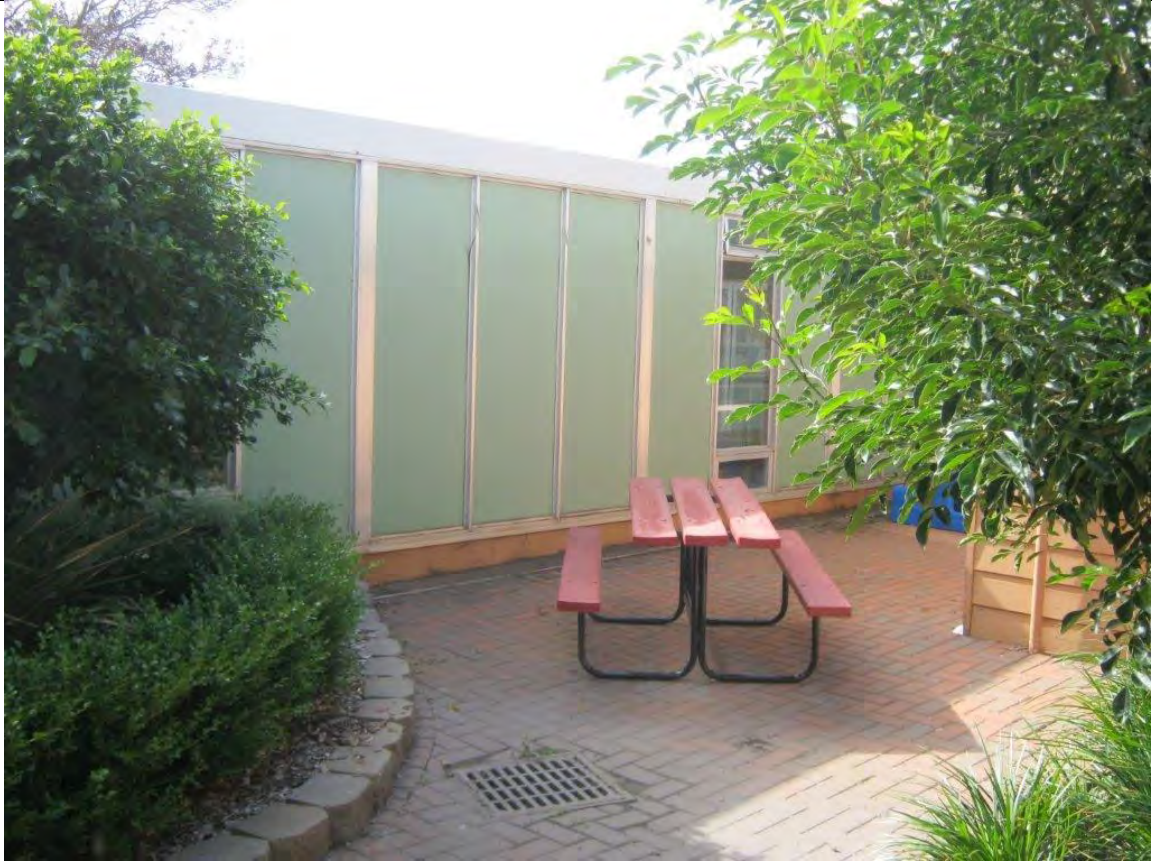
No.	Building Name	Floor of Building	Location	Material	Asbestos Type	Photo No.	Sample Test Result	Comments
54	North / south walkway	Ground	Green wall panels (98 panels)	Double (laminated) flat sheeting	Assume asbestos	37	-	Good condition

Photograph 37: North / south walkway, green wall panels

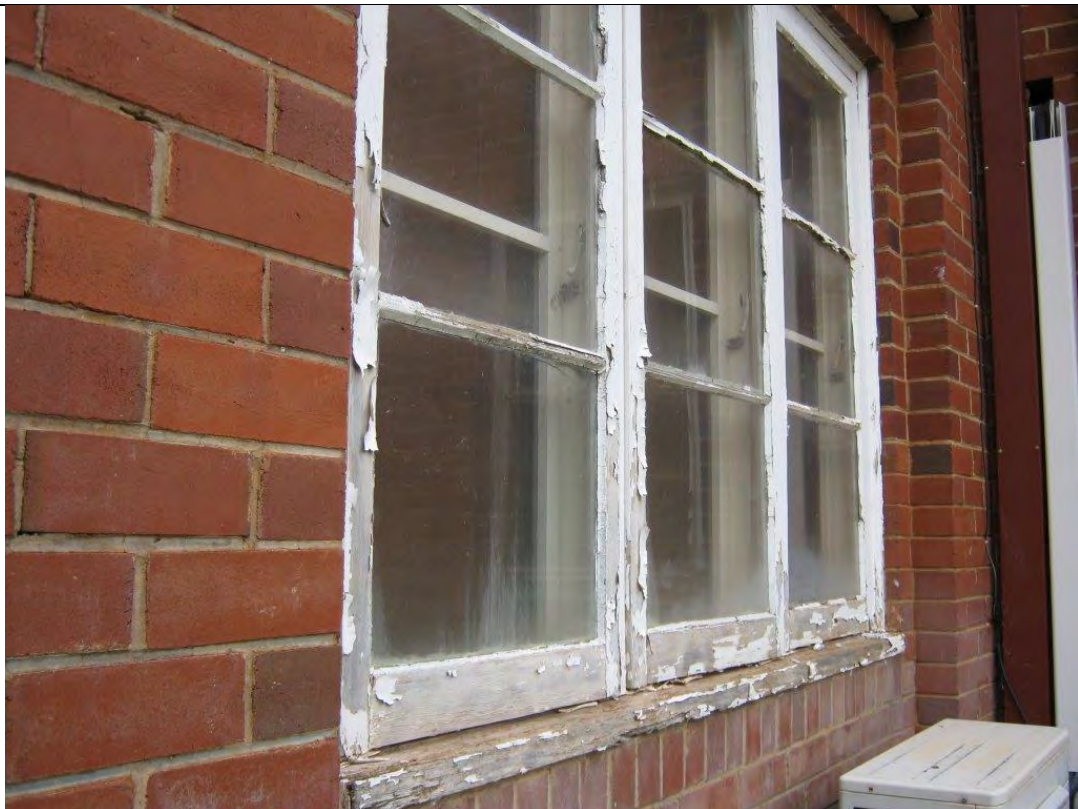
Paint work on the outside of the windows / doors *etc* of the George Hatch building was in particularly degraded condition, and these areas had obviously not been painted for 20-30 years. A sample of paint flakes was taken from a window of the southern side of the George Hatch building and analysed for lead. The result was 70,200 mg/kg of lead, or 7 percent, which indicates lead paint. The Certificate of Analysis is attached in Appendix E.

Photograph 38: George Hatch, flaking paint on southern windows
