Demolition/Refurbishment Hazardous Material Risk Assessment St George Community Housing SGCH 9-11 Gibbons Street, Redfern NSW 2016

Our Reference : C122647 : J155653

Date: March 2018

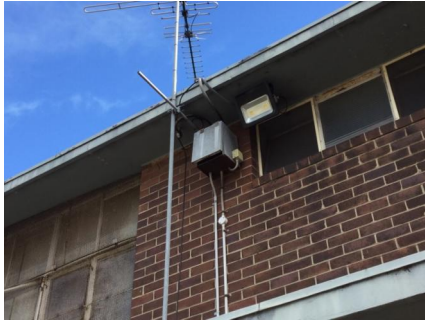
PHOTO NO.: J155653-001-PHOTO018
 RESULT: **ASBESTOS - PRESUMED POSITIVE**
 BUILDING/LEVEL: **MAIN BUILDING - GROUND LEVEL**
 ROOM/LOCATION: **ELECTRICAL BOX - ON UPPER WALL**
 FEATURE/MATERIAL: **ELECTRICAL - FUSE BOARD - COMPRESSED BITUMINOUS ELECTRICAL PANEL**
 SAMPLE NO.: **NOT SAMPLED HEIGHT RESTRICTED**

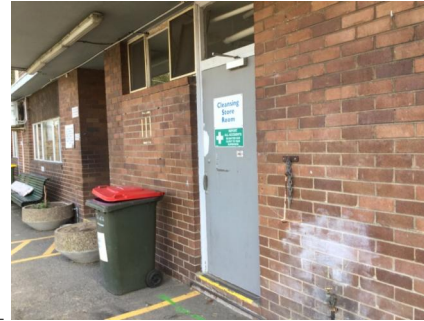
External window frames - Main elevations Door & Frame - Upper & Lower Paint System/s	Lead (Paint)	J155653-001-LP-005	Positive, 3.9% w/w	J155653-001-P hoto021	50 m ²	Good							Remove by an appropriately experienced contractor under controlled conditions and using correct PPE if this item will be impacted by refurbishment/ demolition works.	
External window frames - Main elevations Window Frame - Upper & Lower Paint System/s	Lead (Paint)	J155653-001-LP-004	Negative, <1% w/w											
Pavement - Adjacent outside wall Telecommunications Pit - Moulded Fibre Cement - Outside the perimeter fence on Gibbons Street.	Asbestos	Not Sampled Restricted Access	Presumed Positive	J155653-001-P hoto025 J155653-001-P hoto024	3 Unit/s	Fair	Non Friable	Medium	Medium	Not Labelled	09/06/2018	P2	If it will be affected by the work on the site, engage a licensed asbestos contractor to undertake remedial/removal works on this item as soon as practicable (within 3 months).

PHOTO NO.: J155653-001-PHOTO021
 RESULT: **LEAD (PAINT) - POSITIVE, 3.9% W/W**
 BUILDING/LEVEL: **MAIN BUILDING - GROUND LEVEL**
 ROOM/LOCATION: **EXTERNAL WINDOW FRAMES - MAIN ELEVATIONS**
 FEATURE/MATERIAL: **DOOR & FRAME - UPPER & LOWER PAINT SYSTEM/S**
 SAMPLE NO.: **J155653-001-LP-005**

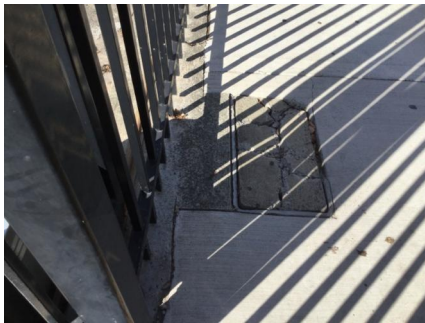
PHOTO NO.: J155653-001-PHOTO025
 RESULT: **ASBESTOS - PRESUMED POSITIVE**
 BUILDING/LEVEL: **MAIN BUILDING - GROUND LEVEL**
 ROOM/LOCATION: **PAVEMENT - ADJACENT OUTSIDE WALL**
 FEATURE/MATERIAL: **TELECOMMUNICATIONS PIT - MOULDED FIBRE CEMENT**
 SAMPLE NO.: **NOT SAMPLED RESTRICTED ACCESS**

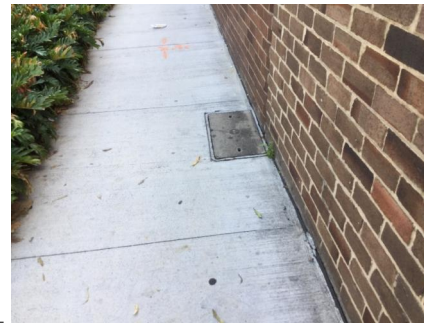
PHOTO NO.: J155653-001-PHOTO024
 RESULT: **ASBESTOS - PRESUMED POSITIVE**
 BUILDING/LEVEL: **MAIN BUILDING - GROUND LEVEL**
 ROOM/LOCATION: **PAVEMENT - ADJACENT OUTSIDE WALL**
 FEATURE/MATERIAL: **TELECOMMUNICATIONS PIT - MOULDED FIBRE CEMENT**
 SAMPLE NO.: **NOT SAMPLED RESTRICTED ACCESS**

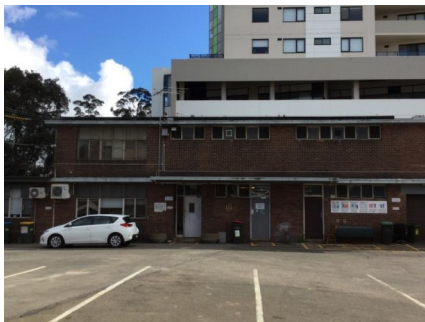
Roof - Throughout Roof Covering - Bituminous Material - No access	Asbestos	Not Sampled Height Restricted	Presumed Positive	J155653-001-P hoto017	200 m ²	Good	Non Friable	Low	Low	Not Labelled	09/03/2023	P4	Arrange access to sample and confirm asbestos content. If positive, remove under controlled conditions by an appropriately licensed asbestos contractor prior to refurbishment likely to disturb the material.	
Soffit - Main elevations Bulkhead - Upper & Lower Paint System/s	Lead (Paint)	Not Sampled Height Restricted	Presumed Positive	J155653-001-P hoto022	10 m ²	Fair							Remove by an appropriately experienced contractor under controlled conditions and using correct PPE if this item will be impacted by refurbishment/ demolition works.	
Main building - Interior - Ground Level														
Cleansing store - Throughout Floor Covering - Vinyl Tiles & Adhesive	Asbestos	Similar To: J155653-001-003	Presumed Negative

PHOTO NO.: J155653-001-PHOTO017
 RESULT: **ASBESTOS - PRESUMED POSITIVE**
 BUILDING/LEVEL: **MAIN BUILDING - GROUND LEVEL**
 ROOM/LOCATION: **ROOF - THROUGHOUT**
 FEATURE/MATERIAL: **ROOF COVERING - BITUMINOUS MATERIAL**
 SAMPLE NO.: **NOT SAMPLED HEIGHT RESTRICTED**

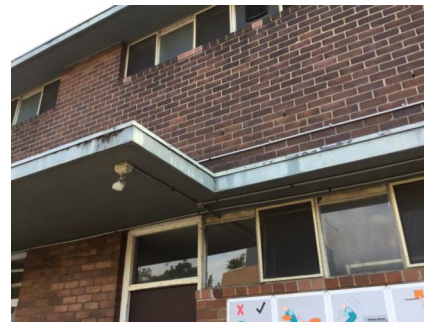
PHOTO NO.: J155653-001-PHOTO022
 RESULT: **LEAD (PAINT) - PRESUMED POSITIVE**
 BUILDING/LEVEL: **MAIN BUILDING - GROUND LEVEL**
 ROOM/LOCATION: **SOFFIT - MAIN ELEVATIONS**
 FEATURE/MATERIAL: **BULKHEAD - UPPER & LOWER PAINT SYSTEM/S**
 SAMPLE NO.: **NOT SAMPLED HEIGHT RESTRICTED**

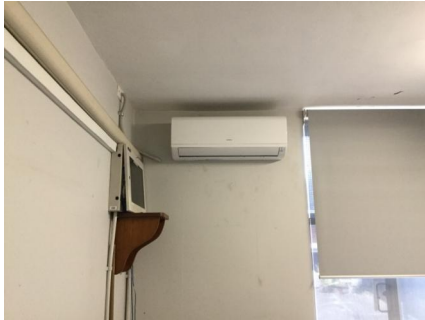
PHOTO NO.: J155653-001-PHOTO019
 RESULT: ODS - PRESUMED POSITIVE
 BUILDING/LEVEL: MAIN BUILDING - GROUND LEVEL
 ROOM/LOCATION: OFFICE - FRONT WALL
 FEATURE/MATERIAL: SPLIT SYSTEM AIR CON UNIT - R401A - HCFC BLEND
 SAMPLE NO.: -

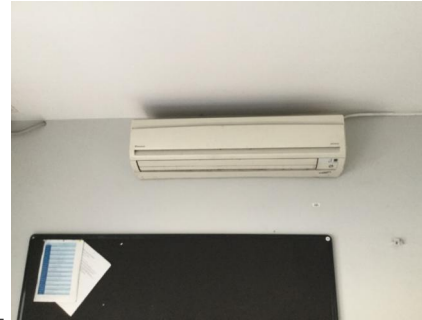
PHOTO NO.: J155653-001-PHOTO015
 RESULT: ODS - PRESUMED POSITIVE
 BUILDING/LEVEL: MAIN BUILDING - GROUND LEVEL
 ROOM/LOCATION: TEAM LEADERS OFFICE - REAR WALL
 FEATURE/MATERIAL: SPLIT SYSTEM AIR CON UNIT - R401A - HCFC BLEND
 SAMPLE NO.: -

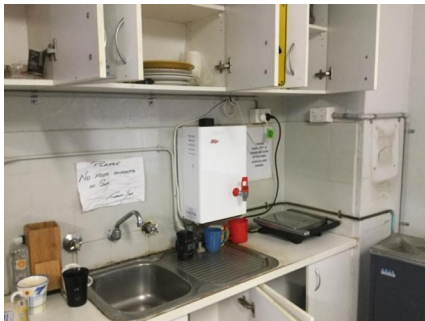
PHOTO NO.: J155653-001-PHOTO007
 RESULT: SMF - PRESUMED POSITIVE
 BUILDING/LEVEL: MAIN BUILDING - LEVEL ONE
 ROOM/LOCATION: LUNCH ROOM
 FEATURE/MATERIAL: HOT WATER HEATER - INSULATION MATERIAL
 SAMPLE NO.: -

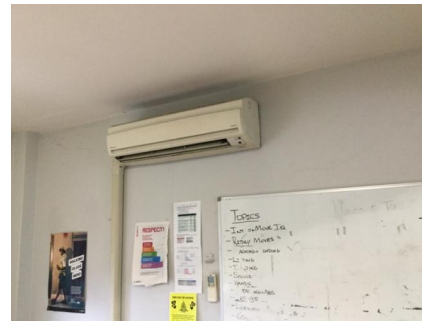
PHOTO NO.: J155653-001-PHOTO008
 RESULT: ODS - PRESUMED POSITIVE
 BUILDING/LEVEL: MAIN BUILDING - LEVEL ONE
 ROOM/LOCATION: LUNCH ROOM - REAR WALL
 FEATURE/MATERIAL: SPLIT SYSTEM AIR CON UNIT - R401A - HCFC BLEND
 SAMPLE NO.: -

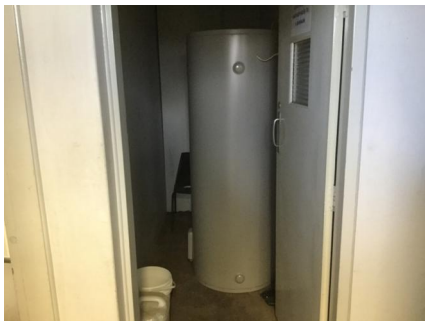
PHOTO NO.: J155653-001-PHOTO003
 RESULT: SMF - PRESUMED POSITIVE
 BUILDING/LEVEL: MAIN BUILDING - LEVEL ONE
 ROOM/LOCATION: UTILITY ROOM - THROUGHOUT
 FEATURE/MATERIAL: HOT WATER HEATER - INSULATION MATERIAL
 SAMPLE NO.: -

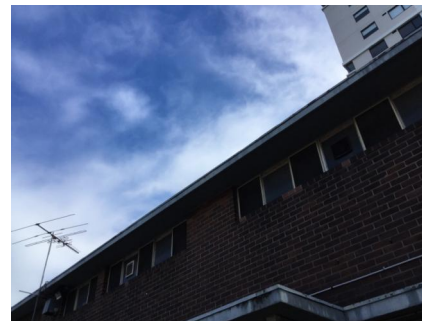
Main building - Exterior - Roof														
Roof - Main elevations Fascia - Upper & Lower Paint System/s	Lead (Paint)	Not Sampled Height Restricted	Presumed Positive	J155653-001-P hoto023	10 m ²	Fair							Remove by an appropriately experienced contractor under controlled conditions and using correct PPE if this item will be impacted by refurbishment/ demolition works.

PHOTO NO.: J155653-001-PHOTO023
 RESULT: LEAD (PAINT) - PRESUMED POSITIVE
 BUILDING/LEVEL: MAIN BUILDING - ROOF
 ROOM/LOCATION: ROOF - MAIN ELEVATIONS
 FEATURE/MATERIAL: FASCIA - UPPER & LOWER PAINT SYSTEM/S
 SAMPLE NO.: NOT SAMPLED HEIGHT RESTRICTED

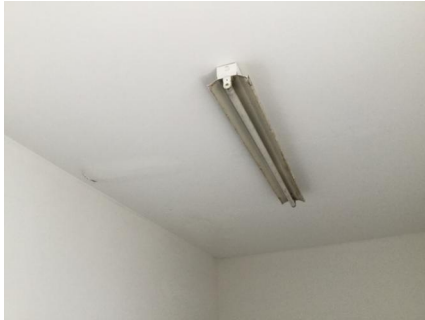
PHOTO NO.: J155653-001-PHOTO029
 RESULT: PCB - PRESUMED POSITIVE
 BUILDING/LEVEL: MOWERS SHED - ALL LEVELS
 ROOM/LOCATION: ALL AREAS - CEILINGS
 FEATURE/MATERIAL: FLUORESCENT LIGHT FITTING - CAPACITOR
 SAMPLE NO.: -

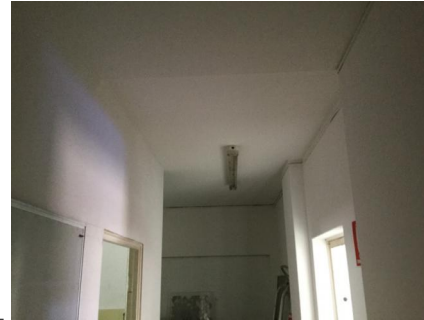
PHOTO NO.: J155653-001-PHOTO030
 RESULT: PCB - PRESUMED POSITIVE
 BUILDING/LEVEL: MOWERS SHED - ALL LEVELS
 ROOM/LOCATION: ALL AREAS - CEILINGS
 FEATURE/MATERIAL: FLUORESCENT LIGHT FITTING - CAPACITOR
 SAMPLE NO.: -

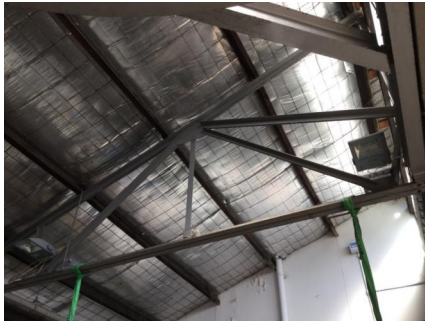
PHOTO NO.: J155653-001-PHOTO034
 RESULT: LEAD (PAINT) - PRESUMED POSITIVE
 BUILDING/LEVEL: MOWERS SHED - ALL LEVELS
 ROOM/LOCATION: ROOF - ROOF FRAME
 FEATURE/MATERIAL: FRAMEWORK - UPPER & LOWER PAINT SYSTEM/S
 SAMPLE NO.: NOT SAMPLED HEIGHT RESTRICTED

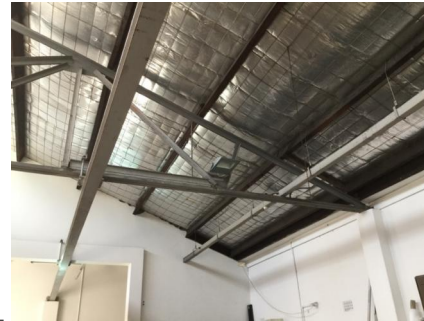
PHOTO NO.: J155653-001-PHOTO033
 RESULT: LEAD (PAINT) - PRESUMED POSITIVE
 BUILDING/LEVEL: MOWERS SHED - ALL LEVELS
 ROOM/LOCATION: ROOF - ROOF FRAME
 FEATURE/MATERIAL: FRAMEWORK - UPPER & LOWER PAINT SYSTEM/S
 SAMPLE NO.: NOT SAMPLED HEIGHT RESTRICTED

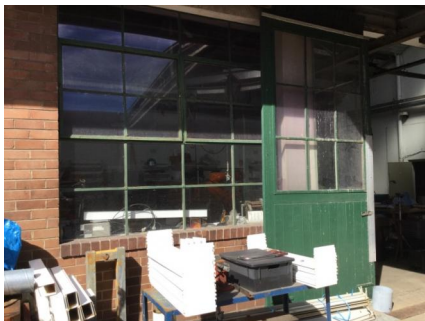
Mowers Shed - Interior & Exterior - All Levels														
All areas - Doors and windows Door & Frame - Upper & Lower Paint System/s - Green paint systems	Lead (Paint)	J155653-001-LP-007	Positive, 3.5% w/w	J155653-001-P hoto031 J155653-001-P hoto032		Fair							Remove by an appropriately experienced contractor under controlled conditions and using correct PPE if this item will be impacted by refurbishment/ demolition works.	
Mowers Shed - Interior - Ground Level														
Below stairs - Adjacent outside wall Electrical - Fuse Board - Bituminous Material	Asbestos	J155653-001-004	Positive	J155653-001-P hoto036	1 m ²	Good	Non Friable	Low	Low	Not Labelled	09/03/2023	P4	Remove under controlled conditions by an appropriately licensed asbestos contractor prior to refurbishment likely to disturb the material. Maintain in-situ if not to be affected by proposed works.	
Electrical cupboard - Fuses Fuse Holders - Internal Components - Older ceramic fuses	Asbestos	J155653-001-005	Negative

PHOTO NO.: J155653-001-PHOTO031
 RESULT: LEAD (PAINT) - POSITIVE, 3.5% W/W
 BUILDING/LEVEL: MOWERS SHED - ALL LEVELS
 ROOM/LOCATION: ALL AREAS - DOORS AND WINDOWS
 FEATURE/MATERIAL: DOOR & FRAME - UPPER & LOWER PAINT SYSTEM/S
 SAMPLE NO.: J155653-001-LP-007

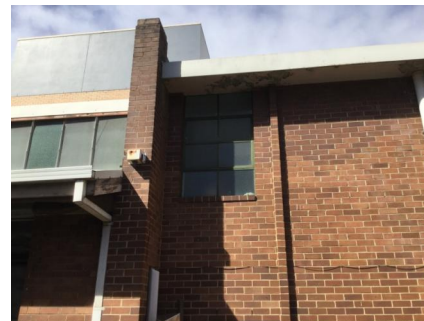
PHOTO NO.: J155653-001-PHOTO032
 RESULT: LEAD (PAINT) - POSITIVE, 3.5% W/W
 BUILDING/LEVEL: MOWERS SHED - ALL LEVELS
 ROOM/LOCATION: ALL AREAS - DOORS AND WINDOWS
 FEATURE/MATERIAL: DOOR & FRAME - UPPER & LOWER PAINT SYSTEM/S
 SAMPLE NO.: J155653-001-LP-007

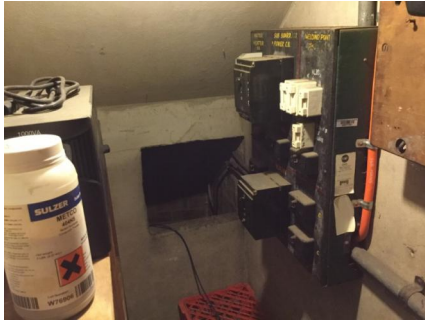
PHOTO NO.: J155653-001-PHOTO036
 RESULT: ASBESTOS - POSITIVE
 BUILDING/LEVEL: MOWERS SHED - GROUND LEVEL
 ROOM/LOCATION: BELOW STAIRS - ADJACENT OUTSIDE WALL
 FEATURE/MATERIAL: ELECTRICAL - FUSE BOARD - BITUMINOUS MATERIAL
 SAMPLE NO.: J155653-001-004

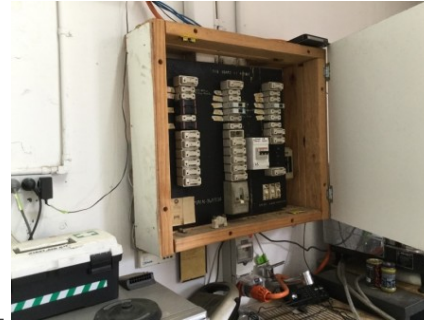
Main shed - At Gibbons St end Electrical Distribution Board - Compressed Bituminous Electrical Panel	Asbestos	Similar To: J155653-001-004	Presumed Positive	J155653-001-P hoto038	1 Unit/s	Good	Non Friable	Low	Low	Not Labelled	09/03/2023	P4	Remove under controlled conditions by an appropriately licensed asbestos contractor prior to refurbishment likely to disturb the material. Maintain in-situ if not to be affected by proposed works.	
Main shed - Below floor	Storage Tanks	Not Sampled No access to area below floor	Presumed Positive	J155653-001-P hoto027		Not able to determine							It appears that there are tanks or voids below the floor slab but there is currently no access. Their presence should be confirmed prior to the commencement of demolition works.	
Main shed - Roof lining Insulation - Sarking Insulation	SMF		Presumed Positive	J155653-001-P hoto026	300 m ²	Good	Bonded (SMF)						Remove by an appropriately experienced contractor under controlled conditions and using correct PPE if this material will be impacted by refurbishment/ demolition works.

PHOTO NO.: J155653-001-PHOTO038
 RESULT: ASBESTOS - PRESUMED POSITIVE
 BUILDING/LEVEL: MOWERS SHED - GROUND LEVEL
 ROOM/LOCATION: MAIN SHED - AT GIBBONS ST END
 FEATURE/MATERIAL: ELECTRICAL DISTRIBUTION BOARD - COMPRESSED BITUMINOUS ELECTRICAL PANEL
 SAMPLE NO.: SIMILAR TO: J155653-001-004

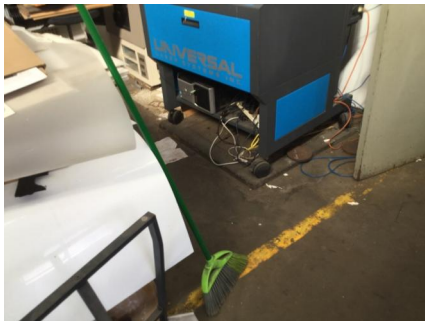
PHOTO NO.: J155653-001-PHOTO027
 RESULT: STORAGE TANKS - PRESUMED POSITIVE
 BUILDING/LEVEL: MOWERS SHED - GROUND LEVEL
 ROOM/LOCATION: MAIN SHED - BELOW FLOOR
 FEATURE/MATERIAL: NON-HAZARDOUS FEATURE - NON-HAZARDOUS MATERIAL
 SAMPLE NO.: NOT SAMPLED NO ACCESS TO AREA BELOW FLOOR

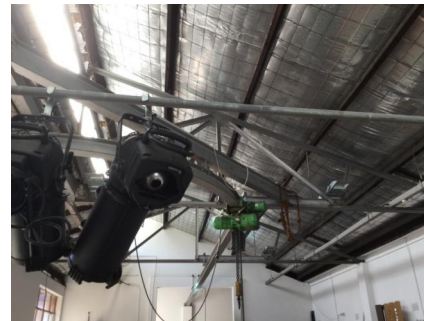
PHOTO NO.: J155653-001-PHOTO026
 RESULT: SMF - PRESUMED POSITIVE
 BUILDING/LEVEL: MOWERS SHED - GROUND LEVEL
 ROOM/LOCATION: MAIN SHED - ROOF LINING
 FEATURE/MATERIAL: INSULATION - SARKING INSULATION
 SAMPLE NO.: -

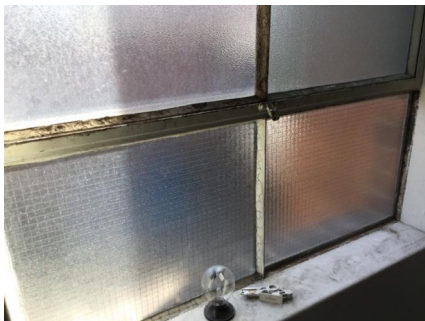
PHOTO NO.: J155653-001-PHOTO028
 RESULT: LEAD (PAINT) - POSITIVE, 1.1% W/W
 BUILDING/LEVEL: MOWERS SHED - LEVEL ONE
 ROOM/LOCATION: ALL AREAS - WINDOW FRAMES
 FEATURE/MATERIAL: WINDOW FRAME - UPPER & LOWER PAINT SYSTEM/S
 SAMPLE NO.: J155653-001-LP-006
