# HAZARDOUS MATERIALS SURVEY REPORT

136 NEW SOUTH HEAD ROAD  
EDGECLIFF NSW, 2027

Hazardous Materials Survey Report  
136 New South Head Road Edgecliff NSW, 2027  
LENDLEASE DEVELOPMENT

## Hazardous Materials Survey Report 142-146 & 148 New South Head Road Edgecliff, NSW, 2027 LENDLEASE DEVELOPMENT

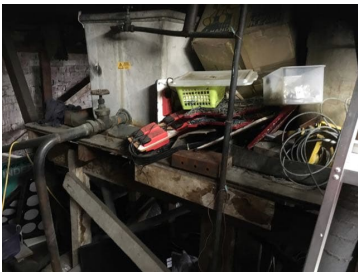
| NON-ASBESTOS CONTAINING MATERIAL | | | |
|---|---|---|---|
| Material | Dust | | |
| Risk Rating | No Asbestos | | |

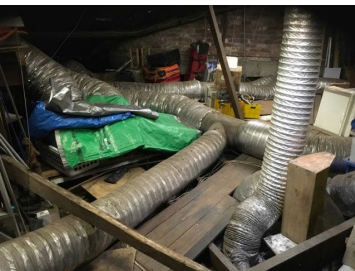
| SYNTHETIC MINERAL FIBRE | | | |
|---|---|---|---|
| Application | Air conditioning ductwork, insulation material | | |
| Risk Rating | Low Risk | | |

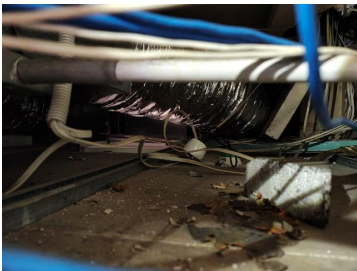
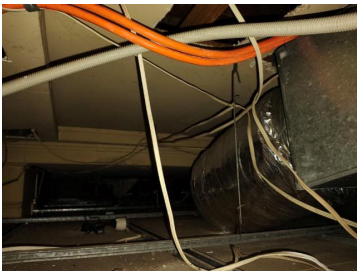
| SYNTHETIC MINERAL FIBRE | | | |
|---|---|---|---|
| Application | Air conditioning ducting | | |
| Risk Rating | Low Risk | | |

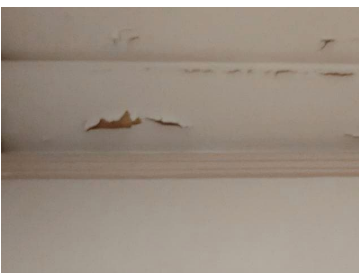
| LBP DETECTED | | | |
|---|---|---|---|
| Risk Rating | Medium Risk | | |

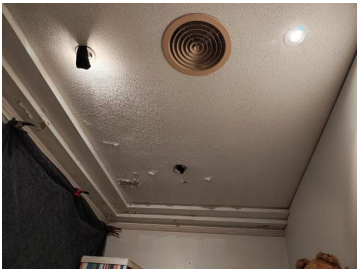
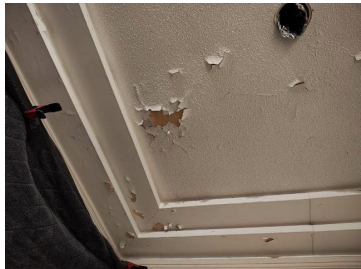
| LBP DETECTED | | | |
|---|---|---|---|
| Photo Ref | <a href="#">LBP-30369</a> | Sample No | Lead Paint Sample WSP-326751 |

| LBP DETECTED | | | |
|---|---|---|---|
| Application | Ceiling texture white based paint system throughout | | |
| Risk Rating | Medium Risk | | |

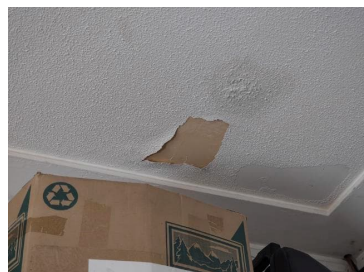
| LBP DETECTED | | | |
|---|---|---|---|
| Risk Rating | Medium Risk | | |

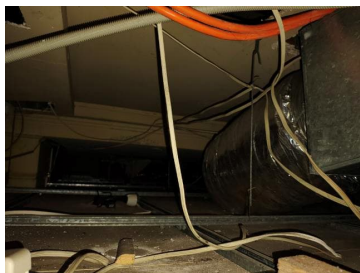
| LEAD DUST DETECTED | | | |
|---|---|---|---|
| Risk Rating | High Risk | | |

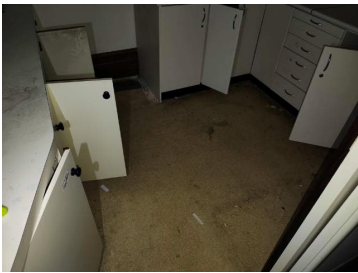
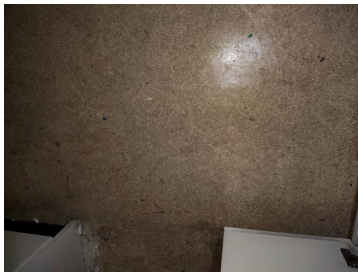
| NON-ASBESTOS CONTAINING MATERIAL | | | |
|---|---|---|---|
| Material | Vinyl sheeting | | |
| Risk Rating | No Asbestos | | |

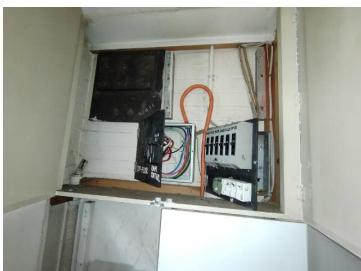
| NON-ASBESTOS CONTAINING MATERIAL | | | |
|---|---|---|---|
| Material | Other | | |
| Risk Rating | No Asbestos | | |

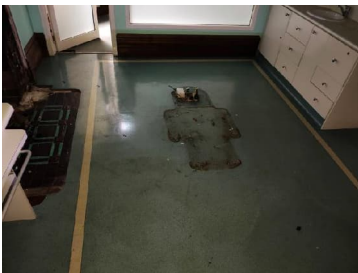
| NON-ASBESTOS CONTAINING MATERIAL | | | |
|---|---|---|---|
| Material | Vinyl sheeting and adhesive | | |
| Risk Rating | No Asbestos | | |

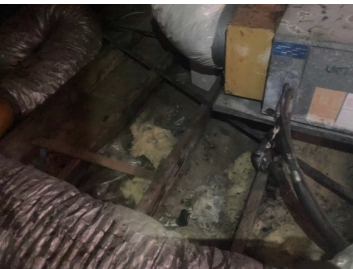
| SYNTHETIC MINERAL FIBRE | | | |
|---|---|---|---|
| Application | Ceiling loose insulation | | |
| Risk Rating | Low Risk | | |

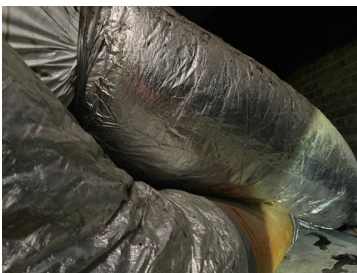
| SYNTHETIC MINERAL FIBRE | | | |
|---|---|---|---|
| Application | Air conditioning ductwork - insulation material | | |
| Risk Rating | Low Risk | | |

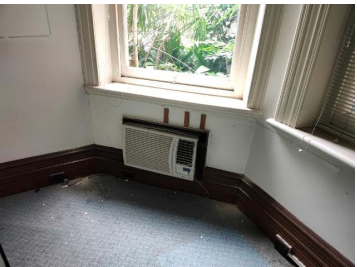
| SYNTHETIC MINERAL FIBRE | | | |
|---|---|---|---|
| Application | Window air conditioner | | |
| Risk Rating | Low Risk | | |

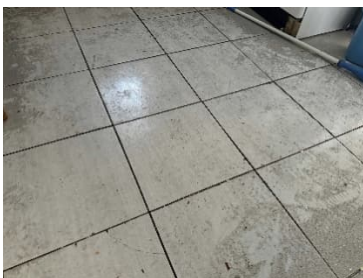
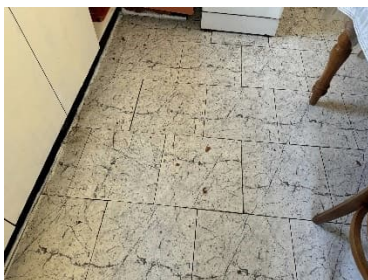
| ASBESTOS - Confirmed | | | |
|---|---|---|---|
| Material | Vinyl sheeting | | |
| Risk Rating | Low | | |

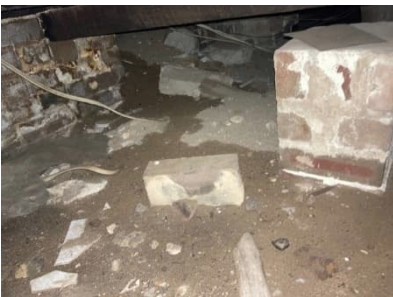
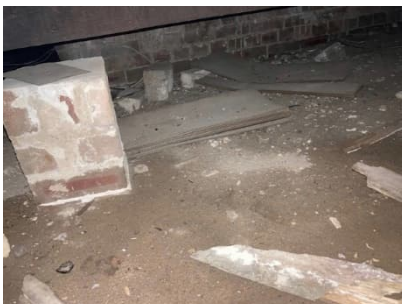
| NO ACCESS | | | |
|---|---|---|---|
| Material | - | | |
| Risk Rating | Inaccessible | | |

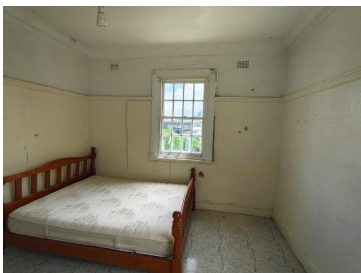
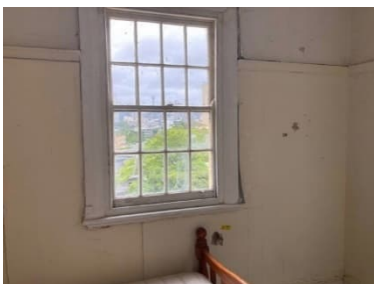
| ASBESTOS - Confirmed | | | |
|---|---|---|---|
| Photo Ref | <a href="#">169802</a> | Sample No | WSP-326715 |

| ASBESTOS - Confirmed | | | |
|---|---|---|---|
| Material | Fibre cement sheeting | | |
| Risk Rating | High | | |

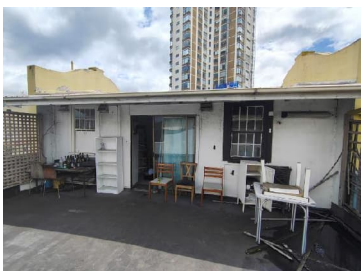
| ASBESTOS - Confirmed | | | |
|---|---|---|---|
| Photo Ref | <a href="#">169799</a> | Sample No | WSP-326719 |

| ASBESTOS - Confirmed | | | |
|---|---|---|---|
| Material | Fibre cement sheeting | | |
| Risk Rating | Low | | |

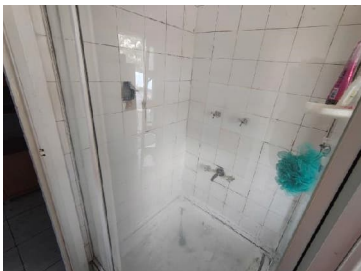
| ASBESTOS - Confirmed | | | |
|---|---|---|---|
| Material | Fibre cement sheeting | | |
| Risk Rating | Low | | |

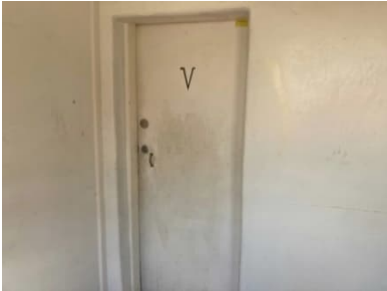
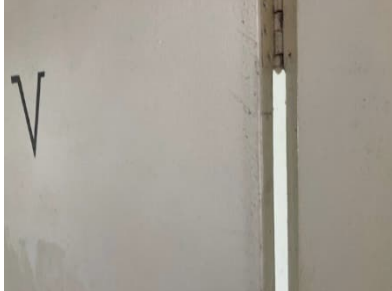
| NON-ASBESTOS CONTAINING MATERIAL | | | |
|---|---|---|---|
| Material | Vermiculite | | |
| Risk Rating | No Asbestos | | |

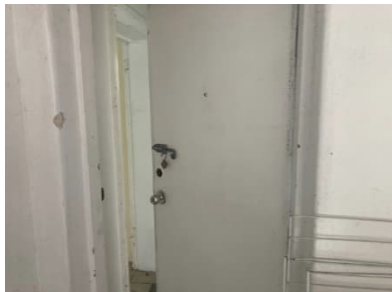
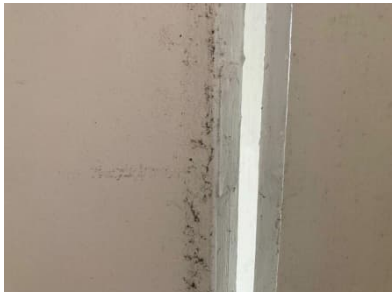
| NON-ASBESTOS CONTAINING MATERIAL | | | |
|---|---|---|---|
| Photo Ref | <a href="#">170502</a> | Sample No | Ref: WSP-231483 |

| NON-ASBESTOS CONTAINING MATERIAL | | | |
|---|---|---|---|
| Material | Vermiculite | | |
| Risk Rating | No Asbestos | | |

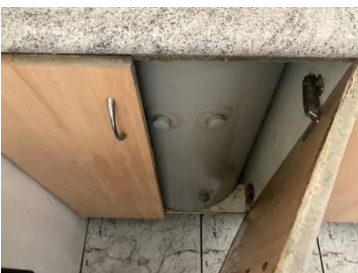
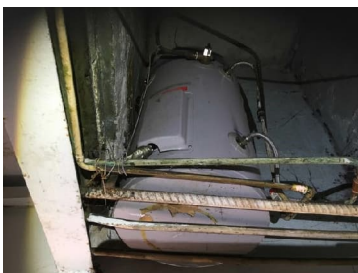
| SYNTHETIC MINERAL FIBRE | | | |
|---|---|---|---|
| Application | Hot water unit - insulation material | | |
| Risk Rating | Low Risk | | |
