## AQUALAND PRESTIGE 2 PTY LTD

## Hazardous Materials Survey

2-16 Pockley Avenue, Roseville NSW

**Report No:** E26491.E10\_Rev1

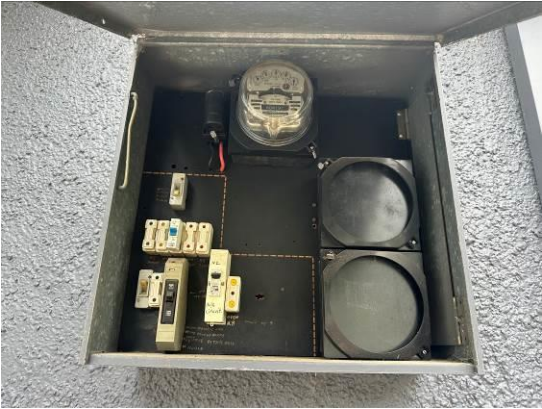
| Location | Material | Friability | Sample | Analysis Result | Quantity | Condition / Accessibility | Priority | Date of Identification | Recommendations / Comments | Photograph |
|---|---|---|---|---|---|---|---|---|---|---|
| External, main dwelling, south eastern side, black meter backing board | ACM (assumed) | Non-friable | Visual inspection - electrical hazard | - | 1 x board | Good / Maintenance only | Priority 4 - Negligible Risk Level | 20/02/2025 | Remove during initial stage of demolition works | |

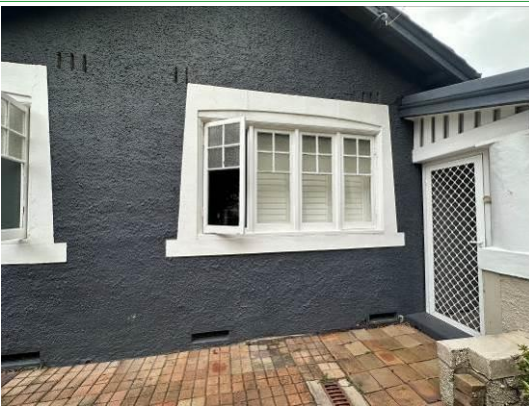
| External, main dwelling, eastern side, window frame | Putty | Non-friable | Asb-01 | No Asbestos Detected | N/A | N/A | N/A | N/A | N/A | |

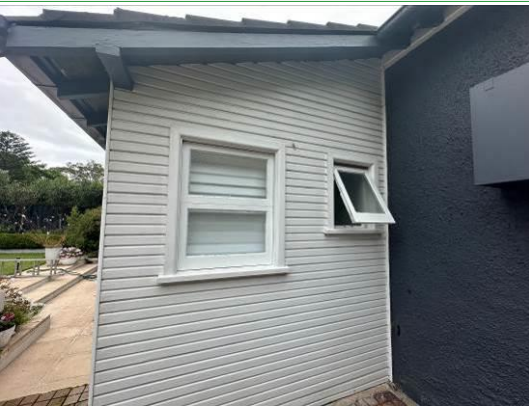
| External, main dwelling, northern side, window frame | White LBP | Non-friable | LP-1 | 0.88% w/w | 1 x window | Good / Maintenance only | Priority 4 - Negligible Risk Level | 20/02/2025 | Remove grossly peeling paint. Stabilise remaining membrane. Minimise abrasive works that will disturb paint during demolition. | |

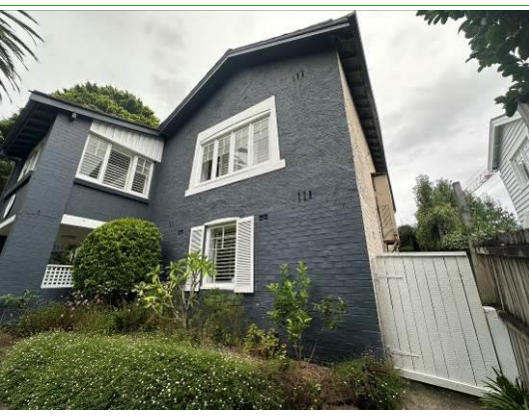
| External / Internal, main dwelling, window frames / door frames throughout | White LBP (assumed) | Non-friable | Visual inspection – similar to LP-01 | - | ND | Good / Maintenance only | Priority 4 - Negligible Risk Level | 20/02/2025 | Remove grossly peeling paint. Stabilise remaining membrane. Minimise abrasive works that will disturb paint during demolition. | |

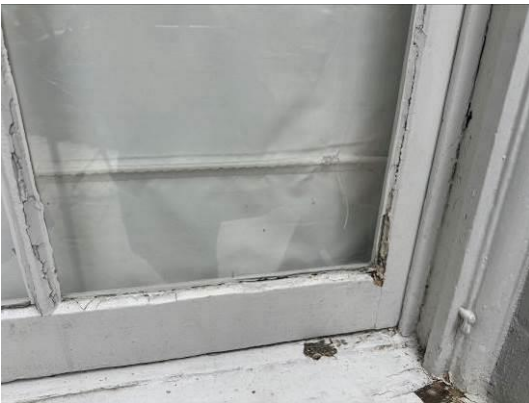
| External, main dwelling , ground level, south eastern side, window frame, putty | ACM | Non-friable | Asb-3 | Chrysotile Asbestos Detected<br>Organic Fibres Detected | <1m <sup>2</sup> | Good / Occasional | Priority 3 - Low Risk Level | 20/02/2025 | Refer to Section 6.1 for removal recommendations.<br>Remove during initial stage of demolition works | |

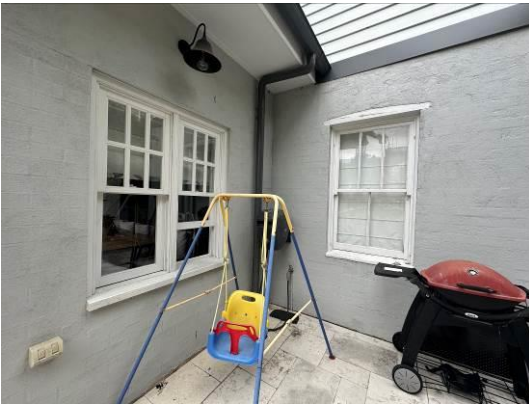
| External, main dwelling ,window putty throughout | ACM (assumed) | Non-friable | Visual inspection – similar to Asb-03 | - | ND | Good / Occasional | Priority 3 - Low Risk Level | 20/02/2025 | Remove during initial stage of demolition works | |

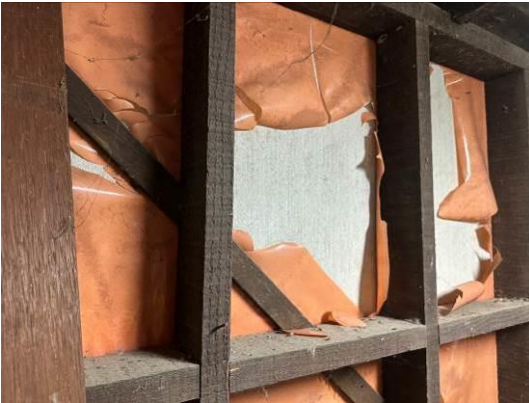
| Internal, detached garage, south western and southern wall | ACM | Non-friable | Asb-4 | Chrysotile Asbestos Detected<br>Organic Fibres Detected | Approximately 15m <sup>2</sup> | Good / Occasional | Priority 4 - Negligible Risk Level | 20/02/2025 | Remove during initial stage of demolition works | |

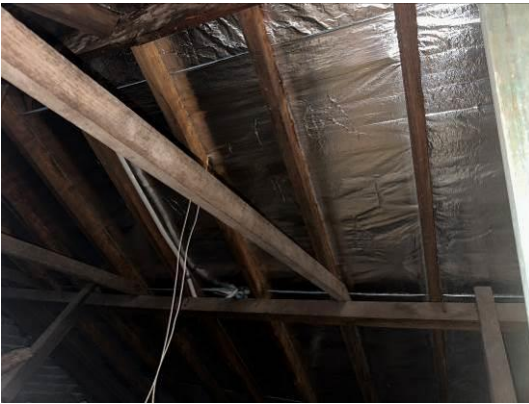
| Internal, main dwelling, ceiling cavity, roof sarking, insulation | SMF | Sealed | Asb-2 | SMF Detected<br>No Asbestos Detected | Approximately 150m <sup>2</sup> | Fair / Maintenance only | Priority 4 - Negligible Risk Level | 20/02/2025 | Remove during initial stage of demolition works | |

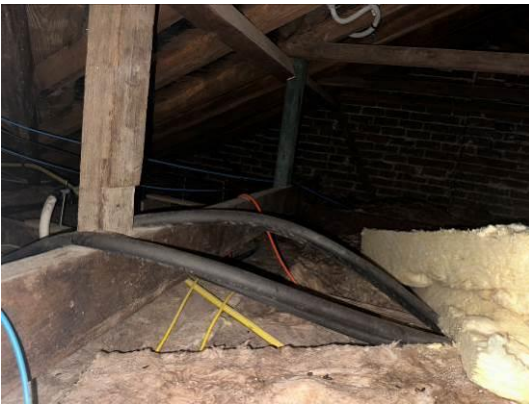
| Internal, main dwelling, ceiling cavity, insulation | SMF-lined insulation (assumed) | Sealed | Visual inspection | - | Approximately 150m <sup>2</sup> | Good / Maintenance only | Priority 4 - Negligible Risk Level | 20/02/2025 | Remove during initial stage of demolition works | |

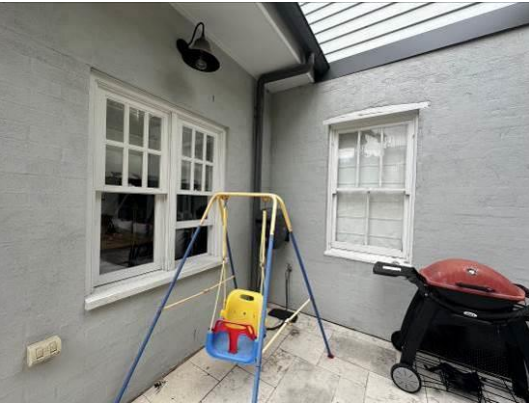
| External, main dwelling , window frames and doors throughout | White LBP (assumed) | Non-friable | Visual inspection – similar to LP-6 | - | ND | Good / Fair / Occasional | | 20/02/2025 | Remove grossly peeling paint. Stabilise remaining membrane. Minimise abrasive works that will disturb paint during demolition. | |

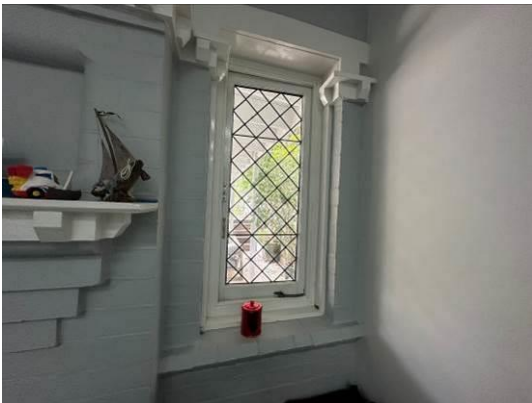
| Internal, main dwelling, ground level, north western / western sides, playroom, window frames | White LBP | Non-friable | LP-4 | 2.8% w/w | Approximately 2m <sup>2</sup> | Good Occasional | Priority 4 - Negligible Risk Level | 20/02/2025 | Remove grossly peeling paint. Stabilise remaining membrane. Minimise abrasive works that will disturb paint during demolition. | |

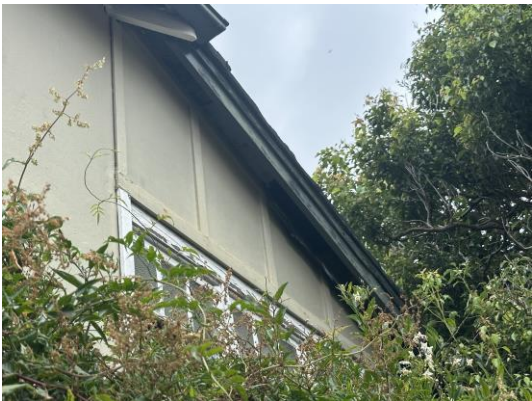
| External, south western side, gable infill panels | ACM | Non-friable | Visual inspection - height restriction | - | Approximately 15m <sup>2</sup> | Good / Maintenance only | Priority 4 - Negligible Risk Level | 21/02/2025 | Remove during initial stage of demolition works | |

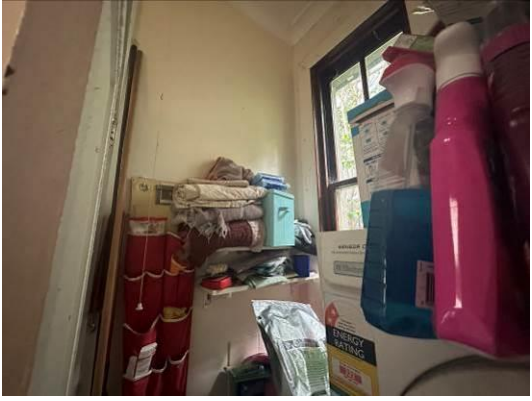
| Internal, central-western side, laundry, northern walls | ACM (assumed) | Non-friable | Visual inspection - inaccessible | - | Approximately 20m <sup>2</sup> | Good / Maintenance only | Priority 4 - Negligible Risk Level | 21/02/2025 | Remove during initial stage of demolition works | |

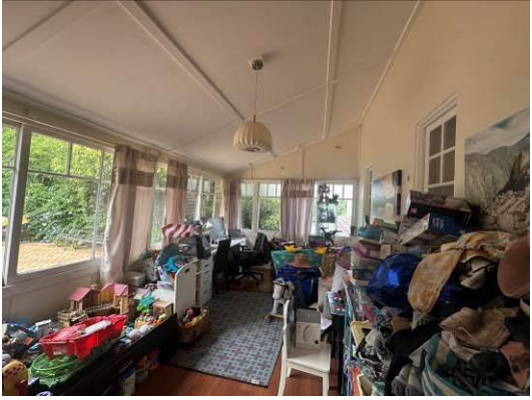
| Internal, southern side, sunroom, ceiling and walls | ACM (assumed) | Non-friable | Visual inspection - inaccessible | - | Approximately 30m <sup>2</sup> | Good / Occasional | Priority 4 - Negligible Risk Level | 21/02/2025 | Remove during initial stage of demolition works | |

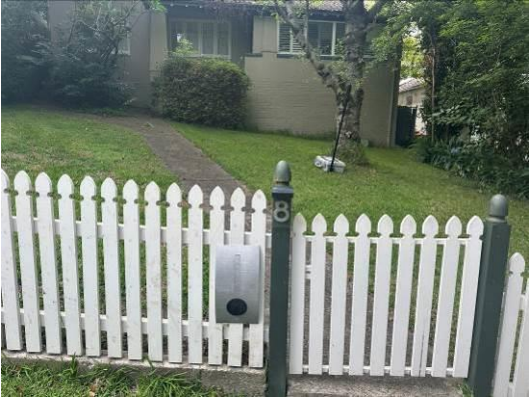
| External, window frames and fence posts throughout | Green LBP | Non-friable | Visual inspection – similar to LP-11 | - | Approximately 30m <sup>2</sup> | Good / Occasional | Priority 4 - Negligible Risk Level | 21/02/2025 | Remove grossly peeling paint. Stabilise remaining membrane. Minimise abrasive works that will disturb paint during demolition. | |

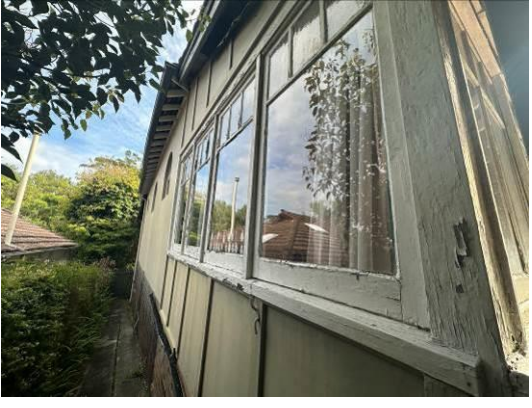
| External, western side, window frames | White LBP | Non-friable | LP-13 | 5.5% w/w | Approximately 2m <sup>2</sup> | Fair / Occasional | Priority 3 - Low Risk Level | 21/02/2025 | Remove grossly peeling paint. Stabilise remaining membrane. Minimise abrasive works that will disturb paint during demolition. | |

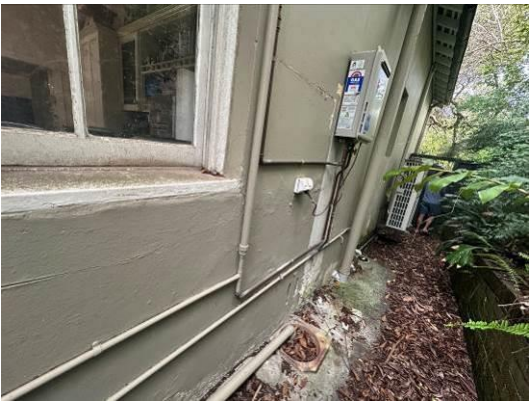
| External, window frames throughout | White LBP (assumed) | Non-friable | Visual inspection – similar to LP-13 | - | ND | Good / Fair / Occasional | Priority 3 - Low Risk Level | 21/02/2025 | Remove grossly peeling paint. Stabilise remaining membrane. Minimise abrasive works that will disturb paint during demolition. | |

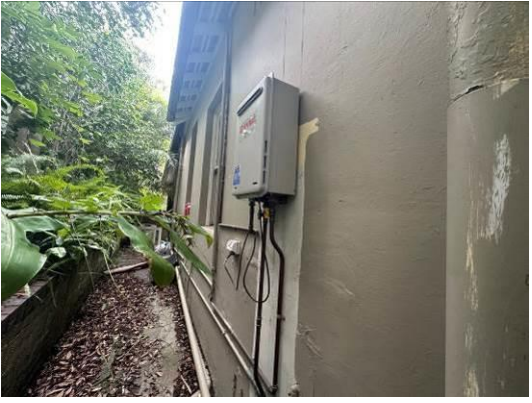
| External, walls throughout | Brown LBP (assumed) | Non-friable | Visual inspection – similar to LP-12 | - | >100m <sup>2</sup> | Good / Fair Occasional | Priority 3 - Low Risk Level | 21/02/2025 | Remove grossly peeling paint. Stabilise remaining membrane. Minimise abrasive works that will disturb paint during demolition. | |

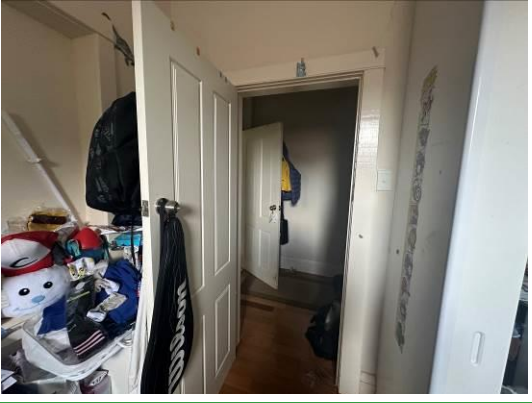
| Internal, central western bedroom, door frame | Cream LBP | Non-friable | LP-9 | 4.9% w/w | Approximately 3m <sup>2</sup> | Good / Occasional | Priority 4 - Negligible Risk Level | 21/02/2025 | Remove grossly peeling paint. Stabilise remaining membrane. Minimise abrasive works that will disturb paint during demolition. | |

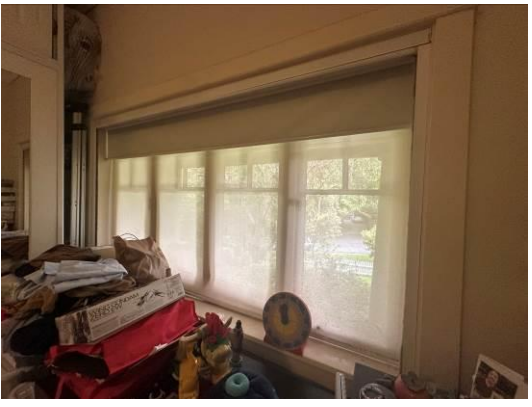
| Internal, window frames, doors and skirting throughout | Cream LBP (assumed) | Non-friable | Visual inspection – similar to LP-9 | - | ND | Good / Occasional | Priority 4 - Negligible Risk Level | 21/02/2025 | Remove grossly peeling paint. Stabilise remaining membrane. Minimise abrasive works that will disturb paint during demolition. | |

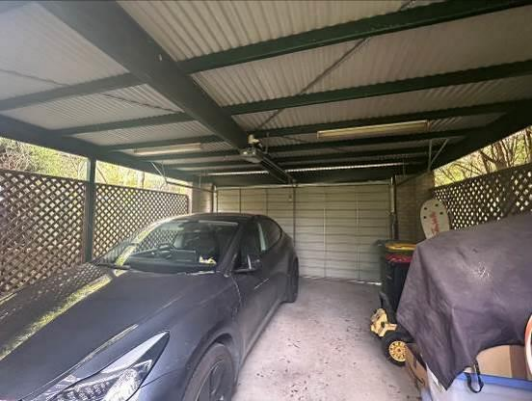
| External, south eastern side, car port, ceiling, fluorescent light fittings | PCB-containing single-tube fluorescent light fitting capacitors (assumed) | N/A | Visual inspection - electrical hazard | - | 2 x units | Good / Maintenance only | Priority 4 - Negligible Risk Level | 21/02/2025 | Remove prior to demolition works. Avoid damage to capacitors. | |

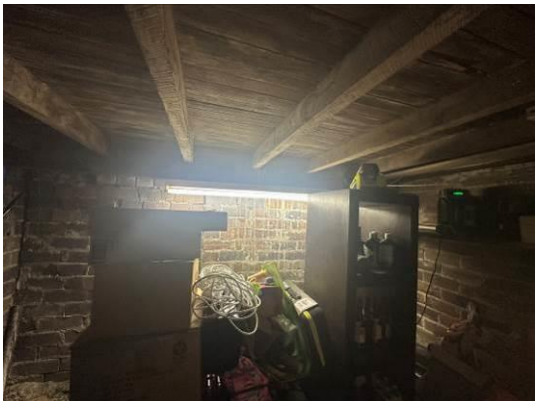
| Subfloor space, western wall, fluorescent light fittings | PCB-containing single-tube fluorescent light fitting capacitors (assumed) | N/A | Visual inspection - electrical hazard | - | 1 x unit | Good / Maintenance only | Priority 4 - Negligible Risk Level | 21/02/2025 | Remove prior to demolition works.<br>Avoid damage to capacitors. | |

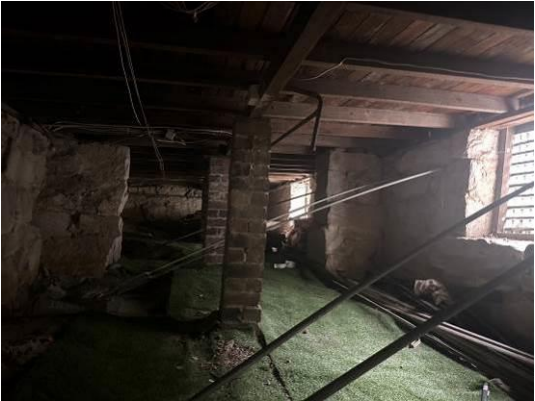
| Hazardous Materials Register<br>10 Pockley Avenue, Roseville NSW | | | | | | | | | | Single storey dwelling & detached shed |
|---|---|---|---|---|---|---|---|---|---|---|
| Subfloor space, main dwelling, partially accessible | Possible hazardous materials | Unknown | - | - | Unknown | Unknown | Unknown | - | Inspect when access is made available, prior to demolition | |

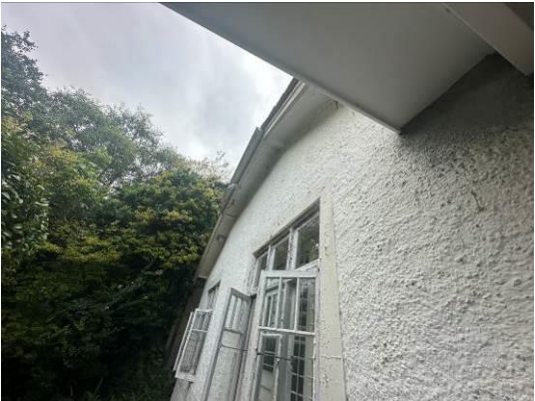
| Hazardous Materials Register<br>10 Pockley Avenue, Roseville NSW | | | | | | | | | | Single storey dwelling & detached shed |
|---|---|---|---|---|---|---|---|---|---|---|
| External, main dwelling, eaves throughout | ACM (assumed) | Non-friable | Visual inspection - height restriction | - | 50-100m <sup>2</sup> | Good / Maintenance only | Priority 4 - Negligible Risk Level | 21/02/2025 | Remove during initial stage of demolition works | |

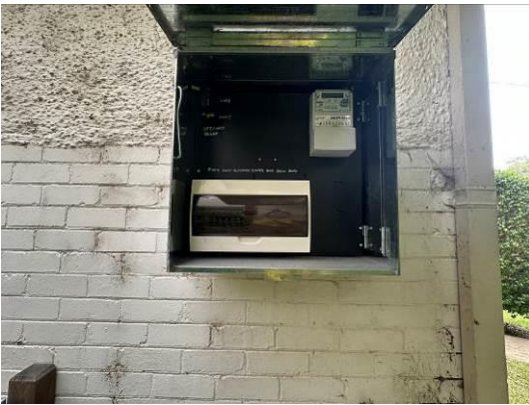
| External, main dwelling, eastern side, black meter backing board | ACM (assumed) | Non-friable | Visual inspection - electrical hazard | - | 1 x board | Good / Maintenance only | Priority 4 - Negligible Risk Level | 21/02/2025 | Remove during initial stage of demolition works | |

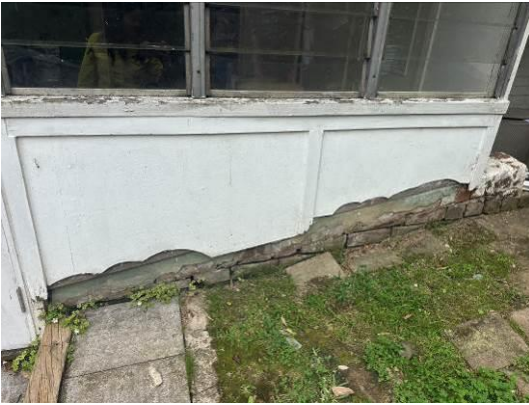
| External, main dwelling, southern side, sunroom, lower panels | ACM | Non-friable | Asb-6 | Chrysotile, Amosite and Crocidolite Asbestos Detected | Approximately 20m <sup>2</sup> | Poor / Occasional | Priority 3 - Low Risk Level | 21/02/2025 | Remove during initial stage of demolition works | |

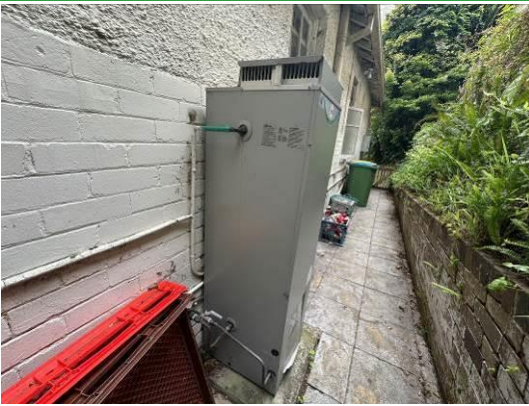
| External, main dwelling, eastern side, hot water unit | SMF-lined insulation (assumed) | Sealed | Visual inspection | - | 1 x unit | Good / Maintenance only | Priority 4 - Negligible Risk Level | 21/02/2025 | Remove during initial stage of demolition works | |

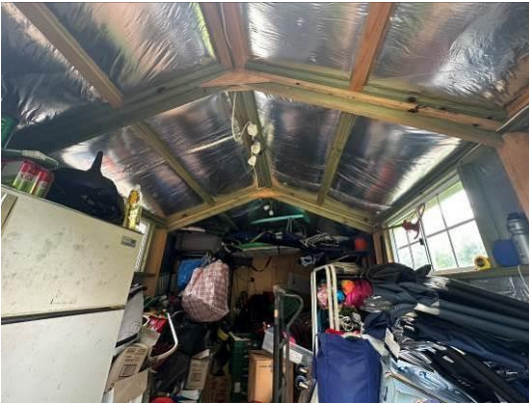
| Internal, detached shed, southern side, ceiling and walls, roof sarking | SMF-lined insulation (assumed) | Sealed | Visual inspection | - | Approximately 30m <sup>2</sup> | Good / Maintenance only | Priority 4 - Negligible Risk Level | 21/02/2025 | Remove during initial stage of demolition works | |

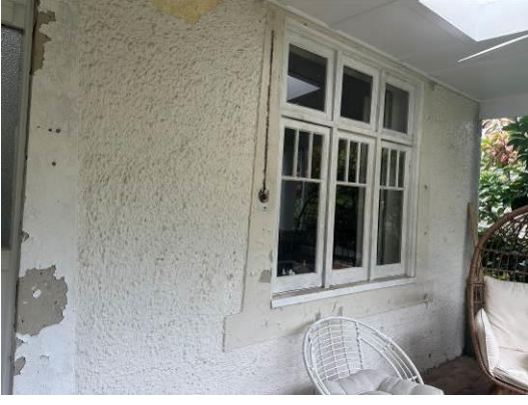
| External, main dwelling, northern side, inner window frame | White LBP | Non-friable | LP-16 | 0.43% w/w | Approximately 2m <sup>2</sup> | Fair / Occasional | Priority 3 - Low Risk Level | 21/02/2025 | Remove grossly peeling paint. Stabilise remaining membrane. Minimise abrasive works that will disturb paint during demolition. | |

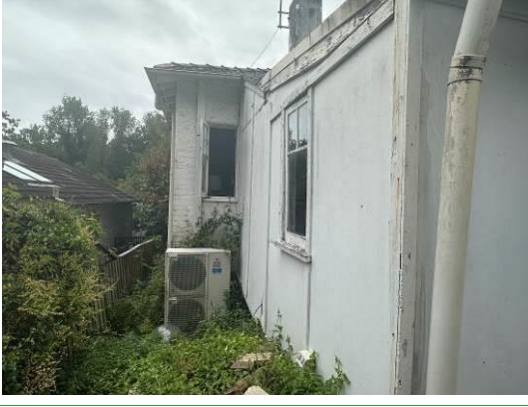
| External, main dwelling, inner window frames throughout | White LBP (assumed) | Non-friable | Visual inspection – similar to LP-16 | - | ND | Fair / Occasional | Priority 3 - Low Risk Level | 21/02/2025 | Remove grossly peeling paint. Stabilise remaining membrane. Minimise abrasive works that will disturb paint during demolition. | |

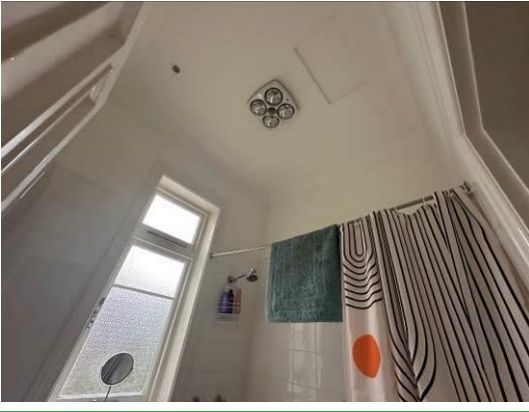
| Main dwelling, ceiling cavity | Possible hazardous materials | Unknown | - | - | Unknown | Unknown | Unknown | - | Inspect when access is made available, prior to demolition | |

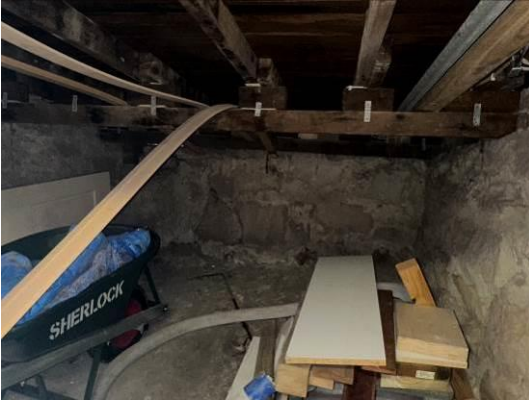
| Main dwelling, subfloor space, partially accessible | Possible hazardous materials | Unknown | - | - | Unknown | Unknown | Unknown | - | Inspect when access is made available, prior to demolition | |

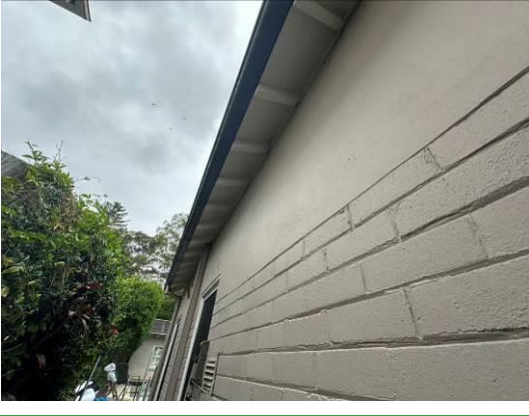
| External, main dwelling, eaves throughout | ACM (assumed) | Non-friable | Visual inspection - height restriction | - | >100m <sup>2</sup> | Good / Maintenance only | Priority 4 - Negligible Risk Level | 21/02/2025 | Remove during initial stage of demolition works | |

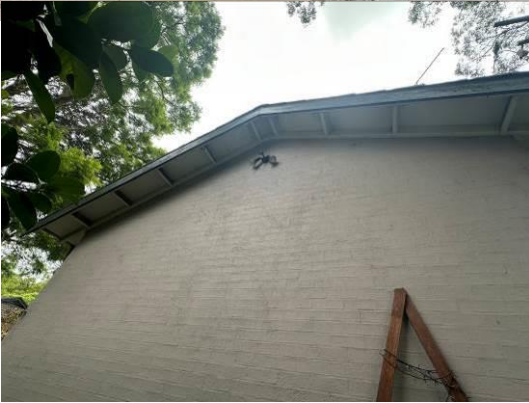
| External, detached granny flat / garage, eaves throughout | ACM<br>(assumed) | Non-friable | Visual inspection - height restriction | - | Approximately 50m <sup>2</sup> | Good / Maintenance only | | 21/02/2025 | Remove during initial stage of demolition works | |

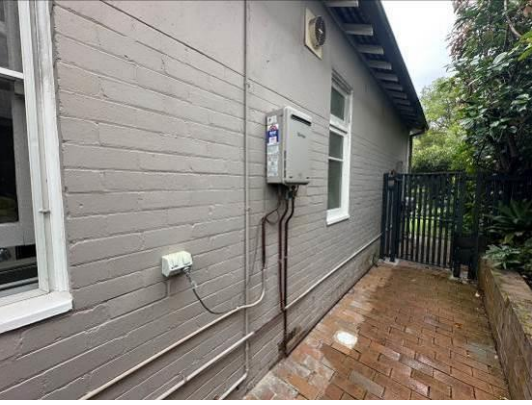
| External, main dwelling, eastern side, backyard gate | Grey LBP | Non-friable | LP-23B | 1.1% w/w | Approximately 2m <sup>2</sup> | Good Occasional | Priority 4 - Negligible Risk Level | 21/02/2025 | Remove grossly peeling paint. Stabilise remaining membrane. Minimise abrasive works that will disturb paint during demolition. | |

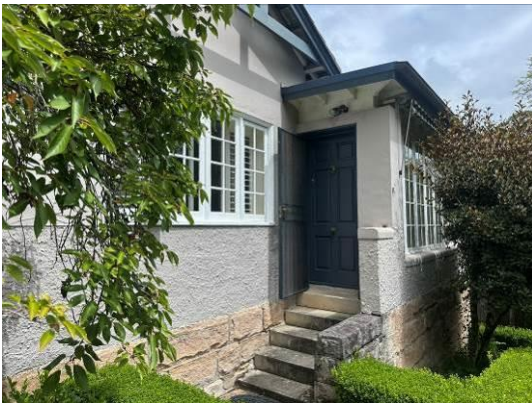
| External, main dwelling, doors | Grey LBP (assumed) | Non-friable | Visual inspection – similar to LP-23B | - | ND | Good Occasional | Priority 4 - Negligible Risk Level | 21/02/2025 | Remove grossly peeling paint. Stabilise remaining membrane. Minimise abrasive works that will disturb paint during demolition. | |

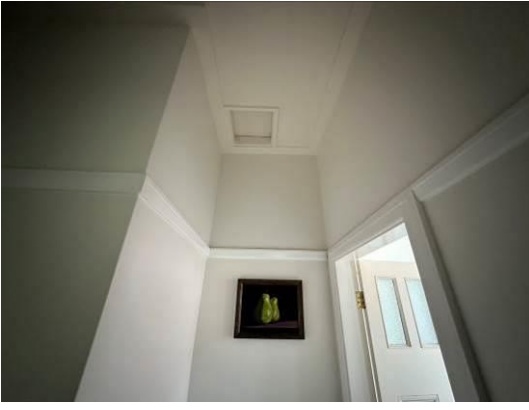
| Main dwelling, ceiling cavity | Possible hazardous materials | Unknown | - | - | Unknown | Unknown | Unknown | - | Inspect when access is made available, prior to demolition | |

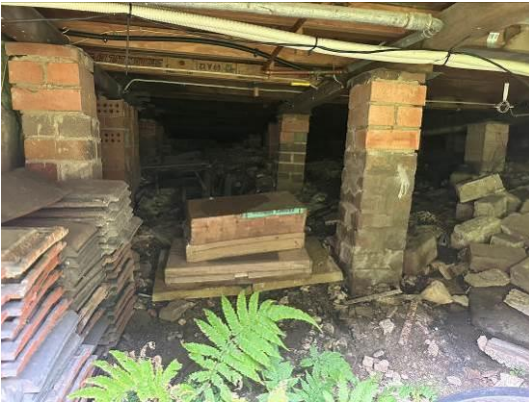
| Main dwelling, subfloor space, partially accessible | Possible hazardous materials | Unknown | - | - | Unknown | Unknown | Unknown | - | Inspect when access is made available, prior to demolition | |

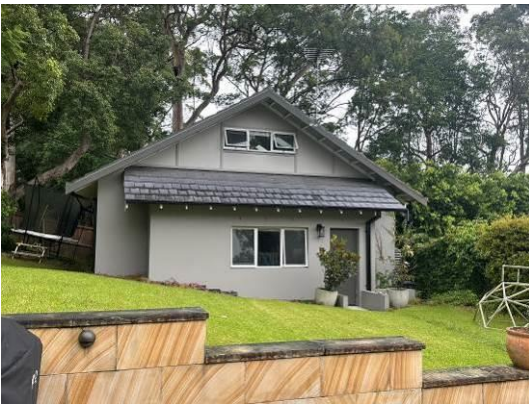
| Internal, detached granny flat / garage, level 1 | Possible hazardous materials | Unknown | - | - | Unknown | Unknown | Unknown | - | Inspect when access is made available, prior to demolition | |

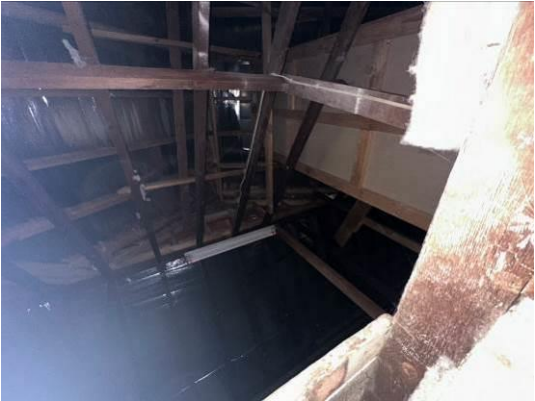
| Hazardous Materials Register | | | | | | | | | | Two storey dwelling & detached granny flat |
|---|---|---|---|---|---|---|---|---|---|---|
| Main dwelling, ceiling cavity, partially accessible | Possible hazardous materials | Unknown | - | - | Unknown | Unknown | Unknown | - | Inspect when access is made available, prior to demolition | |

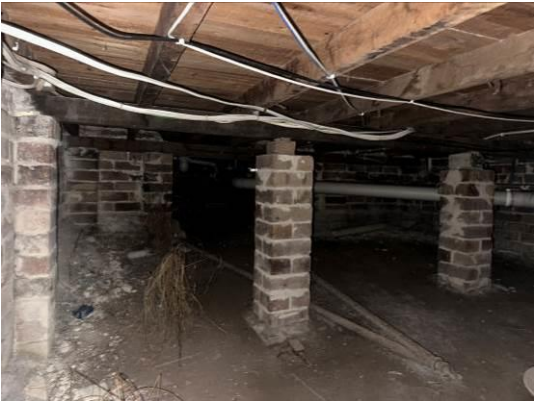
| Hazardous Materials Register | | | | | | | | | | Two storey dwelling & detached granny flat |
|---|---|---|---|---|---|---|---|---|---|---|
| Main dwelling, subfloor space, partially accessible | Possible hazardous materials | Unknown | - | - | Unknown | Unknown | Unknown | - | Inspect when access is made available, prior to demolition | |

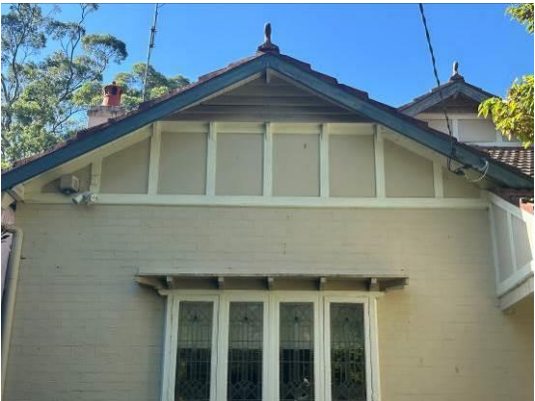
| Hazardous Materials Register | | | | | | | | | | Two storey dwelling & detached granny flat |
|---|---|---|---|---|---|---|---|---|---|---|
| External, main dwelling, gable infill panels | ACM (assumed) | Non-friable | Visual inspection - height restriction | - | Approximately >50m <sup>2</sup> | Good / Maintenance only | Priority 4 - Negligible Risk Level | 24/02/2024 | Remove during initial stage of demolition works | |

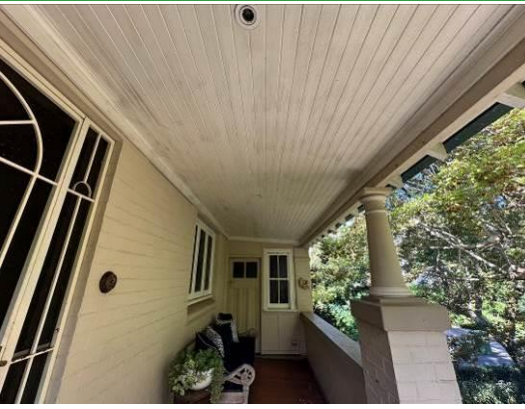
| External, main dwelling, walls throughout | Cream LBP (assumed) | Non-friable | Visual inspection – similar to LP-24 | - | ND | Good Occasional | Priority 4 - Negligible Risk Level | 24/02/2025 | Remove grossly peeling paint. Stabilise remaining membrane. Minimise abrasive works that will disturb paint during demolition. | |

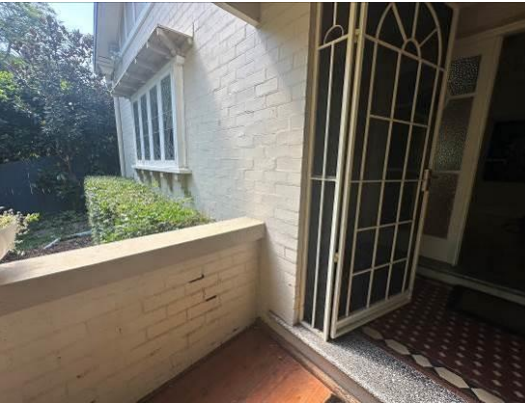
| External, main dwelling, northern side, main entrance area, door | Cream LBP | Non-friable | LP-26 | 2.6% w/w | Approximately 20m <sup>2</sup> | Good Occasional | Priority 3 - Low Risk Level | 24/02/2025 | Remove grossly peeling paint. Stabilise remaining membrane. Minimise abrasive works that will disturb paint during demolition. | |

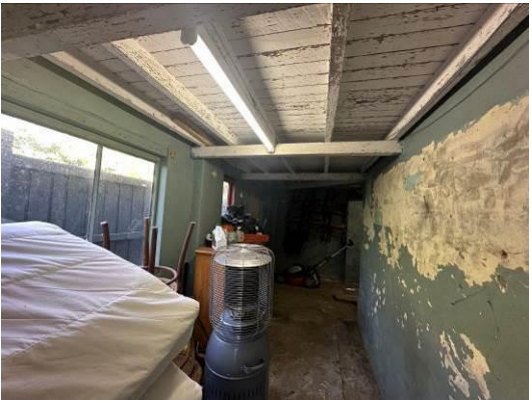
| Main dwelling, subfloor space, western access, ceiling | White LBP | Non-friable | LP-31 | 0.12% w/w | >20m <sup>2</sup> | Poor Occasional | Priority 3 - Low Risk Level | 24/02/2025 | Remove grossly peeling paint. Stabilise remaining membrane. Minimise abrasive works that will disturb paint during demolition. | |
