## Appendix 29: Public Infrastructure – The Rifleway, Roseville

**PROJECT NUMBER. V260105**

Project Address: 2-4 Larkin Street & 1,3,5 Pockley Avenue, Roseville

10 June 2026

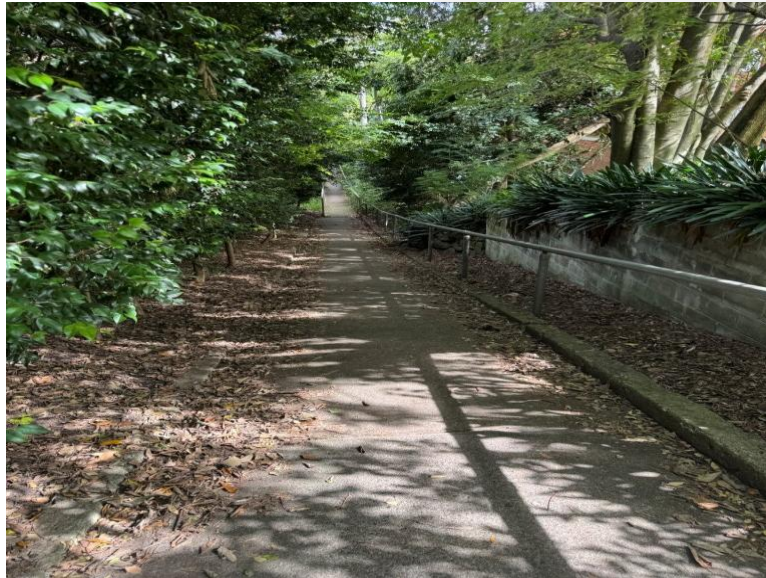
*Figure 1*

General condition along the Council concrete pathway

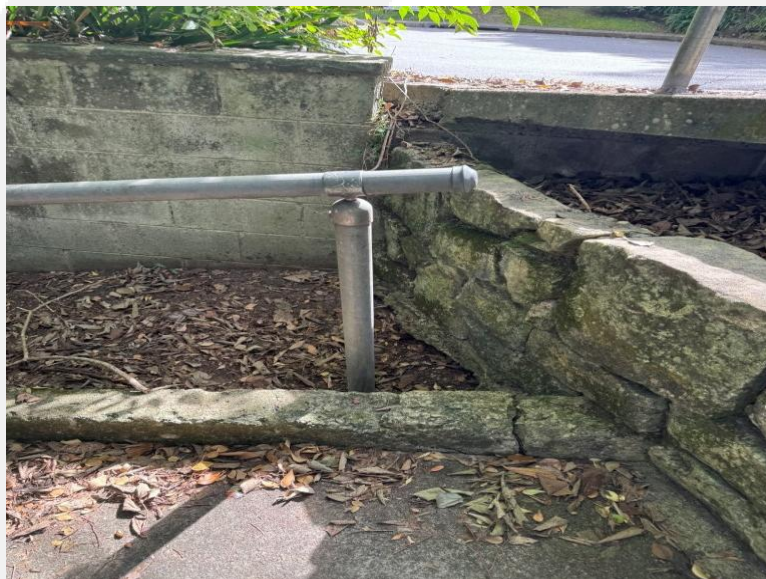
*Figure 2*

General condition along the Council retaining wall

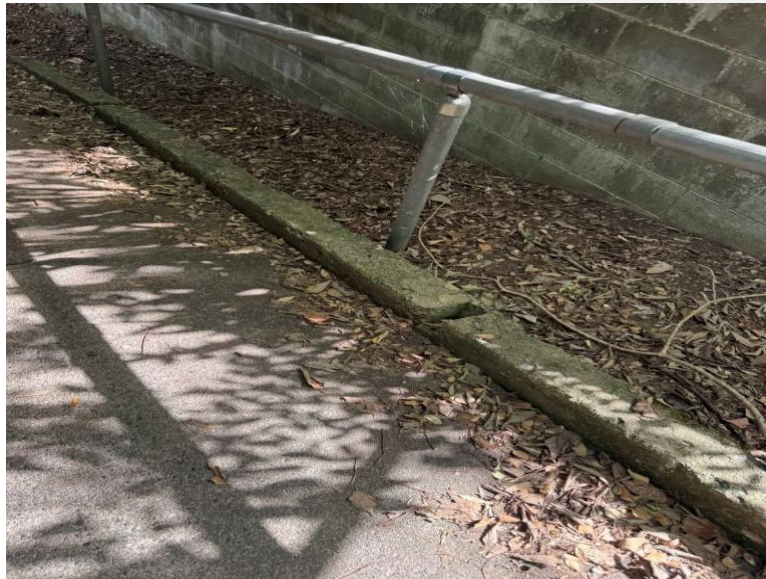
*Figure 3*

General condition along the Council concrete pathway

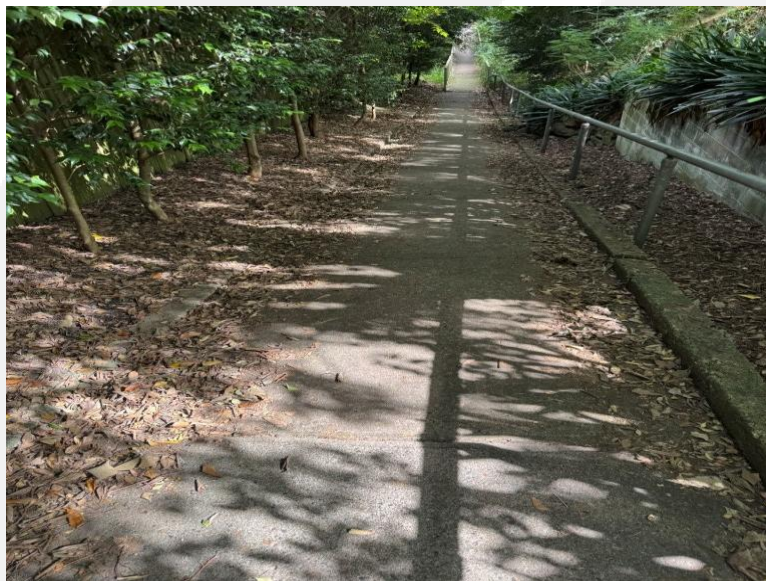
*Figure 4*

General condition along the Council concrete pathway

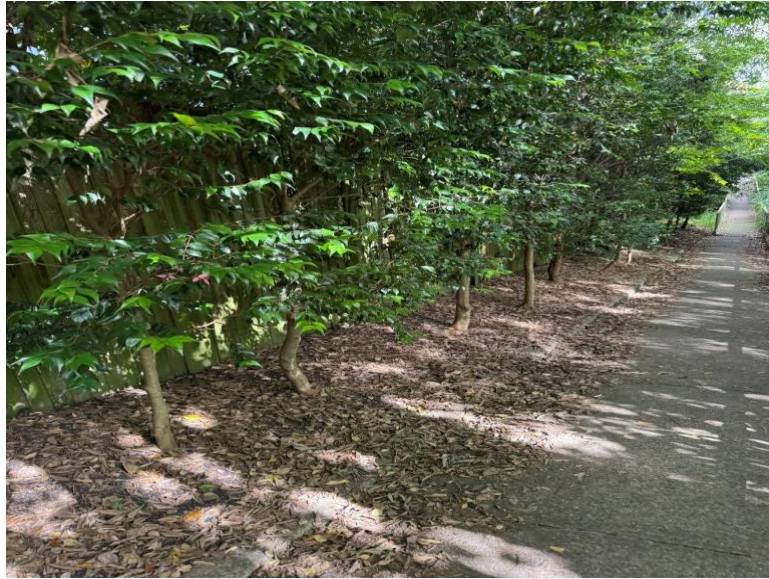
*Figure 5*

General condition along the development site Northern boundary

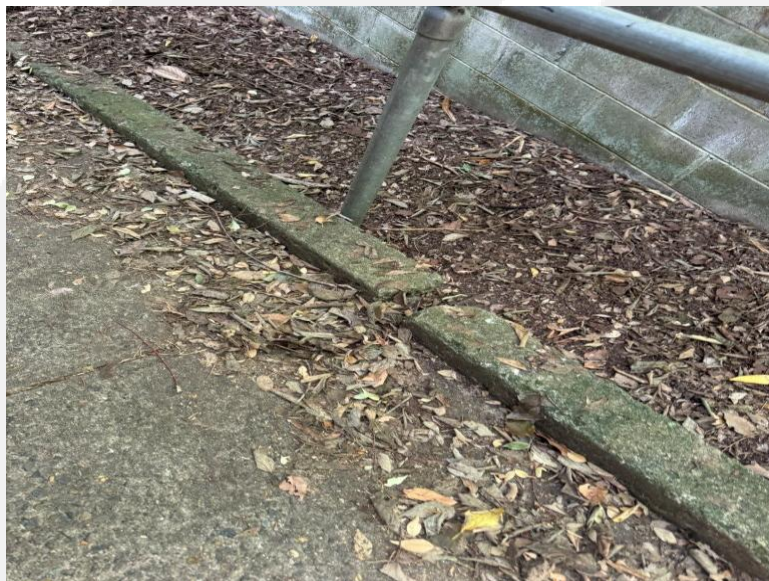
*Figure 6*

General condition along the Council concrete pathway

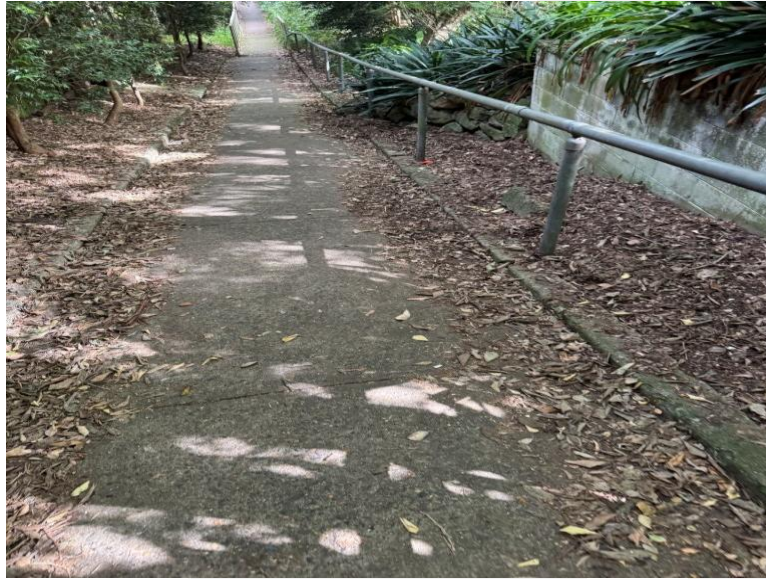
*Figure 7*

General condition along the Council concrete pathway

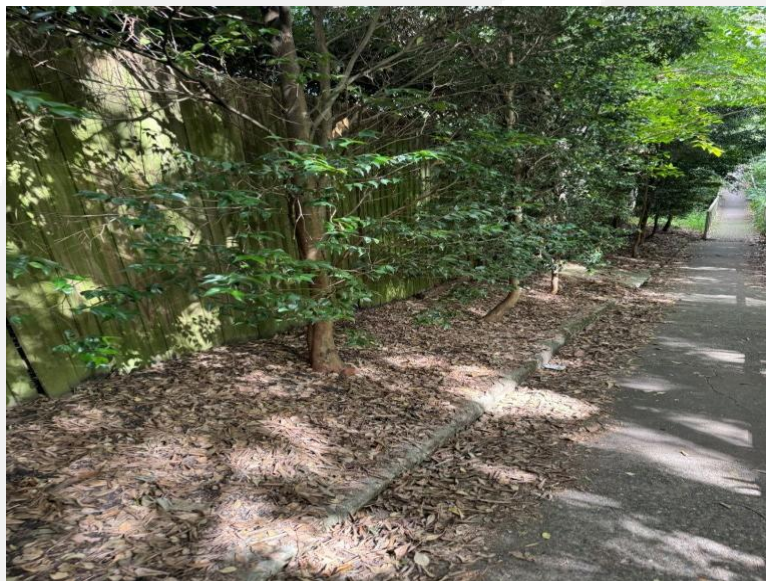
*Figure 8*

General condition along the development site Northern boundary

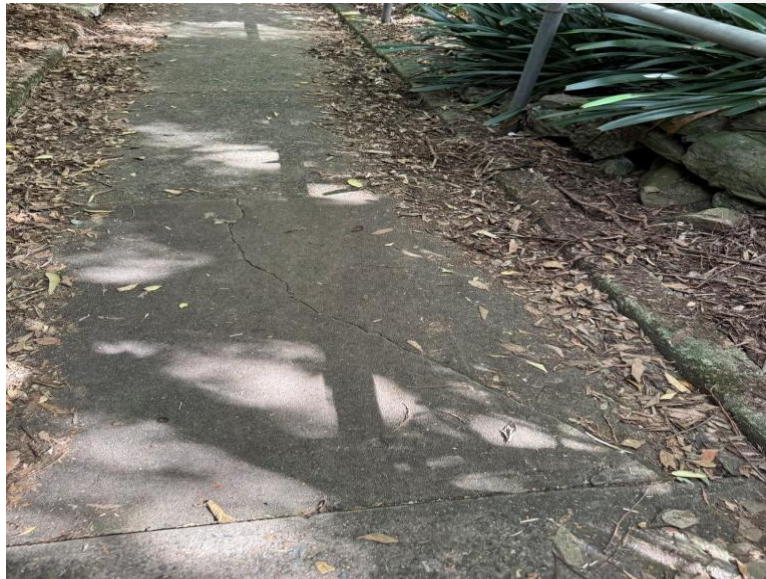
*Figure 9*

Cracking found along the Council concrete pathway

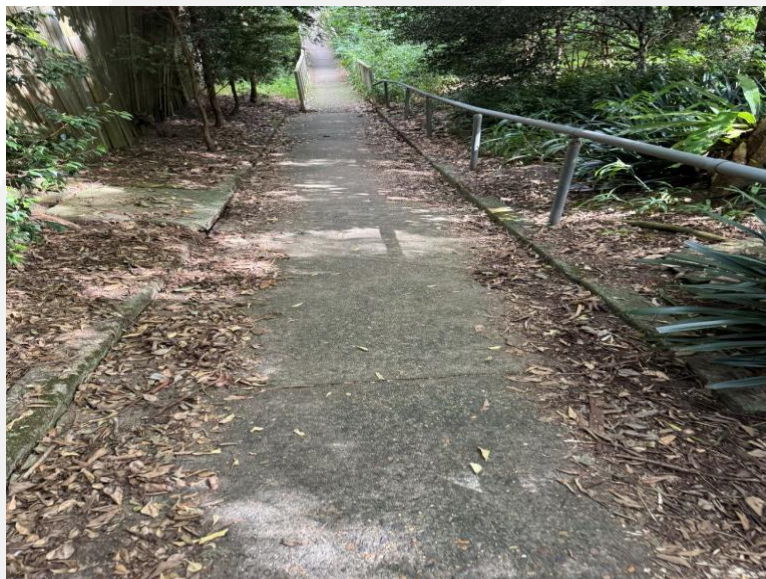
*Figure 10*

General condition along the Council concrete pathway

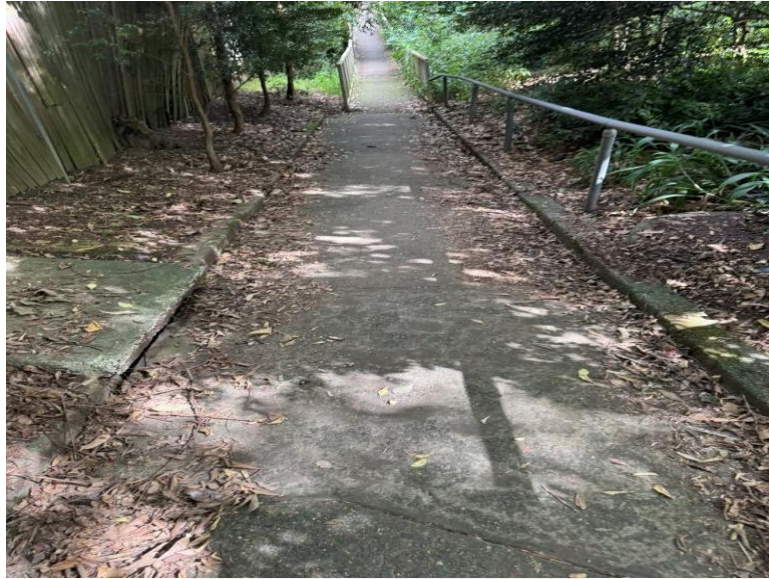
*Figure 11*

General condition along the Council concrete pathway

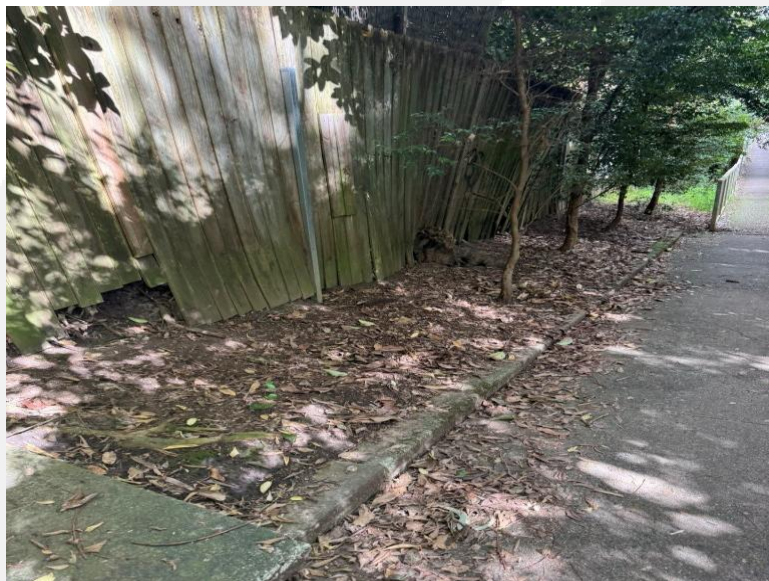
*Figure 12*

General condition along the development site Northern boundary

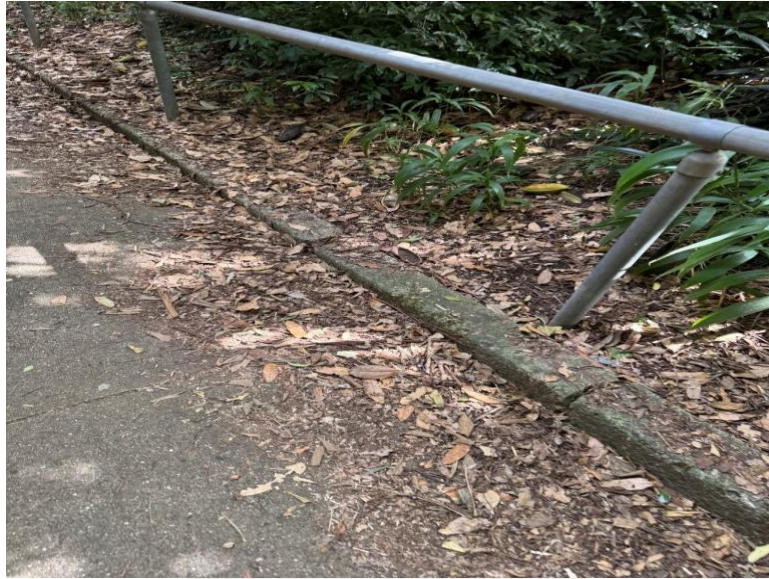
*Figure 13*

General condition along the Council concrete pathway

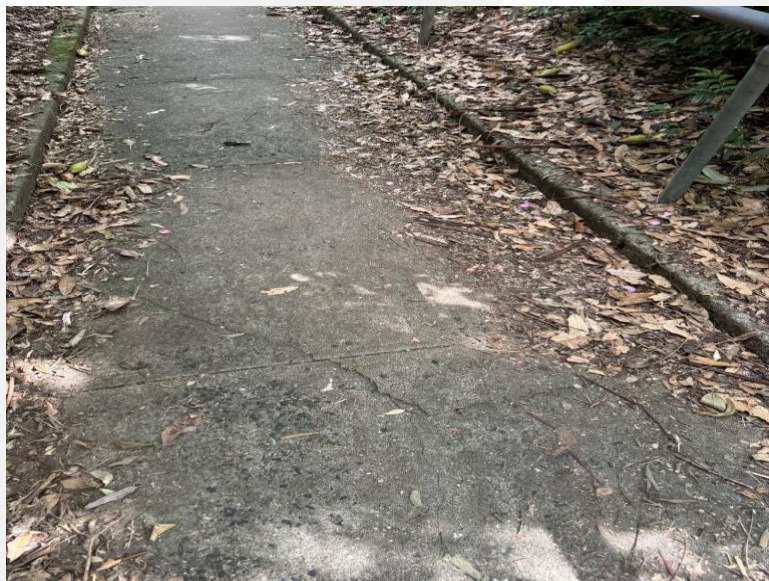
*Figure 14*

Cracking found along the Council concrete pathway

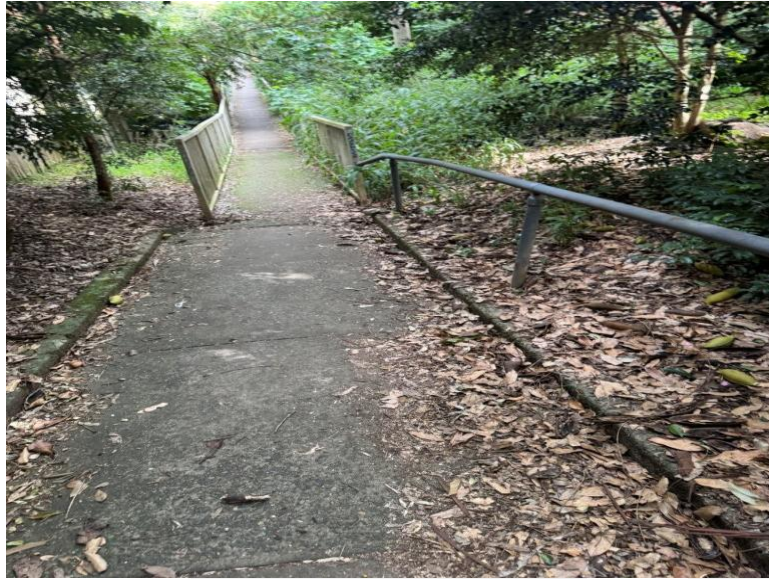
*Figure 15*

General condition along the Council concrete pathway

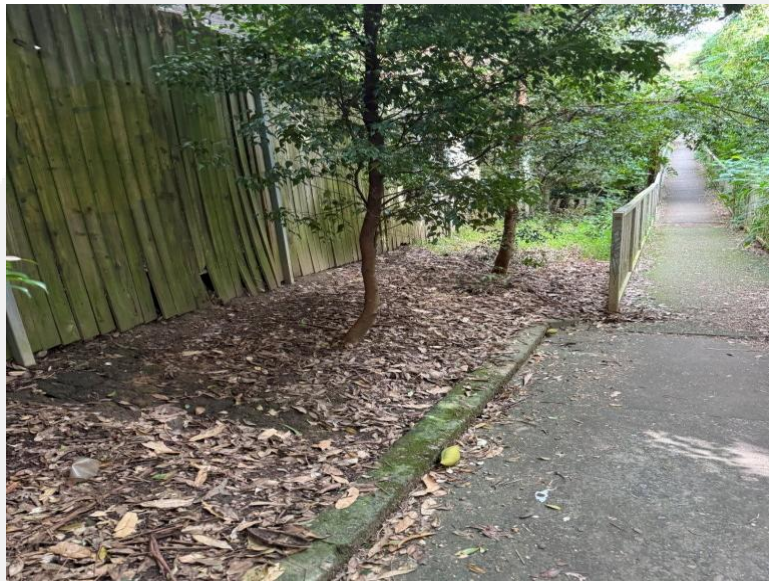
*Figure 16*

General condition along the development site Northern boundary

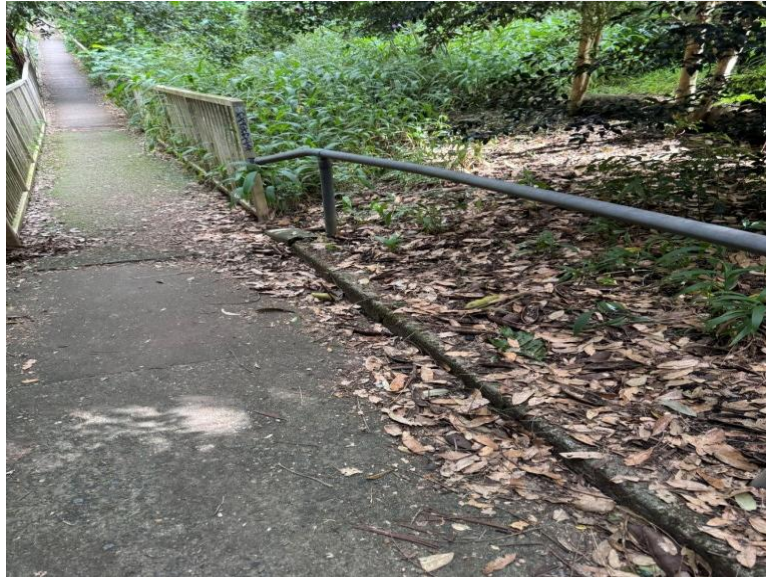
*Figure 17*

General condition along the Council concrete pathway

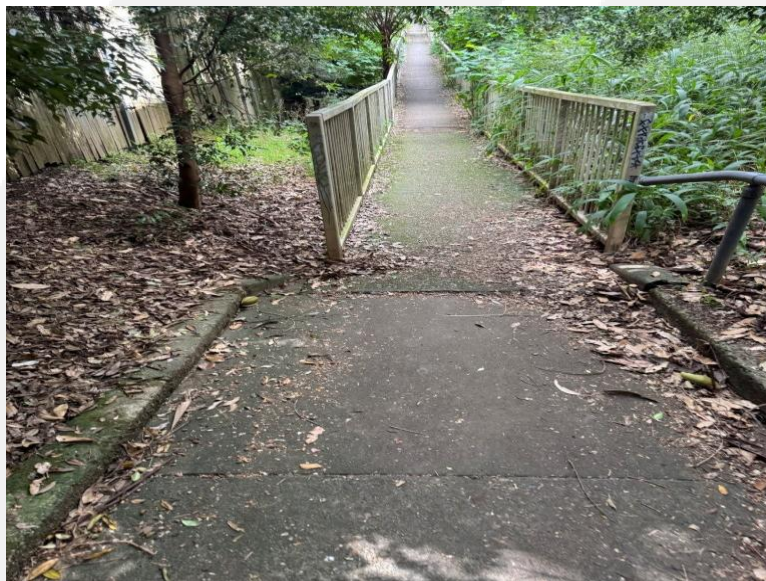
*Figure 18*

General condition along the Council concrete pathway

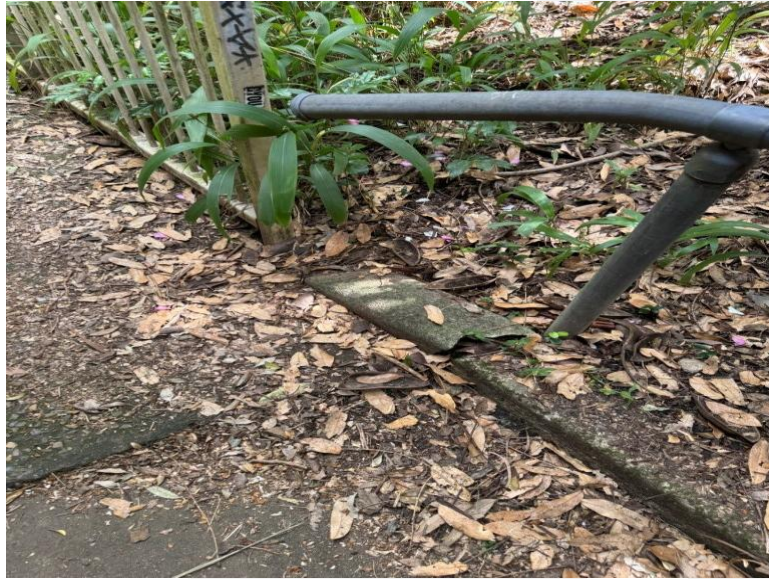
*Figure 19*

General condition along the Council concrete pathway

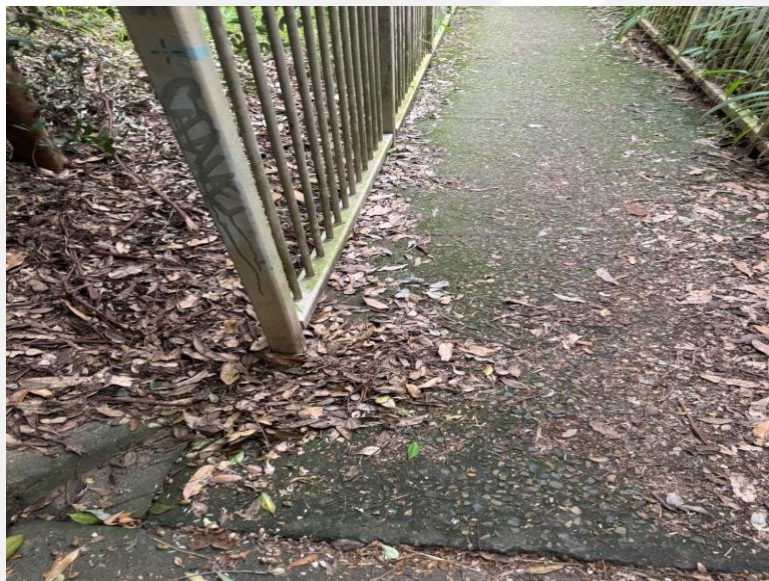
*Figure 20*

General condition along the Council concrete pathway

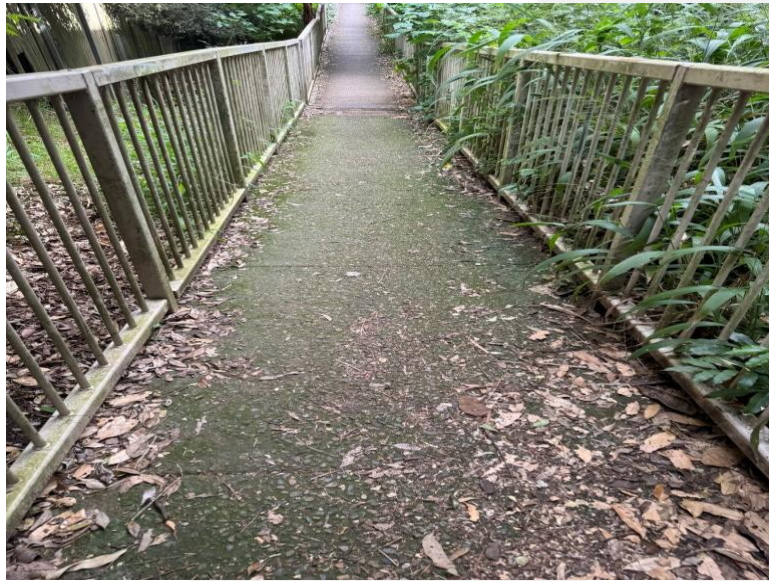
*Figure 21*

General condition along the Council concrete pathway

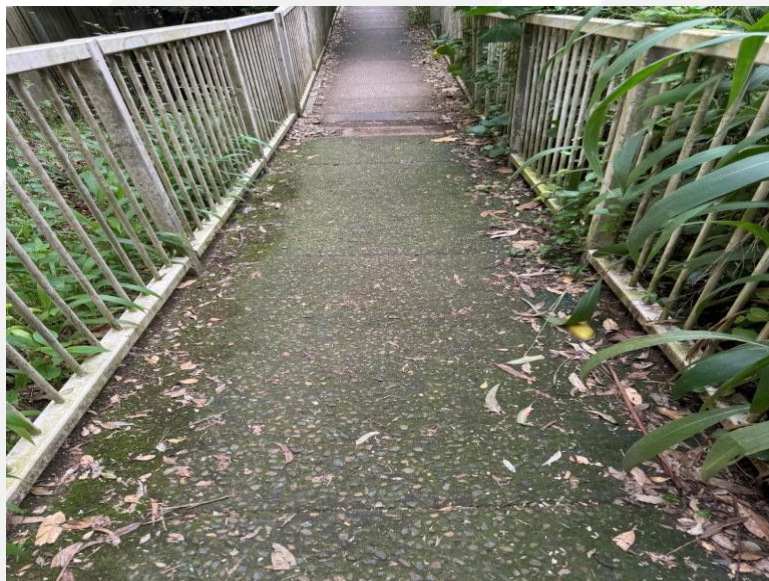
*Figure 22*

General condition along the Council concrete pathway

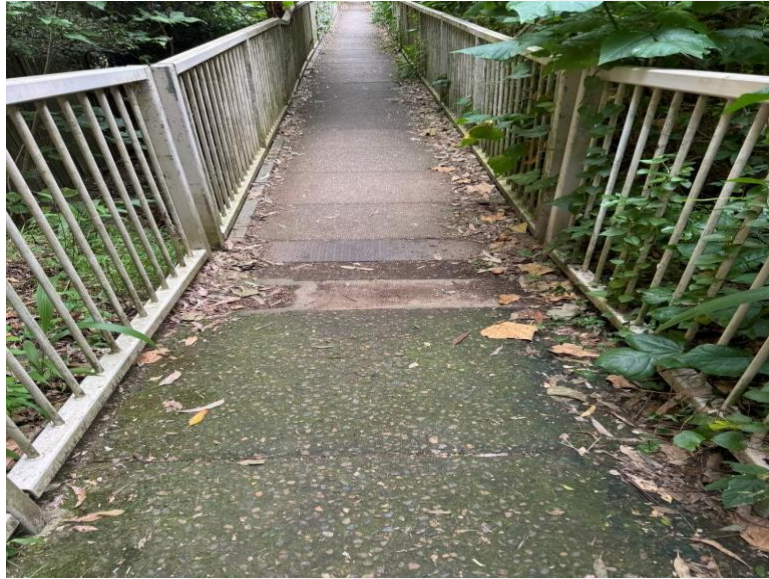
*Figure 23*

General condition along the Council concrete pathway

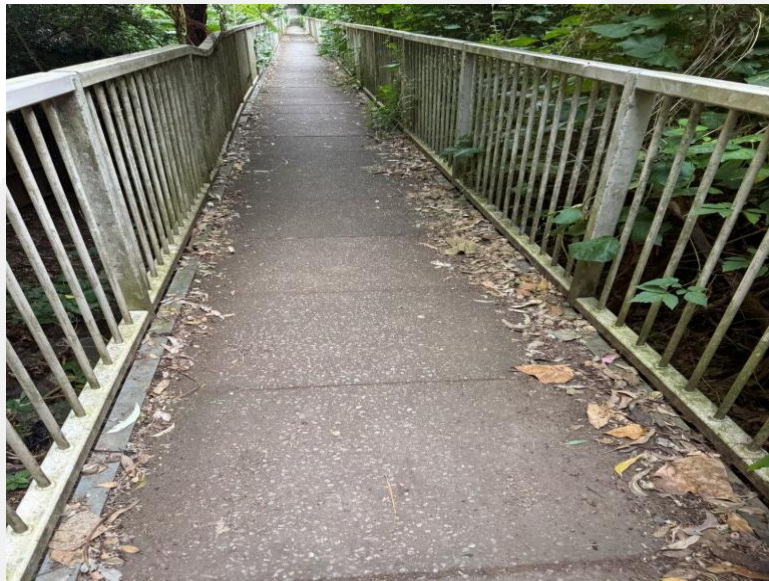
*Figure 24*

General condition along the Council suspended pedestrian bridge

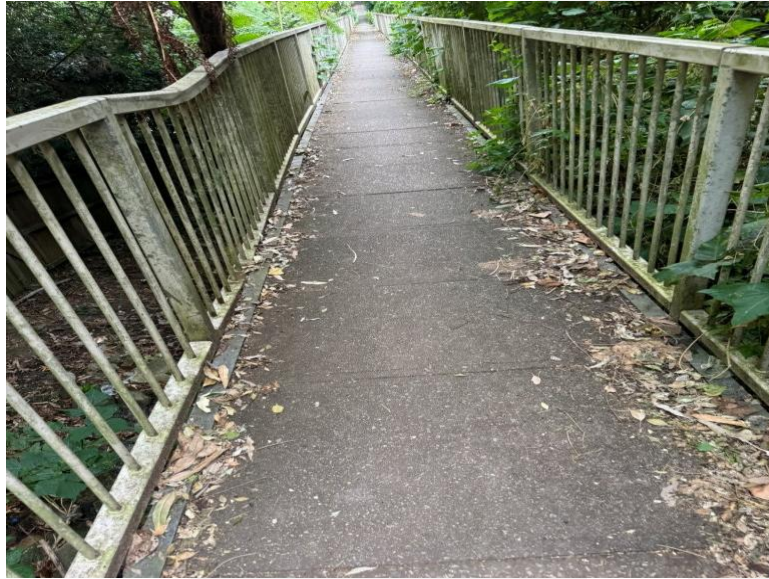
*Figure 25*

General condition along the Council suspended pedestrian bridge

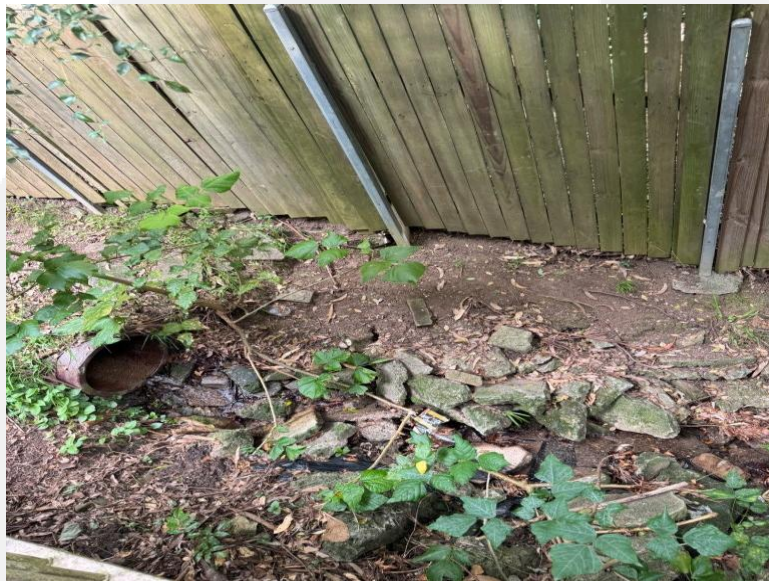
*Figure 26*

General condition of the Council culvert/ drainage pipe

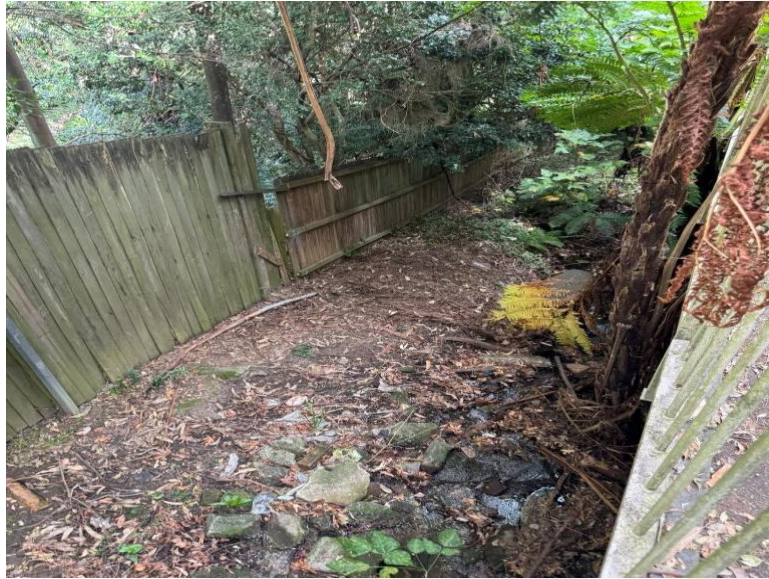
*Figure 27*

General condition of the Council culvert

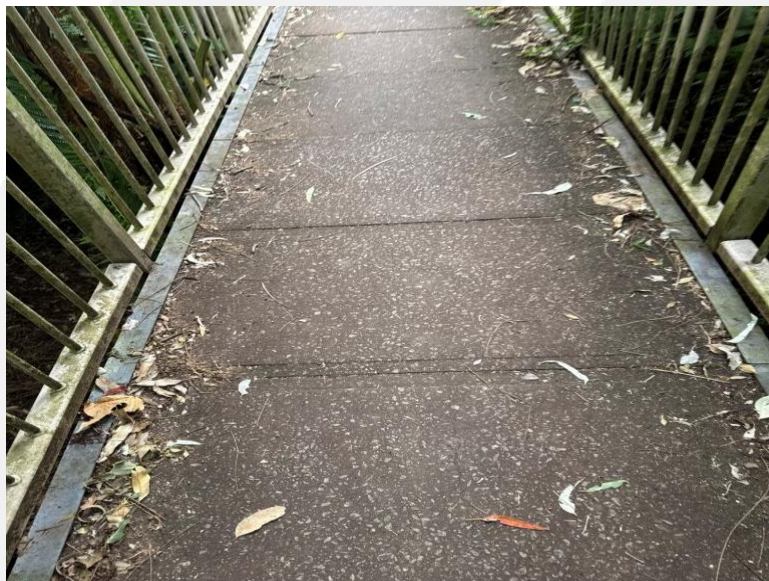
*Figure 28*

General condition along the Council suspended pedestrian bridge

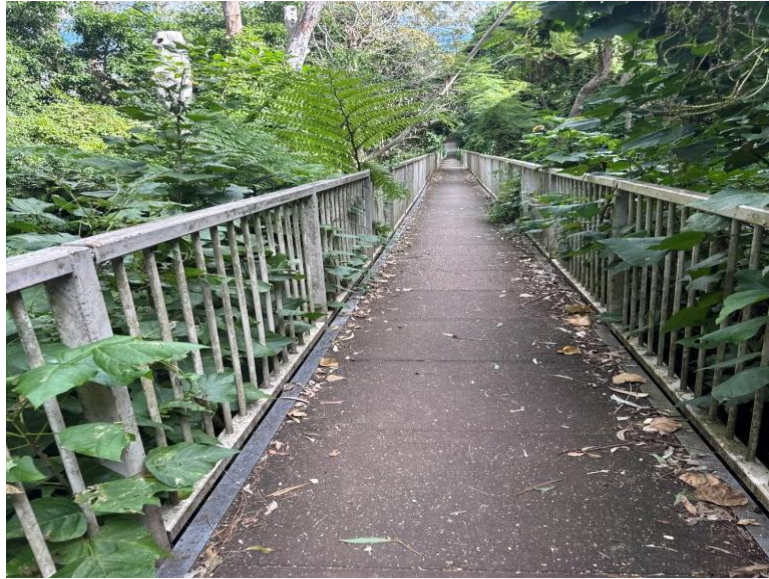
*Figure 29*

General condition along the Council suspended pedestrian bridge

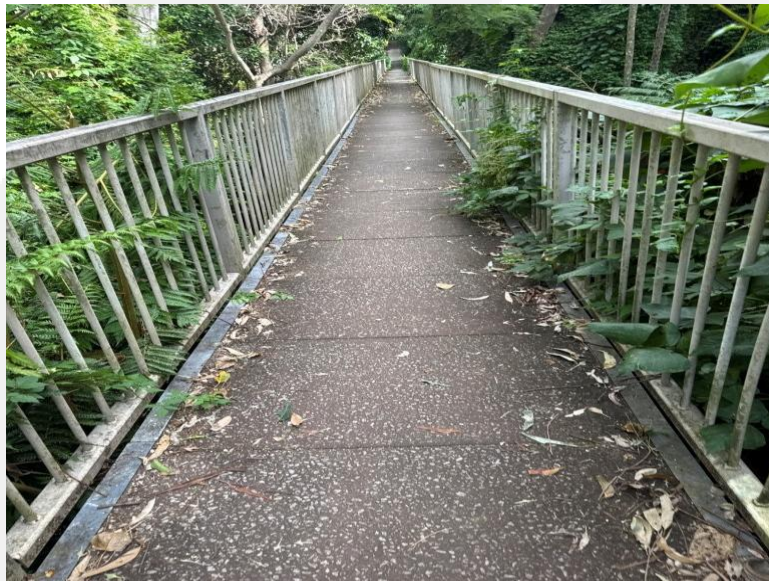
*Figure 30*

General condition along the Council suspended pedestrian bridge

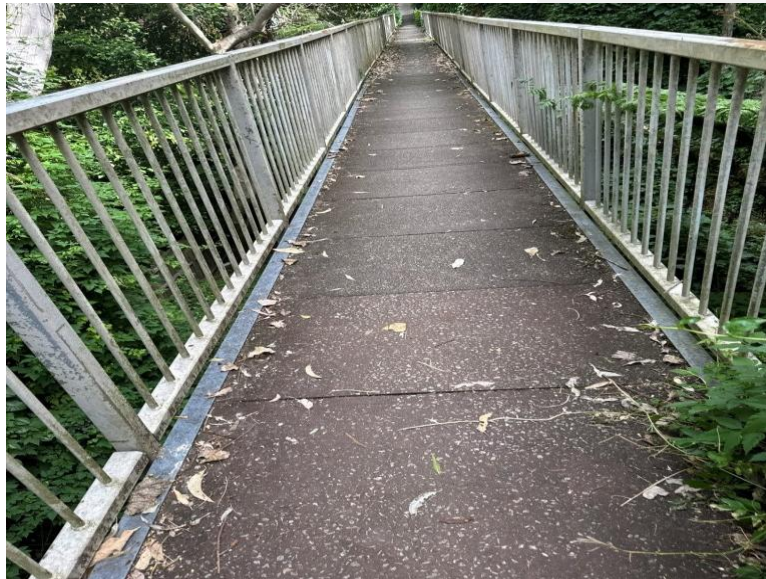
*Figure 31*

General condition along the Council suspended pedestrian bridge

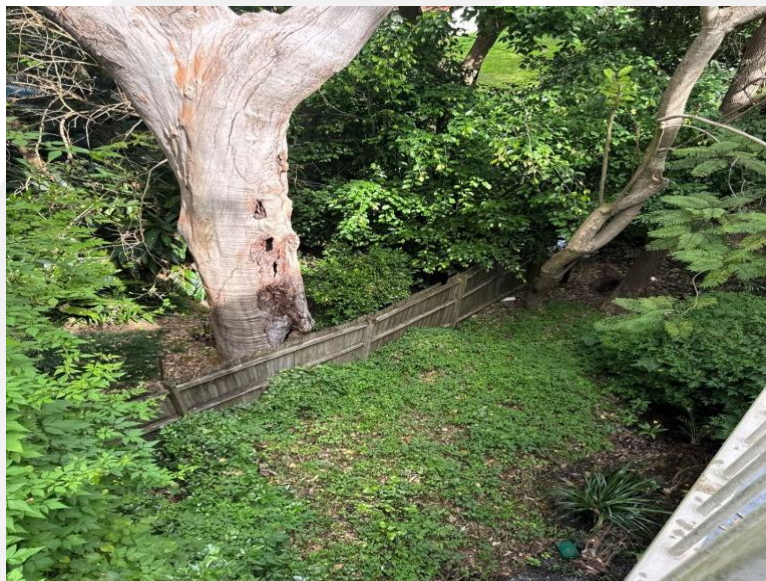
*Figure 32*

General condition of the Council reserve

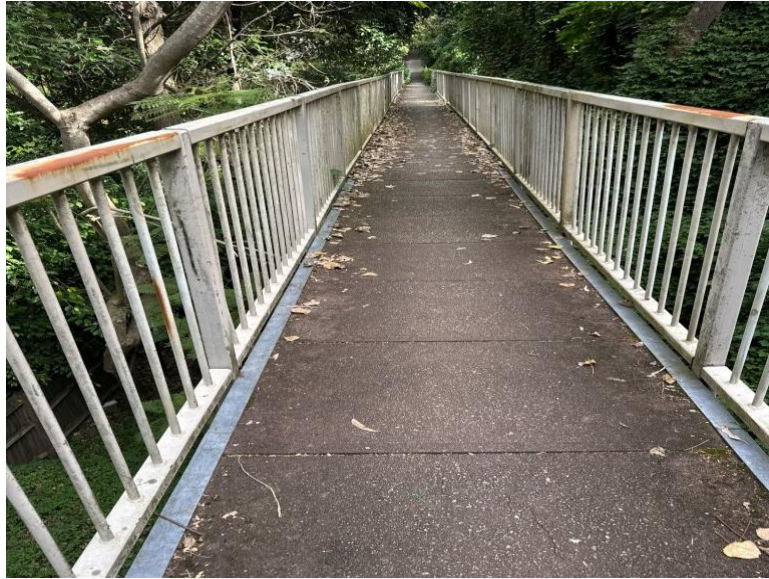
*Figure 33*

General condition along the Council suspended pedestrian bridge

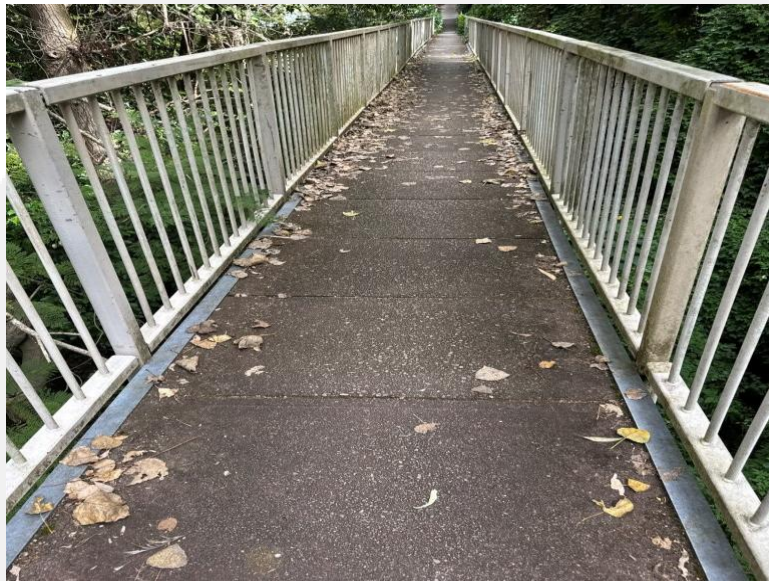
*Figure 34*

General condition along the Council suspended pedestrian bridge

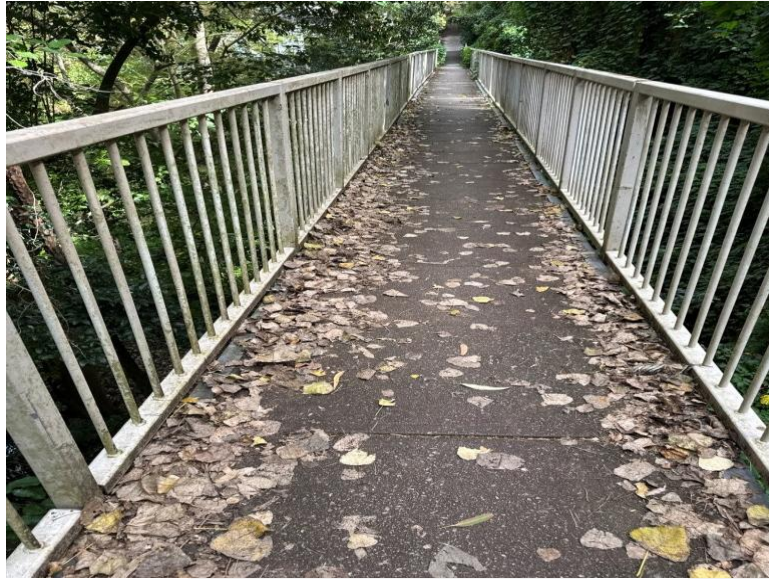
*Figure 35*

General condition along the Council suspended pedestrian bridge

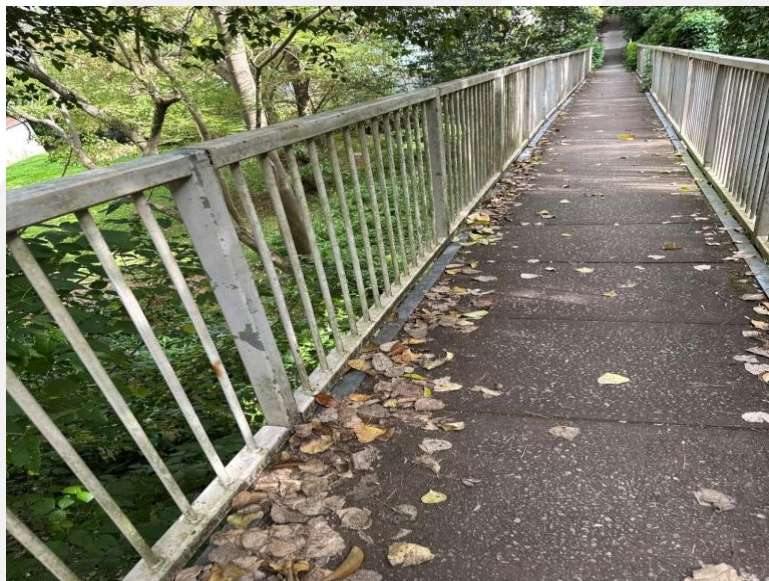
*Figure 36*

General condition along the Council suspended pedestrian bridge

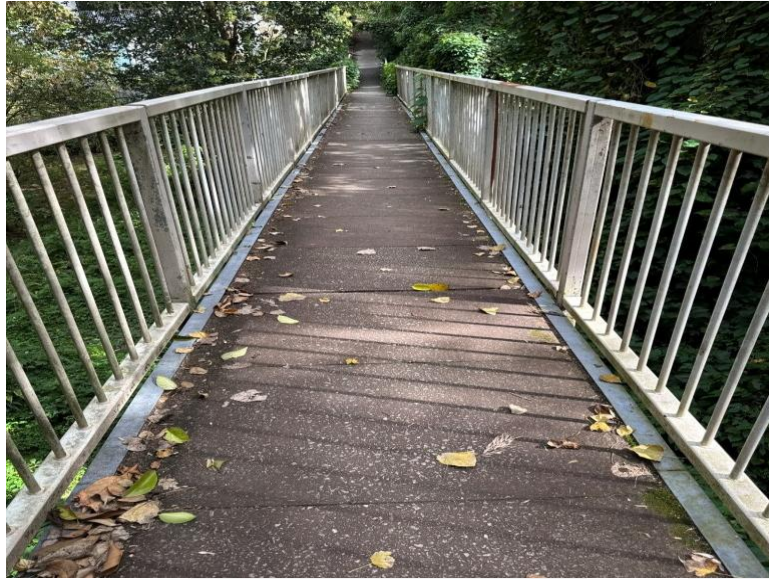
*Figure 37*

General condition along the Council suspended pedestrian bridge

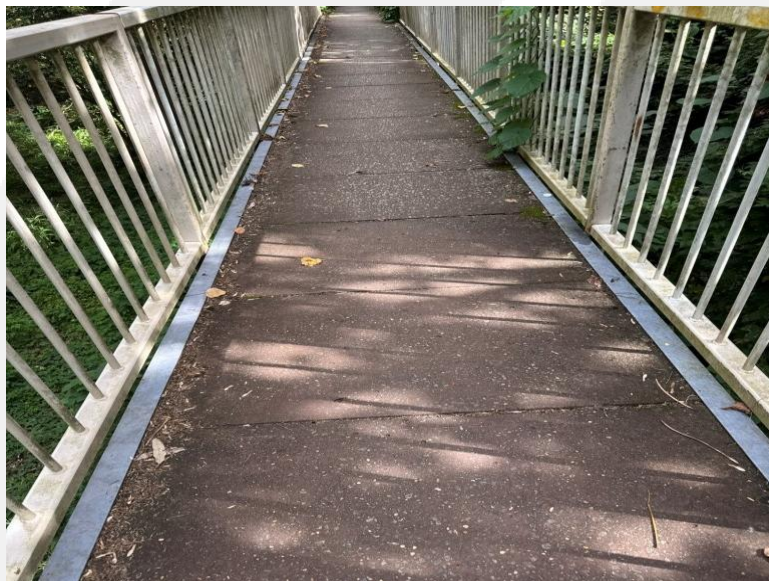
*Figure 38*

General condition along the Council suspended pedestrian bridge

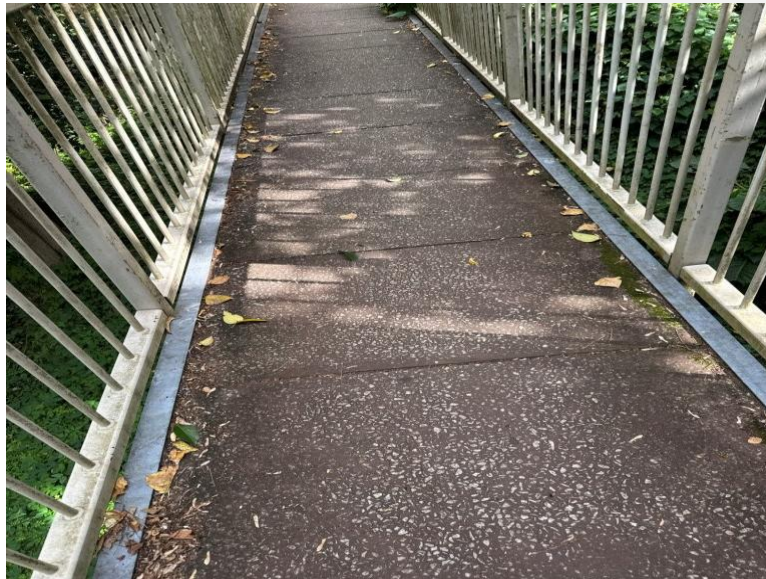
*Figure 39*

General condition along the Council suspended pedestrian bridge

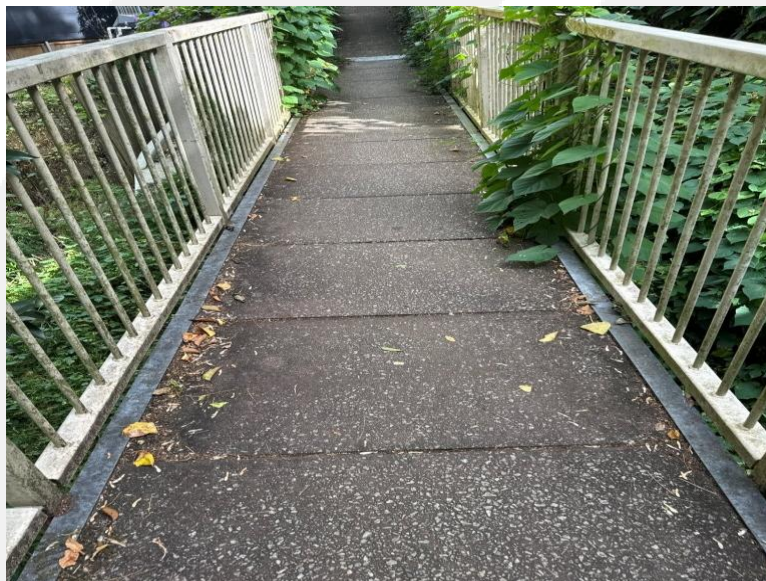
*Figure 40*

General condition along the Council suspended pedestrian bridge

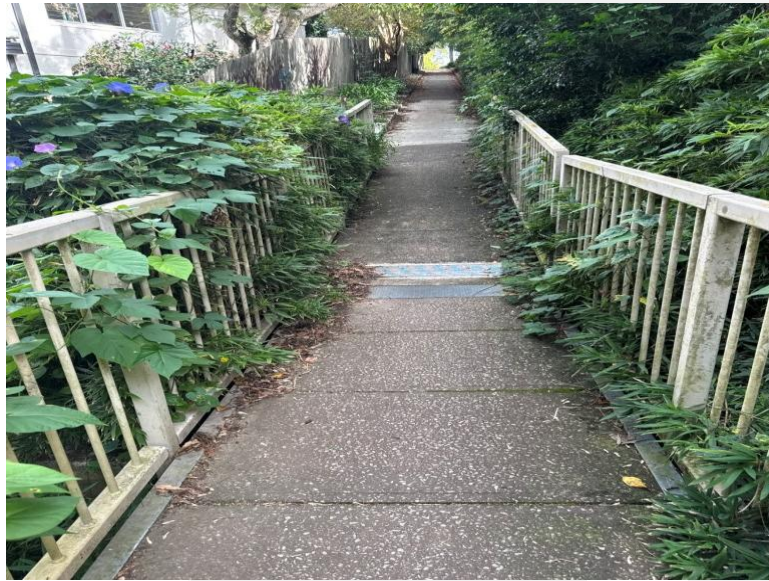
*Figure 41*

General condition along the Council suspended pedestrian bridge

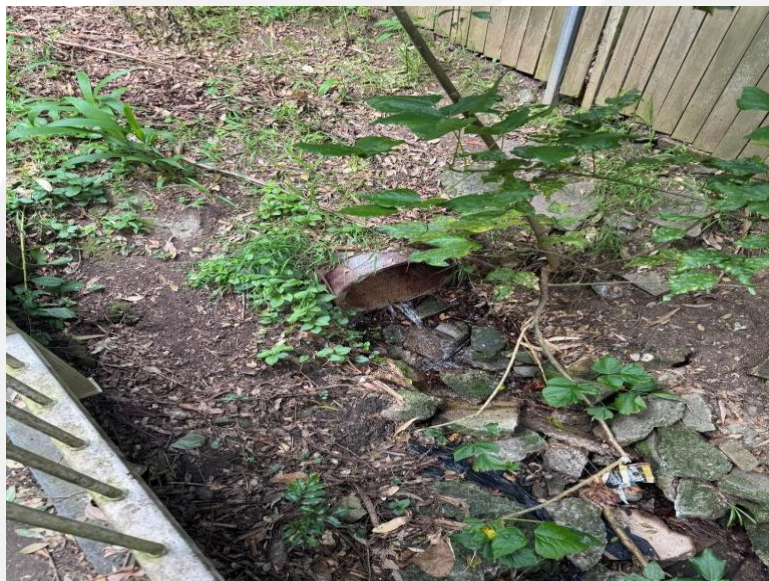
*Figure 42*

General condition of the Council culvert/ drainage pipe

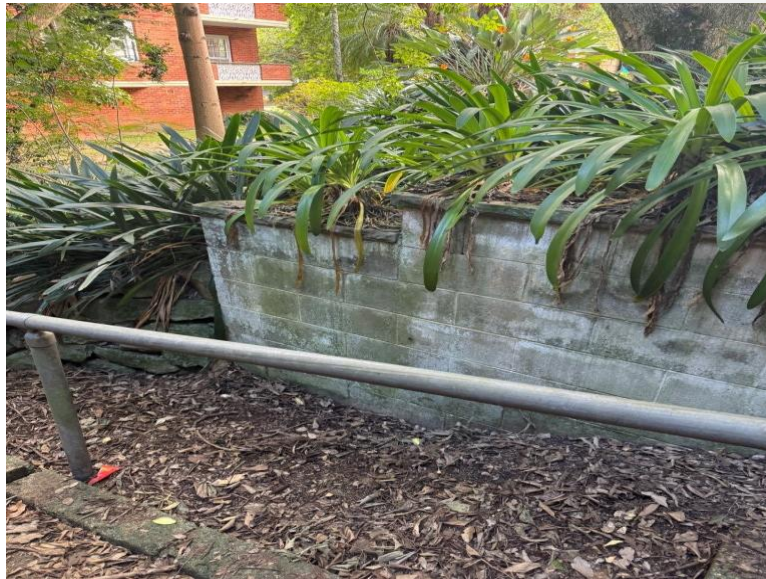
*Figure 43*

General condition along the Council block retaining wall

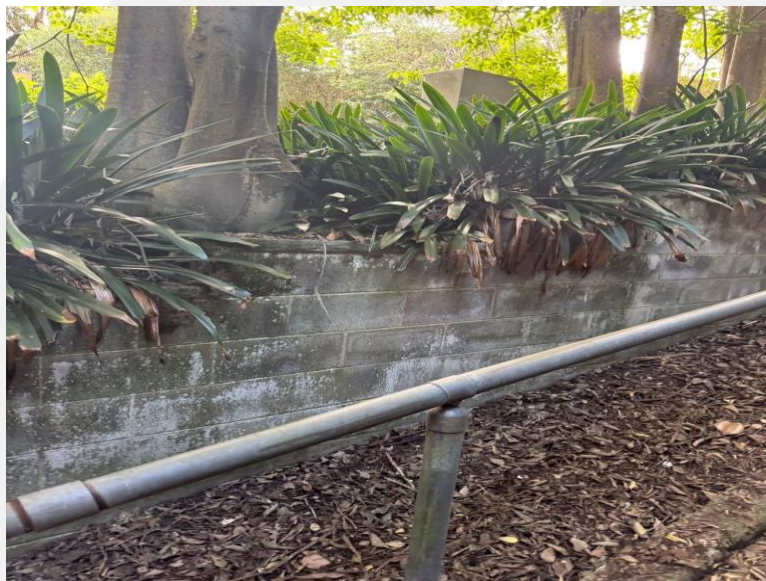
*Figure 44*

General condition along the Council block retaining wall

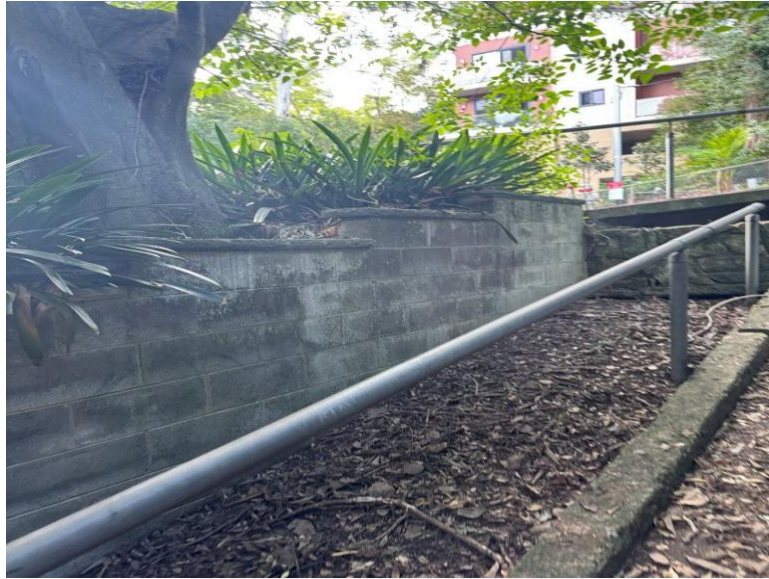
*Figure 45*

General condition along the Council block retaining wall
