## Appendix 32:

## Public Infrastructure – Maclaurin Parade, Roseville

**PROJECT NUMBER. V260255**

Project Address: 2-4 Larkin Street & 1,3,5 Pockley Avenue, Roseville

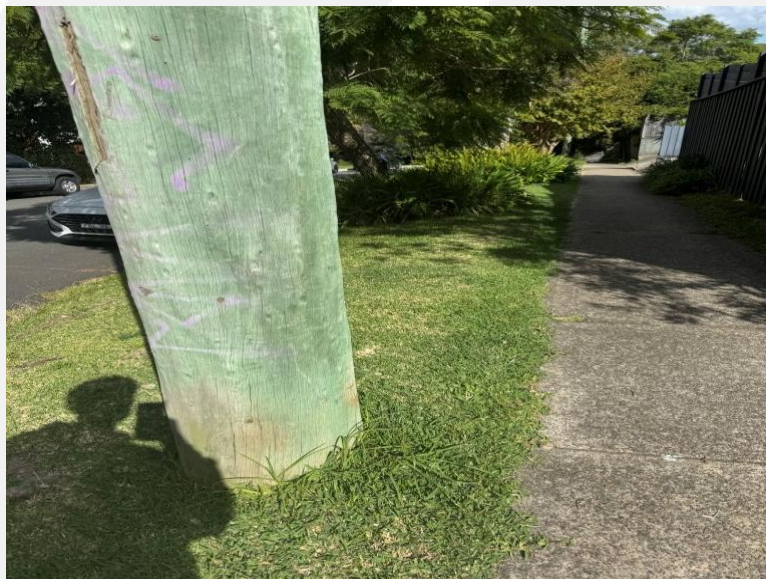
*Figure 2*

General condition of the Council utility post

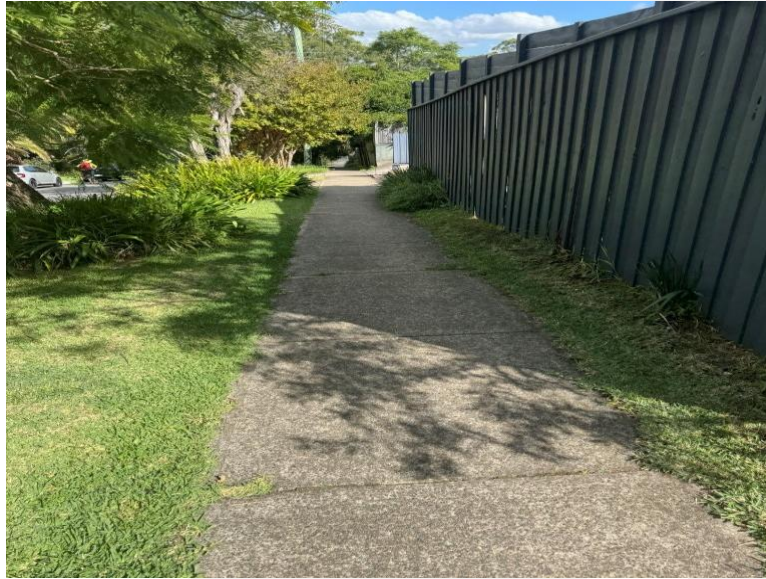
*Figure 3*

General condition along the Council concrete pathway

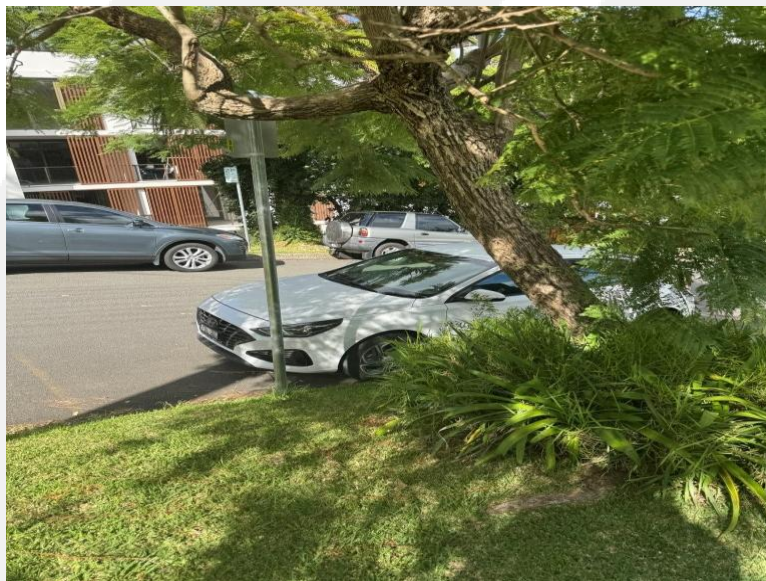
*Figure 4*

General condition of the Council utility post

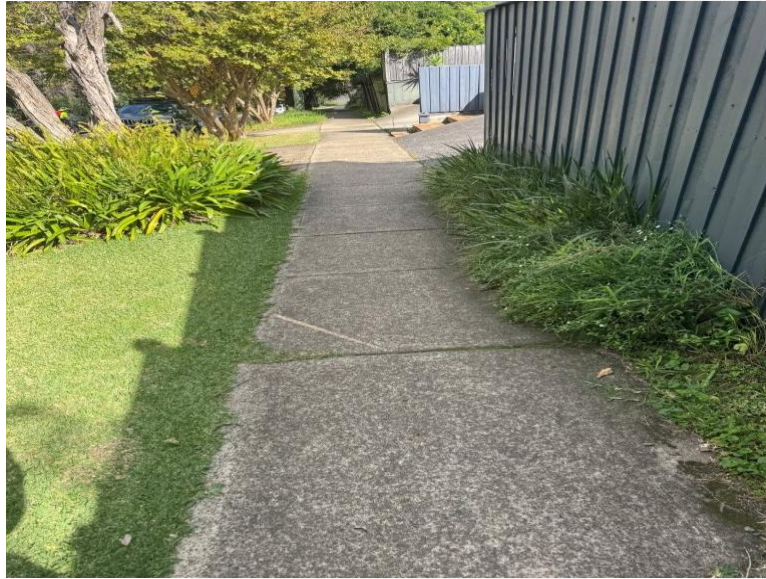
*Figure 5*

General condition along the Council concrete pathway

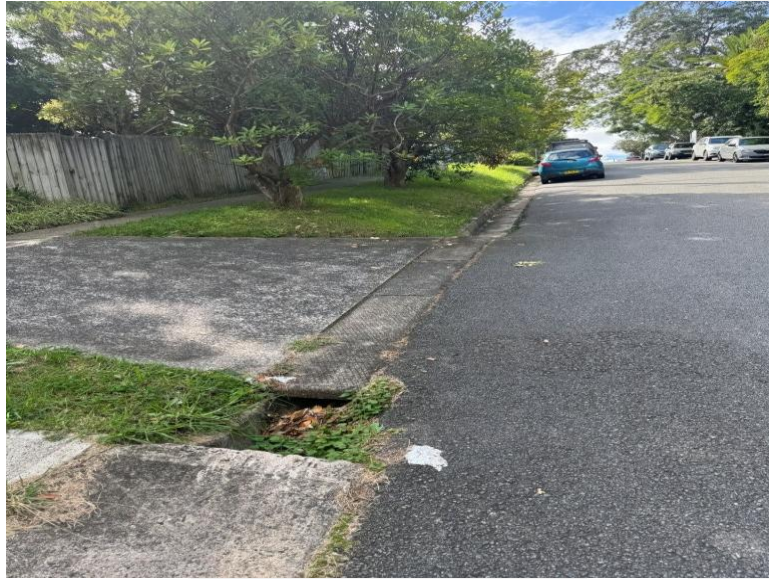
*Figure 86*

Cracking found along the Council concrete layback and gutter

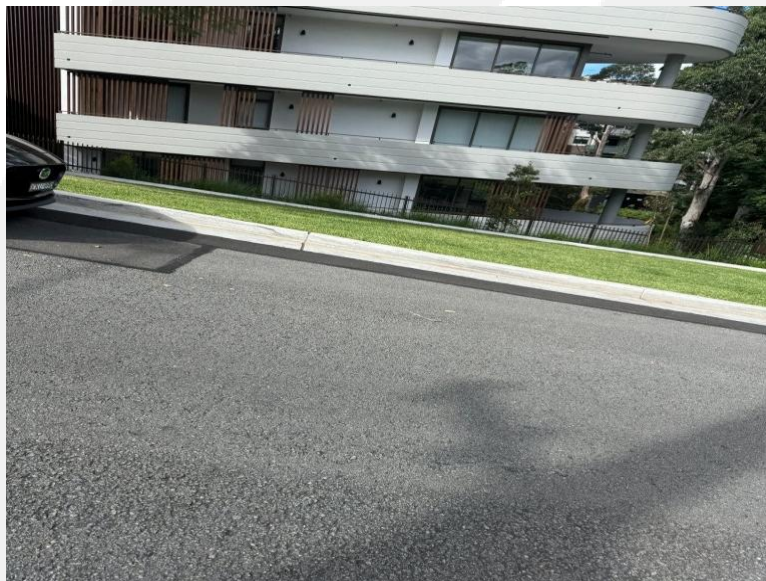
*Figure 95*

Cracking found along the Council bitumen road

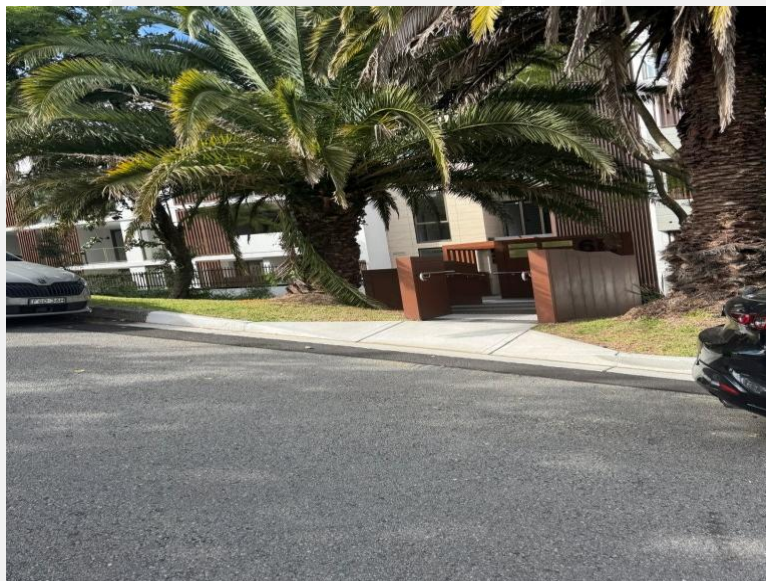
*Figure 97*

Cracking found along the Council bitumen road
