Hazardous Materials Survey

93-107 Cecil Avenue and 9-10 Roger Avenue, Castle Hill,
NSW

E26536.E10_Rev1
6 December 2024

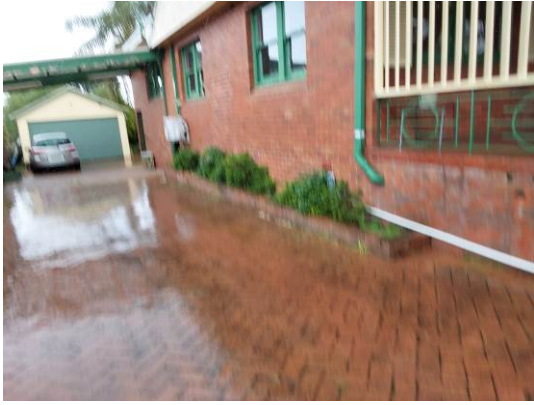
Main dwelling, external, window sills, green paint	Green LBP	Non-friable	Pb-7	3.0% w/w	4 x windows	Good / Occasional	Priority 4 - Negligible Risk Level	Remove grossly peeling paint. Stabilise remaining membrane. Minimise abrasive works that will disturb paint during demolition.

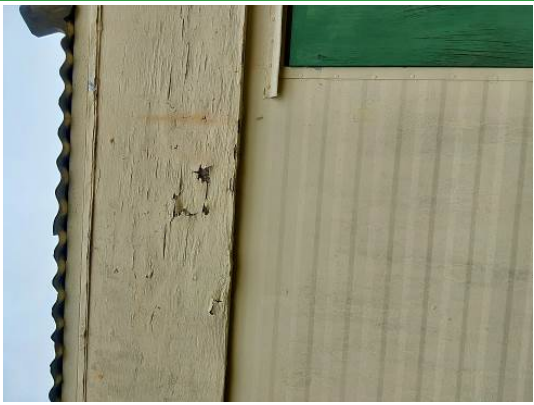
Detached southern sheds, external, white paint throughout	White LBP	Non-friable	Pb-12	2.5% w/w	Approximately 20m ²	Fair / Occasional	Priority 4 - Negligible Risk Level	Remove grossly peeling paint. Stabilise remaining membrane. Minimise abrasive works that will disturb paint during demolition.

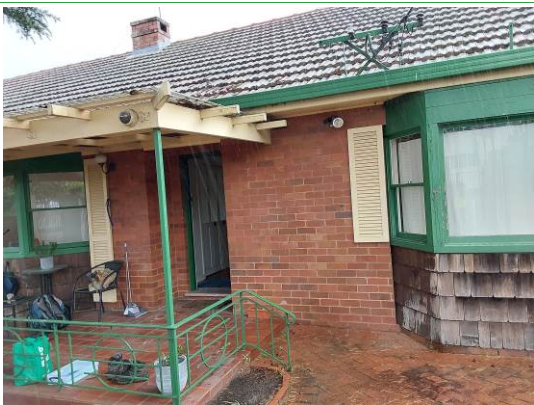
Main dwelling, external, northern railings, green paint	Green Paint	Non-friable	Pb-8	0.086% w/w	N/A	N/A	N/A	N/A

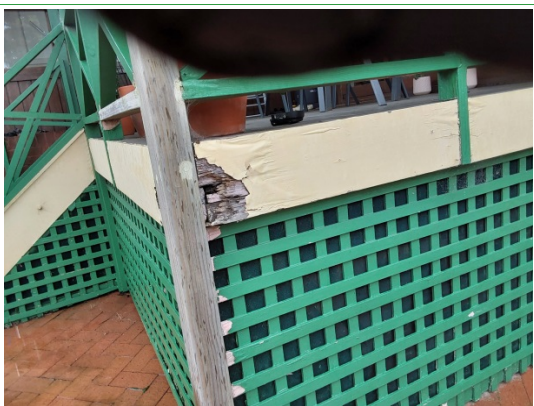
Main dwelling, external, southern stairwell, cream paint	Cream Paint	Non-friable	Pb-9	<0.001% w/w	N/A	N/A	N/A	N/A

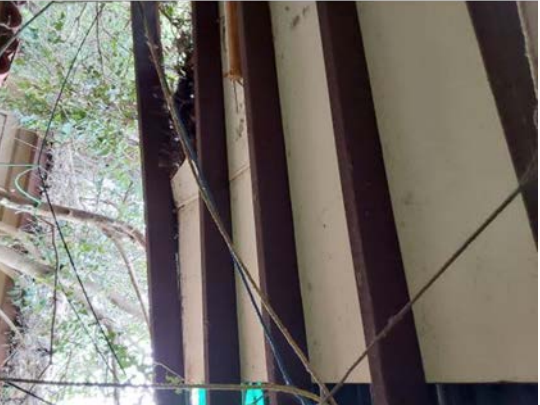
External, southern awning, cement ceiling	FCS	Non-friable	Asb-9	No Asbestos Detected Organic Fibres Detected	N/A	N/A	N/A	N/A

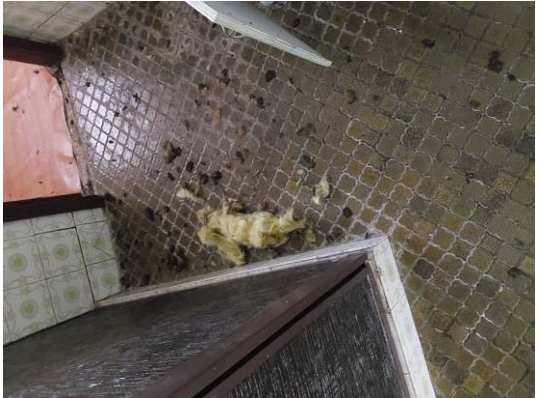
SMF									
Internal, ceiling cavity, insulation	SMF	Unsealed	Visual inspection - height restriction	-	Approximately 30m ²	Good / Maintenance only	Priority 4 - Negligible Risk Level	Remove during initial stage of demolition works

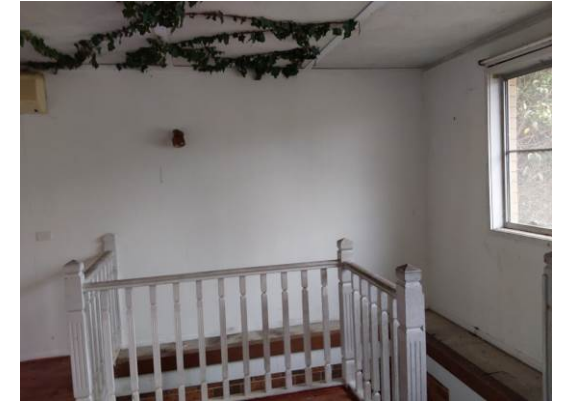
Internal, southern wall, white paint	White Paint	Non-friable	Pb-31	<0.001% w/w	N/A	N/A	N/A	N/A
--------------------------------------	-------------	-------------	-------	-------------	-----	-----	-----	-----

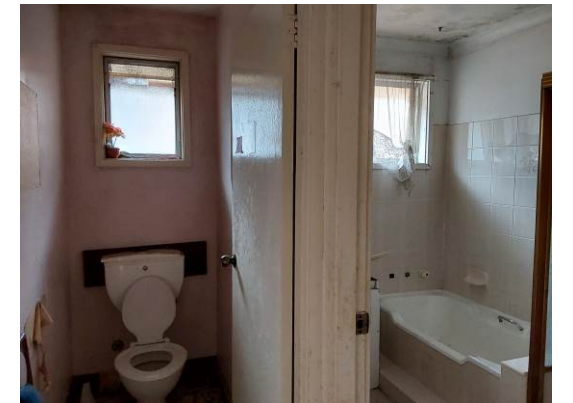
Internal, bathroom, wall	Pink paint	Non-friable	Pb-32	<0.001% w/w	N/A	N/A	N/A	N/A
--------------------------	------------	-------------	-------	-------------	-----	-----	-----	-----

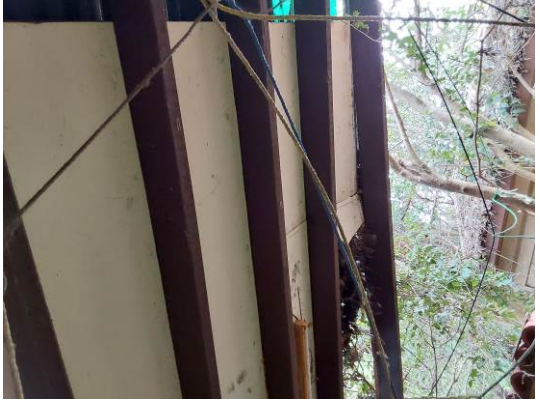
External, southern awning, fluorescent light	PCB	N/A	Visual inspection	-	1 x fixture	Good / Maintenance only	Priority 4 - Negligible Risk Level	Remove prior to demolition works. Avoid damage to capacitors.

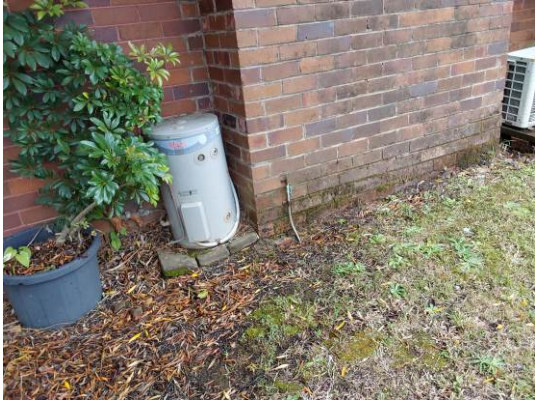
Main dwelling, external, eastern wall, water heating unit	SMF (assumed)	Sealed	Visual inspection	-	1x unit	Good / Maintenance only	Priority 4 - Negligible Risk Level	Remove during initial stages of demolition

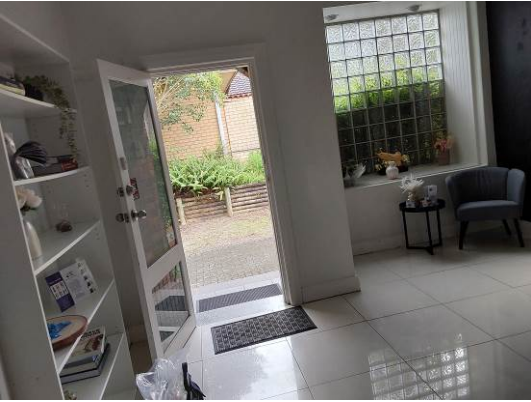
Main dwelling, external, western entrance, door frame, white paint	White Paint	Non-friable	Pb-22	0.032% w/w	N/A	N/A	N/A	N/A

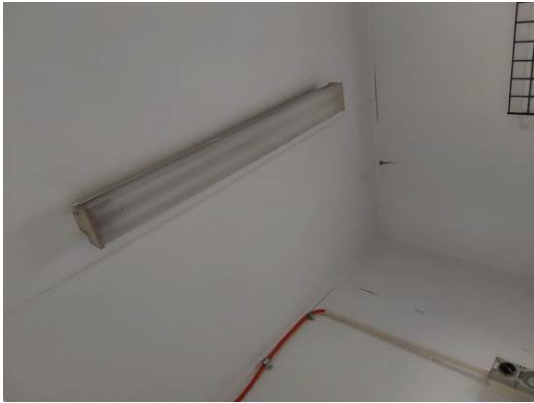
PCB									
Main dwelling, internal, southern room, ceiling, fluorescent light fitting	PCB-containing single-tube fluorescent light fitting capacitors (assumed)	N/A	Visual inspection - electrical hazard	-	1x fixture	Good / Maintenance only	Priority 4 - Negligible Risk Level	Remove prior to demolition works. Avoid damage to capacitors.

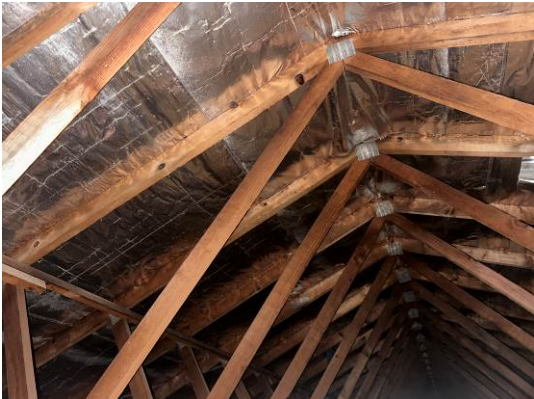
SMF									
Internal, ceiling cavity, insulation	SMF-lined insulation (assumed)	Sealed	Visual inspection	-	ND	Good / Maintenance only	Priority 4 - Negligible Risk Level	Remove during initial stage of demolition works

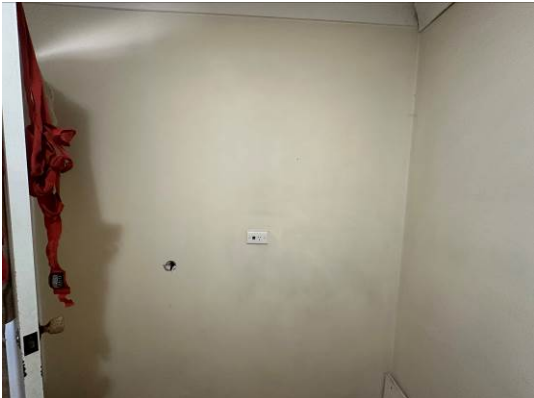
LBP									
Internal, laundry, walls	Cream paint	Non-friable	Pb2-5	0.001% w/w	N/A	N/A	N/A	N/A

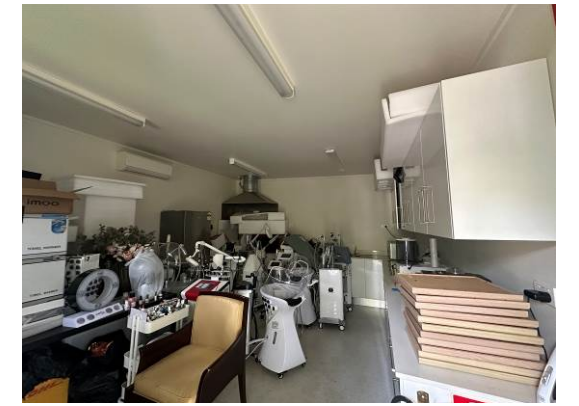
North western detached office, internal, walls, paint	White paint	Non-friable	Pb2-10	<0.001% w/w	N/A	N/A	N/A	N/A
---	-------------	-------------	--------	-------------	-----	-----	-----	-----

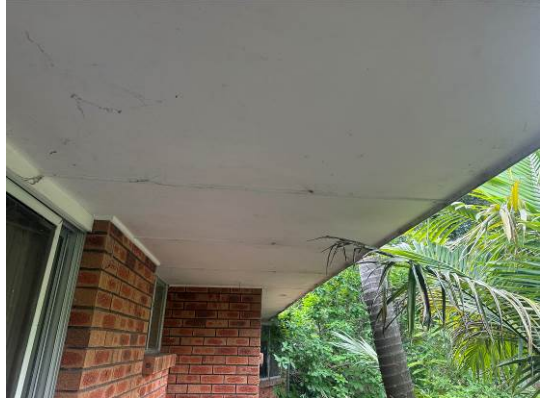
Internal, laundry, walls	ACM	Non-friable	Asb2-10	Chrysotile Asbestos Detected Organic Fibres Detected	Approximately 20m ²	Good / Maintenance only	Priority 3 - Low Risk Level	Remove during initial stage of demolition works	 
External, eaves/soffits throughout	ACM	Non-friable	Asb2-11	Chrysotile Asbestos Detected	Approximately 20m ²	Good / Maintenance only	Priority 3 - Low Risk Level	Remove during initial stage of demolition works

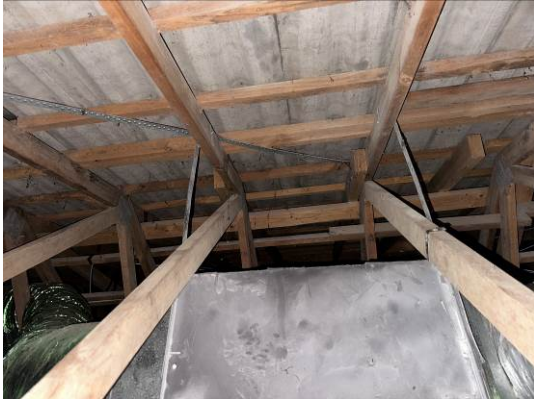
SMF									
Main dwelling, internal, ceiling cavity, insulation	SMF-lined insulation (assumed)	Unsealed	Visual inspection	-	ND	Good / Maintenance only	Priority 4 - Negligible Risk Level	Remove during initial stage of demolition works

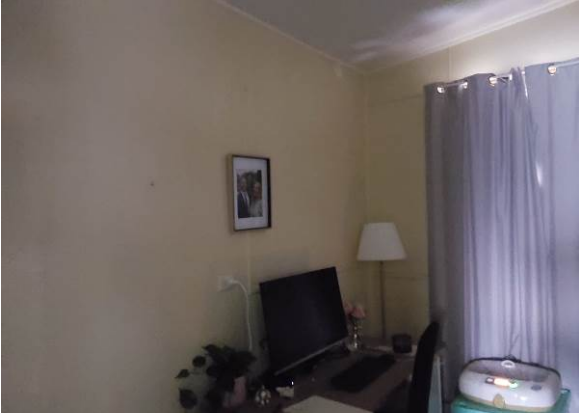
LBP									
Main building, internal, central living room, walls	White paint	Non-friable	Pb-36	0.002% w/w	N/A	N/A	N/A	N/A

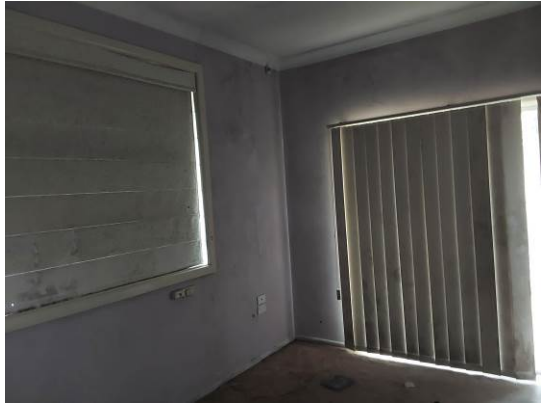
Internal, central room, walls	Purple paint	Non-friable	Pb-25	<0.001% w/w	N/A	N/A	N/A	N/A

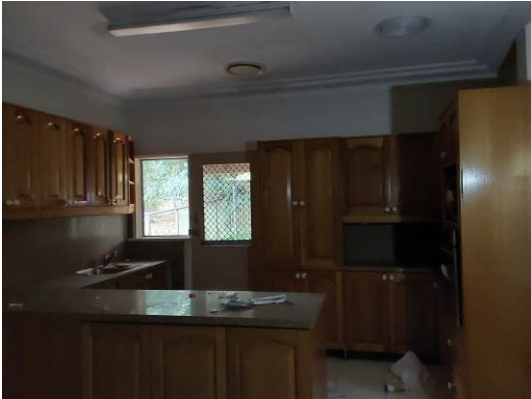
<p>Internal, kitchen, fluorescent light</p>	<p>PCB-containing single-tube fluorescent light fitting capacitors (assumed)</p>	<p>N/A</p>	<p>Visual inspection - electrical hazard</p>	<p>-</p>	<p>1x unit</p>	<p>Good / Maintenance only</p>	<p>Priority 4 - Negligible Risk Level</p>	<p>Remove prior to demolition works. Avoid damage to capacitors.</p>
