## Hazardous Construction Materials Survey

12 – 16 Bent Street, Lindfield NSW

10 February 2025

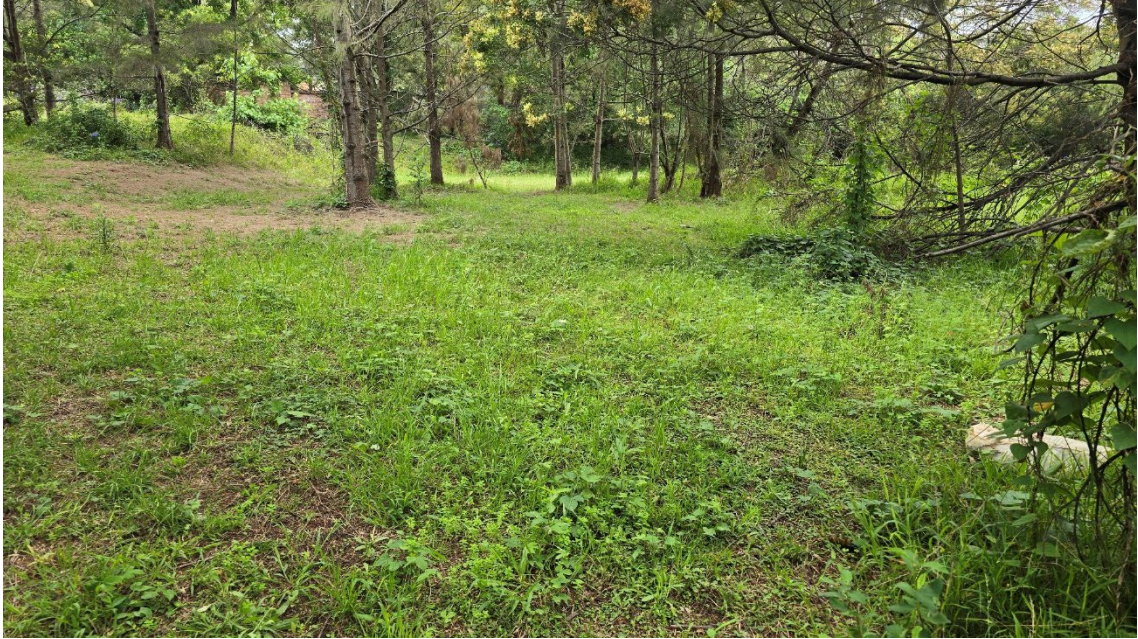
**Vacant land at 12 Bent Street, Lindfield NSW**

The eastern area of the site comprises vacant land which is identified as 12 Bent Street. A walkover inspection of this land found it to be mostly covered with ground cover vegetation and there to be a number of large trees and shrubs of various sizes present.

In areas where the surface soil was exposed, some random pieces of building / demolition debris were found to be present. No visible asbestos containing material debris was sighted on the soil that is exposed amongst the ground cover vegetation within this property at the site.

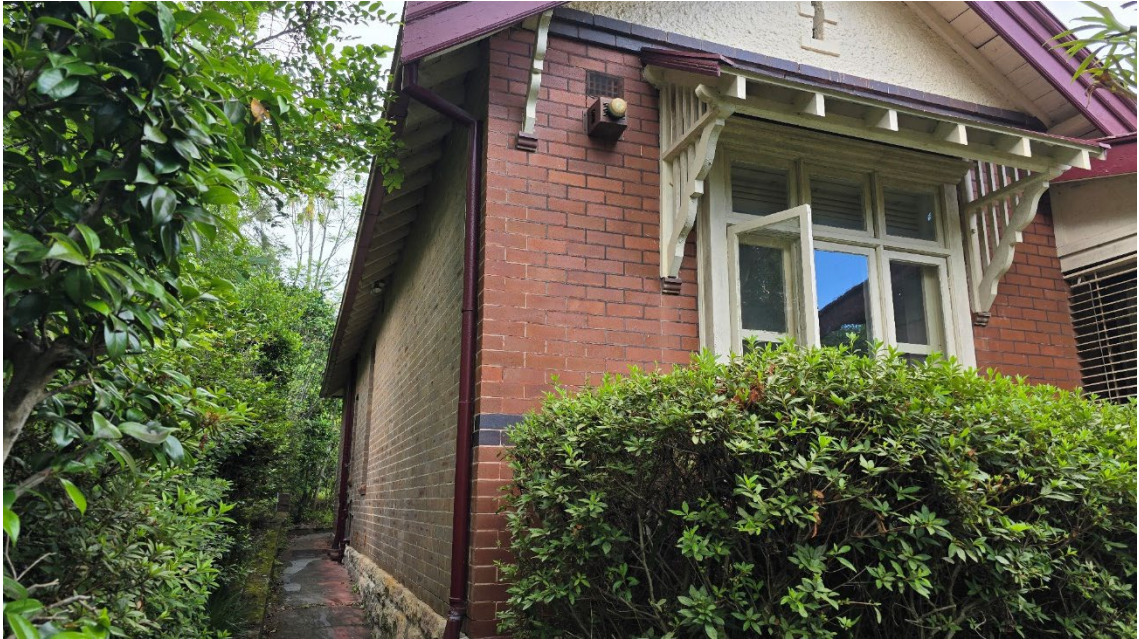
**Photograph No. 1: Front north east area of house at 14 Bent Street**

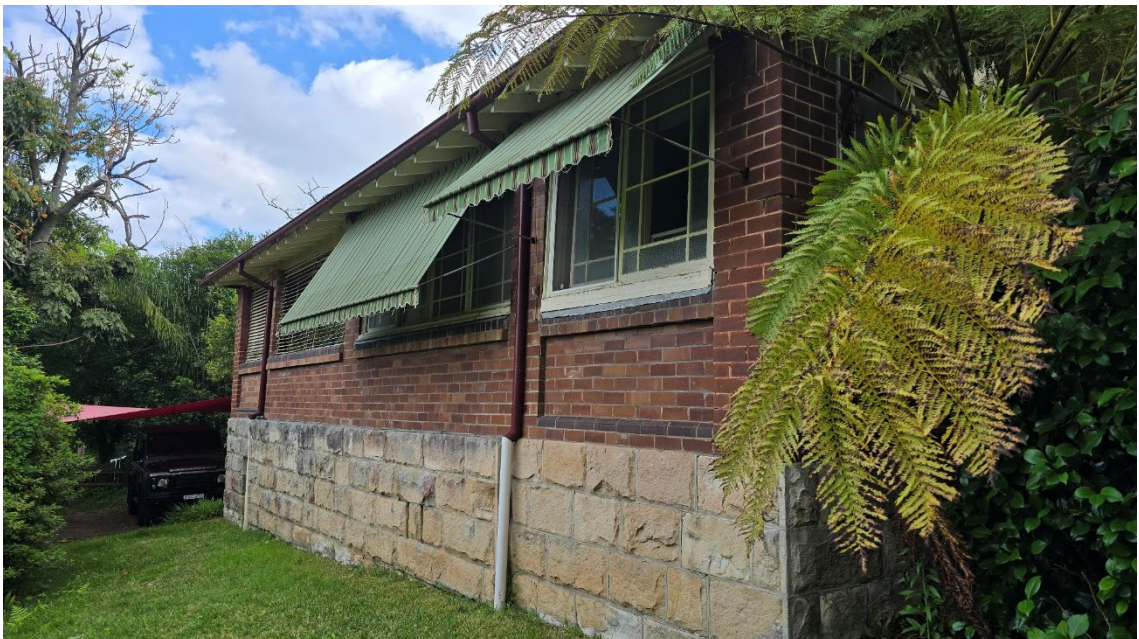
**Photograph No. 2: West side of house at 14 Bent Street**

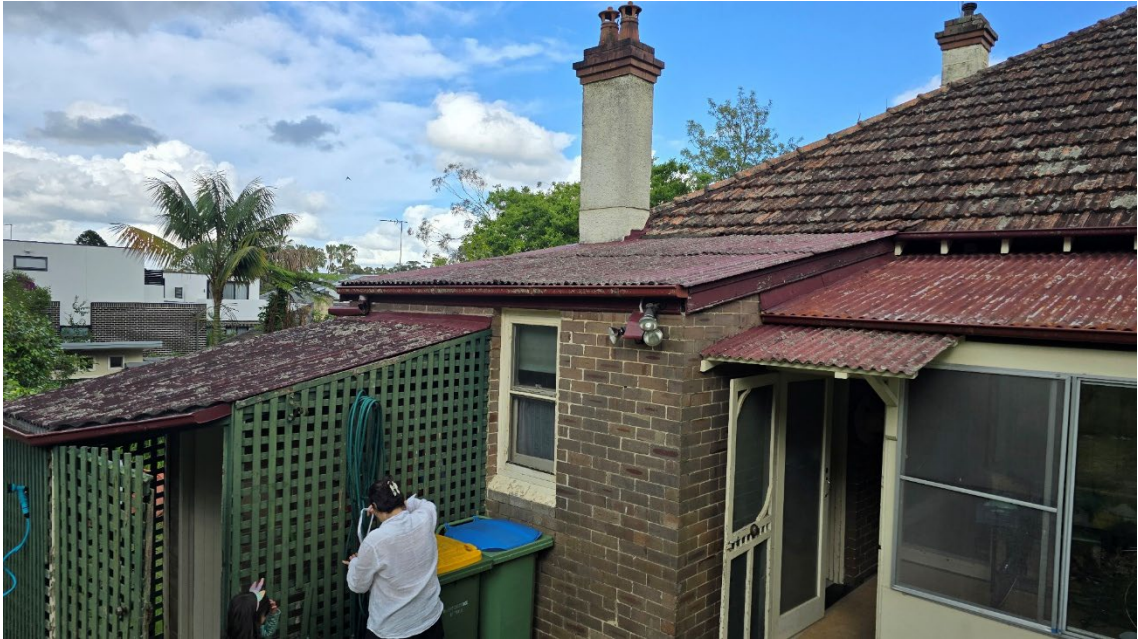
**Photograph No. 3: Three asbestos cement sheet roofs on rear side of house at 14 Bent Street. These roofs are over the laundry, rear toilet and rear entry**

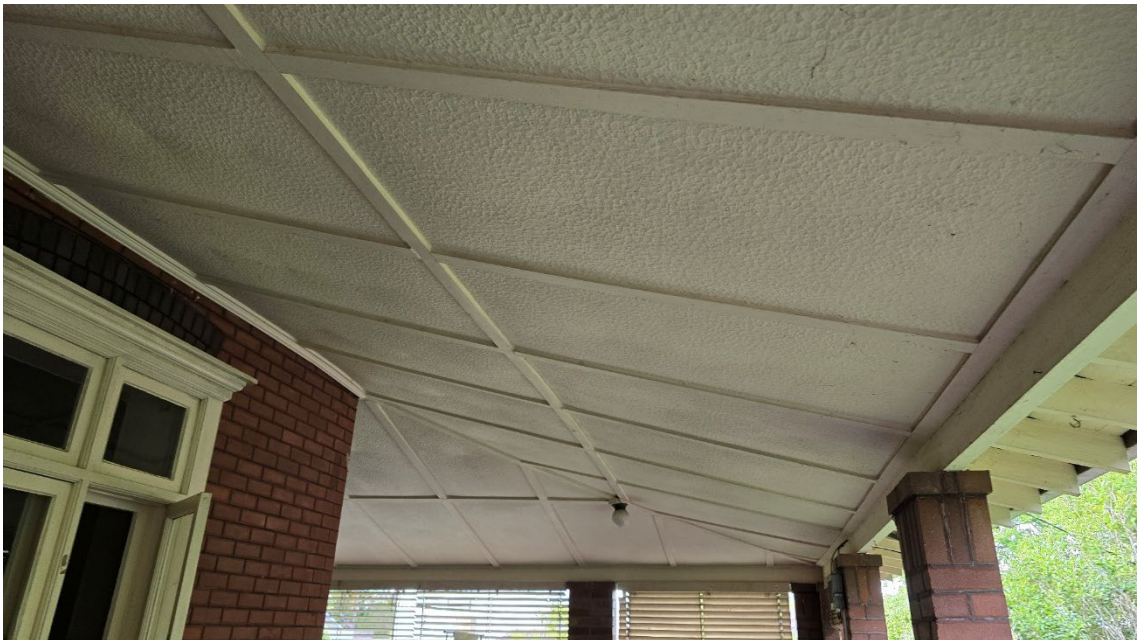
**Photograph No. 4: Fibrous plaster ceiling lining over front verandah at 14 Bent Street**

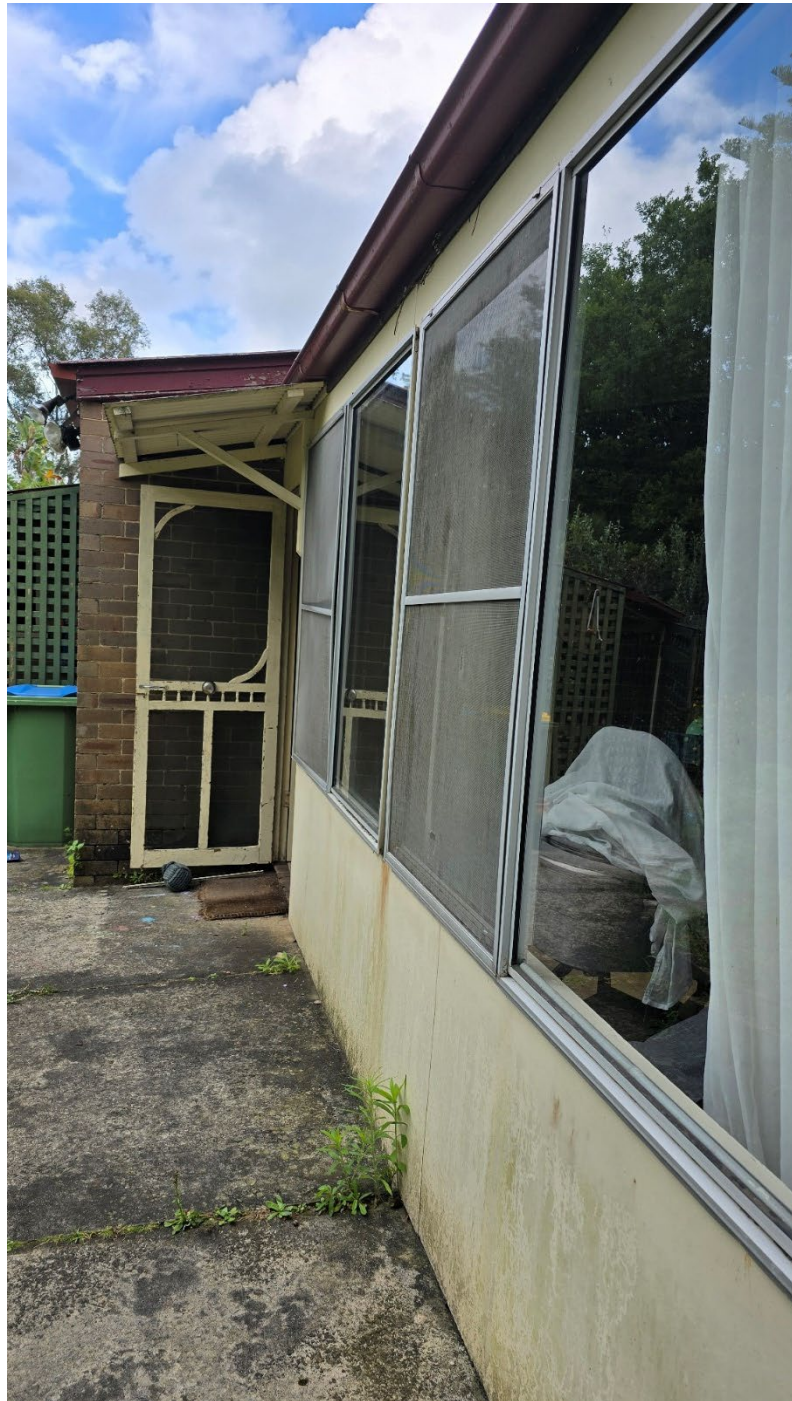
The timber framed walls on the rear part of the house above and below the aluminium framed windows are clad with panels of flat fibrous cement sheet. See photograph No. 5. A sample of this cladding material was analysed and found to be free of asbestos. The framed walls at the eastern end of this enclosed verandah are clad with timber boards.

**Photograph No. 5: Flat fibrous cement sheet cladding on rear external wall at 14 Bent Street. A sample of this material was found to be free of asbestos**

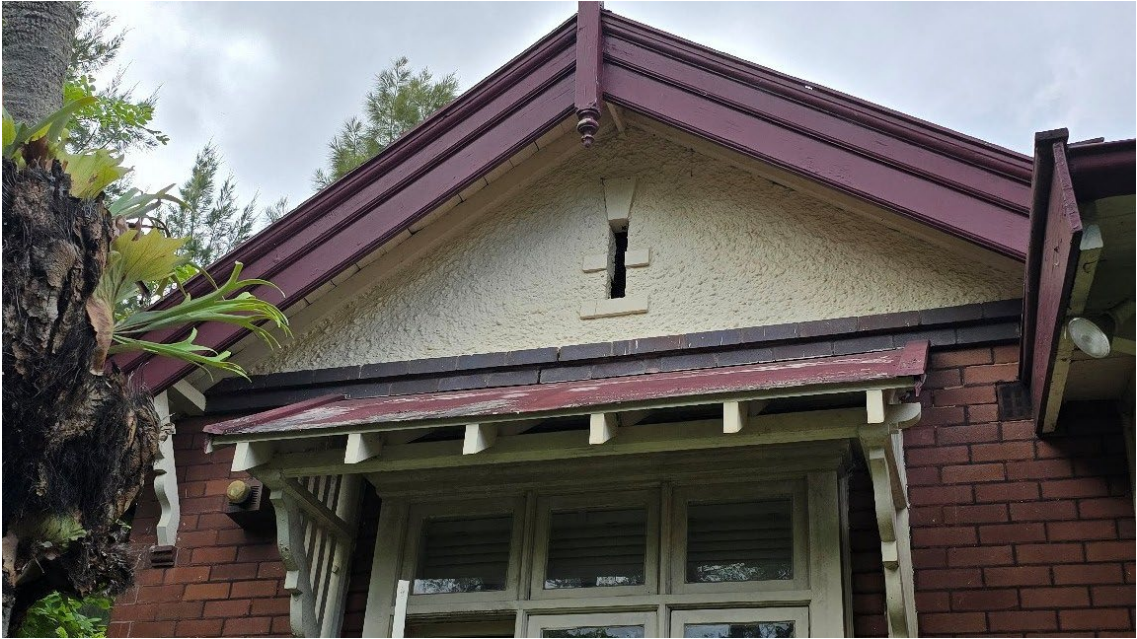
**Photograph No. 6: Front of house showing gable roof end where the verge tiles are presumed to be supported on flat asbestos cement sheet.  
The roof of the window awning is flat asbestos cement sheet**

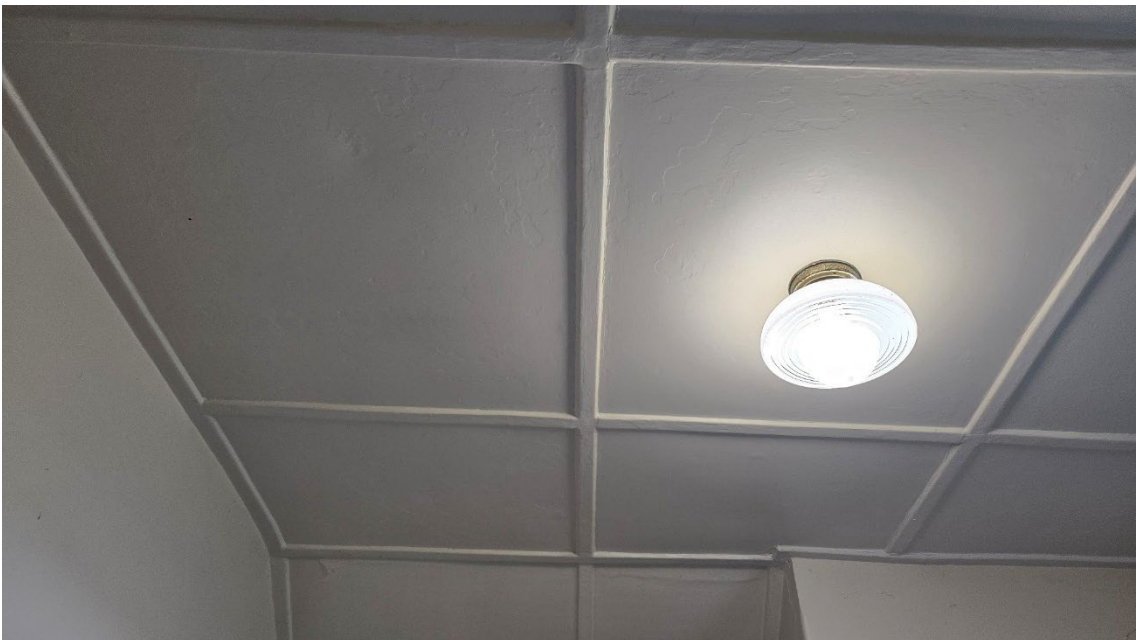
**Photograph No. 7: Flat asbestos cement sheet ceiling lining in kitchen at 14 Bent Street**

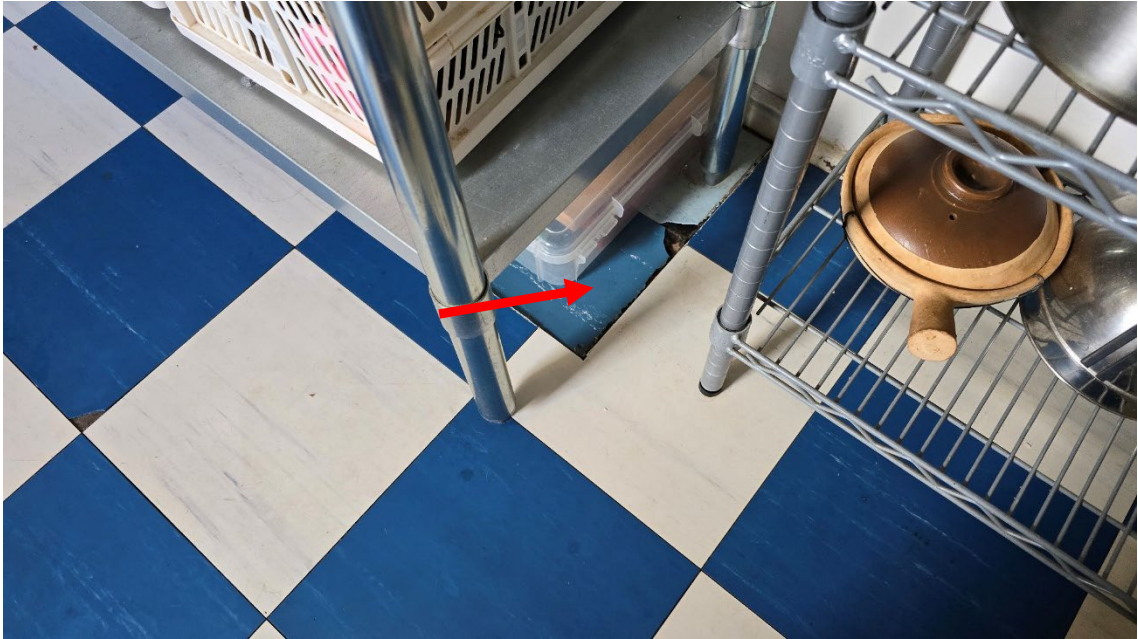
In the kitchen there are two layers of chequer patterned vinyl tiles covering the floor. A sample of the blue upper tiles and the grey lower tiles were analysed and found to be free of asbestos whilst the lower light blue tiles were sampled and found to contain chrysotile asbestos. See photograph No. 8.

**Photograph No. 8: Vinyl floor tiles in kitchen. Arrow indicates lower layer of tiles which were analysed and confirmed to contain chrysotile asbestos**

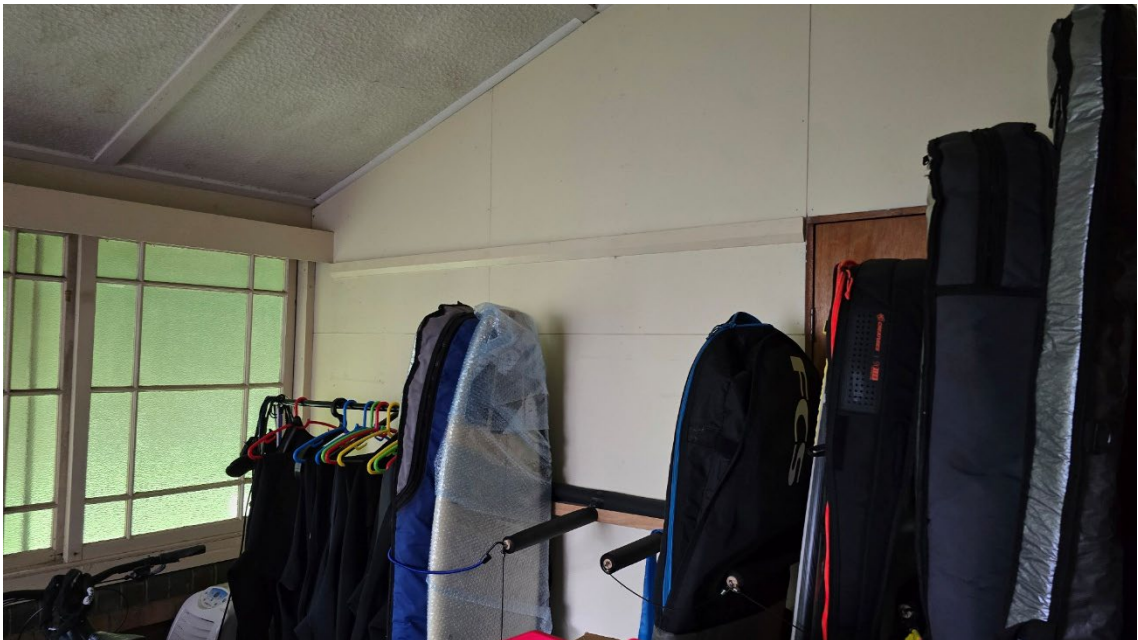
**Photograph No. 9: Fibrous plaster ceiling lining and plywood wall lining in centre west enclosed sun room at 14 Bent Street**

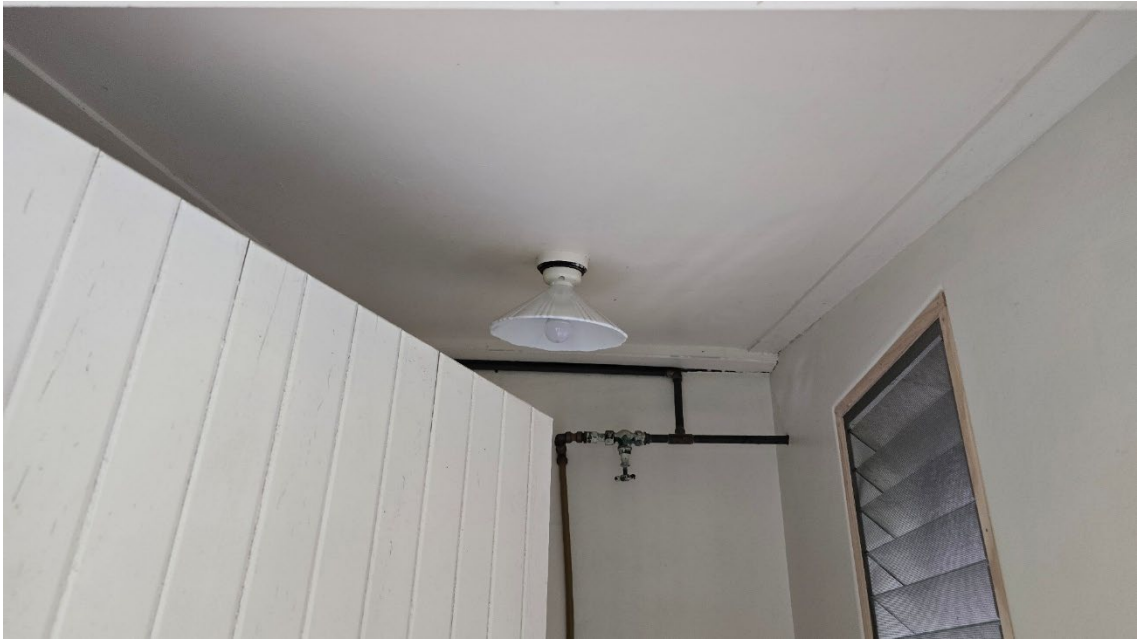
**Photograph No. 10: Flat asbestos cement sheet ceiling lining in rear toilet at 14 Bent Street**

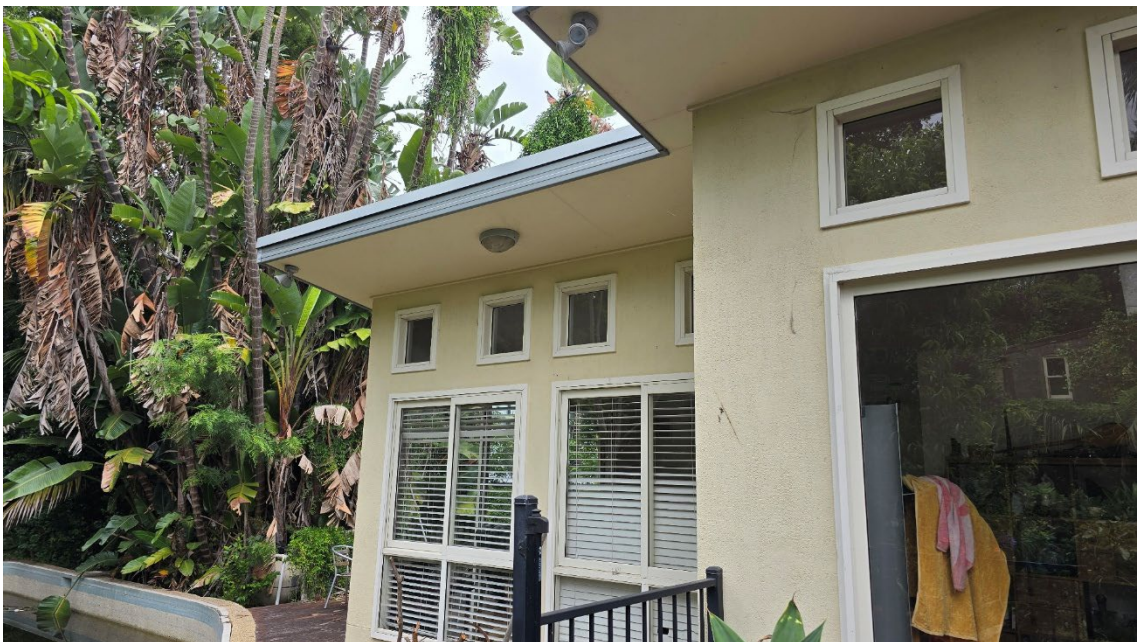
**Photograph No. 11: Rear extension on house at 16 Bent Street that has asbestos free fibrous cement sheet eave lining and wall cladding substrate (presumed)**

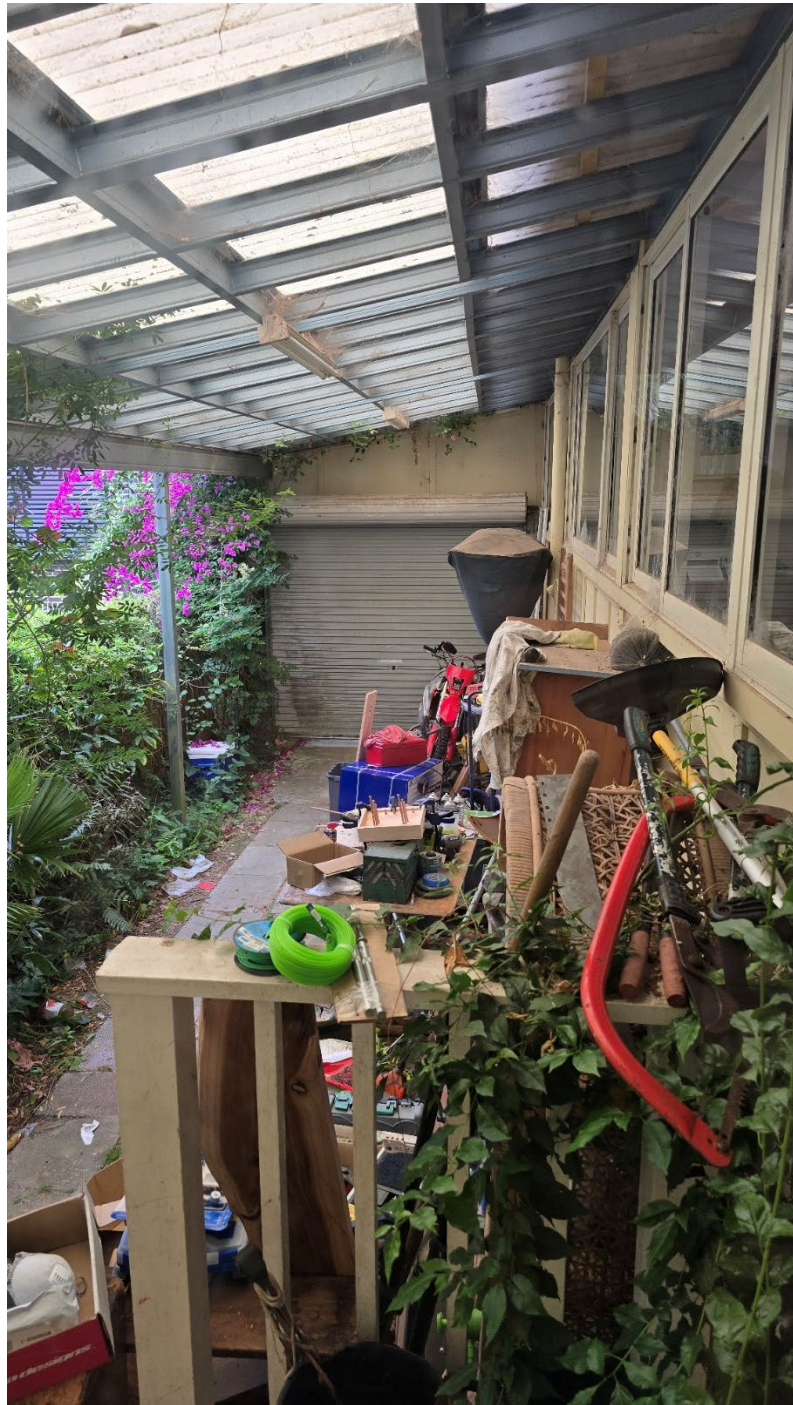
**Photograph No. 12: Interior of west side garage at 16 Bent Street. The cladding to the wall of the house and around the roller door is flat asbestos cement sheet**

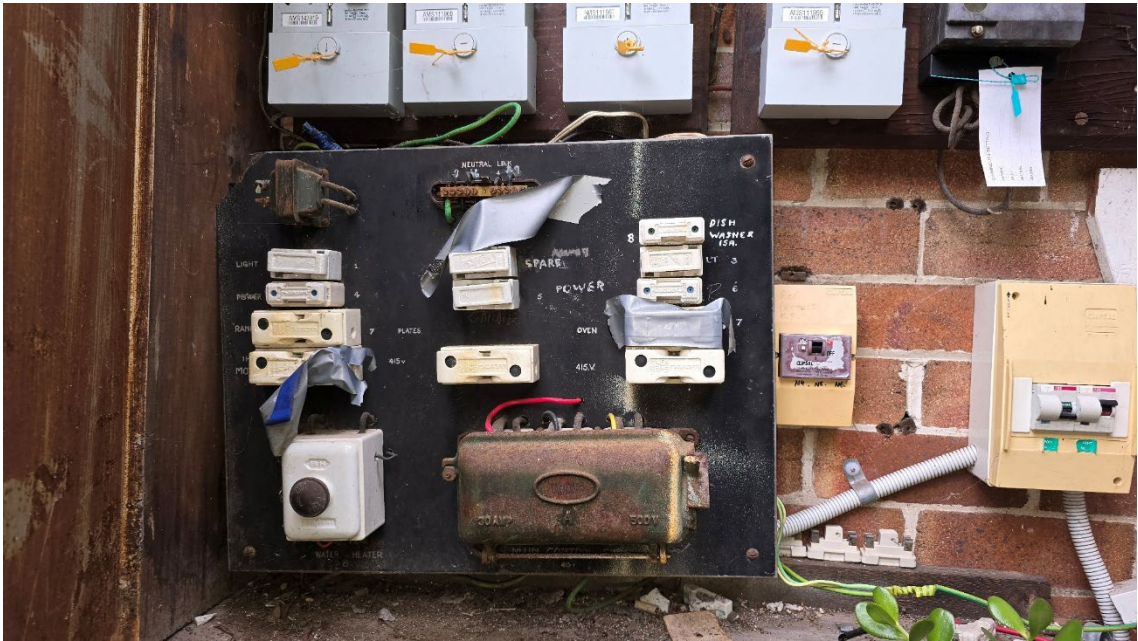
**Photograph No. 13: Asbestos based backing board  
in electrical supply cabinet at 16 Bent Street**

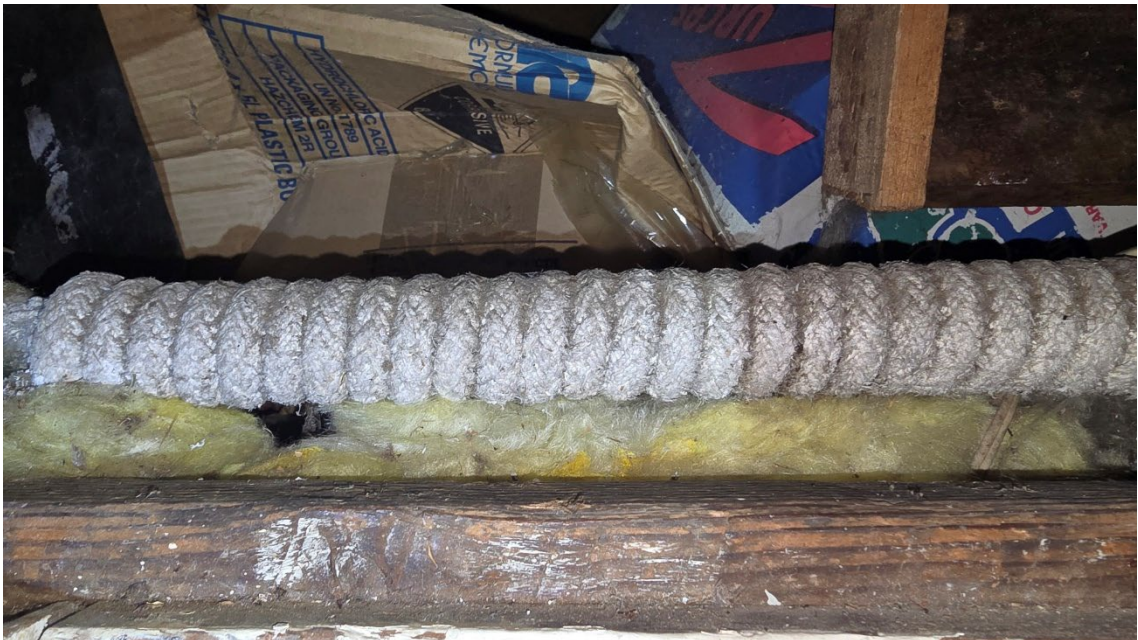
Inspection within the roof space of the original part of the house found a hot water pipe to be insulated with asbestos rope. See photograph No. 14. This pipe is located adjacent to the roof access panel and the insulation has been damaged by persons accessing this area and scrapping the insulation with the access panel and / or the movement of items into and out of the roof space. See photograph No. 15. Accordingly, all dust in the roof space is deemed to be asbestos contaminated.

**Photograph No. 14: Close view of asbestos rope insulation  
on pipe in ceiling space at 16 Bent Street**

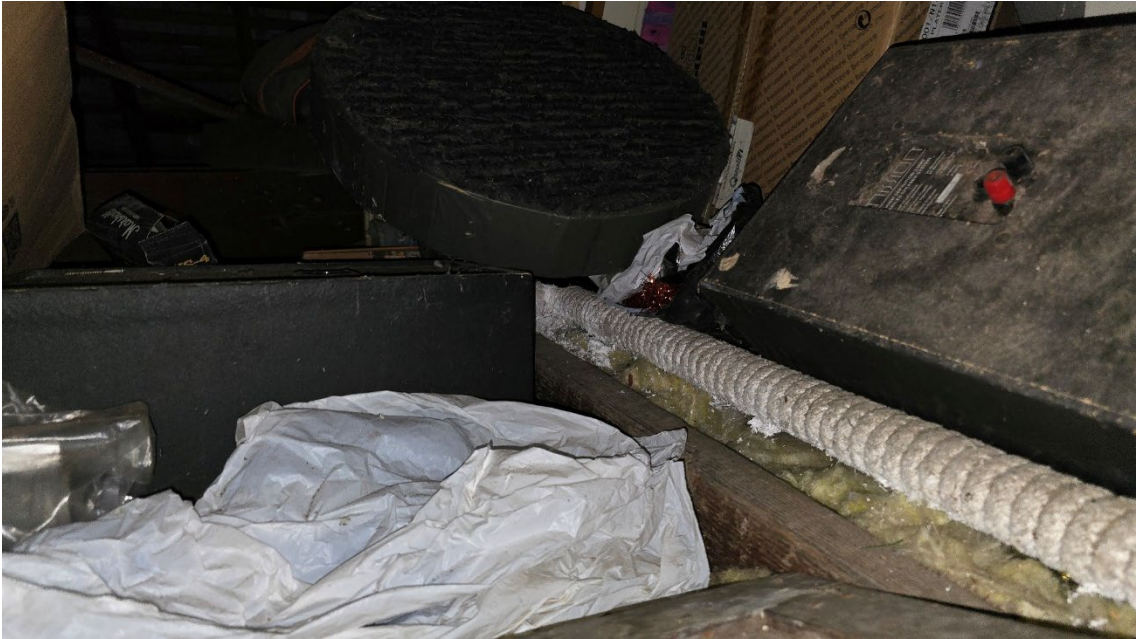
**Photograph No. 15: Asbestos rope debris on SMF insulation batts in roof space at 16 Bent Street**

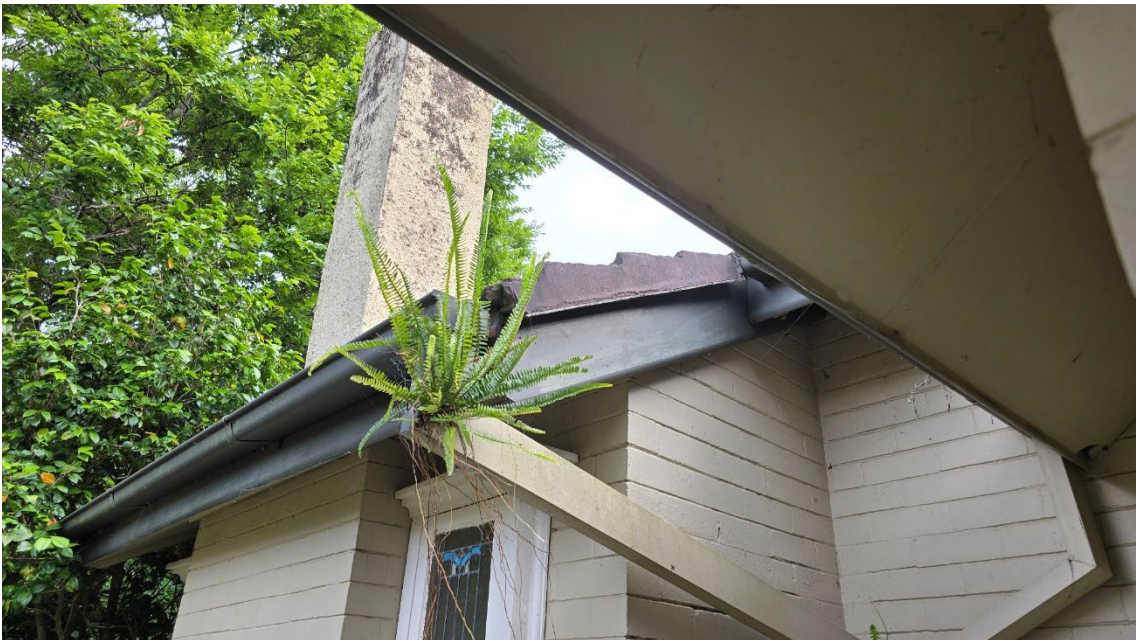
**Photograph No. 16: Asbestos cement sheet eave lining and supporting strip below verge tile on west side of house at 16 Bent Street**

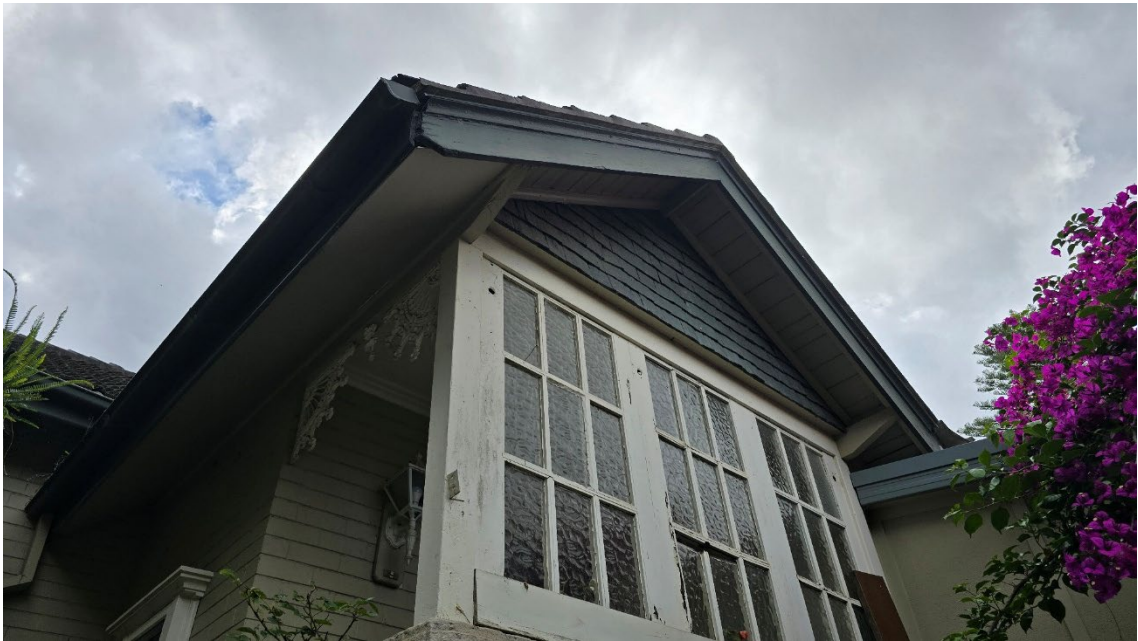
**Photograph No. 17: Timber shingles on west side of house at 16 Bent Street.  
There may be asbestos cement sheet substrate behind these shingles**

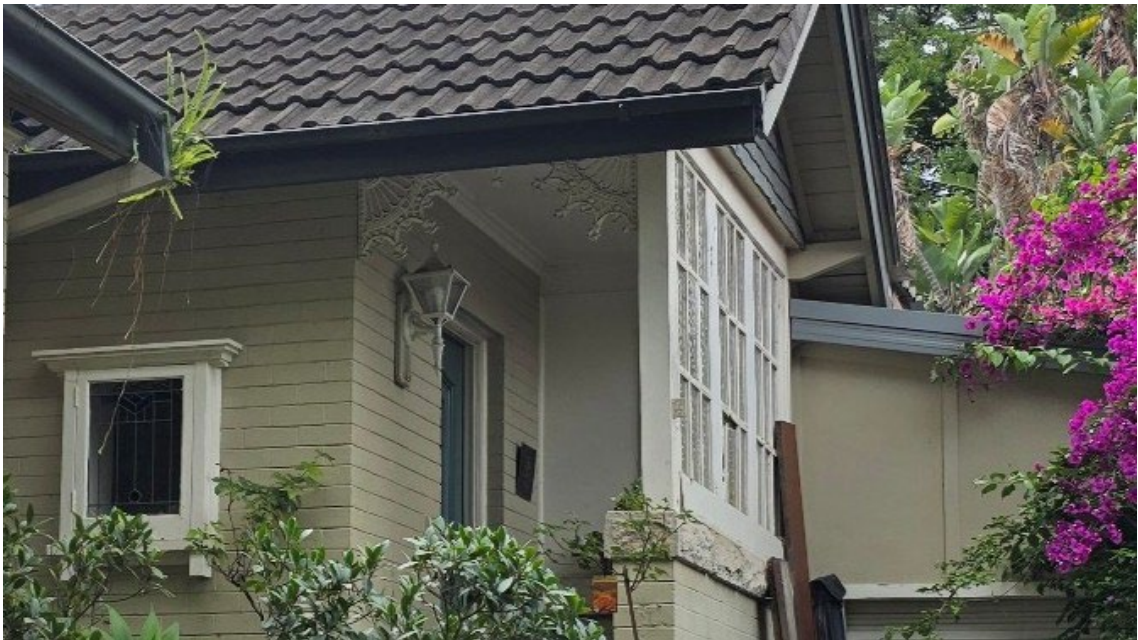
**Photograph No. 18: Flat asbestos cement sheet ceiling and  
wall linings in west side entry porch at 16 Bent Street**

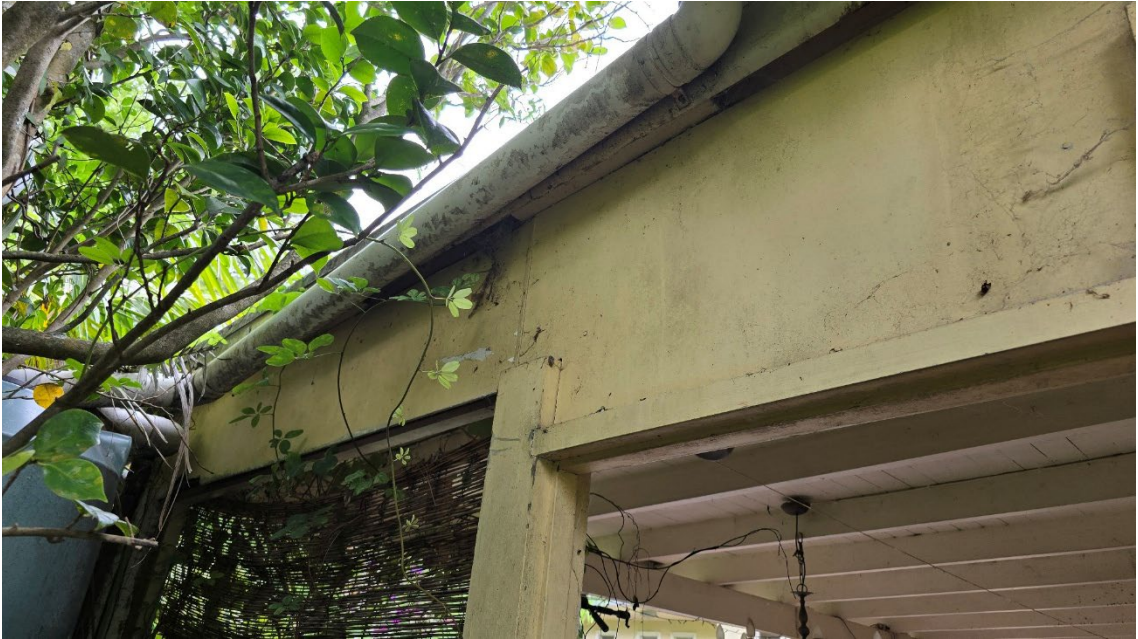
**Photograph No. 19: Flat asbestos cement sheet cladding on external side of wall to rear covered verandah at 16 Bent Street**

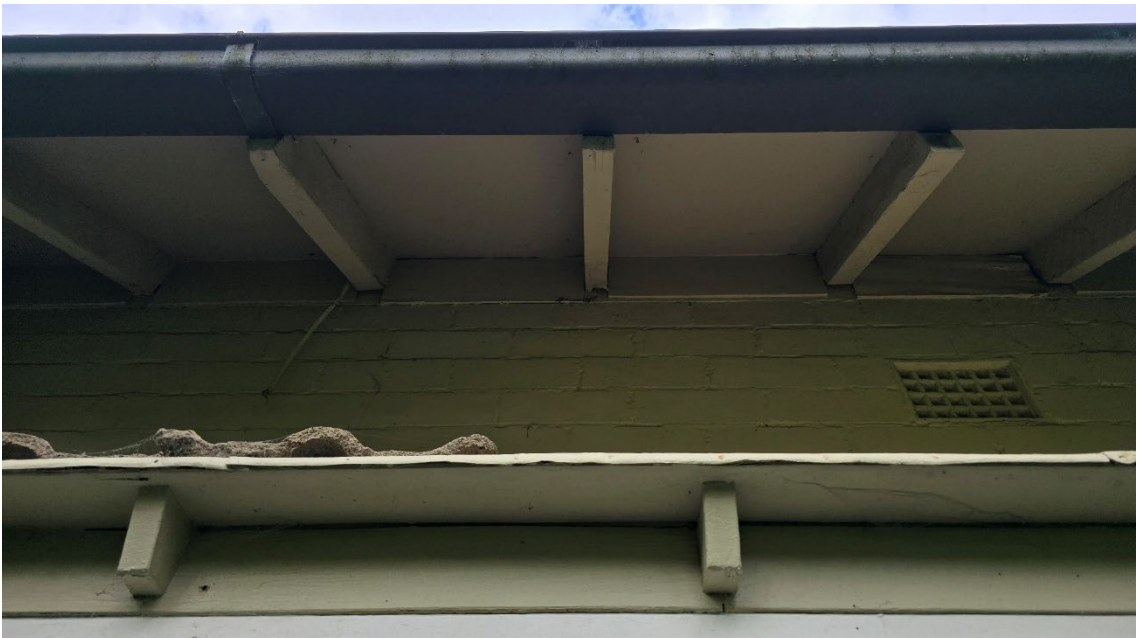
**Photograph No. 20: Flat asbestos cement sheet eave lining on east side of house at 16 Bent Street**

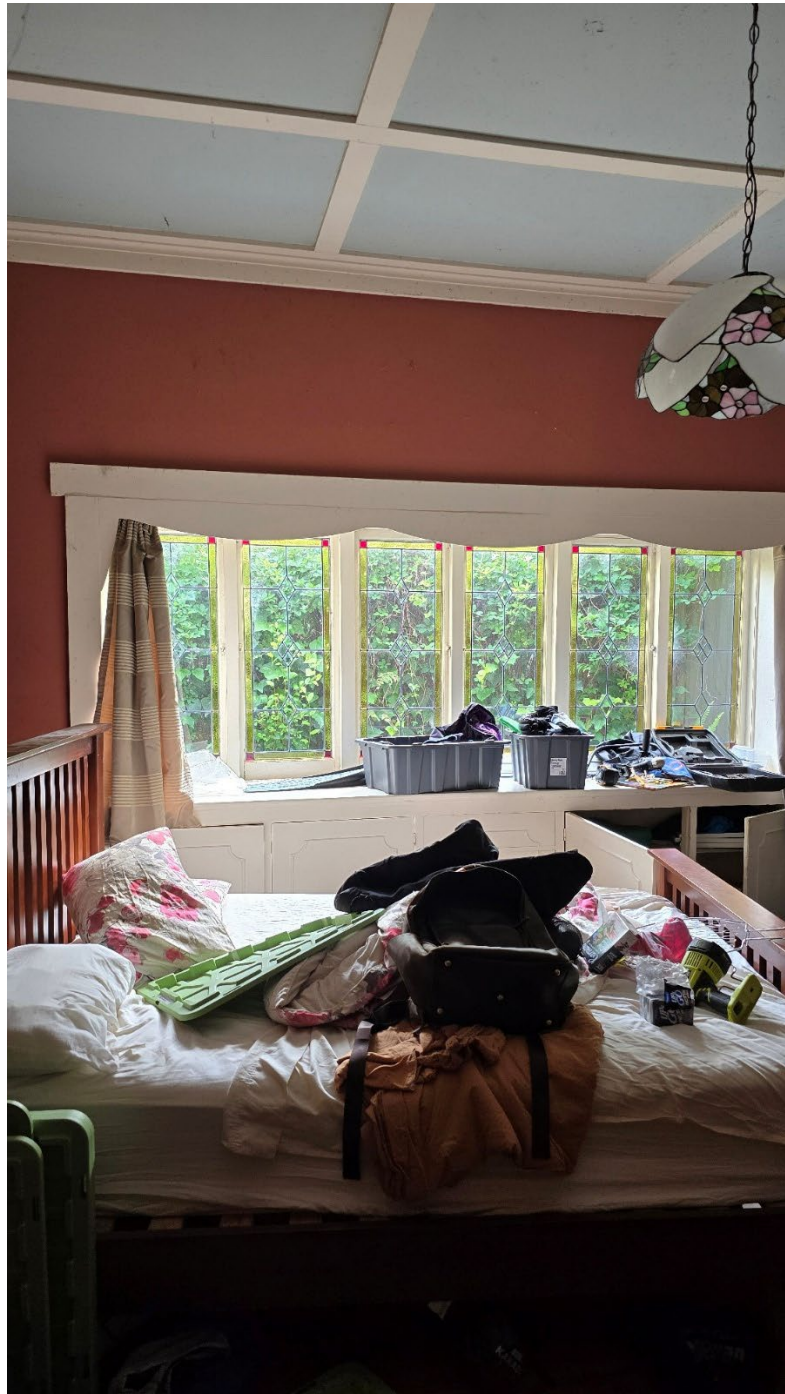
**Photograph No. 21: Presumed asbestos cement sheet ceiling lining in east side centre bedroom in house at 16 Bent Street. The bay window has similar lining materials**
