**Client:** AJC\_24.11.2025 Council of Newington College  
**Project Reference:** P25090095  
**Report Date:** 07/10/2025  
**Version:** 2.0

## Newington College SSDA

Newington College, Stanmore NSW 2048

**Scope of audit:** Targeted Hazmat Reinspection for detailed SSDA Report (Stage 2 & 3). Stage 6 hazmat to be conducted closer to the date of planned works.

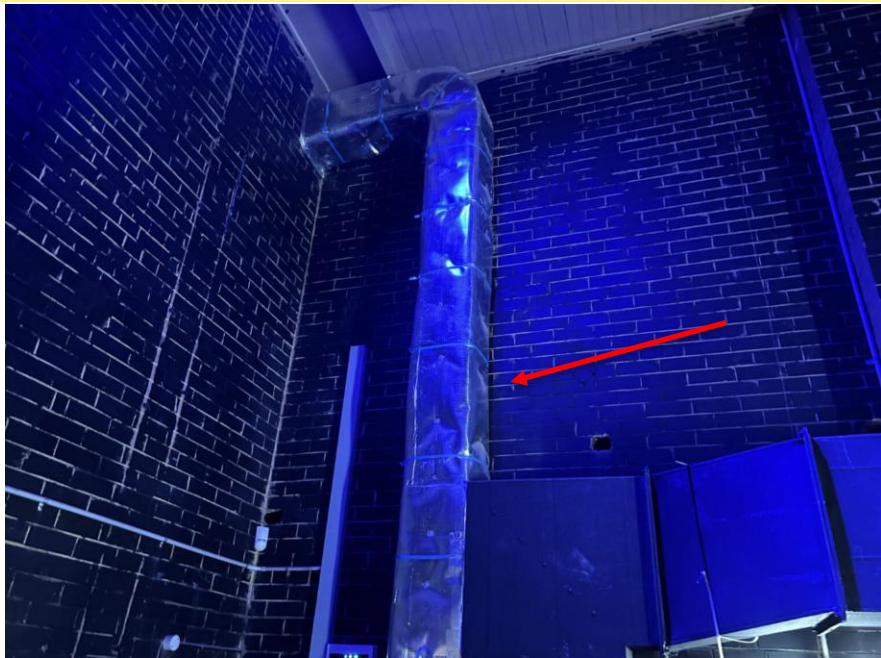
| Sample Number | Primary Location | Specific Location | Material type | Estimated Quantity m² | Laboratory analysis result (Asbestos type) | Condition | Activities that may lead to further damage/ deterioration | Risk assessment | Control of risk | Photos |
|---|---|---|---|---|---|---|---|---|---|---|
| Not Sampled (Visual ID) | Centenary Hall | Throughout | HVAC Insulation | 340 | Presumed Positive | Good | Renovation or Removal works | Low | Leave and Maintain in Good Condition Conduct any works that may disturb SMF in accordance with the Synthetic Mineral Fibres National Standard (NOHSC:1004) and National Code of Practice (NOHSC:2006) | 1 |

Photo 1: Assumed SMF insulation for HVAC system in Centenary Hall

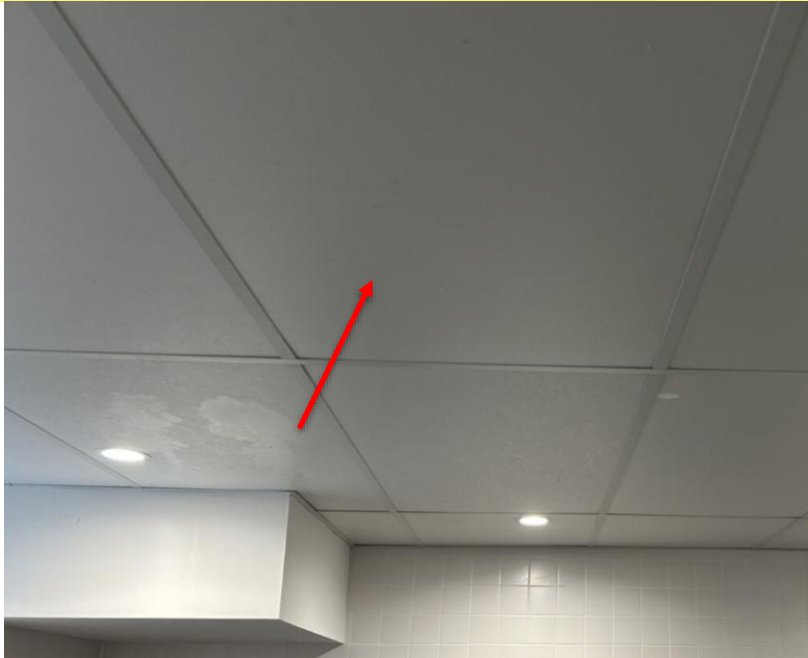
| Sample Number | Primary Location | Specific Location | Material type | Estimated Quantity m² | Laboratory analysis result (Asbestos type) | Condition | Activities that may lead to further damage/ deterioration | Risk assessment | Control of risk | Photos |
|---|---|---|---|---|---|---|---|---|---|---|
| Not Sampled (Visual ID) | Centenary Hall | Classroom spaces on the ground floor, level 1 and level 2 | Ceiling tiles | 400 | Presumed Positive | Good | Renovation or Removal works | Low | Leave and Maintain in Good Condition Conduct any works that may disturb SMF in accordance with the Synthetic Mineral Fibres National Standard (NOHSC:1004) and National Code of Practice (NOHSC:2006) | 2 |

Photo 2: Assumed SMF ceiling tiles in bathrooms, classrooms and offices in Centenary Hall

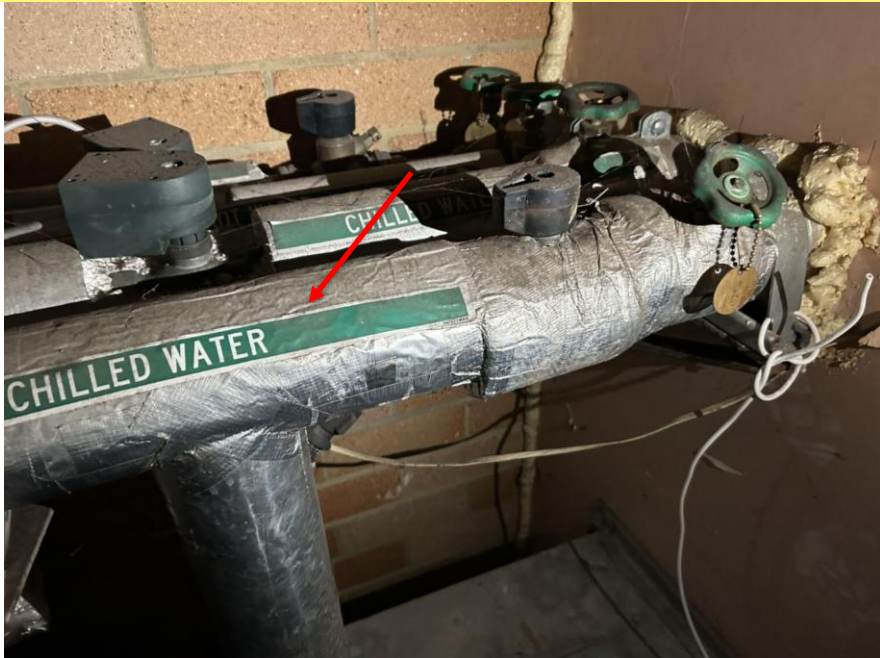
| Sample Number | Primary Location | Specific Location | Material type | Estimated Quantity m² | Laboratory analysis result (Asbestos type) | Condition | Activities that may lead to further damage/ deterioration | Risk assessment | Control of risk | Photos |
|---|---|---|---|---|---|---|---|---|---|---|
| Not Sampled (Visual ID) | Centenary Hall | Throughout, primarily in plantroom and risers | Chilled water pipe insulation | 50 | Presumed Positive | Good | Renovation or Removal works | Low | Leave and Maintain in Good Condition Conduct any works that may disturb SMF in accordance with the Synthetic Mineral Fibres National Standard (NOHSC:1004) and National Code of Practice (NOHSC:2006) | 3 |

Photo 3: Assumed SMF insulation surrounding chilled water pipe in Centenary Hall

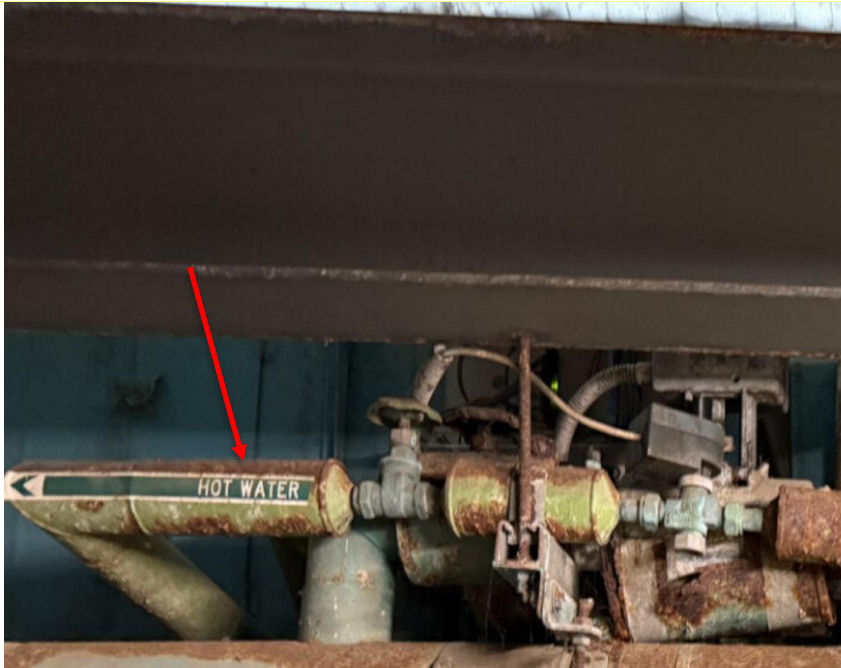
| Sample Number | Primary Location | Specific Location | Material type | Estimated Quantity m² | Laboratory analysis result (Asbestos type) | Condition | Activities that may lead to further damage/ deterioration | Risk assessment | Control of risk | Photos |
|---|---|---|---|---|---|---|---|---|---|---|
| Not Sampled (Visual ID) | Centenary Hall | Throughout, primarily in plantroom and risers | Hot water pipe insulation | 50 | Presumed Positive | Good | Renovation or Removal works | Low | Leave and Maintain in Good Condition Conduct any works that may disturb SMF in accordance with the Synthetic Mineral Fibres National Standard (NOHSC:1004) and National Code of Practice (NOHSC:2006) | 4 |

Photo 4: Assumed SMF insulation surrounding hot water pipe in Centenary Hall

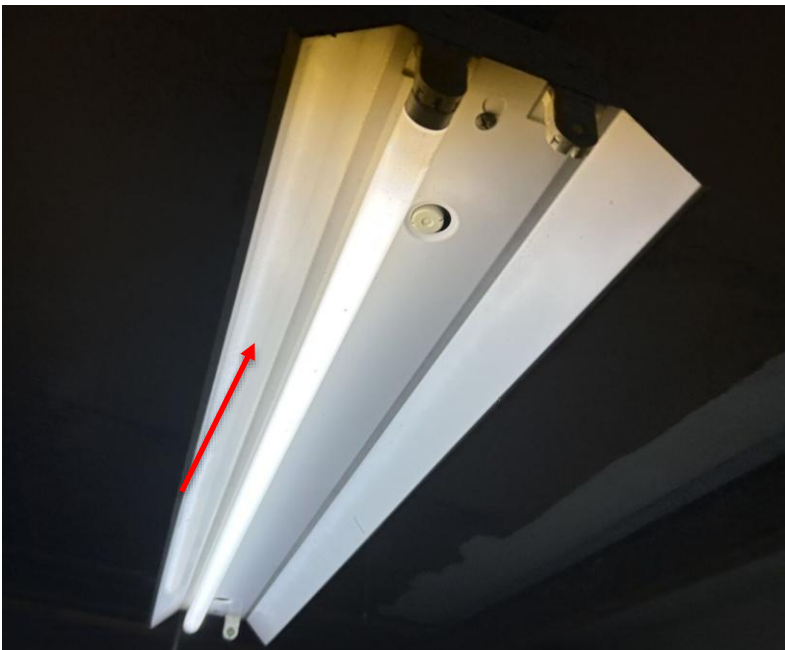
| Sample Number | Primary Location | Specific Location | Material type | Estimated Quantity m <sup>2</sup> | Laboratory analysis result (Asbestos type) | Condition | Activities that may lead to further damage/ deterioration | Risk assessment | Control of risk | Photos |
|---|---|---|---|---|---|---|---|---|---|---|
| Visually identified | Throughout Centenary Hall | Primarily in the plantroom and | Mercury in old Lightings | 10 units | Presumed Positive | Good | Renovation or Removal Works | Low | Leave and Maintain in Good Condition. If damaged replace with non-mercury containing lighting in line with Recycling and Waste Reduction (Mandatory Product Stewardship—Mercury-added Products) Rules 2021 | 5 |

Photo 5: Assumed mercury containing lightings throughout Centenary Hall

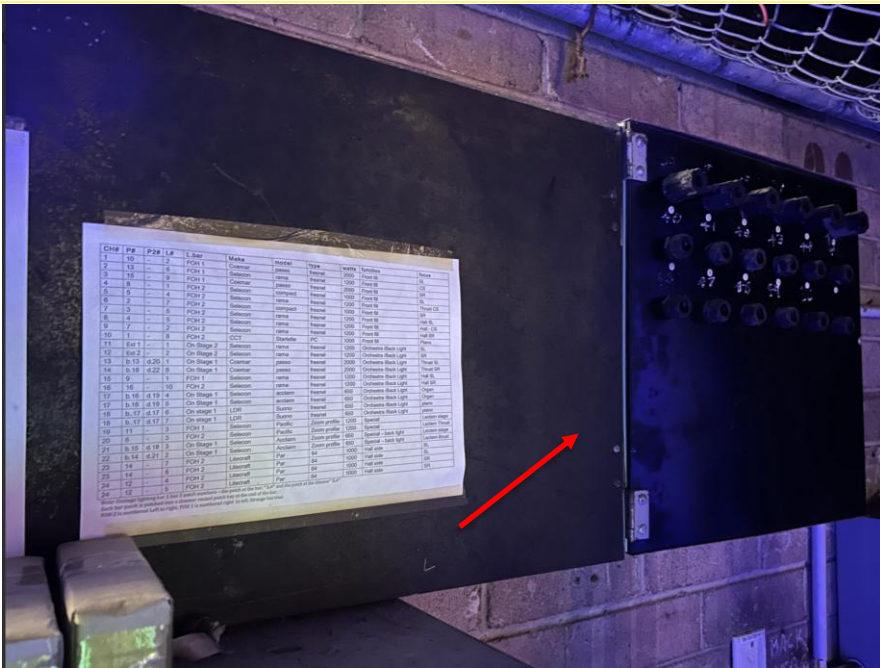
| Sample Number | Primary Location | Specific Location | Material type | Estimated Quantity m² | Laboratory analysis result (Asbestos type) | Friable / non-friable | Sealed / Unsealed / Enclosed | Condition | Activities that may lead to further damage/ deterioration | Risk assessment | Control of risk | Photos |
|---|---|---|---|---|---|---|---|---|---|---|---|---|
| 182319 | Centenary Hall, Internal | Back of Stage | Electrical Backing Board | 3 units | Positive | Non-Friable | Enclosed | Good | Renovation or Removal works | Low | Leave, Label in current condition, encapsulate any exposures areas with PVA or appropriate sealant. Remove the material prior to works which may disturb the material. If over 10m² remove using a Class B licenced asbestos contractor [Safe Work NSW] per the WHS Reg. (2017) | 6 |

Photo 6: Asbestos containing electrical backing board, back of stage, Centenary Hall

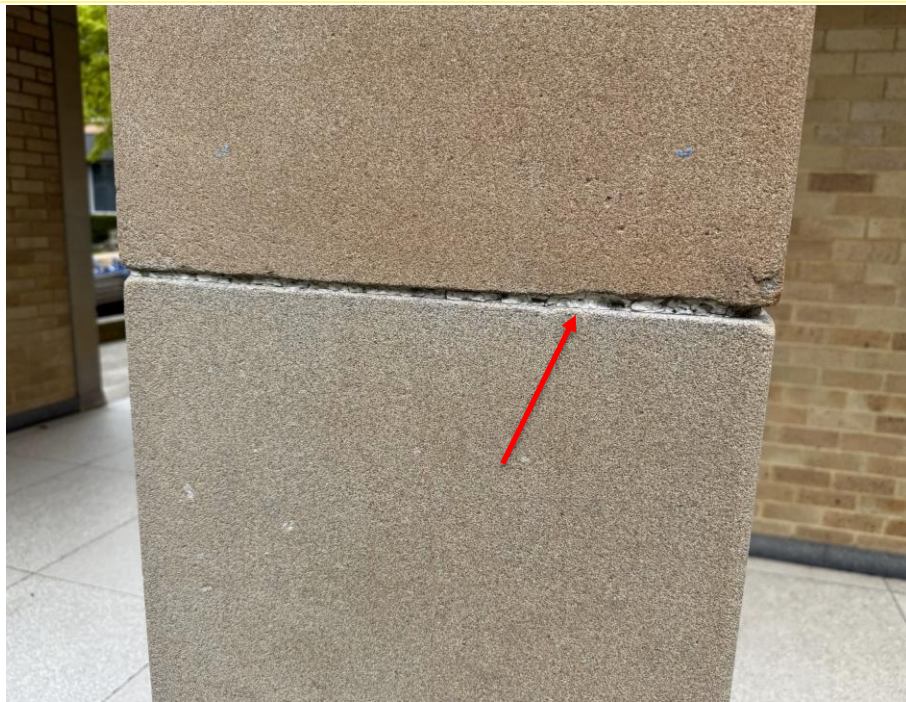
| Sample Number | Primary Location | Specific Location | Material type | Estimated Quantity m² | Laboratory analysis result (Asbestos type) | Friable / non-friable | Sealed / Unsealed / Enclosed | Condition | Activities that may lead to further damage/ deterioration | Risk assessment | Control of risk | Photos |
|---|---|---|---|---|---|---|---|---|---|---|---|---|
| 182323 | Centenary Hall, External | Mastic on pillars surrounding building | Mastic | 30m | Positive | Friable | Unsealed | Poor | Student Activities, Renovation or Removal works | High | Immediately encapsulate any exposed asbestos containing mastic as a temporary measure and remove as soon as reasonably practicable as mastic is loose and unsealed posing a health risk to anyone who disturbs the material. Engage Class A safe work NSW. Friable Removal, Wrap and Cut Method, air monitoring, clearance by LAA. | 7 |

**Photo 7:** Asbestos containing mastic around pillars at Centenary Hall's exterior

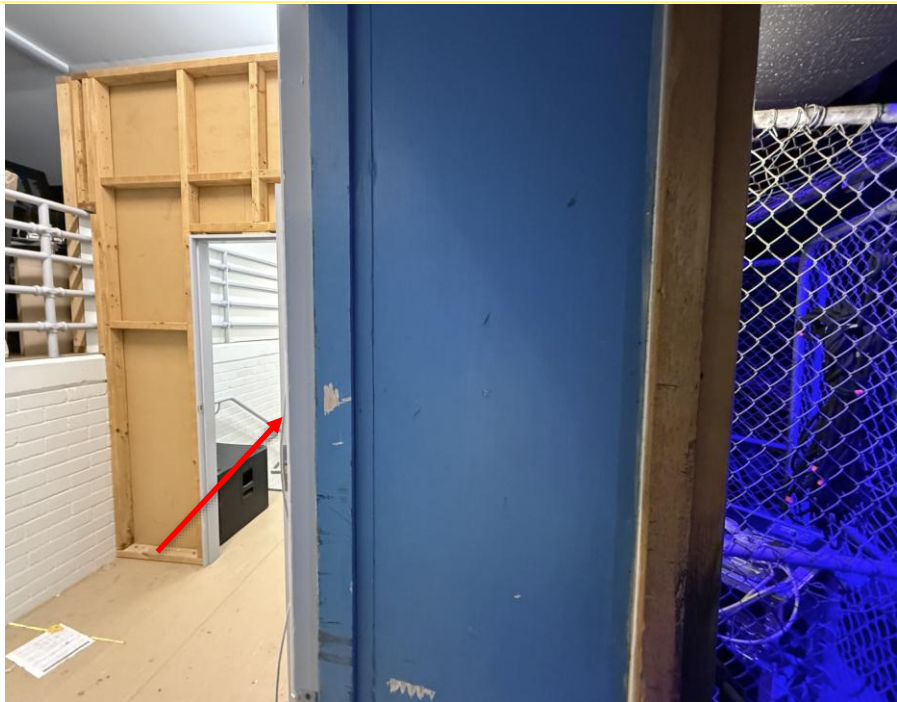
| Sample umber | Primary Location | Specific Location | Material type | Estimated Quantity m² | Laboratory analysis result | Condition | Activities that may lead to further damage/ deterioration | Risk assessment | Control of risk | Photos |
|---|---|---|---|---|---|---|---|---|---|---|
| 182309 | Centenary Hall, Internal | Back of stage doors and door frames surrounding the stage | Blue Paint | 12 | 0.20 %w/w | Good | Paint removal, maintenance, renovations or demolition work | Low | The hazardous flaking paint must first be removed and a clean conducted of the general vicinity to “Make Safe” the area prior to overpainting with a lead free substitute. Label maintain and ensure current condition of lead paint is maintained to reduce the potential risk of exposure to occupants. | 8 |

**Photo 8:** Blue lead containing paint on doors and door frames surrounding backstage in Centenary Hall

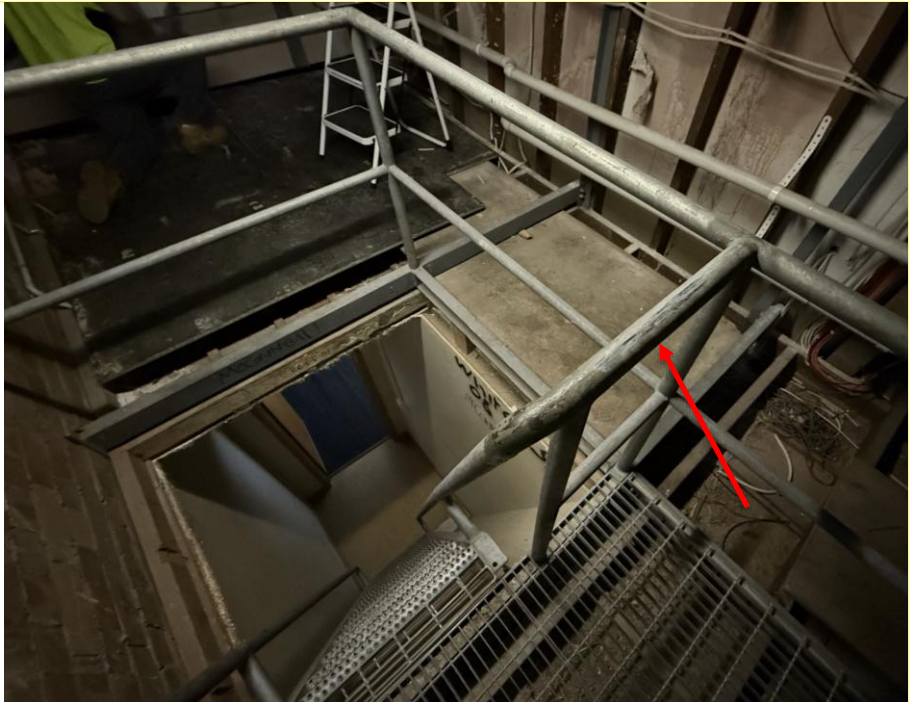
| Sample umber | Primary Location | Specific Location | Material type | Estimated Quantity m <sup>2</sup> | Laboratory analysis result | Condition | Activities that may lead to further damage/ deterioration | Risk assessment | Control of risk | Photos |
|---|---|---|---|---|---|---|---|---|---|---|
| 182317 | Centenary Hall, Internal | Handrail adjacent to level 3 plantroom | Grey Paint | 8 | 0.81 %w/w | Good | Paint removal, maintenance, renovations or demolition work | Low | The hazardous flaking paint must first be removed and a clean conducted of the general vicinity to “Make Safe” the area prior to overpainting with a lead free substitute. Label maintain and ensure current condition of lead paint is maintained to reduce the potential risk of exposure to occupants. | 9 |

**Photo 9:** Grey lead containing paint on handrail, L02-L03 Ladder to plantroom
