Client: Pymble Ladies' College
Project Reference: P25010061
Report Date: 13/02/2025
Inspection Date: 01/02/2024
Report Review Date: 13/02/2030
Version: V2.0 [27.02.2025]

Hazardous Materials Report & Register

Pymble Ladies College: Robert Vicars, Jack Vicars, Dorothy Knox, and Isabel
McKinney Harrison Building

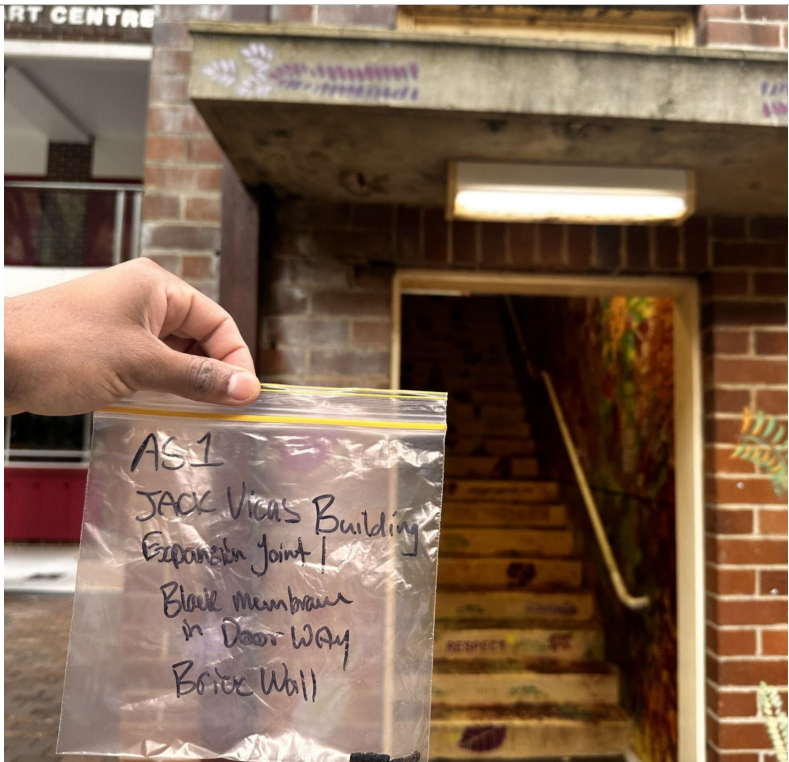
Photo 1: RVB – Sample 1 (S1)

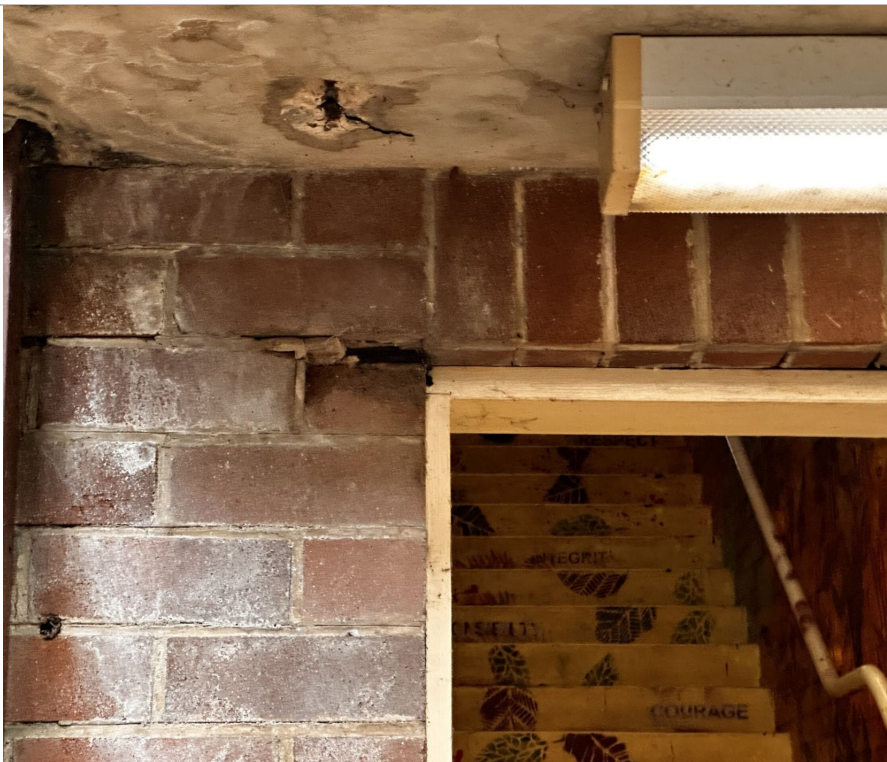
Photo 2: RVB - Sample 1 Location: Expansion joint/black membrane in doorway near brick wall

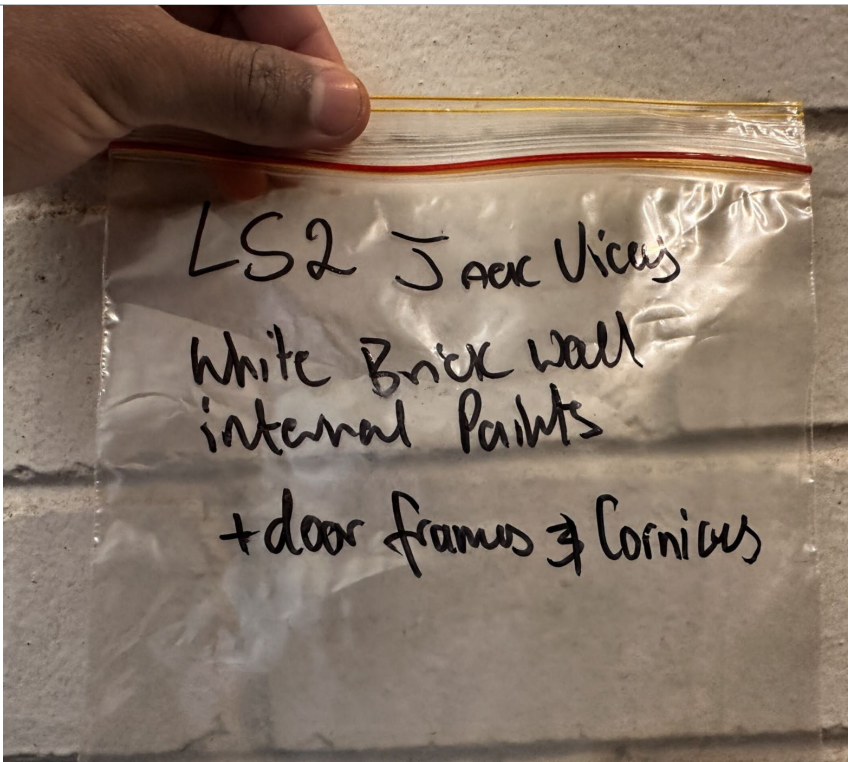
Photo 3: RVB – Sample 2 (S2): White brick wall, internal paint

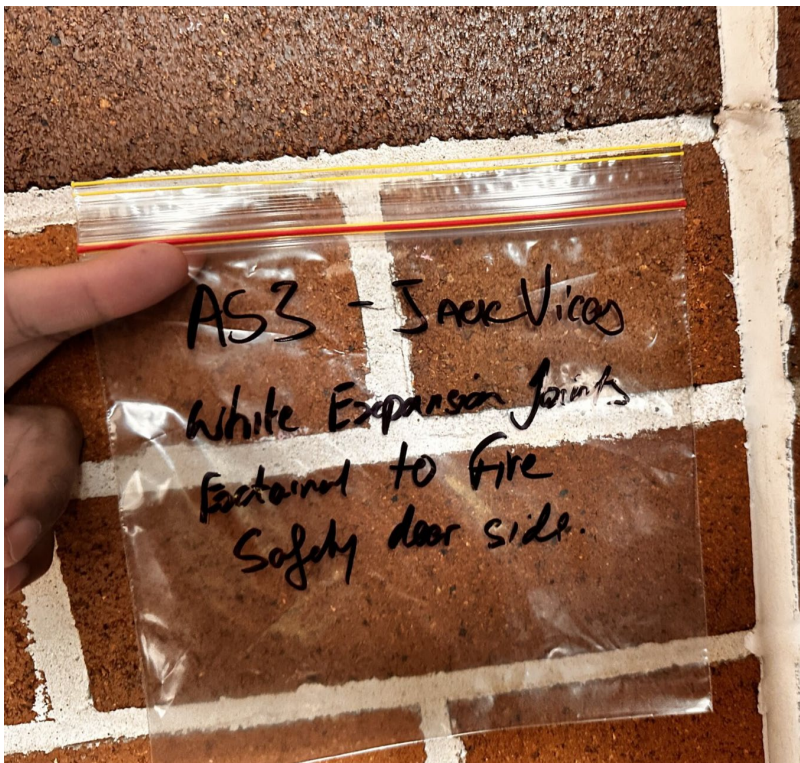
Photo 4: RVB – Sample 3 (S3)

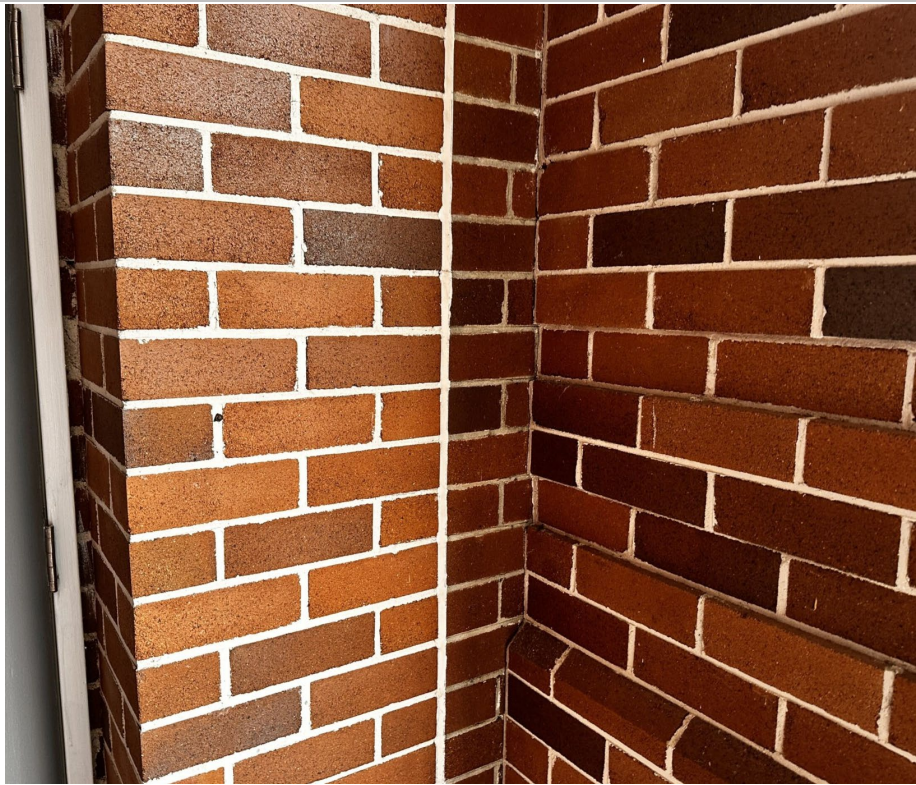
Photo 5: RVB - Sample 3 Location: White expansion joints external to fire safety doors

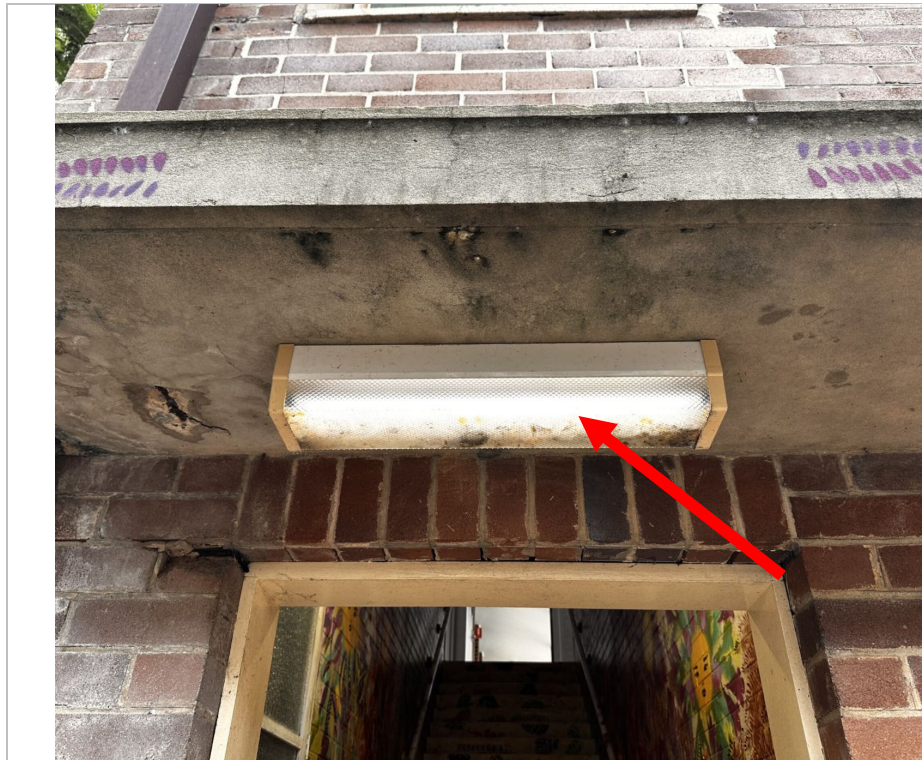
Photo 7: RVB – Mercury in floccrescent light fixtures

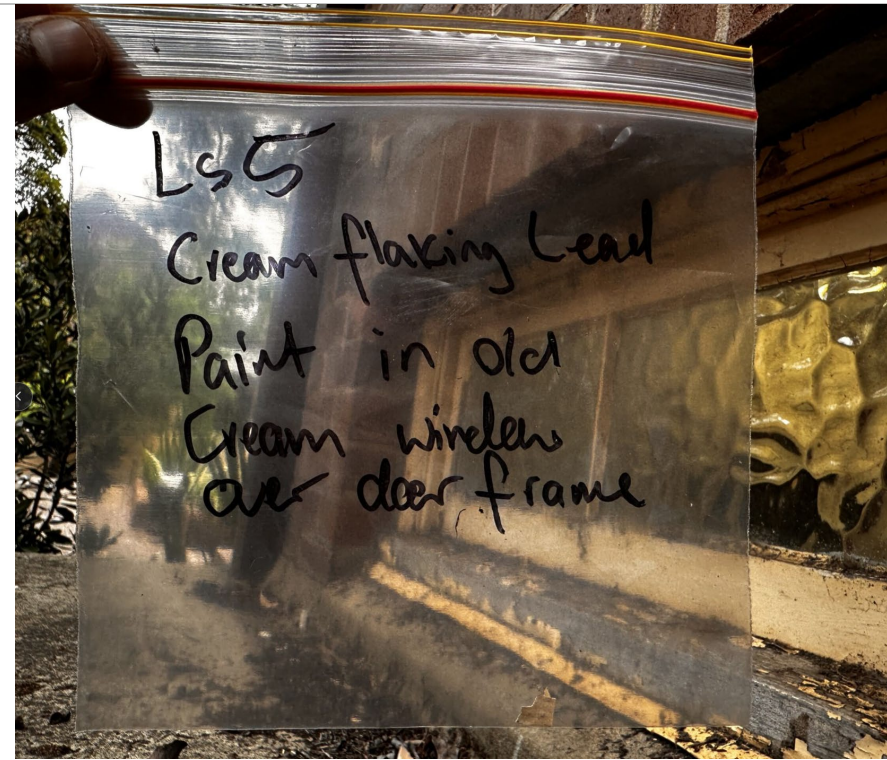
Photo 8: RVB – Sample 5 (S5)

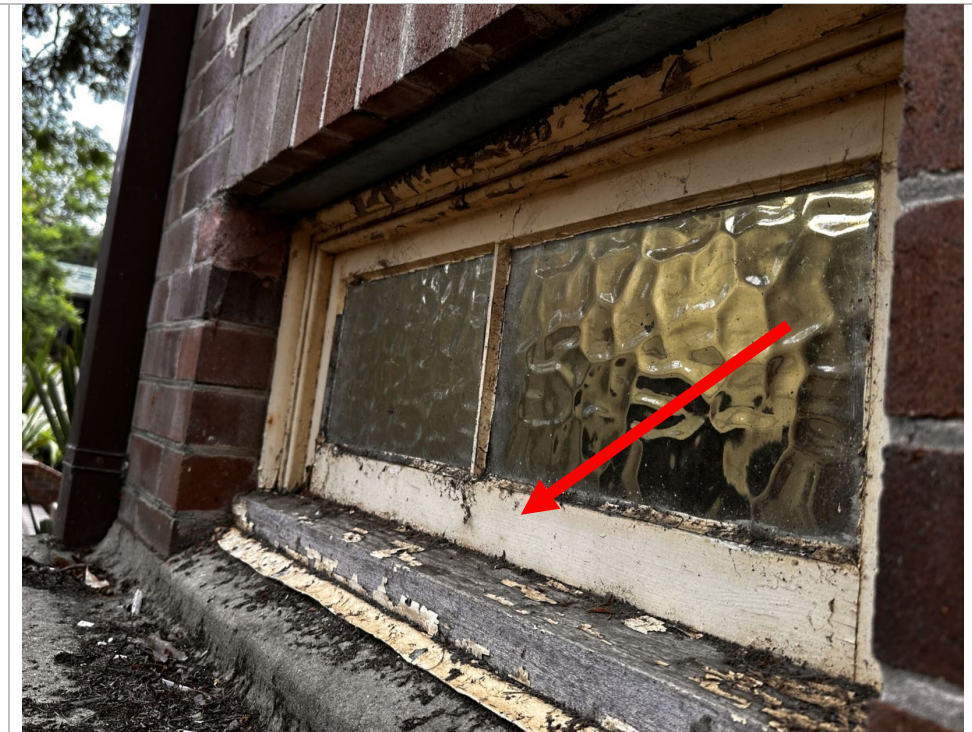
Photo 9: RVB - Sample 4 & 5 Location – Flaking paint in old cream window over door frame contains lead

Lead paint was detected on the cream windows and the dark green doors on the RVB. These areas should be Overpainted with a lead-free substitute. Label maintenance and ensure the current condition of lead paint is maintained to reduce the potential risk of exposure to staff and students. Refer section 3: Guide to hazardous paint management Part 2: Lead paint in residential, public and commercial buildings, AS/NZS 4361.2:2017.

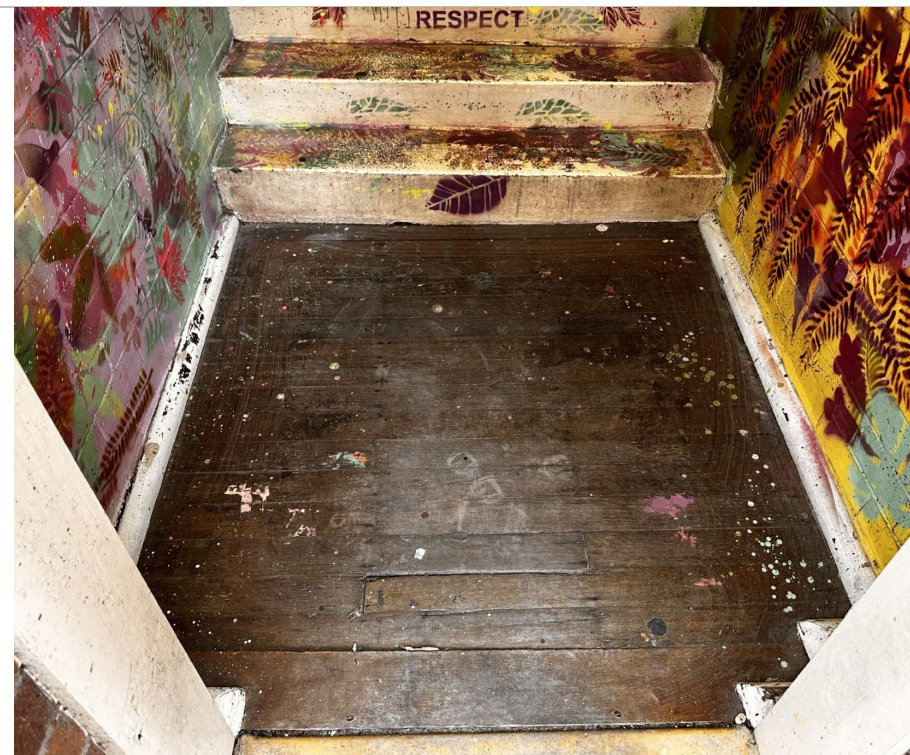
Photo 10: RVB – Stairway with asbestos ceiling.

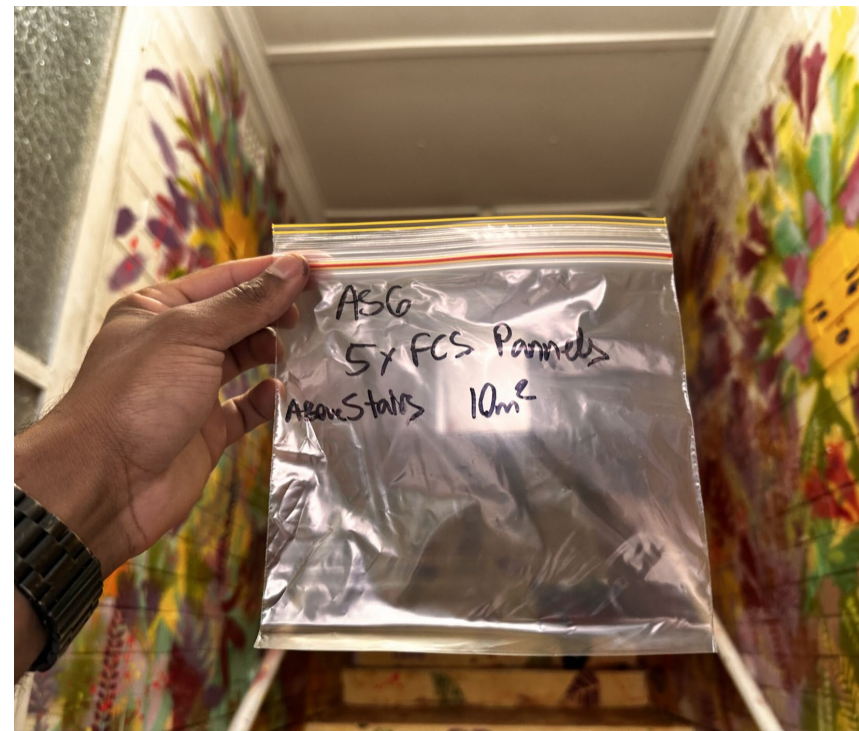
Photo 11: RVB – Sample 6 (S6): Ceiling pannels

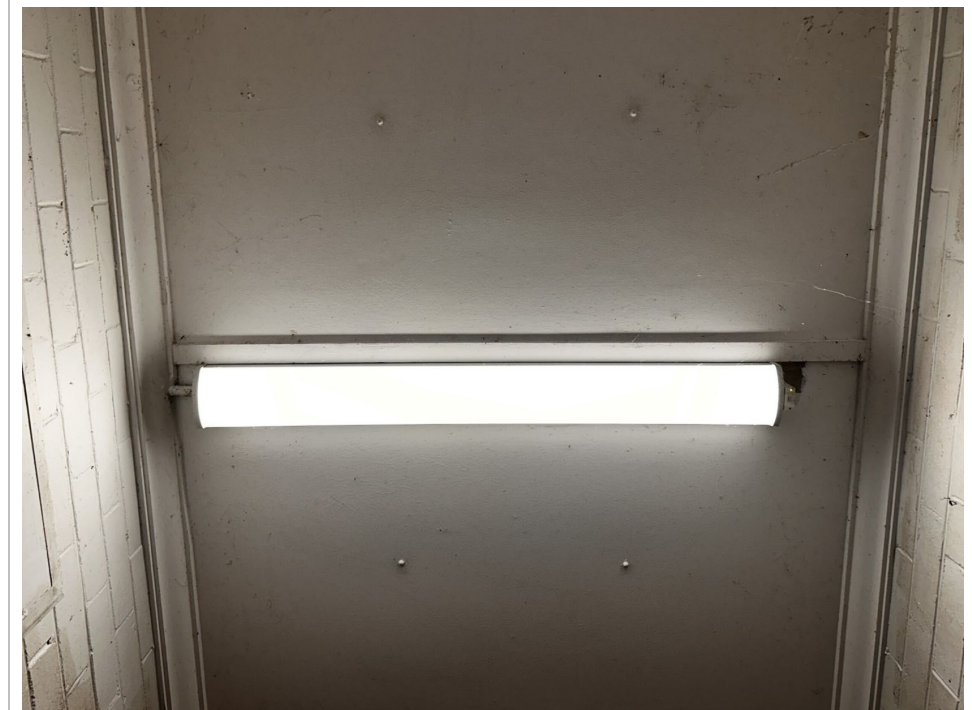
Photo 12: RVB – Ceiling above the stairs contains asbestos.

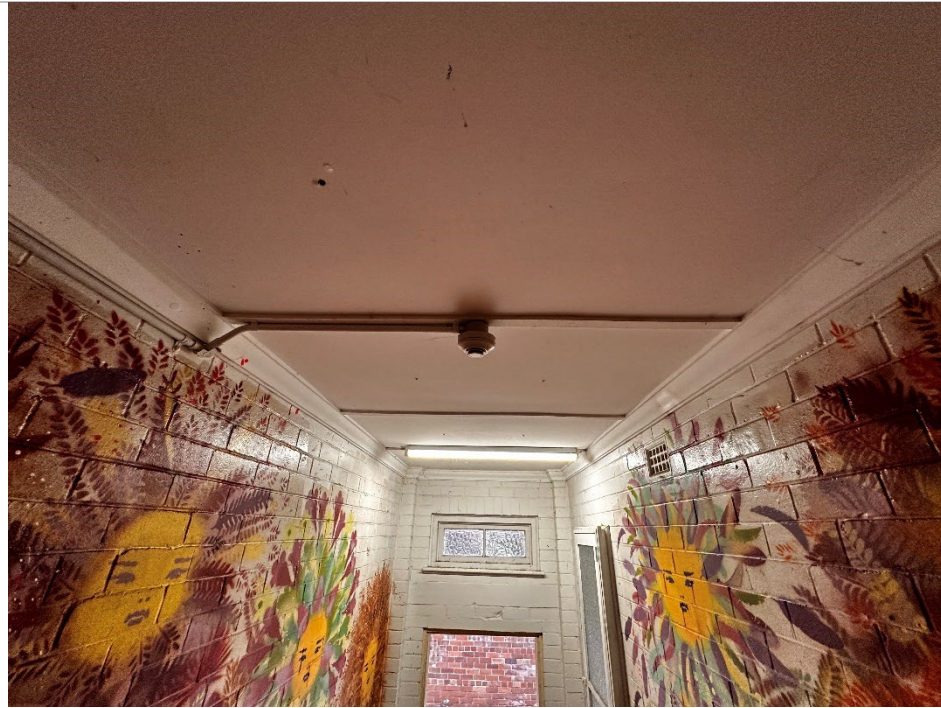
Photo 13: RVB – Ceiling above stairs contains asbestos

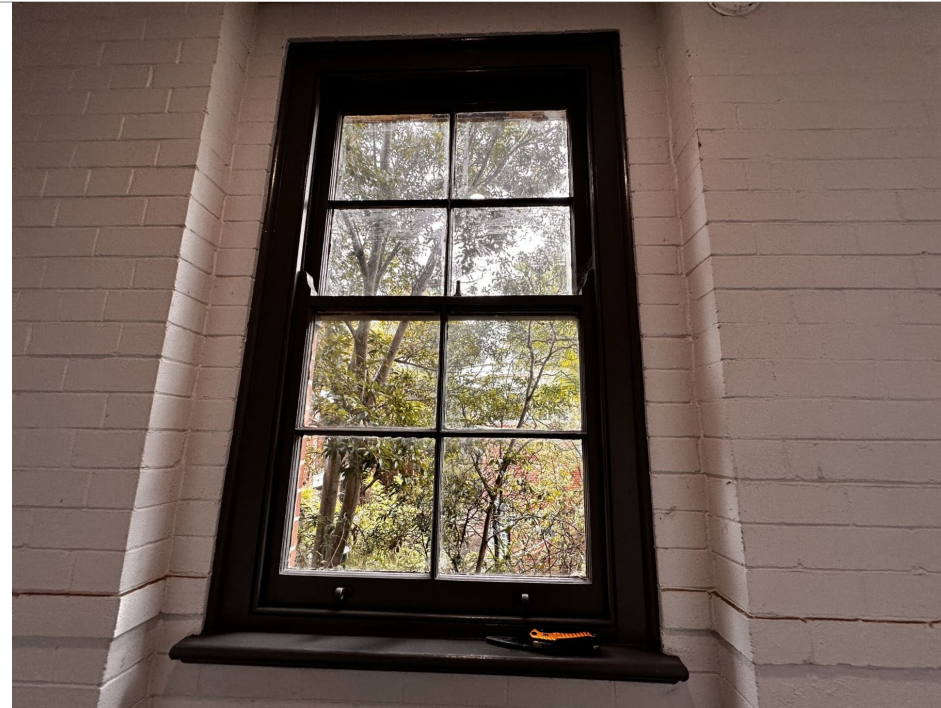
Photo 14: RVB – Internal window mastic

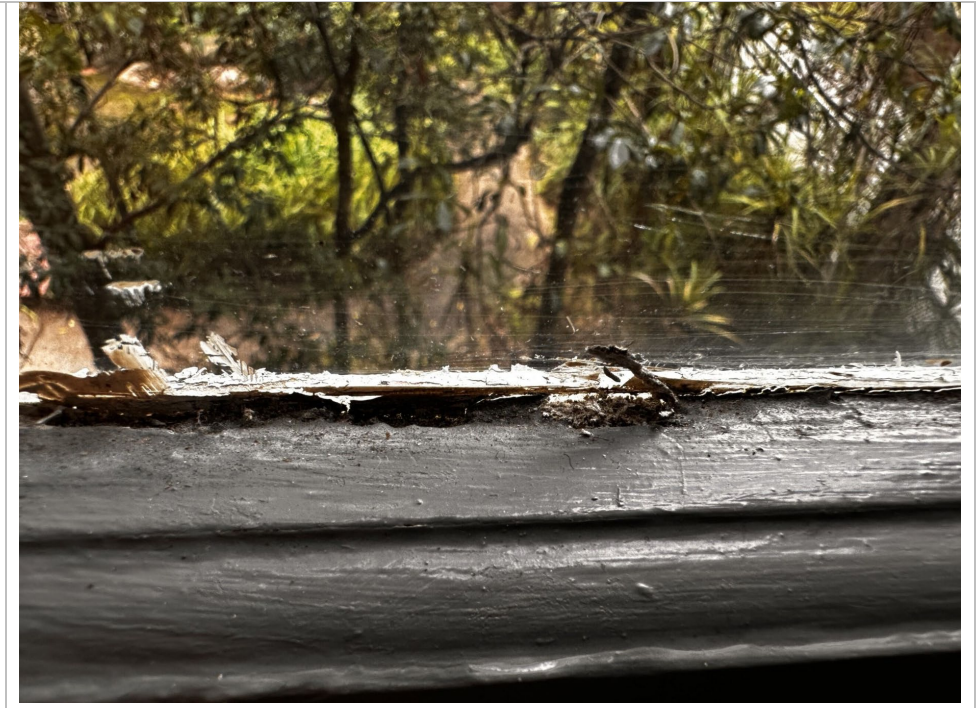
Photo 15: RVB – mastic on window

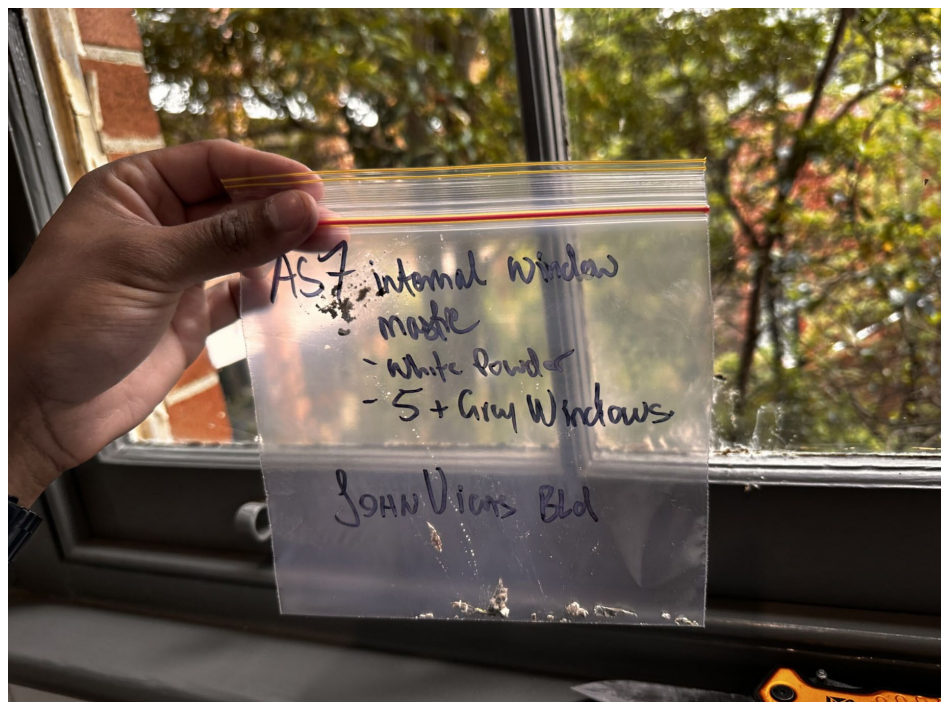
Photo 16: RVB – Sample 7 (S7): White powder

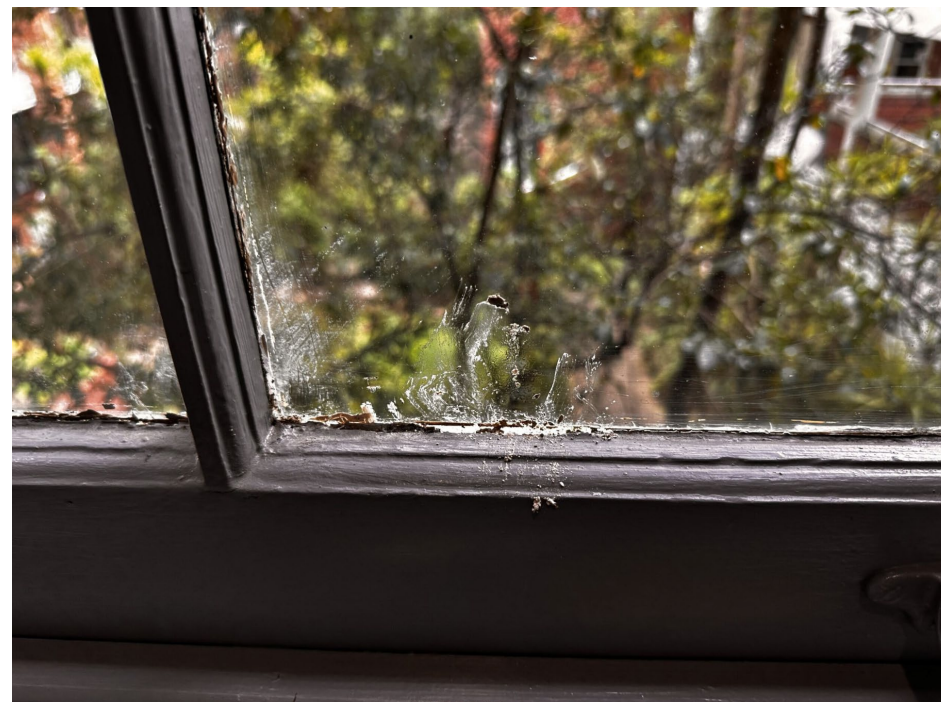
Photo 17: RVB – White mastic sample from internal window sills

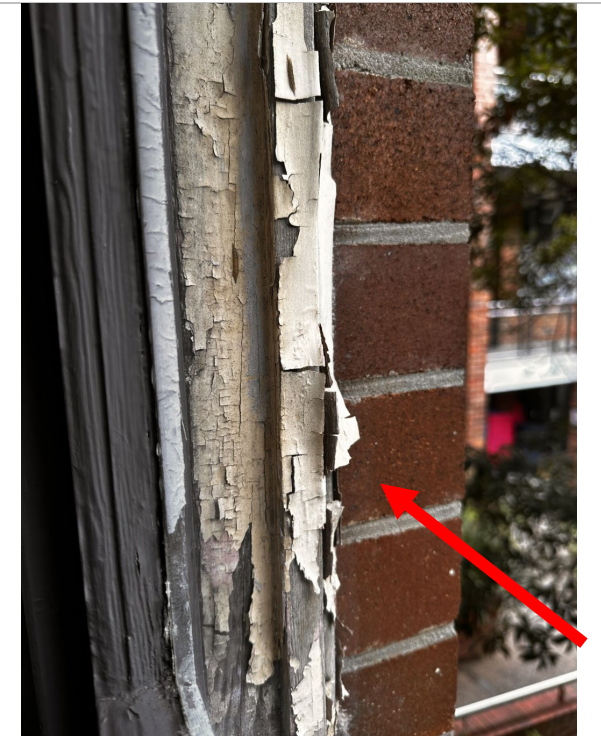
Photo 18: RVB – Deterioration on external door frame may contain lead.

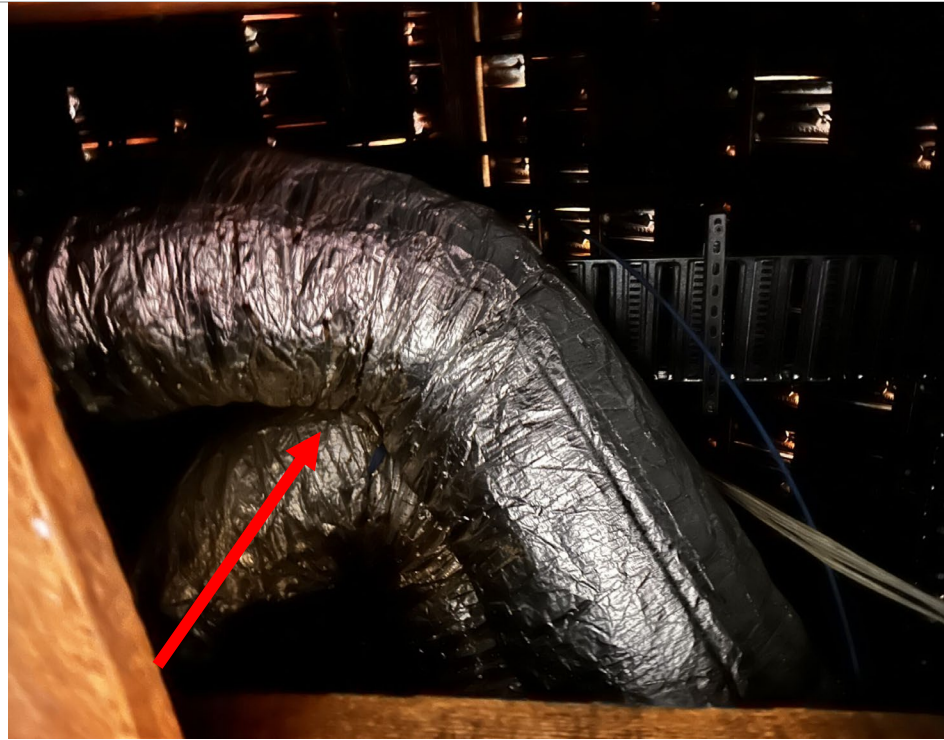
Photo 19: RVB – Synthetic mineral fibers SMF can be found in AC Ductwork

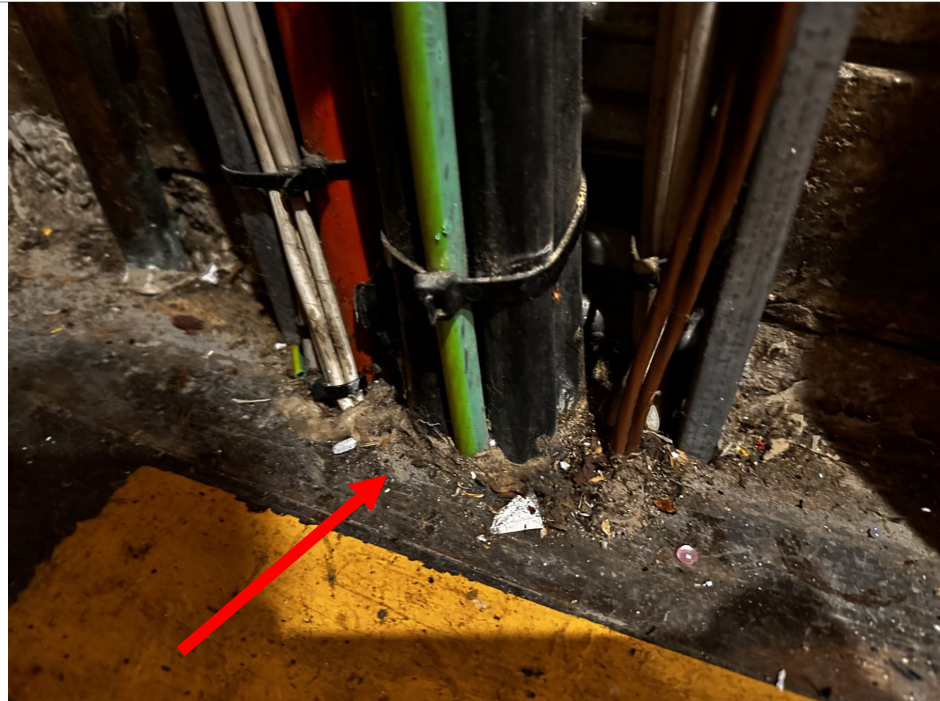
Photo 20: RVB - Old cable sheath in risers may contain asbestos.

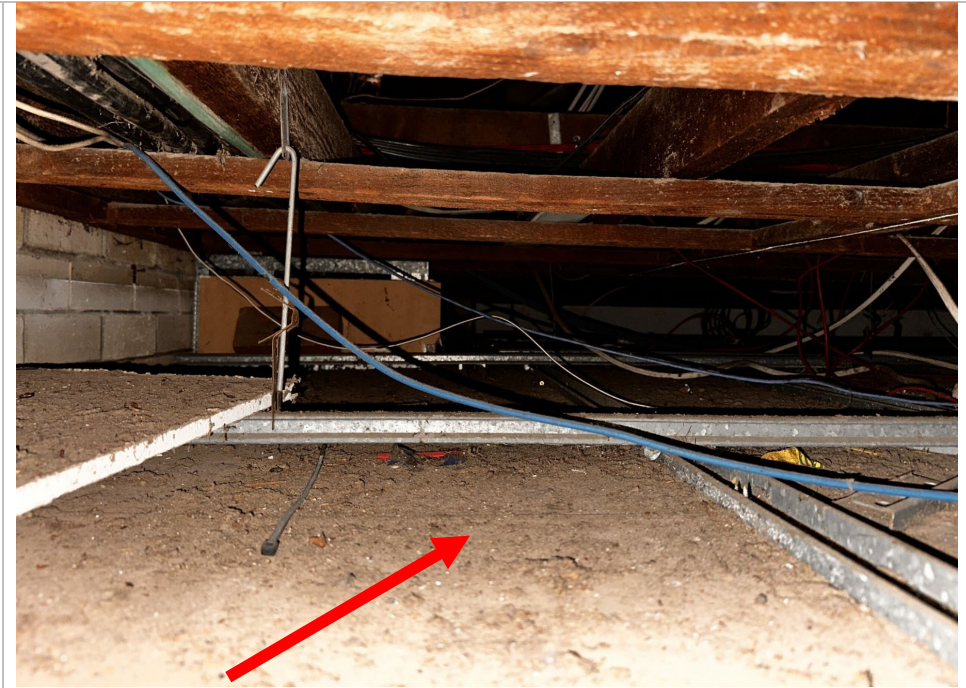
Photo 21: RVB – Asbestos ceiling Dust, location of samples 24 and 25

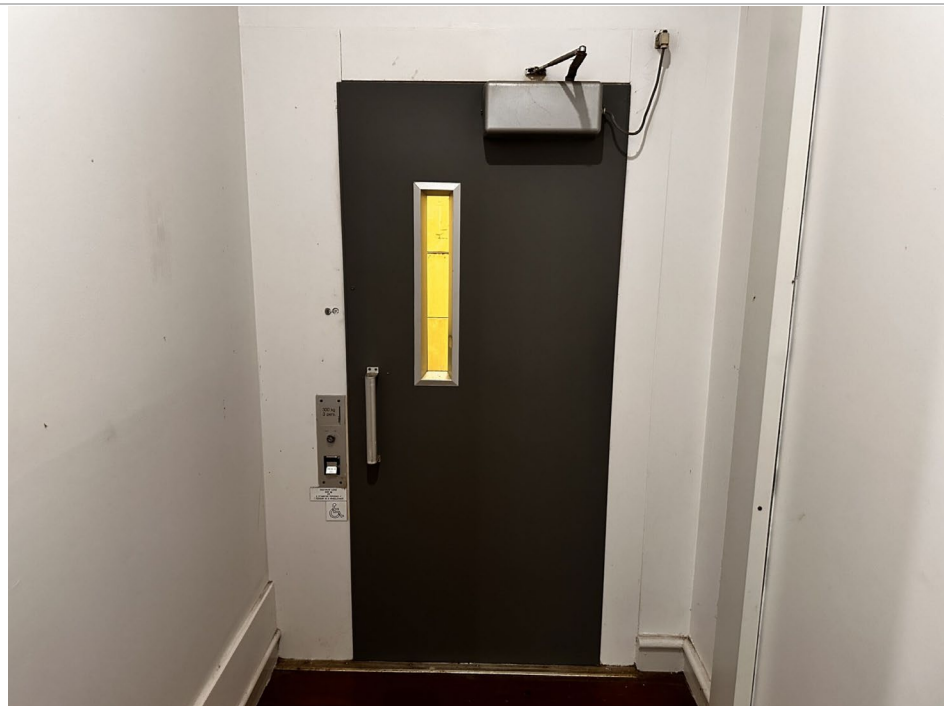
Photo 22: RVB – Dark green paint on door. Lift Door cores may contain asbestos.

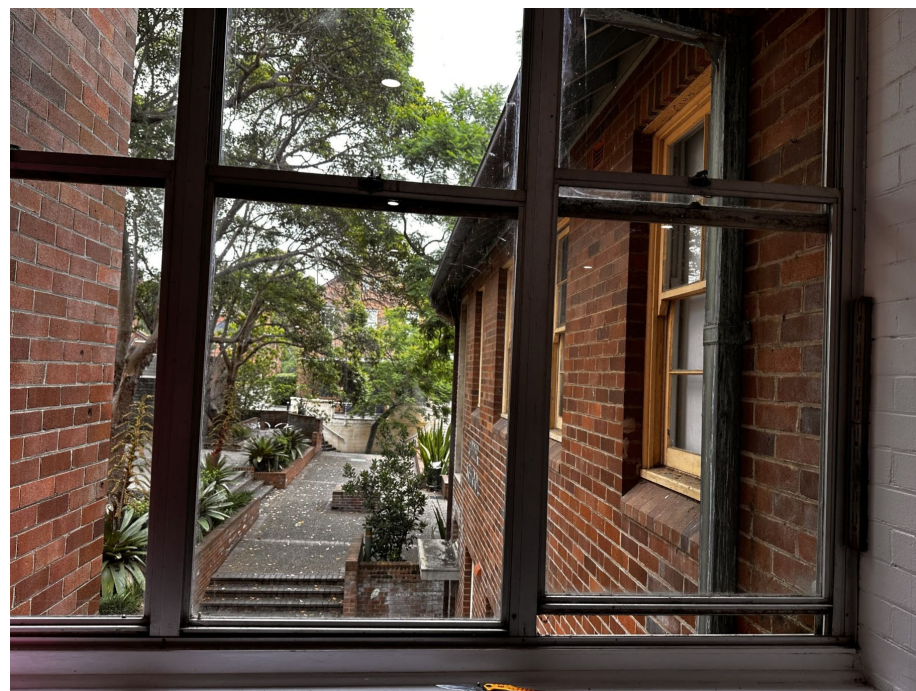
Photo 23: RVB – Steel window mastic

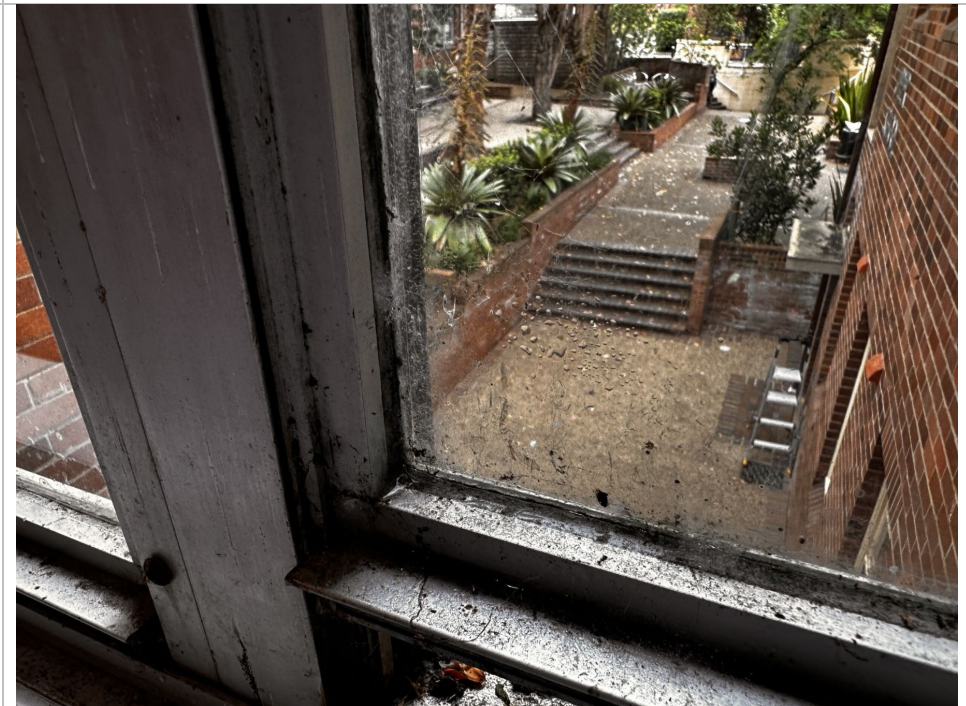
Photo 24: RVB – Window mastic

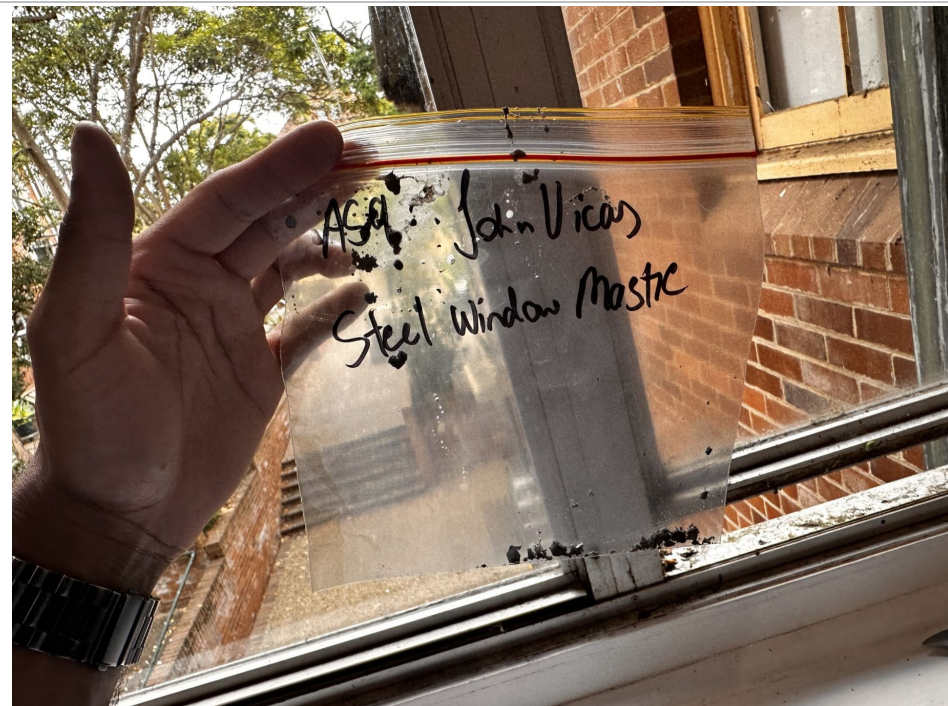
Photo 25: RVB – Sample 9 (S9): Sample of dust accumulation on steel window

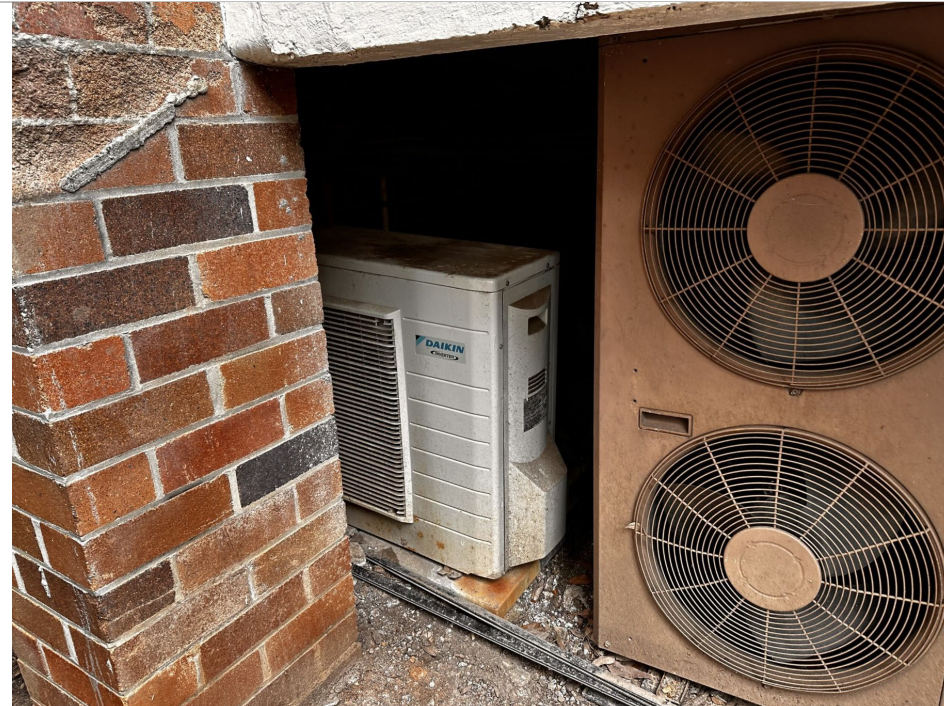
Photo 26: RVB – Ozone-depleting substances & SMF in AC units

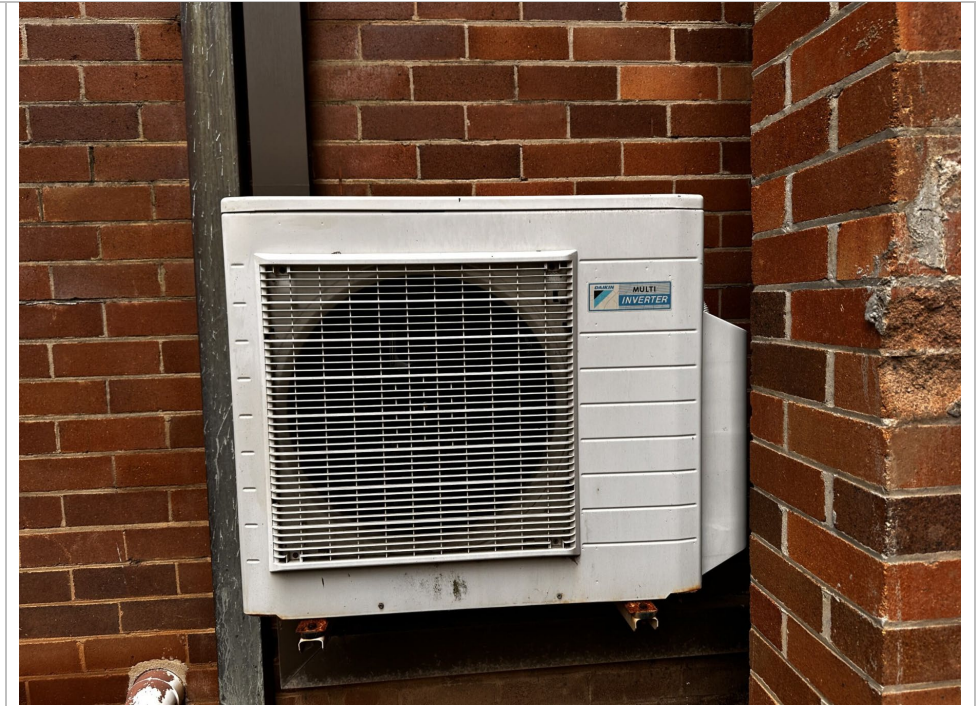
Photo 27: RVB – AC units contain SMF as well as ozone depleting substances.

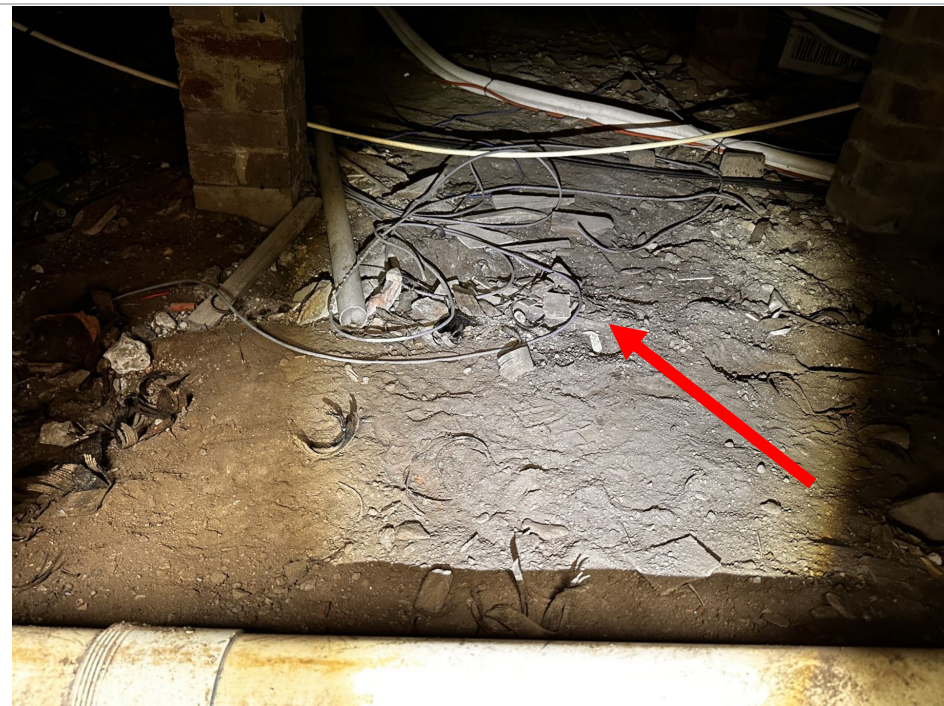
Photo 29: RVB - Subfloor of manhole; ACM fragments and debris contain asbestos.

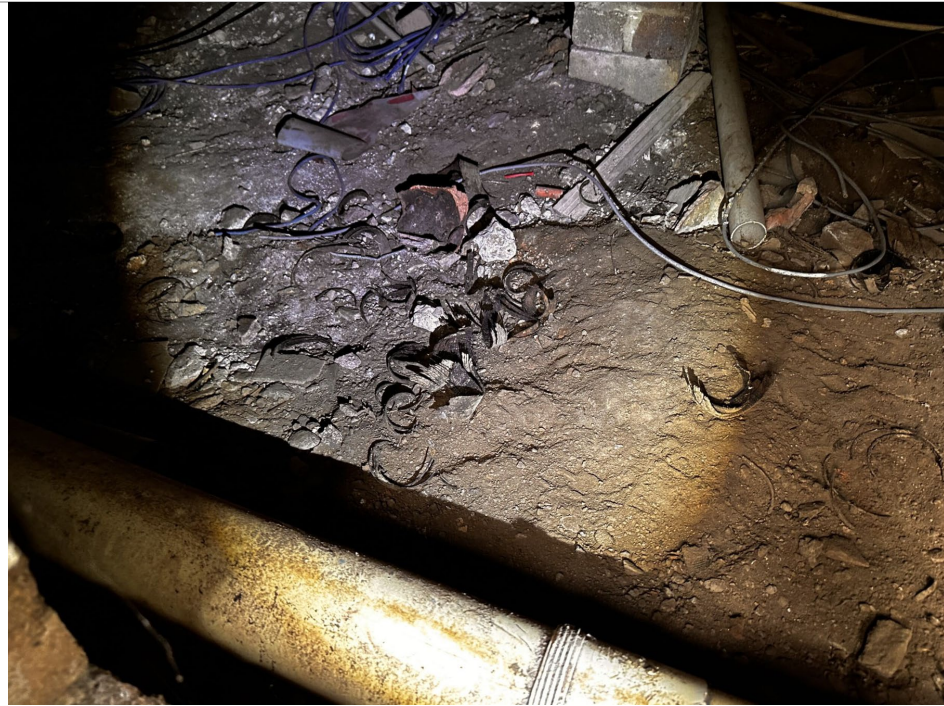
Photo 31: RVB - Subhole of manhole with black membrane spread throughout

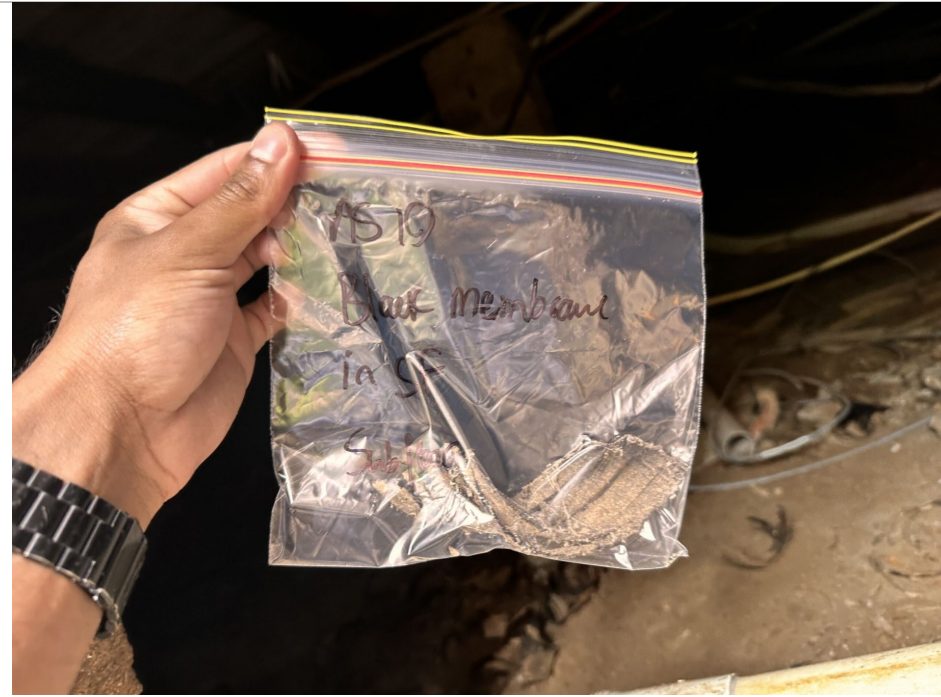
Photo 32: RVB – Sample 10 (S10): Black membrane sample

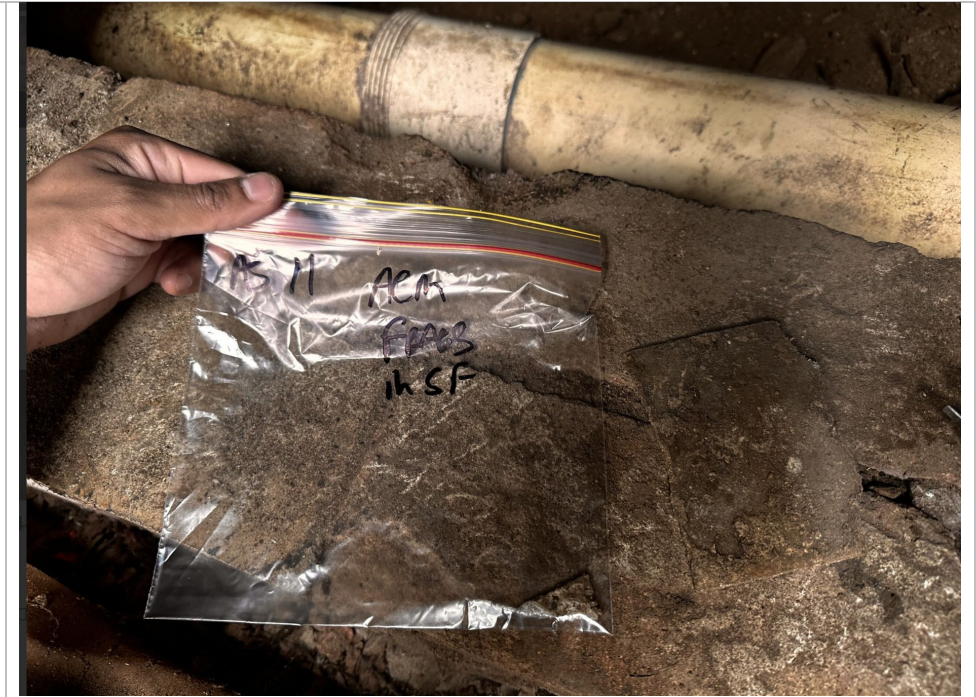
Photo 33: RVB – Sample 11 (S11): Sample of debris and ACM

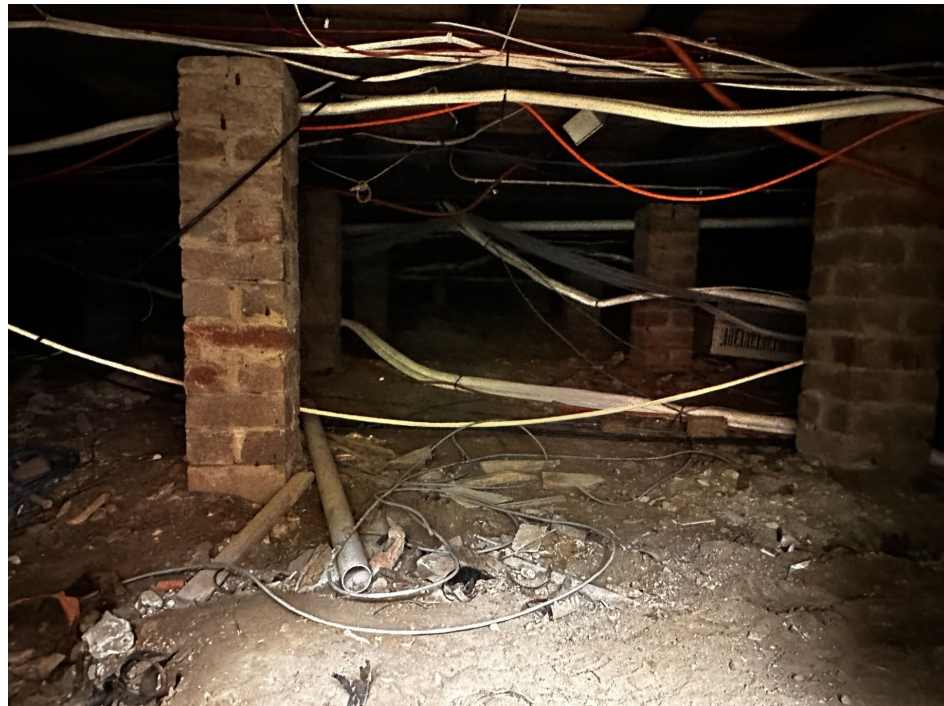
Photo 34: RVB – Internal of manhole contains asbestos debris.

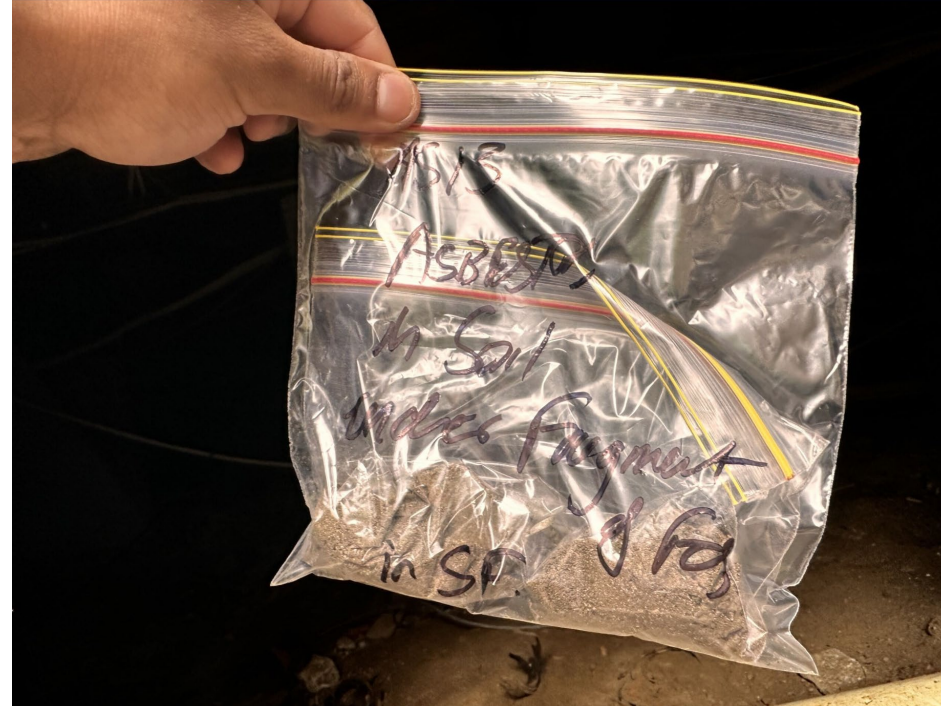
Photo 35: RVB –Sample 13 (S13): Samples of possible asbestos in soil

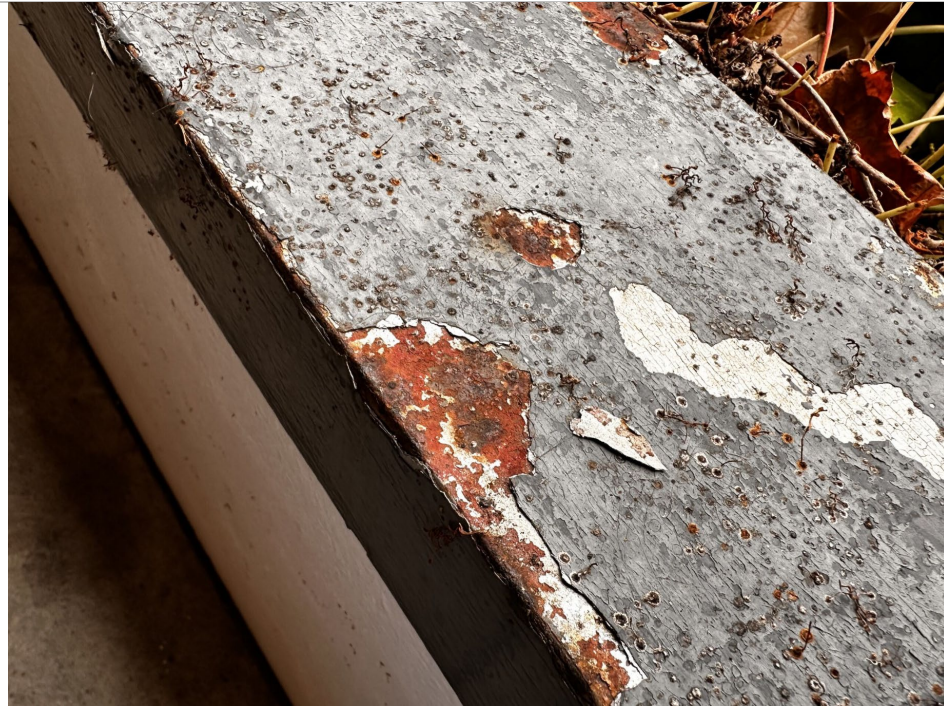
Photo 37: JVB – Grey lead paint to levels 1 and 2 rails, walls and beams

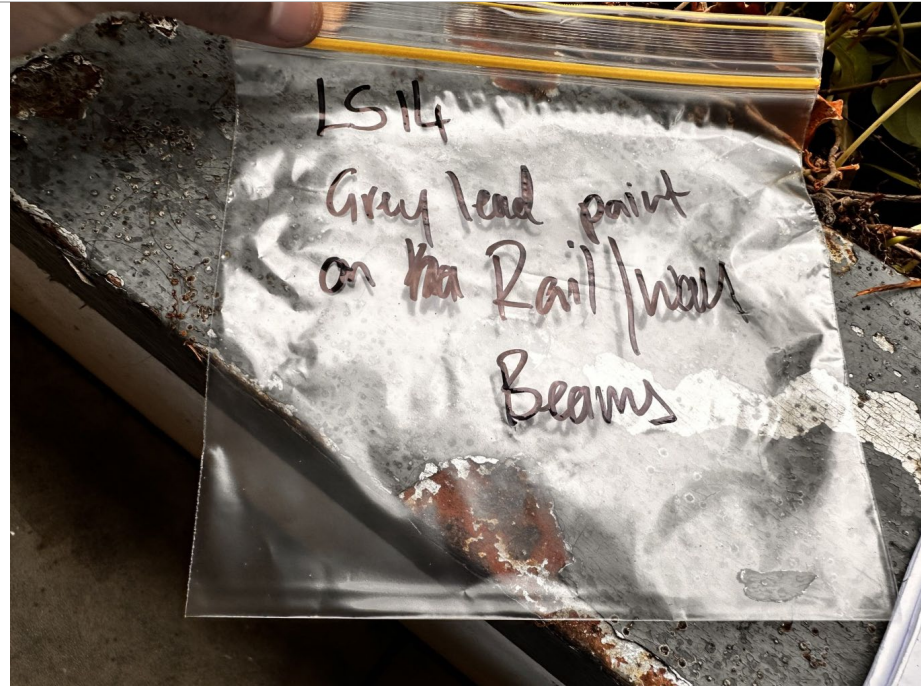
Photo 38: JVB – Sample 14 (S14): Sample of lead grey paint
