Client: Pymble Ladies' College
Project Reference: P25010061
Report Date: 13/02/2025
Inspection Date: 01/02/2024
Report Review Date: 13/02/2030
Version: V2.0 [27.02.2025]

Hazardous Materials Report & Register

Pymble Ladies College: Robert Vicars, Jack Vicars, Dorothy Knox, and Isabel
McKinney Harrison Building

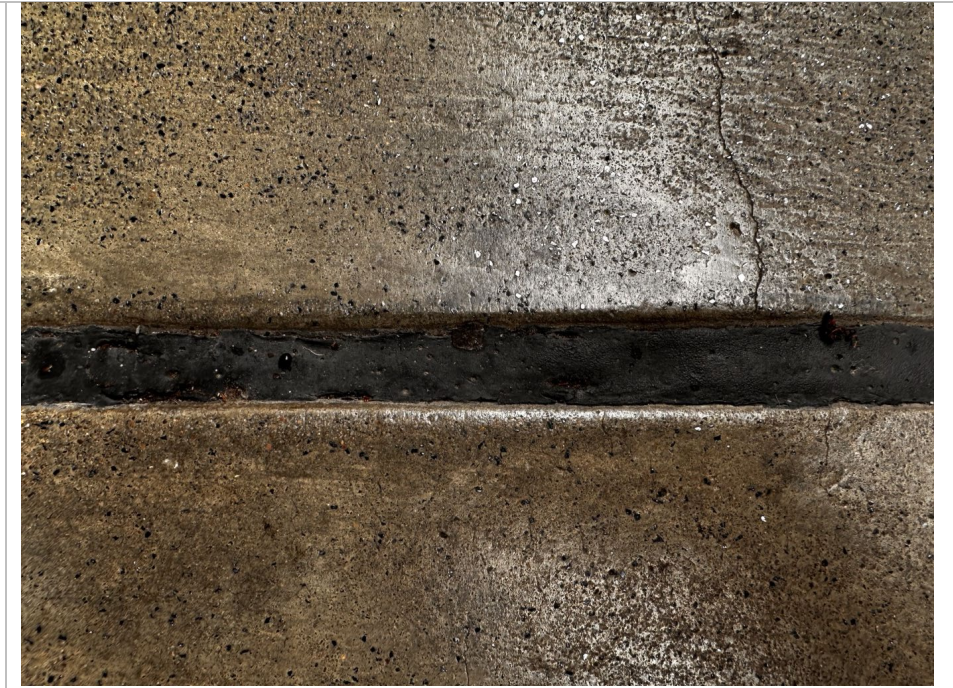
Photo 39: JVB – Expansion joint on level 1 floor

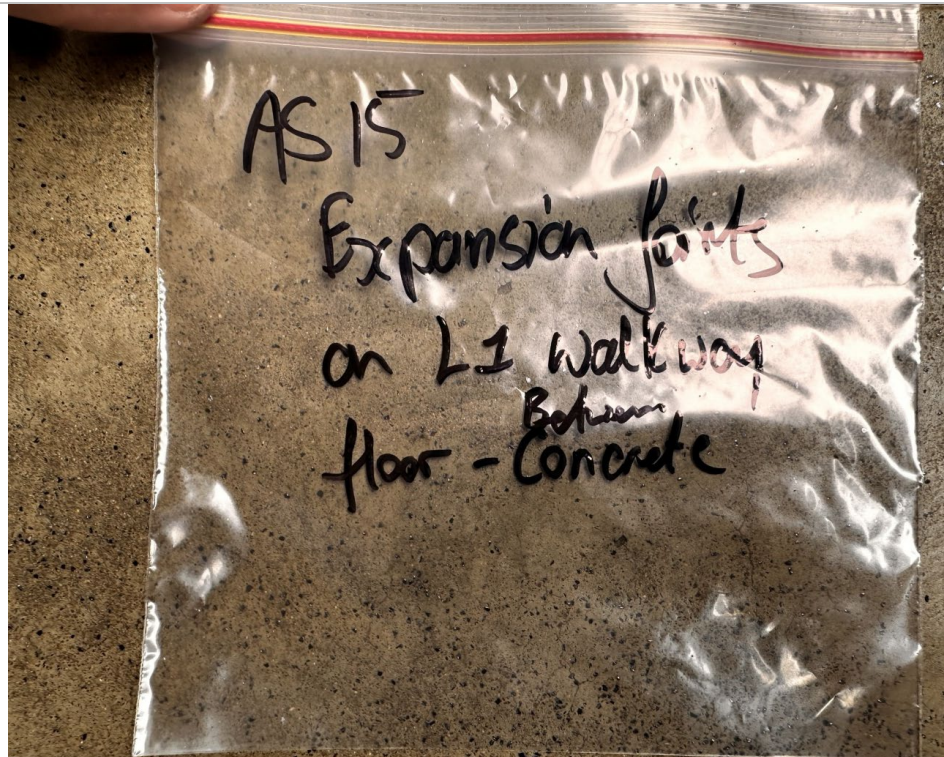
Photo 40: JVB – Sample 15 (S15): Sample of concrete expansion joints

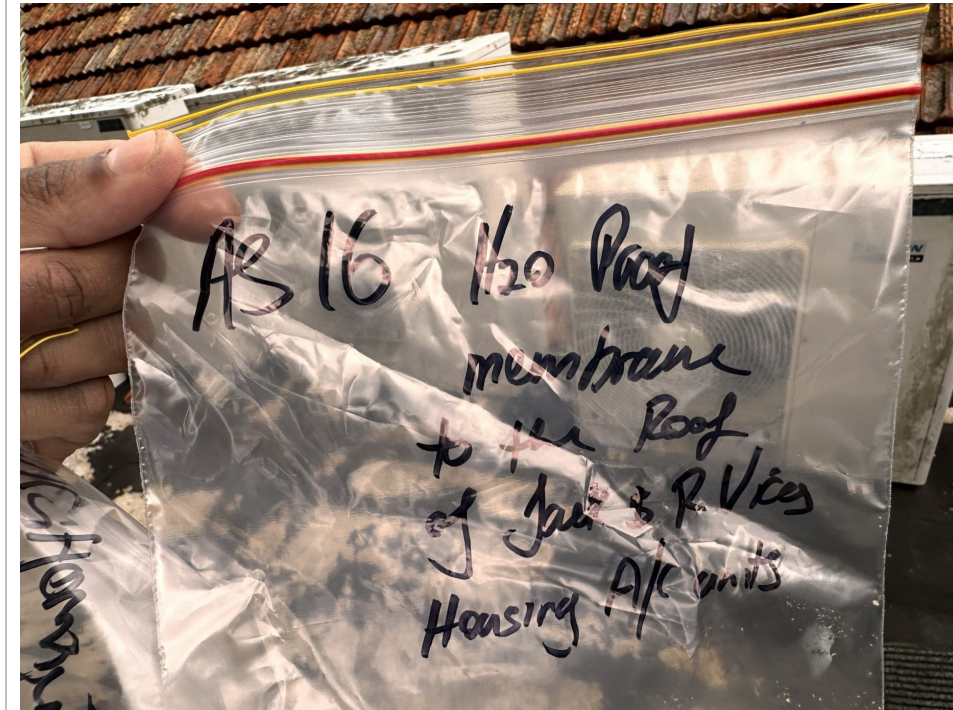
Photo 42: JVB – Sample 16 (S16): Sample of waterproof membrane on roof containing AC units

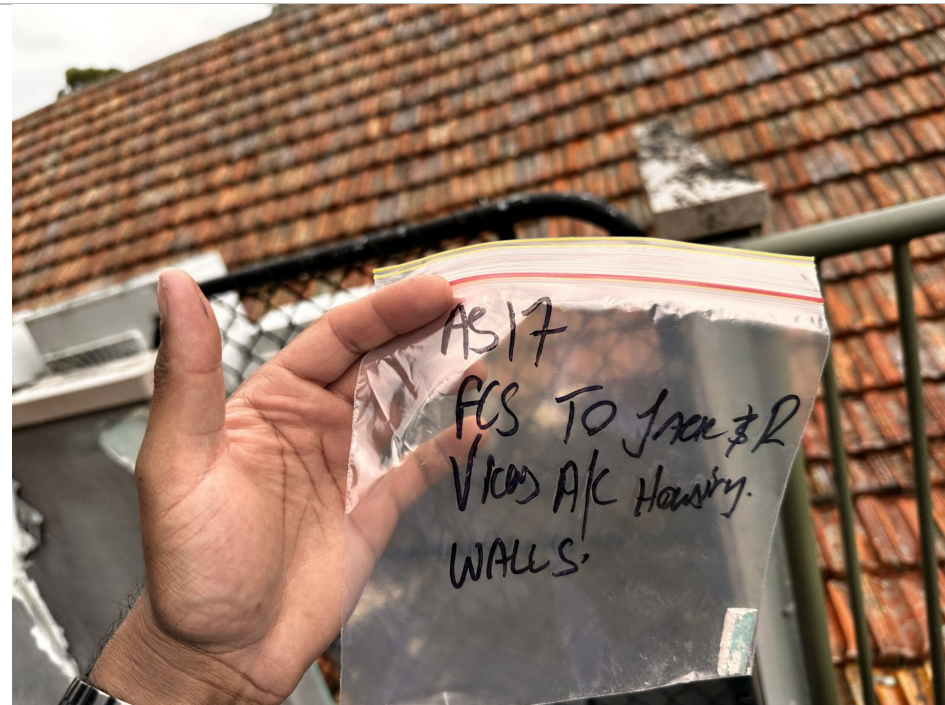
Photo 43: JVB and RVB – Sample 17 (S17): Housing to the AC unit walls

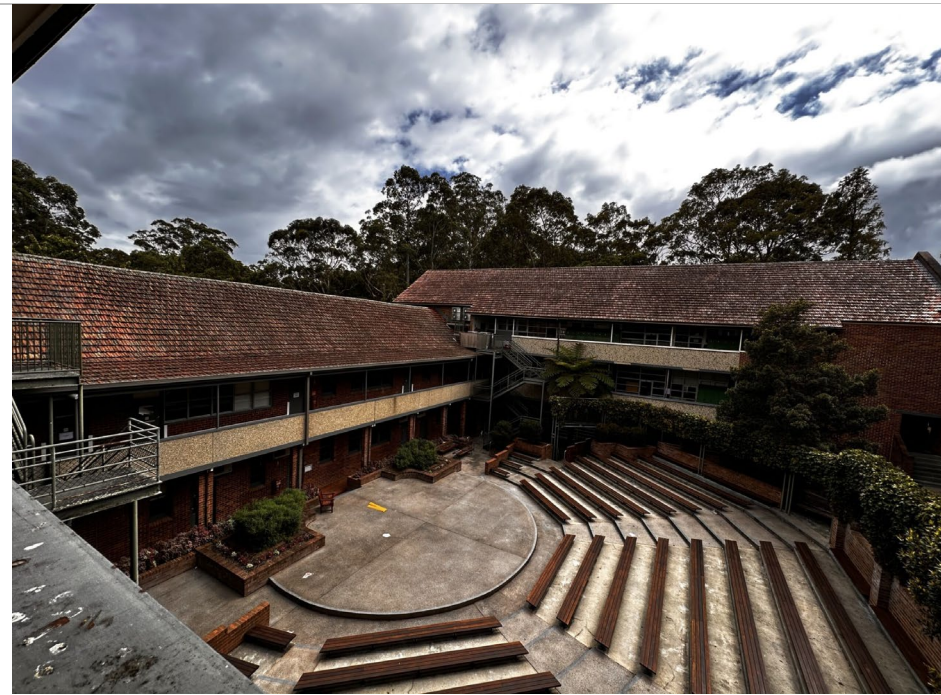
Photo 44: JVB and RVB awning contains asbestos.

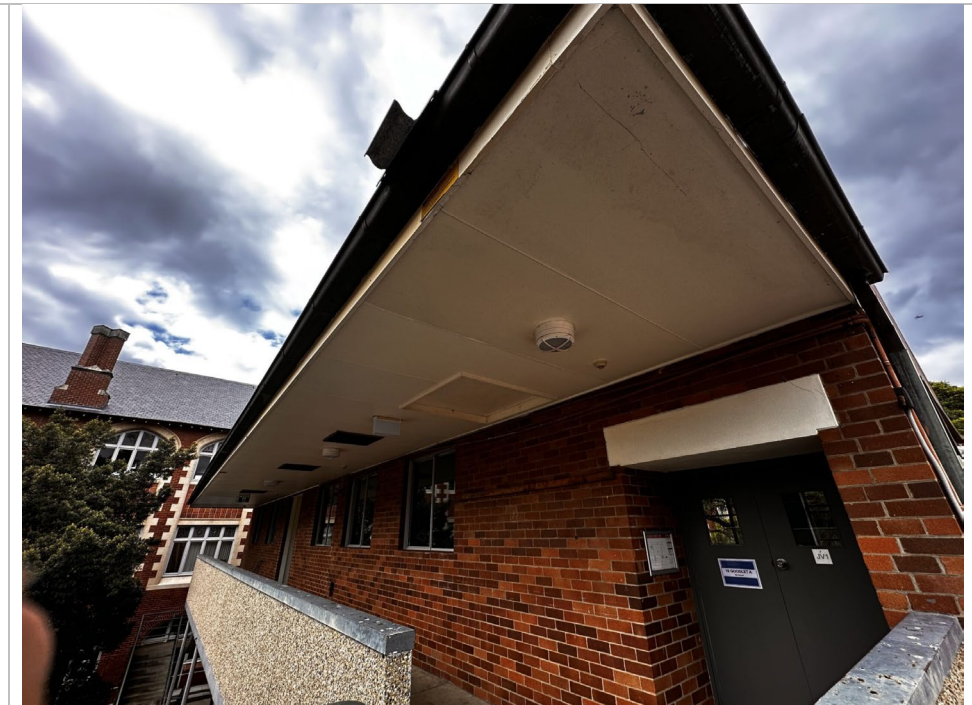
Photo 45: JVB and RVB balcony ceiling contain asbestos.

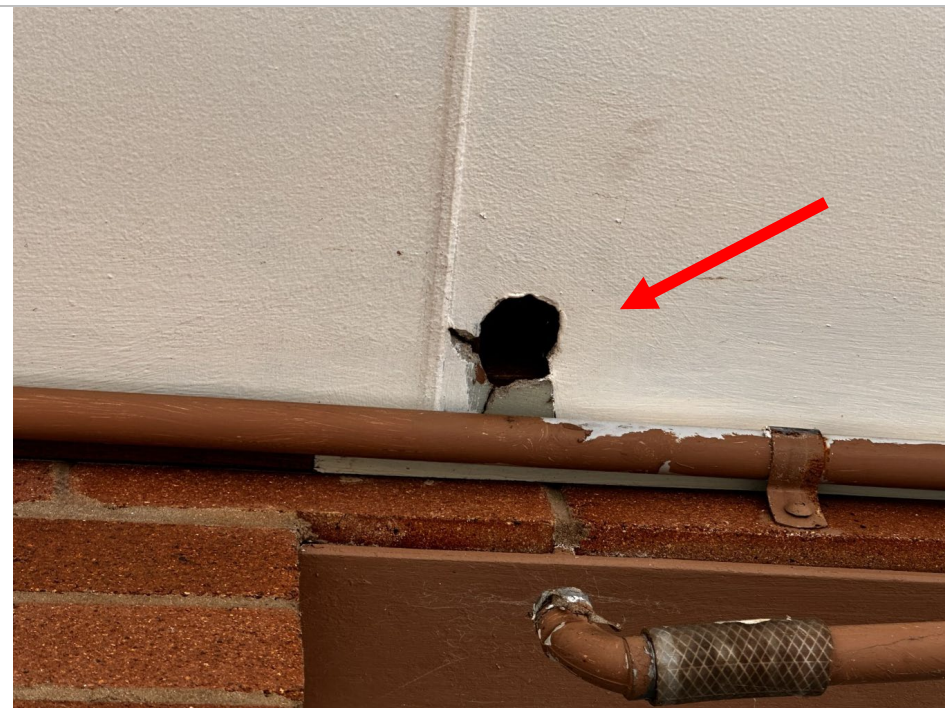
Photo 46: JVB and RVB ceiling contains asbestos and is exposed.

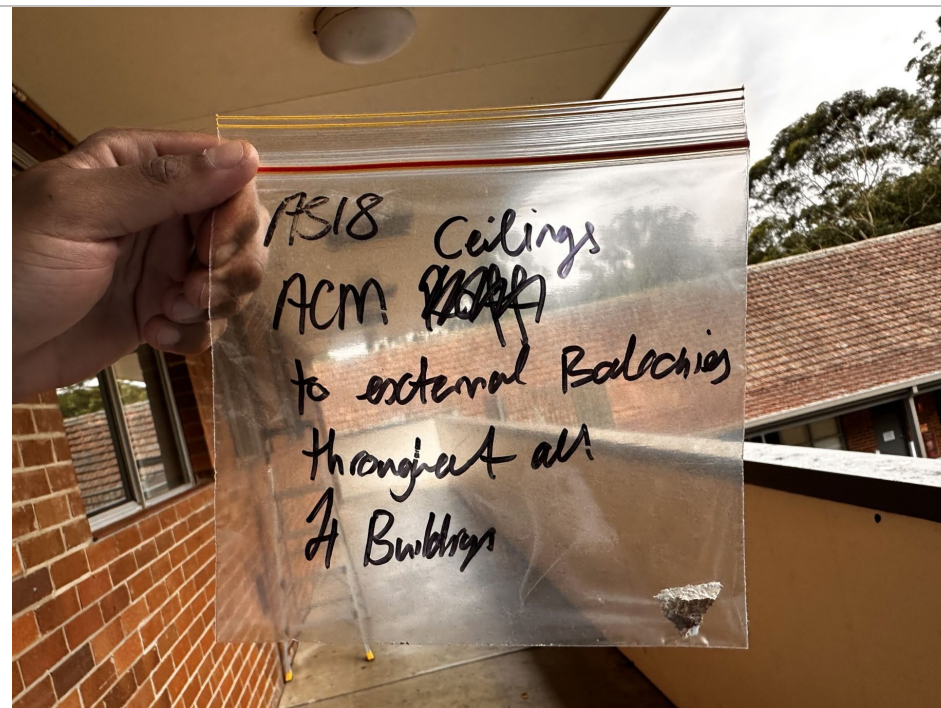
Photo 47: JVB and RVB – Sample 18 (S18): Sample of ceiling panels throughout balconies

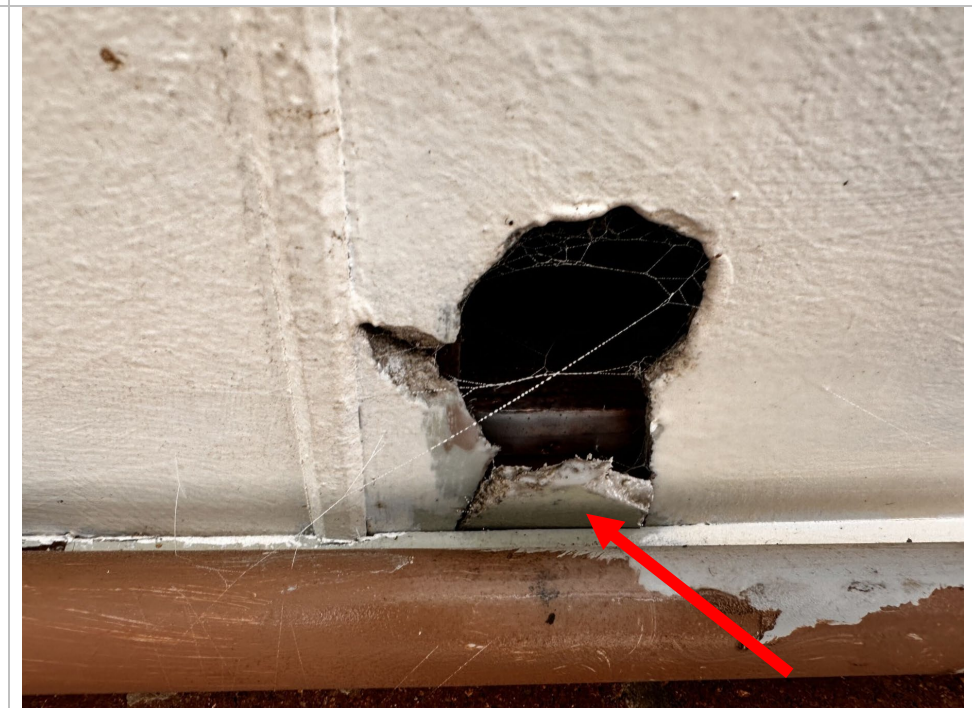
Photo 48: JVB and RVB ceiling contains asbestos and is exposed.

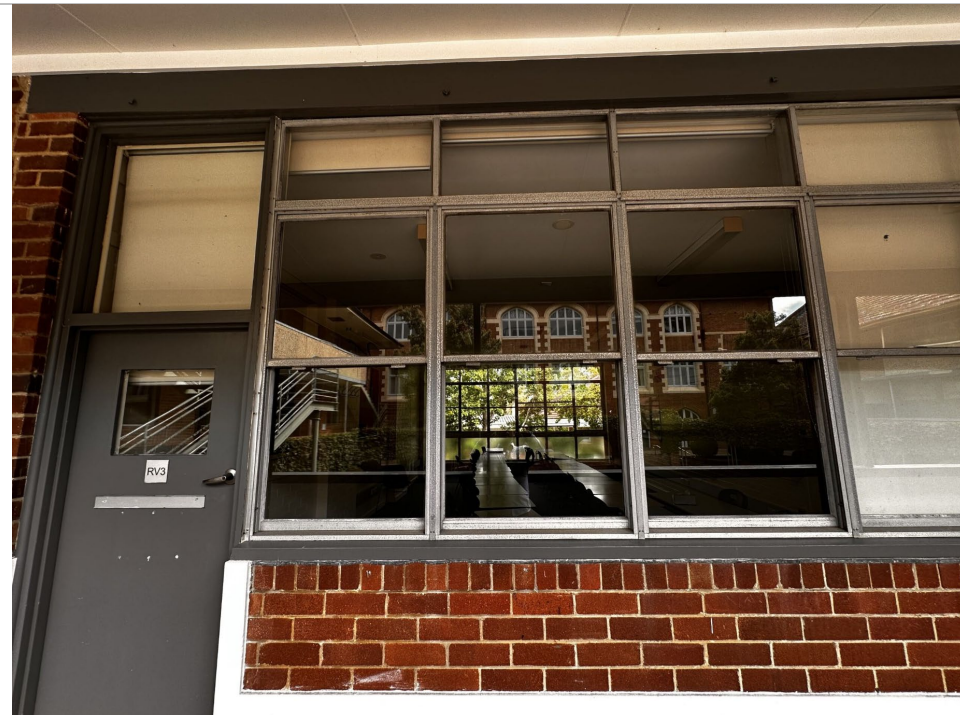
Photo 49: RVB - External steel window mastic

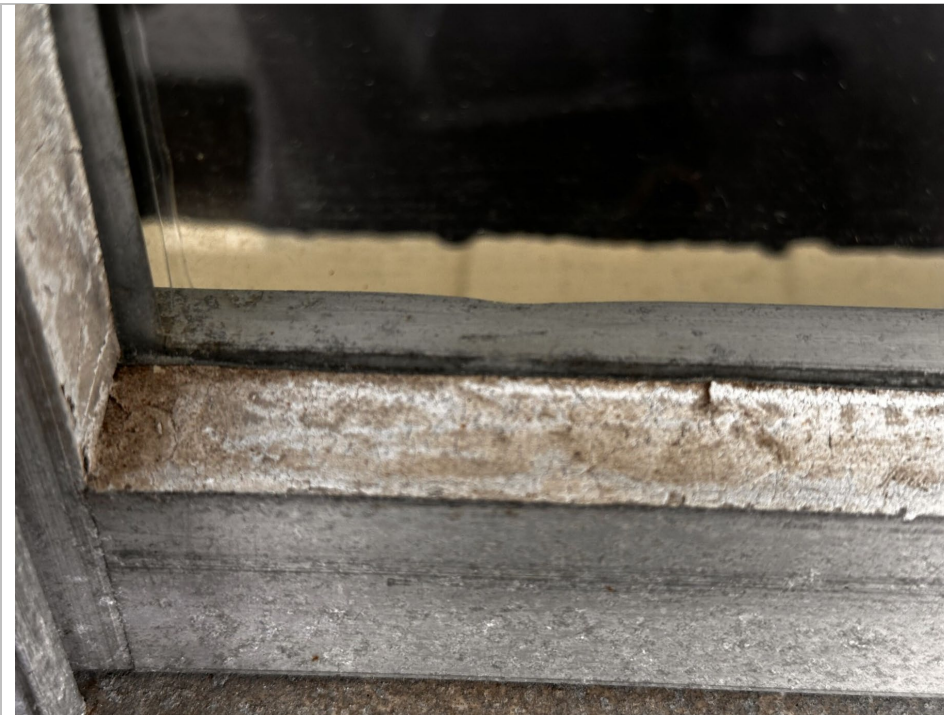
Photo 50: RVB – Mastic on window frame

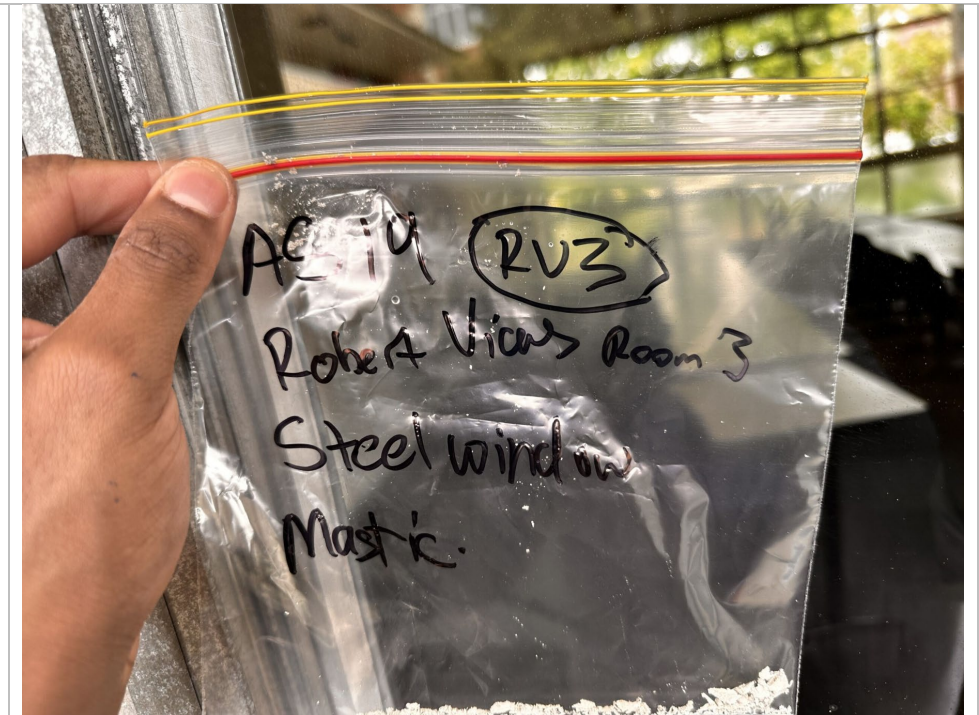
Photo 51: RVB – Sample 19 (S19): Sample from steel window frame

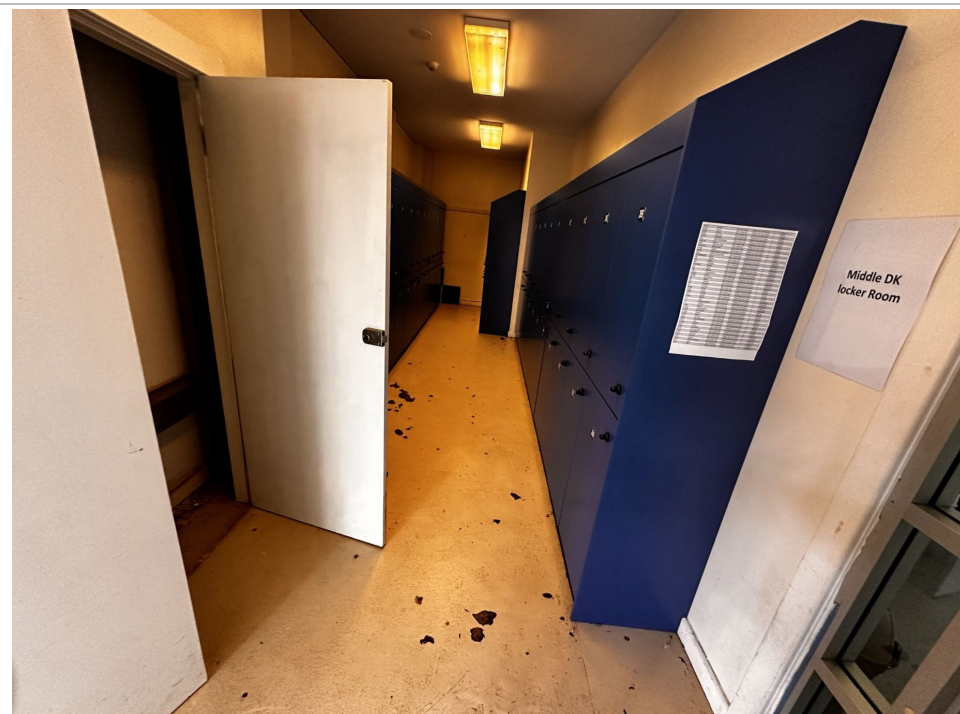
Photo 52: Locker room of Dorothy Knox Building (DKB), locations of samples 20 and 21 Floor paint.

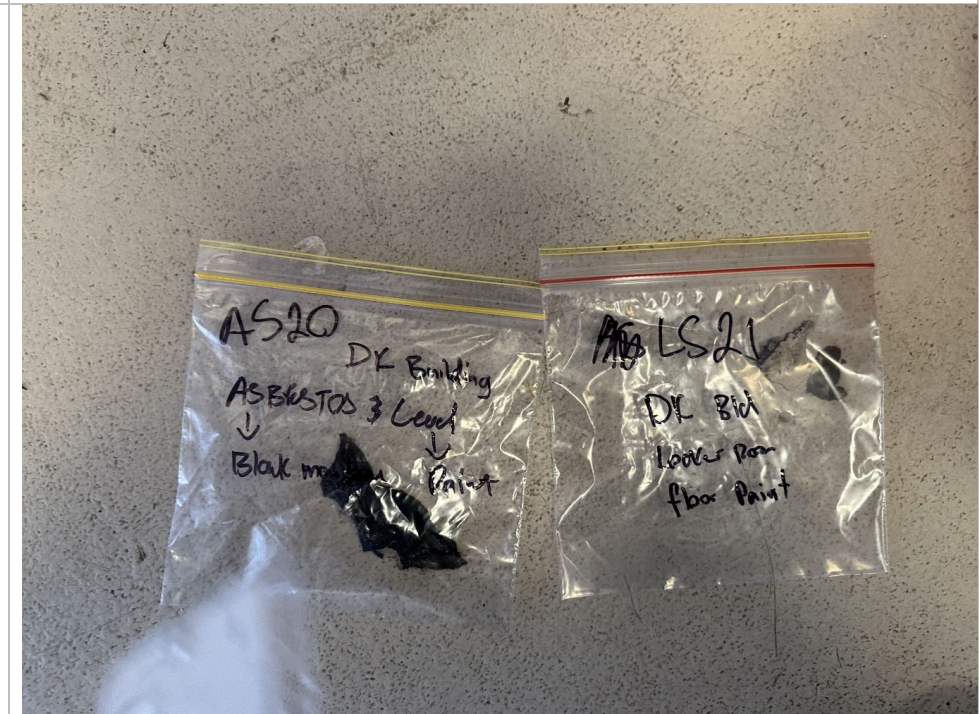
Photo 54: DKB - Samples 20 (asbestos in black adhesive) and sample 21 (Lead in cream paint)

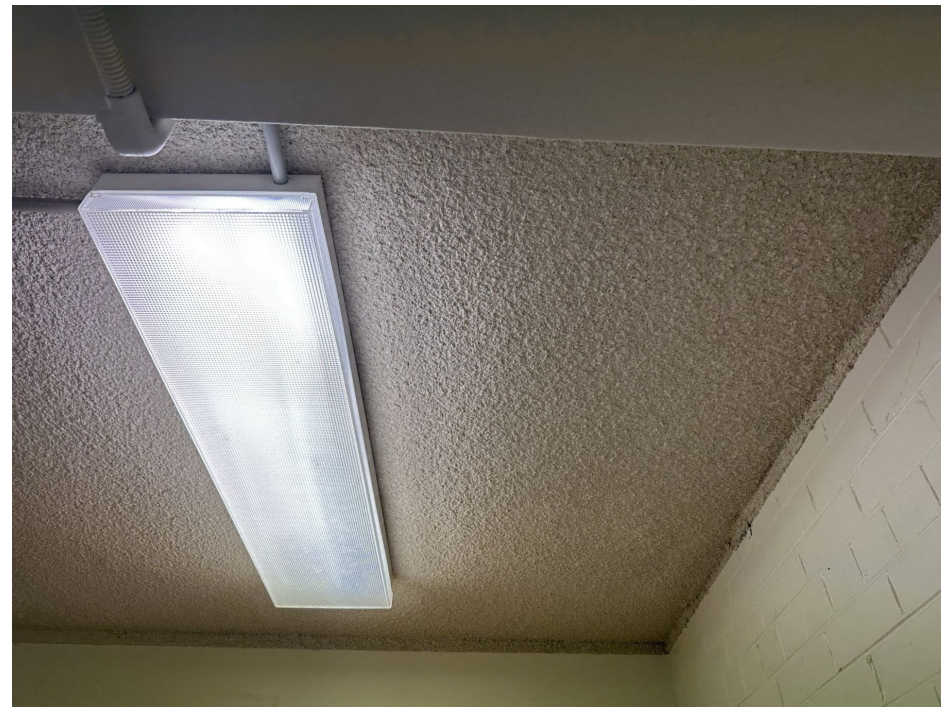
Photo 56: DKB – Archive room ceiling lights may contain mercury.

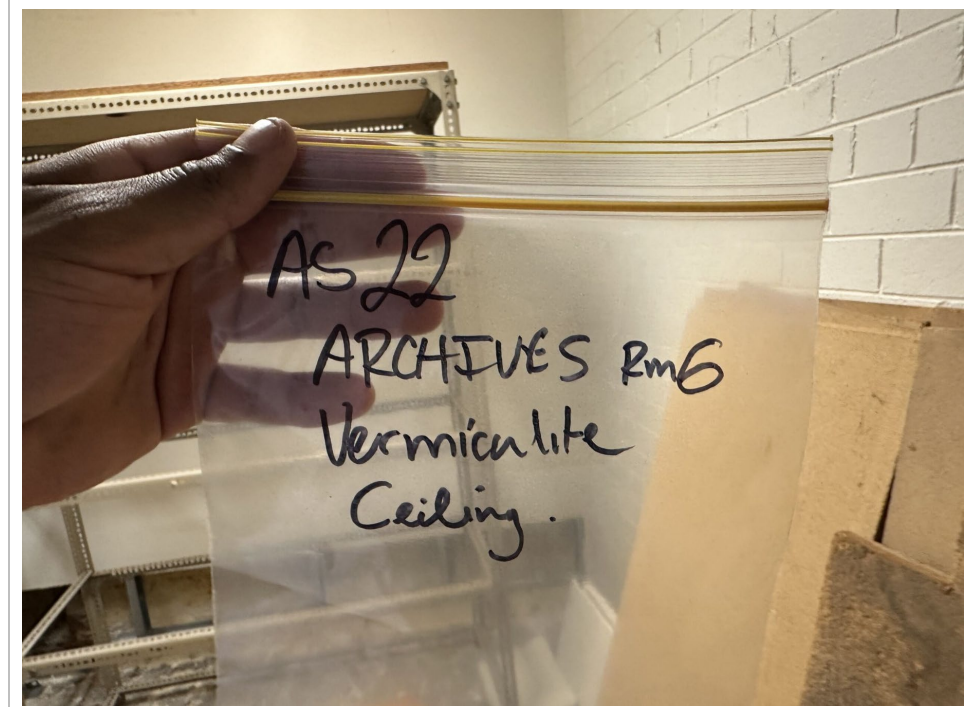
Photo 57: DKB – Sample 22 (S22): Sample of vermiculite ceiling

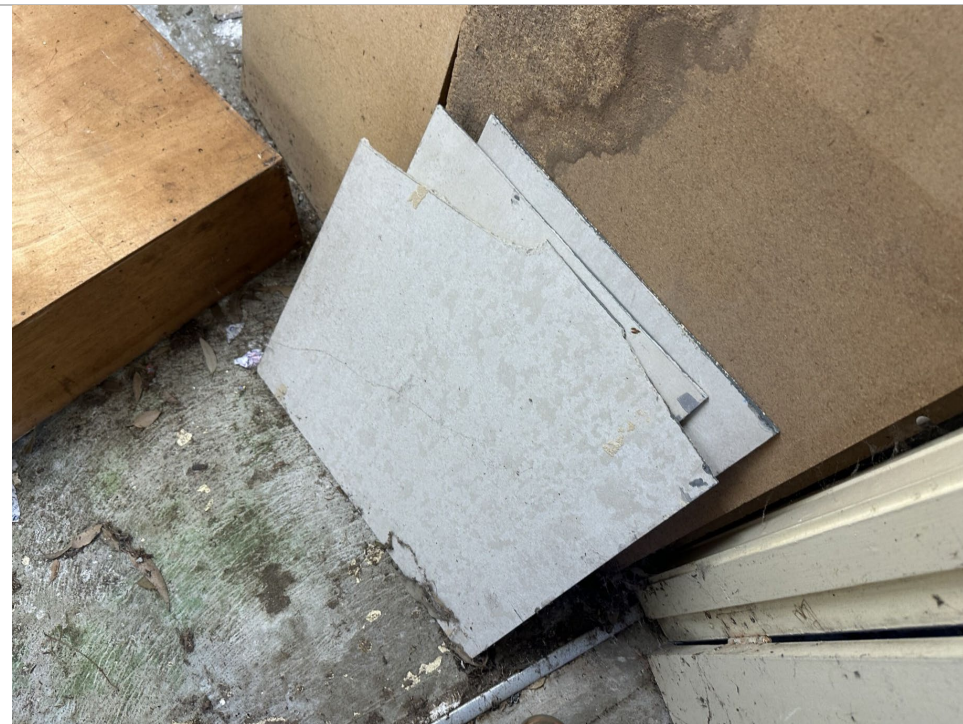
Photo 58: DKB – Fireboard cement sheeting on ground

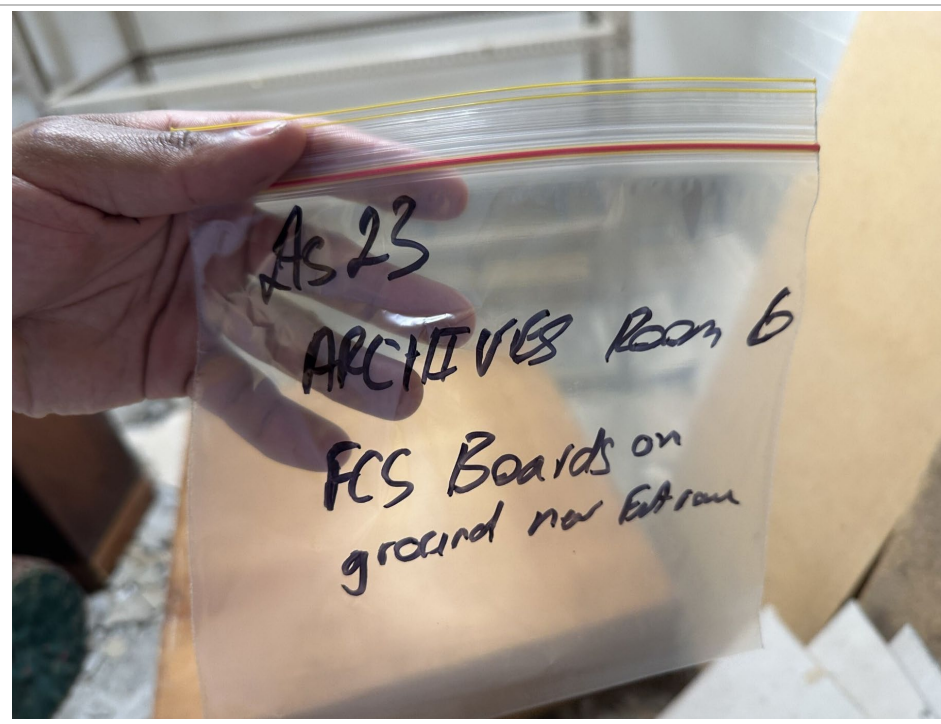
Photo 59: DKB – Sample 23 (S23): Sample of FCS floorboards

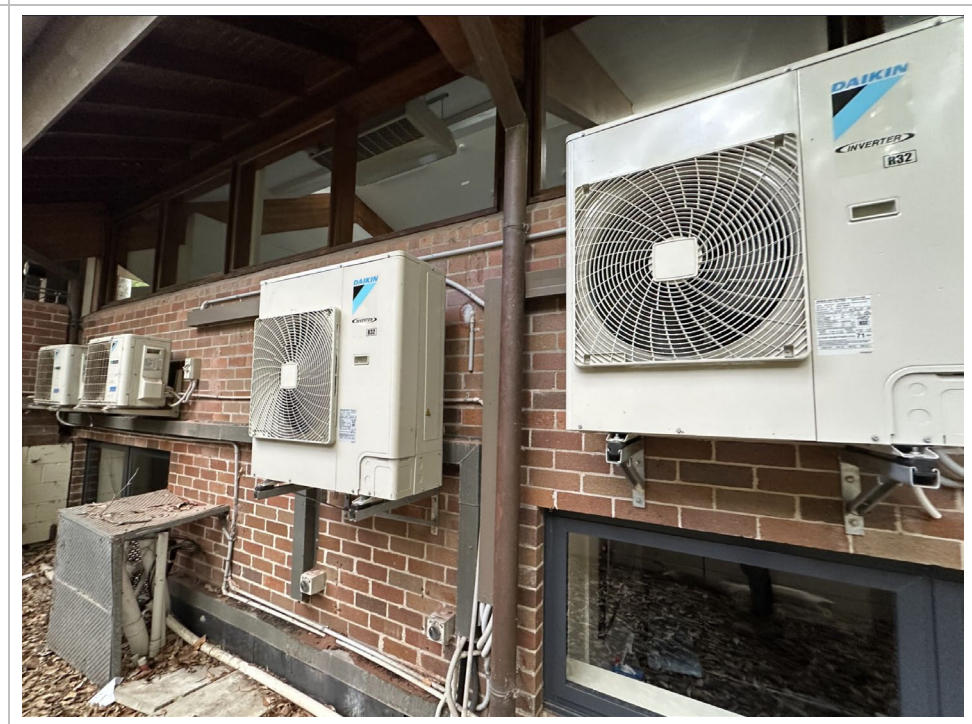
Photo 60: AC units on exterior of Isabel McKinney Harrison Building

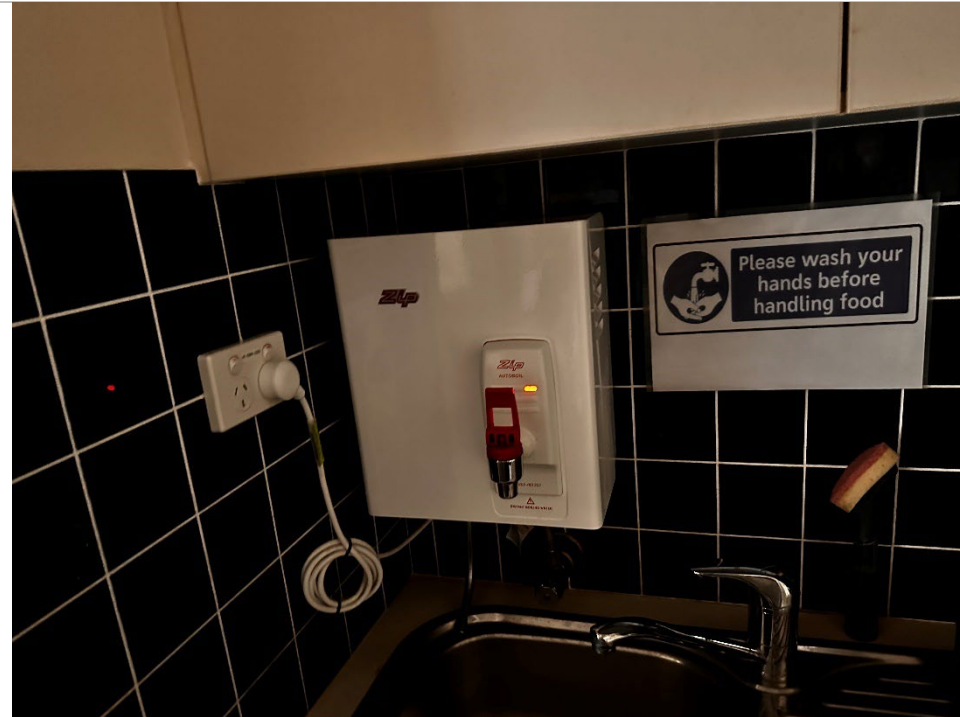
Photo 61: JVB Zip Hot Water Taps contain SMF in boilers.

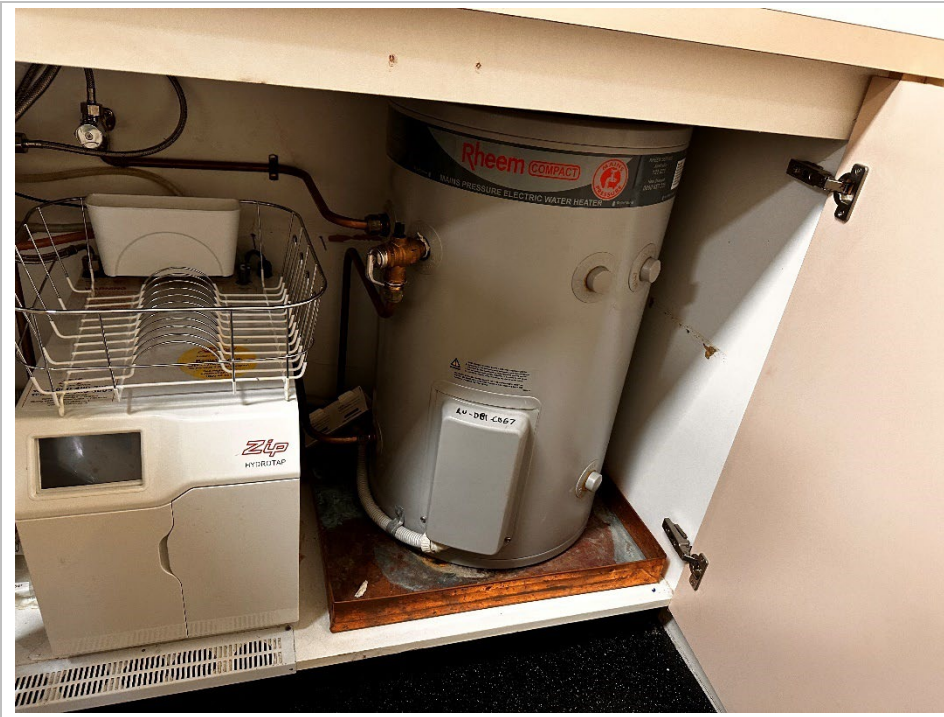
SMF	Internal	Jack Vicars Building, Robert Vicars Buildings, Dorothy Knox Building, and Isabel McKinney Harrison Building	Hot water heaters	Insulation	>10	Good	Maintenance and renovation	Low	Seal / encapsulate all worn out areas with suitable controls to prevent creation of dust as soon as practicable. Appropriate PPE (fitted P2/P3 masks) should be worn by individuals conducting the removal.	Ensure current condition of SMF is maintained to reduce the potential risk of exposure to occupants.	62

Photo 62: RVB Hot Water Heaters contain SMF.
