# **DILAPIDATION REPORT**

**For Property At  
3A Valley Rd,  
Lindfield, NSW 2070**

**For Development At  
59-63 Trafalgar Ave & 1A-1B Valley Rd,  
Lindfield, NSW 2070**

**Ref: 26009-DR-001-R1-3A Valley Rd  
Date: 25.05.2026**

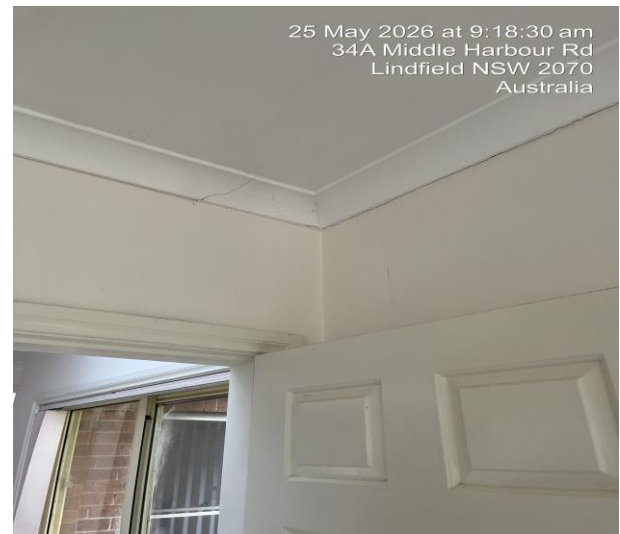
Photo 2 – Cracking observed to coving

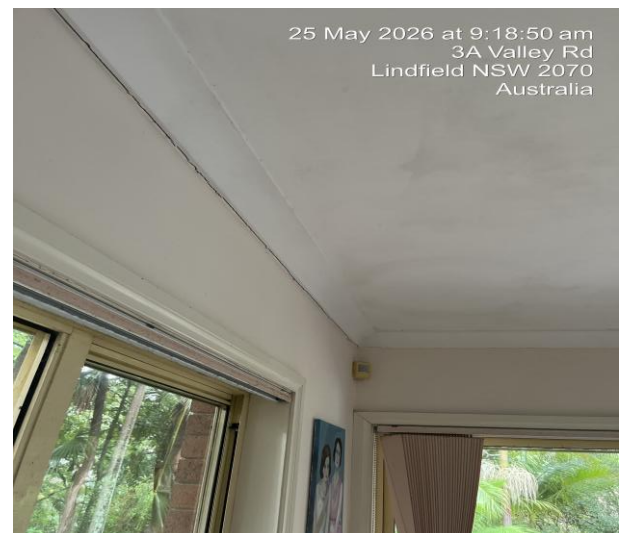
Photo 4 – Cracking observed to coving

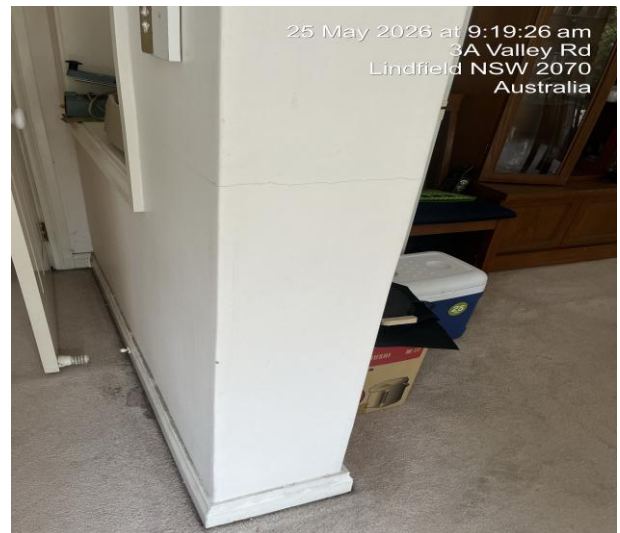
Photo 10 – Cracking observed to wall

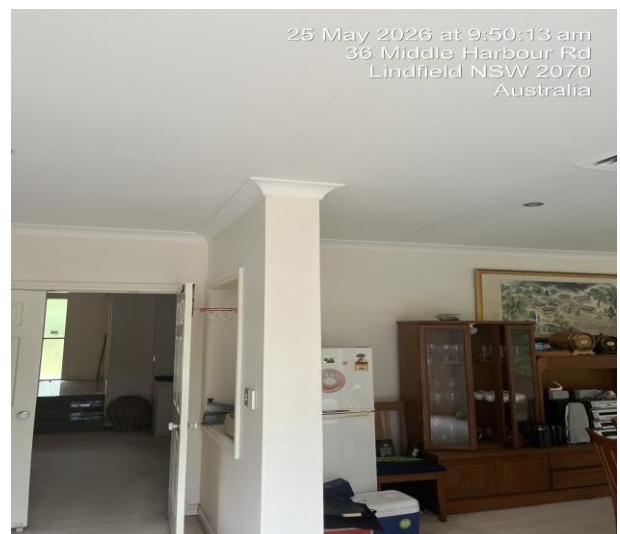
Photo 11 – Cracking observed to coving

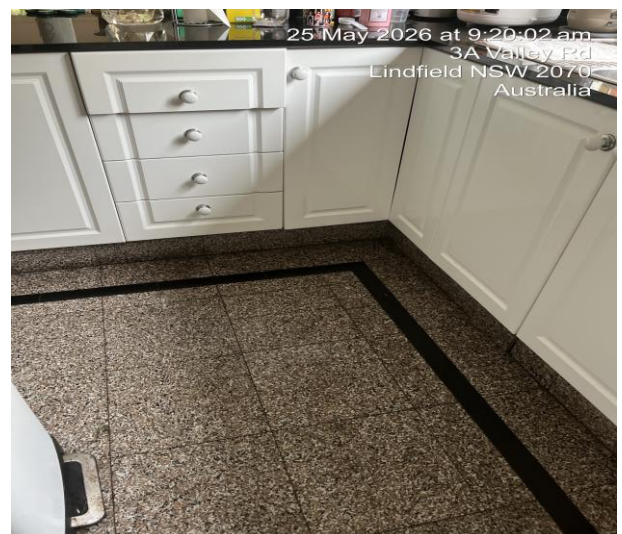
Photo 18 – Loose tiling observed

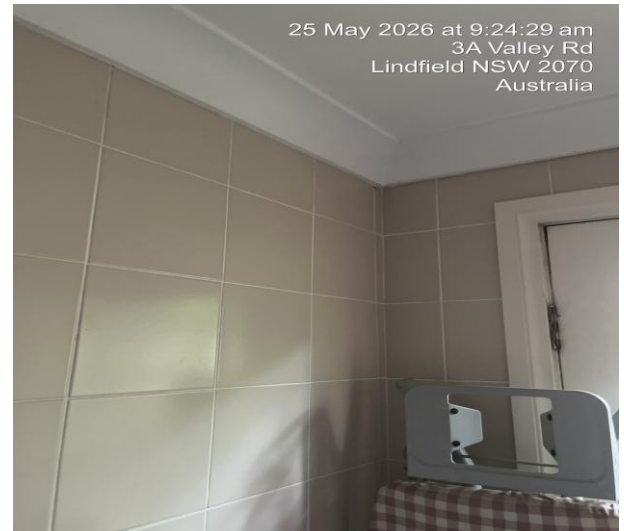
Photo 37 – Cracking observed to framing

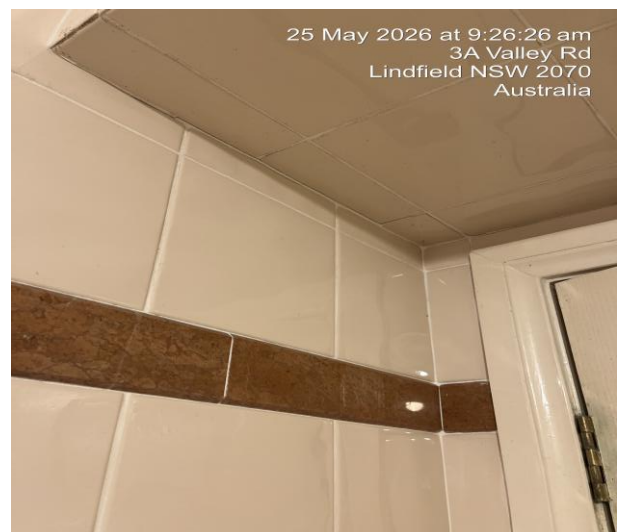
Photo 48 – Cracking observed to grout

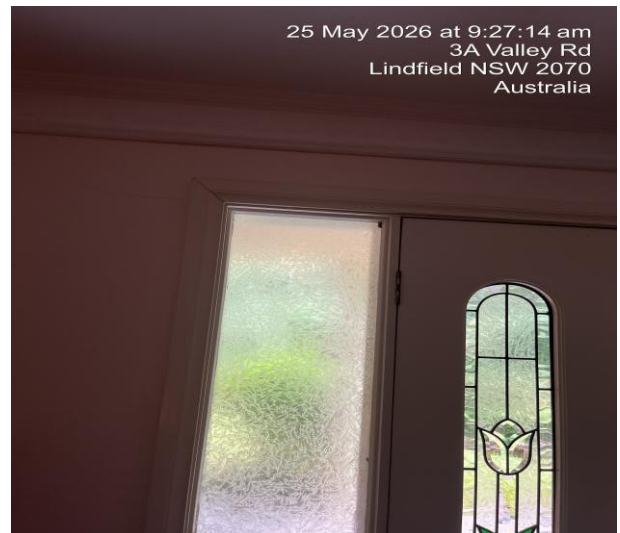
Photo 52 – Cracking observed to wall and frame

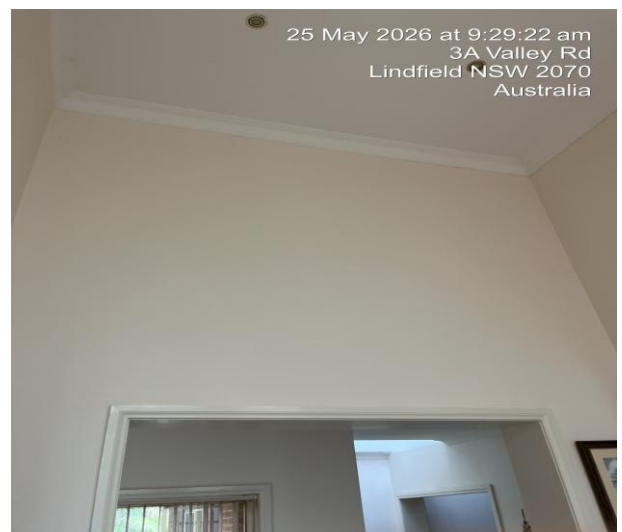
Photo 66 - Cracking observed to coving

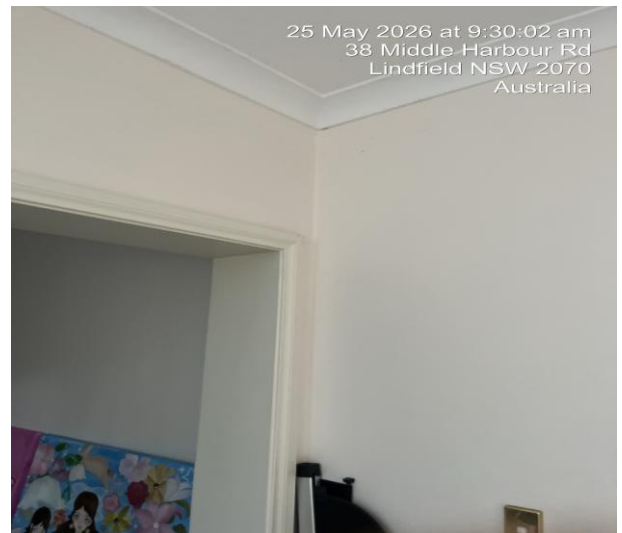
Photo 70 – Cracking observed to coving

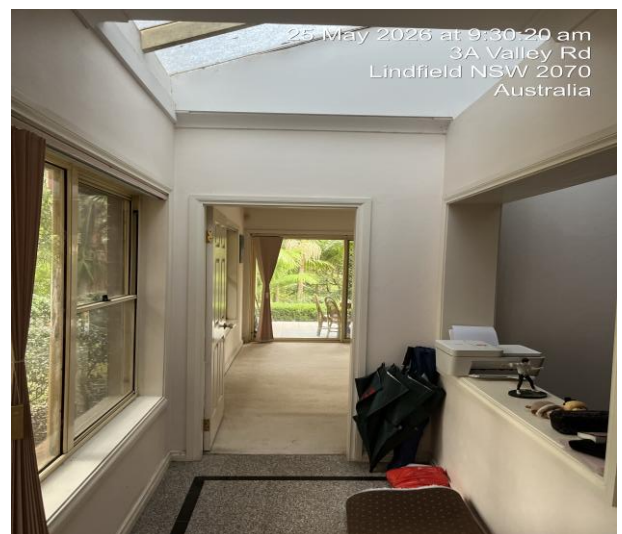
Photo 71 – Cracking observed to coving

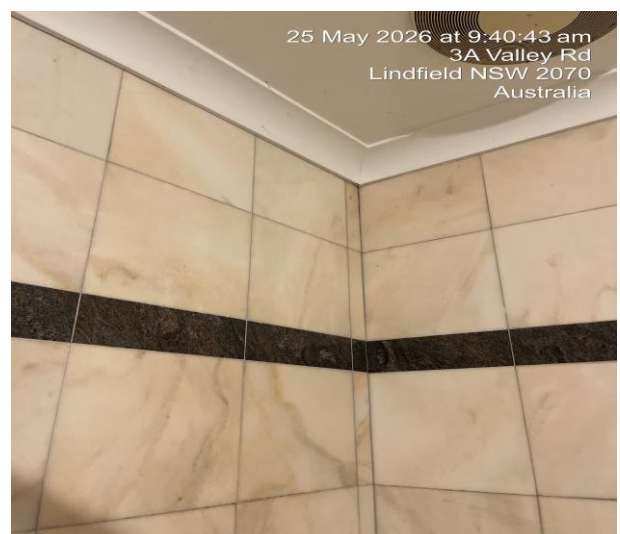
Photo 114 – Cracking observed to coving

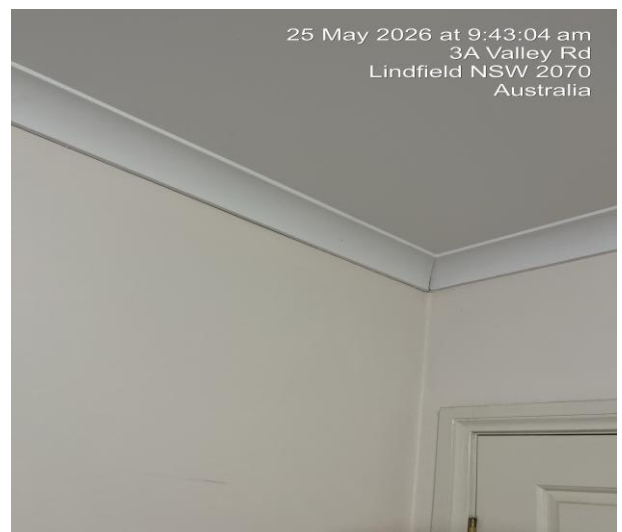
Photo 126 – Cracking observed to coving

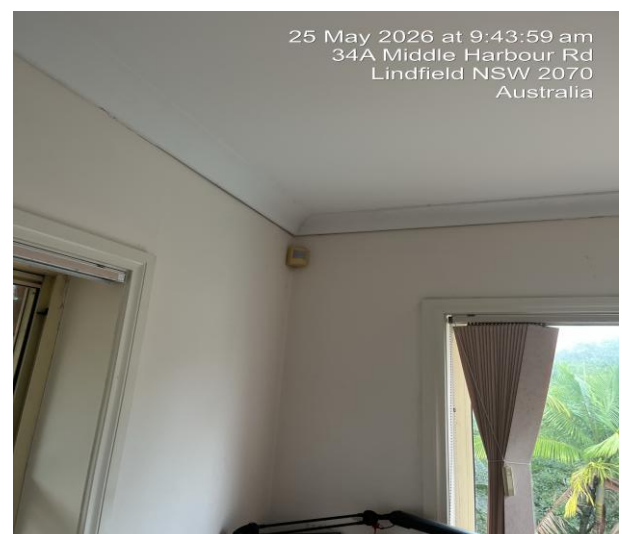
Photo 132 – Movement observed to coving

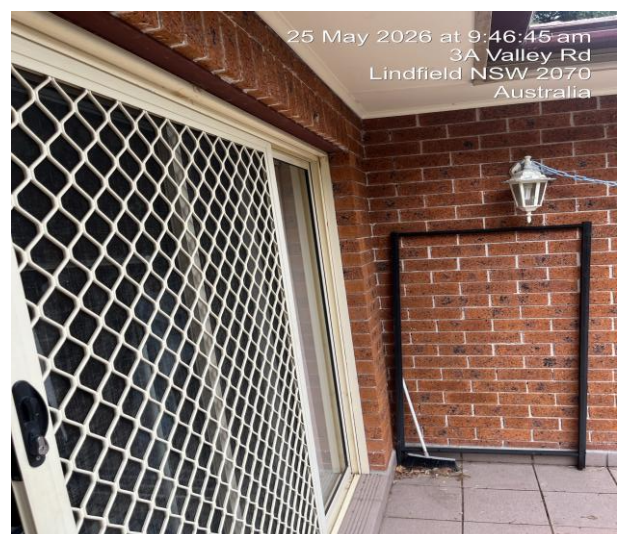
Photo 143 – Water ingress and delamination of paint observed

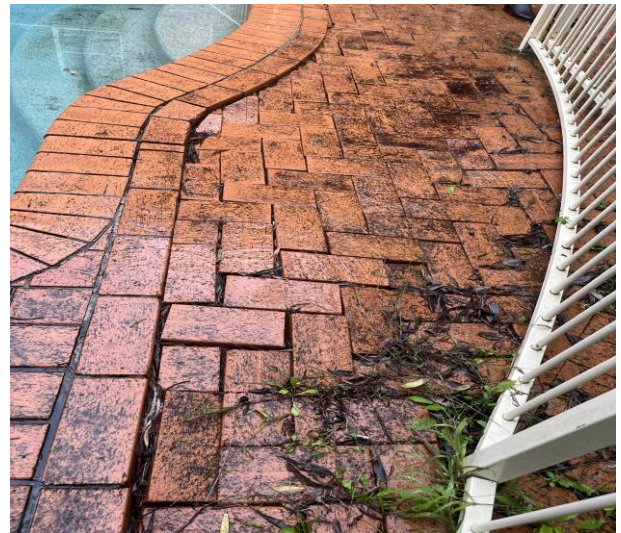
Photo 196 – Settlement observed to pavers

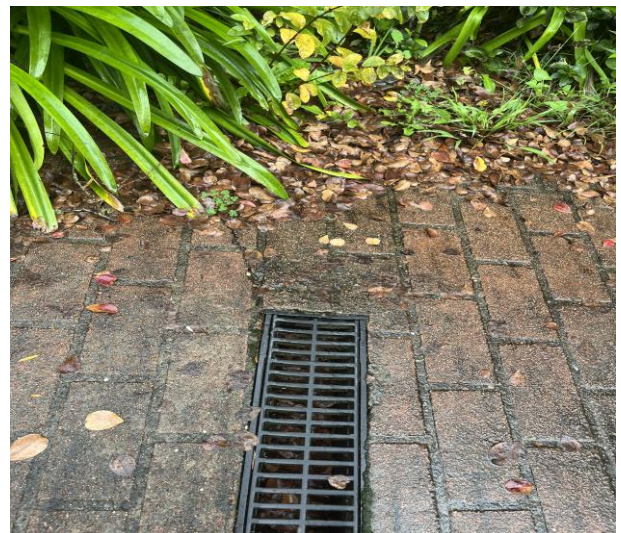
Photo 220 – Cracking observed to pavers

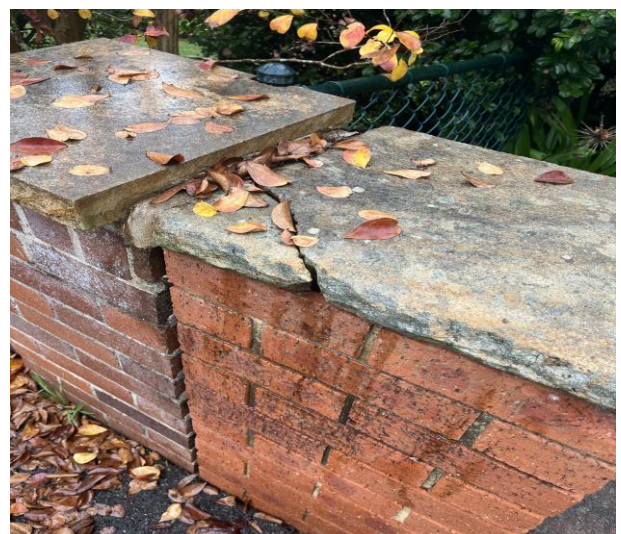
Photo 222 – Cracking observed to stone

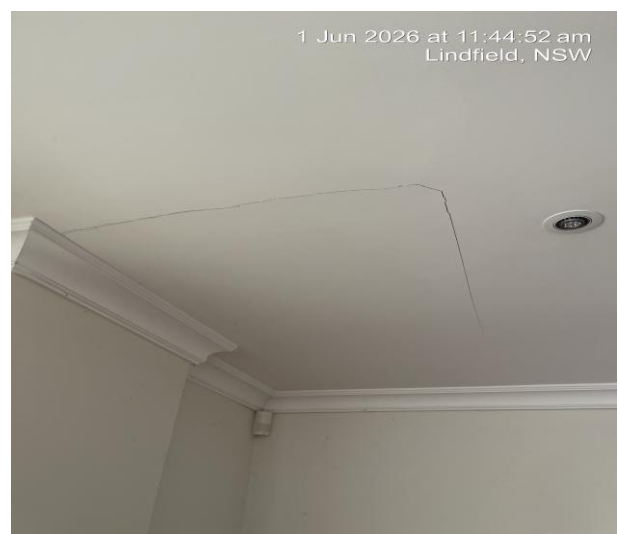
Photo 48 - Cracking observed to ceiling

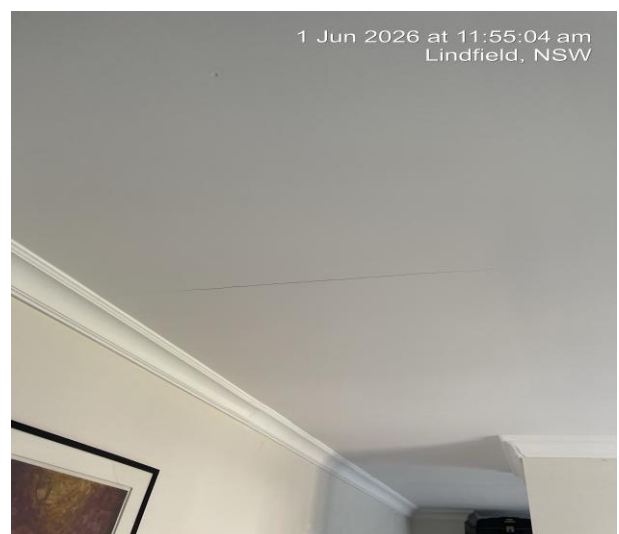
Photo 120 - Cracking observed to ceiling

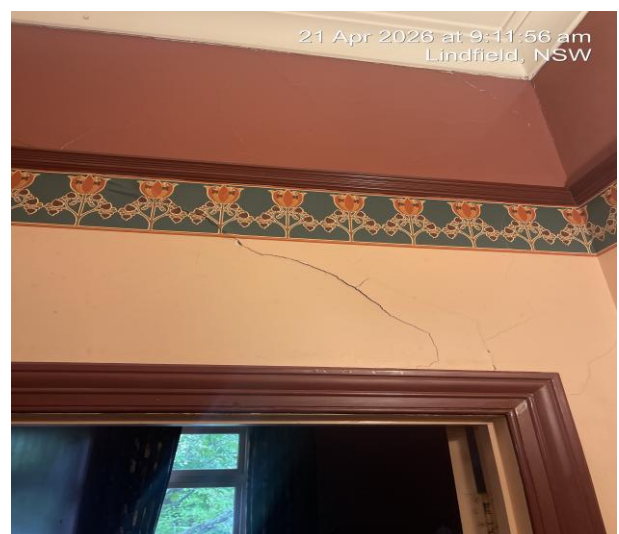
Photo 24 – 45° crack observed to wall

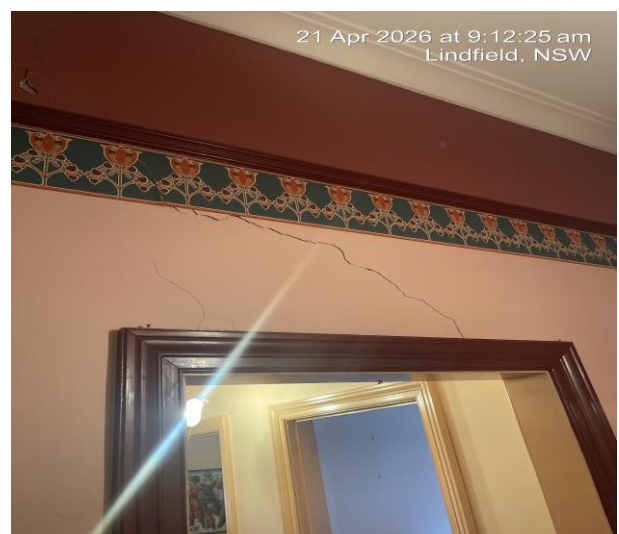
Photo 30 – 45° crack observed to wall

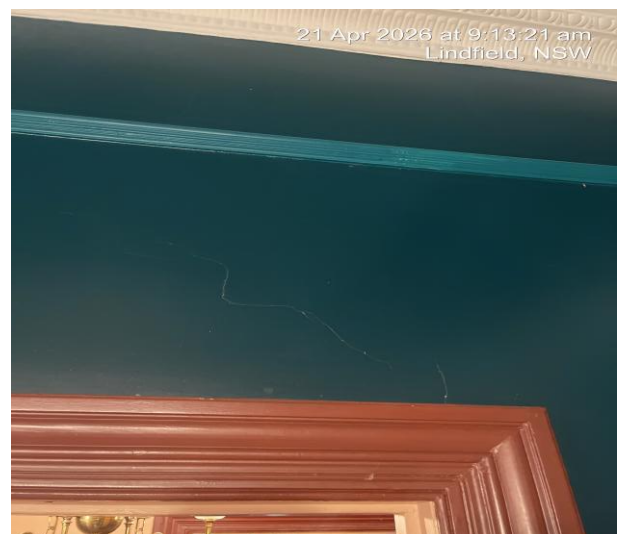
Photo 36 - Cracking observed to wall

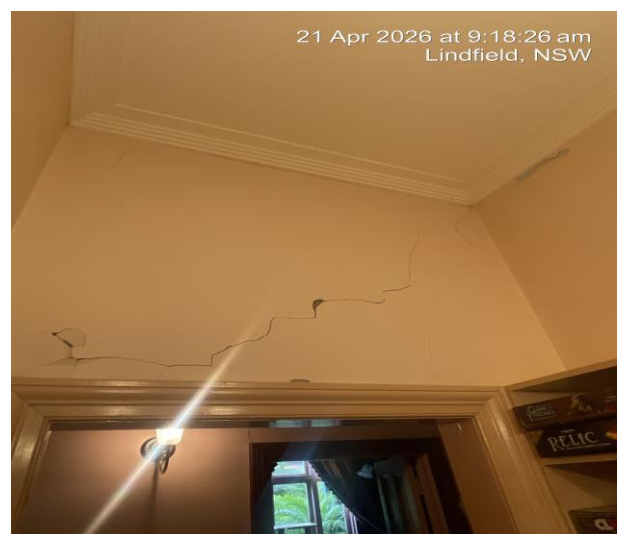
Photo 66 – 45° crack observed to wall

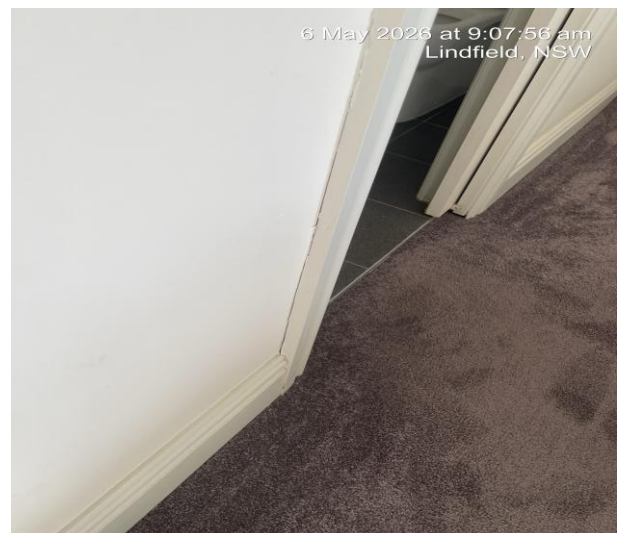
Photo 10 - Cracking observed to doorframe

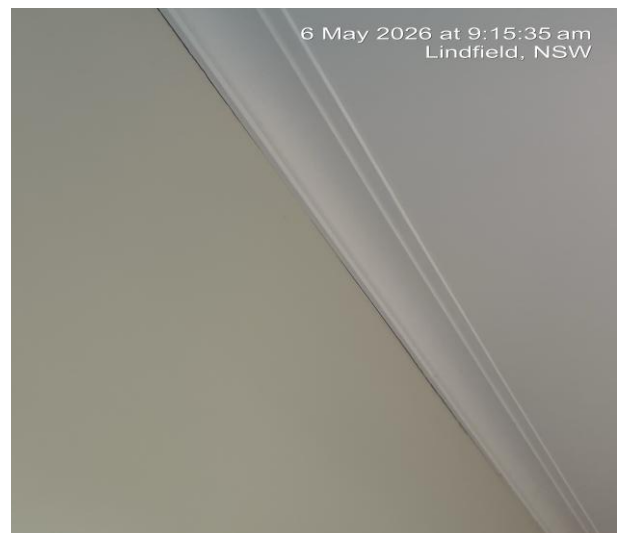
Photo 46 – Movement observed to coving

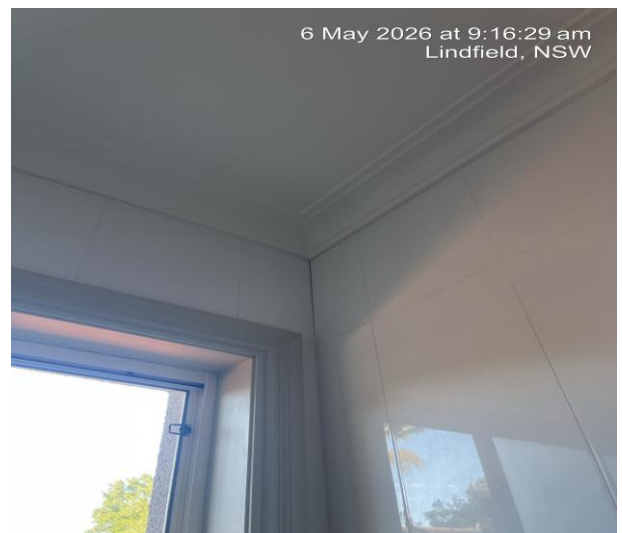
Photo 52 – Cracking observed to grout and coving

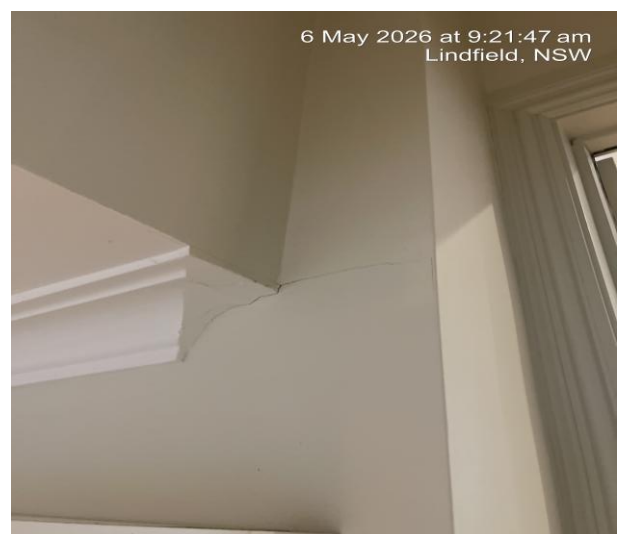
Photo 78 – Cracking observed to gyprock wall

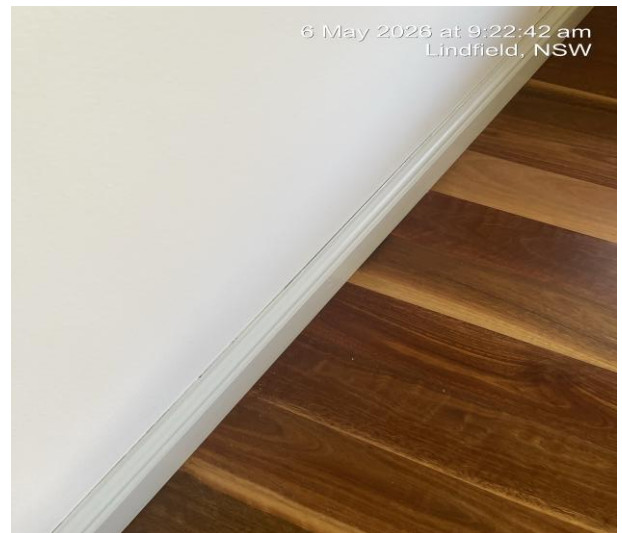
Photo 82 – Cracking observed to skirting

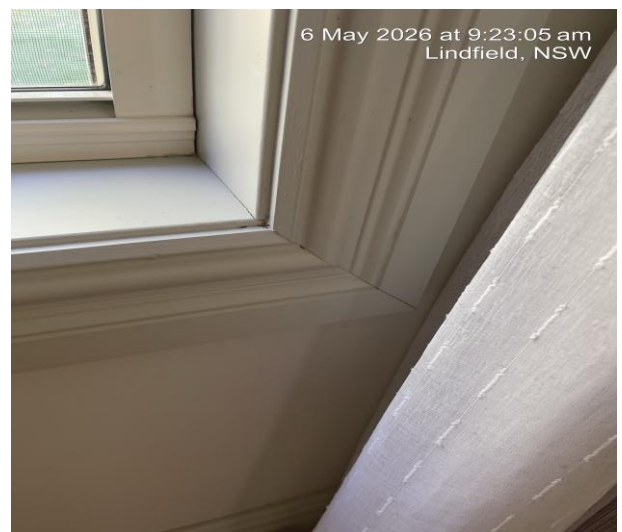
Photo 84 – Cracking observed to window frame

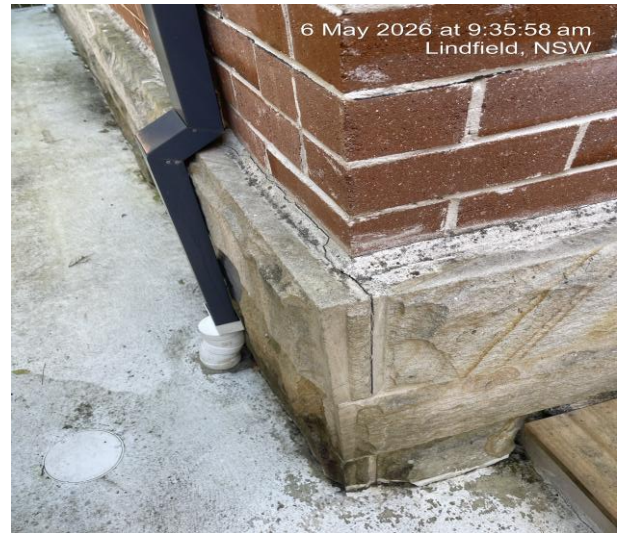
Photo 140 – Cracking observed to mortar

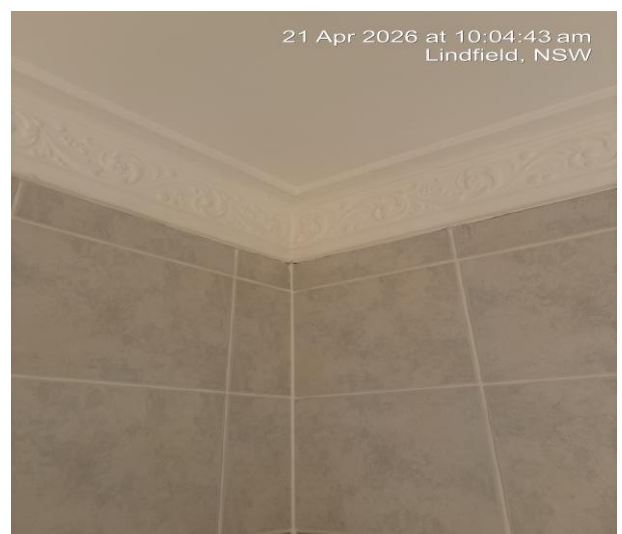
Photo 24 – Cracking observed to coving

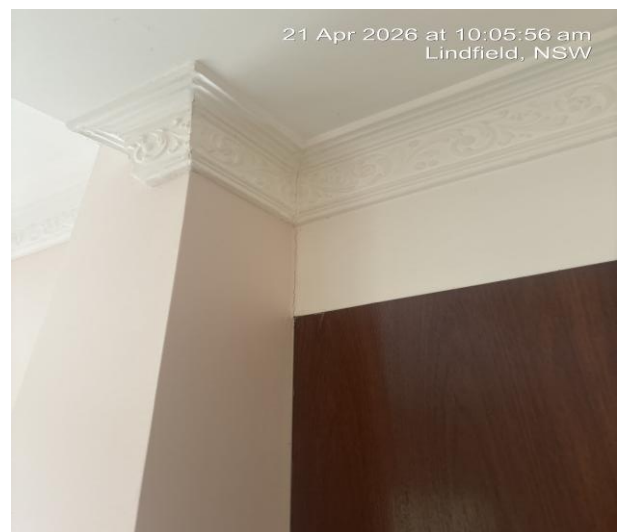
Photo 30 - Cracking observed to wall and coving

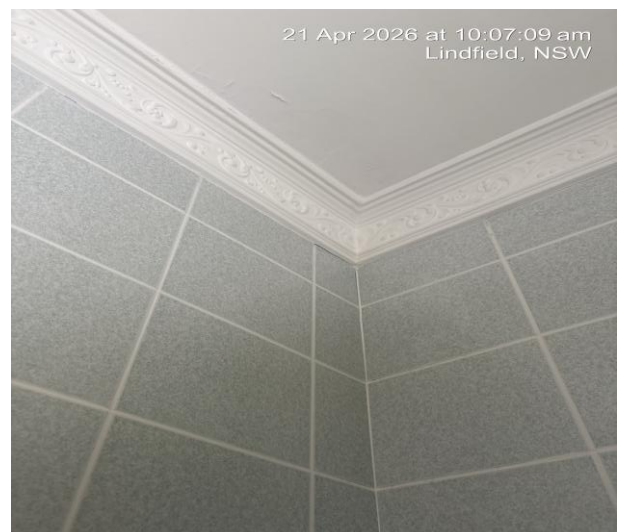
Photo 36 – Cracking observed to grout

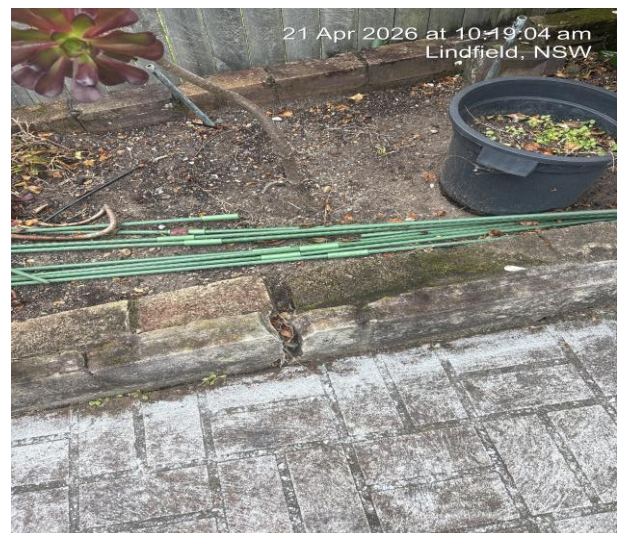
Photo 70 – Cracking observed to stone

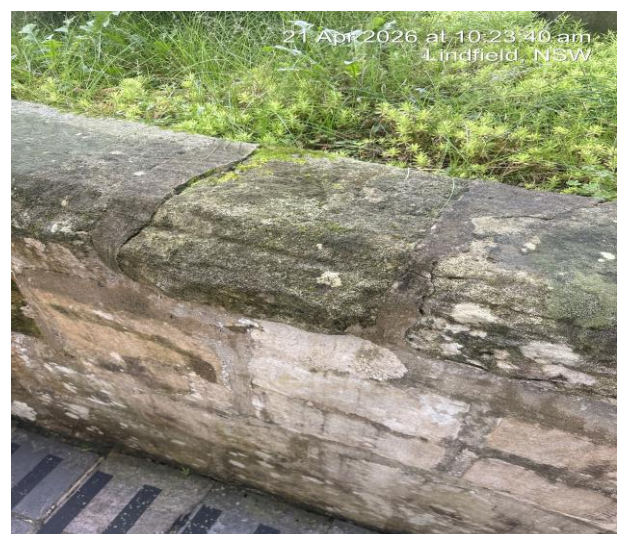
Photo 84 – Cracking observed to mortar

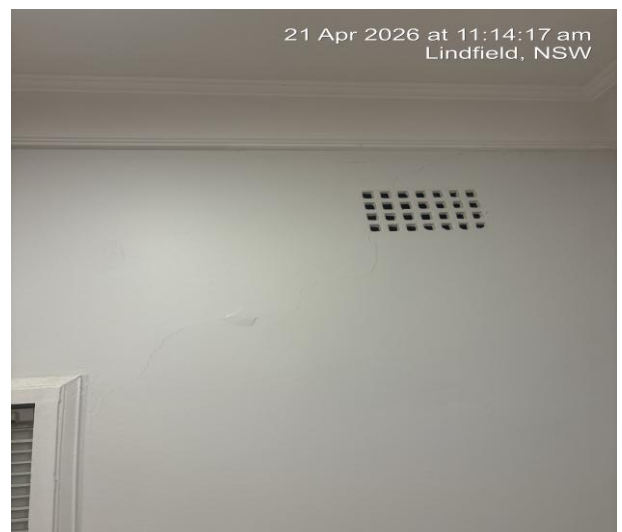
Photo 24 – 45° crack observed to wall

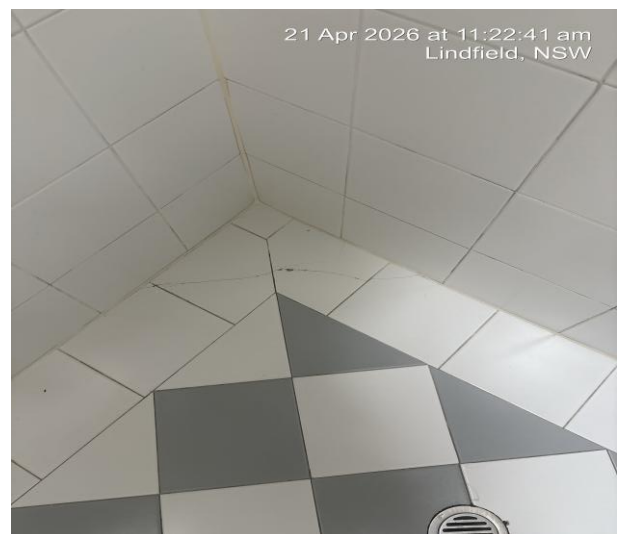
Photo 54 – Cracking observed to tiles

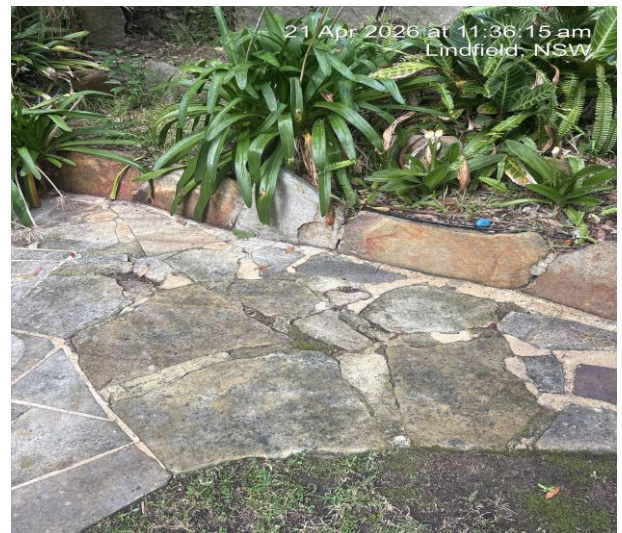
Photo 94 – Cracking observed to mortar

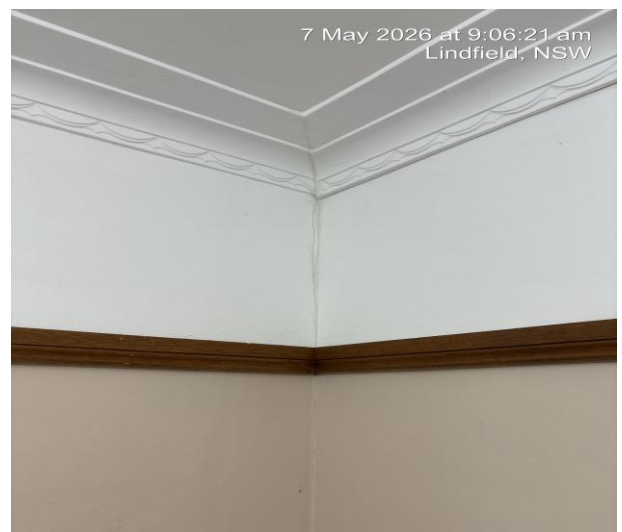
Photo 12 – Cracking and water damage observed to wall and coving

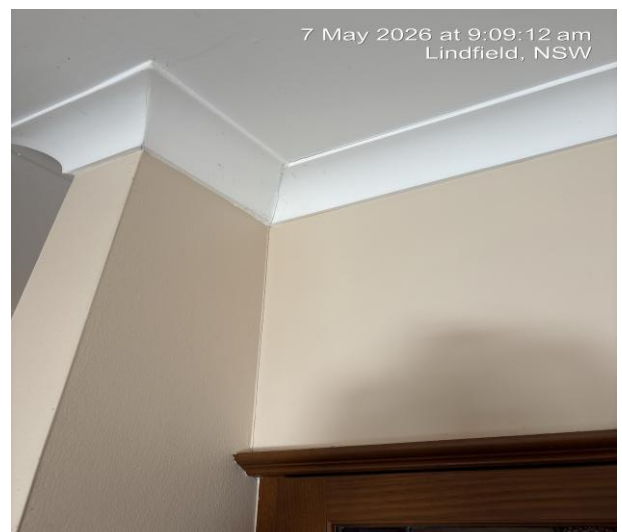
Photo 24 – Cracking observed to wall and coving

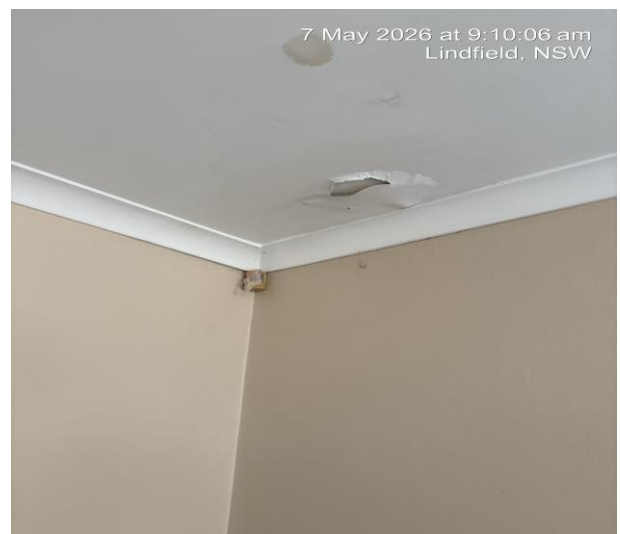
Photo 30 – Water damage observed to ceiling

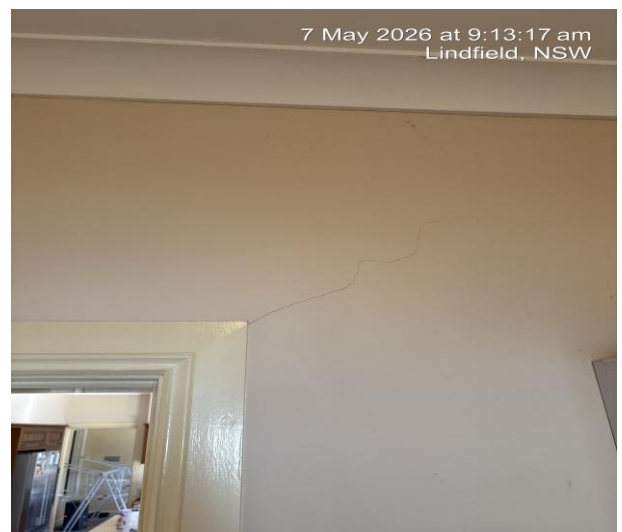
Photo 42 – Cracking observed to wall

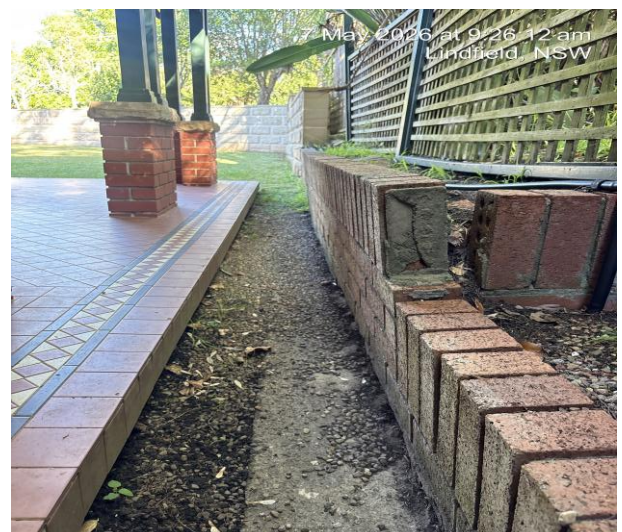
Photo 90 – Cracking and bowing observed to brick wall

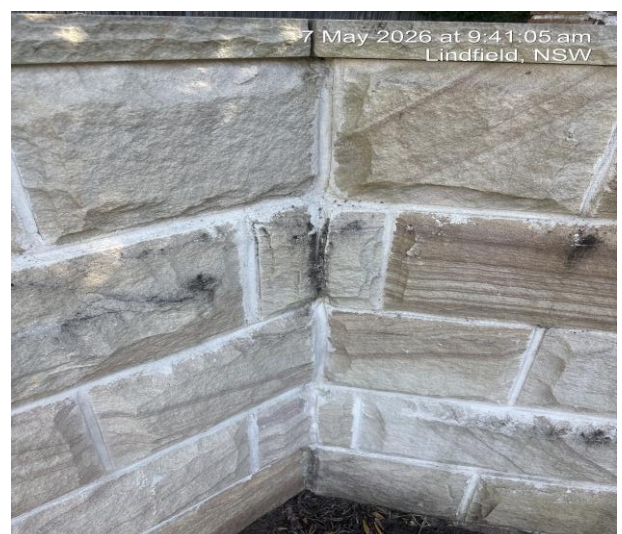
Photo 96 – Cracking observed to mortar
