Robert
Bird
Group

Adaptive Re-Use
45-53 Macleay St, Potts Point

29 September 2021

Document No.: 27199T-RBG-ZZ-XX-RP-ST-00001

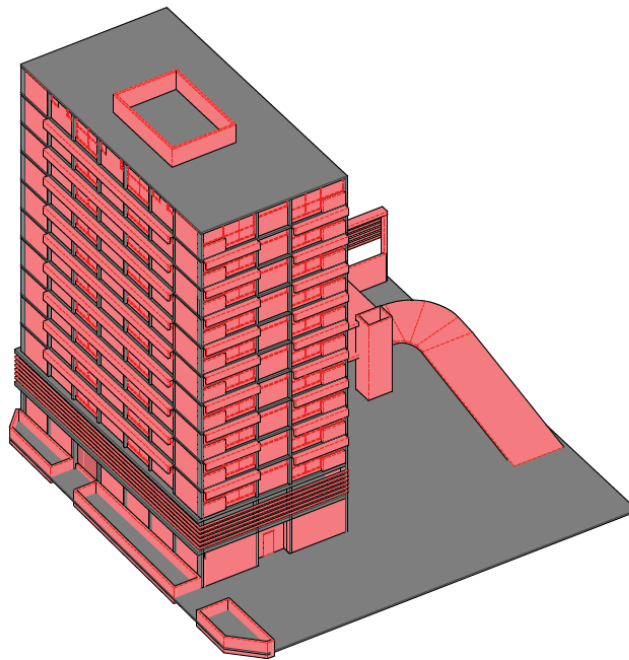
Figure 2

Extensive demolition required

Existing façade to be removed to accommodate new openings and bring external skin up to code meeting current regulations including waterproofing, thermal & ESD requirements (BASIX) as well as cladding standards.

A significant amount of the façade volume is non-load bearing precast, namely the brick elements. This removal is relatively straight forward. However, it is the removal of the wall elements which appear to be load bearing, as well as the integral façade feature, which will likely result in removal of primary structural which will not be able to be accommodated without significant additional structure being added. Furthermore, this isolated demolition risks local damage to the primary which will be required for structural integrity of the building.

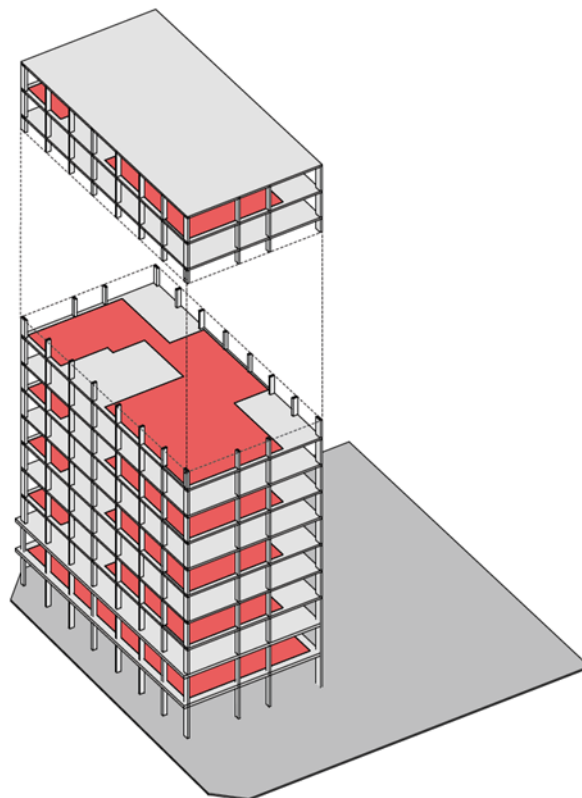
Figure 4

Slab removal to provide ADG compliance in living areas

Review of these requirements results in extensive floor slab removal whereby triggers the following affects to the existing structure;

- **Double Height Vertical Elements** – Slab removal in these zones results in the attached vertical elements now being ‘double height’. This is a condition which the existing structure is not designed or detailed. Most of these elements (likely all) will not have the structural capacity to accommodate this condition.

This is especially critical for the walls, which are assumed to be providing the lateral resisting elements for this building. New walls would need to be constructed throughout the full building height, and this is likely to result in more demolition and removal of floor slabs. This condition would result in nearly all of slab on every second level to be removed.

- **Removal of Floor diaphragm** – The floor diaphragm is what is used to transfer the lateral loads from the relevant level into the lateral resisting frame of the building. Significant removal of this diaphragm on every second levels means that the lateral load will be induced into elements at higher loads which was not considered by the original design.

Very significant local strengthening works would be required to accommodate this upgrade to structure. However, it is likely that additional lateral resisting elements would be required to be introduced throughout the building footprint.

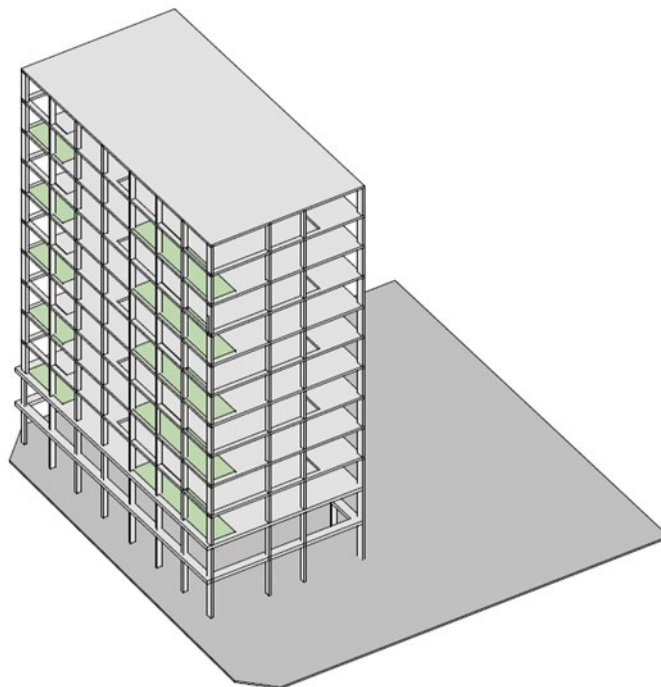
Figure 5

Balconies

Removal of the existing structure in those locations can occur, but this would require local demolition and extensive temporary works. When considering the extent of demolition that would be required by the other ADG requirements, much of the floor plate disappears and the issues of double height elements is further compounded.

To achieve a set down in the balconies, a topping slab of 50mm could be applied across the entire remaining floor plates i.e. non-set down locations. This would result in additional loading to the structure of approximately 1.25kPa. Typically, apartments are designed for a total finishes allowance of 1.0 – 1.5kpa, thus including the topping would exceed the expected design allowance for this building. Additionally, this would increase the seismic mass of the building at the floor locations, which the existing structure is not designed for.

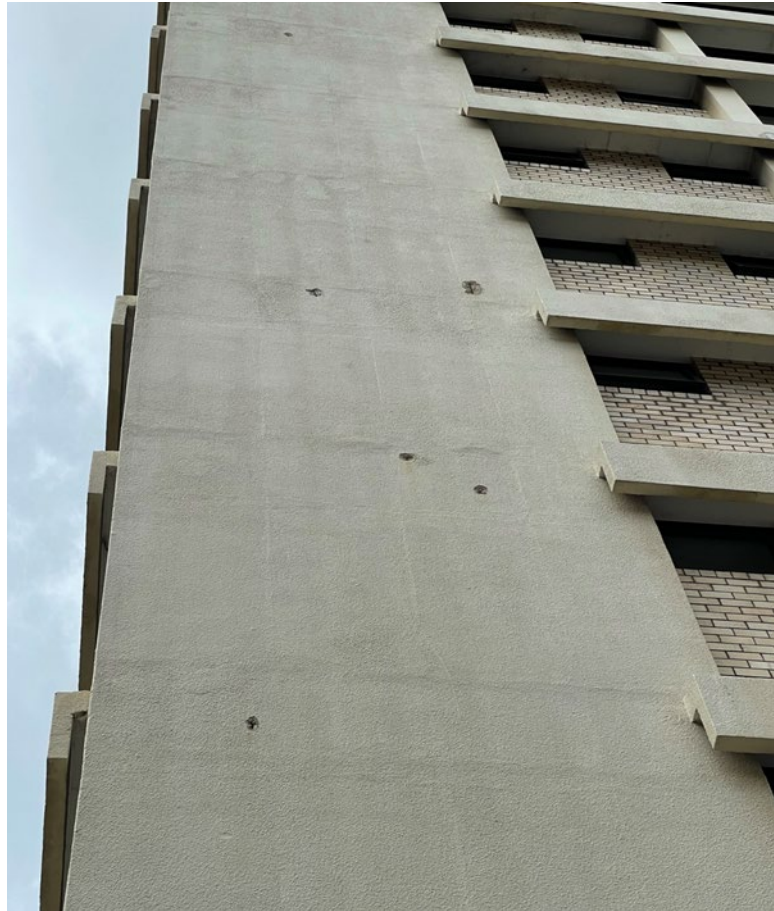
- Quality of construction materials, namely concrete placement and material is much poorer when compared to today's standards as required to meet 50-year design life.
- Reduced concrete cover which is the largest factor in reviewing a buildings ability to meet its durability requirement. The concrete cover in this building is highly likely to be insufficient to meet 50 year design life in this location (proximately to the coast), let alone exceed it by another 50 + years. This is further explained in section 4.3 of this report.
- Construction detailing – many of the details evident on the façade of this building are typical of similar age buildings in Sydney. The detailing of the façade / primary structure interface means that some locations trap water and thus increase the rate of corrosion.

Figure 6 - Spalling of concrete on wall elevation due to corrosion and 'concrete cancer'. Likely to be caused by reinforcement with insufficient cover and building exceeding its design life. Poses a very significant safety risk due to concrete pieces falling without notice to ground.

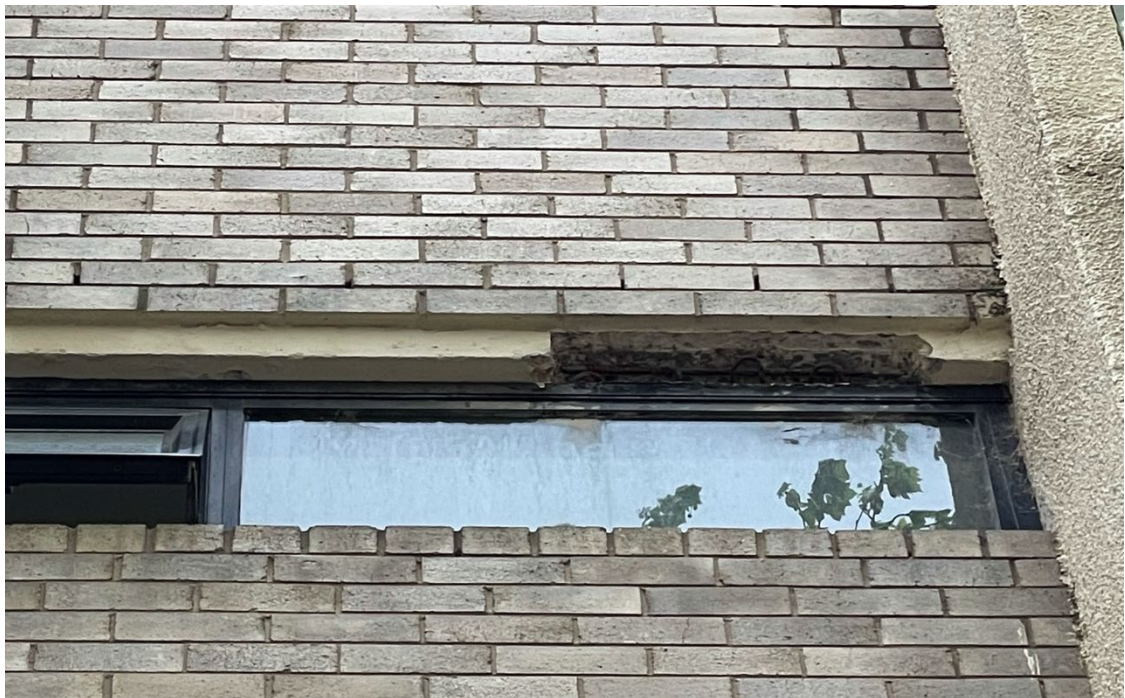
Figure 7 - Spalling concrete at façade / primary structure interface. Primary structure is supporting brick façade. Poses a very significant safety risk due to concrete pieces falling without notice to ground.

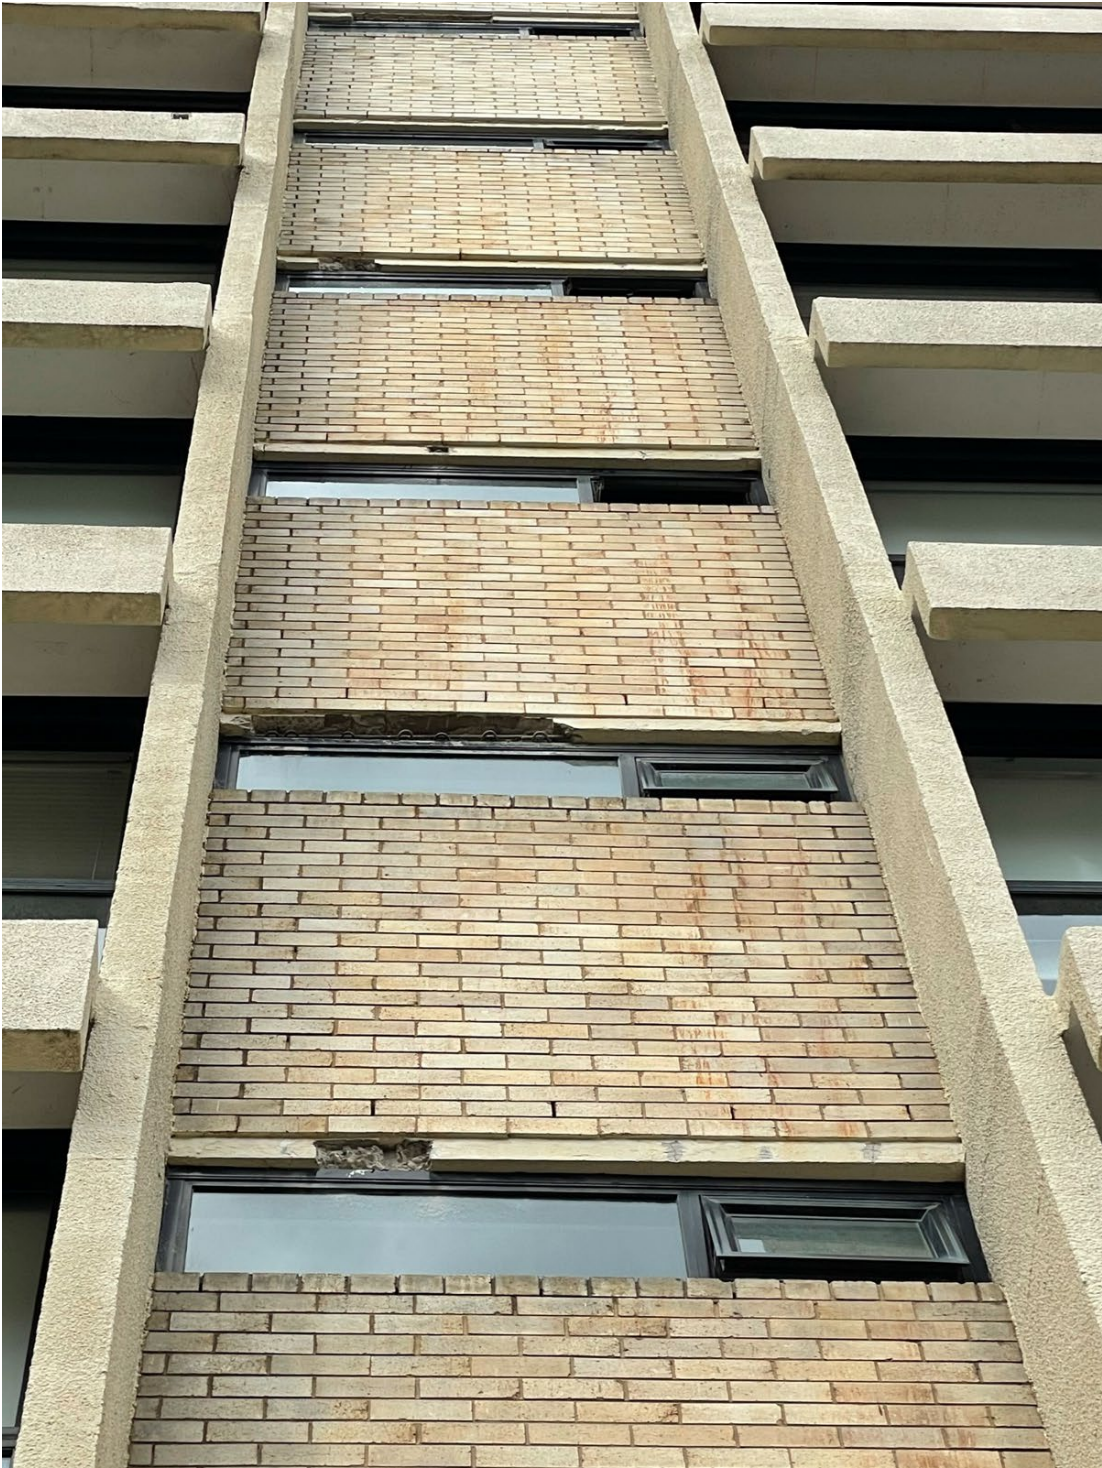
Figure 8 - Elevation shot showing extent of building damage. In this location all but one floor has been affected by concrete cancer (or evidence of it).

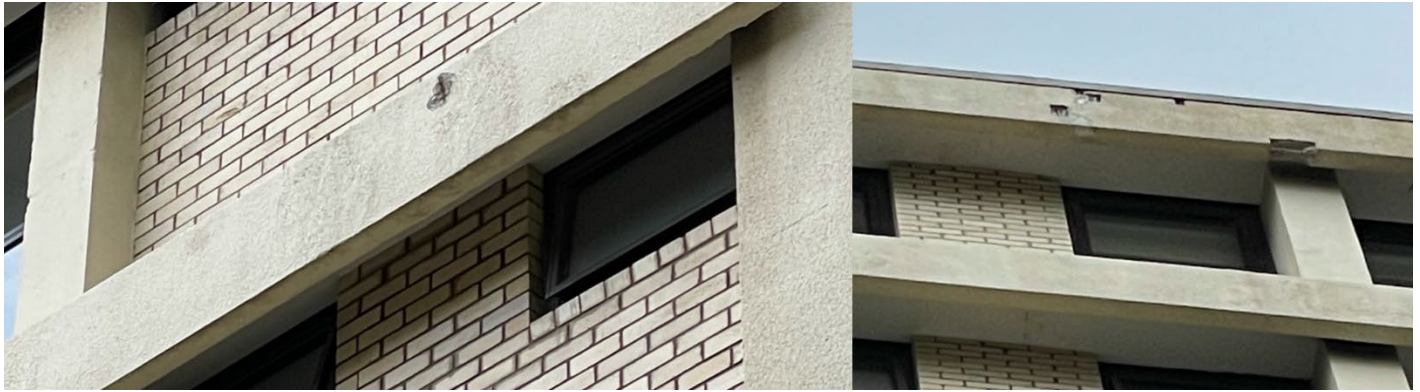
Figure 9 - Additional locations of spalling of external concrete façade elements. Poses a very significant safety risk due to concrete pieces falling without notice to ground

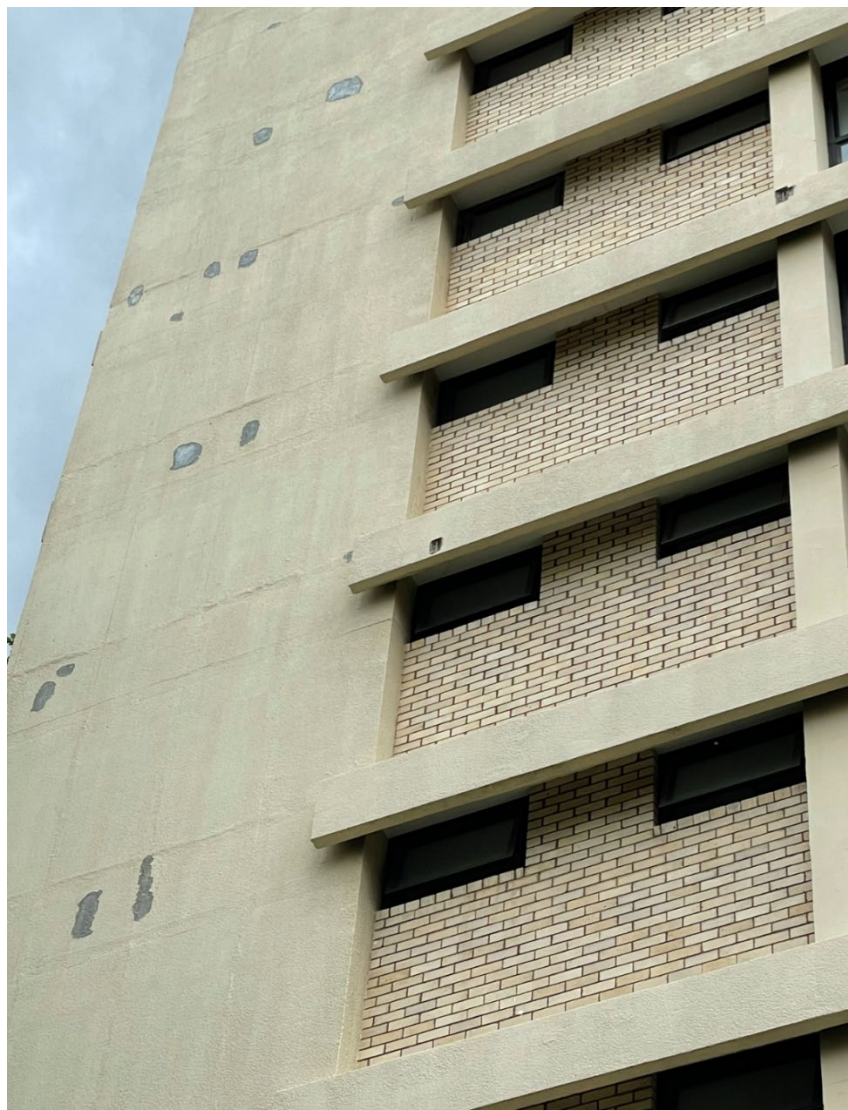
Figure 10 - Elevation of façade showing previous repair of concrete elements. If this building was to remain, it would require constant repair and maintenance of the external building fabric. This maintenance would not stop safety concern, but rather be required for the building to remain serviceable. This repair would require concrete and steel removal and reinstatement. These works would likely require scaffolding to be erected around the perimeter for long periods and cause significant disruption to the residents and public.

It must be noted that these repairs may assist to ensure the building is serviceable, but it is likely that this could be carried out for 15-20 years (as an expected maximum), before the building would not be able to remain.
