# Hazardous Materials Survey

Mixed Use Development

461 Chapel Road, Bankstown NSW 2200

**Project No. 24334**  
Version 1

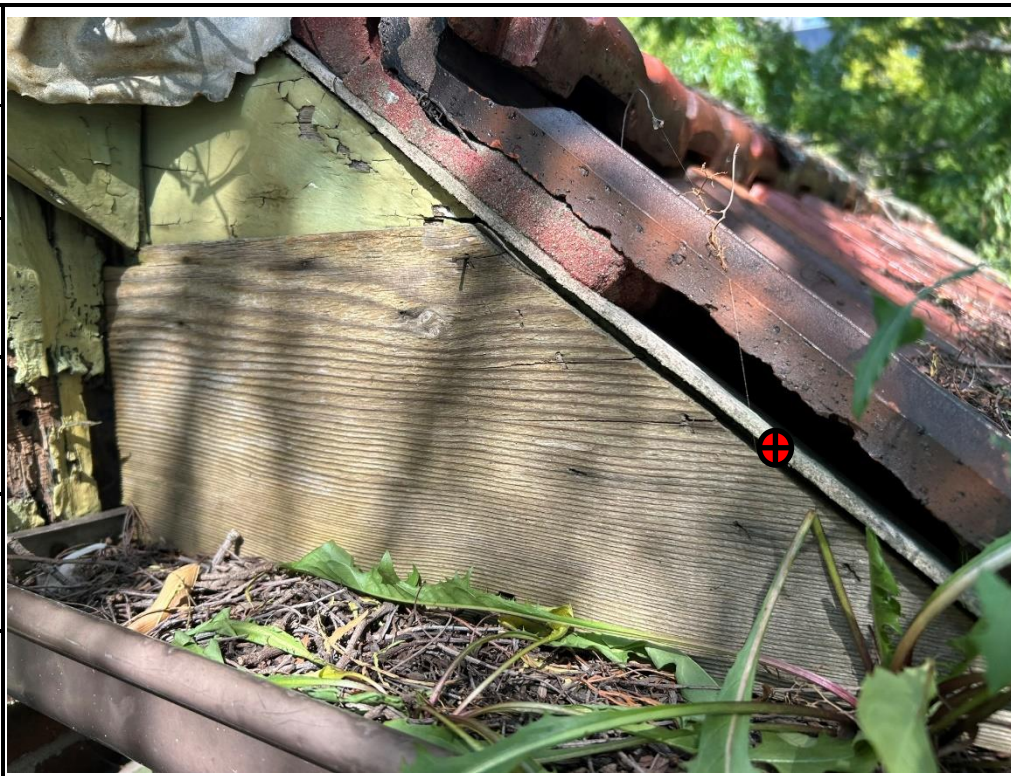
Photo No. 35	Date 6 February 25
Direction Facing West	
Location Gable verge board, northern facade roof.	
Material Pink fibre cement sheeting.	
Sample ID PACM3	
Result Contains asbestos (chrysotile).

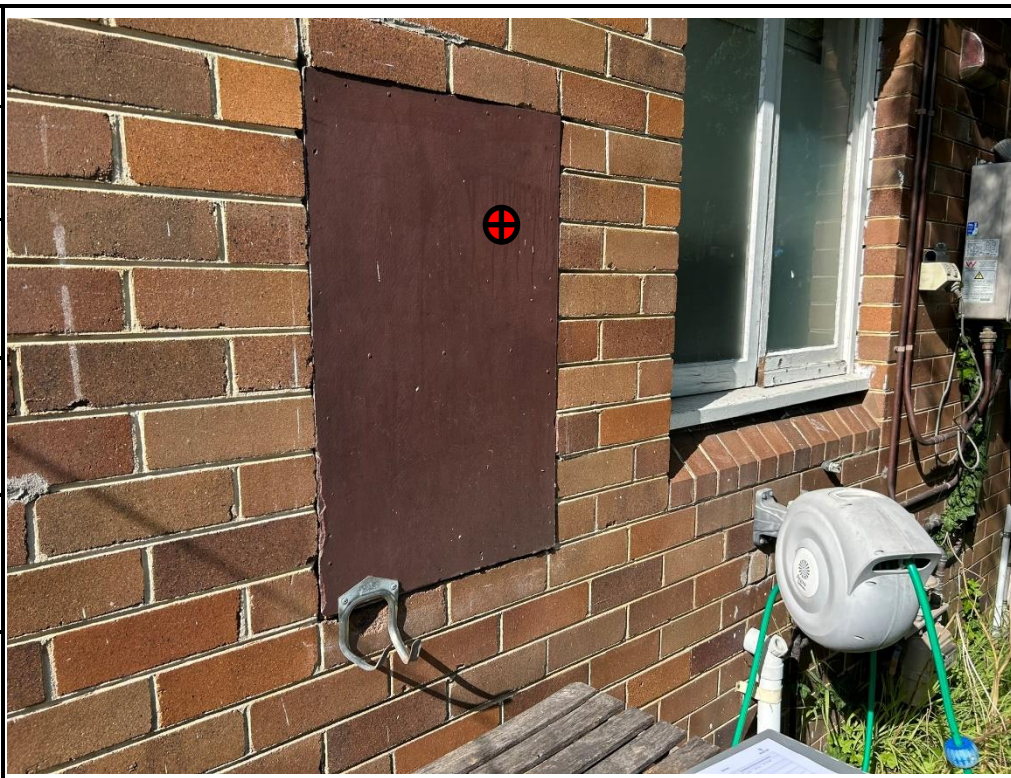
Photo No. 36	Date 6 February 25
Direction Facing Southwest	
Location Wall covering, northern façade.	
Material Beige fibre cement sheeting.	
Sample ID PACM4	
Result Contains asbestos (chrysotile).
