## **HAZARDOUS MATERIALS REPORT AFRICAN SAVANNAH & CONGO EXHIBITS MOSMAN TARONGA ZOO**

12 October 2016

Ref: Taronga-161007-Savannah & Congo

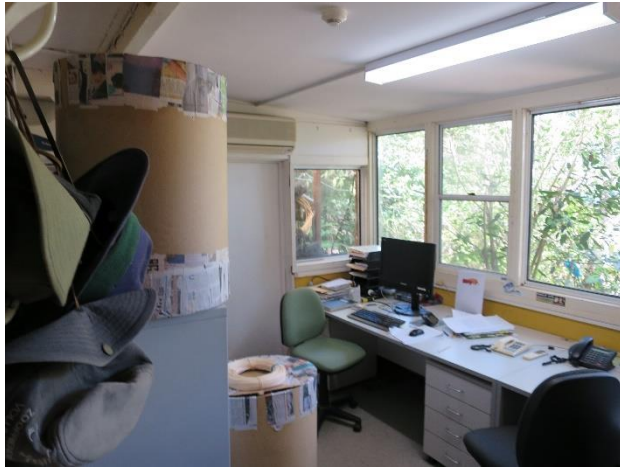
Turner House – Contains ACM walls, ceilings and eaves. All of the ACM in the building is non friable and currently in good condition.

**Photo 1** Turner House front office – AC walls and ceiling

A Safework NSW licensed asbestos removalist will be used to remove the ACM from the buildings and an Asbestos Clearance Report issued prior to demolition works.

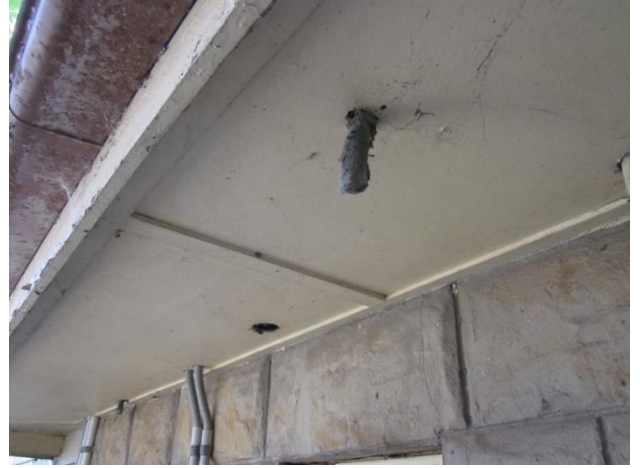
**Photo 2** Turner House – AC eaves

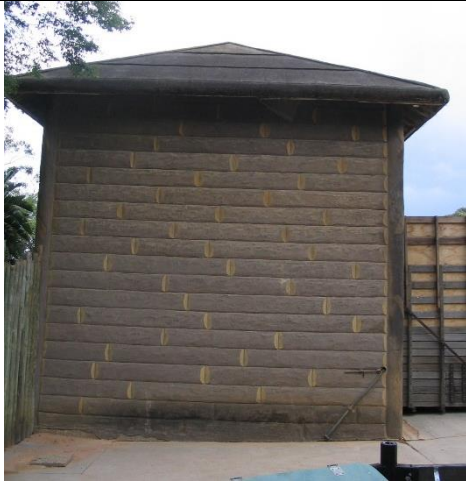
**Photo 3** Original Giraffe House

Giraffe House - Contains ACM in the form of a water proofing membrane on the roof.
