Report on  
Preliminary Geotechnical Investigation

African Safari, Taronga Zoological Park  
Bradleys Head Road, Mosman

Prepared for  
Taronga Conservation Society Australia

Project 85537.00  
August 2016

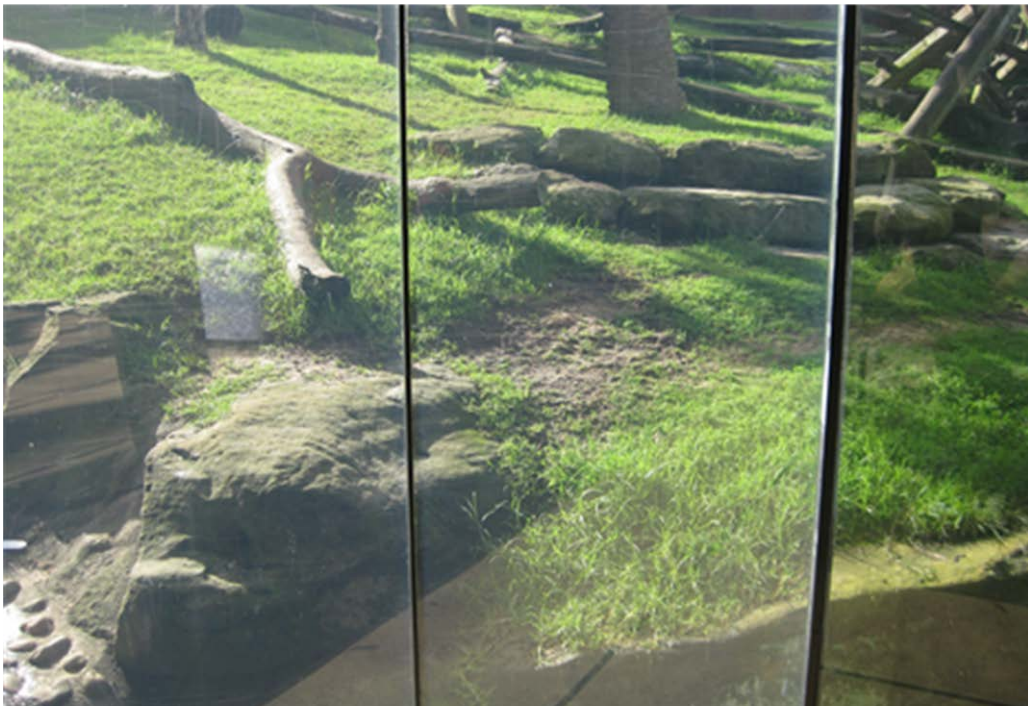
Photo 1 – Rock outcrop and landscaped rocks in Chimpanzee enclosure

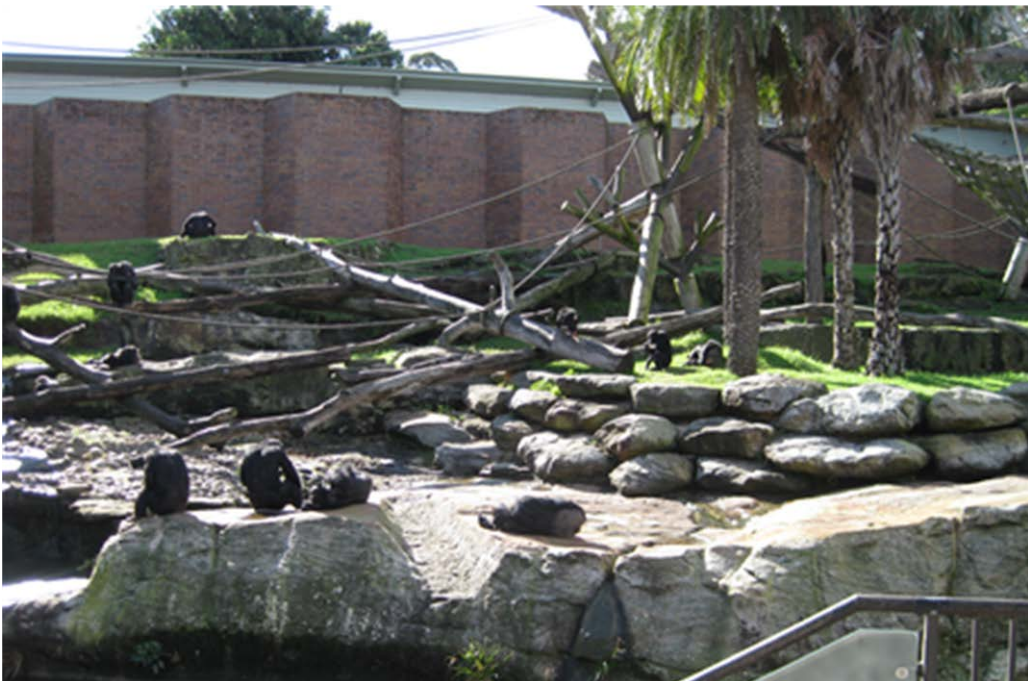
Photo 2 – Landscaping in Chimpanzee enclosure. Some rock exposure in the background

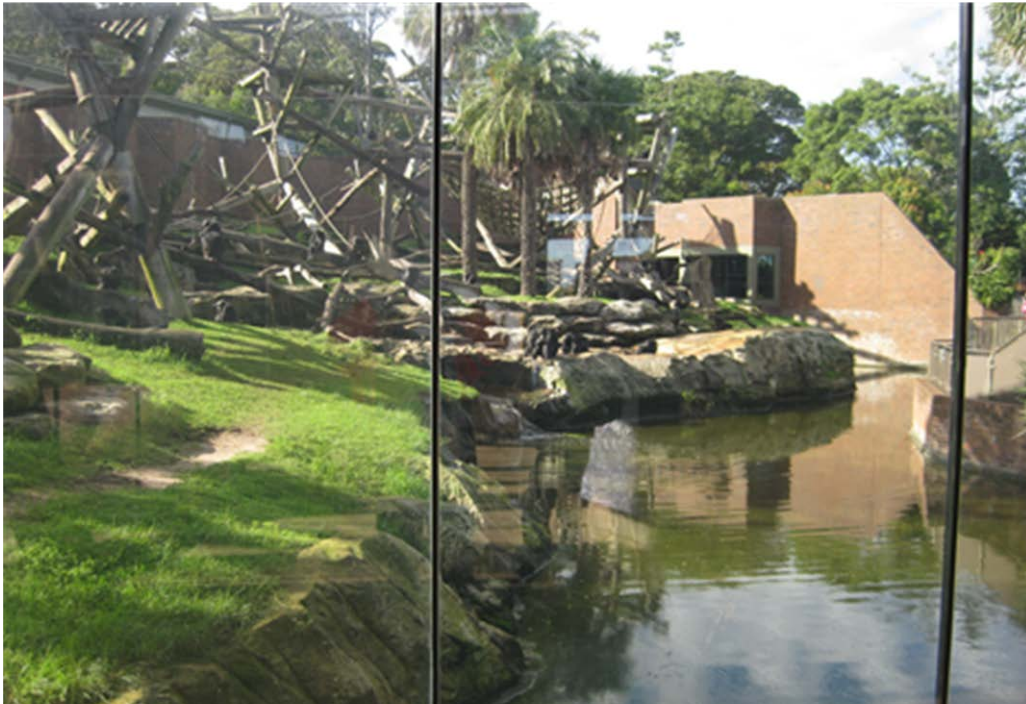
Photo 3 – Rock outcrop with gorges in Chimpanzee enclosure

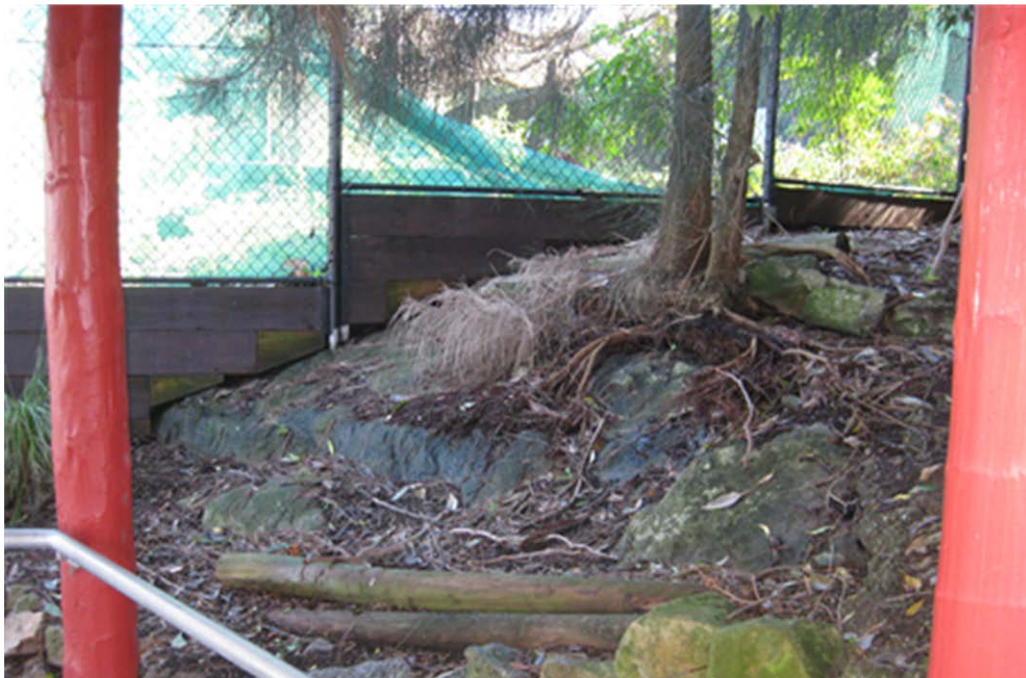
Photo 4 – Rock outcrop near African Safari Hut

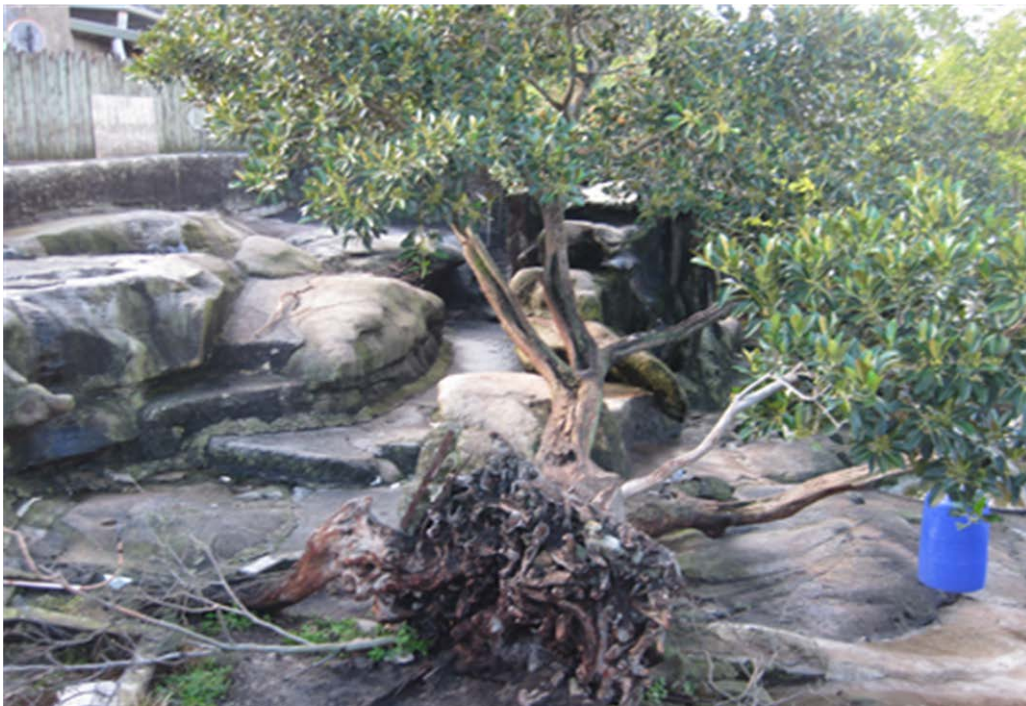
Photo 5 – Rock Outcrop in Barbary Sheep enclosure

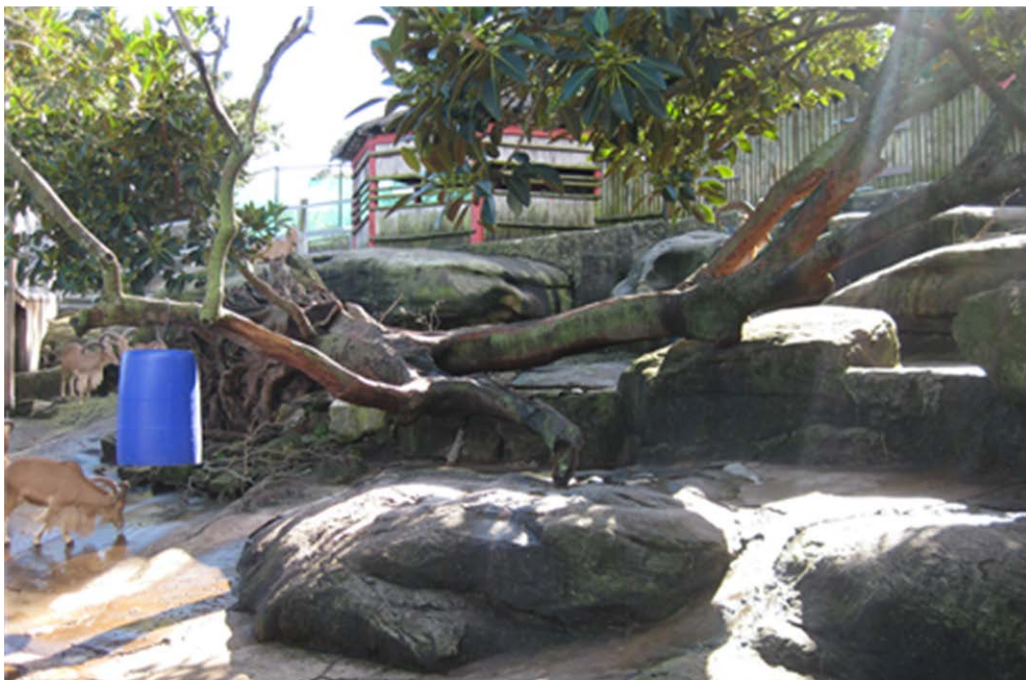
Photo 6 – Outcropping rock and concrete in Barbary Sheep enclosure

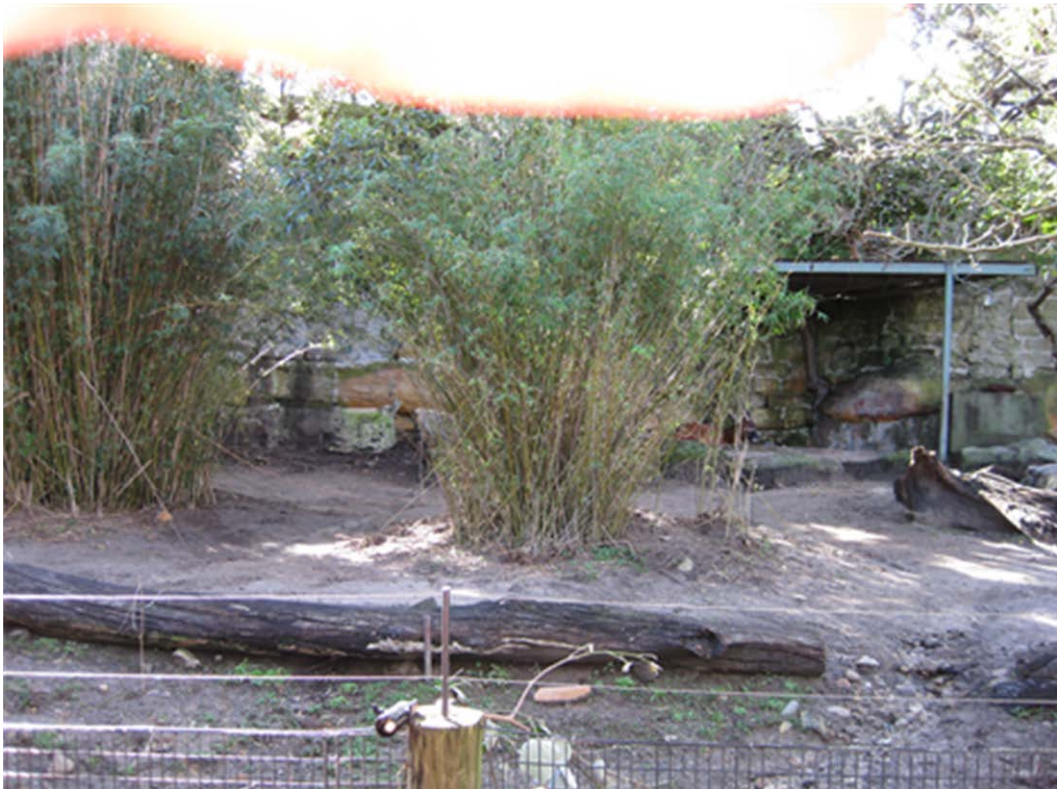
Photo 7 – Rock outcrop, block retaining wall, shotcrete in Bongo enclosure

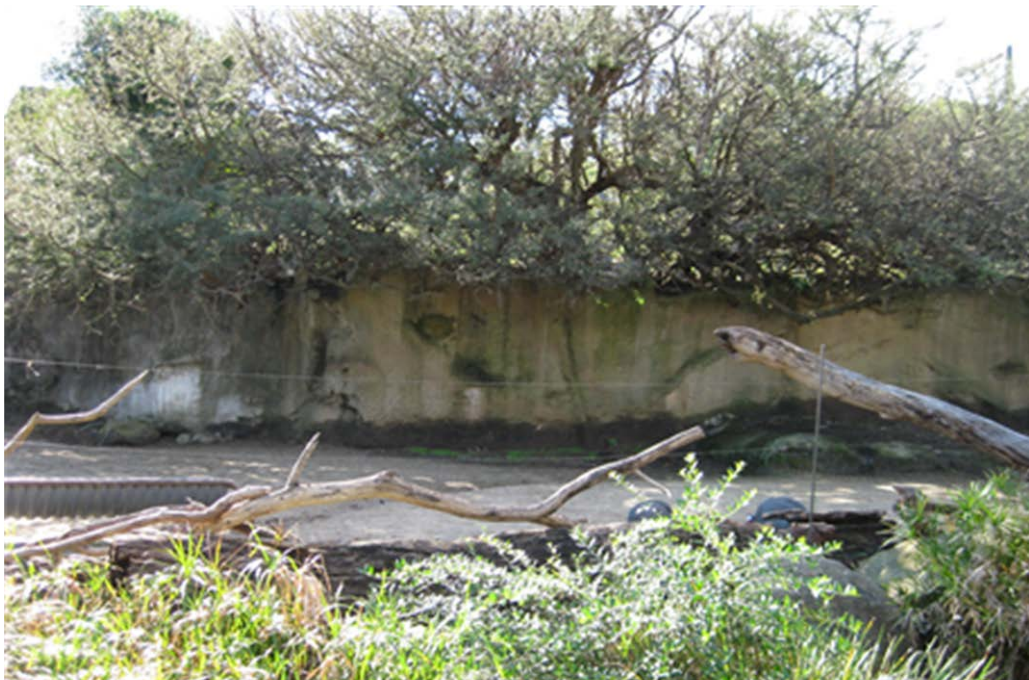
- H. Zebra Enclosure: The rear of enclosure is some exposed sandstone and shotcrete face forming a vertical wall. See Photo 8.
- I. (not used)
- J. Giraffe Enclosure: Medium to high strength sandstone observed in road side wall of enclosure. See Photo 9.

Photo 8 – Shotcrete and sandstone in Zebra enclosure

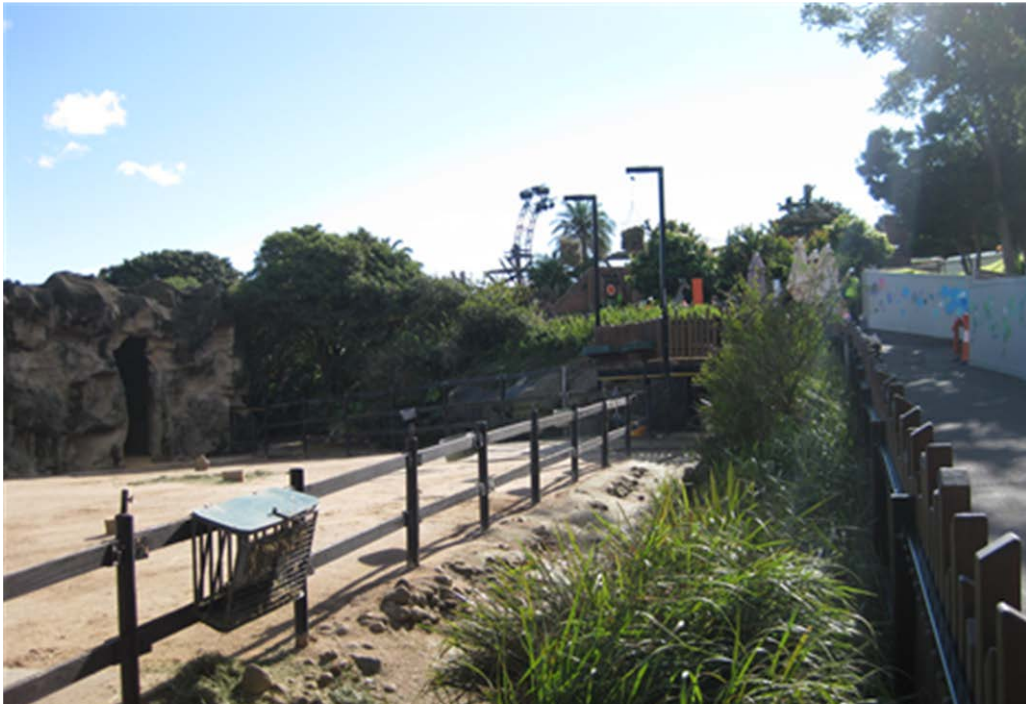
Photo 9 – Sandstone exposure in Giraffe enclosure

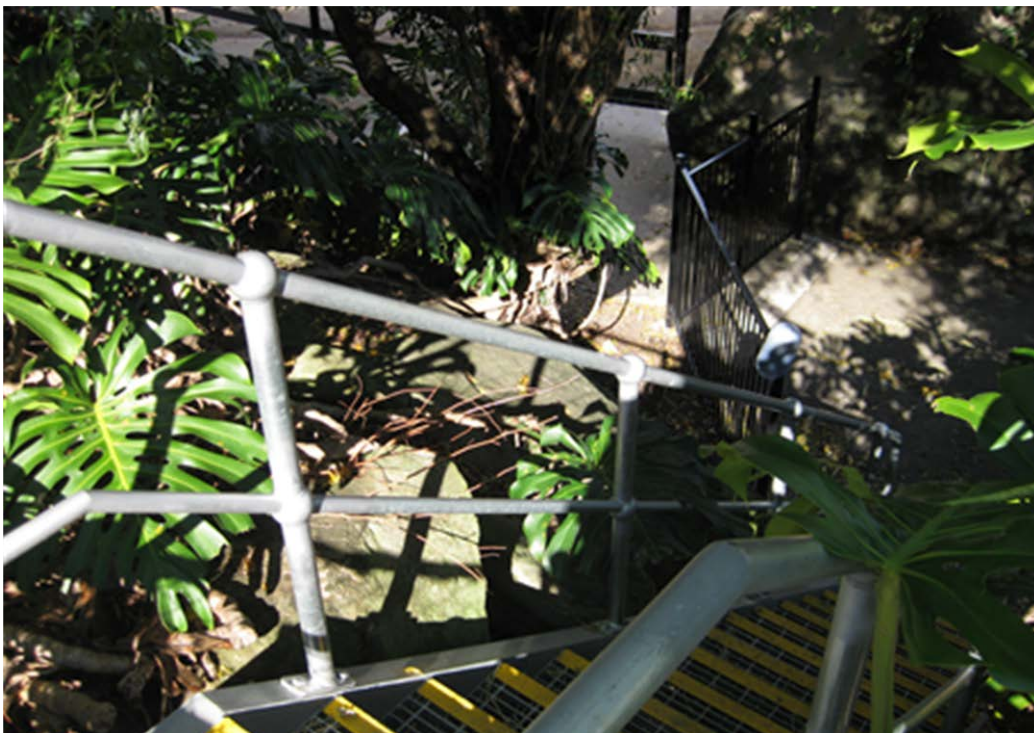
Photo 10 – Floater exposed near stairs

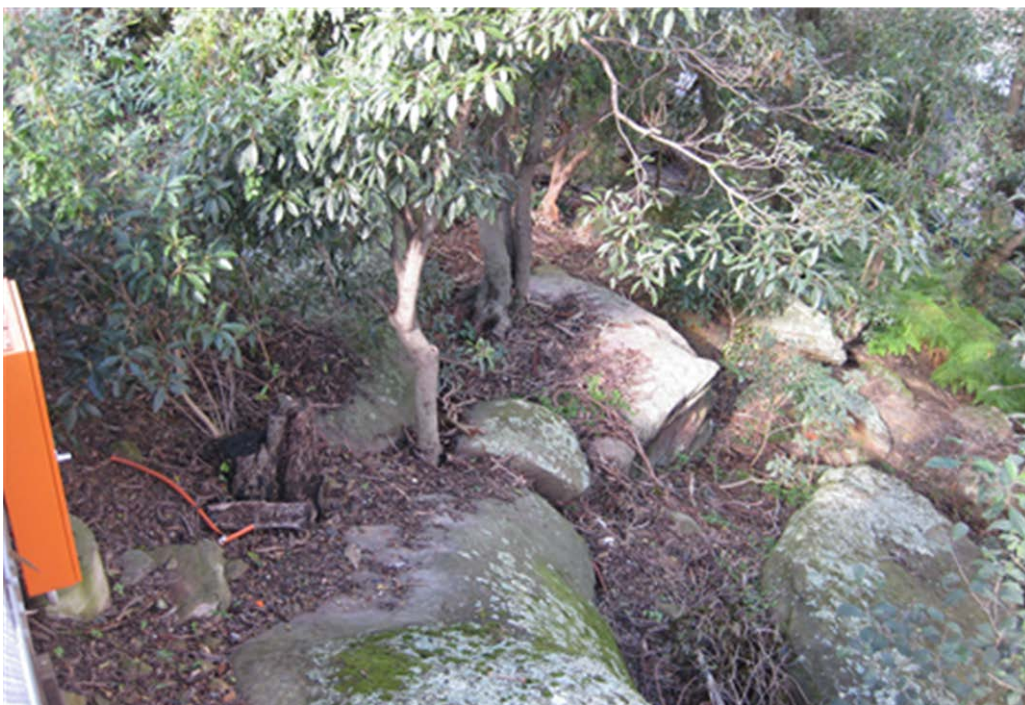
Photo 11 – Sandstone floaters

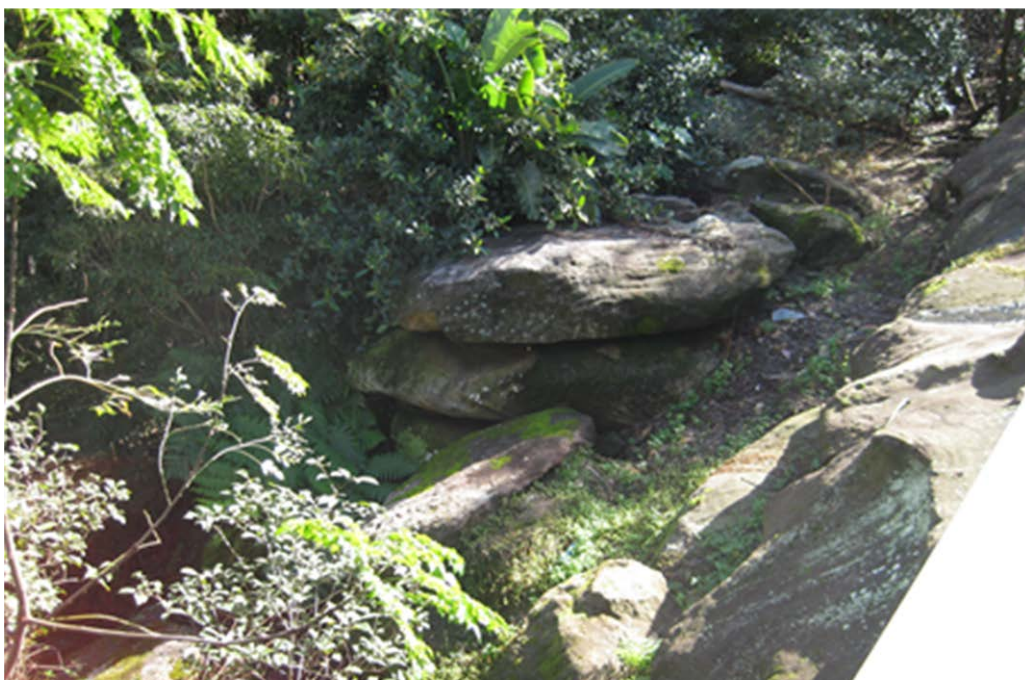
Photo 12 – Rock bedrock and floaters

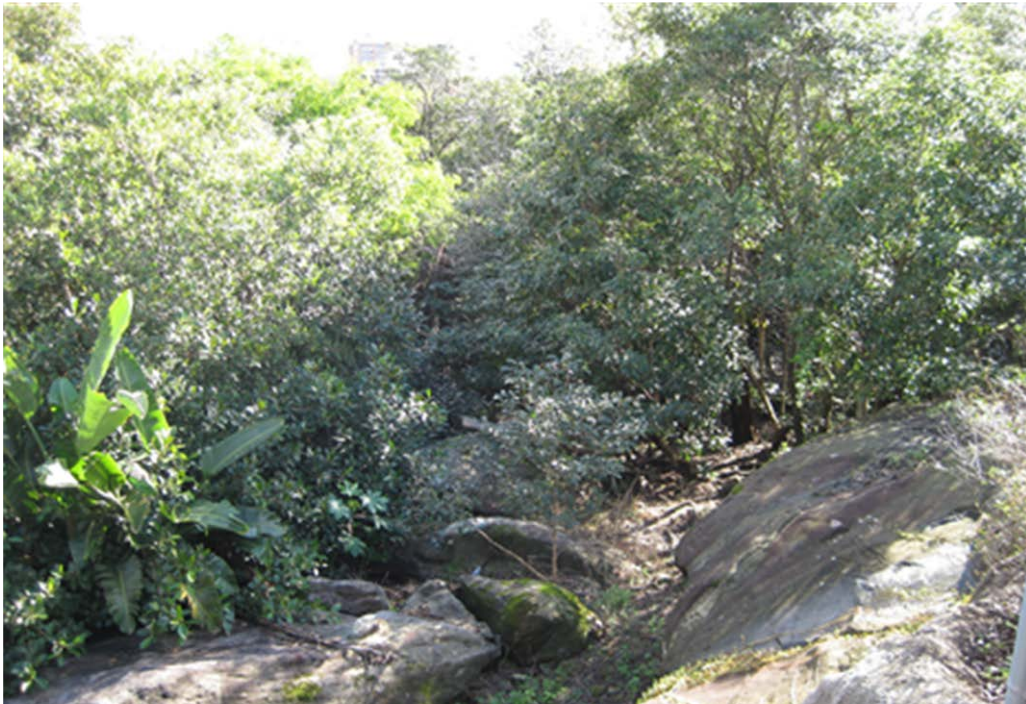
Photo 13 – Sandstone bedrock and floaters

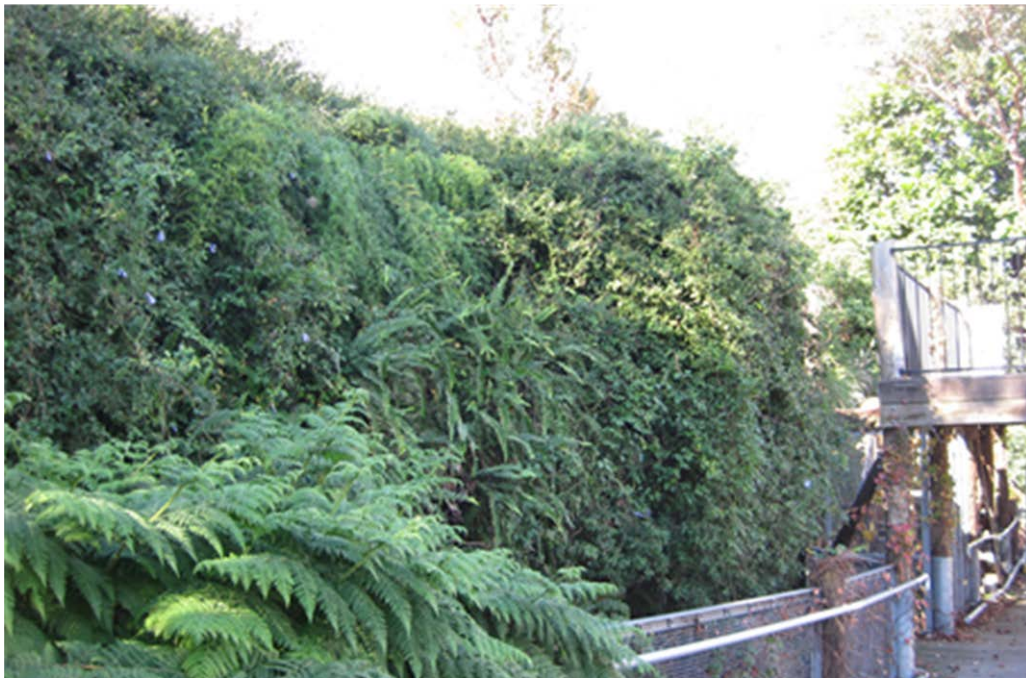
Photo 14 – Sandstone and possibly retaining wall cliff covered with vegetation

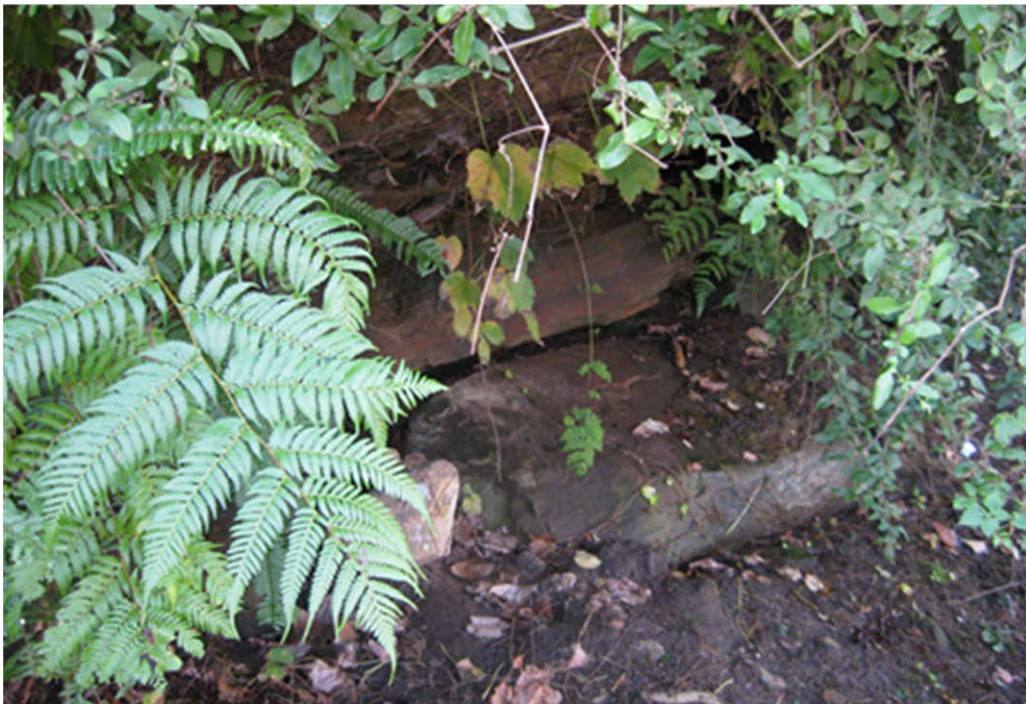
Photo 15 – Sandstone bedrock at base of wall covered with vegetation

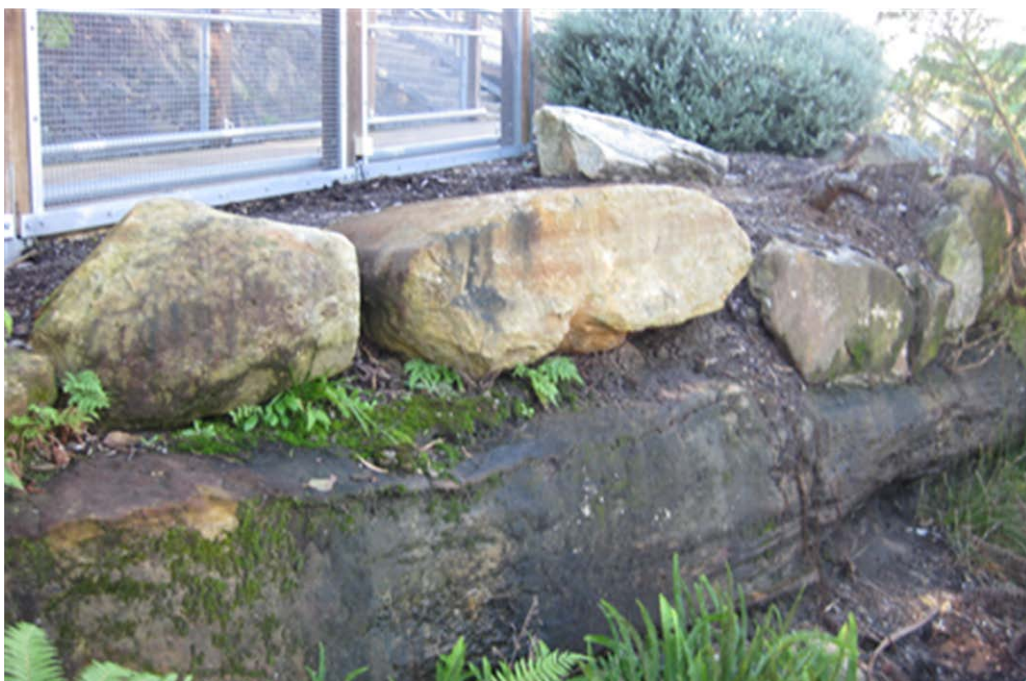
Photo 16 – Sandstone bedrock above path

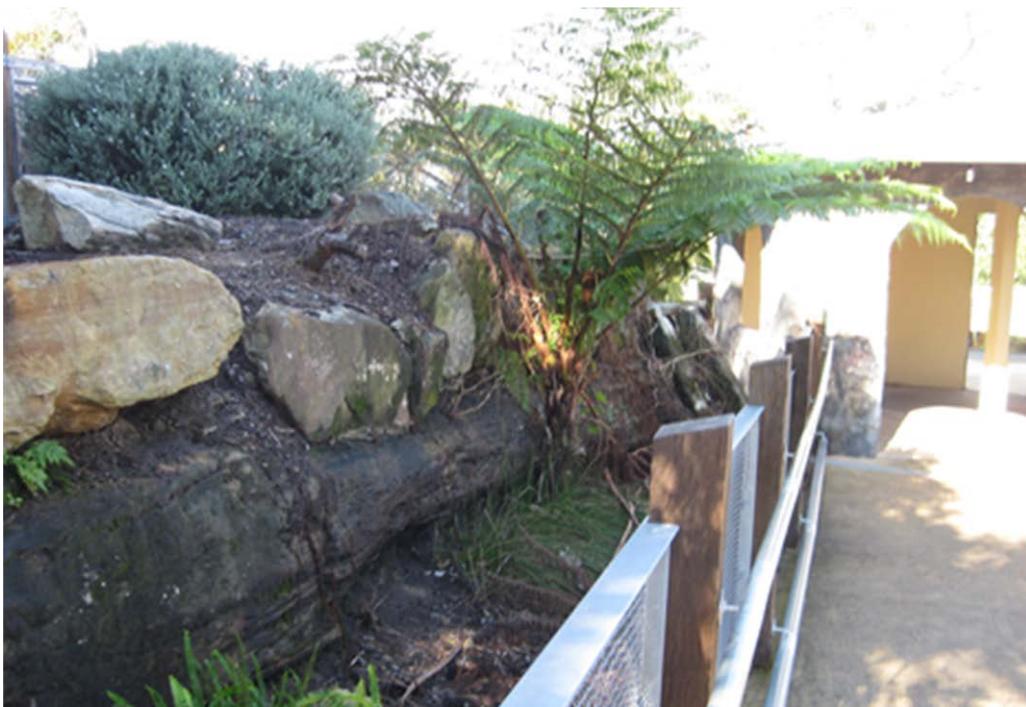
Photo 17 – Sandstone bedrock with boulders and soil on top adjacent to path

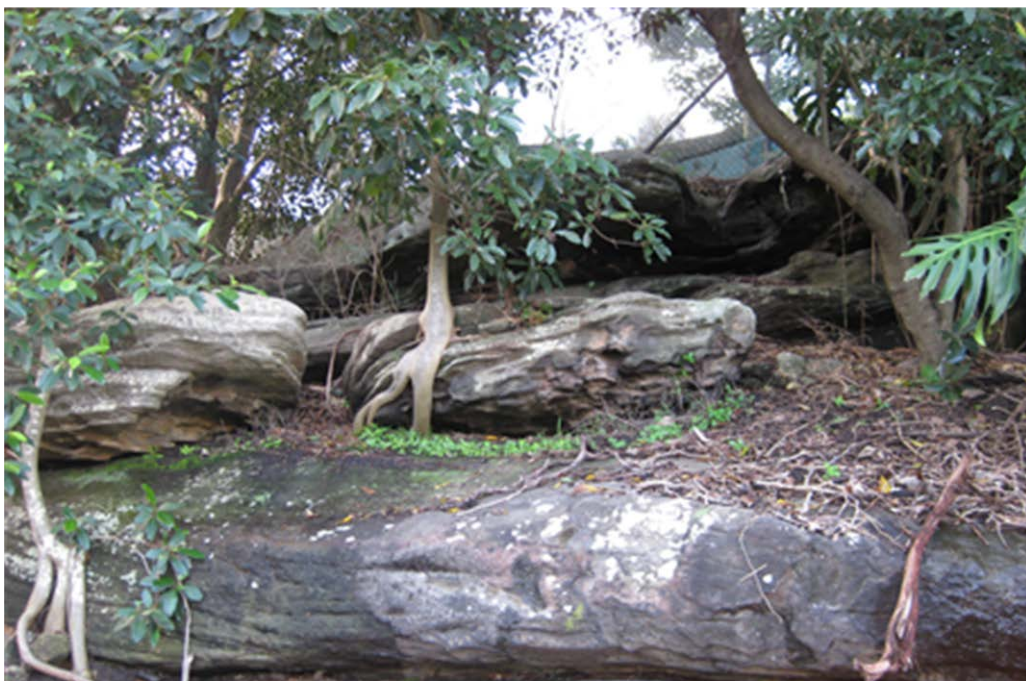
Photo 18 – Sandstone bedrock with floaters

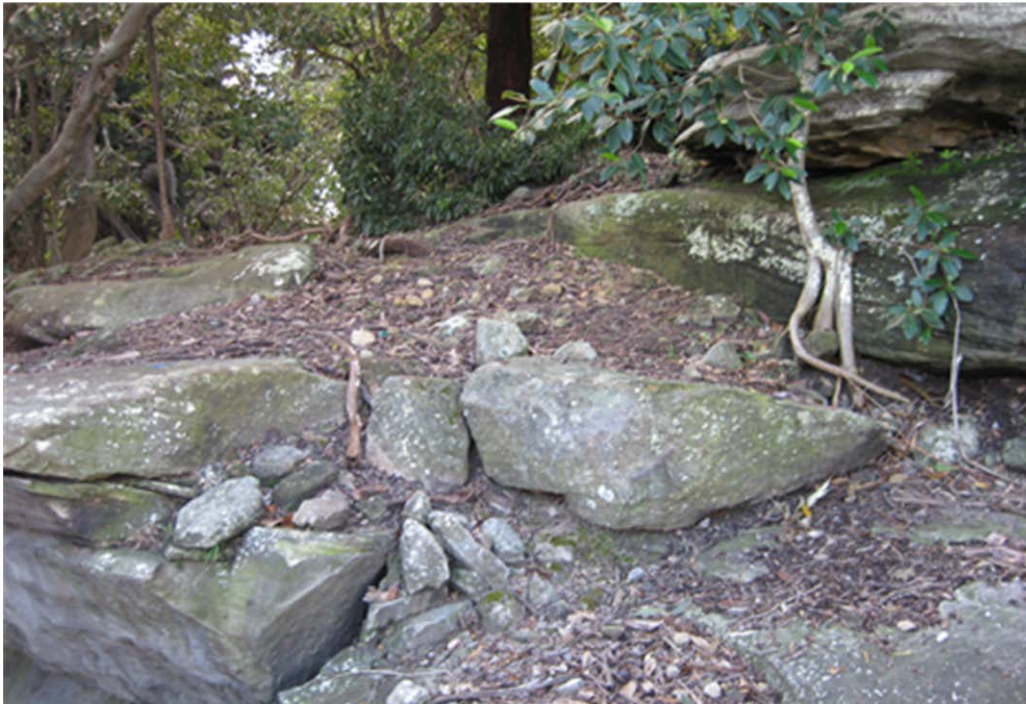
Photo 19 – Sandstone bedrock with floaters

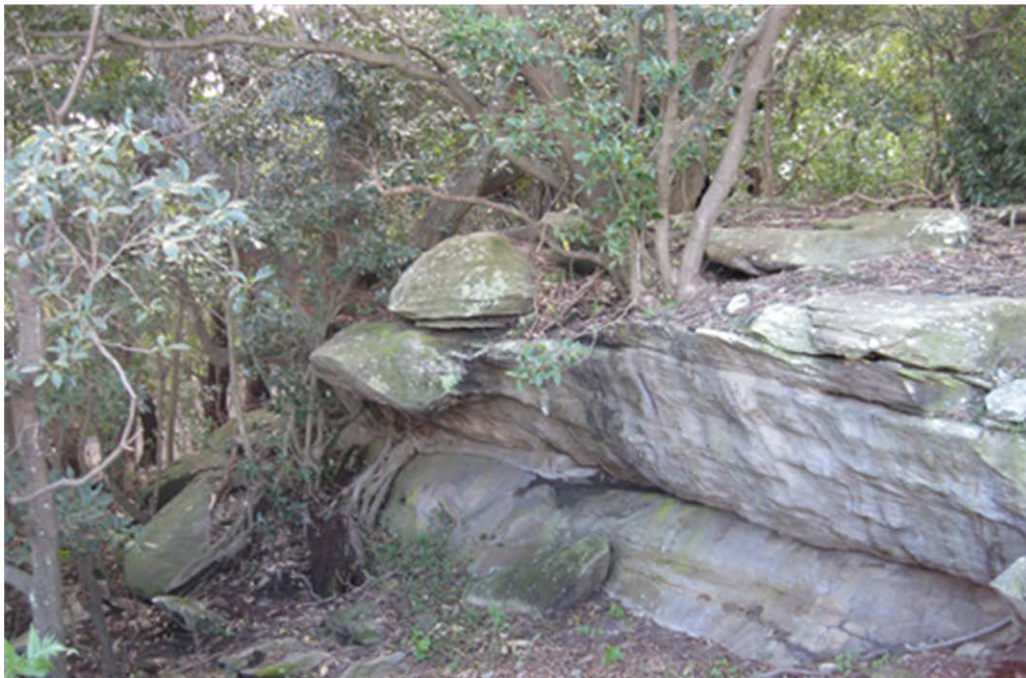
Photo 20 – Sandstone bedrock with floaters

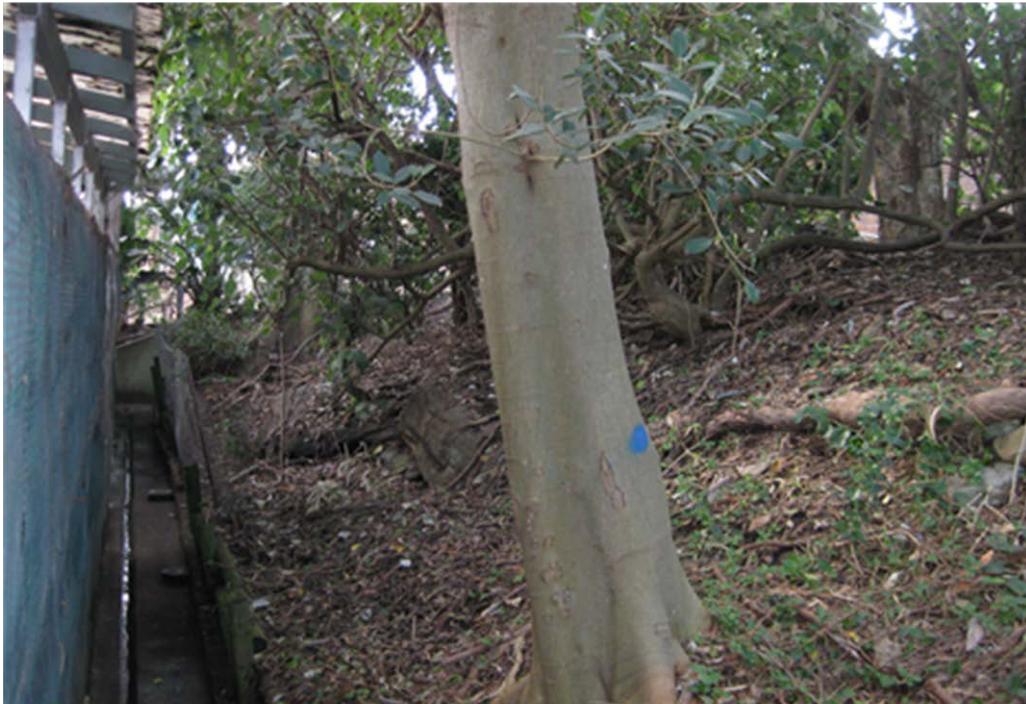
- Q. Next to Wildlife Hospital: There is a small retaining wall adjacent to the hospital supporting a slope with some outcropping rock. See Photo 21. Also appears to be some filling on the slope.

Photo 21 – Sandstone outcrop at back of Wildlife hospital

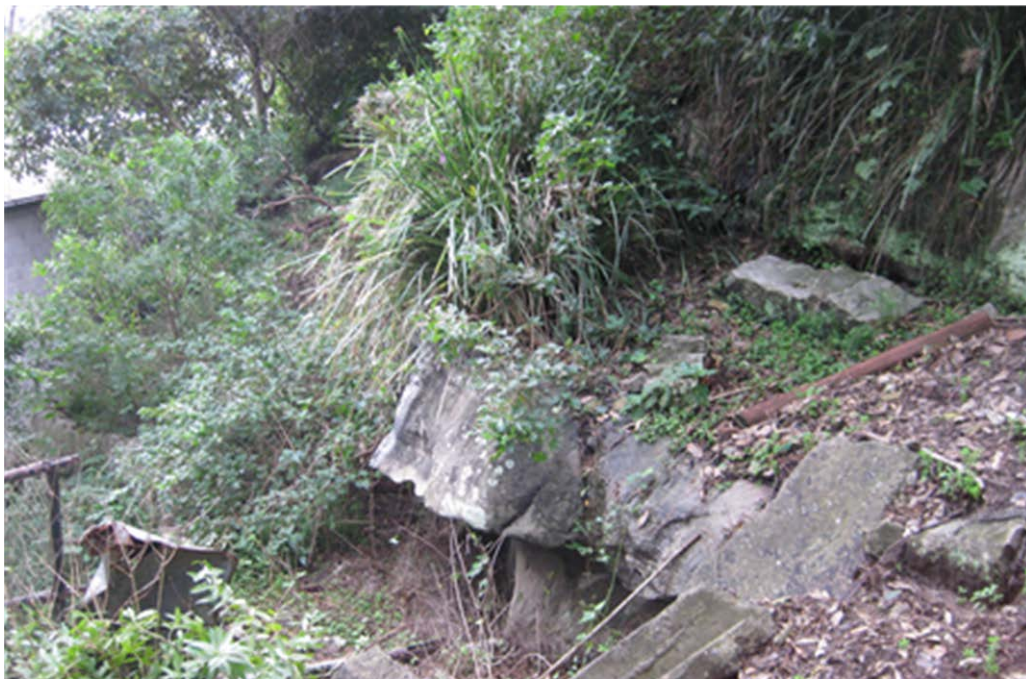
- R. Downslope of Rehabilitation Yards: This is a talus slope. There are outcrops of rock above and below road with road cut through sandstone. See Photos 22 to 26.

Photo 22 – Sandstone outcrop

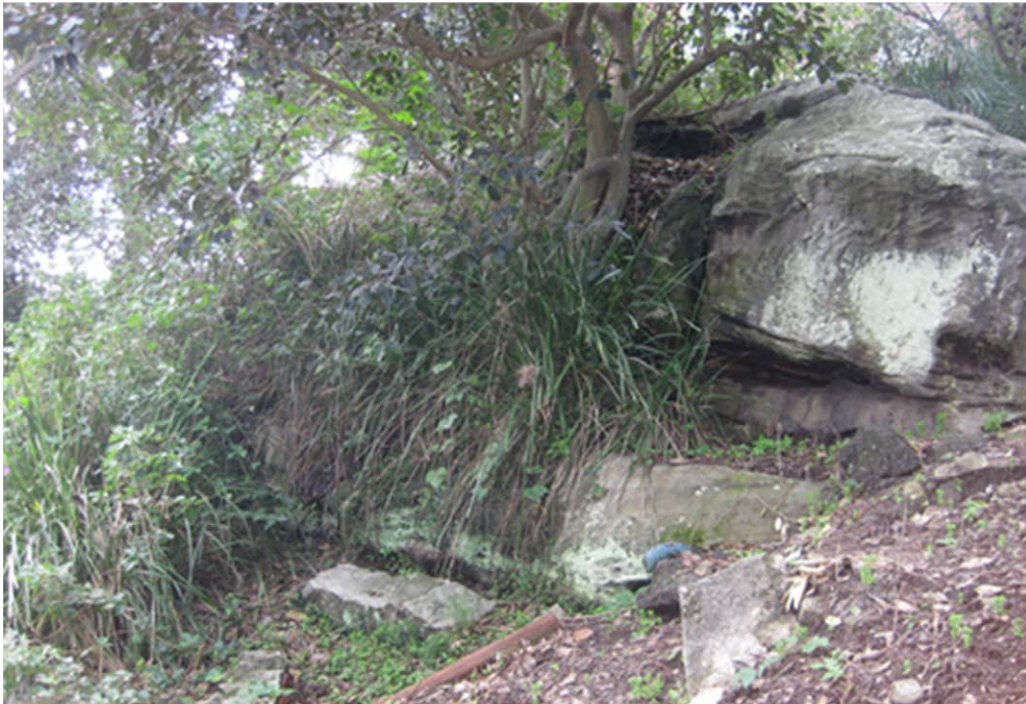
Photo 23 – Sandstone outcrop

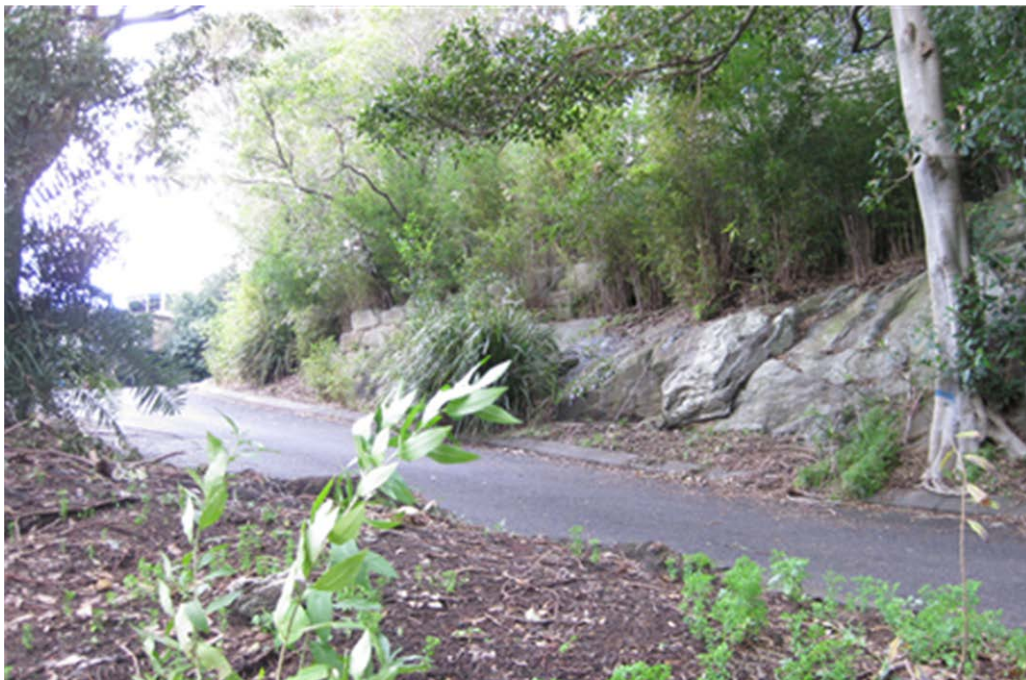
Photo 24 – Sandstone outcrop

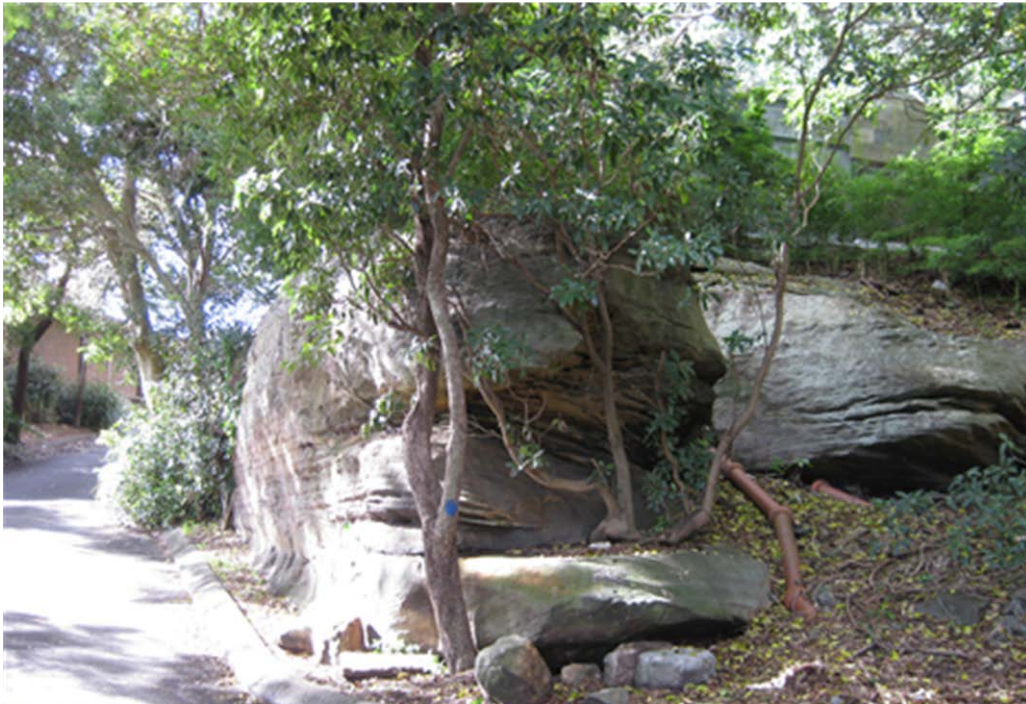
Photo 25 – Sandstone outcrop

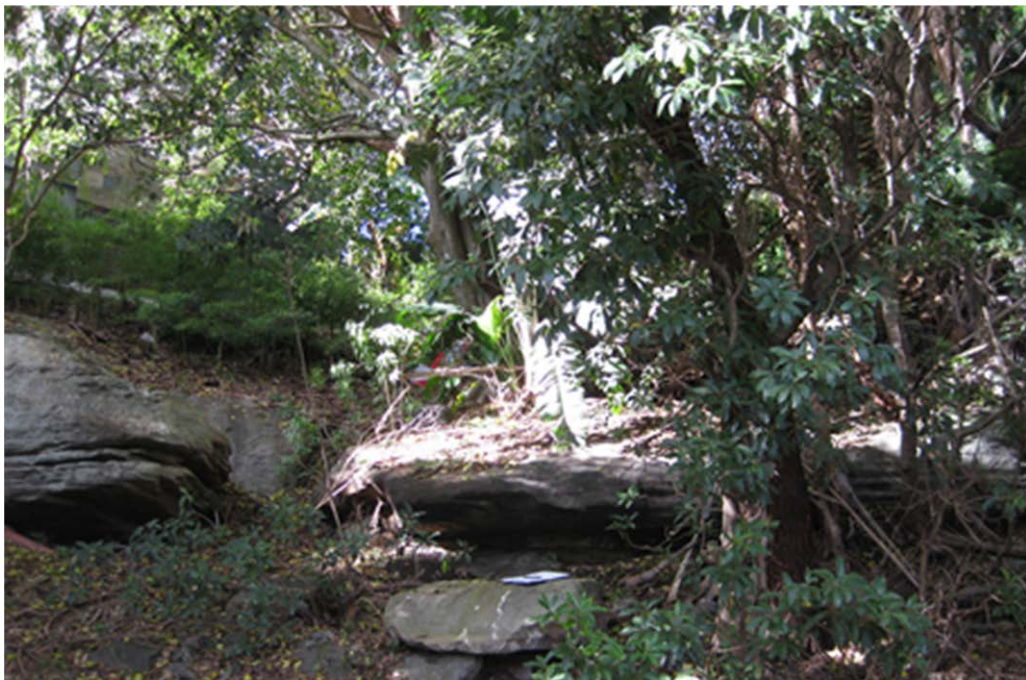
Photo 26 – Sandstone outcrop
