NSW EPA Audit Site Visit

Jeffman Danks Street South Precinct Stage 1 - Site Audit Report

Project name	Jeffman Audit				
Document title	Jeffman Danks Street South Precinct Stage 1 - Site Audit Report Site Audit Report No. SAR - 2128078				
Project number	2128078				
File name	2128078_REP_JEFFMAN_STAGE 1_SAR.docx				
Author	Reviewer		Approved for issue		
	Name	Signature	Name	Signature	Date
S Vaughan	A Kohlrusch

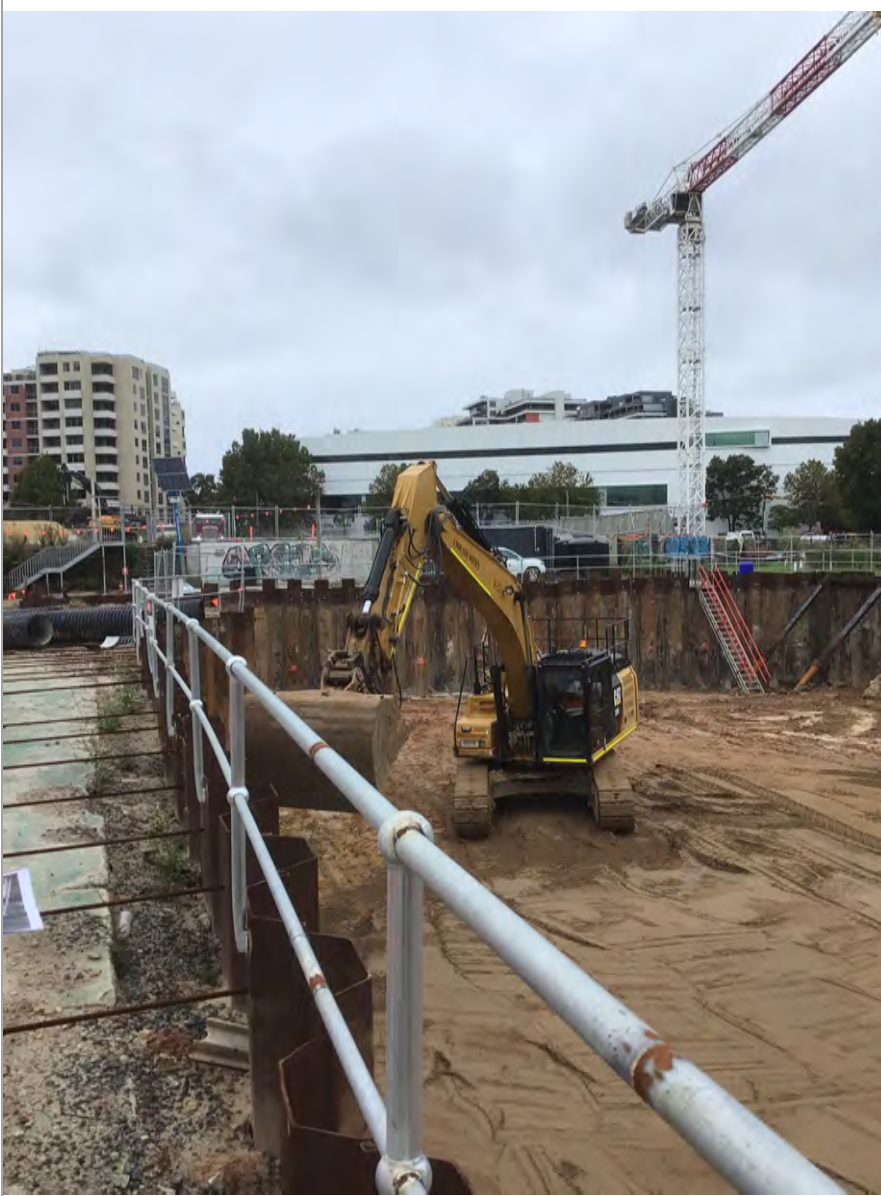
Photo 1: RA2 – placement and compaction of remediated Botany Sands

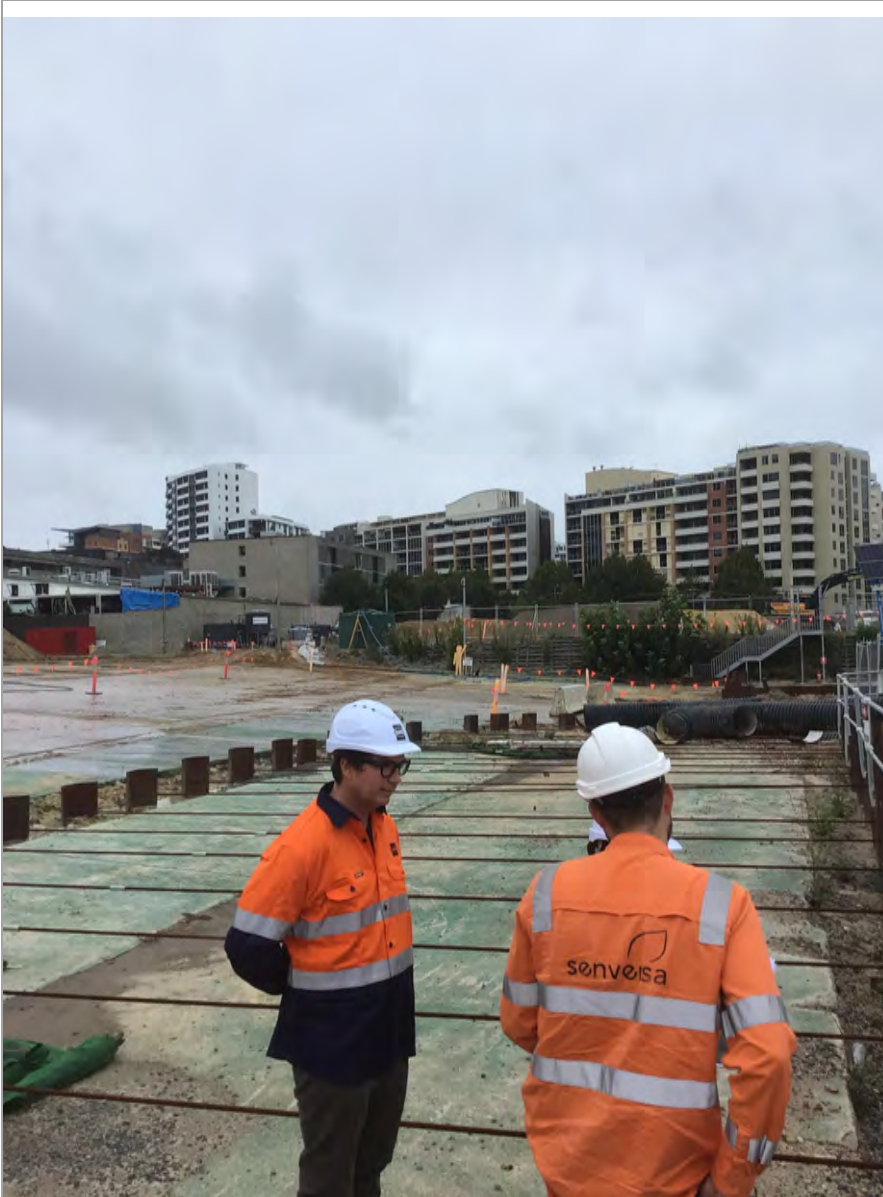
Photo 3: Sheet pile wall and anchors

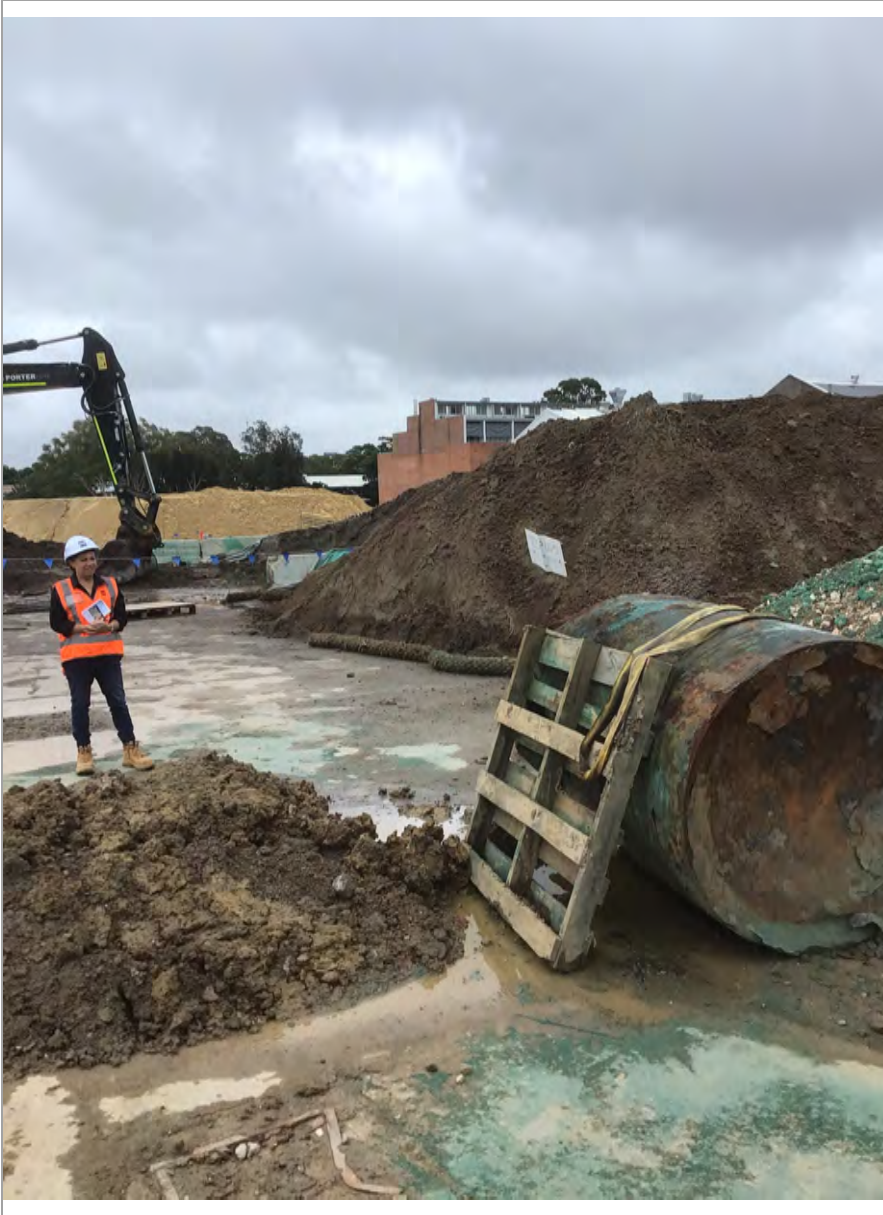
Photo 5: Recovered UST

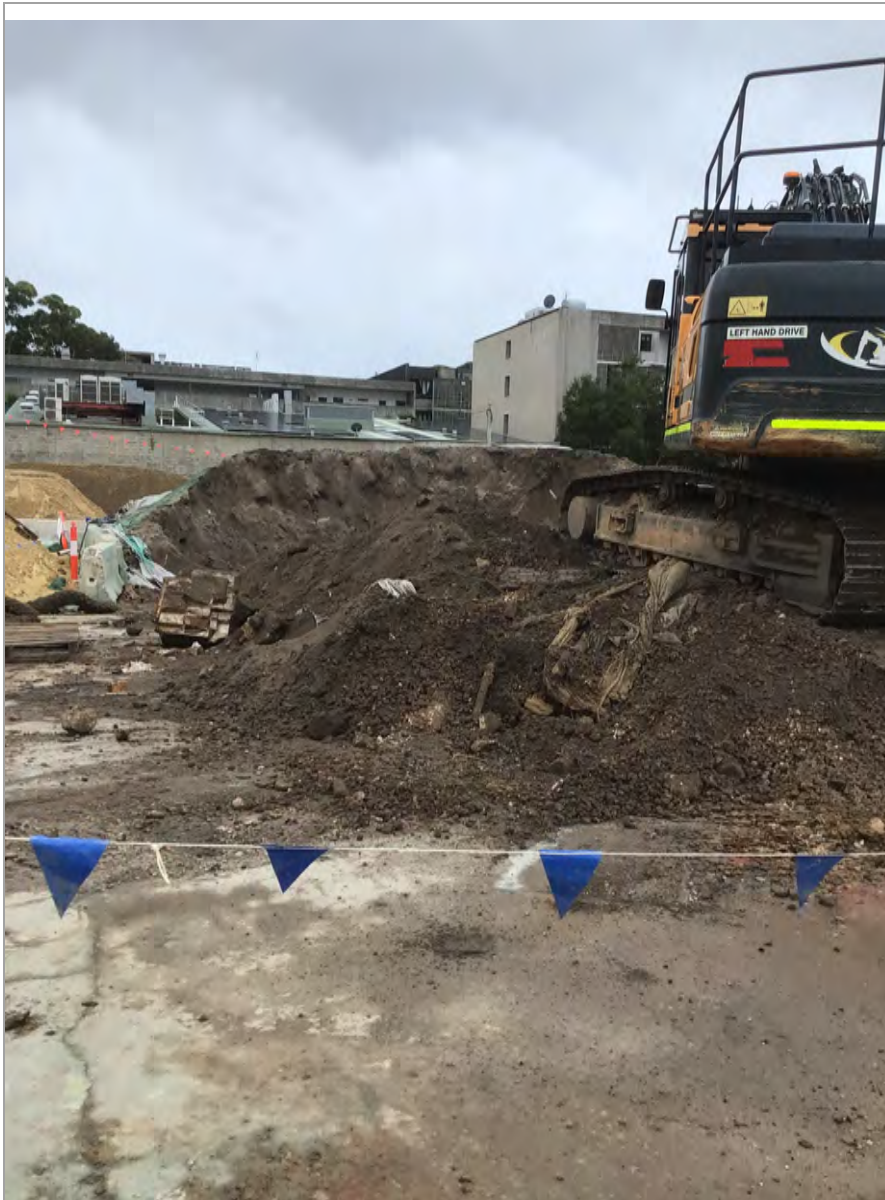
Photo 6: Stockpiled material in stage 1 contains bonded asbestos. Being taken off-site to landfill as GSW special waste.

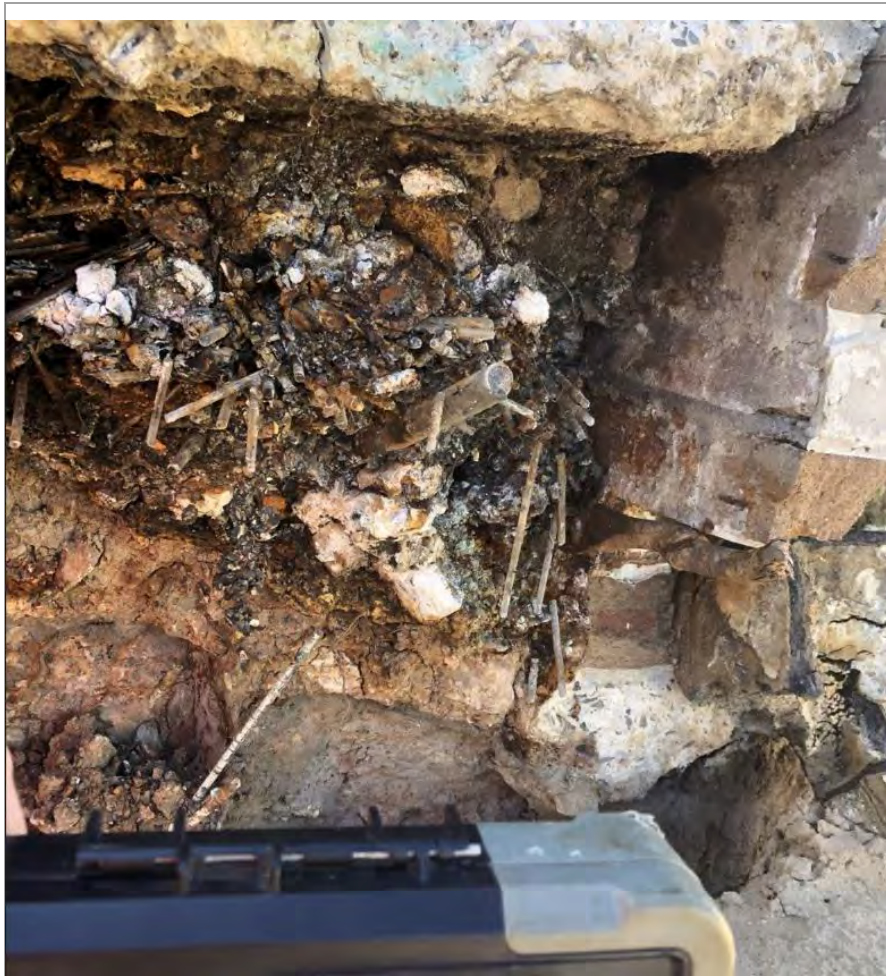
Photo 7: Glass tubes represent possible capacitors within fill materials on Stage 2 (source anticipated to be former electrical manufacturing business). Anecdotal evidence indicates PCBs at around 180mg/kg in this area.

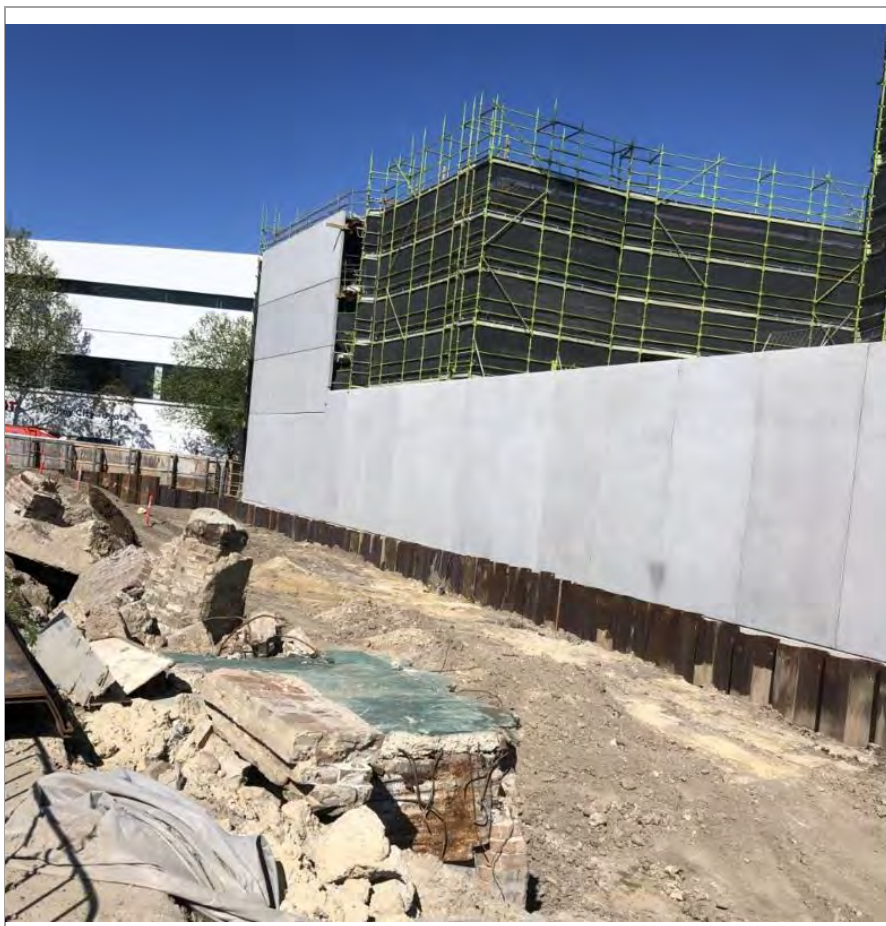
Photo 9: Looking south-east from southern portion of Stage 2. Sheet pile walling has been installed along southern boundary of Stage 2 to prevent off-site migration. Groundwater extraction is also occurring along this boundary.
