**Arborist Impact and Tree Risk
Assessment Report**

**NSW Department of Education
and School Infrastructure**

Lindfield Learning Village

30th of August, 2019

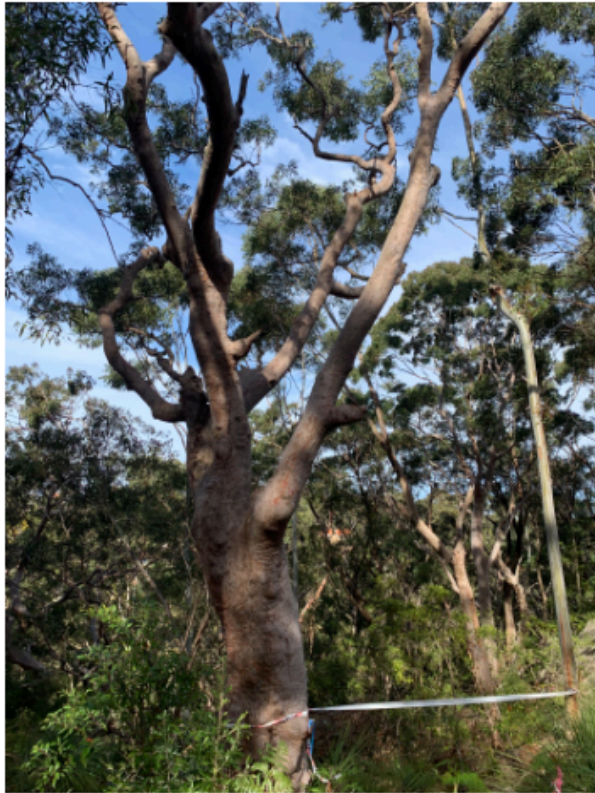
Plate 1:

Tree 138, an *Angophora costata* (Smooth-Barked Apple) tree of high value to be retained.

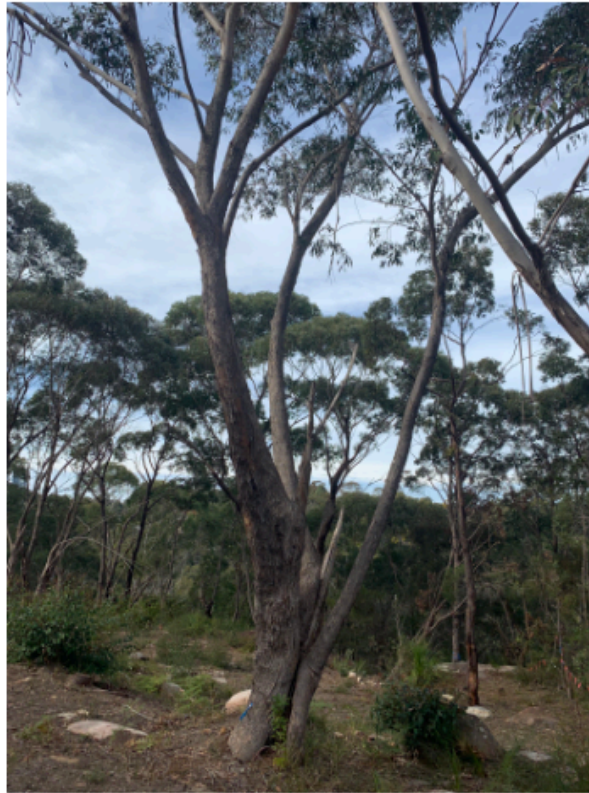
Plate 2:

Surrounding bushland south of the proposed works. Species include *Eucalyptus botryoides* (Bangalay), *Eucalyptus piperita* (Sydney Peppermint), *Eucalyptus haemastoma* (Scribbly Gum) & *Angophora costata* (Smooth-Barked Apple).

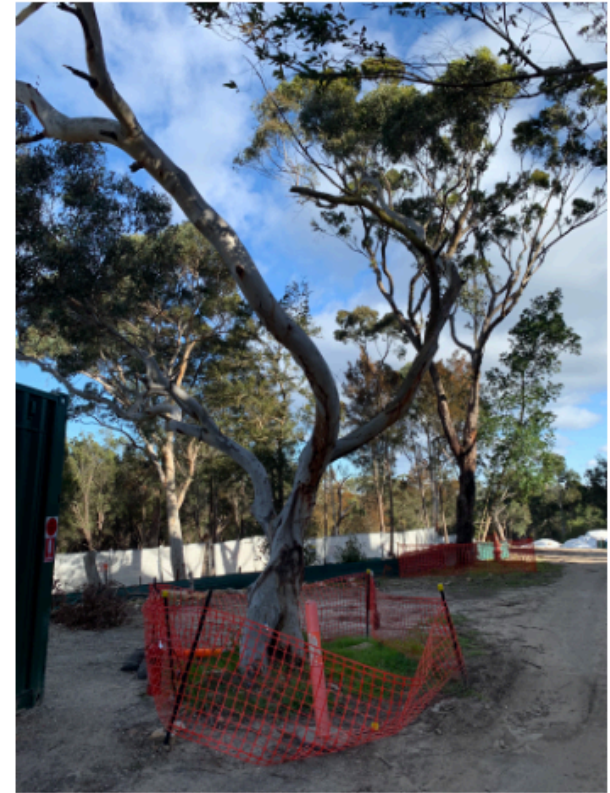
Plate 3:

Tree 71, a *Eucalyptus haemastoma* (Scribbly Gum) to be removed.

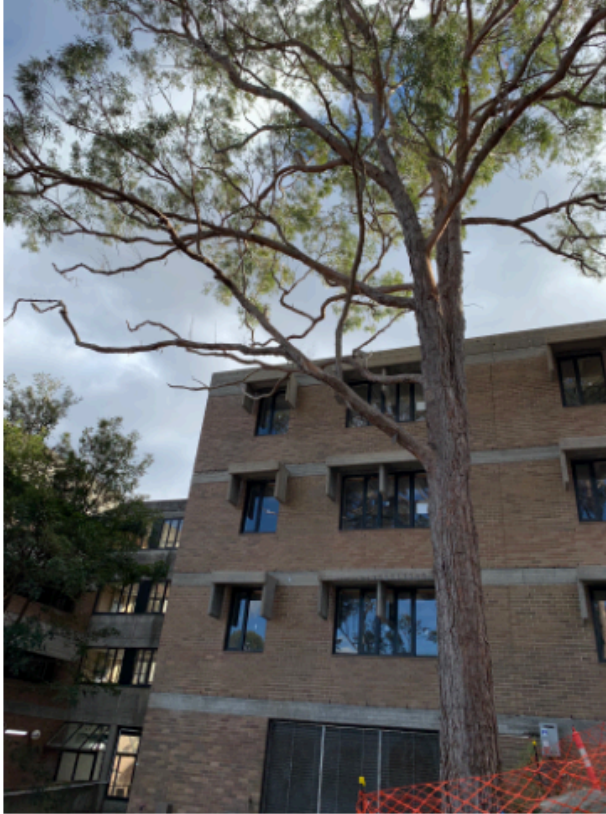
Plate 4:

Tree 70, a *Eucalyptus botryoides* (Bangalay) tree of high value to be pruned of dead wood by an AQF Level 3 arborist.

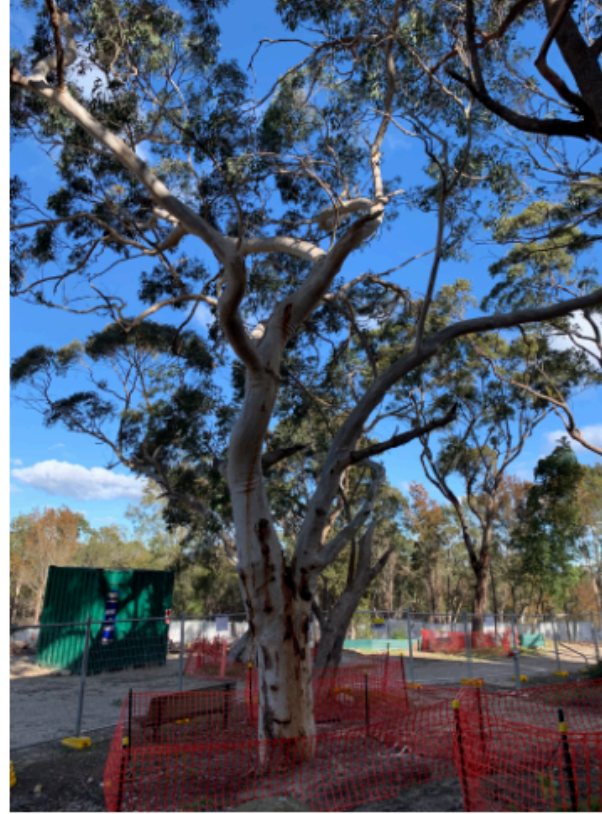
Plate 5:

Tree 583, a *Eucalyptus racemosa* (Scribbly Gum) tree of high value to be retained and protected.

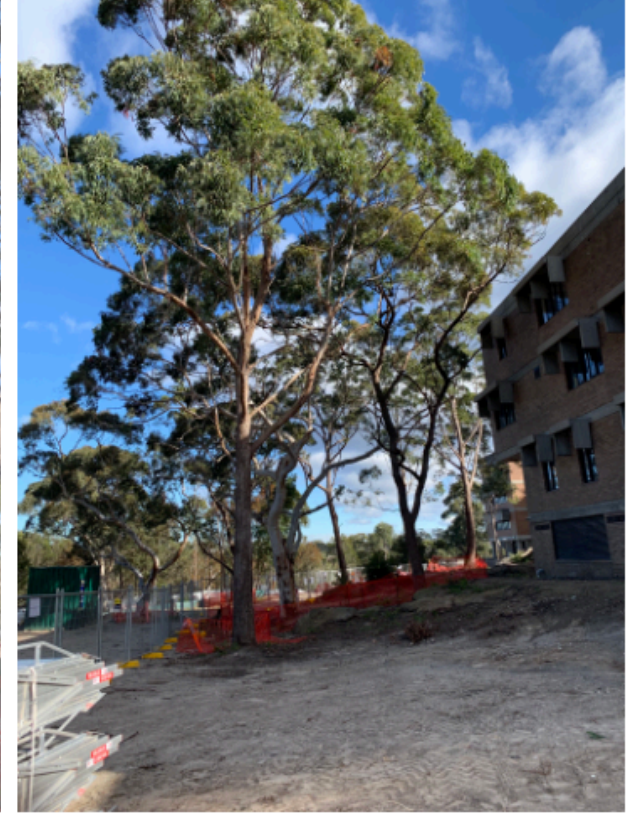
Plate 6:

Trees 63, *Eucalyptus pilularis* (Blackbutt), 72 *Eucalyptus piperita* (Sydney Peppermint), 583 *Eucalyptus racemosa* (Scribbly Gum), 584 *Corymbia gummifera* (Red Bloodwood) adjacent to the proposed COLA building.

- The proposed vegetable garden within the TPZ of trees 584 and 583 is to be elevated and in a contained system to ensure no phosphate fertilisers leaked into the TPZ of the trees. Vegetables that grow well in acidic soils are preferred and remediation of the soil is recommended by adding sulphate potash.
