## **Report on Preliminary Site (Contamination Investigation**

**Proposed 330kV High Voltage Cable Route**

**Lenore Drive, Erskine Park**

**Project 207476.12**

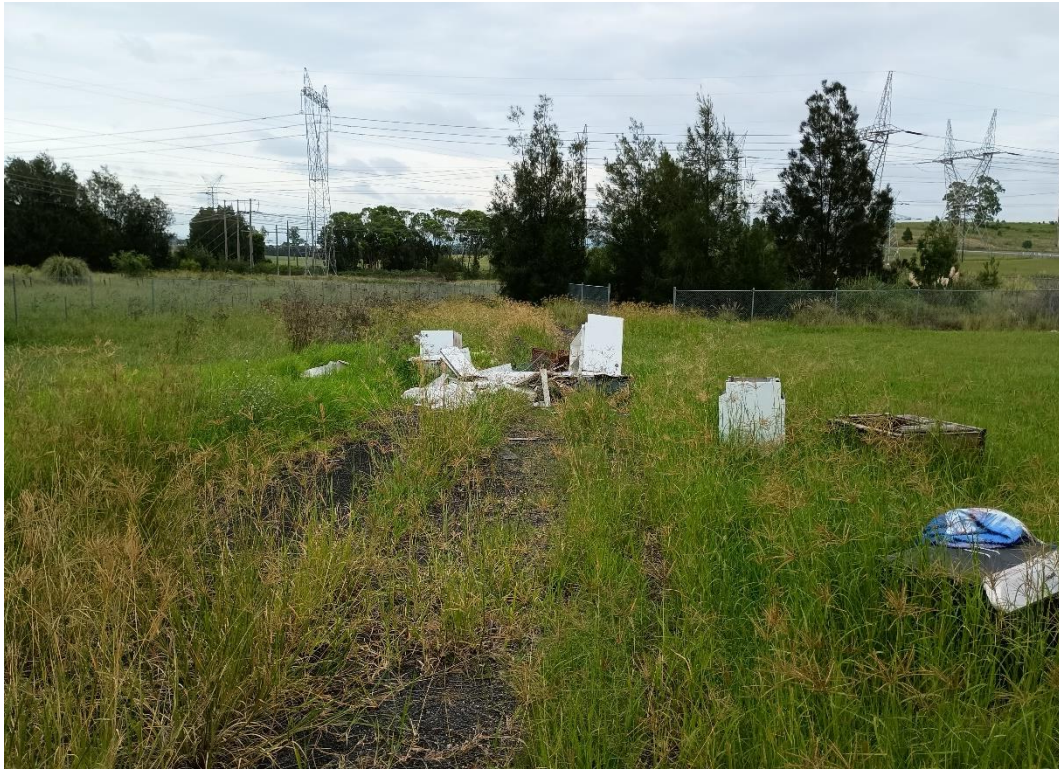
- Evidence of fly tipping, typically comprising general rubbish, either side of the Lenore Drive along the service alignment. More significant fly tipping was observed between service alignment chainage ~90 m and ~360 m (Photograph 1 and 2), at service alignment chainage ~470 m (Photograph 3) and at service alignment chainage ~1,060 m (Photograph 4);

Photograph 1: Evidence of Fly Tipping Between Service Alignment Chainage 90 m and 360 m

- o Collection of samples from the subject materials and analysis of these samples for CoPC.
- Implementation of suitable site management protocols where fly tipping is encountered within the site. For instance, as part of site preparation works and prior to commencing civil works in the subject area, the respective area is inspected for fly tipping material, and if present, the material is appropriately removed and disposed of. Where appropriate, a suitably qualified environmental consultant is to be engaged if material showing signs of contamination is observed during this process (e.g. asbestos, odours, staining, etc.); and

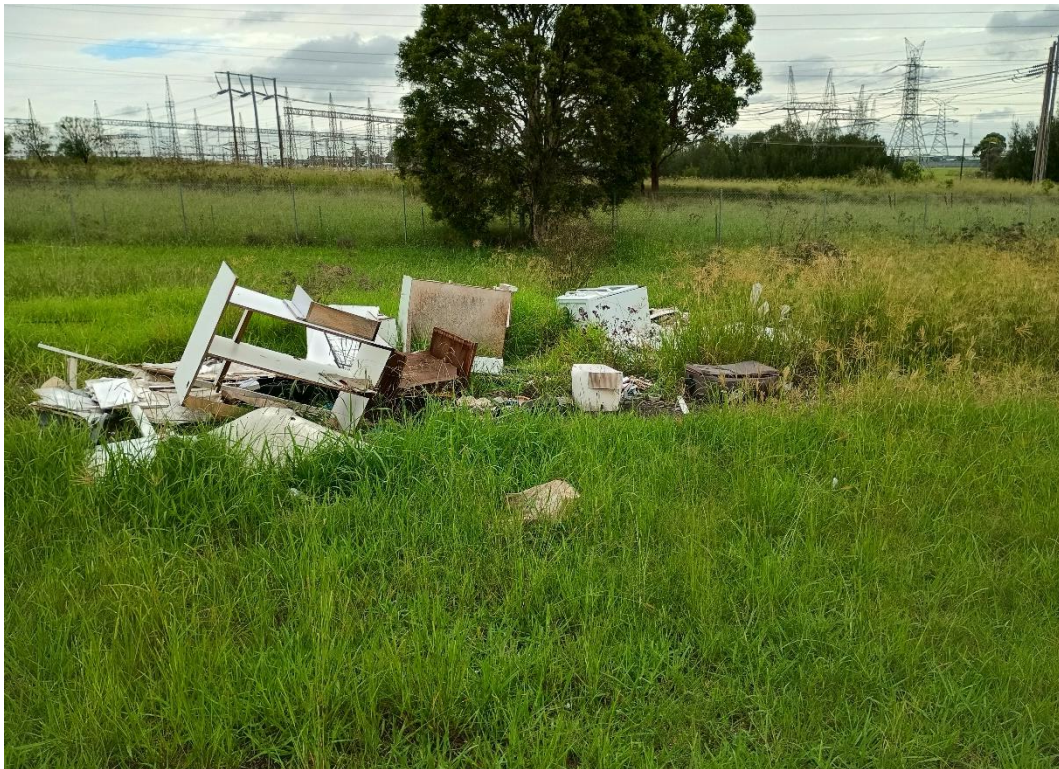
Photograph 2: Evidence of Fly Tipping Between Service Alignment Chainage 90 m and 360 m

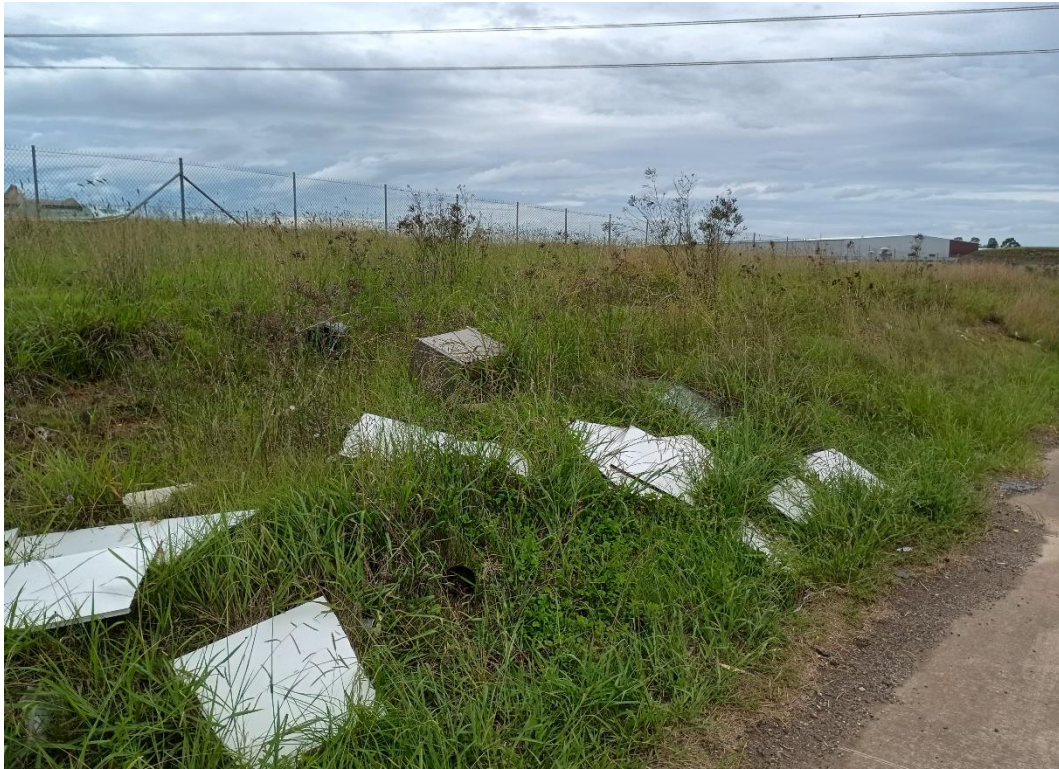
Photograph 3: Evidence of Fly Tipping at Service Alignment Chainage CH 470 m

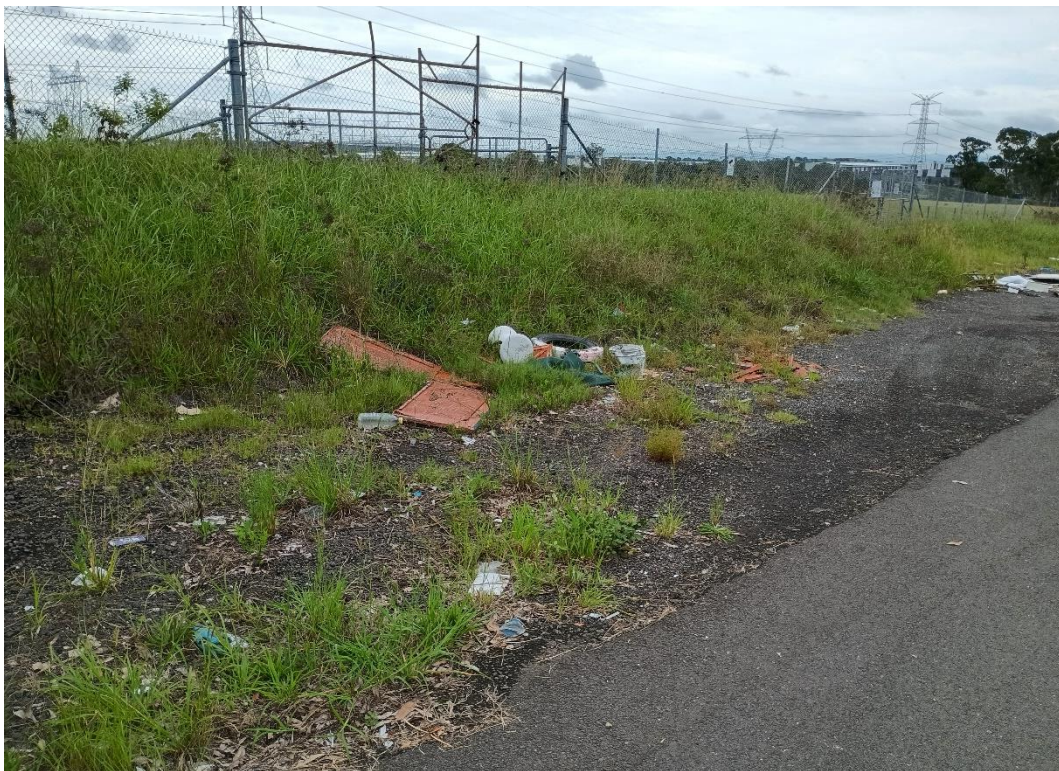
Photograph 4: Evidence of Fly Tipping at Service Alignment Chainage 1060 m

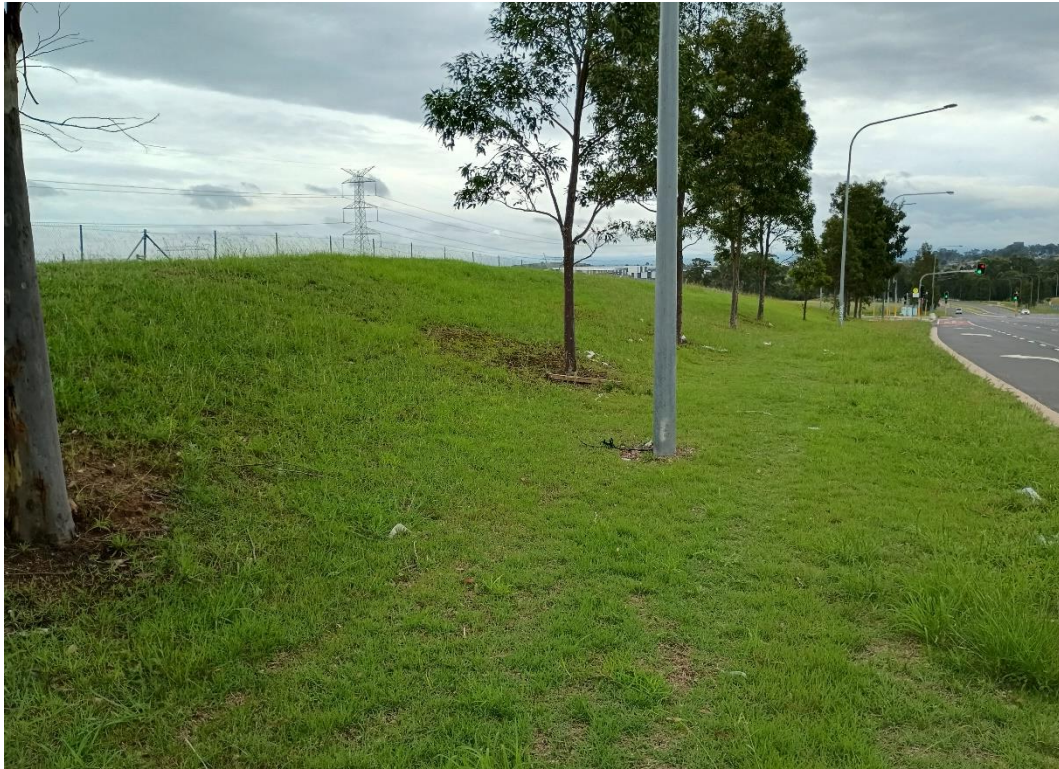
- Mounding along the side of Lenore Drive was observed between service alignment chainage ~900 m and ~1,060 m (Photograph 5);
- Two artificial wetlands were present, one each to the north and south of Lenore Drive. These were located between service alignment chainage ~90 m and ~360 m between (Photograph 6 and 7);

Photograph 5: Mounding Along Side of Road Between Service Alignment Chainage 900 m and 1060 m

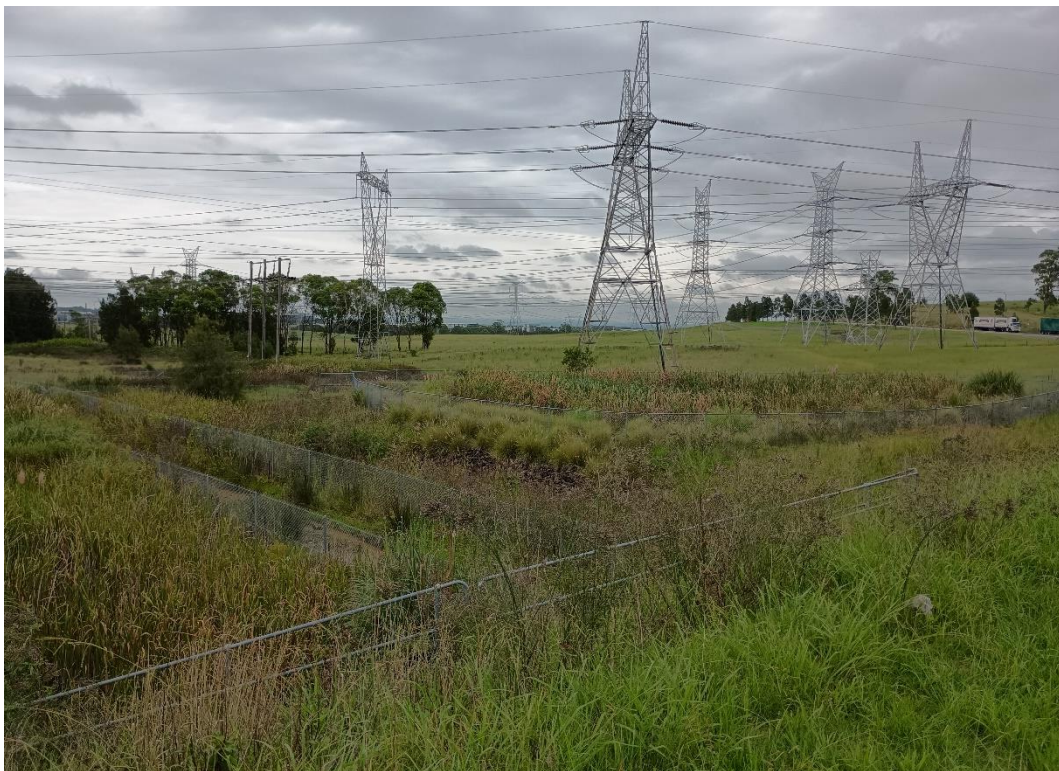
Photograph 6: Wetland at Between Service Alignment Chainage 90 m and 360 m

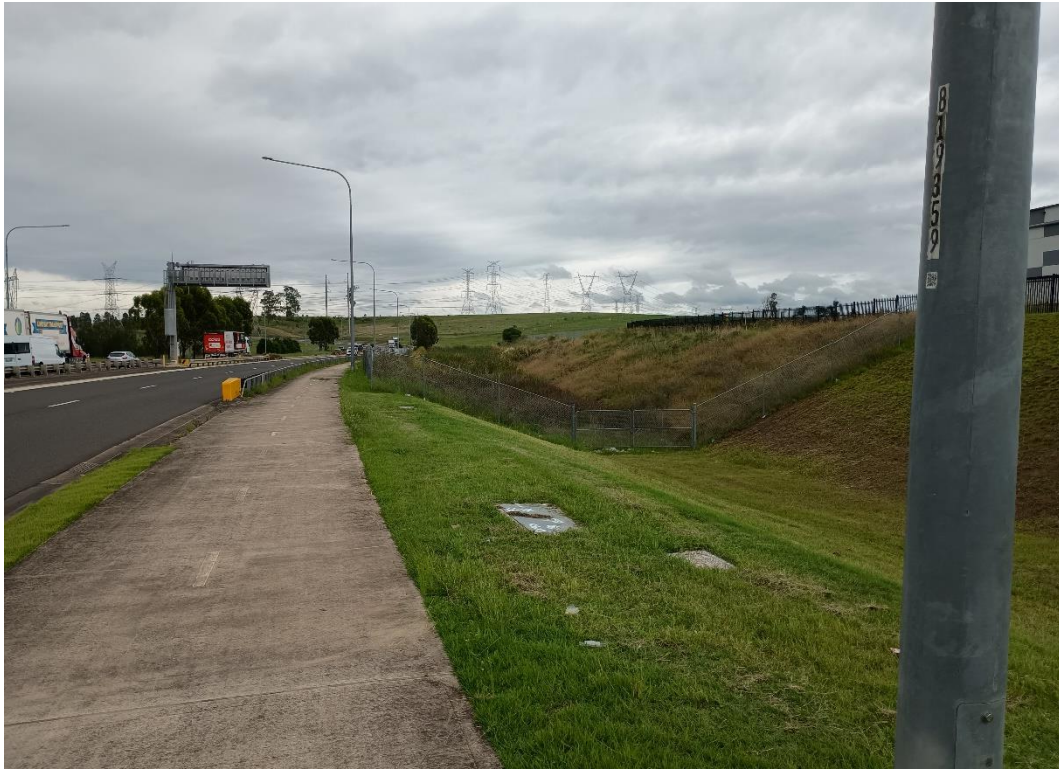
Photograph 7: Wetland Between Service Alignment Chainage 90 m and 360 m

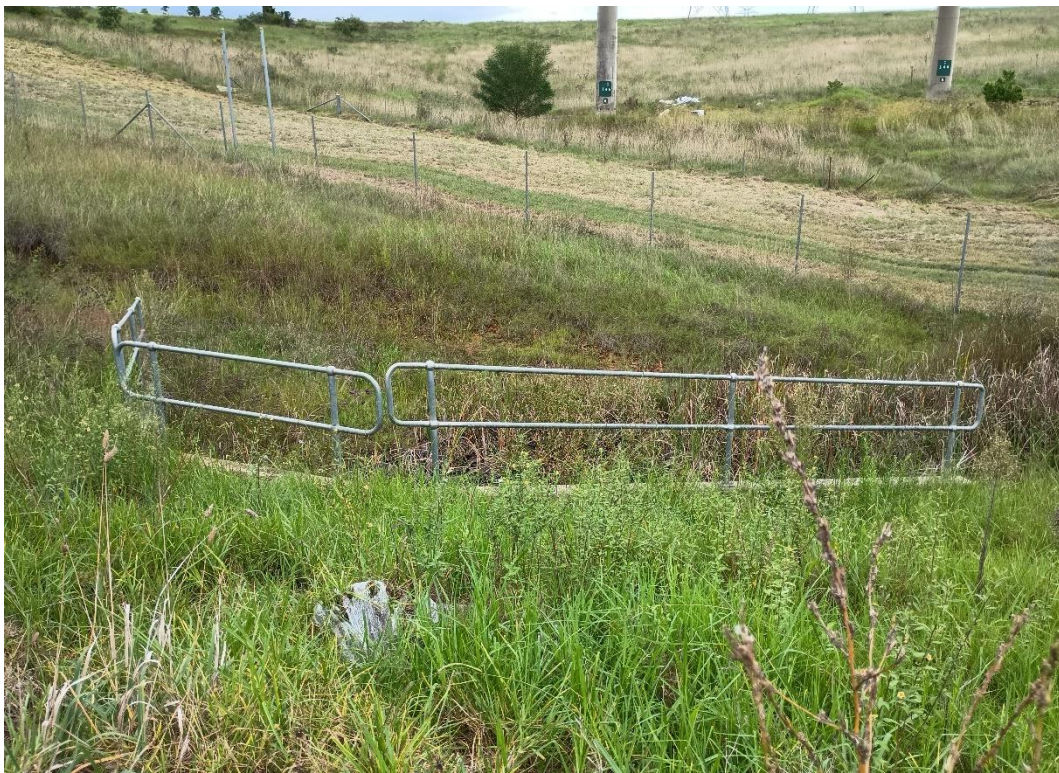
Photograph 8: Stormwater System at Service Alignment Chainage 560 m

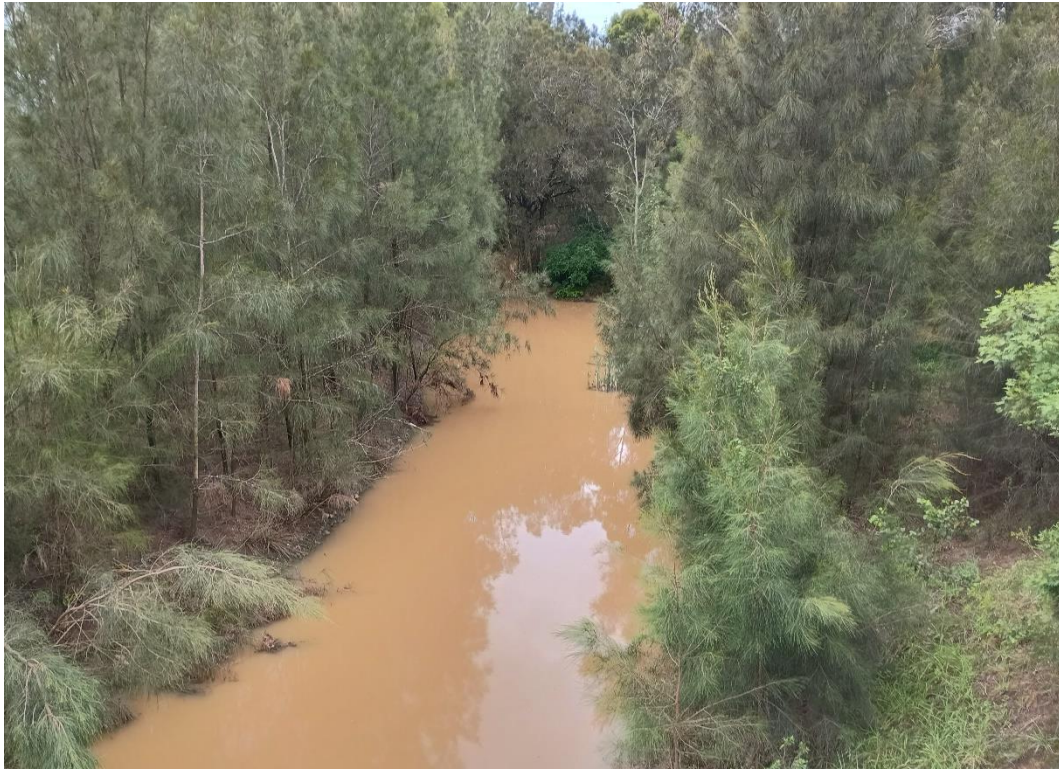
- Ropes Creek was identified in the western third of the site aligned north-south between service alignment chainage ~1,570 m and ~1,670 m. The water within the creek was noted to be brown and turbid (Photograph 9); and

Photograph 9: Ropes Creek Facing North from Lenore Drive

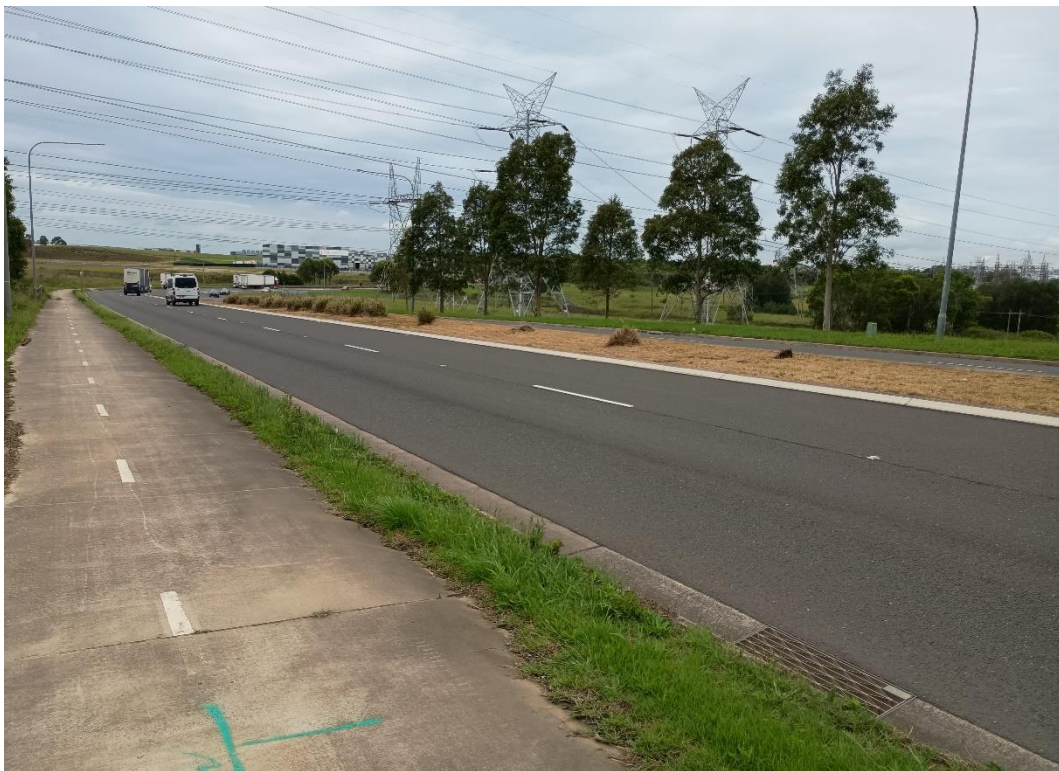
Photograph 10: Lenore Road at Service Alignment Chainage CH 1500 m Facing East

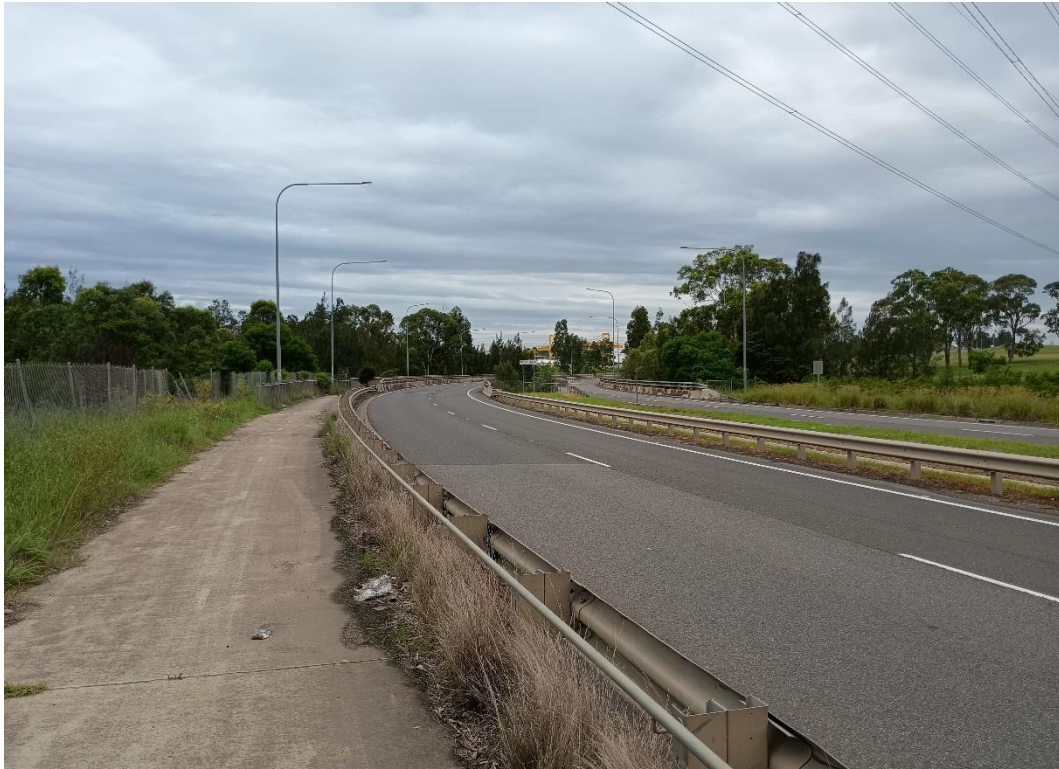
Photograph 11: Lenore Road at Service Alignment Chainage CH 1700 m Facing East
