TANNER KIBBLE DENTON ARCHITECTS PTY LTD HAZARDOUS BUILDING MATERIALS SURVEY

NORTH CURL CURL PRIMARY SCHOOL PLAYFAIR ROAD, NORTH CURL CURL NSW 2099

REFERENCE No. S9372

NOVEMBER 2016

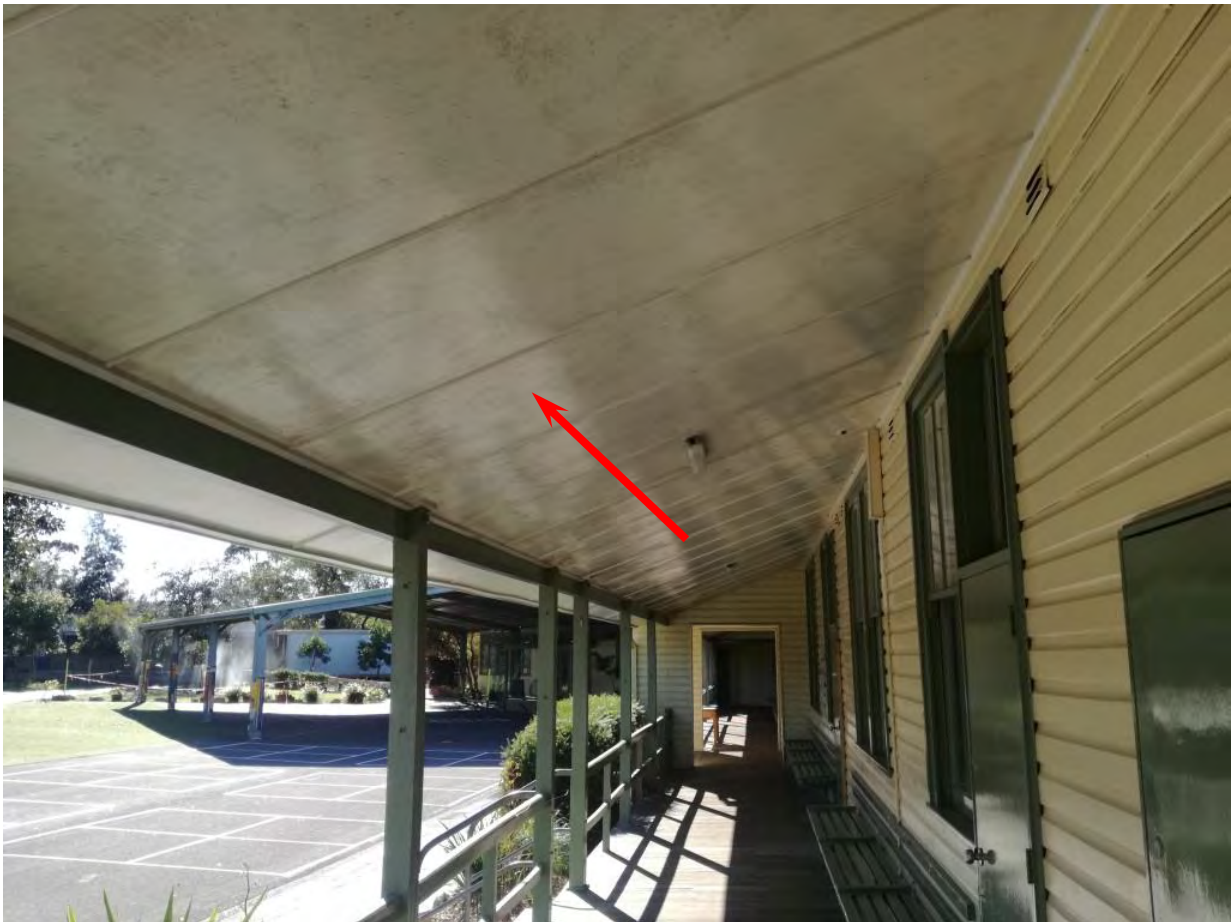
Site: North Curl Curl Primary School.
Location: Building A. Verandah, awning sheeting.
Description: The red arrow points to flat asbestos cement sheet.
Recommendation: Leave and maintain in good condition.

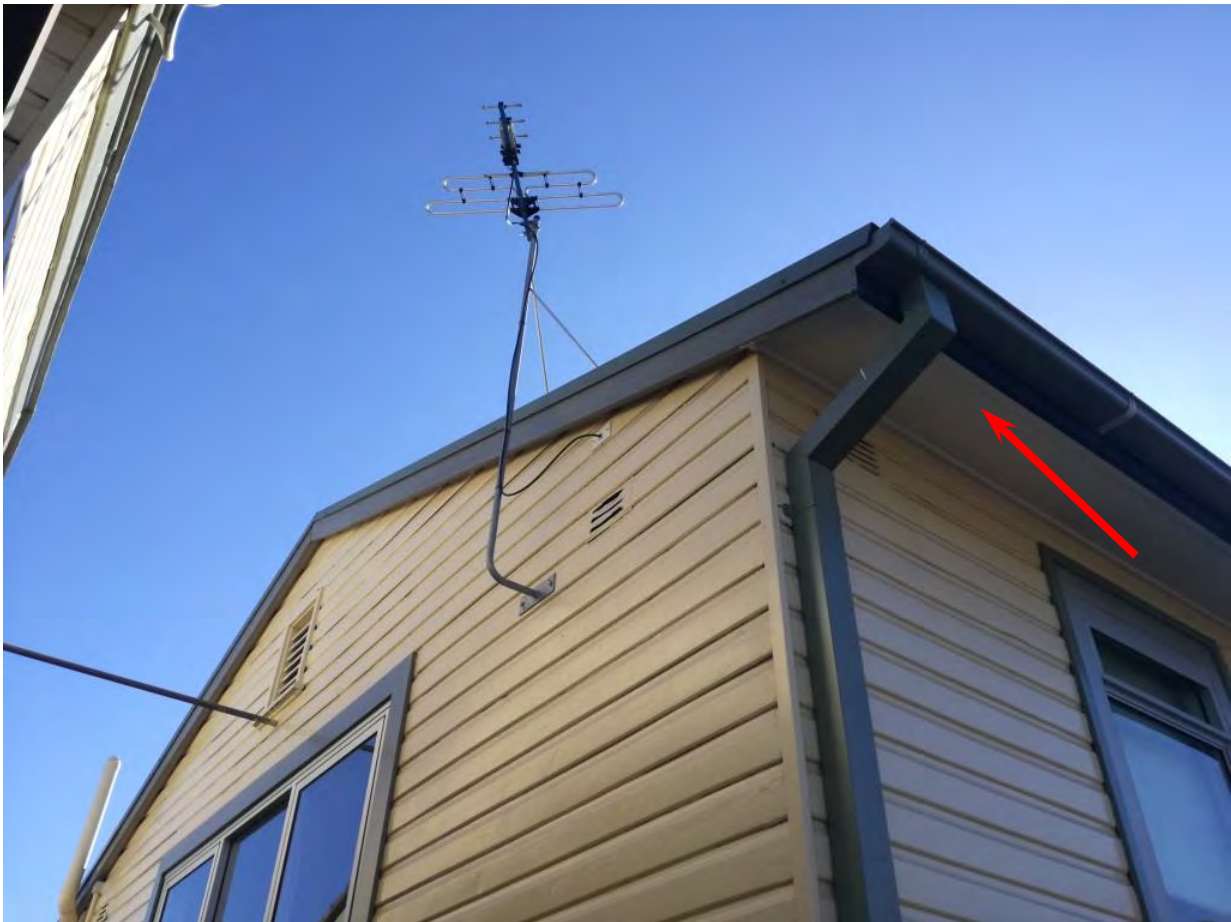
Photograph 02

Site: North Curl Curl Primary School.
Location: Building A. External, eaves on the southern side.
Description: The red arrow points to flat asbestos cement sheet.
Recommendation: Leave and maintain in good condition.

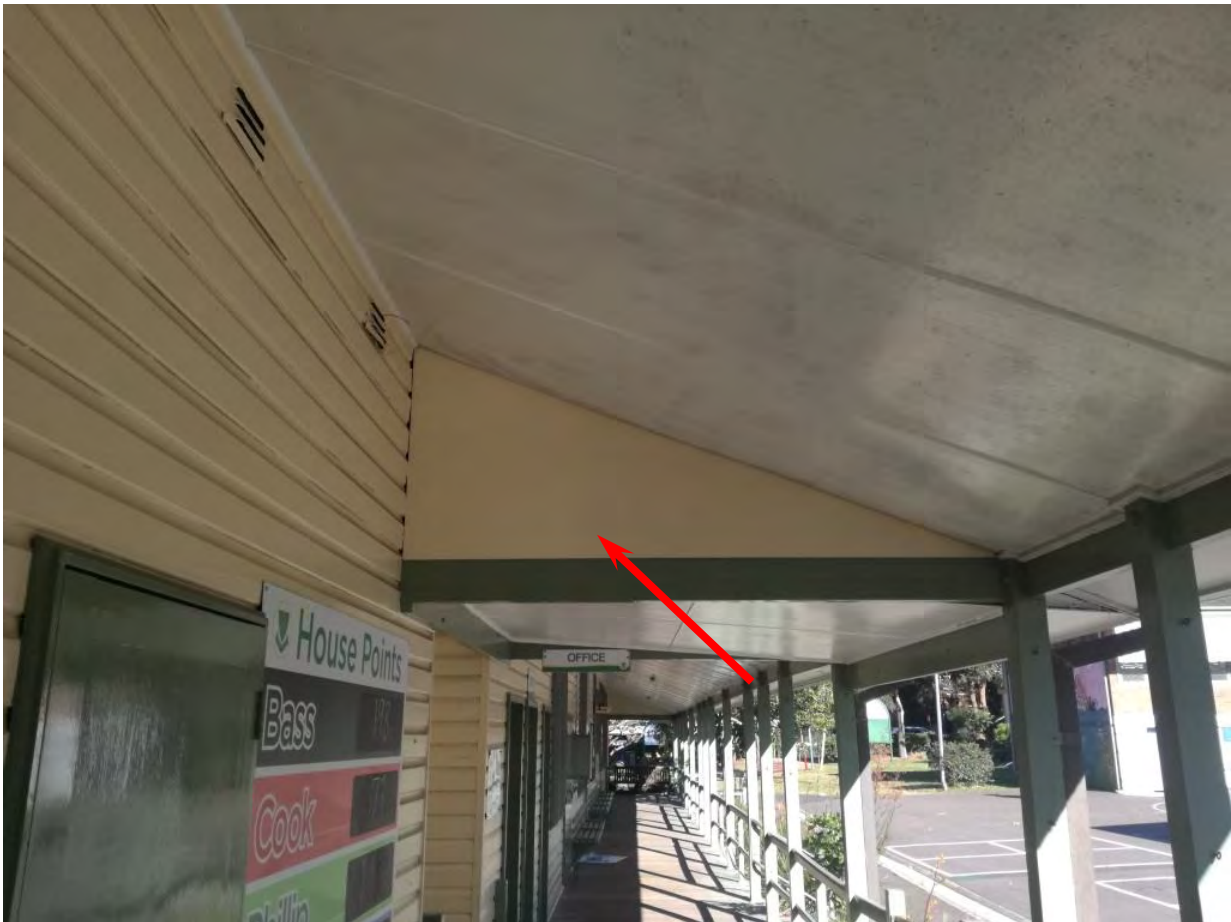
Photograph 03

Site: North Curl Curl Primary School.
Location: Building A. Verandah, infill panel on eastern and western side
Description: The red arrow points to flat asbestos cement sheet.
Recommendation: Leave and maintain in good condition.

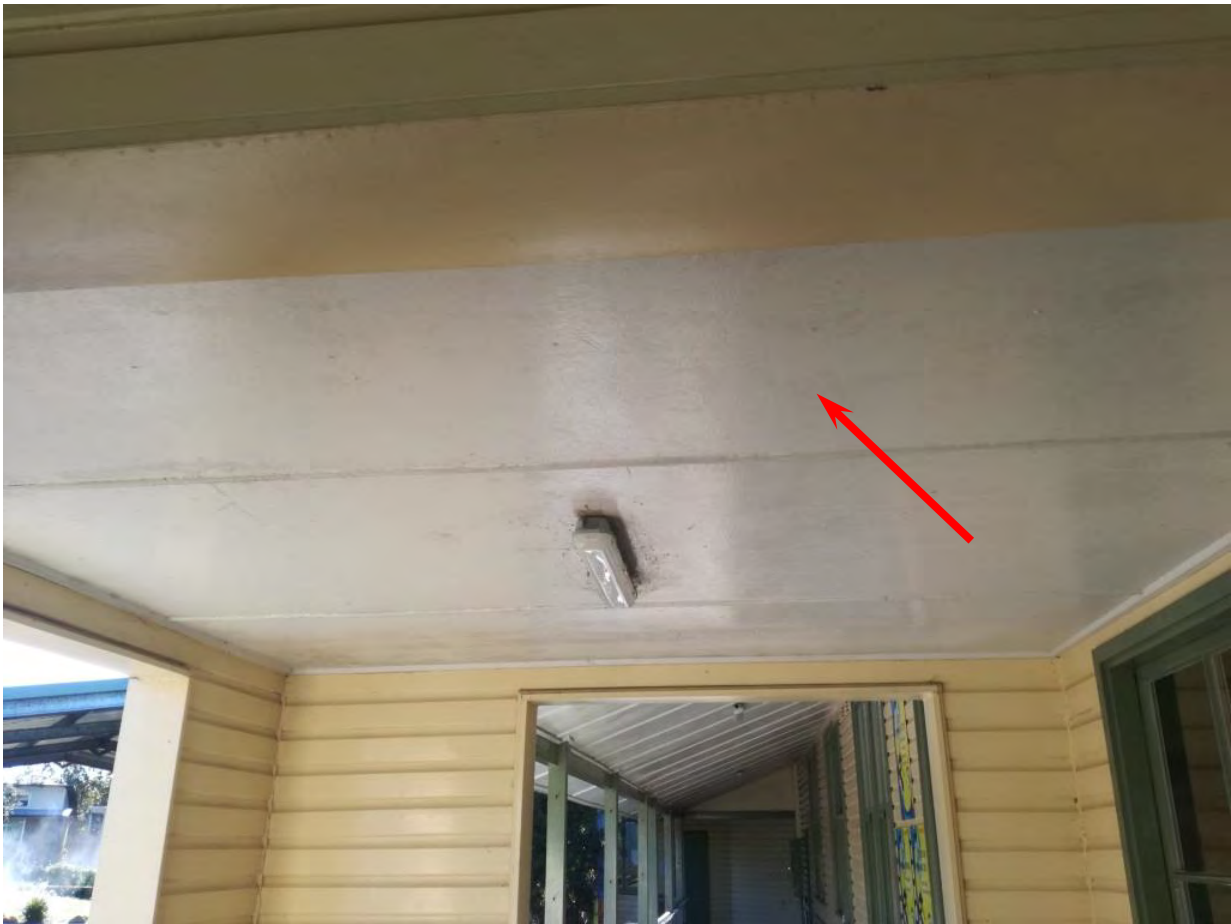
Photograph 04

Site: North Curl Curl Primary School.
Location: Building A. Movement, bridging ceiling panels.
Description: The red arrow points to flat asbestos cement sheet.
Recommendation: Leave and maintain in good condition.

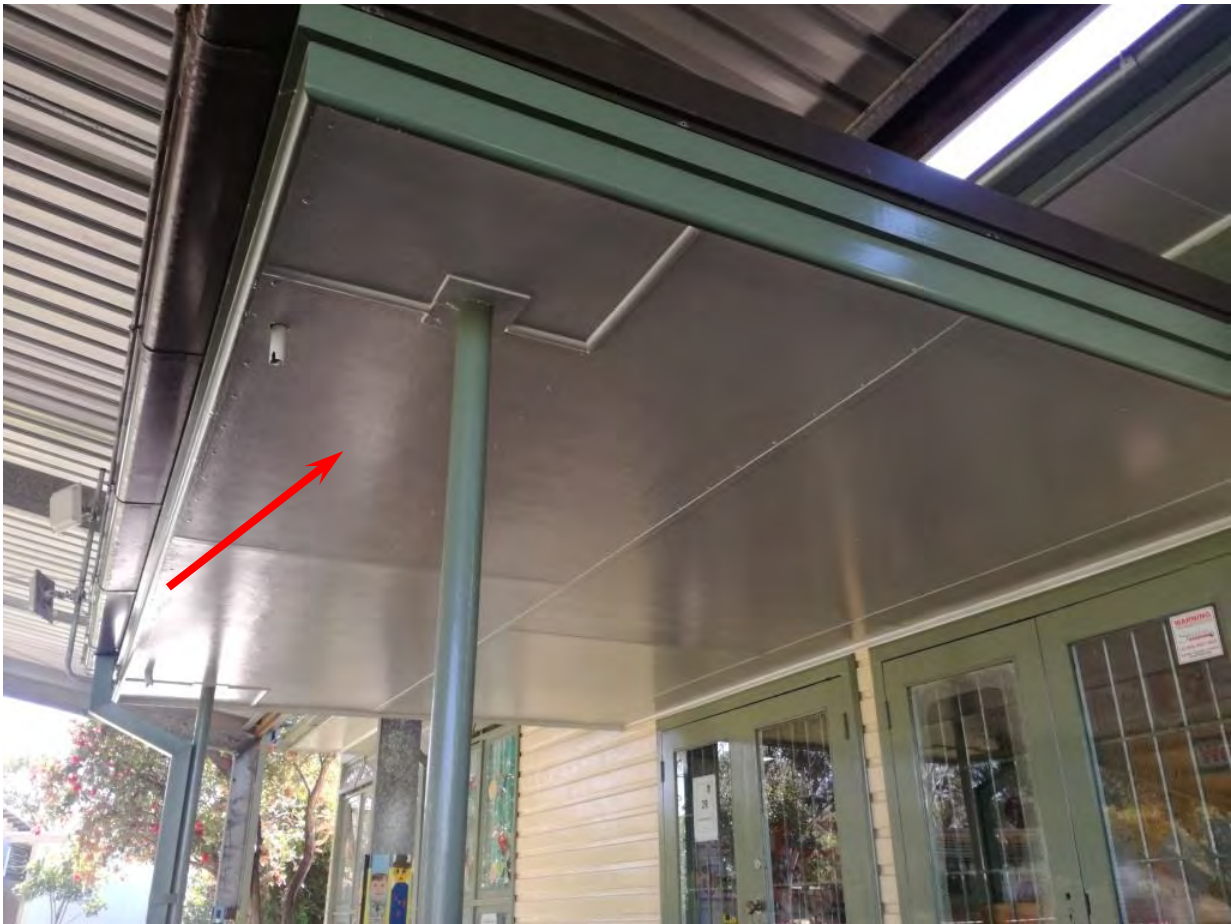
Photograph 05

Site: North Curl Curl Primary School.
Location: Building B. Awning, adjacent to entrance.
Description: The red arrow points to flat asbestos cement sheet.
Recommendation: Leave and maintain in good condition.

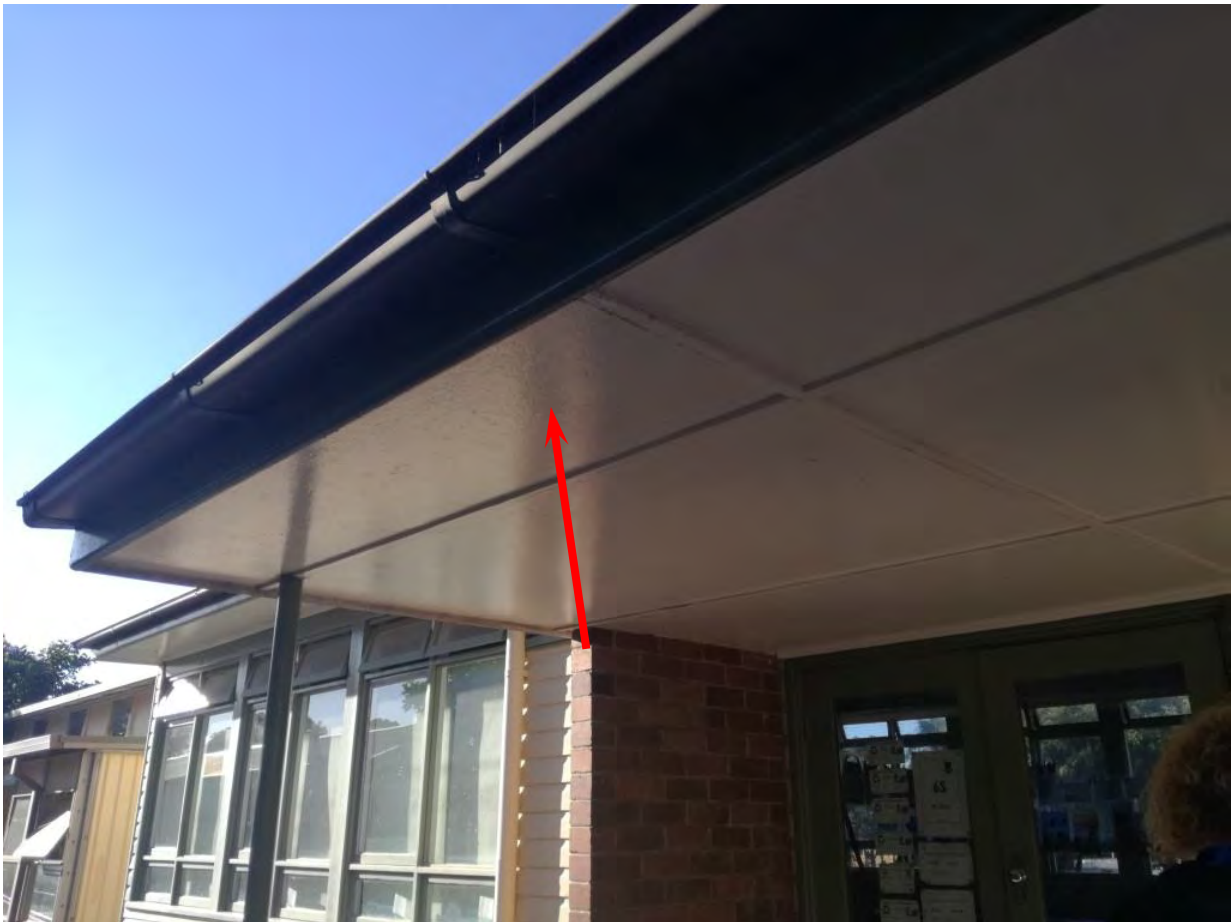
Photograph 11

Site: North Curl Curl Primary School.
Location: Building F. Awning, sheeting above entrance.
Description: The red arrow points to flat asbestos cement sheet.
Recommendation: Leave and maintain in good condition.

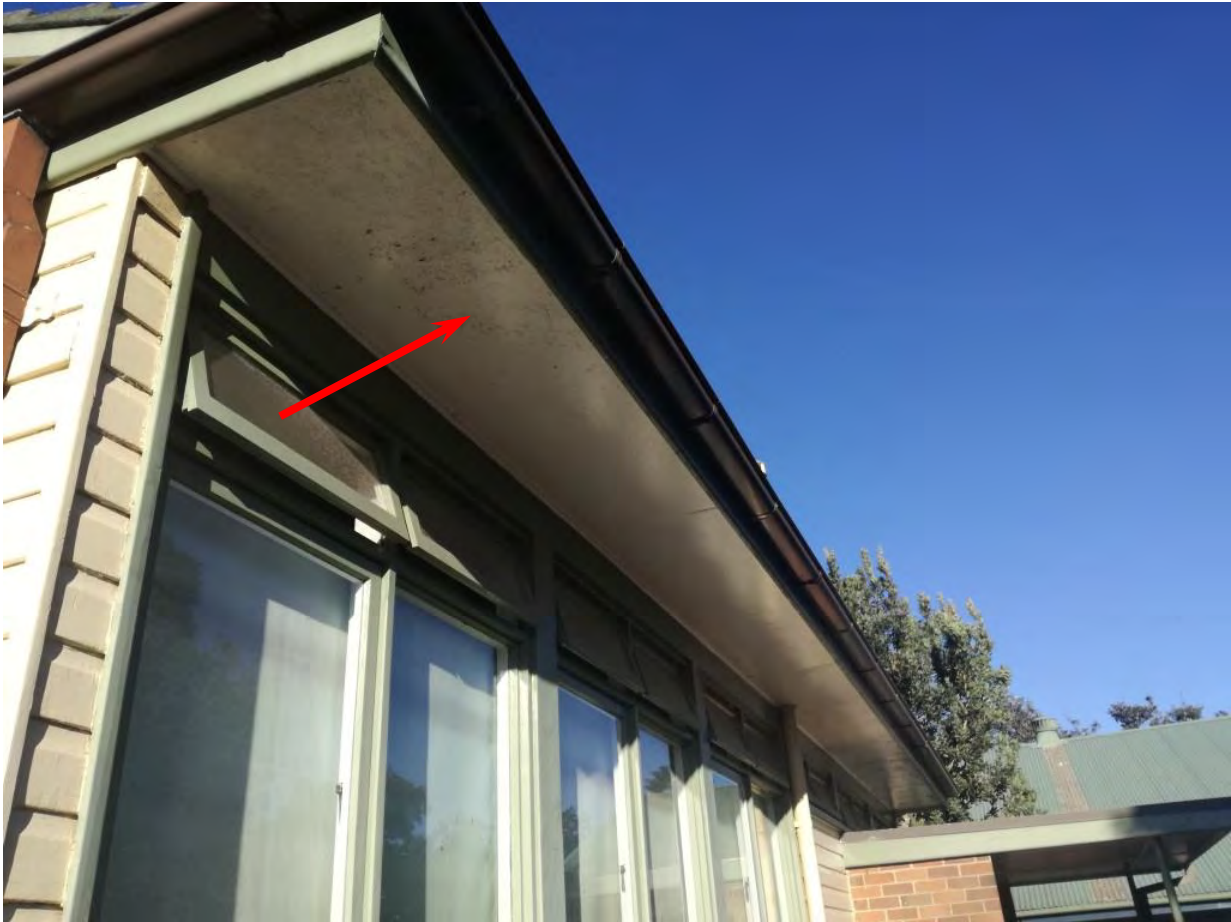
Photograph 12

Site: North Curl Curl Primary School.
Location: Building F. External, eaves.
Description: The red arrow points to flat asbestos cement sheet.
Recommendation: Leave and maintain in good condition.

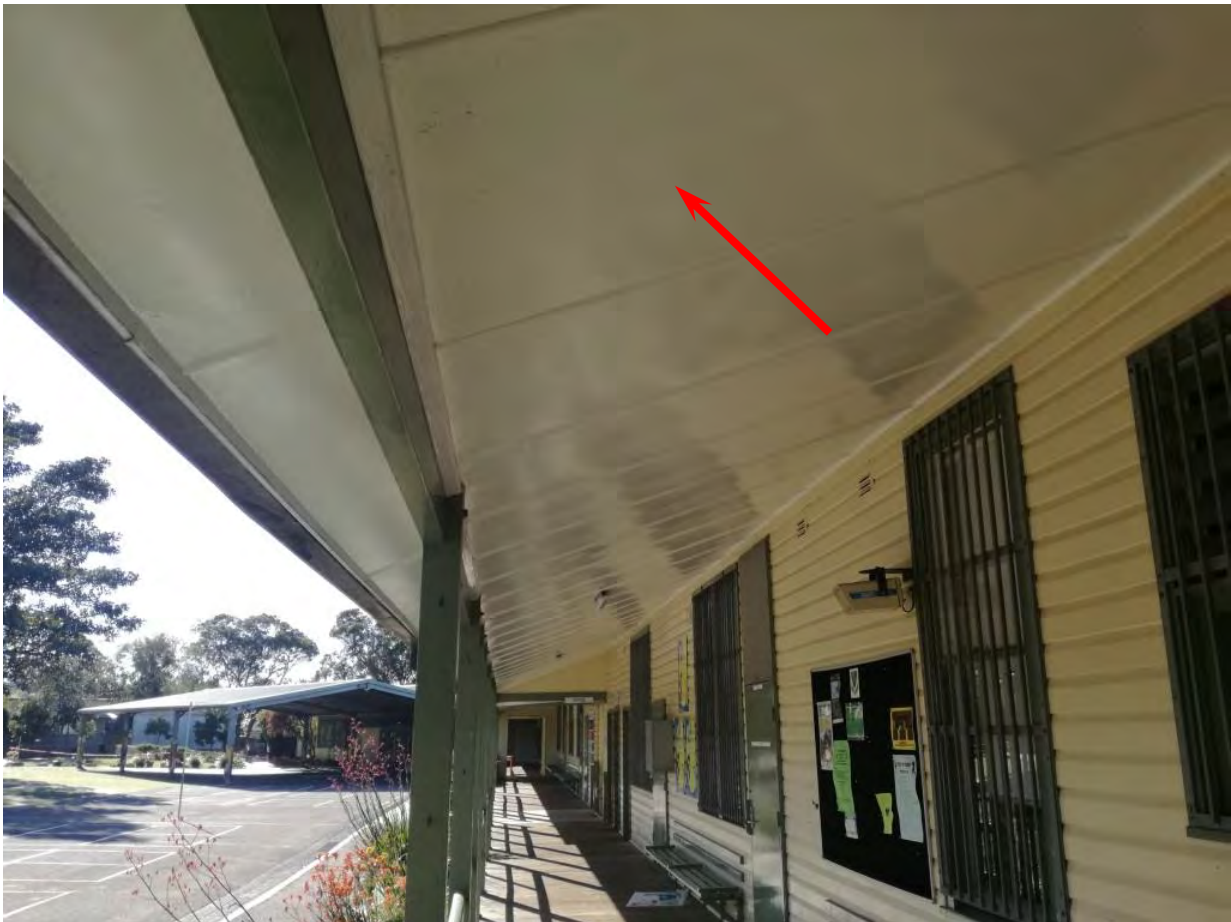
Photograph 13

Site: North Curl Curl Primary School.
Location: Building G. Awning, northern side verandah.
Description: The red arrow points to flat asbestos cement sheet.
Recommendation: Leave and maintain in good condition.

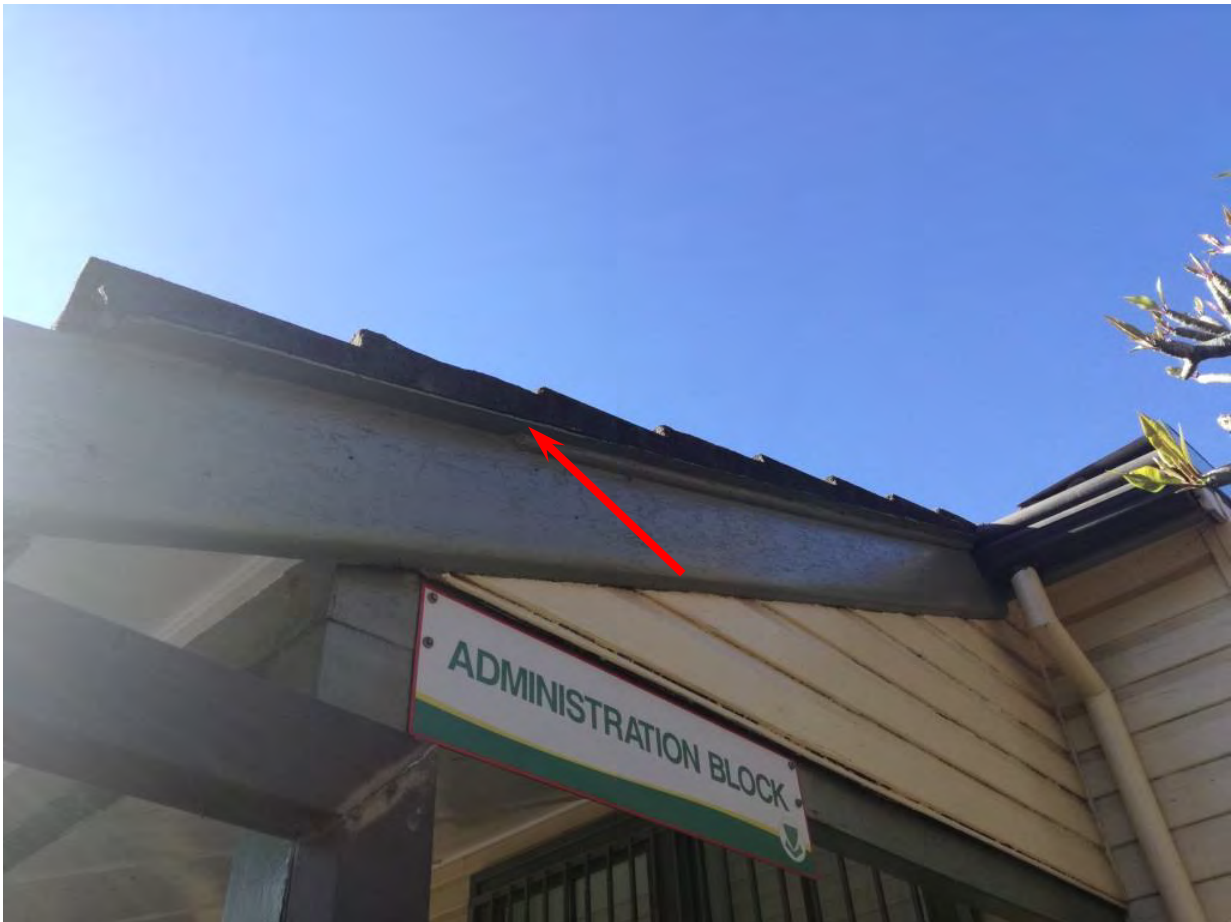
Photograph 14

Site: North Curl Curl Primary School.
Location: Building G. Gable end, tile support.
Description: The red arrow points to flat asbestos cement sheet.
Recommendation: Leave and maintain in good condition.

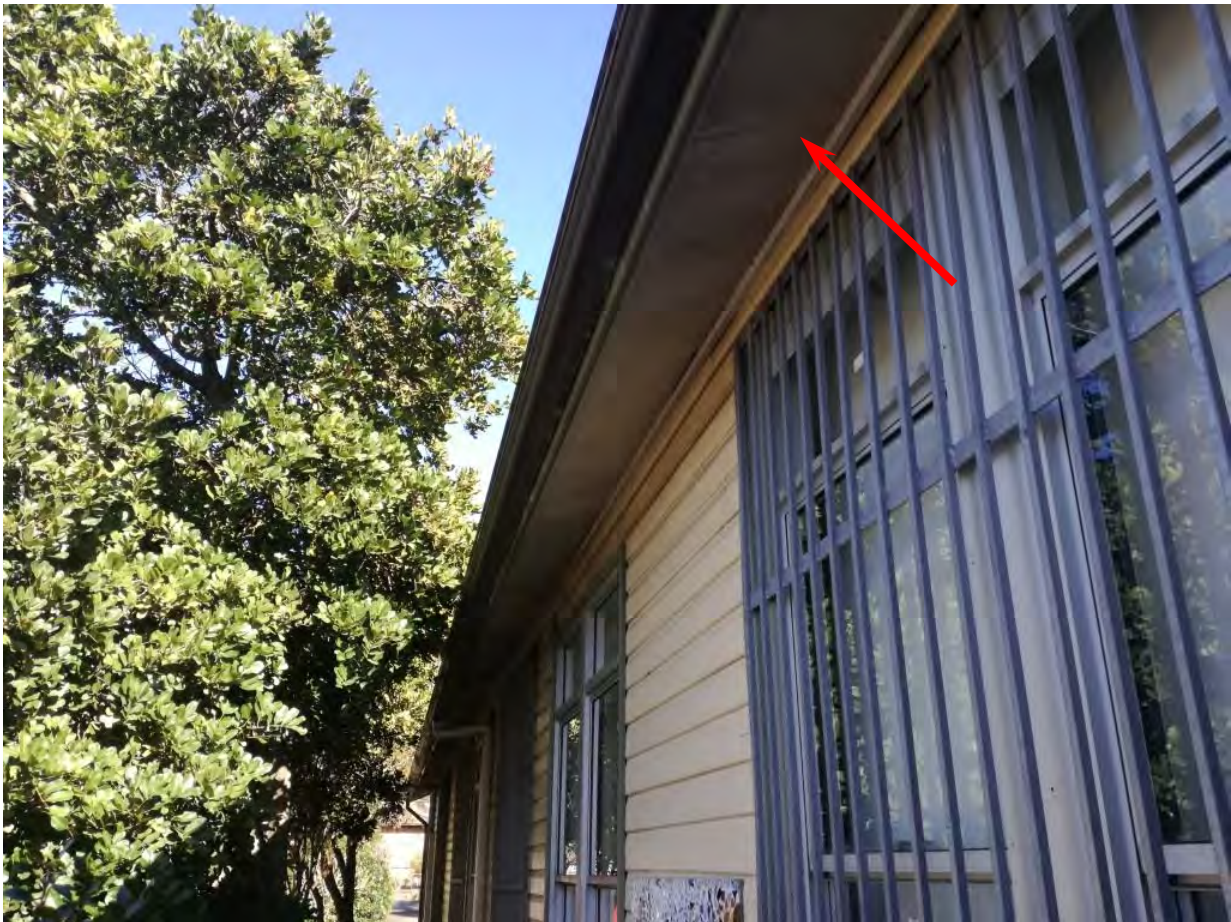
Photograph 16

Site: North Curl Curl Primary School.
Location: Building G. External, eaves on southern side.
Description: The red arrow points to flat asbestos cement sheet.
Recommendation: Leave and maintain in good condition.

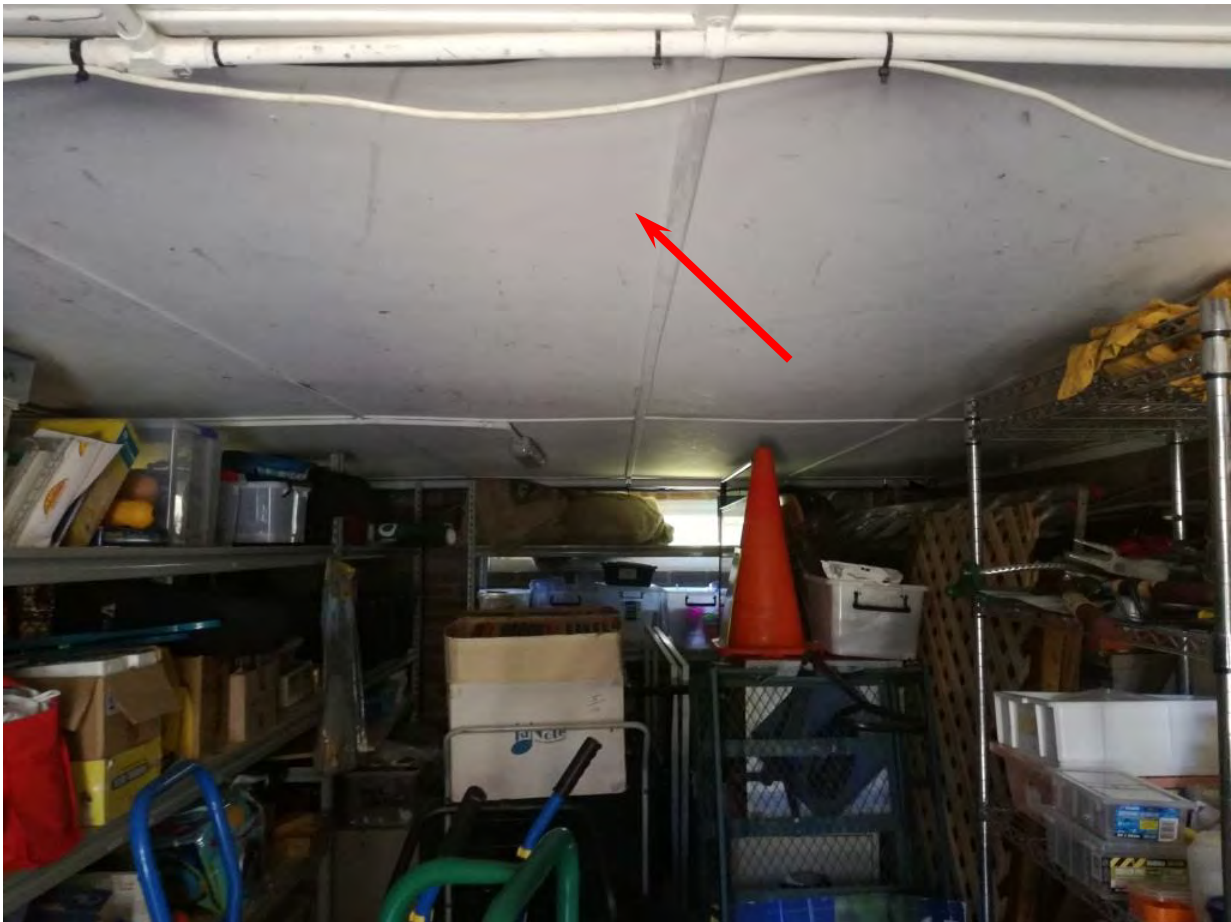
Photograph 18

Site: North Curl Curl Primary School.
Location: Building H. Ground floor, ceiling in store.
Description: The red arrow points to flat asbestos cement sheet.
Recommendation: Leave and maintain in good condition.

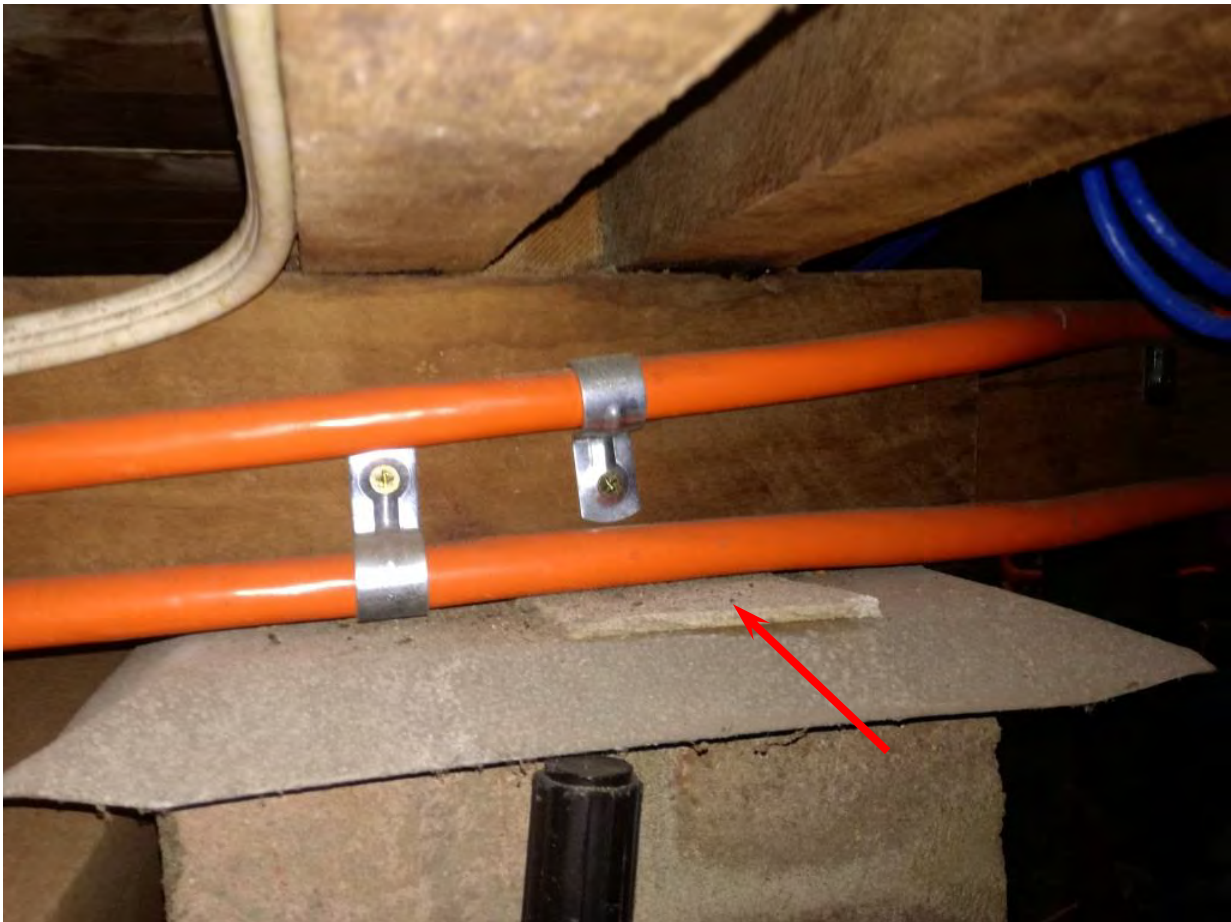
Photograph 19

Site: North Curl Curl Primary School.
Location: Building H. Sub-floor, packing material.
Description: The red arrow points to flat asbestos cement sheet.
Recommendation: Leave and maintain in good condition.

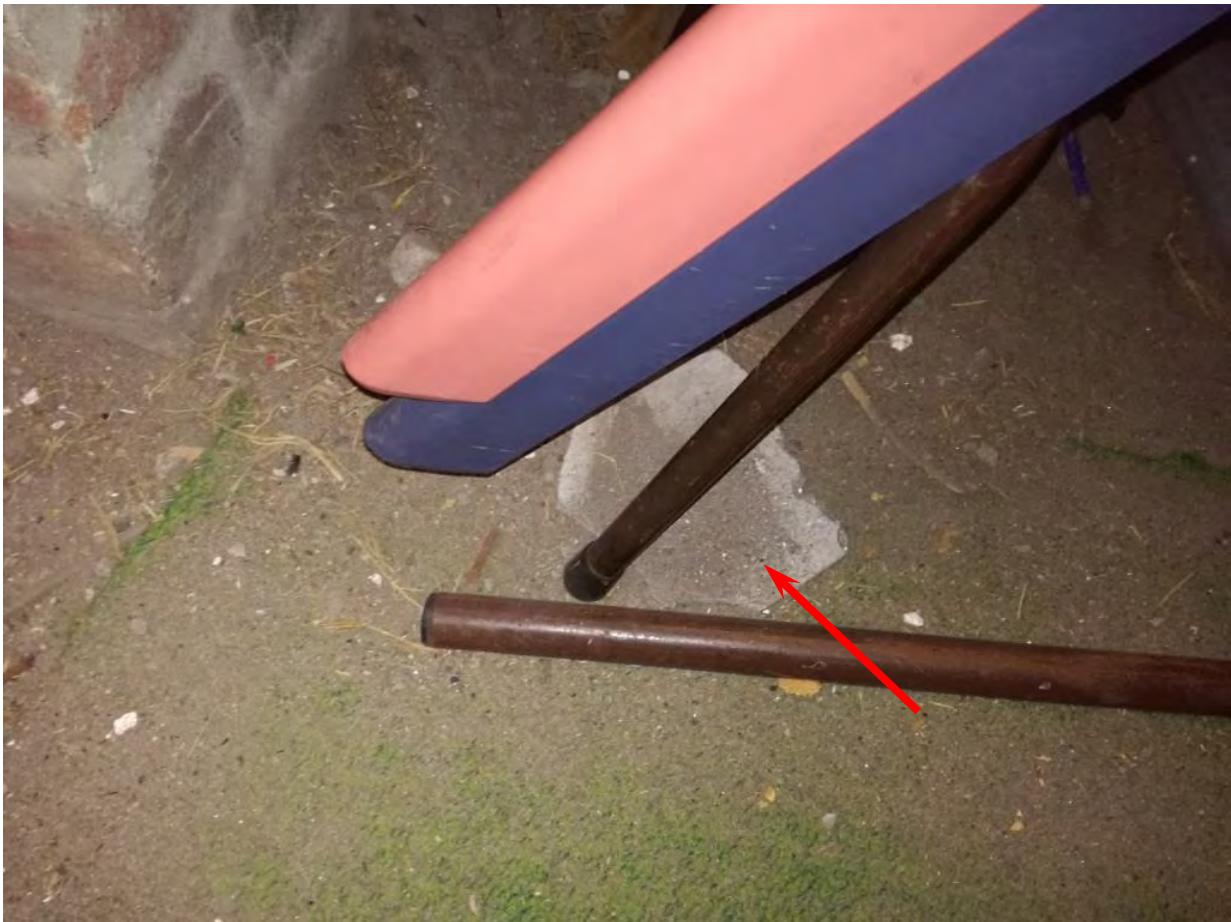
Photograph 20

Location of Hazardous Material	Priority Rating	Recommendations
Building H. Ground floor, debris on the floor - Asbestos cement debris	Priority 3: Low Risk Requiring Minor Maintenance	Remove debris

Site: North Curl Curl Primary School.
Location: Building H. Ground floor, debris on the floor.
Description: The red arrow points to asbestos cement debris.
Recommendation: Remove debris

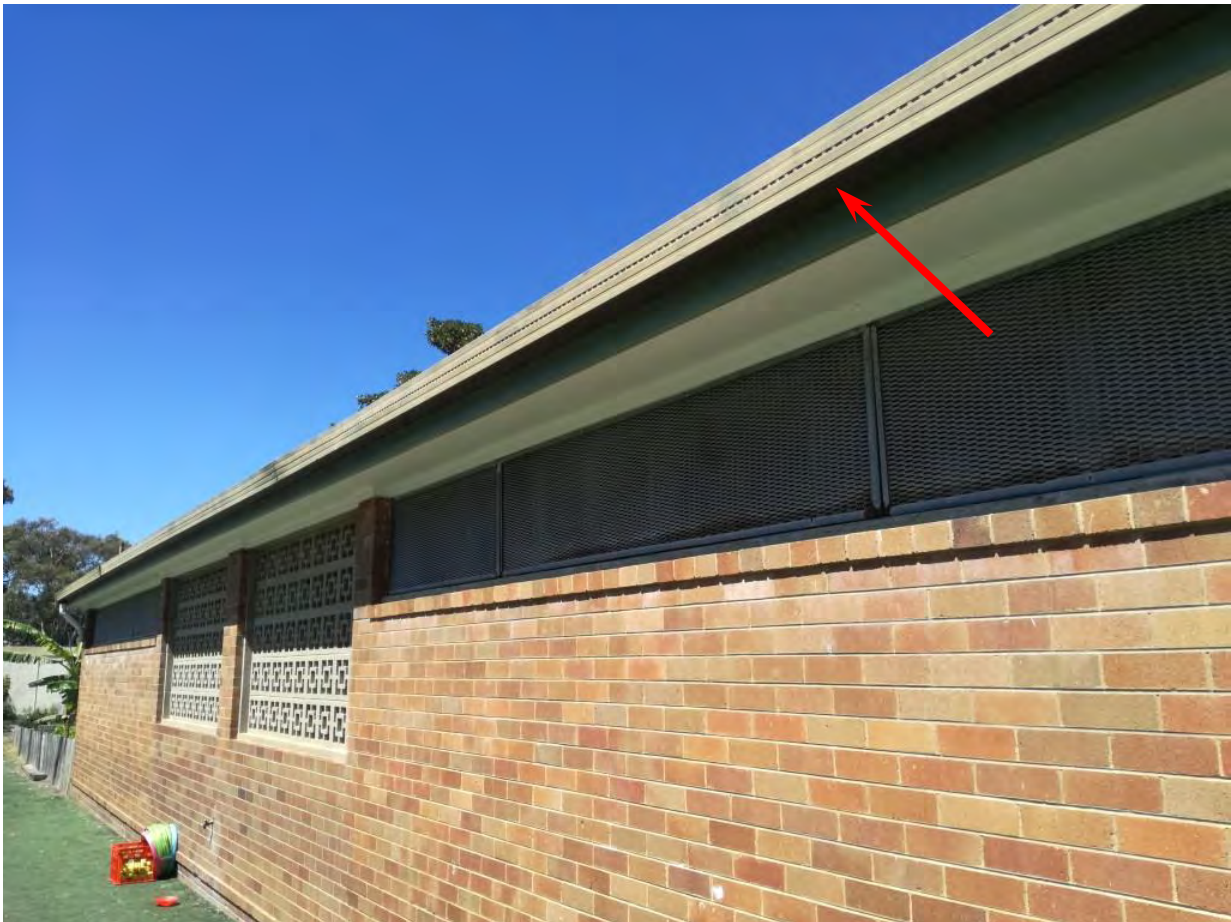
Photograph 22

Site: North Curl Curl Primary School.
Location: Building J. External, eaves.
Description: The red arrow points to flat asbestos cement sheet.
Recommendation: Leave and maintain in good condition.

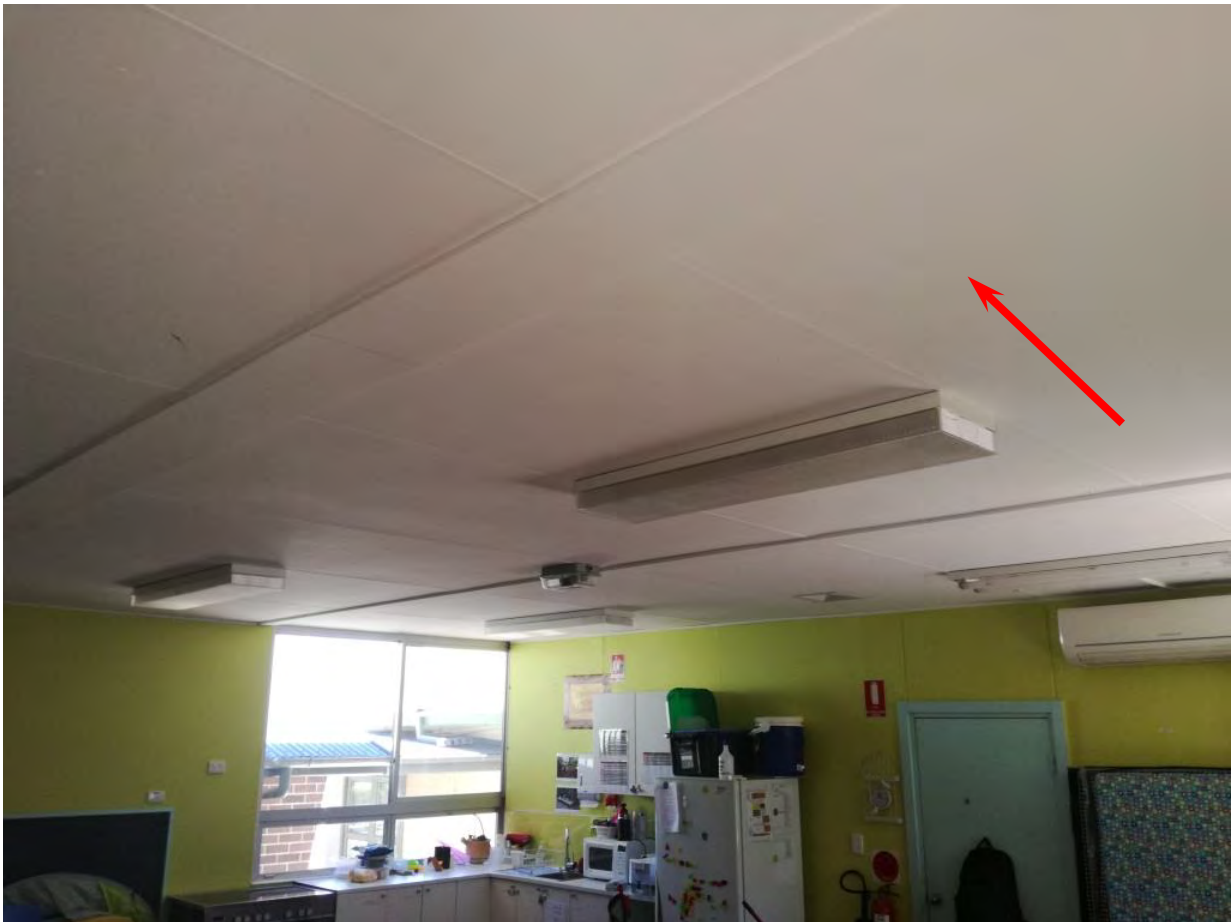
Photograph 23

Site: North Curl Curl Primary School.
Location: D10503 OOSH. Internal, ceiling.
Description: The red arrow points to flat asbestos cement sheet.
Recommendation: Leave and maintain in good condition.

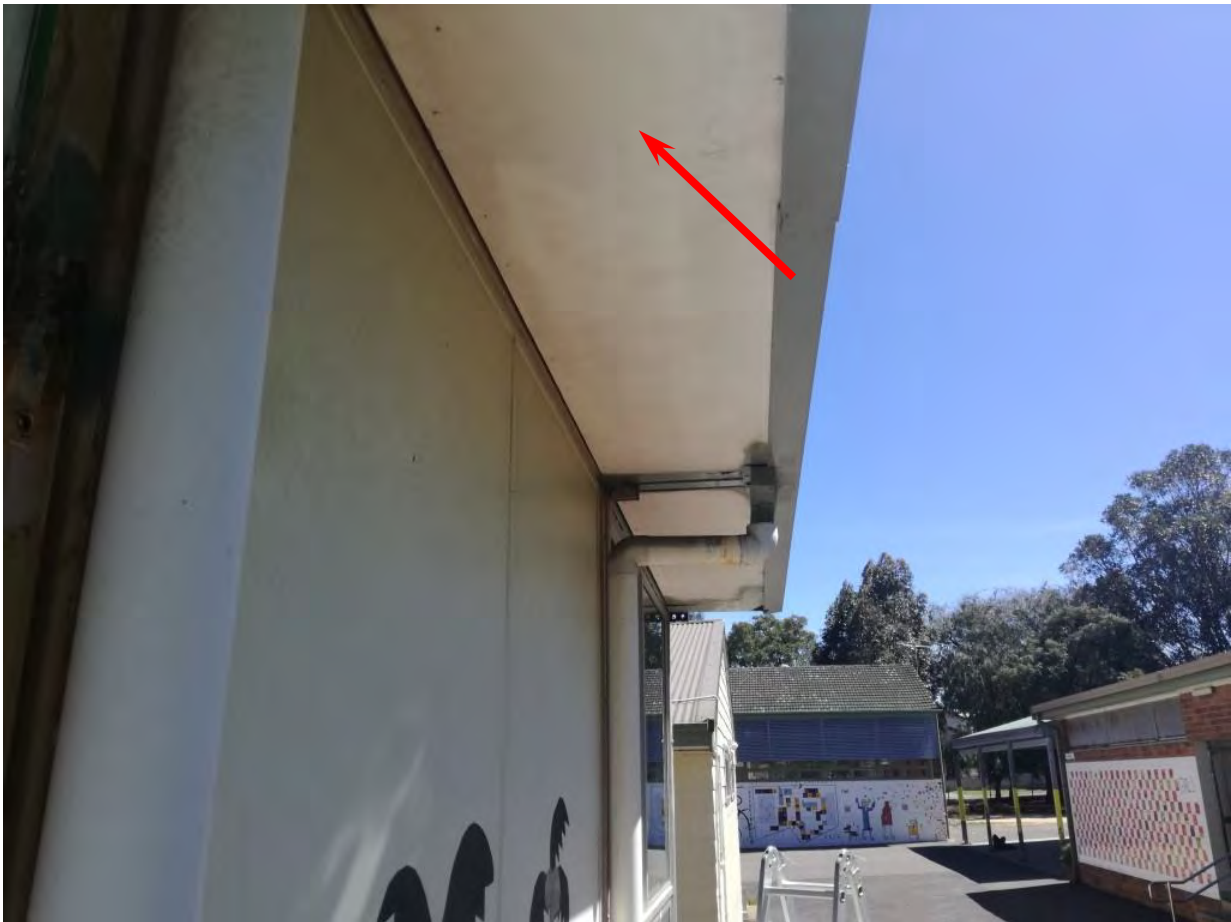
Photograph 24

Site: North Curl Curl Primary School.
Location: D10503 OOSH. External, eaves.
Description: The red arrow points to flat asbestos cement sheet.
Recommendation: Leave and maintain in good condition.
