# **Preliminary Hazardous Materials Assessment**

2-12 Middleton Avenue, Castle Hill NSW

June 2024

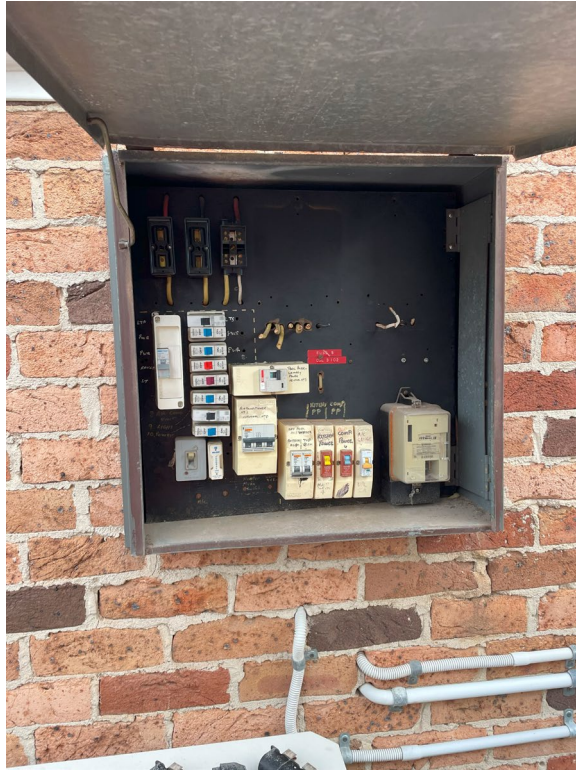
Switchboard backing board example.

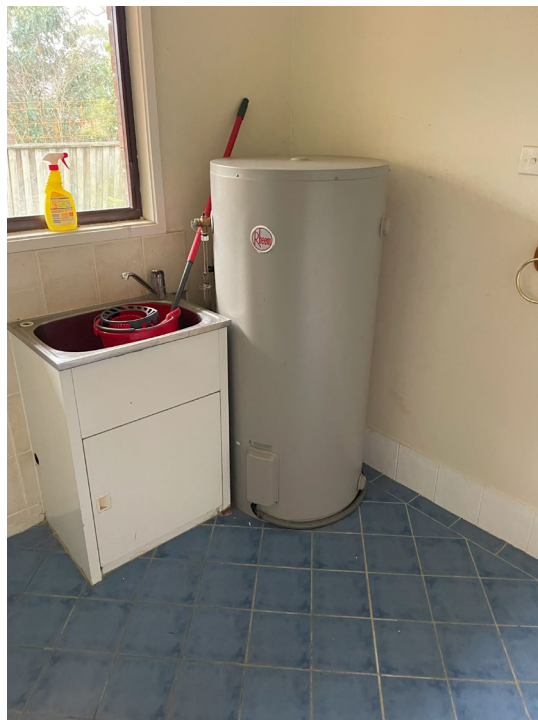
Hot water systems example.

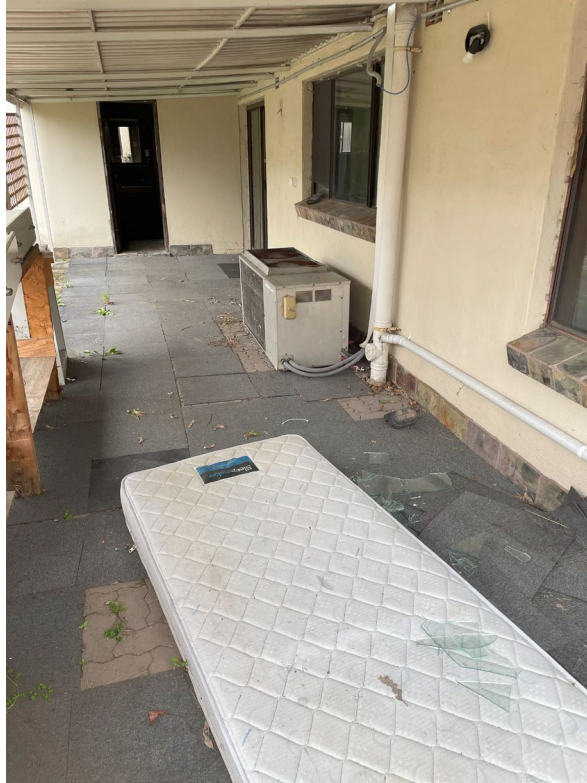
AC systems example.

Refrigerants and air conditioning units should be removed under controlled conditions by a licensed contractor prior to renovation or demolition works. Through field examination vapour compression cycles containing CFCs are expected to be present within the refrigerates and air conditioning units. A more detailed inspection and/or laboratory analysis would require a qualified refrigeration specialist who holds a Refrigerant Handling Licence to assess the vapour compression cycle.

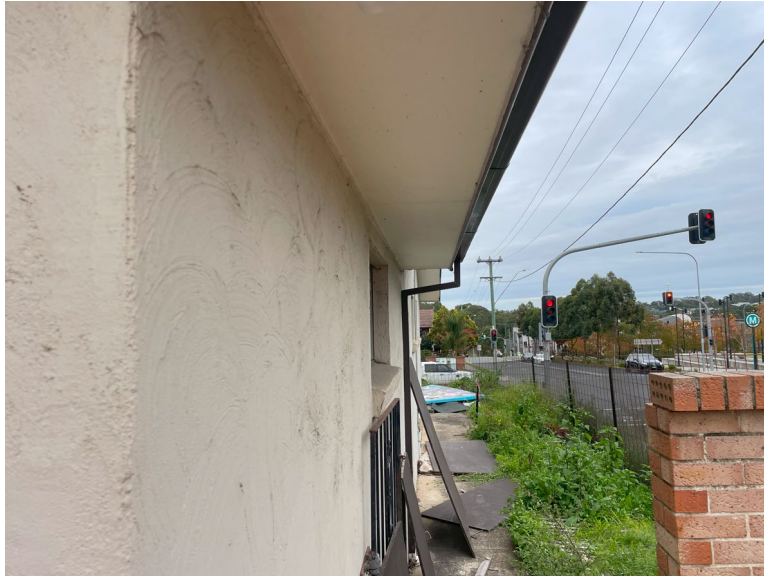
AS1: 2 Middleton Avenue, eaves of extension

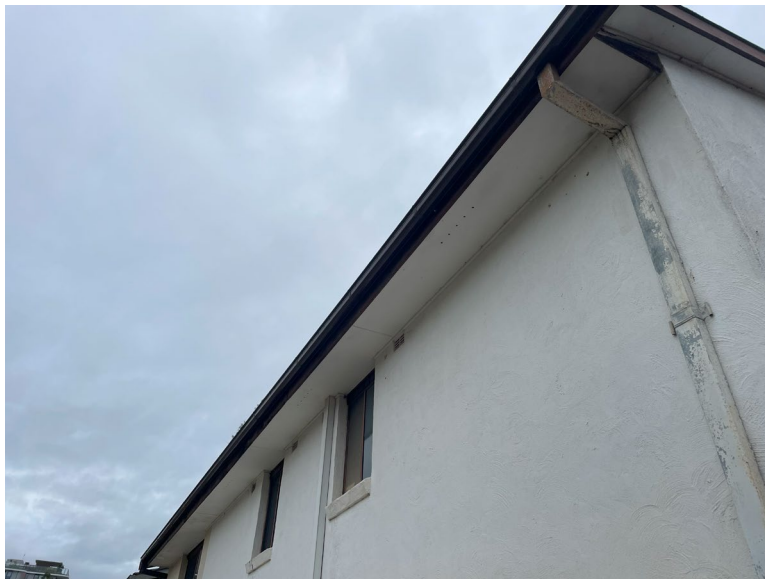
2 Middleton Avenue, eaves of main building

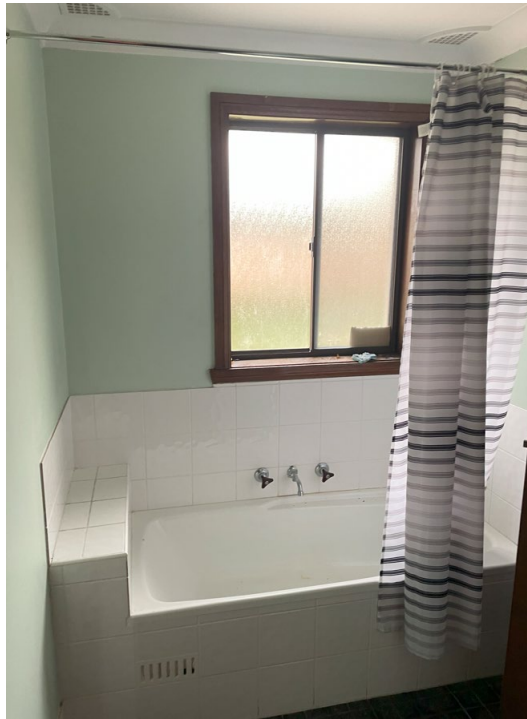
AS3	2 Middleton Avenue, upstairs bathroom.	Internal walls	Fibrous cement sheeting. Good condition.	<b>Material assessed and asbestos presence expected.</b>	Med	Non-friable	Not accessible without equipment.	<b>Licensed removal prior to demolition.</b>	N/A
N/A	2 Middleton Avenue, exterior.	Front veranda ceiling and panels	Fibrous cement sheeting. Good condition.	<b>Material assessed and asbestos presence expected.</b>	Med	N/A	Not accessible without equipment.	<b>Appropriate removal prior to demolition.</b>	N/A
N/A	4 Middleton Avenue, exterior.	Eaves of main building	Fibrous cement sheeting. Good condition.	<b>Material assessed and asbestos presence expected.</b>	Med	Non-friable	Not accessible without equipment.	<b>Licensed removal prior to demolition.</b>	N/A

AS3: 2 Middleton Avenue, second floor bathroom walls

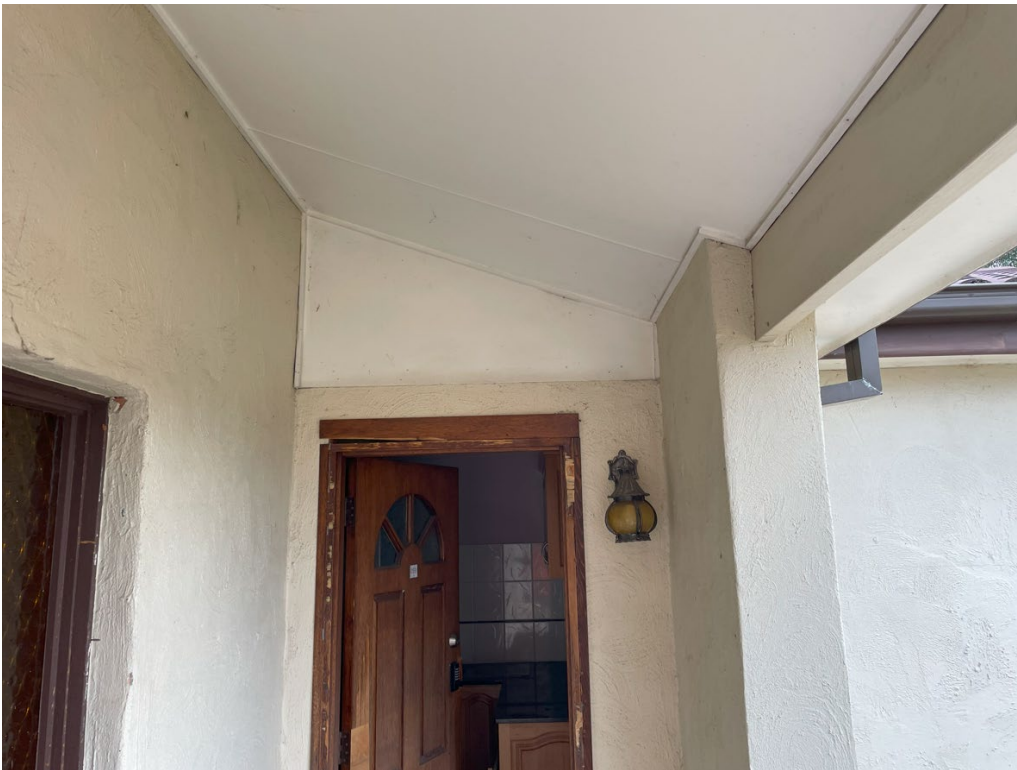
2 Middleton Avenue, veranda ceiling and panels

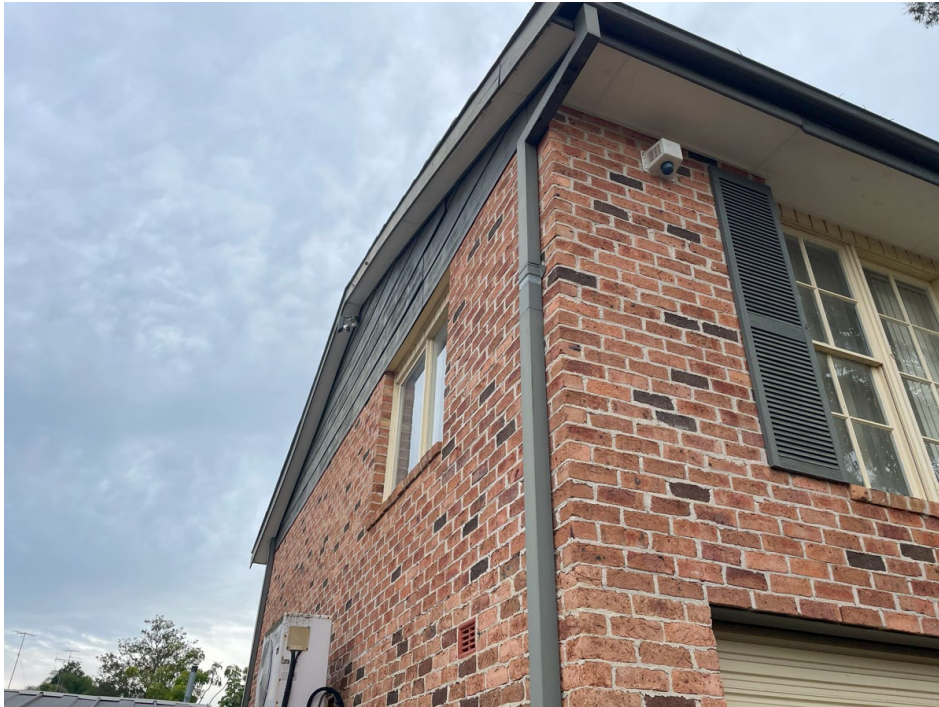
4 Middleton Avenue, exterior eaves

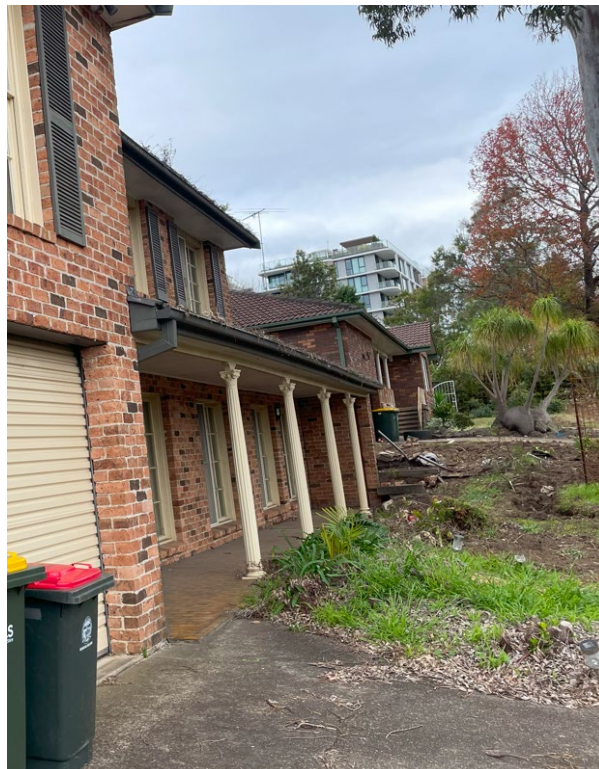
AS4	4 Middleton Avenue, ground floor exterior.	Front veranda ceiling	Fibrous cement sheeting. Good condition.	<b>Material assessed and asbestos presence expected.</b>	Med	Non-friable	Not accessible without equipment.	<b>Licensed removal prior to demolition.</b>	N/A
AS5	4 Middleton Avenue, ground floor exterior.	Facia cladding	Fibrous cement sheeting. Good condition.	<b>Material assessed and asbestos presence expected.</b>	Med	Non-friable	Not accessible without equipment.	<b>Licensed removal prior to demolition.</b>	N/A
AS6	4 Middleton Avenue, ground floor bathroom.	Internal walls	Fibrous cement sheeting. Good condition.	<b>Material assessed and asbestos presence expected.</b>	Med	Non-friable	Not accessible without equipment.	<b>Licensed removal prior to demolition.</b>	N/A
AS7	4 Middleton Avenue, ground floor garage.	Internal wall	Fibrous cement sheeting. Good condition.	<b>Material assessed and asbestos presence expected.</b>	Med	Non-friable	Not accessible without equipment.	<b>Licensed removal prior to demolition.</b>	N/A

AS4: 4 Middleton Avenue, veranda ceiling

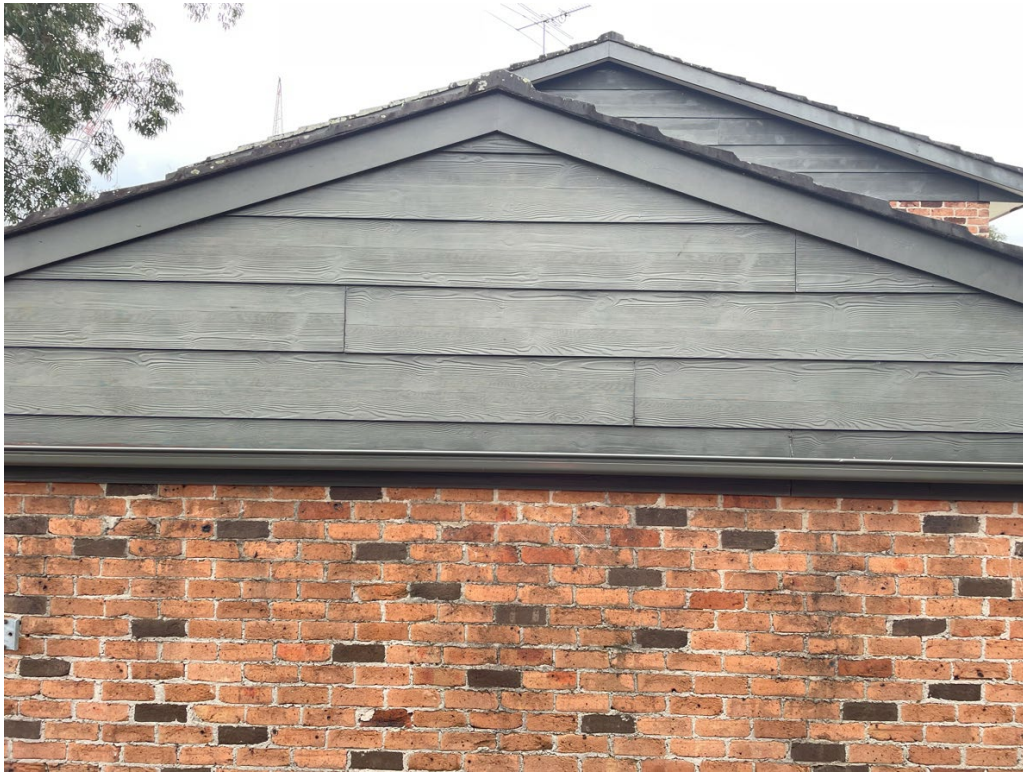
AS5: 4 Middleton Avenue, fascia cladding

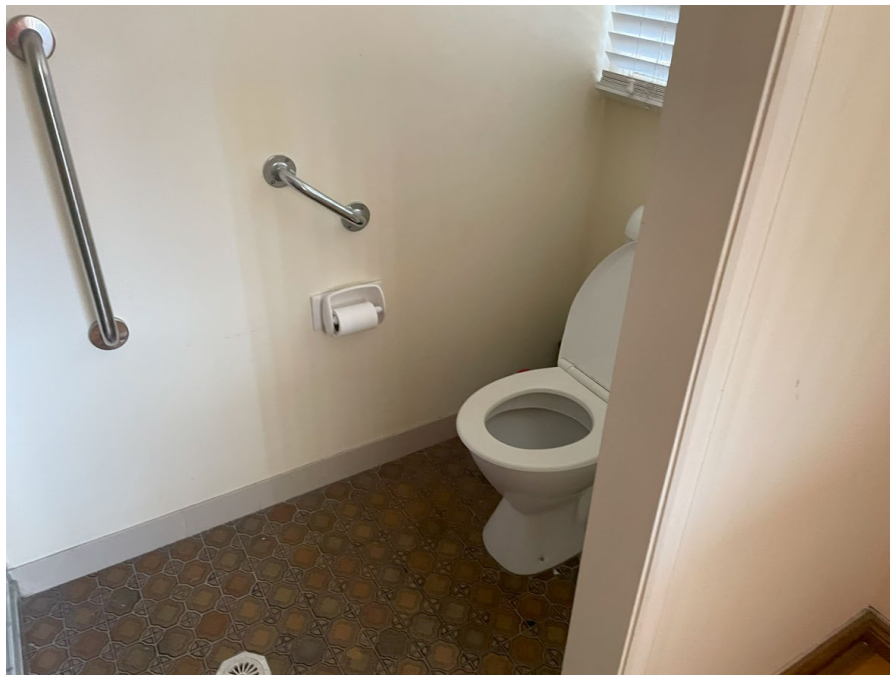
AS6: 4 Middleton Avenue, ground floor bathroom walls

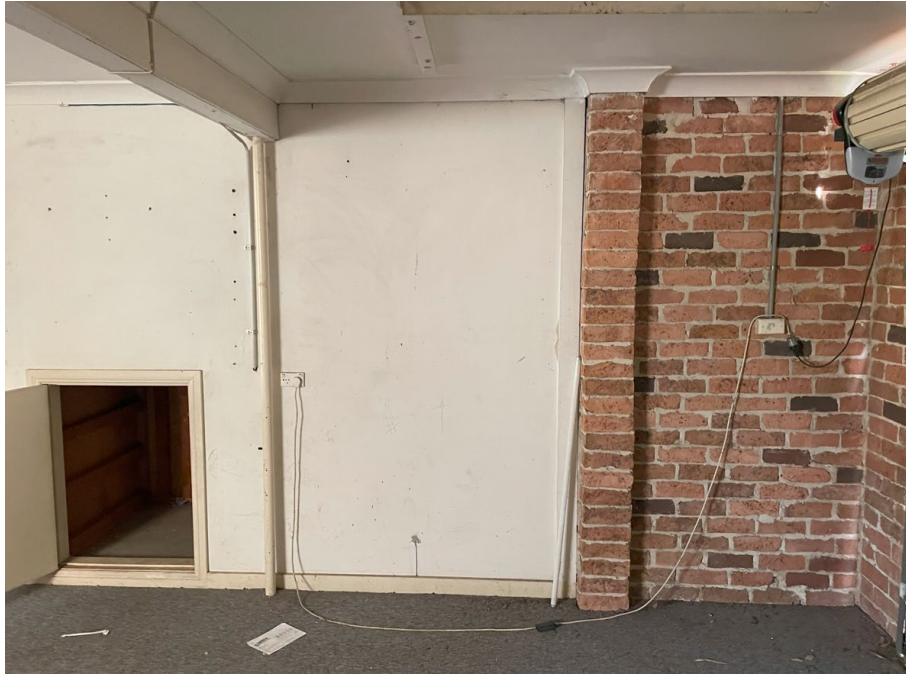
AS7: 4 Middleton Avenue, ground floor bathroom walls

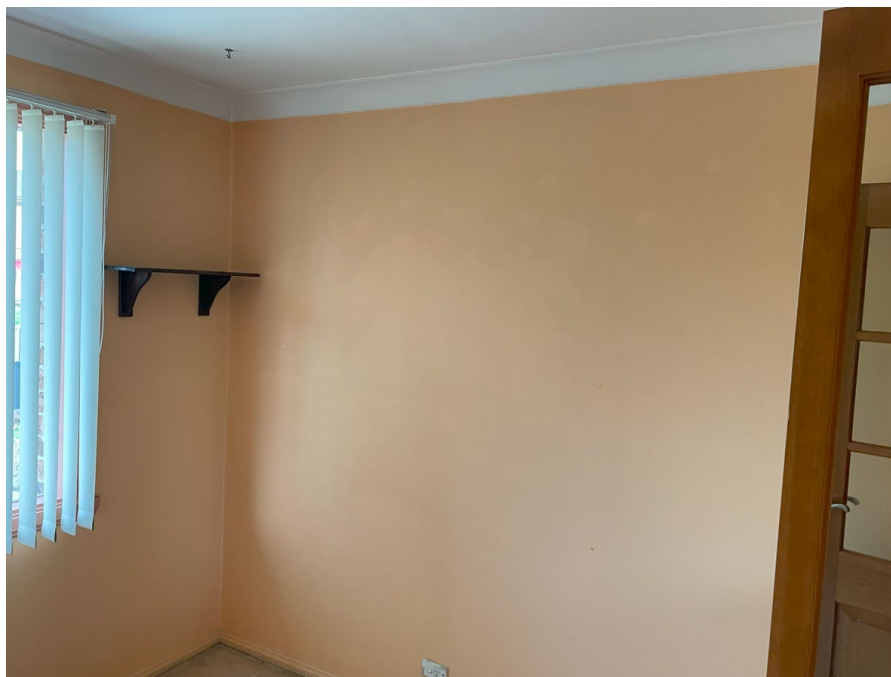
AS8	4 Middleton Avenue, second floor interior.	Orange internal wall.	Fibrous cement sheeting. Good condition.	<b>Material assessed and asbestos presence expected.</b>	Med	Non-friable	Not accessible without equipment.	<b>Licensed removal prior to demolition.</b>	N/A
N/A	6 Middleton Avenue, ground floor exterior.	Eaves of main building	Fibrous cement sheeting. Good condition.	<b>Material assessed and asbestos presence expected.</b>	Med	Non-friable	Not accessible without equipment.	<b>Licensed removal prior to demolition.</b>	N/A
N/A	6 Middleton Avenue, ground floor garage.	Ceiling	Fibrous cement sheeting. Good condition.	<b>Material assessed and asbestos presence expected.</b>	Med	Non-friable	Not accessible without equipment.	<b>Licensed removal prior to demolition.</b>	N/A
AS9	6 Middleton Avenue, ground floor garage.	Internal wall	Fibrous cement sheeting. Good condition.	<b>Material assessed and asbestos presence expected.</b>	Med	Non-friable	Not accessible without equipment.	<b>Licensed removal prior to demolition.</b>	N/A

AS8: 4 Middleton Avenue, second floor internal wall

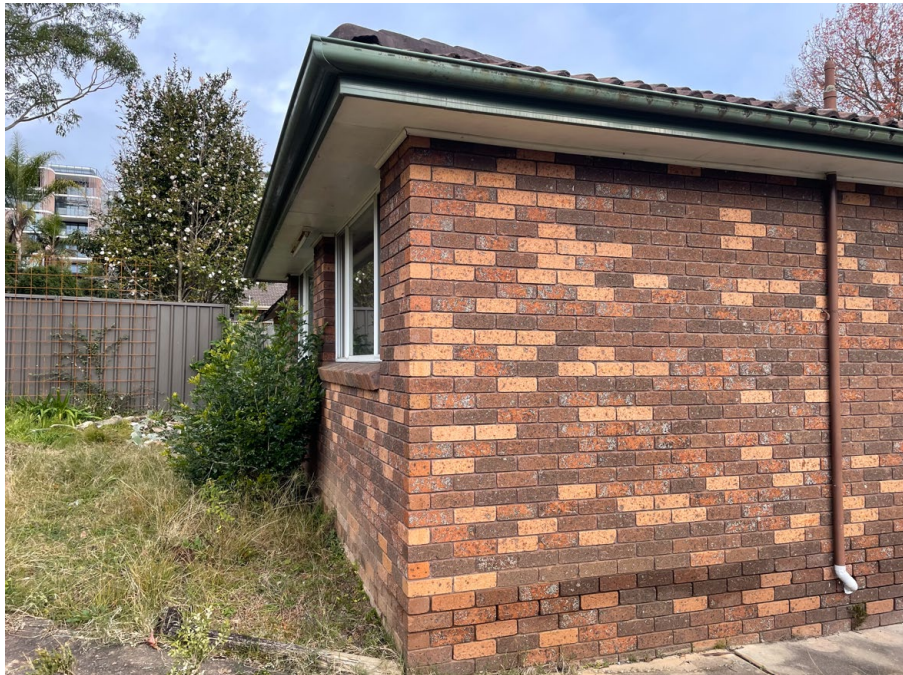
6 Middleton Avenue, exterior eves

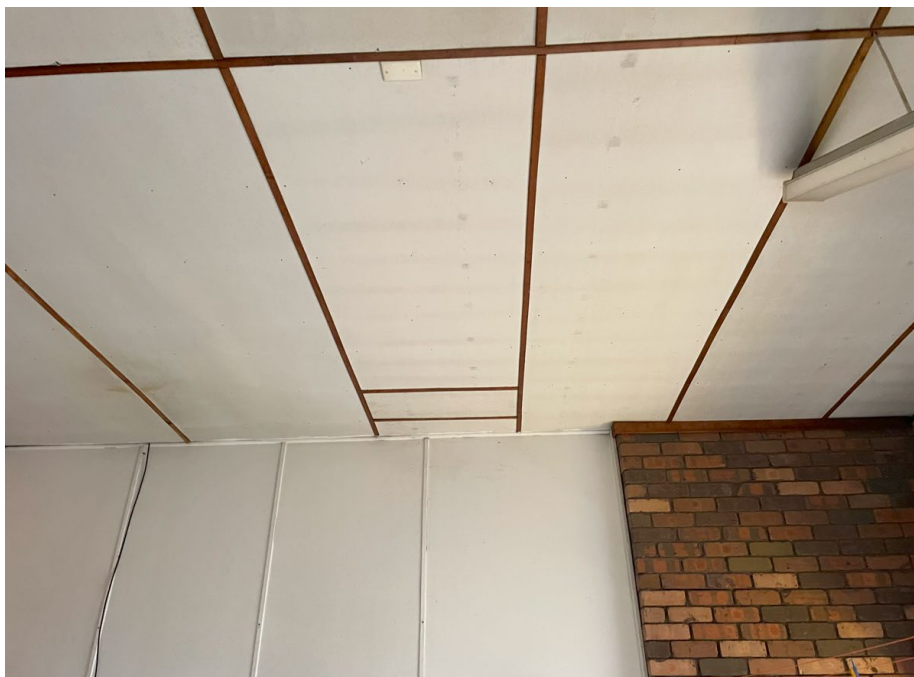
6 Middleton Avenue, garage ceiling

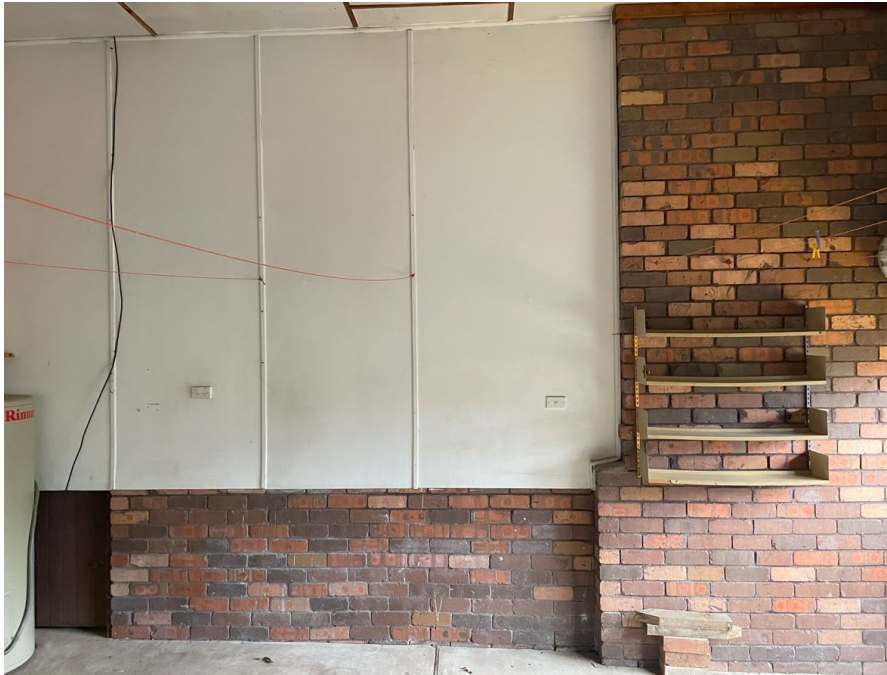
AS9: 6 Middleton Avenue, garage internal walls

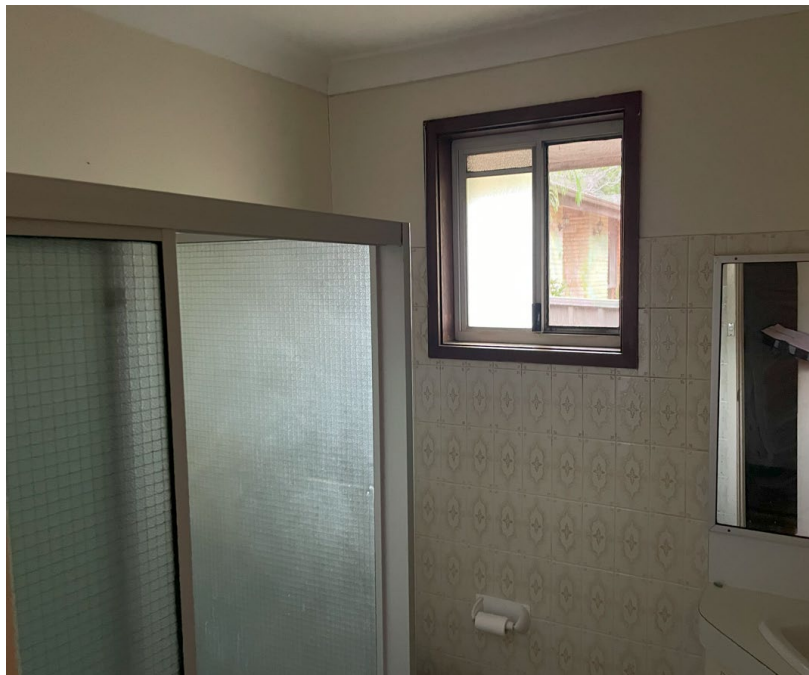
AS10	6 Middleton Avenue, internal bathroom.	Internal walls	Fibrous cement sheeting. Good condition.	<b>Material assessed and asbestos presence expected.</b>	Med	Non-friable	Not accessible without equipment.	<b>Licensed removal prior to demolition.</b>	N/A

AS10: 6 Middleton Avenue, internal bathroom walls

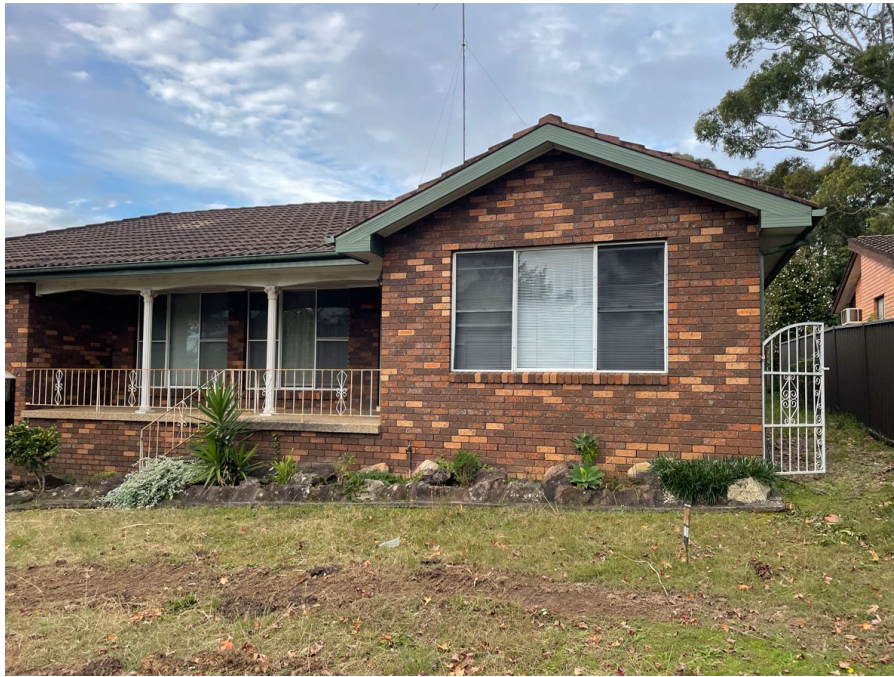
AS11	6 Middleton Avenue, ground floor exterior.	Front veranda ceiling	Fibrous cement sheeting. Good condition.	<b>Material assessed and asbestos presence expected.</b>	Med	Non-friable	Not accessible without equipment.	<b>Licensed removal prior to demolition.</b>	N/A
AS12	10 Middleton Avenue, ground floor exterior.	Facia cladding	Fibrous cement sheeting. Good condition.	<b>Material assessed and asbestos presence expected.</b>	Med	Non-friable	Not accessible without equipment.	<b>Licensed removal prior to demolition.</b>	N/A
N/A	10 Middleton Avenue, exterior.	Eaves of main building	Fibrous cement sheeting. Good condition.	<b>Material assessed and asbestos presence expected.</b>	Med	Non-friable	Not accessible without equipment.	<b>Licensed removal prior to demolition.</b>	N/A
AS13	10 Middleton Avenue, ground floor laundry.	Internal walls	Fibrous cement sheeting. Good condition.	<b>Material assessed and asbestos presence expected.</b>	Med	Non-friable	Not accessible without equipment.	<b>Licensed removal prior to demolition.</b>	N/A

AS11: 6 Middleton Avenue, front veranda ceiling

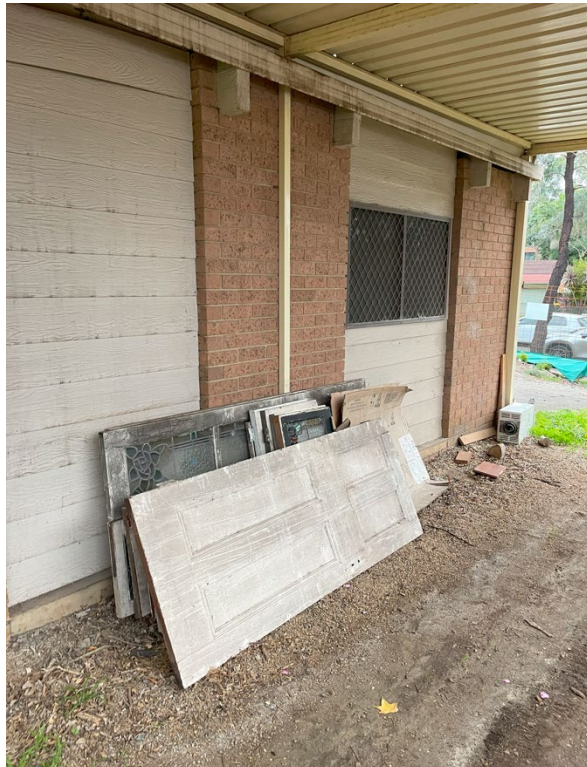
AS12: 10 Middleton Avenue, external cladding

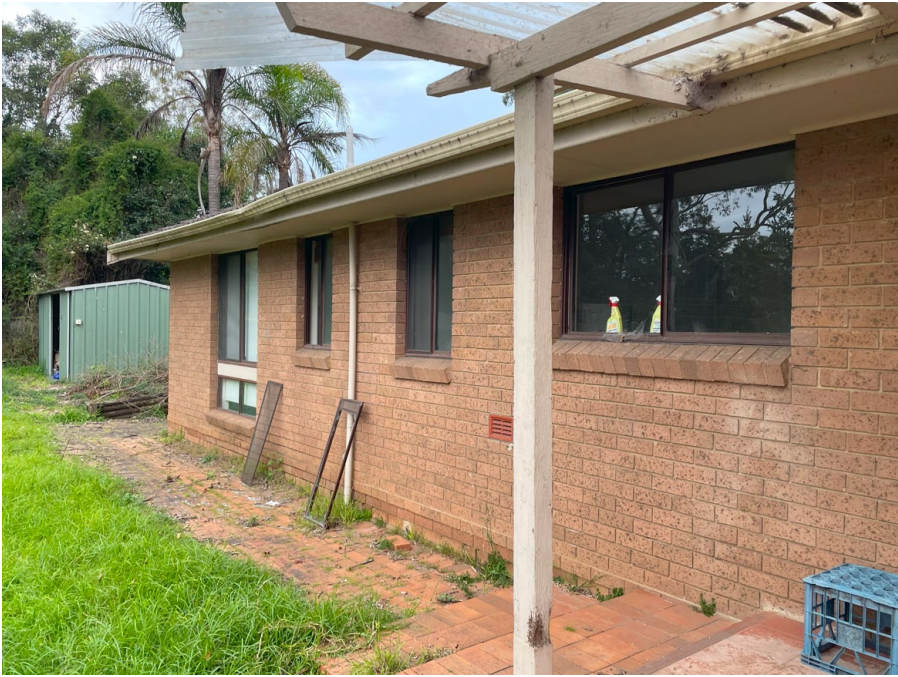
10 Middleton Avenue, external eves

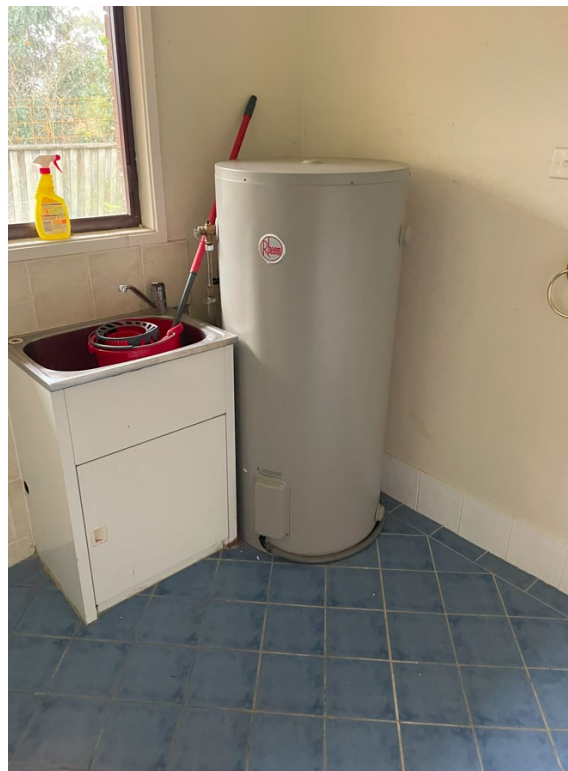
AS13: 10 Middleton Avenue, laundry walls
