# arboricultural impact assessment report

Revision A, Issued for SSDA  
2 September 2025

## AFFORDABLE HOUSING

211A-215 Harbour Drive,  
Coffs Harbour, NSW, 2450

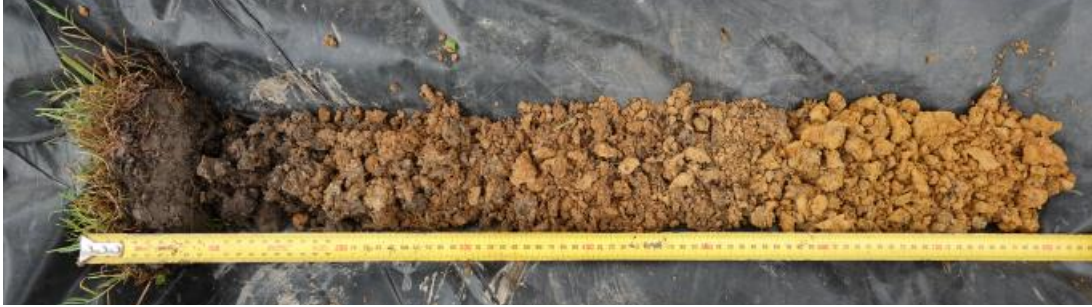
A representative soil sample was taken in the field, near Tree T24 in the lower south of the site. The results from the sample taken were somewhat reflective of the naturally occurring soils and did indicate a yellow podzolic soil. From the topsoil sample taken at a 200mm depth, the soil structure was strongly pedal with medium to coarse sub angular blocky peds. The soil texture was a clay loam trending towards light clay with the colour being a mid to dark brown. The soil was neutral with a pH of 7.0-7.5. There was moderately distinct change from A to B horizons at around 500mm depth. The subsoil from a depth of 700mm was also sampled. The subsoil structure was very strongly pedal with fine to moderate sub angular blocky peds. The soil texture was a light to medium clay. Its colour was orange brown. The soil pH was moderately acidic at pH 5.5

Figure 2.7 – Topsoil sample / profile noting extremely light to medium clay subsoil. (Photos: Arterra 8 March 2025).

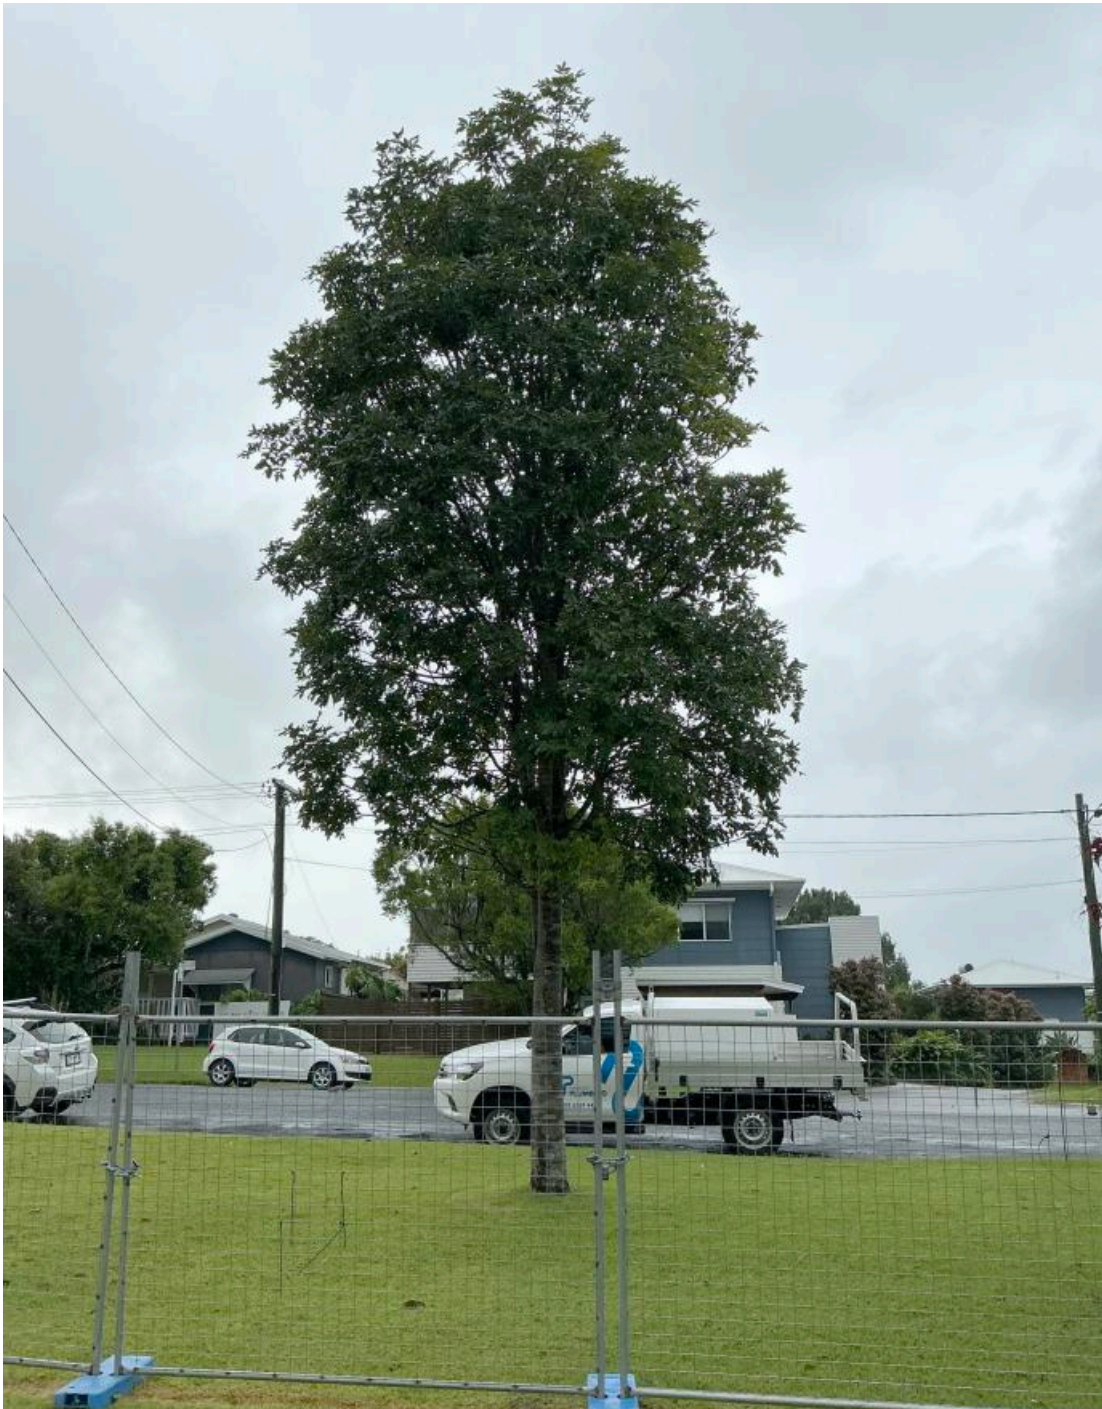
Figure 2.9 – 'High' retention value street tree T01 (*Flindersia australis*) at right, on the North Street frontage. (Photo: Arterra 8 March 2025)

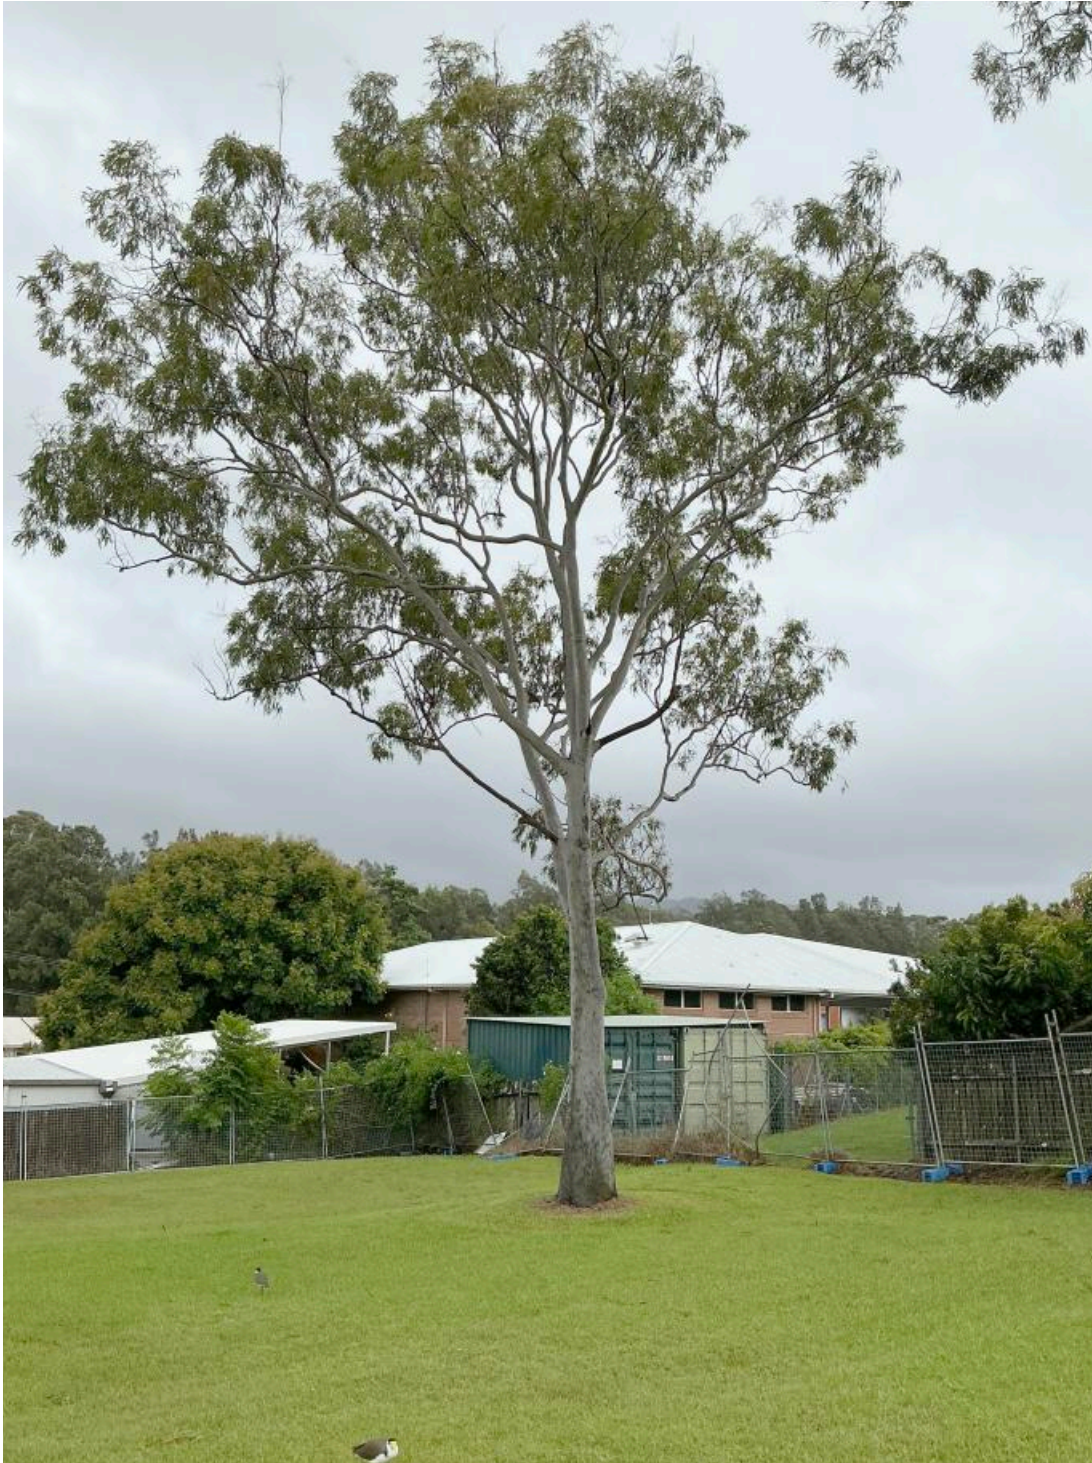
Figure 2.10 – 'Moderate' retention value tree T11 (*Corymbia citriodora*) near the northern site boundary. (Photo: Arterra 8 March 2025)

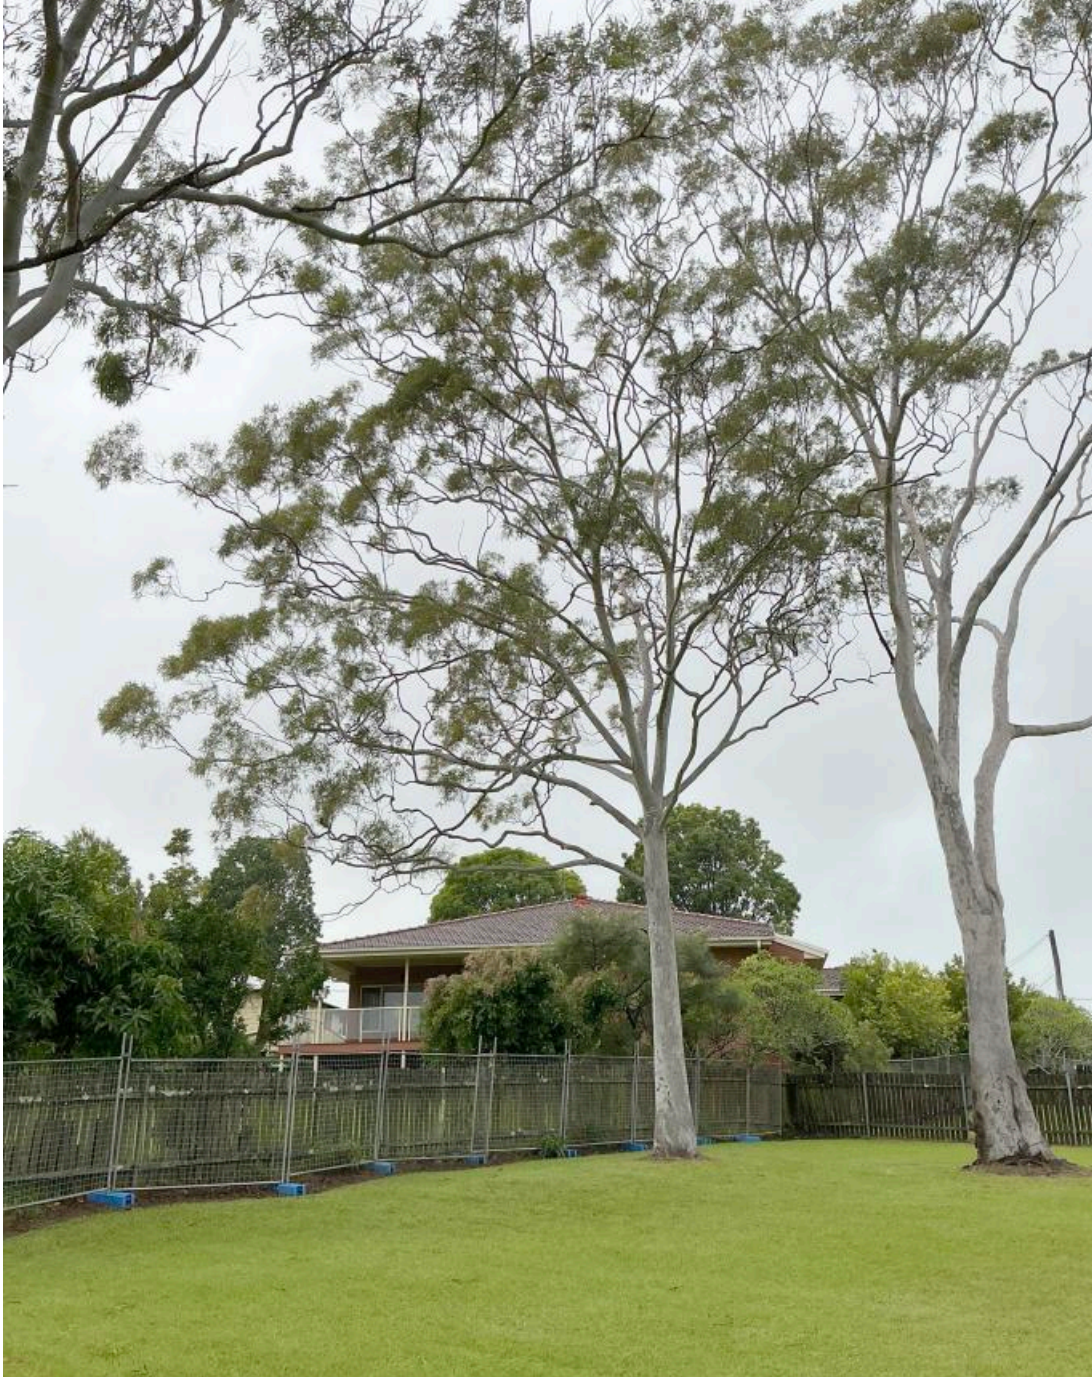
Figure 2.11 – 'Moderate' retention value tree T112(*Corymbia citriodora*) near the northern site boundary. (Photo: Arterra 8 March 2025)

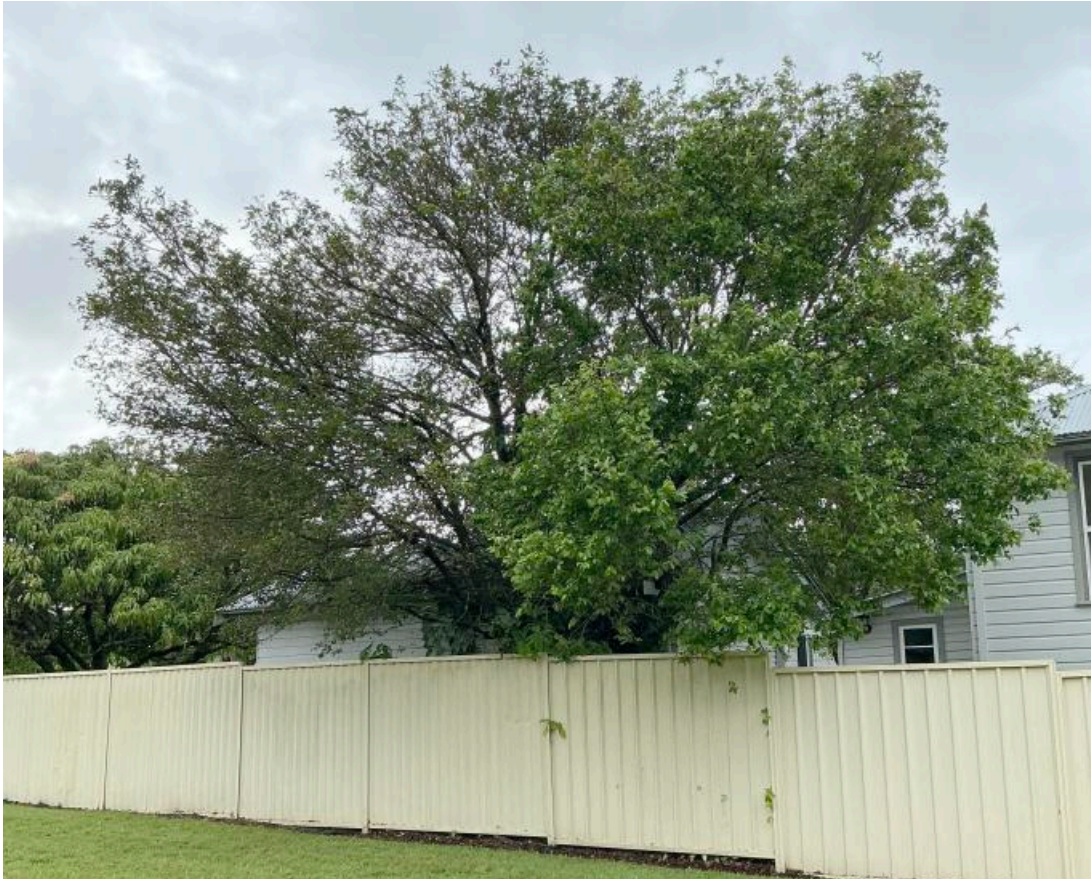
Figure 2.12 – ‘Moderate’ retention value tree T36 (*Glochidion ferdinandi*) in adjacent property to the east. (Photo: Arterra 8 March 2025)

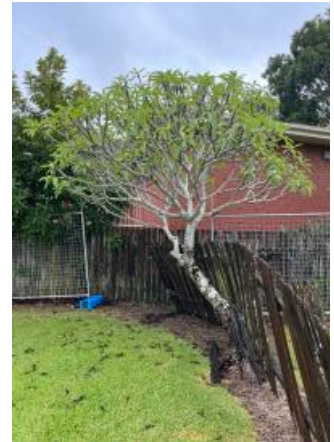
**ID # 004**  
 Species: *Plumeria rubra*  
 Common: Frangipani  
 Height: 4.0  
 No. in grp 1  
 DBH: 0.17 DGL: 0.19  
 TPZ: 2.04 SRZ: 1.65  
 Current Form: Poor  
 Current Vigour: Fair  
 Age Class: Mature  
 SULE: Replaceable  
 Retention Value: **Low**

Major lower trunk lean, then corrected in upper canopy. Small tree, replaceable.

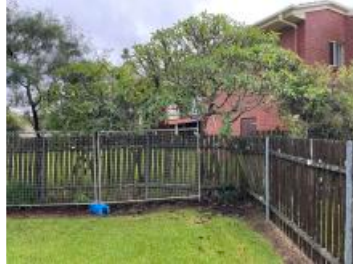
**ID # 007**  
 Species: *Plumeria rubra*  
 Common: Frangipani  
 Height: 4.0  
 No. in grp 2  
 DBH: 0.16 DGL: 0.22  
 TPZ: 2 SRZ: 1.75  
 Current Form: Average  
 Current Vigour: Fair  
 Age Class: Mature  
 SULE: Replaceable  
**Retention Value: Low**  
**Comments**

Neighbouring property tree, very close to fenceline.

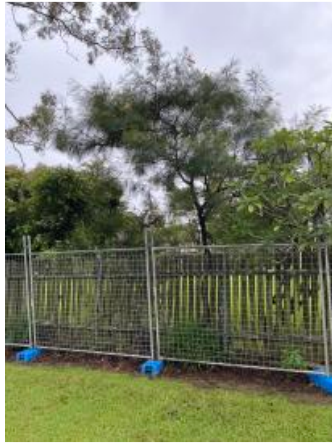
**ID # 008**  
 Species: *Grevillea 'Sandra Gordon'*  
 Common: *Grevillea* Cultivar  
 Height: 5.0  
 No. in grp 1  
 DBH: 0.09 DGL: 0.11  
 TPZ: 2 SRZ: 1.5  
 Current Form: Average  
 Current Vigour: Good  
 Age Class: Mature  
 SULE: Medium (15-40 years)  
**Retention Value: Low**  
**Comments**

Neighbouring property tree, very close to fenceline.

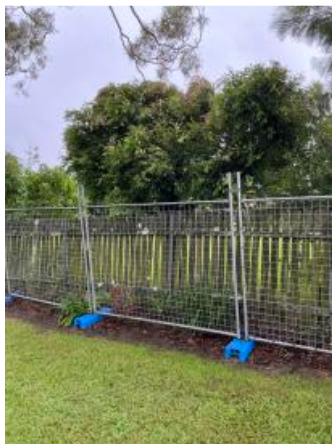
Neighbouring property tree, very close to fenceline. Previously heavily pruned.

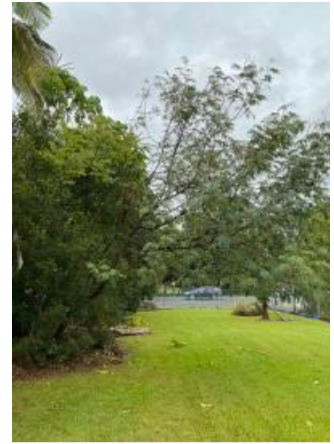
**ID # 028**  
Species: Albizia julibrissin  
Common: Persian Silk Tree  
Height: 7.0  
No. in grp 1  
DBH: 0.17 DGL: 0.24  
TPZ: 2.04 SRZ: 1.82  
Current Form: Poor  
Current Vigour: Fair  
Age Class: Semi-mature  
SULE: Remove (<5 years)  
Retention Value: **Nil / Remove**  
**Comments**

Somewhat invasive species. Likely self sown. Very poor form.

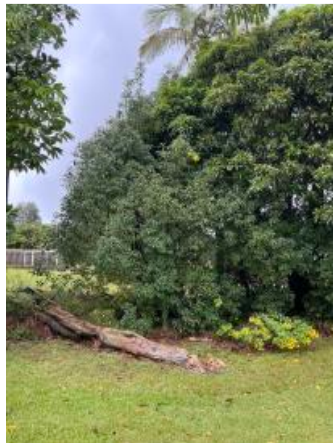
Group of four self sown, saplings. Invasive and undesirable species, should be removed.

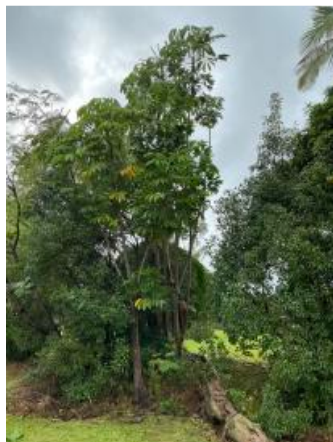
Also includes smaller self sown sapling coming through nearby Mango. Generally invasive and undesirable exotic species. Larger specimens dimensions given.
