28<sup>th</sup> November 2017

**Re: Retention of the *Eucalyptus tereticornis* (Forest Red Gum) located near the existing dam at 120-126 Hezlett Road, North Kellyville**

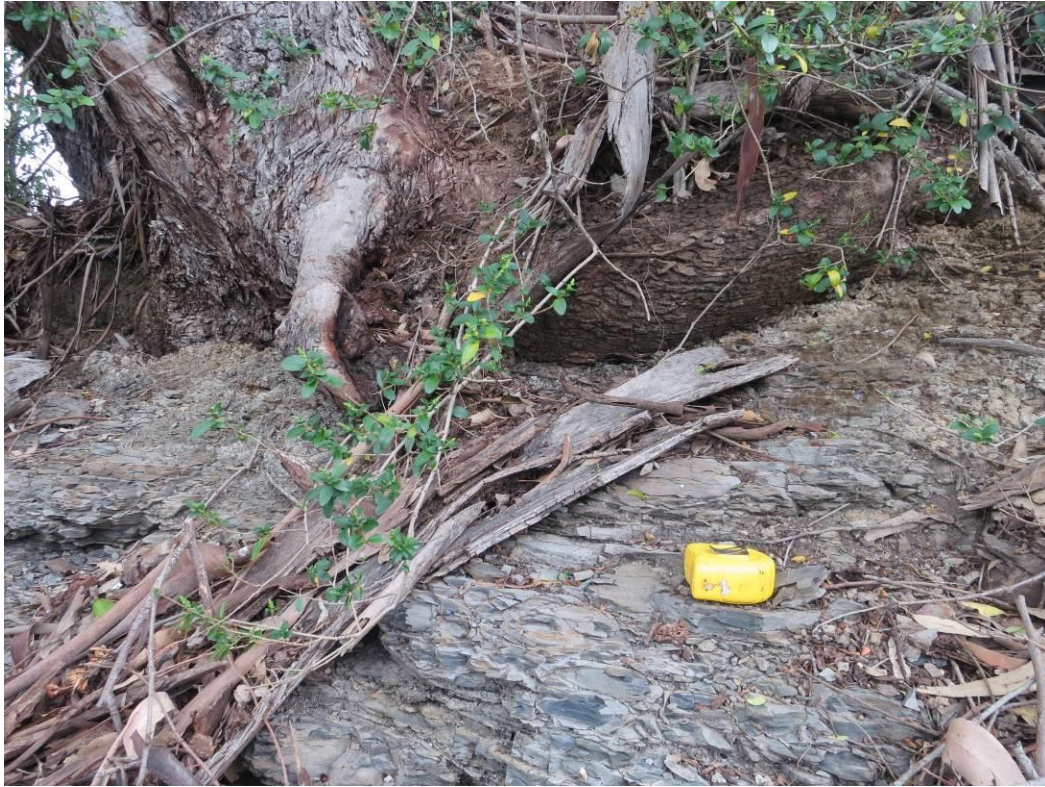
After close observation of the exposed soil profile on the side of the dam and beneath the existing root buttress of the interconnecting tree trunks, it is determined that the base of the root buttress is 200mm above shale bedrock (**Images 1 & 2**). Based on this observation, the majority of the root mass is likely to only inhabit the soil to the southern side of the tree (**Image 8**). Therefore, filling to the proposed RL of +73.00 as per the landscape plan will not contribute to tree impact from the development.

**Image 1** – Photo taken from north/dam side of tree, showing shale beneath the root buttress of the tree

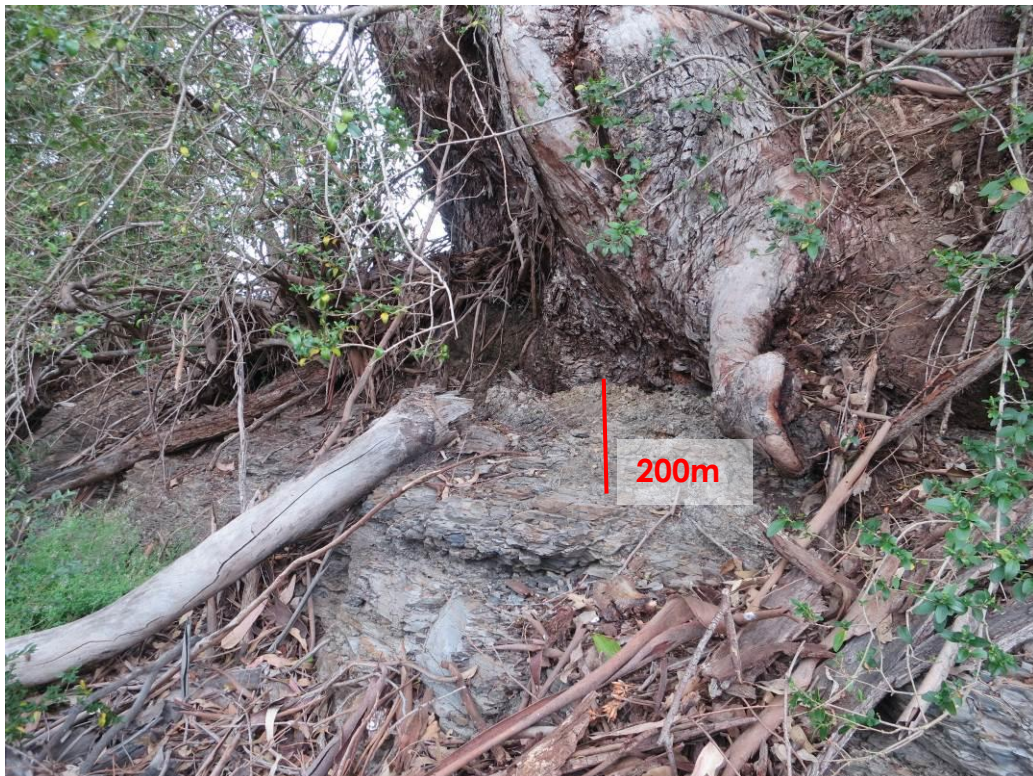
**Image 2** – Shale beneath the root buttress of the tree, 200mm below.

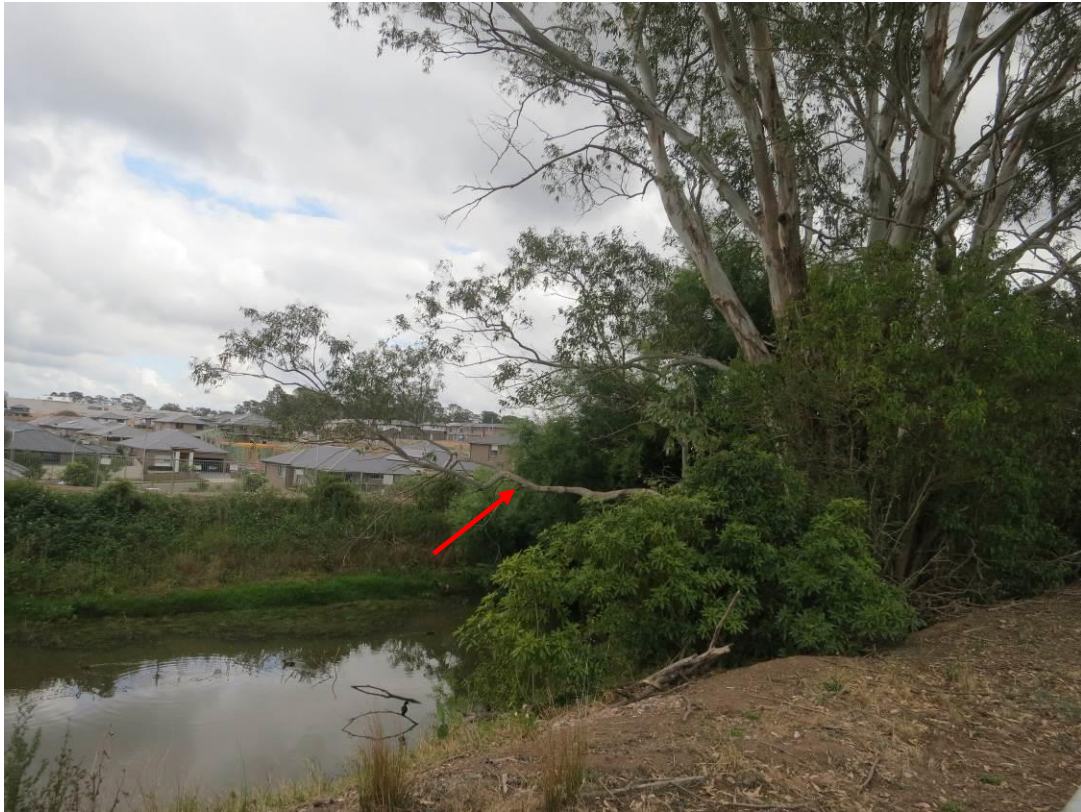
There is a lateral branch extending over the existing dam to the north of the tree (**Image 3**). This will require pruning to provide pedestrian access, as this may become a hazard once the dam is filled.

**Image 3** – Photo taken from south-west, showing lateral branch over dam that will require removal

- Tree pruning of the tree trunk 'Tree 1A' and the lateral branch above the existing dam should be undertaken by a Level 3 Arborist. The final cut of 'Tree 1A' should be approximately 200mm above the existing ground level without stump grinding the root plate. Please refer to the images regarding pruning and the Tree Location Plan that indicates which trunk is to be removed.

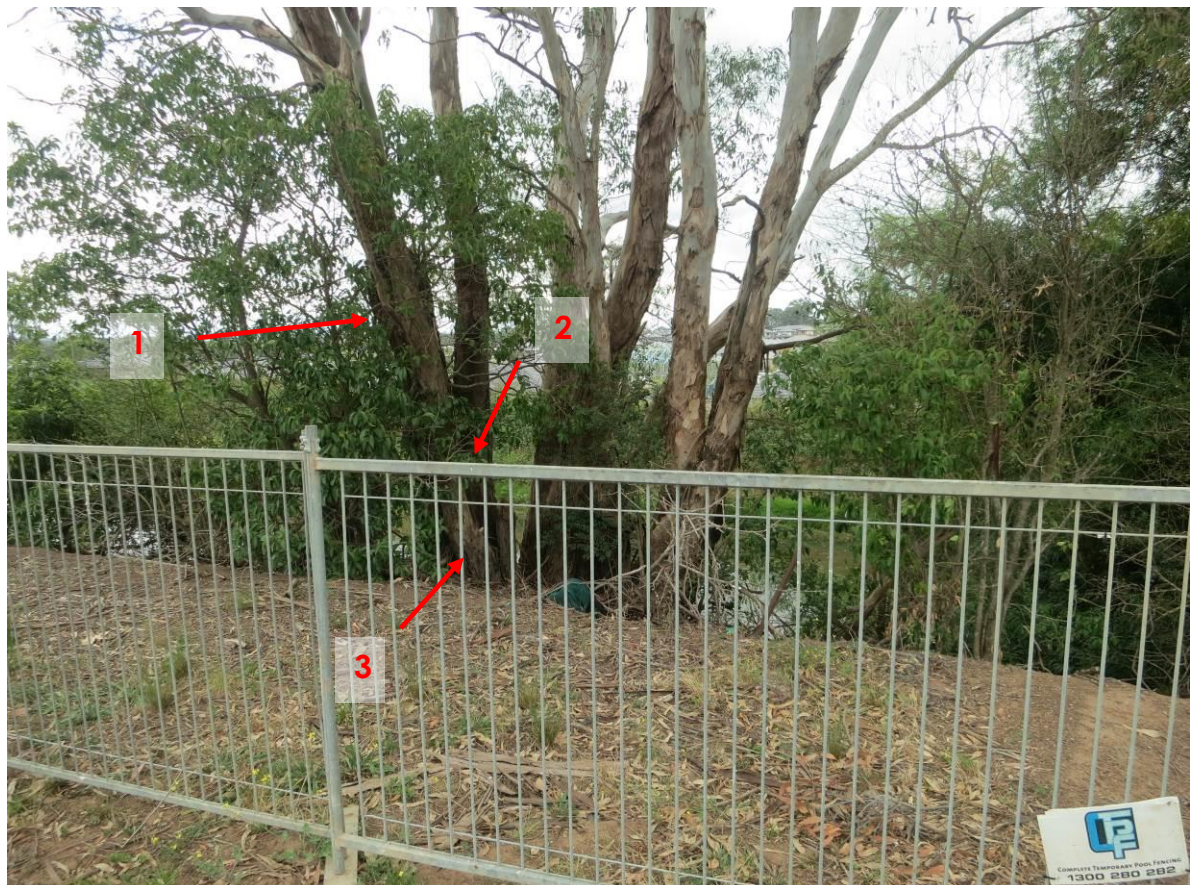
Upon closer inspection of the tree's structure on the 22/11/17, defects were sighted on the south-western trunk that will be of great concern once the occupancy of the surrounding area is increased as a result of the proposed school. The trunk referred to as Tree 1A on the data sheet, has inclusions (structural defects that cause weakness and possible internal decay) at 0.5m and 2.5m bifurcations (**Images 4, 5 & 6**) that have the potential to fail during severe weather during stages of prolonged stress that may be suffered by the tree during construction and/or periods of drought. There is also a cavity at the smaller diameter stem's base (**Images 4 & 5**) which is also of concern once the occupancy of the surrounding area is increased. This cavity is considered to be a structural defect. No habitat was observed within the

cavity, and there were no other cavities/hollows observed to be within the tree's crown during the ground-based tree assessment.

**Image 4** – Photo taken from south-east, showing location of structural defects (1, 2 & 3)

If this trunk (Tree 1A) is to remain, the likelihood of failure would potentially increase due to unforeseen loss of vigour and changes in the surrounding area, if construction impacts are excessive and negligence to tree protection measures are not put in place. Removing this trunk with the identified defects, to ground level would eliminate the risk of this part of the tree causing injury or damage.

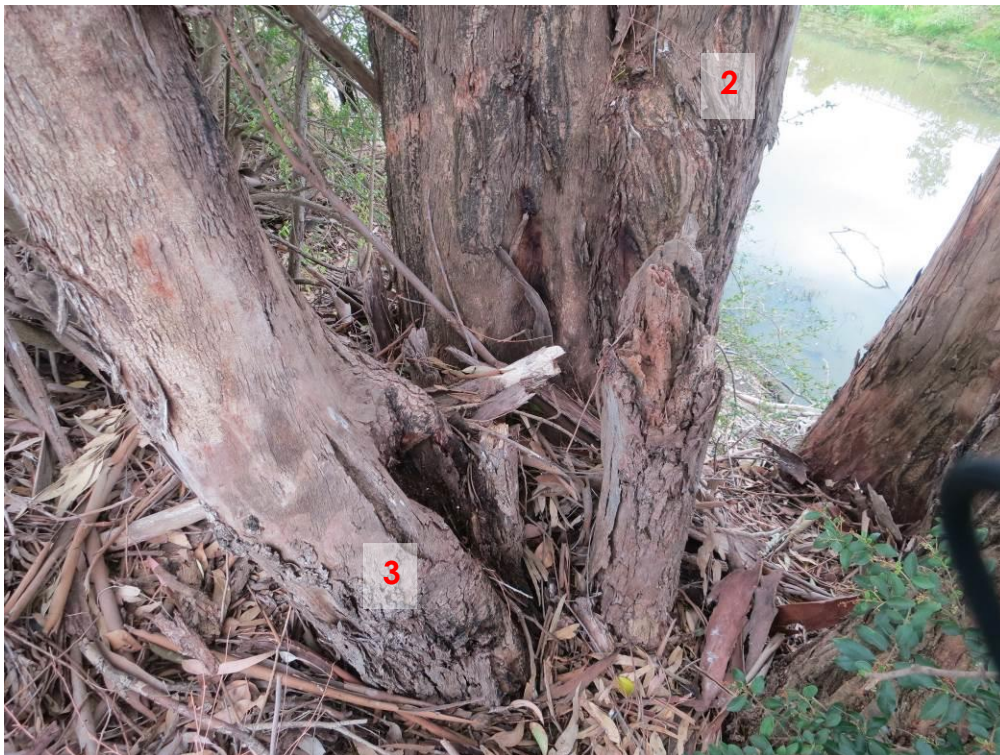
**Image 5** –Structural defects 2 & 3, near base of tree. Inclusion (2) and cavity (3)

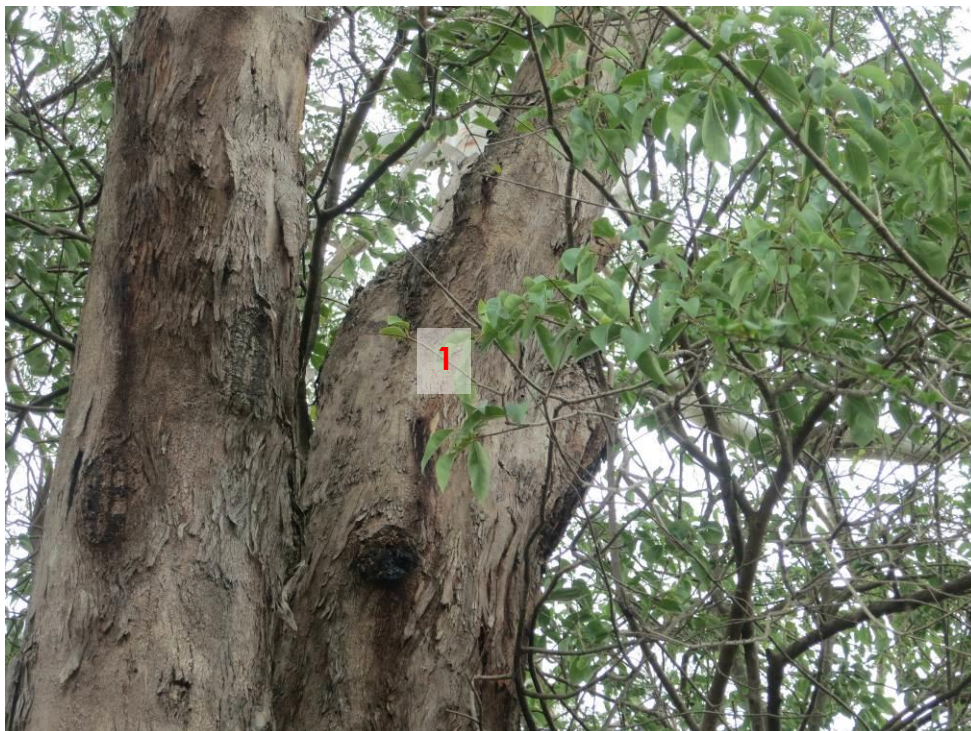
**Image 6** –Structural defect 1 at 2.5m from ground. Inclusion (1)

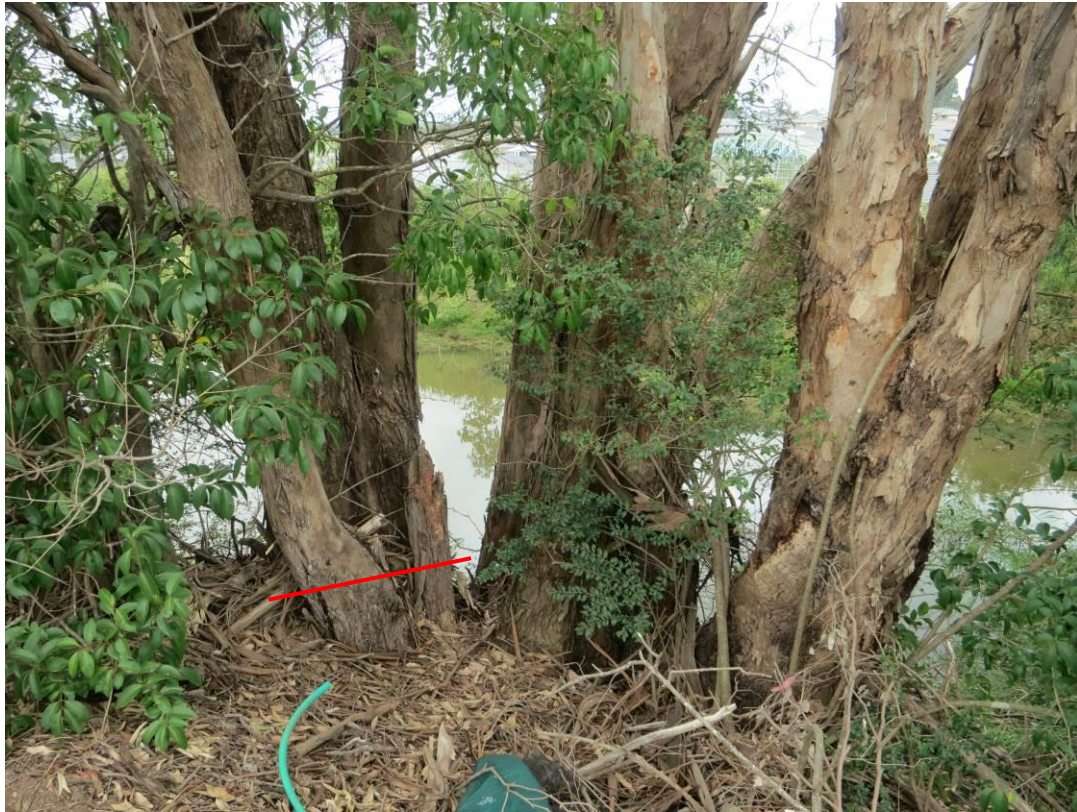
This pruning would result in a 25-30% loss of combined crown and associated sugar reserves that would have a moderate but sustainable impact on the tree. The pruning is unlikely to compromise the overall structure or increase the likelihood of failure of the remaining crown and the tree would remain prominent in the surrounding landscape. The final cut should be approximately 200mm above ground level without stump grinding the root plate (**Image 7**).

**Image 7** –Recommended location of cut to remove tree part with defects, indicatively 200mm above natural ground level

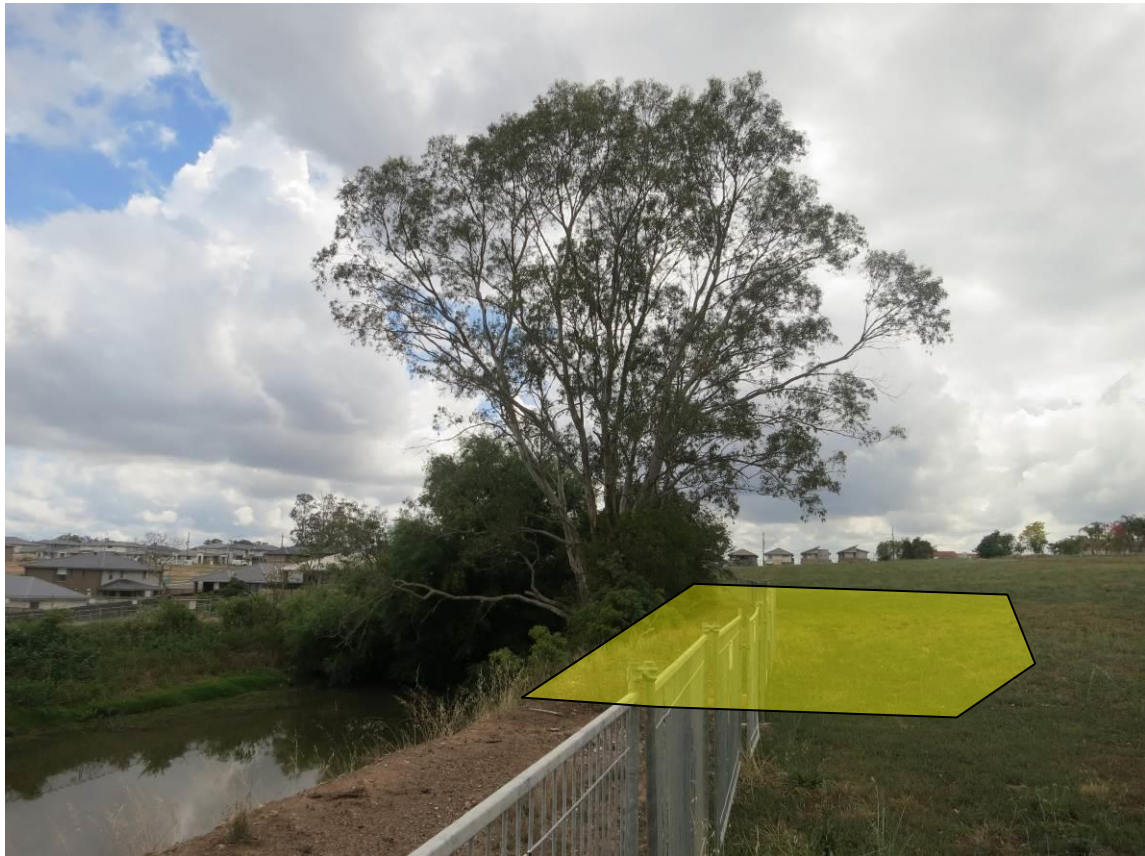
This tree/group of trees growing in close proximity is of high significance in the surrounding landscape and a dominant canopy tree of the endangered Cumberland Plain Woodland ecological community, which is the indigenous vegetation of the area. The tree has frontline exposure to all varying wind conditions (**Image 8**). The Department of Planning NSW requires this tree to be retained and protected.

**Image 8** –Photo of tree taken from west, showing exposure, landscape significance and indicative assumed area of tree's root system (yellow area)
