## Six Mile Lane, Old Six Mile Lane and Airport Road, Glenugie

Existing stage road safety audit

TRF-PROJ-0024-01 ES RSA GLENUGIE REV 1

19/11/2019

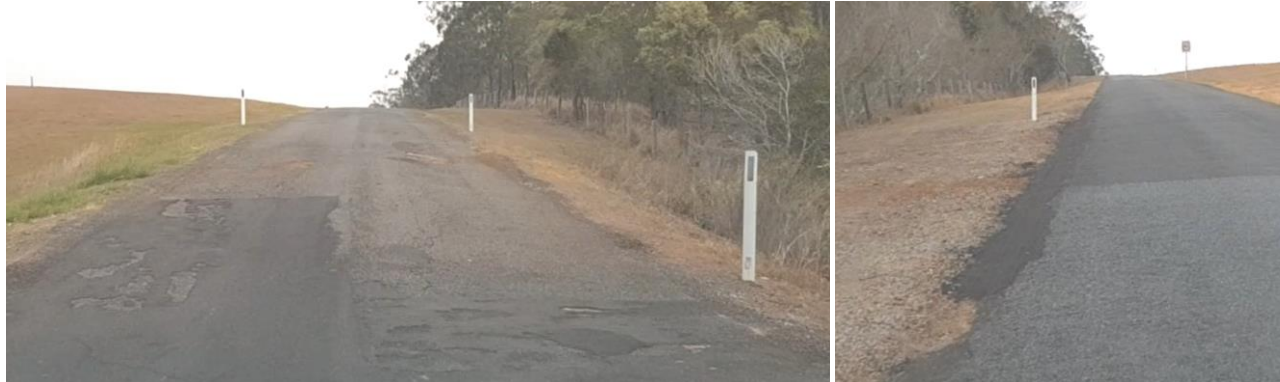
Ref	Location	Road safety audit finding – Airport Road	Priority
2-1a	Airport Road, between Old Six Mile Lane and the Clarence Valley Airport – General comment on pavement width and condition.	<p>In general, Airport Road has an approximate sealed width of 5m. This is narrow for two-way travel and as the principle access road to the Clarence Valley Airport. The narrow sealed width generally increases the risk of <i>head-on</i> crashes between northbound and southbound vehicles. There may also be more likelihood of wheel tracking over the edges of seal and onto the soft verge areas. This could increase the risk of <i>loss of control</i> crashes.</p> <p>Further to the narrow sealed width, there were numerous pavement failures including potholes and associated patchwork, cracked/ jagged edges and tacked on repair work. The poor edge conditions may increase the risk of <i>loss of control</i> crashes in two ways. Firstly, by offering insufficient sealed shoulder for recovery/ corrective steering or deceleration of errant vehicles. Secondly, any attempt to recover and steer back into the trafficable portion of the road could lead to tyre scrubbing on the prominent vertical lips at the edge of pavement. Frequent wheel tracking is also suspected as the cause of pavement edge and width deterioration. That is, wheel tracking on the edges leads to damage, which makes the sealed width narrower and hence increases the likelihood of future wheel tracking over the newly formed edges. The subsequent wheel tracking over the edges leads to further damage and the process repeats itself.</p> <p>Table 4.5 of the Austroads <i>Guide to Road Design Part 3</i> indicates that the minimum sealed width for a two-lane-two-way rural road (assuming that the traffic volume does not exceed 500 vehicles/day) is 7.2m. This is based on 2 x 3.1m lanes and 0.5m sealed shoulders either side. A 7.2m sealed width would vastly improve safety conditions on Airport Road.</p>

<p><b>Left:</b> Looking southbound along Airport Road showing the limited width of seal and the poor edge conditions. Note also the potholes and associated patchwork. <b>Right:</b> Looking northbound at an example of a degraded edge. The repair effort included a tacked on strip of asphalt with limited work to the sub-base. The tacked on portion appears to be on top of granular, unbound material with little structural capacity. Hence it is susceptible to ongoing damage.</p>	High

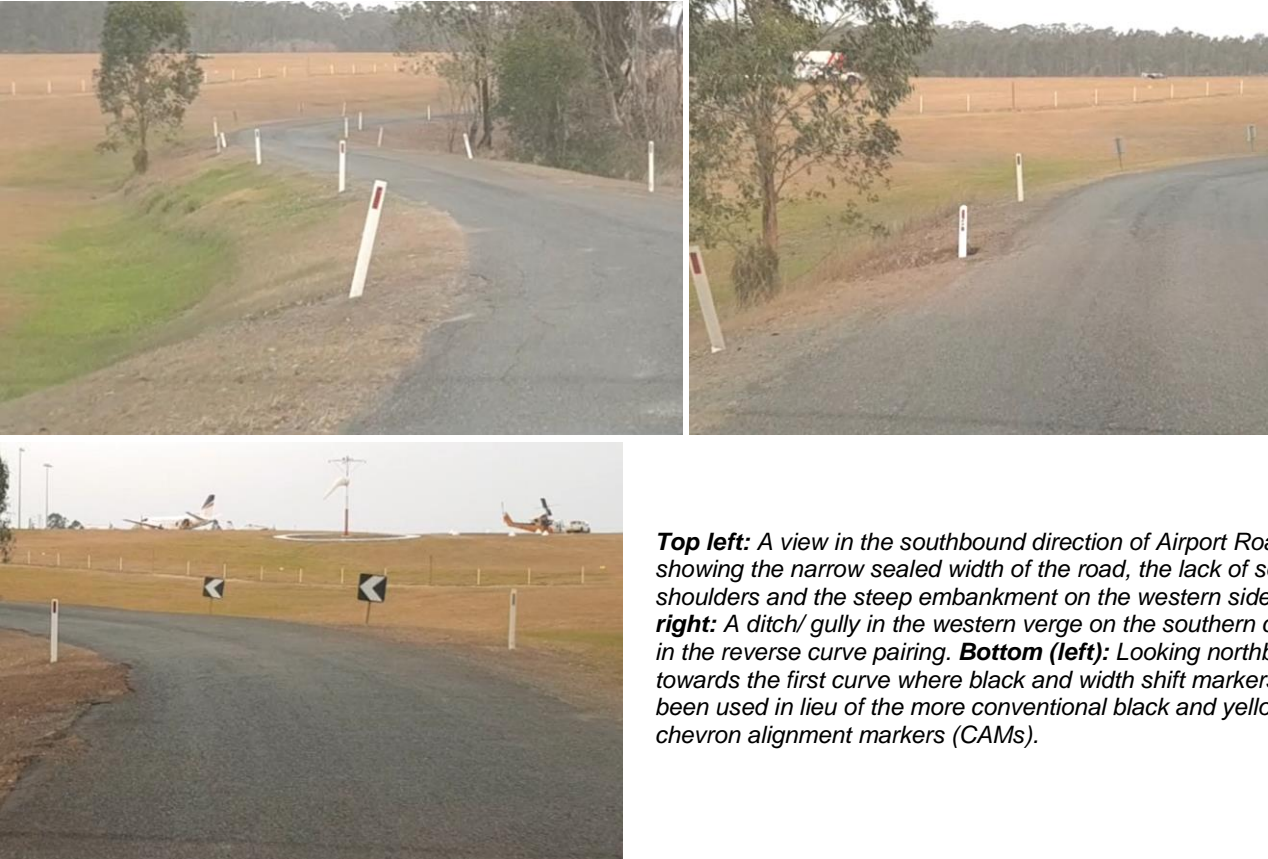
Ref	Location	Road safety audit finding – Airport Road	Priority
2-1b	Airport Road, between Old Six Mile Lane and the Clarence Valley Airport – Pavement width and condition with an emphasis on the reverse curves near the airport car park.	<p>Further to item 2-1a, the narrow sealed width of Airport Road continues northward to the airport car park. At the northern end, there is a pair of left-right reverse curves which makes the narrow width of seal even more critical. There is virtually no shoulder width provided (sealed or unsealed), and the verge hinges into a steep embankment and drop off either side of the road. As such, any errant vehicle movements may lead to <i>run off road</i> events where there is little recovery area (in the form of a sealed shoulder) and a steep embankment with rollover crash potential. The curvilinear alignment increases the likelihood of <i>run off road</i> crashes.</p> <p>In addition to increasing the width of seal as suggested in item 2-1a, the curves could be better delineated with edge and centrelines (once the pavement width becomes wide enough to accommodate two opposing lanes and the sealed shoulder becomes wide enough to accommodate an edgeline), and chevron alignment markers (CAMs). At present, there are black and white shift markers in the northbound direction. However, these are not the conventional signs for curve delineation.</p>

<p><b>Top left:</b> A view in the southbound direction of Airport Road showing the narrow sealed width of the road, the lack of sealed shoulders and the steep embankment on the western side. <b>Top right:</b> A ditch/ gully in the western verge on the southern curve in the reverse curve pairing. <b>Bottom (left):</b> Looking northbound towards the first curve where black and white shift markers have been used in lieu of the more conventional black and yellow chevron alignment markers (CAMs).</p>	High

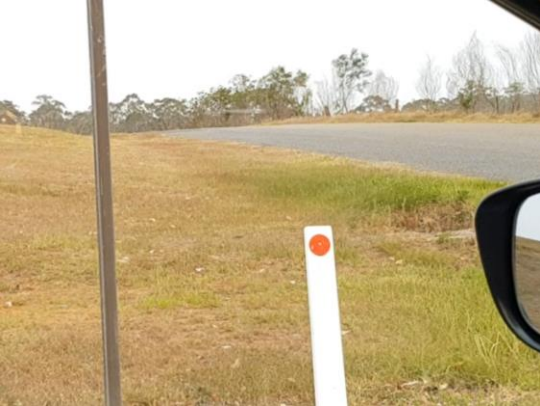
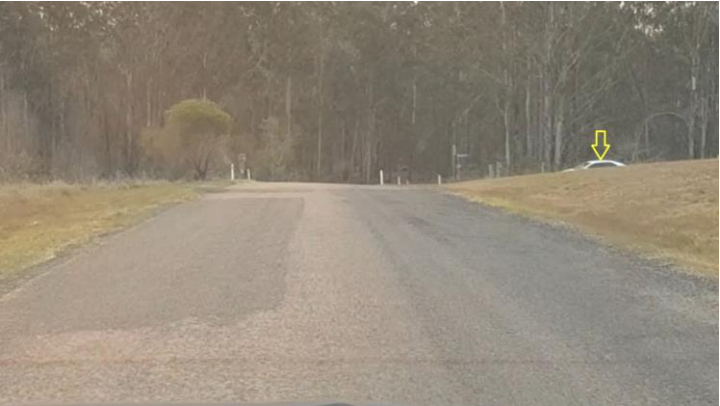
Ref	Location	Road safety audit finding – Airport Road	Priority
2-2	Airport Road/ Aerodrome Road/ Old Six Mile Lane intersection – <i>Minimum gap sight distance</i> (MGSD) from Airport Road to Old Six Mile Lane.	<p>The Airport Road/ Aerodrome Road/ Old Six Mile Lane intersection is a T intersection configuration with Old Six Mile Lane- Aerodrome Road as the eastern and western continuous route (respectively), and Airport Road as the northern and terminating leg to the intersection. Furthermore, as the terminating leg, Airport Road is controlled by a STOP sign.</p> <p>There is limited <i>minimum gap sight distance</i> (MGSD) from Airport Road to the east due to a crest vertical curve on Old Six Mile Lane. The MGSD was estimated on site as 60-70m which corresponds to a 2.5 second gap at the rural default speed limit of 100km/h. As such, if an eastbound vehicle was travelling at 100km/h, the outbound driver on Airport Drive may have insufficient sight distance to judge safe gaps to turn right into. The saving grace is that to the east of Airport Road, Old Six Mile Lane contains an unsealed section of road where it is difficult to achieve and sustain a travel speed of 100km/h. However, if this is sealed in future (which is a significant safety benefit in its own right), the limited MGSD may become a more prominent issue.</p> <div style="display: flex; justify-content: space-around;">

</div> <p><b>Left:</b> Looking east from Airport Road to Old Six Mile Lane. The crest vertical curve limits the MGSD sight line to approximately 60-70m. <b>Right:</b> The corresponding view from Old Six Mile Lane westbound towards Airport Road. Note the extremely limited visibility to the vehicle approaching the intersection from Airport Road (as marked by the yellow arrow).</p>	High

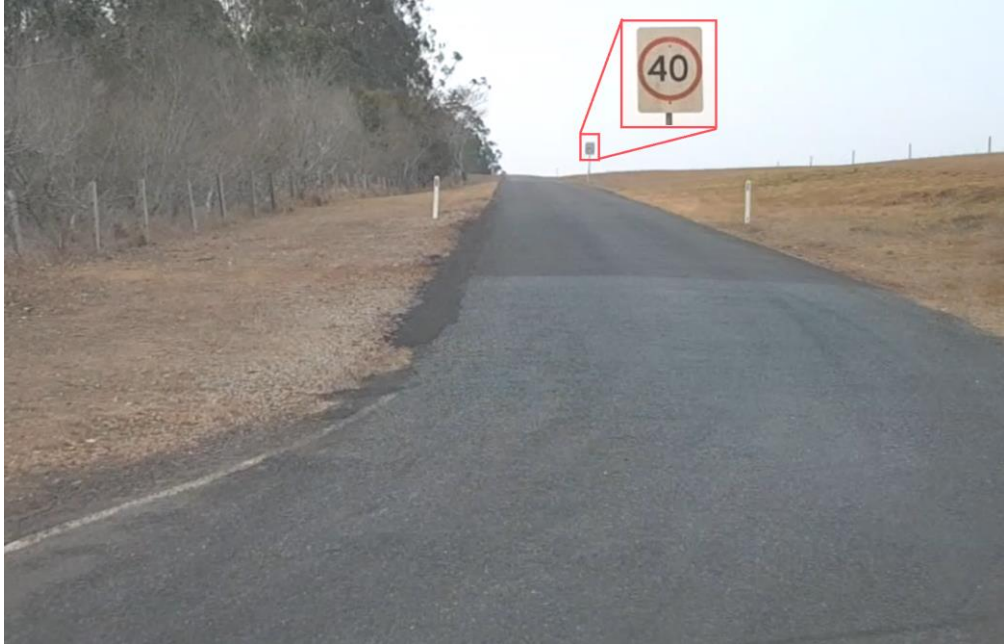
Ref	Location	Road safety audit finding – Airport Road	Priority
2-3	Airport Road, general speed management issues.	<p>Airport Road is a designated 40km/h speed environment. Whilst this lowered speed limit mitigates many of the issues identified along this route, the audit team notes the following issues:</p> <ul style="list-style-type: none"> <li>There is only one R4-1 SPEED LIMIT sign provided on this road, which is for the northbound travel direction. This sign is located approximately 100m north of Aerodrome Road-Old Six Mile Lane. As such, legally, the 40km/h limit only commences from this sign to the north. The speed limit for the section between this sign and Aerodrome Road-Old Six Mile Lane is not defined or signposted. As such, it would default to a 100km/h speed limit for rural areas. This is (i) a dramatic change in speed environments given that the geometric, width, pavement and clear zone conditions remain the same and (ii) it allows drivers to travel up to 100km/h for a very short section of road between a T intersection, and the desired low-speed environment immediately south of the airport. It may be more appropriate to relocate this speed limit sign closer to the T intersection so that a constant 40km/h speed environment is in place for the entire road.</li> <li>There is no corresponding R4-1 SPEED LIMIT sign at the northern end of the road for drivers departing from the airport. Many of these drivers would be visitors and may not be aware of the prevailing speed limit. With no regulatory speed limit sign in place for outbound traffic from the airport, many of these drivers would default to the rural speed limit of 100km/h. A 40km/h speed limit sign should be provided at the northern end and should face north (for southbound/ outbound drivers from the airport). Accompanying pavement numerals should be provided in the same manner as speed zone changes. Also, typically, for the start of a speed zone, the speed limit signs are paired with one side either side of the road.</li> </ul>

<p><b>Above:</b> Looking northbound along Airport Road towards the 40km/h speed limit sign, which is approximately 100m north of the Aerodrome Road-Old Six Mile Lane intersection.</p>	Medium

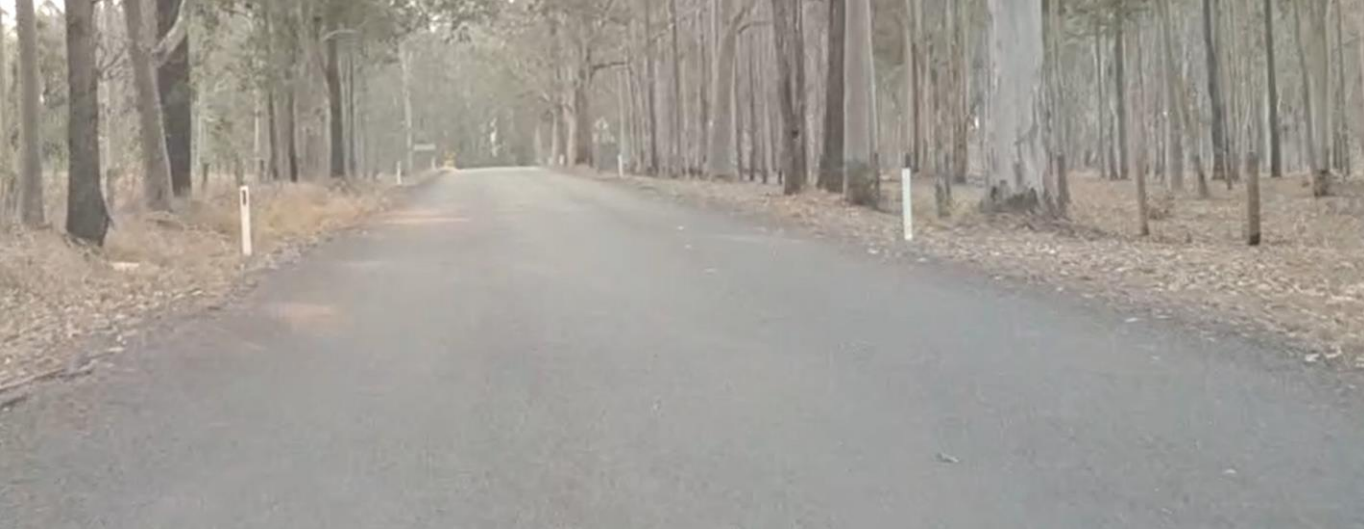
Ref	Location	Road safety audit finding – Aerodrome Road-Six Mile Lane	Priority
3-1a	Aerodrome Road - General linemarking and lane delineation issues.	<p>In general, the section of Aerodrome Road between Airport Road and Six Mile Lane lacks on-road delineation in the form of edgelines and centrelines. These would greatly enhance the delineation of the route, and the alignment and spatial positions of the opposing lanes. Such delineation would improve driver guidance along the route and allow them to maintain a consistent trajectory and offset from the verge, as well as from opposing traffic. It may also improve driver’s awareness and interpretation of the road alignment at the horizontal curves, which is discussed in items 3-3a to 3-3e.</p> <p>The audit team noted that this section of Aerodrome Road has an approximate sealed width of 6-7m. This should be adequate to accommodate a centreline at the very least. I.e. edgelines could be precluded if there was insufficient sealed shoulder to buffer the edgeline from the edge of pavement seal. Also, the lane widths between the edge and centrelines should be at least 3.0m (see Section 4.2.2.1 of AS1742.2).</p>

<p><b>Above:</b> Looking westbound along Aerodrome Road, approximately 0.7km west of Airport Road. Note the lack of linemarking and the opportunity to enhance route guidance and delineation with centrelines and possibly edgelines.</p>	High

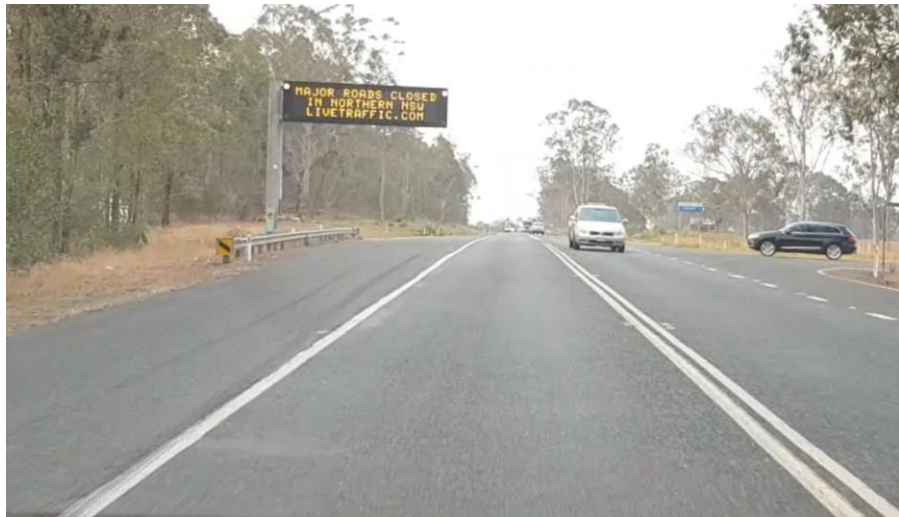
Ref	Location	Road safety audit finding – Aerodrome Road-Six Mile Lane	Priority
3-2	Pacific Highway/ Six Mile Lane intersection.	<p>The Pacific Highway/ Six Mile Lane intersection is a T intersection configuration with Pacific Highway as the north-south major route and Six Mile Lane as the eastern and terminating leg. The intersection is configured as a basic right-turn (BAR) configuration where a single northbound lane is provided, with a wide shoulder. The wide shoulder is presumably used by trailing northbound traffic to pass around any slowed or stopped vehicles waiting to turn right into Six Mile Lane.</p> <p>Although the shoulder is wide and this intersection generally has a layout far more enhanced than a typical BAR treatment, this is still considered a very basic treatment and still allows the potentially high-speed <i>rear-end</i> crash conflict between stopped/ slowed right-turning vehicles, and trailing northbound vehicles. Trailing drivers may fail to acknowledge that drivers in the road ahead are slowing down. This is particularly if the driver drifts excessively before applying the brakes (and hence activating the brake lights). Also, if the brake lights fail, the trailing driver may not be able to determine whether the vehicle in the road ahead is moving or stationary. Even if they are aware the vehicle is moving, they may not be able to determine how fast the vehicle is moving. In these respects, a BAR treatment can never match the road safety amenity of a fully channelised right-turn lane with adequate deceleration and storage length (CHR treatment).</p> <p>The audit team notes that there has been a build-up of tyre marks on the western edgeline due to frequent wheel tracking by vehicles passing around the stopped right-turner. Over time this edgeline will fade/ wear quicker than normal.</p> <p>Consideration should be given to converting this intersection to a channelised right-turn (CHR) configuration. This is justifiable due to the following:</p> <ul style="list-style-type: none"> <li>▪ This section of the Pacific Highway is a high-speed and high-volume route and part of the national highway network (at present).</li> <li>▪ Further to the above, the Pacific Highway would be a freight corridor and would have a considerable volume of trucks.</li> <li>▪ Six Mile Lane is probably the most critical access road to the Clarence Valley Airport and would presumably attract a considerable volume of northbound right-turners.</li> </ul>

<p><b>Above:</b> Looking northbound on Pacific Highway showing the BAR-configured T intersection with Six Mile Lane.</p>	High

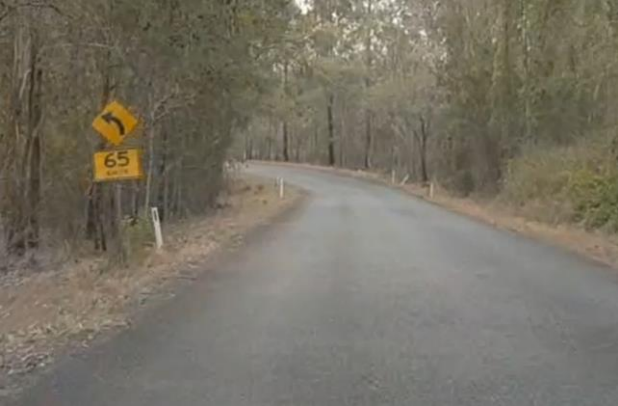
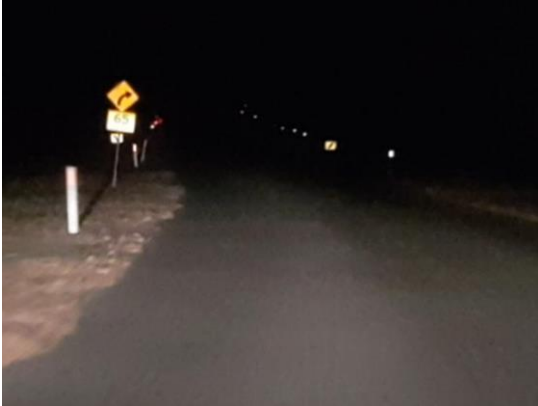
Ref	Location	Road safety audit finding – Aerodrome Road-Six Mile Lane	Priority
3-3a	<p>General – Curve delineation on Aerodrome Road and Six Mile Lane from Airport Drive to Pacific Highway.</p> <p>Site 1 – Aerodrome Road, 0.1-0.3km west of Airport Road (2.7-2.9km east of Pacific Highway).</p>	<p>In general, many of the horizontal curves along Aerodrome Road-Six Mile Lane from Airport Road to Pacific Highway lack delineation devices which would otherwise augment the alignment of the road and guide road users accordingly. In most cases, the identified curves contained W1-3 CURVE + W8-2 ADVISORY SPEED signage combinations. The advisory speeds were significantly less than the default (and unsignposted) speed limit of 100km/h, but yet did not contain D4-6 CHEVRON ALIGNMENT MARKERS (CAMs) around the outside of the curve. The D4-6 “arrow-boards” are beneficial in two ways – firstly by advising drivers which way the road curves, and secondly the spacing between each sign gives the driver an indication of the relative curvature of the road (ie. the rate at which the road is curving away). These signs are retroreflective and also offer enhanced night-time delineation.</p> <p>Example sites are depicted below and in items 3-3b to 3-3e. In each case, the left-hand photo is a view in the westbound direction during day light conditions and the right-hand photo is a view in the eastbound direction during night time conditions. Descriptions of the road safety concerns are provided in the captions.</p> <p>It should be noted that Figure 4.6 of AS1742.2 stipulates that for a 100km/h speed zone, if the advisory speed is less than 75km/h, then D4-6 CAMs should be provided on the outside of the curve.</p> <div style="display: flex; justify-content: space-around;">

</div> <p><b>Left:</b> Looking westbound on Aerodrome Road at the 65km/h curve between 0.1-0.3km west of Airport Drive (2.7-2.9km east of Pacific Highway). The road is signposted as a left-hand curve (in the westbound direction). There are no D4-6 CAMs (black and yellow arrow boards). <b>Right:</b> Looking eastbound towards the same curve at night time (standard headlight beam). The W1-3 + W8-2 signage combination is retroreflective and provides good advanced warning of the curve at night time. However, there are no D4-6 CAMs on the outside of the curve so the driver has little awareness as to when the road commences curving and the rate of curvature.</p>	Medium

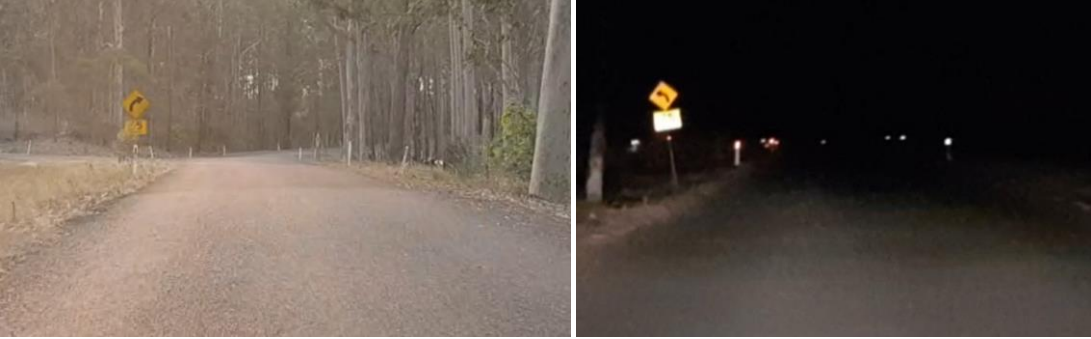
Ref	Location	Road safety audit finding – Aerodrome Road-Six Mile Lane	Priority
3-3b	<p>General – Curve delineation on Aerodrome Road and Six Mile Lane from Airport Drive to Pacific Highway.</p> <p>Site 2 – Six Mile Lane, 0.8-1.0km west of Airport Road (2.0-2.2km east of Pacific Highway).</p>	<p>Continued from item 3-3a...</p>

<p><b>Left:</b> Looking westbound on Aerodrome Road-Six Mile Lane at the 65km/h curve between 0.8-1.0km west of Airport Drive (2.0-2.2km east of Pacific Highway). The road is signposted as a right-hand curve (in the westbound direction). The W8-2 ADVISORY SPEED base plate is partially obscured by tree foliage. There are no D4-6 CAMs (black and yellow arrow boards) on the outside of the curve. The southern leg of Aerodrome Road is visible on the left-hand side of the photo. <b>Right:</b> Looking eastbound towards the same curve at night time (standard headlight beam). The W1-3 + W8-2 signage combination is retroreflective and provides good advanced warning of the curve at night time. However, there are no D4-6 CAMs on the outside of the curve so the driver has little awareness as to when the road commences curving and the rate of curvature.</p>	Medium

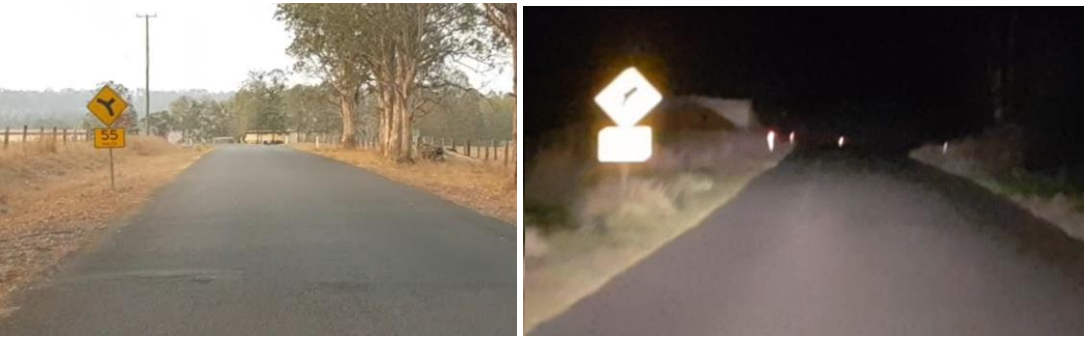
3-3c	<p>General – Curve delineation on Aerodrome Road and Six Mile Lane from Airport Drive to Pacific Highway.</p> <p>Site 3 – Six Mile Lane, 1.4-1.5km west of Airport Road (1.5-1.6km east of Pacific Highway).</p>	<p>Continued from items 3-3a and 3-3b...</p>

<p><b>Left:</b> Looking westbound on Six Mile Lane at the 55km/h curve between 1.4-1.5km west of Airport Drive (1.5-1.6km east of Pacific Highway). The road is signposted as a left-hand curve (in the westbound direction). A W2-9 CURVED ROAD SIDE JUNCTION sign is used in lieu of a W1-3 CURVE sign. This is acceptable since the side road (Carioca Lane) is positioned midway along the curve. There are no D4-6 CAMs (black and yellow arrow boards) on the outside of the curve. <b>Right:</b> Looking eastbound towards the same curve at night time (under high beam). The W2-9 + W8-2 signage combination is retroreflective and provides good advanced warning of the curve at night time. However, there are no D4-6 CAMs on the outside of the curve so the driver has little awareness as to when the road commences curving and the rate of curvature. The road also has a crest vertical curve at this location which limits the driver's visibility to the guideposts.</p>	Medium

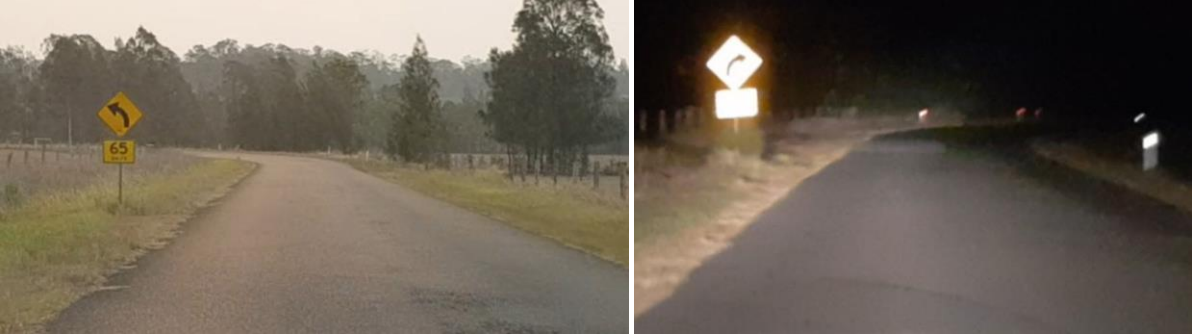
Ref	Location	Road safety audit finding – Aerodrome Road-Six Mile Lane	Priority
3-3d	<p>General – Curve delineation on Aerodrome Road and Six Mile Lane from Airport Drive to Pacific Highway.</p> <p>Site 4 – Six Mile Lane, 2.1-2.3km west of Airport Road (0.7-0.9km east of Pacific Highway).</p>	<p>Continued from items 3-3a to 3-3c...</p>

<p><b>Left:</b> Looking westbound on Six Mile Lane at the 65km/h curve between 2.1-2.3km west of Airport Drive (0.7-0.9km east of Pacific Highway). The road is signposted as a left-hand curve (in the westbound direction). There are no D4-6 CAMs (black and yellow arrow boards) on the outside of the curve. <b>Right:</b> Looking eastbound towards the same curve at night time (under high beam). The W1-3 + W8-2 signage combination is retroreflective and provides good advanced warning of the curve at night time. However, there are no D4-6 CAMs on the outside of the curve so the driver has little awareness as to when the road commences curving and the rate of curvature.</p>	Medium

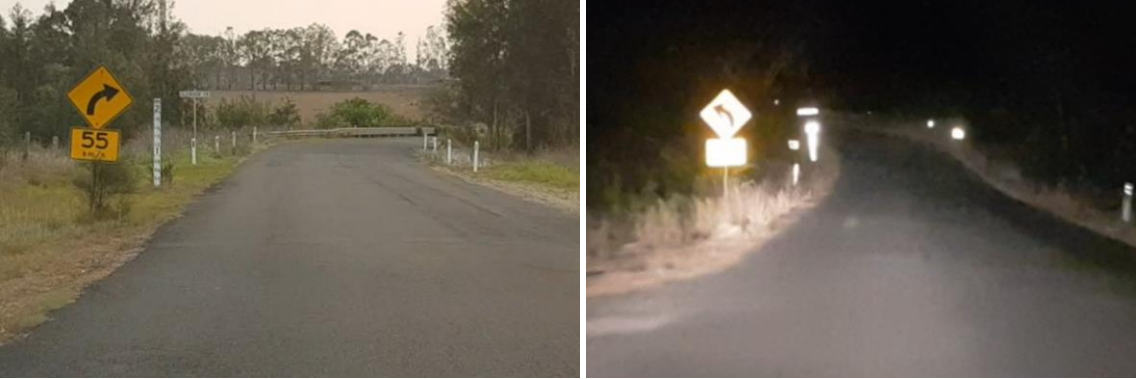
3-3e	<p>General – Curve delineation on Aerodrome Road and Six Mile Lane from Airport Drive to Pacific Highway.</p> <p>Site 5 – Six Mile Lane, 2.4-2.5km west of Airport Road (0.5-0.6km east of Pacific Highway), at Glenugie Creek.</p>	<p>Continued from items 3-3a to 3-3d...</p>

<p><b>Left:</b> Looking westbound on Six Mile Lane at the 55km/h curve between 2.4-2.5km west of Airport Drive (0.5-0.6km east of Pacific Highway). The road is signposted as a right-hand curve (in the westbound direction). There are no D4-6 CAMs (black and yellow arrow boards) on the outside of the curve. <b>Right:</b> Looking eastbound towards the same curve at night time (under high beam). The W1-3 + W8-2 signage combination is retroreflective and provides good advanced warning of the curve at night time. However, there are no D4-6 CAMs on the outside of the curve so the driver has little awareness as to when the road commences curving and the rate of curvature.</p>	Medium

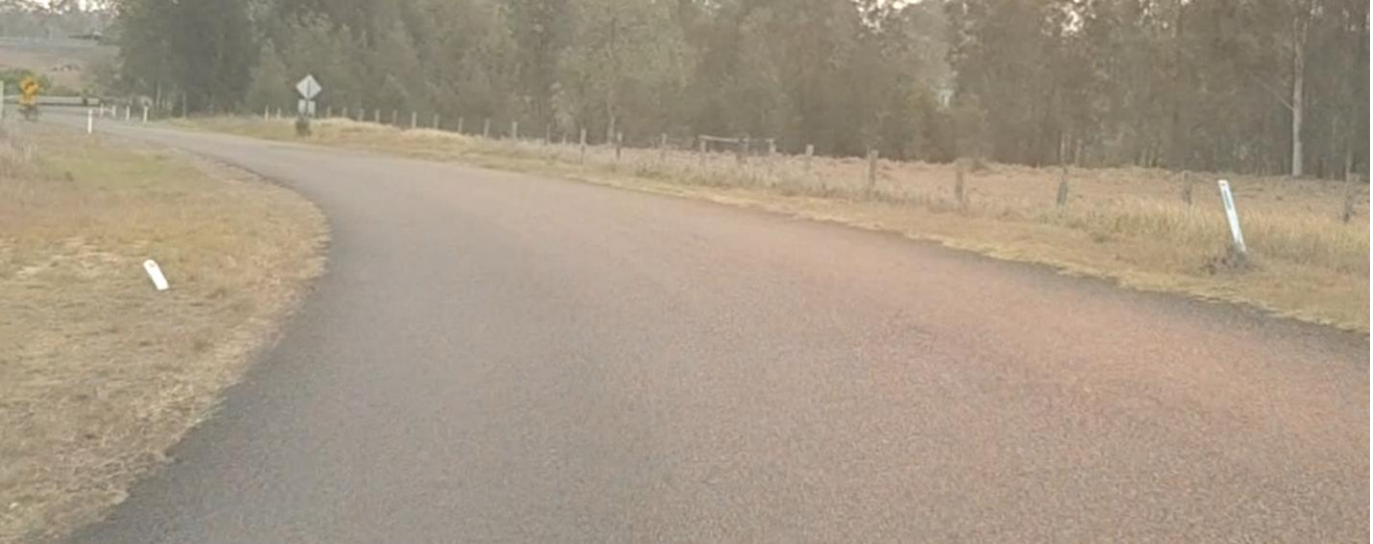
Ref	Location	Road safety audit finding – Aerodrome Road-Six Mile Lane	Priority
3-4	Aerodrome Road and Six Mile Lane, between Airport Road and Pacific Highway - General route delineation issues.	<p>Further to items 3-1a and 3-1b, there were many damaged guideposts along these two routes. This also compromised the delineation of the route. Damaged or missing guideposts also create a misleading impression on road alignment. Typically, at any point in space (particularly at night time), the driver should be able to see three or four sets of guideposts. Furthermore, the left-hand guideposts would conventionally contain red reflectors and the right-hand guideposts would contain white reflectors. This helps the driver to interpret the route alignment and the trafficable portion of roadway (ie. between the red and white reflectors). When guideposts are missing or damaged, this creates gaps in the line of guideposts. The driver may need to rely on guess work to “fill in the blanks”.</p>

<p><b>Above:</b> An example of damaged guideposts on Six Mile Lane near Glenugie Creek.</p>	Medium

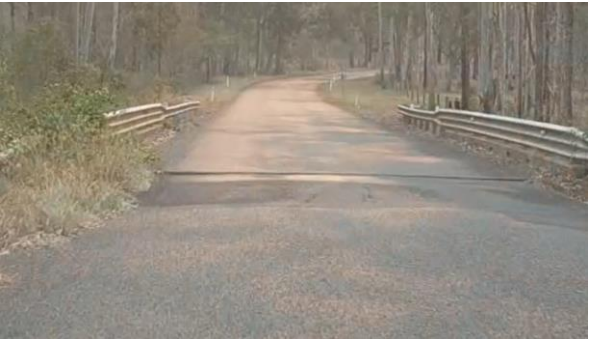
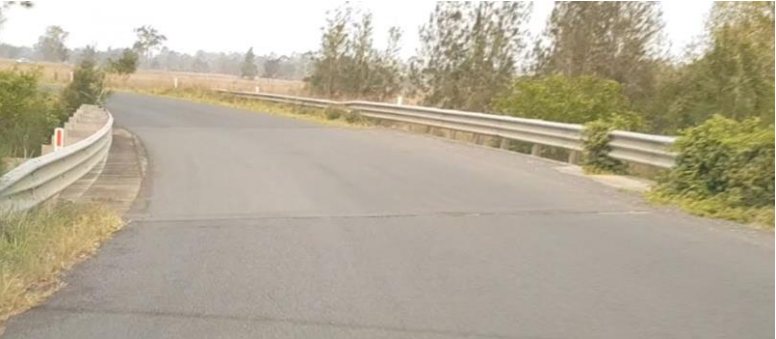
Ref	Location	Road safety audit finding – Aerodrome Road-Six Mile Lane	Priority
3-6	Aerodrome Road and Six Mile Lane – Abrupt level differences at the creek bridges.	<p>There are creek crossings on (i) Aerodrome Road, 0.4km west of Airport Road (2.6km east of Pacific Highway), and (ii) Six Mile Lane, at Glenugie Creek (0.4km east of Pacific Highway). These appear to be box culverts with an asphalt overlay. The sealed sections of Aerodrome Road-Six Mile Lane either side of the creek crossings are bound, flexible pavements. At each location, there is a pronounced vertical discrepancy between the bound, flexible pavement either side of the creek crossing, and the more rigid asphalt layer on top of the culvert. The pronounced lips have the following potential road safety risks:</p> <ul style="list-style-type: none"> <li>▪ Poor ride quality with a discernible bump when moving onto and off the top of the culvert.</li> <li>▪ Destabilisation of the vehicle with associated <i>loss of control</i> crash risks, especially for motorcycles.</li> <li>▪ Possible damage to the tyres, wheels and axles of the vehicle.</li> <li>▪ Progressive degradation of the asphalt overlay on the top of the culvert as well as to the flexible and bound pavements either side of the crossing.</li> </ul> <p>There does not appear to be any gradual transition between the flexible pavements either side of the creek crossings and the more rigid asphalt overlay over the culverts.</p> <div style="display: flex; justify-content: space-around;">

</div> <p><b>Left:</b> Looking westbound along Aerodrome Road at the creek crossing, 0.4km west of Airport Road. This photo shows the eastern “abutment” where the flexible, bound pavement transitions abruptly to the more rigid asphalt layer on top of the culvert.</p> <p><b>Right:</b> Looking eastbound along Six Mile Lane towards the Glenugie Creek crossing. The “crack line” running transversely across the road is the road-culvert interface.</p>	Low

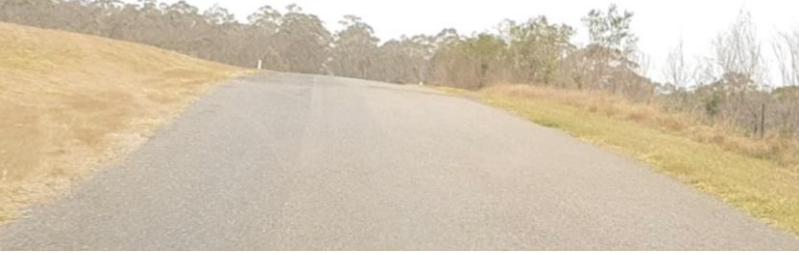
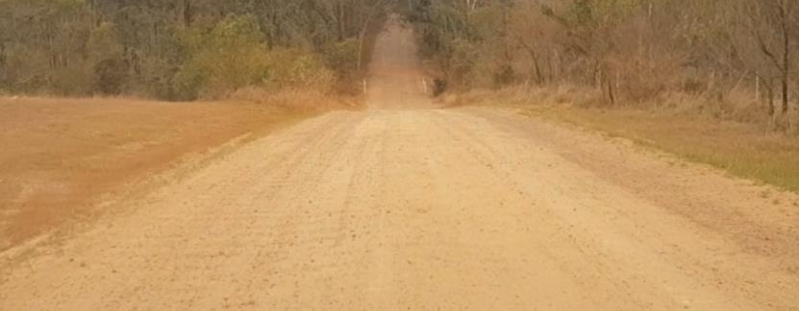
Ref	Location	Road safety audit finding – Old Six Mile Lane	Priority
4-1a	Old Six Mile Lane, 0.1-0.9km east of Airport Road.	<p>Generally, the unsealed section of Old Six Mile Lane between 0.1-0.9km east of Airport Road is a “missing link” and the most critical road safety deficiency along this road. The unseal surface has much poorer skid resistance being made up of loose and unbound material. The surface is also rough and extremely corrugated and results in a very poor ride quality. The audit team were unable to sustain a speed any higher than 40km/h due to the discomfort. Whilst the forced low-speeds would have road safety merit in their own right, there are still residual road safety risks such as:</p> <ul style="list-style-type: none"> <li>▪ The road is generally unfit for high-speed travel. The rough surface and ride quality would increase the risk of <i>loss of control</i> crash events, and tyre/ wheel/ axle damage.</li> <li>▪ The transition points from the sealed sections either side present abrupt changes in road safety conditions. In particular, the unsealed section commences downstream from a sight-limited crest vertical curve at its western end (see images below).</li> <li>▪ There are also prominent vertical lips between the unsealed sections of the road and the adjacent paved sections. This could also impart high forces on the tyre/ wheel.</li> <li>▪ There are many non-frangible clear zone hazards such as trees, and also steep side slopes and culvert openings which may result in rollover events.</li> </ul> <p>This unsealed section presents an extreme-change in road safety and driving conditions and converting this to a sealed road should be the first priority. Furthermore, whilst there are road safety concerns on adjacent paved sections, there is little justification in enhancing these sections if the unsealed section remains as it is. Any improvements to the paved sections would further exacerbate the discrepancy in road safety conditions between the sealed and unsealed sections of the route.</p> <div style="display: flex; justify-content: space-around;"> <div style="text-align: center;">

<p><b>Top:</b> Looking eastbound along Old Six Mile Lane from its intersection with Airport Road. The Road is initially sealed up to and beyond the crest vertical curve.</p> </div> <div style="text-align: center;">

<p><b>Bottom:</b> Beyond the crest vertical curve, the road transitions abruptly to an unsealed road with no warning to the driver. The unsealed section is approximately 800m long and consists of unbound granular material. The skid resistance and ride quality are poor.</p> </div> </div>

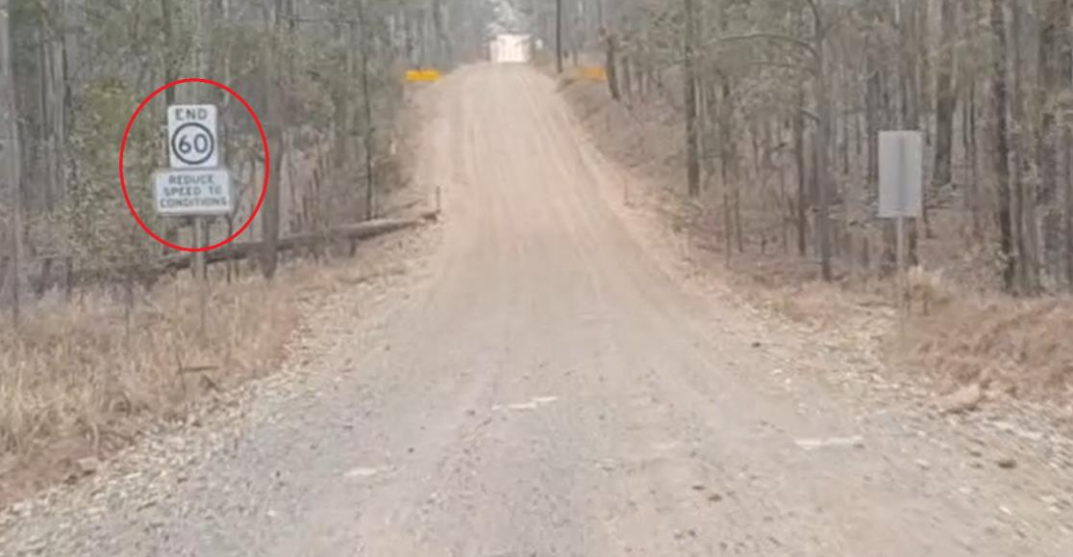
Ref	Location	Road safety audit finding – Old Six Mile Lane	Priority
4-1b	Old Six Mile Lane, 0.1-0.9km east of Airport Road.	<p>Continued from item 4-1a...</p> <p>Further to item 4-1a, there are generally no warning or advisory signs provided in approach to or throughout the unsealed section. This includes advanced warning of the upcoming unsealed section (eg. warning of the gravel and slippery surface). There is very little advice provided with respects to speed zones. In the absence of such advice, many drivers would consider that the rural default speed limit of 100km/h would apply, which is generally inappropriate. As discussed in item 4-1a, the audit team were unable to sustain a speed higher than 40km/h along this road due to the uncomfortable and bumpy ride.</p> <p>At the eastern end, a signage assembly is provided as shown below. This consists of an END 60 + REDUCE SPEED TO CONDITIONS message. This attempts to put the onus back on the driver to select an appropriate speed. However, this would give rise to high speed-differential. Some drivers/ vehicles would be able to negotiate this section at a relatively high speed (eg. 65-70km/h) whilst others may prefer a much lower speed (eg. 25-30km/h). These two speed preferences already present a speed differential of 40km/h.</p> <p>Operating speed is a key consideration in the function and performance of a road and measures should be taken to create a consistent, legible and self-enforcing set of conditions for all road users. Hence, as stated in item 4-1a, consideration should be given to sealing this section as a priority in the short-term.</p>

<p><b>Above:</b> Looking westbound along Old Six Mile Lane with a view of the END 60 + REDUCE SPEED TO CONDITIONS signage combination.</p>	High

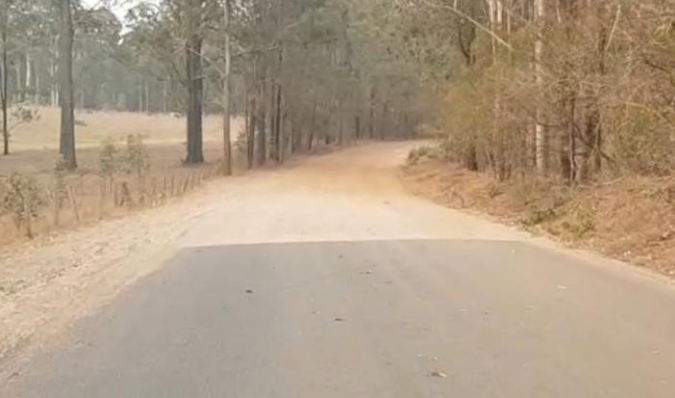
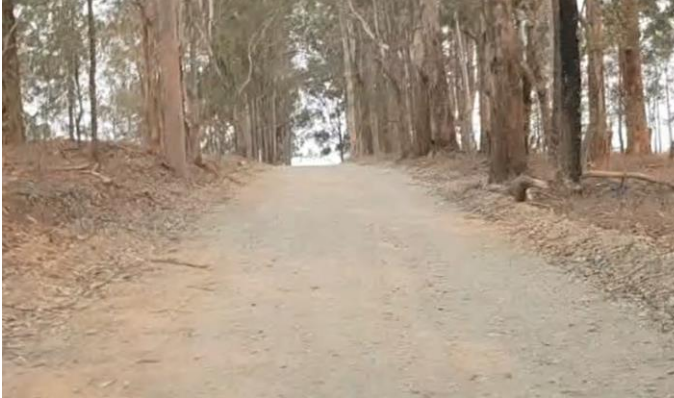
Ref	Location	Road safety audit finding – Old Six Mile Lane North Deviation	Priority
5-1	Old Six Mile Lane North Deviation, from 1.1-1.7km north of Old Six Mile Lane.	<p>The unsealed section of Old Six Mile Lane North Deviation between 1.1-1.7km north of Six Mile Lane is the remnant portion of the former Old Six Mile Lane (the portion on the northern side of the Pacific Motorway corridor). As an unsealed section, this is the “missing link” and the most critical road safety deficiency along this road. The unseal surface has much poorer skid resistance being made up of loose and unbound material. The surface is also rough and extremely corrugated and results in a very poor ride quality. The audit team were unable to sustain a speed any higher than 40km/h due to the discomfort. Whilst the forced low-speeds would have road safety merit in their own right, there are still residual road safety risks such as:</p> <ul style="list-style-type: none"> <li>▪ The road is generally unfit for high-speed travel. The rough surface and ride quality would increase the risk of <i>loss of control</i> crash events, and tyre/ wheel/ axle damage. In particular, the section between 1.4-1.7km north of Six Mile Lane is very rough.</li> <li>▪ The transition points from the sealed sections either side present abrupt changes in road safety conditions. In particular, the unsealed section commences downstream from a sight-limited horizontal curve at its western end.</li> <li>▪ There are also prominent vertical lips between the unsealed sections of the road and the adjacent paved sections. This could also impart high forces on the tyre/ wheel.</li> <li>▪ There are many non-frangible clear zone hazards such as trees, and also steep side slopes and culvert openings which may result in rollover events. Some of these sections are very narrow and unfit for safe, two-way traffic operations.</li> </ul> <p>This unsealed section presents an extreme-change in road safety and driving conditions and converting this to a sealed road should be the first priority. Furthermore, whilst there are road safety concerns on adjacent paved sections, there is little justification in enhancing these sections if the unsealed section remains as it is. Any improvements to the paved sections would further exacerbate the discrepancy in road safety conditions between the sealed and unsealed sections of the route.</p> <div style="display: flex; justify-content: space-around;">

</div> <p><b>Left:</b> Looking northbound on Old Six Mile Lane North Deviation at the transition from sealed to unsealed sections. The initial unsealed section beyond this interface is somewhat better than the sections further downstream. <b>Right:</b> Midway along the unsealed section, the road formation becomes very narrow and generally unfit for safe, two-way traffic operations. There is an increased risk of head-on crashes and run off road crashes into trees, especially since there is a sight-limiting crest vertical curve present.</p>	High

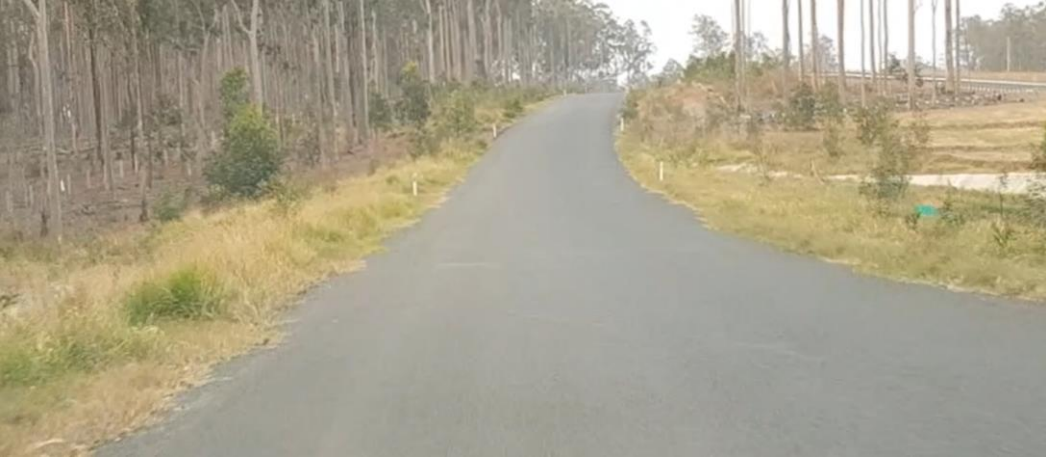
Ref	Location	Road safety audit finding – Old Six Mile Lane North Deviation	Priority
5-2	General – Sealed sections of Old Six Mile Lane North Deviation and lack of linemarking.	<p>Old Six Mile Lane North Deviation has a much better alignment and ride quality compared with the other audited roads. It appears to be a future secondary road to the Pacific Motorway with a high-speed alignment intended for trips to local destinations. However, at present, the route has some minor deficiencies including:</p> <ul style="list-style-type: none"> <li>▪ Lack of edgelines and centrelines to define traffic lanes and improve spatial clearances between opposing vehicles. Or alternatively, where linemarking has been provided, it has become faded due to dust-masking.</li> <li>▪ Grass encroachment onto the edge of pavement and shoulders.</li> </ul> <p>These items should be addressed as part of the longer-term planning horizon for this road. Similar to Old Six Mile Lane (Table 4), there is little justification in carrying out improvements to the sealed portions of this road, when there is still an unsealed section of the route between 1.1-1.7km north of Old Six Mile Lane. Any improvements to the sealed sections would further exacerbate the discrepancy between the sealed and unsealed sections.</p> <p>It should be noted that the audit team were able to comfortably drive the sealed sections of this route at 90-100km/h compared with the forced low speed of 40km/h or less through the unsealed section.</p>

<p><b>Above:</b> The sealed sections of Old Six Mile Lane North Deviation were of much better geometric and width condition compared with the unsealed sections. However, they generally lacked linemarking and the verge grasses have begun to grow over the pavement edges.</p>	Medium

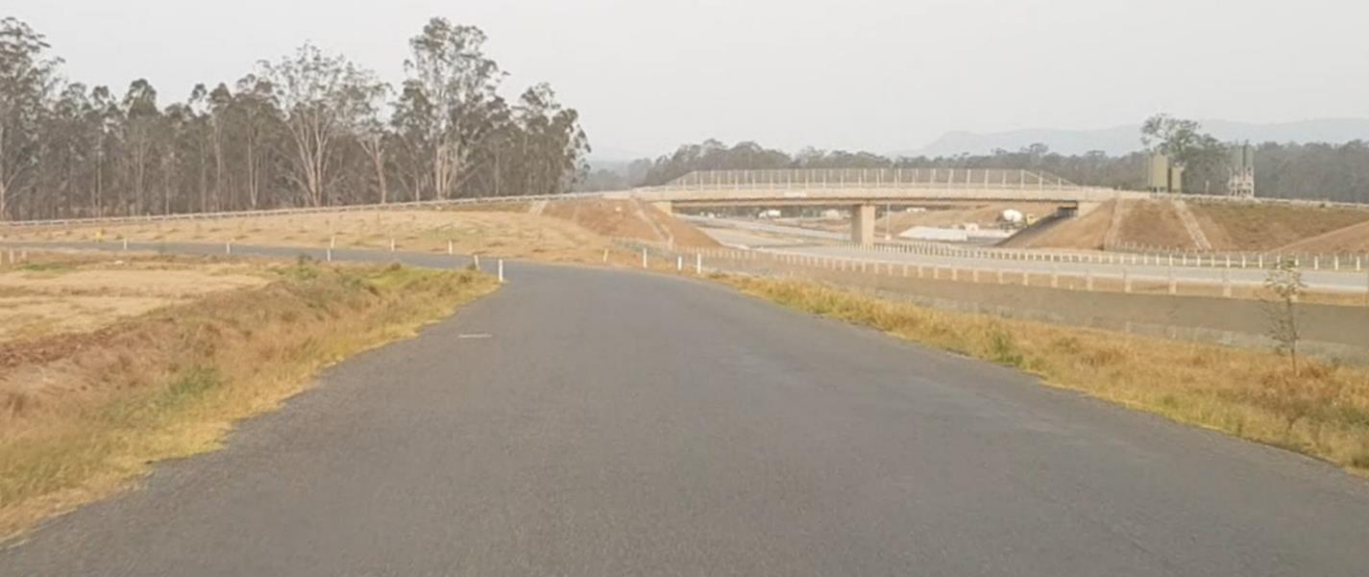
Ref	Location	Road safety audit finding – Old Six Mile Lane North Deviation	Priority
5-3	Old Six Mile Lane North Deviation, eastern end near its intersection with Avenue Road.	<p>The eastern end of Old Six Mile Lane North Deviation contains a pair of left-right reverse curves as the road deviates (in the eastbound direction) away from the future Pacific Motorway and the Avenue Road bridge. As seen in the image below, the horizontal curves are used to deviate this road further north where it can intersect with Avenue Road at-grade and not midway along the fill embankment.</p> <p>The curves present an abrupt change in horizontal alignment, particularly when the straighter and more level alignment of this road enables drivers to reach speeds between 80-100km/h (based on comfort and self-enforcing factors rather than speed limit signs, which were absent). Furthermore, there were no warning signs of the sudden change in conditions such as curve warning and advisory speed signs, chevron alignment markers around the curves, warning of the upcoming T intersection with Avenue Road, and linemarking. Fast-approaching motorists may be at risk of <i>loss of control</i> crashes if they fail to observe the change in horizontal alignment and the sharpness of this curve.</p> <p>This issue would be most prominent for eastbound drivers as they would be moving from a relatively straight and long section of road when entering the curved section. By contrast, westbound drivers would have entered this curved section directly from an intersection and are less likely to enter or negotiate the curves at a high speed.</p>

<p><b>Above:</b> Looking eastbound along Old Six Mile Lane North Deviation where there is a sudden change in horizontal alignment as the road deviates to the north to intersect with Avenue Road on level-grade.</p>	Medium

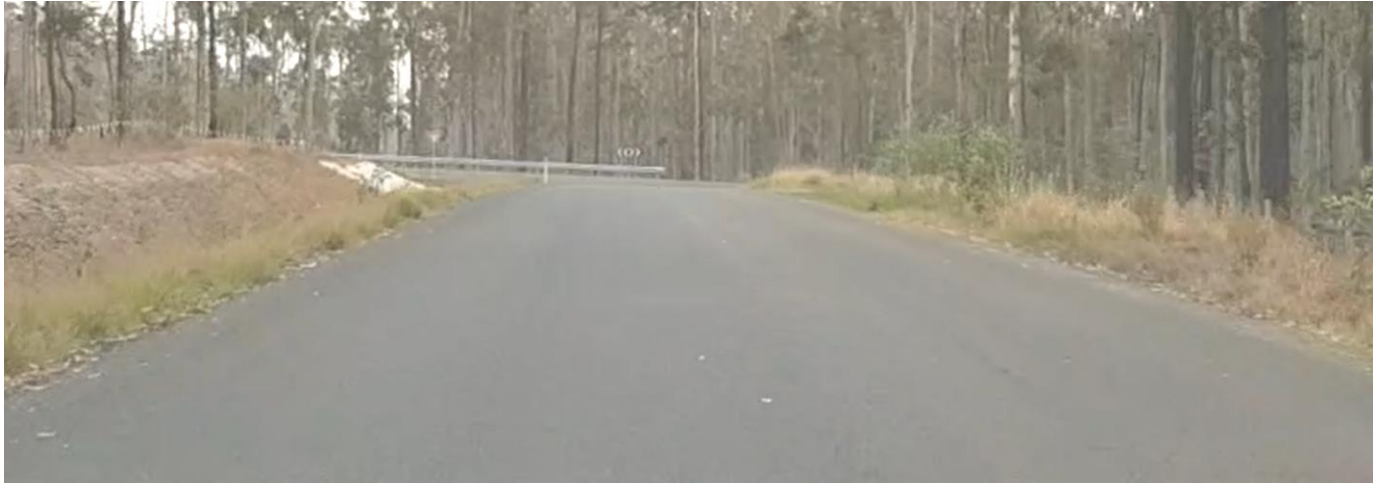
Ref	Location	Road safety audit finding – Old Six Mile Lane North Deviation	Priority
5-4	Westbound travel direction on Old Six Mile Lane North Deviation in approach to the Old Six Mile Lane intersection.	<p>The Old Six Mile Lane/ Old Six Mile Lane North Deviation is a T intersection with Old Six Mile Lane as the east-west major road and Old Six Mile Lane North Deviation as the northern and terminating leg. Old Six Mile Lane North Deviation has a high-speed alignment where the audit team were able to sustain a comfortable speed of 80-100km/h (on the sealed sections). As such, the termination of this road at the Old Six Mile Lane T intersection would be an abrupt change in speed conditions, particularly for southbound drivers (as they would be moving from the high-speed alignment into an intersection). By contrast, eastbound drivers on Old Six Mile Lane, would have just emerged from an unsealed section further west so hence would tend to be speed-limited anyway.</p> <p>Under current conditions, there is a risk of southbound drivers approaching the T intersection at inappropriately high speeds. The intersection lacks visual prominence. In particular, the audit team notes the following:</p> <ul style="list-style-type: none"> <li>▪ There are no advanced warning signs such as W2-3 T JUNCTION AHEAD, or REDUCE SPEED signs.</li> <li>▪ There is one R1-2 GIVE WAY sign but this lacks visual prominence since it is laterally offset from the road alignment and from the driver's focal point to the road ahead. The sign also lacks prominence against the woody visual backdrop.</li> <li>▪ There is no linemarking in place to act as a visual cue on the change of road conditions, eg. a BB double barrier centreline would give an impression that the road conditions will change.</li> </ul> <p>The audit team also notes that the current intersection configuration is not ideal over the longer-term where Old Six Mile Lane North Deviation acts as the <i>through</i> route between Pacific Highway and Avenue Road. This is because the dominant traffic movements would be (i) southbound right-turns from Old Six Mile Lane North Deviation, and (ii) the opposing eastbound left-turn movements from Old Six Mile Lane. Over the longer term, the western and northern legs should become the priority legs (even if this requires reconfiguration of the intersection). The “reversed priority” under the current intersection configuration presents safety issues due to the need for the priority traffic movements to slow down, check for gaps, yield to other lower priority movements, and negotiate the high-angled turns of the intersection.</p>

<p><b>Above:</b> Looking southbound along Old Six Mile Lane North Deviation towards its terminal end and intersection with Old Six Mile Lane.</p>	Medium

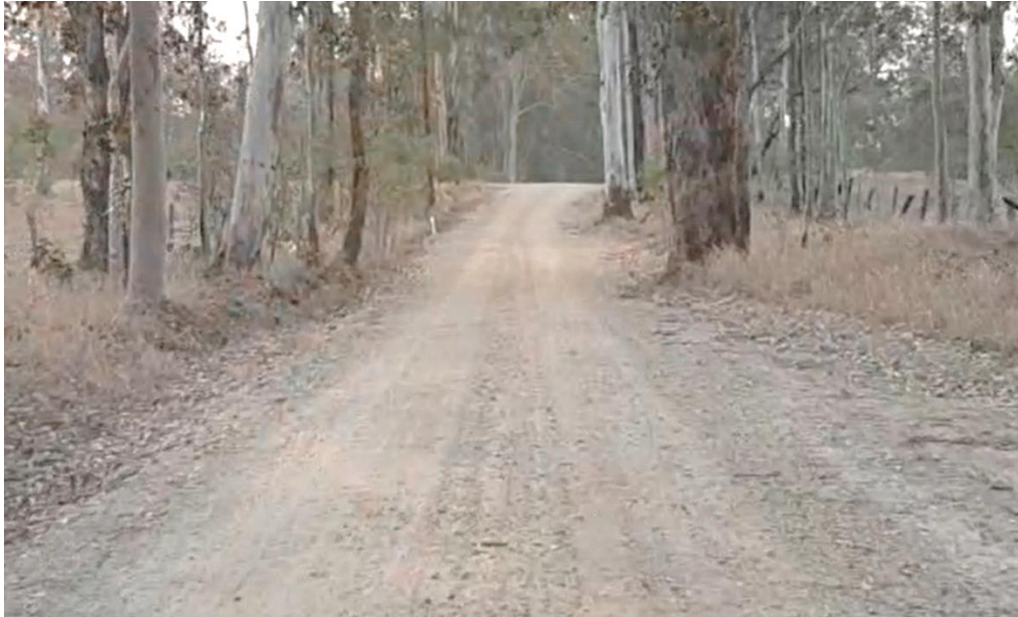
Ref	Location	Road safety audit finding – Old Six Mile Lane <i>no through</i> sections.	Priority
6-2	Old Six Mile Lane, from Avenue Road to its cul-de-sac terminal 1.0km to the west of Avenue Road.	<p>This 1.0km section of road is the remnant portion of Old Six Mile Lane, which was previously a <i>through</i> road with connectivity between Aerodrome Road and Avenue Road. It appears to have been retained only as a local access road to maintain access to land and properties along side it. The road is unsealed for its entire length.</p> <p>Overall, the road is of a poor standard as an unsealed road. There is a high degree of loose and unbound granular material which compromises skid resistance. The clear zone conditions are also poor with little roadside recoverable area. Despite these deficiencies, the audit team acknowledges that this is only a local road, and furthermore, there is no <i>through</i> connectivity. It was also assumed that the severed connectivity will remain since part of the former road corridor is now occupied by the Pacific Motorway corridor. In these respects, since the function and expected usage of this road has been significantly downgraded, these geometric, width and surface deficiencies are less critical. That is, if the road is to function as a local road only for the small number of residents, then it is in a reasonable condition and fit for this new purpose.</p> <p>Unlike the western <i>no through road</i>, this eastern section is already furnished with a NO THROUGH ROAD sign at its intersection with Avenue Road.</p>

<p><b>Above:</b> Looking westbound into the eastern <i>no through</i> section of Old Six Mile Lane.</p>	To note
